Luton Hoo
Hyde
Bedfordshire
Stage III - Trenched Evaluation

Archaeological Evaluation Report

August 2003

Document Title: Luton Hoo, Hyde, Bedfordshire: Stage III - Trenched Evaluation

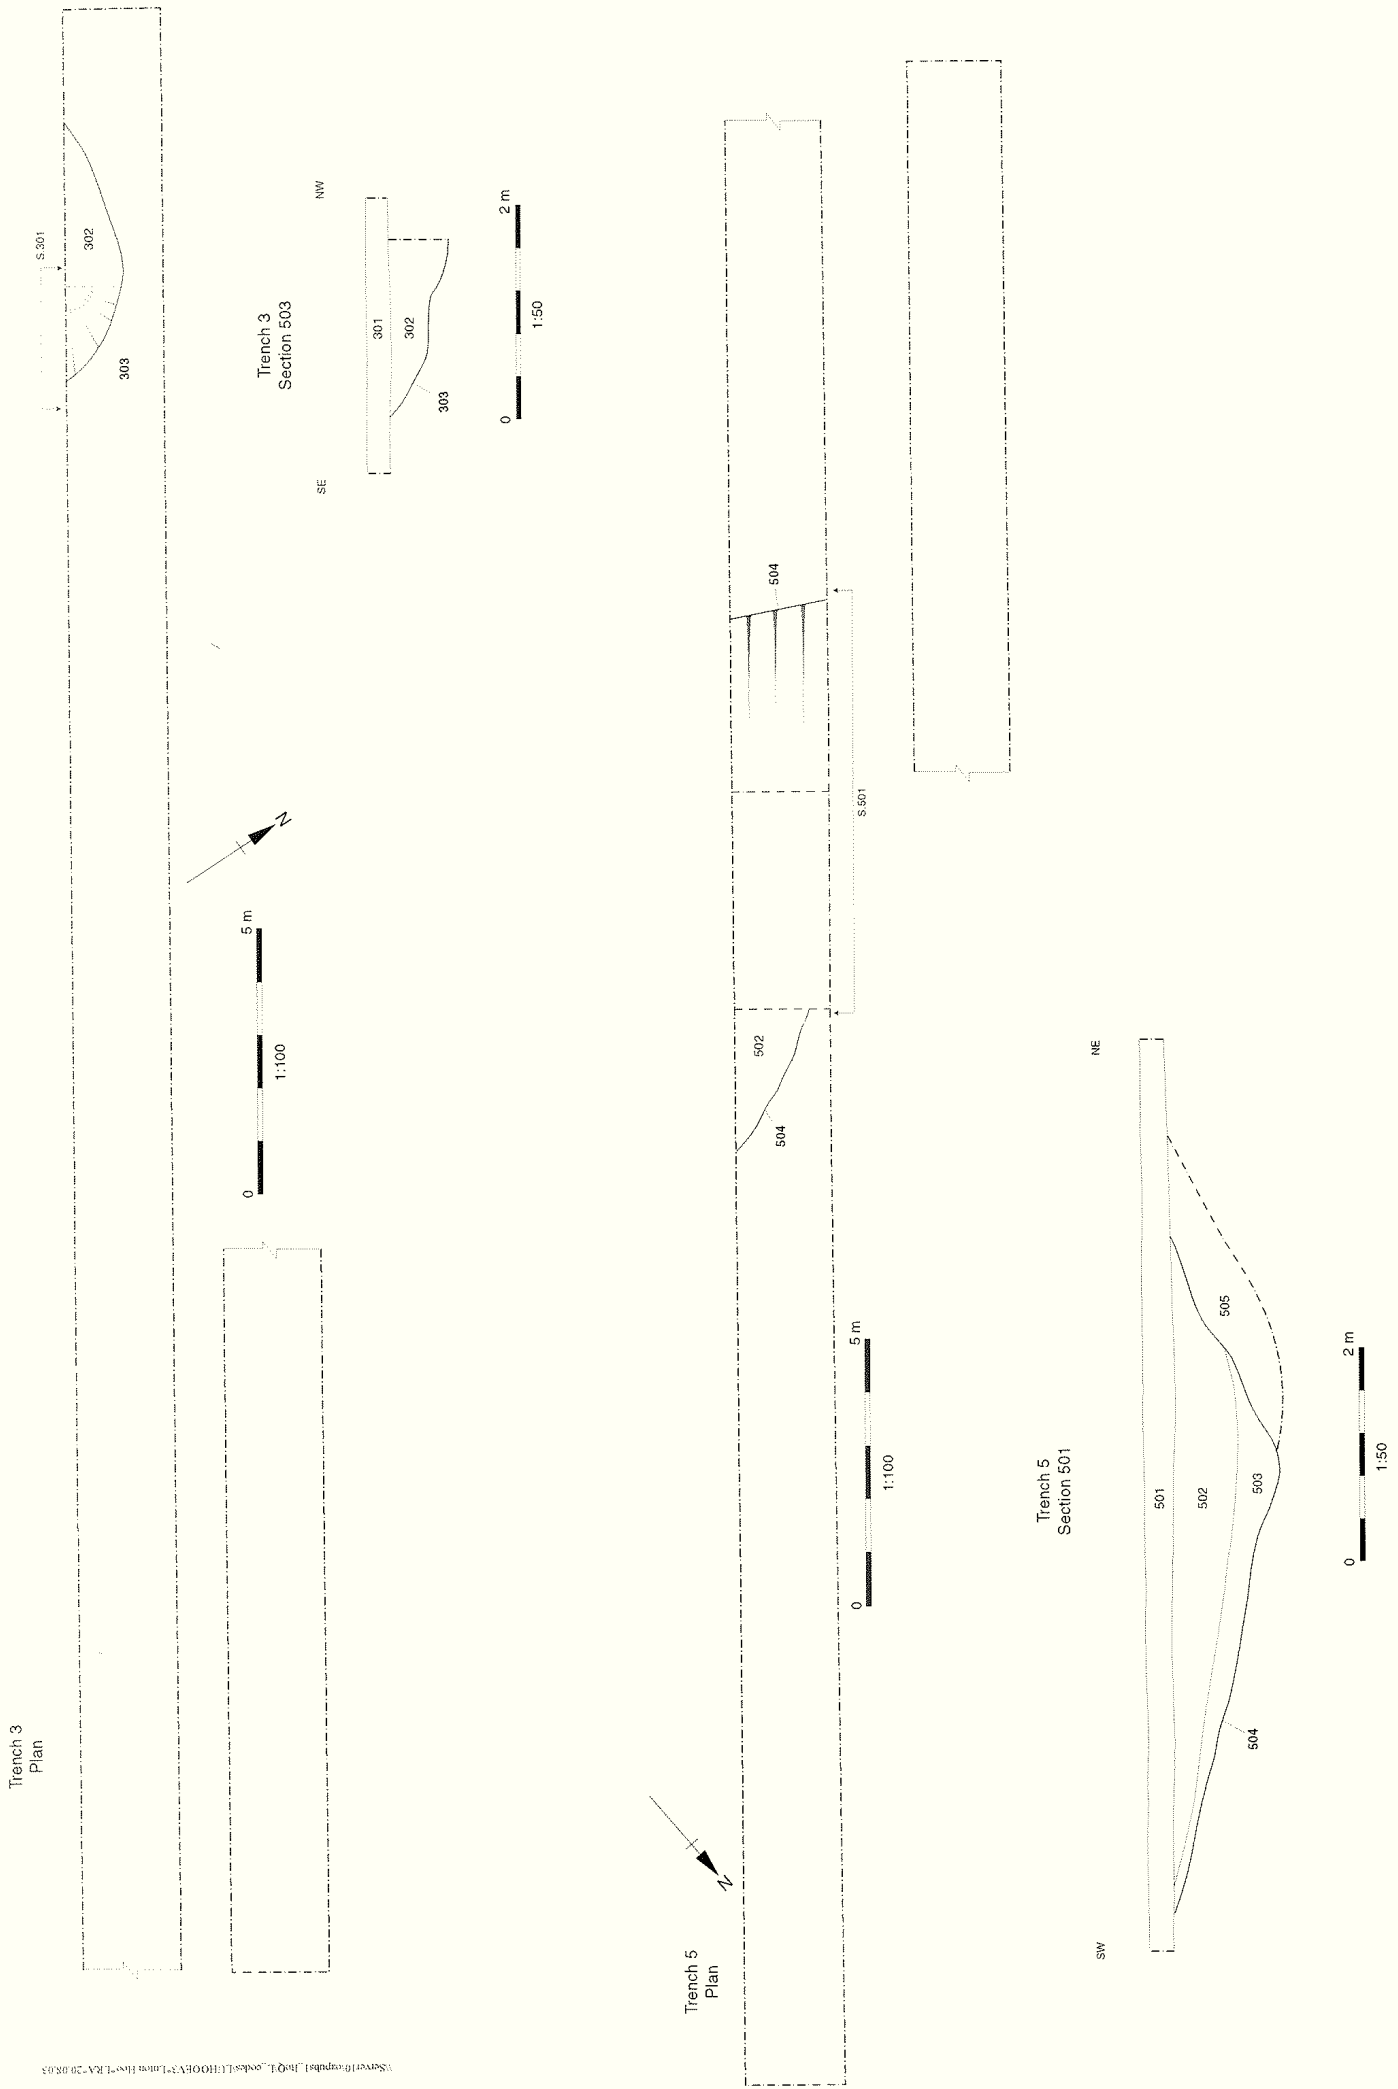
Figure 4: Trenches 3 and 5, plans and sections

- 3.1.4 A pit (303) was seen in Trench 3 (Fig. 4). The feature, cut into the natural clay, was more than 4.8 m wide and 0.56 m deep. No finds were recovered from its silty clay fill. Another three pits were uncovered in Trench 48 (Fig. 7). These had been severely truncated by the plough activity, so that only the bases remained. Pit 4803 survived to a maximum diameter of 0.25 m and a depth of just 0.09 m. The depth of pit 4805 was equally shallow, but was wider at 0.62 m. Pit 4807 was 0.57 m wide and 0.02 m deep. No finds were present

- 3.1.2 Large pits were seen in trenches 5, 14, 18, 39, 50, 52 and 69. All were presumably dug for the purpose of quarrying the natural clay into which the pits were cut. Pit 504, in Trench 5, measured some 10 m in diameter and over 1 m deep (Fig. 4); the top of the feature had been truncated by ploughing. The pit had been backfilled with a mixture of topsoil and redeposited clay. Pit 1403 in Trench 14 was also very large (Fig. 7; Plate 1). Its width extended beyond that of the trench (2 m); excavation ceased after a depth of 1.66 m, but the pit was deeper still. It had been backfilled with a succession of silty clay deposits, which also contained large flint nodules. Another pit was exposed in Trench 18 (1801; Fig. 5; Plate 1). The same feature was also shown in trenches 50 (5001) and 52 (5201), which extended off Trench 18 at 90°. These revealed the full extent of the pit (*c* 30 x 40 m). In Trench 39, Pit 3901 was wider than the 8.8 m exposed (Fig. 6; Plate 2). Excavation continued to a depth of 2.2 m. The feature contained silty clay soil with flint and gravel. The pit in Trench 69 (Plate 2) similarly extended beyond the area of the trench. Modern ceramics, glass and building rubble had been dumped into it.

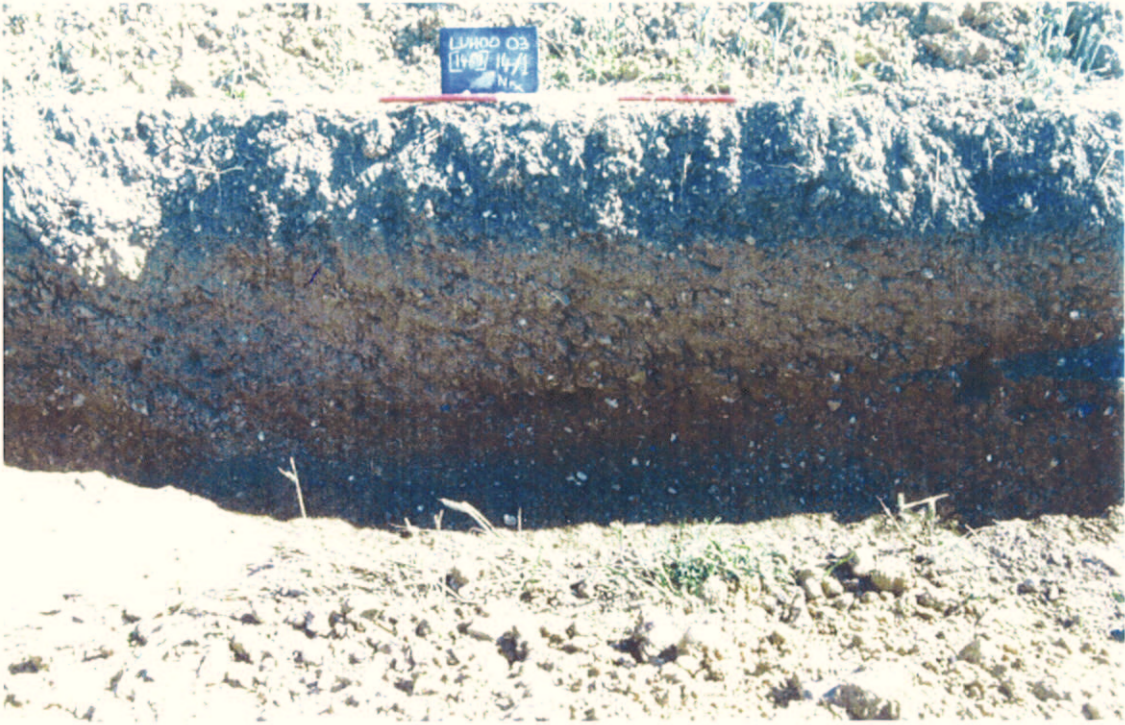
Trench 14, pit 1403 (SW facing)
