Mill Street Aylesbury

Archaeological Evaluation Report

April 2011

Client: Hill Partnerships Ltd
NGR: SP 8237 1404
Planning Reference: 07/02956/APP
OA Job Number: 5019

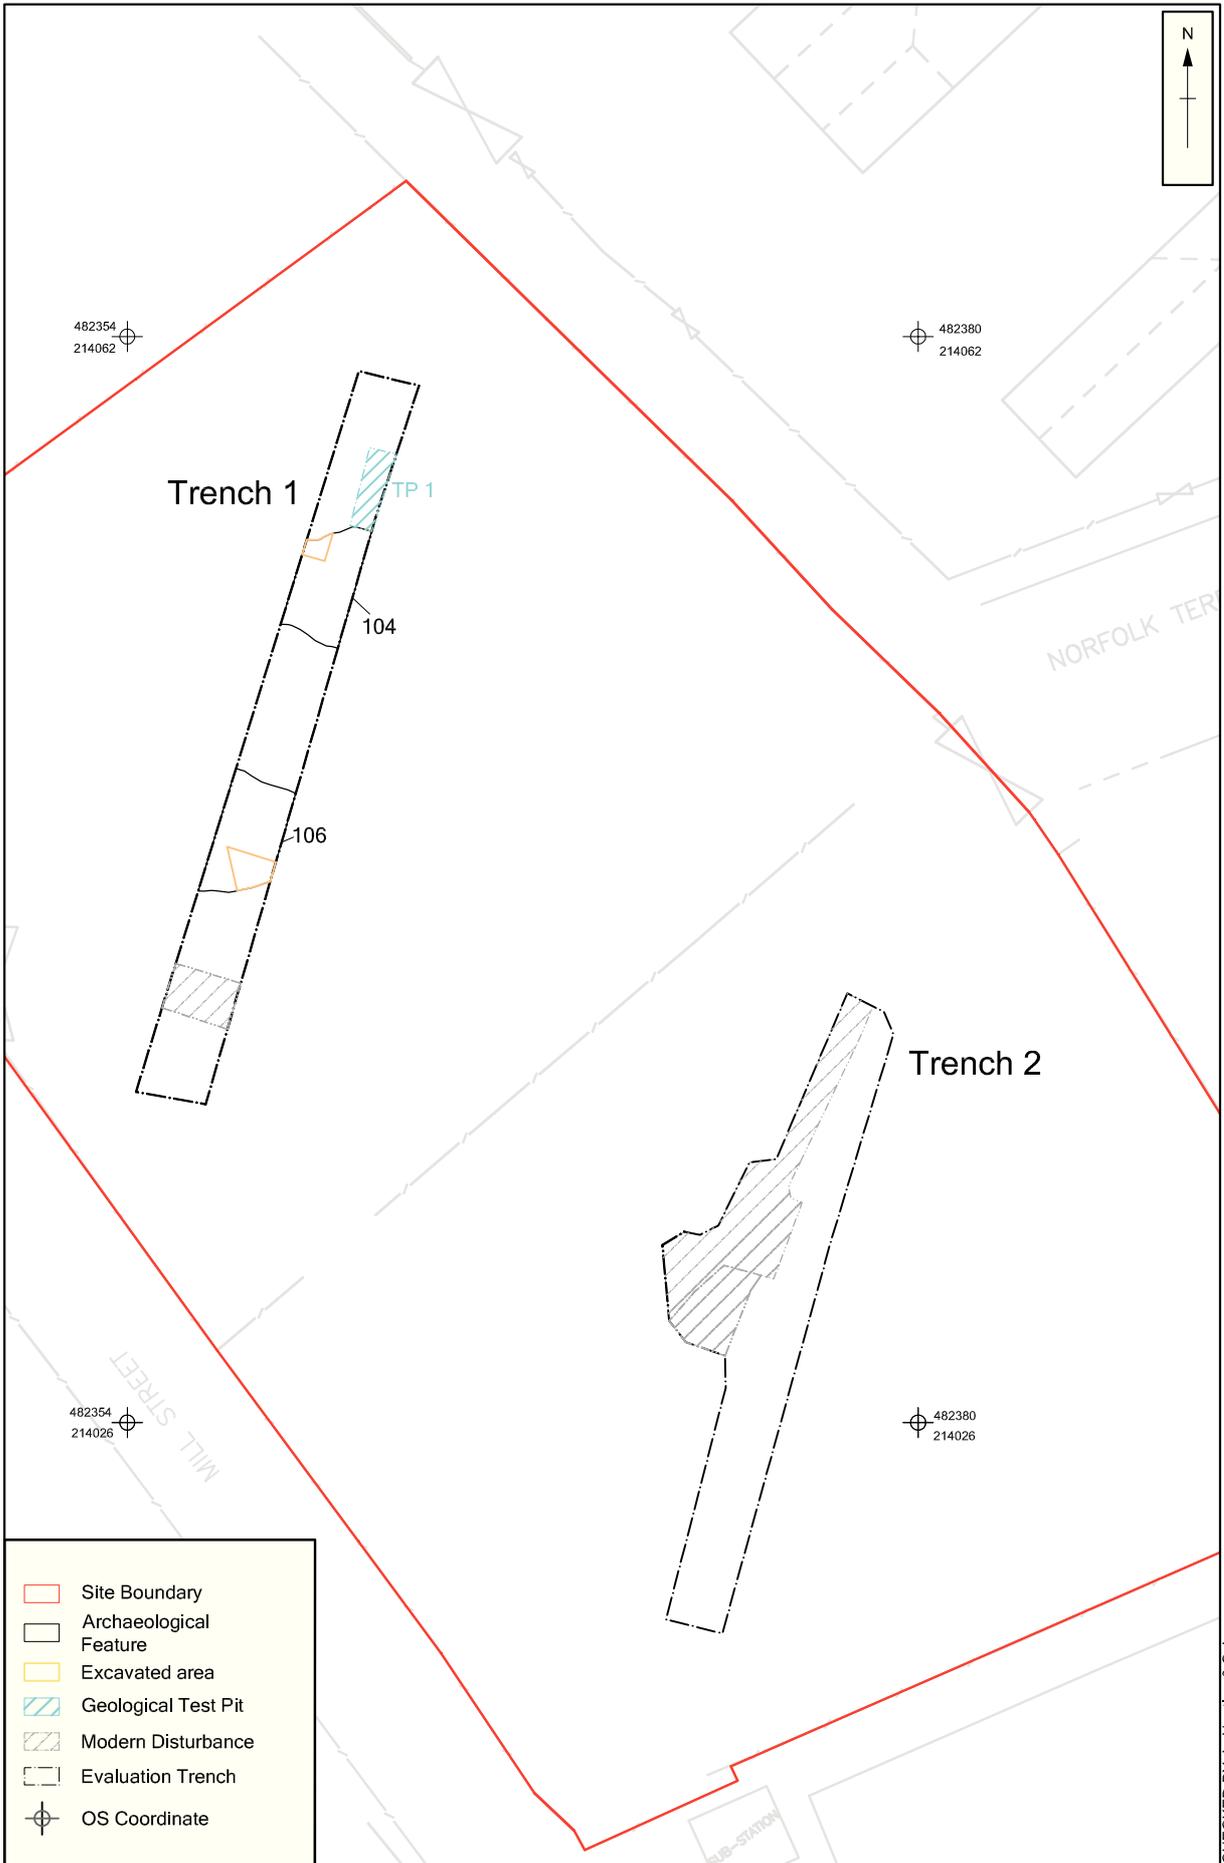
Fig 2: Trench Plan

3.3.1 Trench 1 (Fig. 2) was sealed by concrete along most its length (context 100), except at the northern corner where the trench cut through a former garden area and at the north-eastern side where it had been cut by a geotechnical test pit (TP 1). Below this was context 101, a mix of bricks and garden soil made ground overlying at the northern end context 102, an area of redeposited/disturbed natural (Fig. 3). This contained post-medieval ceramic building material (CBM), glazed pottery and a single abraded sherd of probable Iron Age/Roman pottery.

3.4.1 Trench 2 (Fig. 2) ran for part of its course along the same alignment as a very recently cut service trench which had significantly truncated the central part of the trench's location. As the concrete cap (context 200) had already been broken, it was decided against moving the trench. The service trench allowed view of a deeper (c 2 m) sondage through the encountered soil horizons.

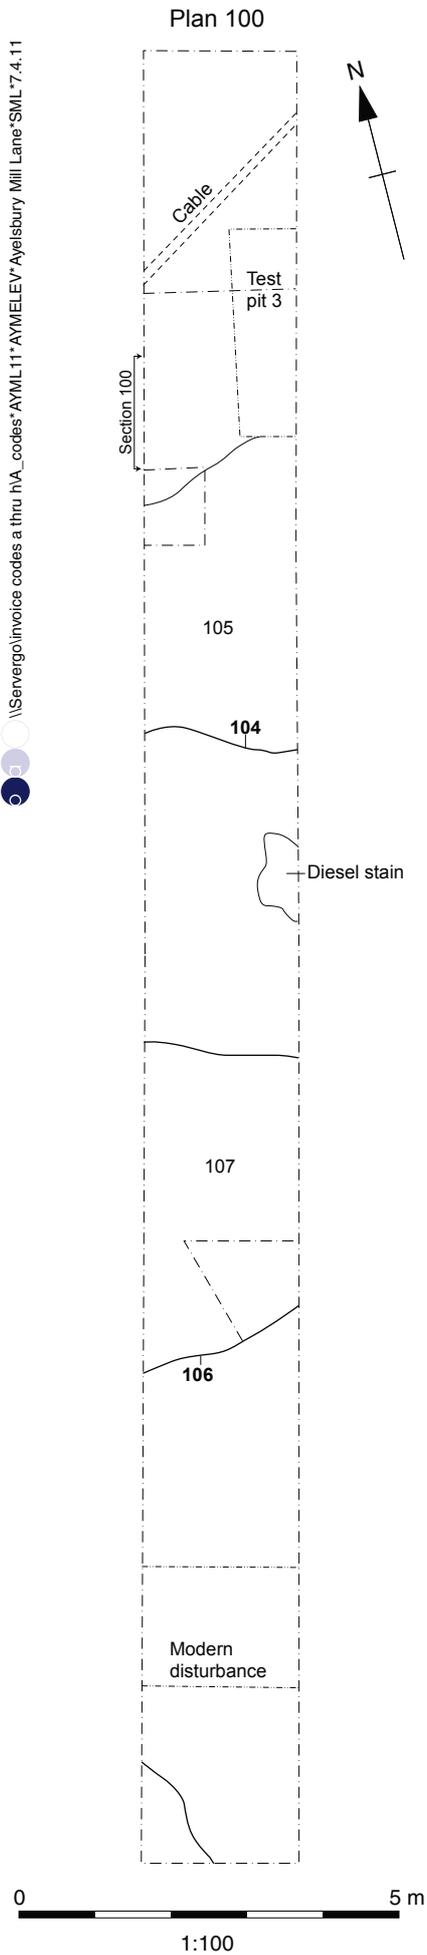
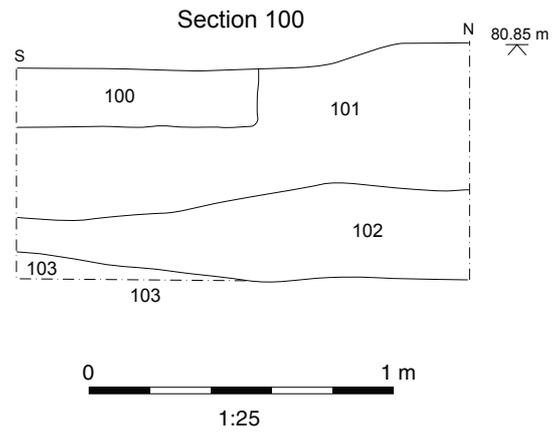
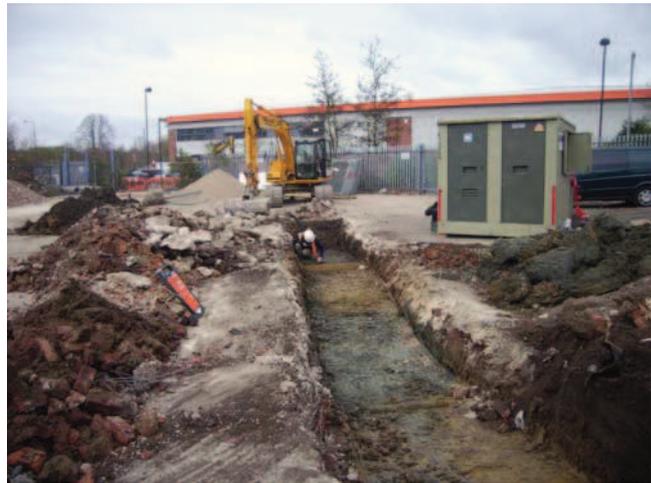
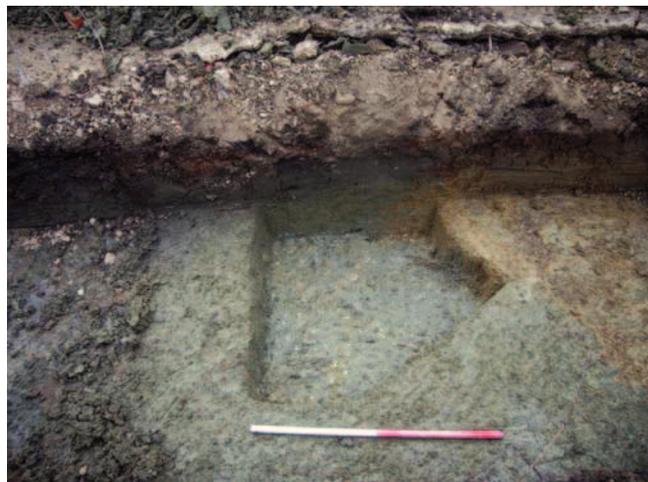
Figure 3: Trench 1, plan, section and photographs

3.3.3 Natural features 104 and 106 showed as broad irregular bands across the trench, similar in plan to slightly irregular ditches around 4 m wide. Their 'cuts' displayed irregular sides, mostly vertical or undercutting, and they were filled with a very dark greyish-blue sandy-clay material with a polygonal pattern of thin brown clayey-sand wedges spaced throughout (Fig. 3). These dived downwards at acute angles through the main body of the fill.

3.3.4 Examination of two of these 'features' revealed them to be natural in origin and they are most likely periglacial ice wedges dating to the late Pliocene.

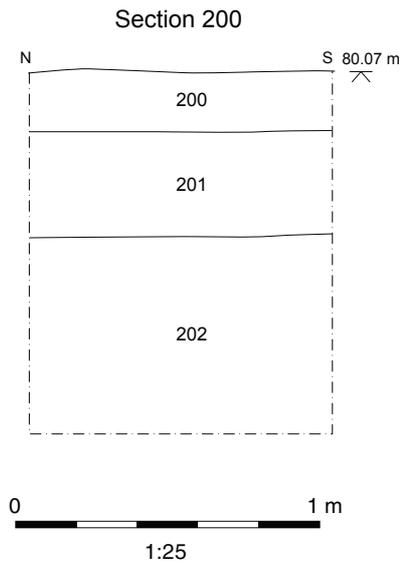
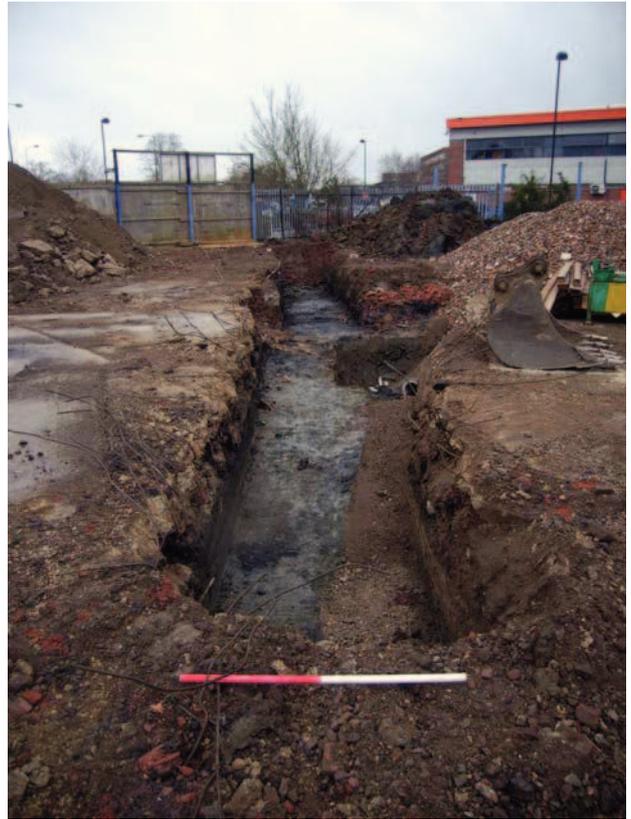
Figure 4: Trench 2, section and photograph

3.4.3 The northern half of Trench 2 contained no obvious archaeology but appeared to contain very contaminated Kimmeridge Clay natural (202)(Fig. 4). Due to the high degree of contamination, no effort was made to establish if this was redeposited or *in situ*.

Trench 2, from the north-east
