Site/Project Name: **OXFORD, Turl Bar, Lincoln College**

Site Code: OXTUBR11

Site/Project Type: Watching Brief, Building Survey and Excavation

Year(s): 2011

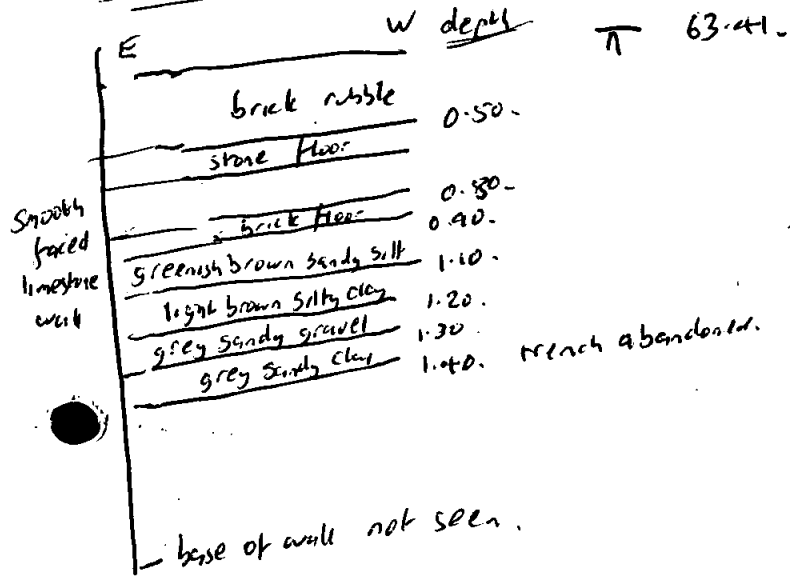
Sketch section

- test pit 1 was a Geotech pit (1.70 x 0.70) dug down against the N-S stone wall to the E of the E wall of the Turl Bar (see sketch plan), excavated by a toothed bucket in order to see the base of the wall

} maybe fills of construction cut for wall or pit fills.

* also present 2 E-W brick walls
no finds.

trench abandoned at 1.40-
0161 1007-9. +15

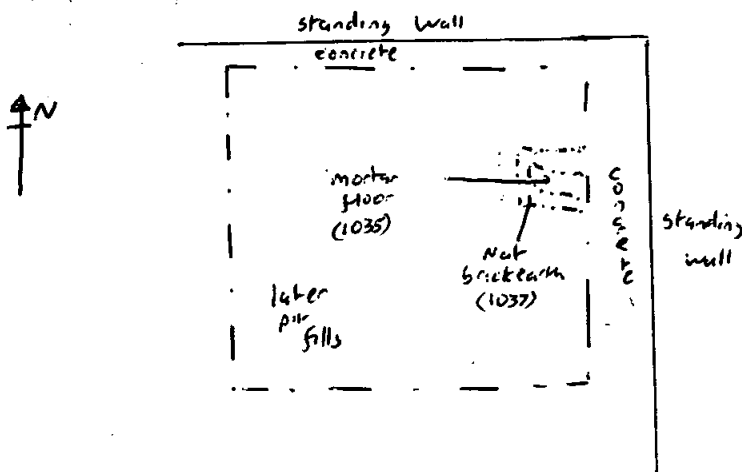
sketch plan of early phase

A Nat brickearth/subsoil layer⁽¹⁰³²⁾ was found at 62.27m OD. It had been heavily truncated by later features. This probably was the original pre-town ground level (the level is comparable to the red brown loam original ground level found under All Saints Church, 25m to the SE - here, Nat gravel was found at 61.90m OD with 0.20-0.35m of the red brown loam over it).

A remnant of a mortar floor (1035) (0.40m x 0.20m) at 62.44m OD over a dirty subsoil foundation layer (1036) overlay (1037). It too had been heavily truncated by later features. No finds were recovered from these layers.

The upper fill of pit 1011 was cut by a possible E-W wall foundation 1024. Only 1 course survived and it had been heavily truncated by later features.

The garden soil was cut by the foundation of a N-S wall (1001). (This wall could be seen incorporated into the standing building to the N of the trench).

It was overlain by modern deposits (1000) related to the recent toilet block on the site.

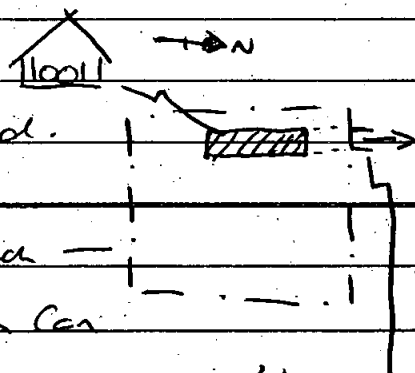
1. Limestone. 2. 100-300mm. Irregular.
3. Course / roughly hewn. 4. None
5. Wall foundation 6. Runs EN-S
7. Pale-yellow, soft sandy mortar.
8. N-S 1.2m, E-W 0.52m, ↓ 0.15m
9. No section drawn as only 1 course remained.

- Foundations for wall, the rest of which can be seen continuing in current building. Wall can be seen continue
- Undated, prob. post-med. be seen continue
- Heavily truncated by modern buildings, drains & into this face foundations - only 1 course remained.
- Continuation to South unknown due to drains.

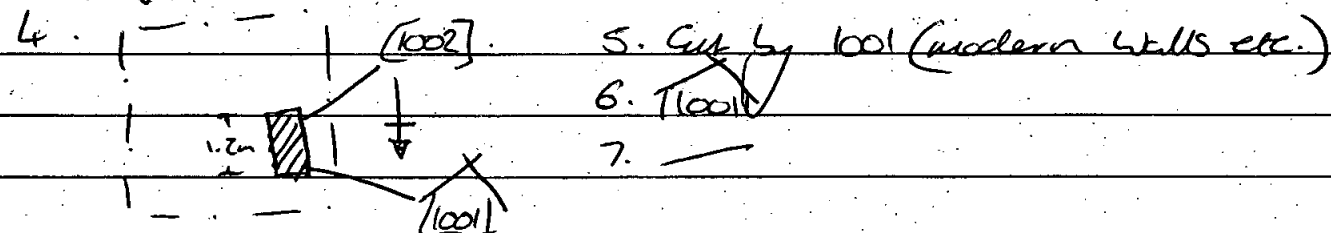
1. linear N-S. 2. N/A not seen in profile. 3. N-S 1.2mt, E-W 0.52m

Construction Cut for PM Wall 1001.
Profile unclear.

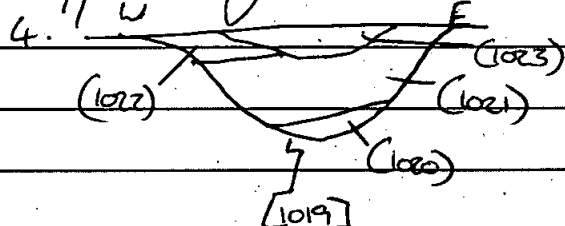
1. Circular 2. Base-concave, regular,
Sides-concave, shallow/moderate
Diffuse edges. 3. Diam. 1m, ↓ 0.4m

4. $\frac{W}{F}$ 5. Cut by modern foundations to N.
cuts/pits (1009) (1017)
6. (1020-3)
7. —

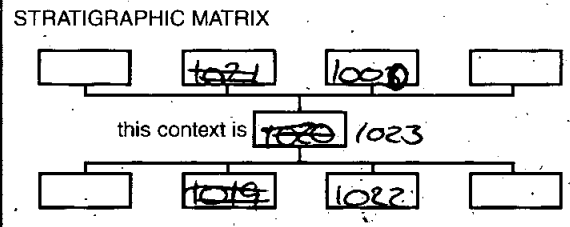
Description (See check lists):
1. loose. 2. Light-Grey-Brown
3. Sand-Silt. 4. Mortar / Stone
30:1. 5. 0.17m ↑ 6. Diam 0.6m
7. — 8. Travel, overcast.

Interpretation/Discussion:
- Disturbance of upper fill (1021) when 26" wall constructed to N.
- Contained white glazed pottery.

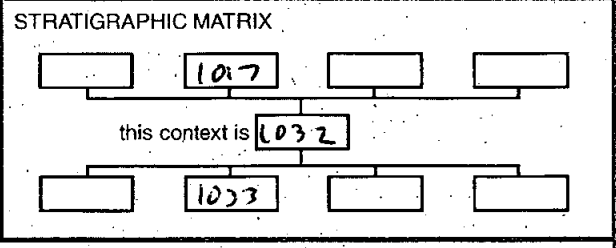
- 1) friable
- 2) red - light brown
- 3) sandy silt
- 4) 5% charcoal lumps 10% gravel
- 5) 0.40 - 0.45
- 6) 0.70 - x 0.30
- 7)
- 8) excavated by mattochi.

Upper half of pit 1034

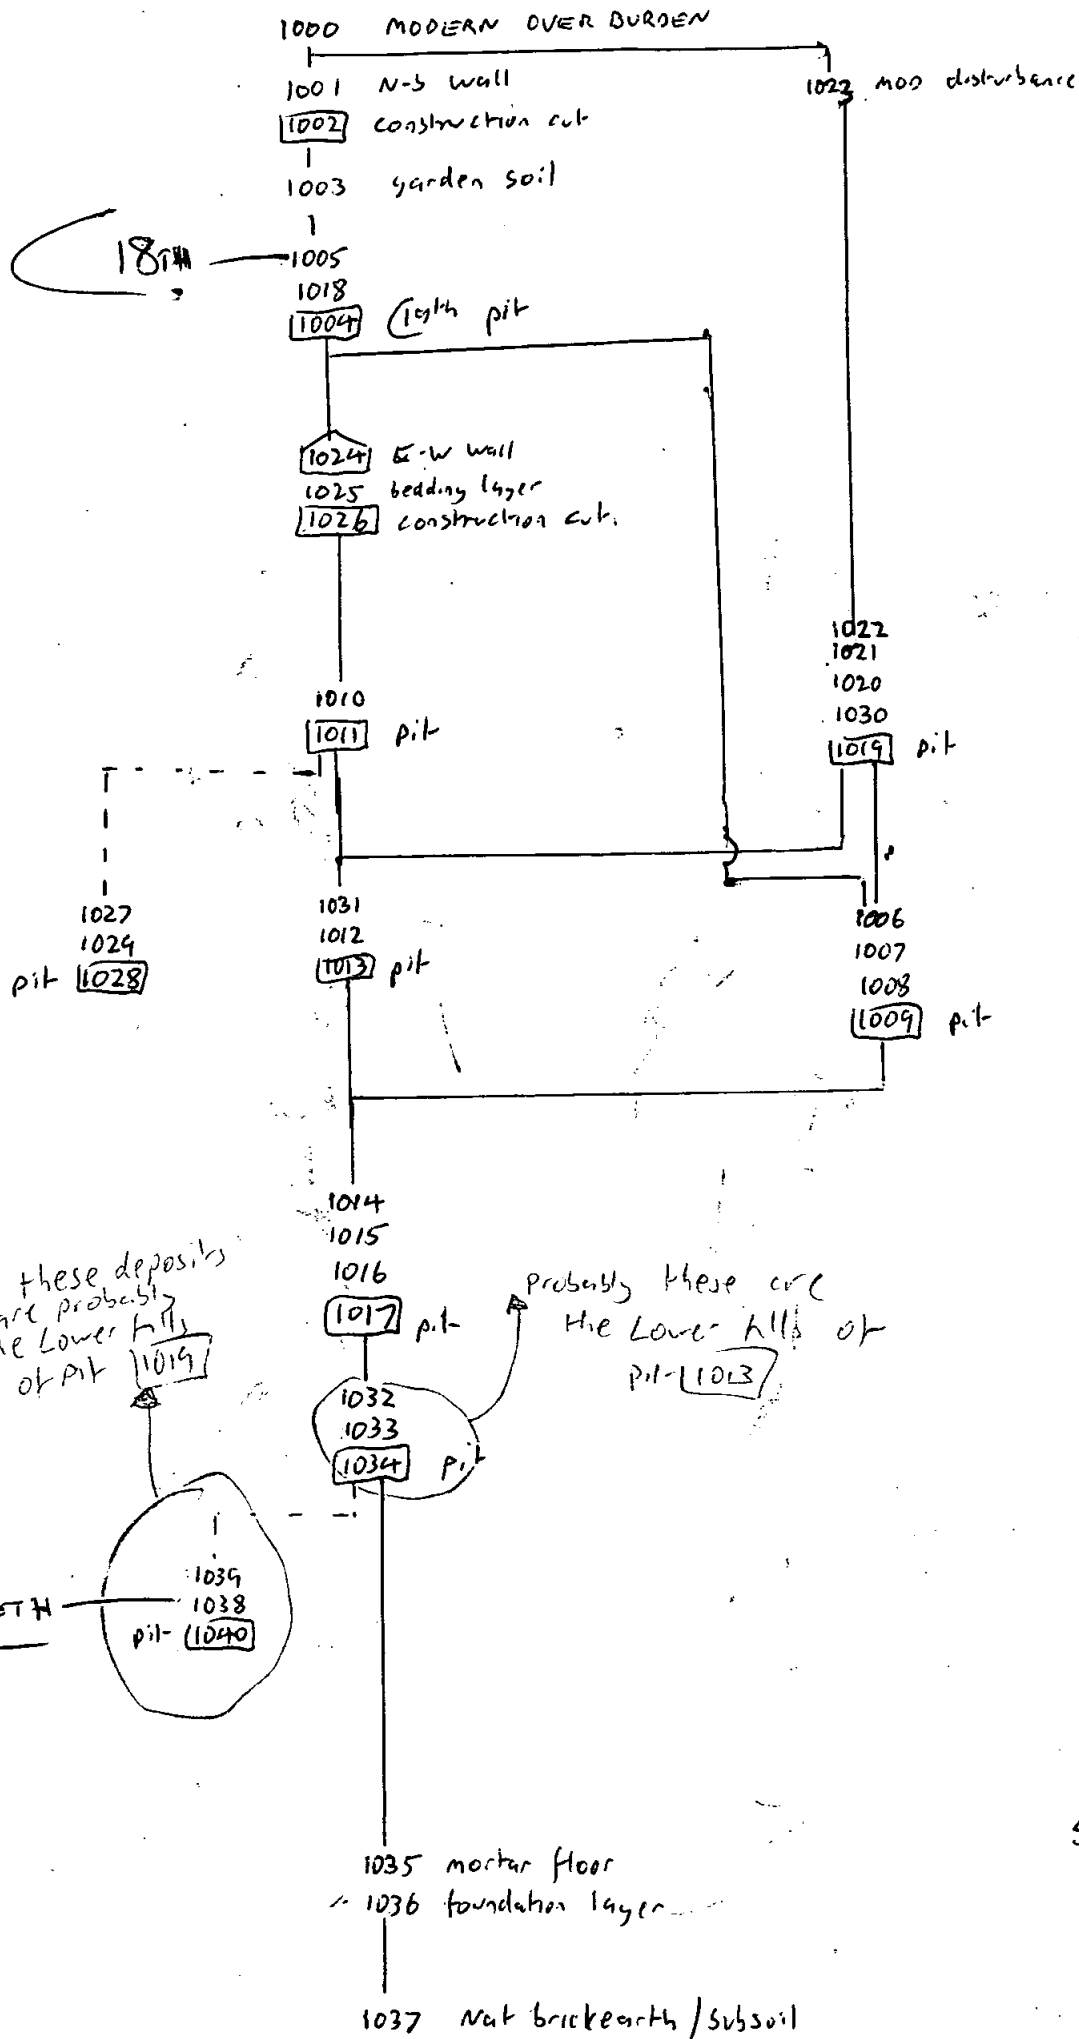
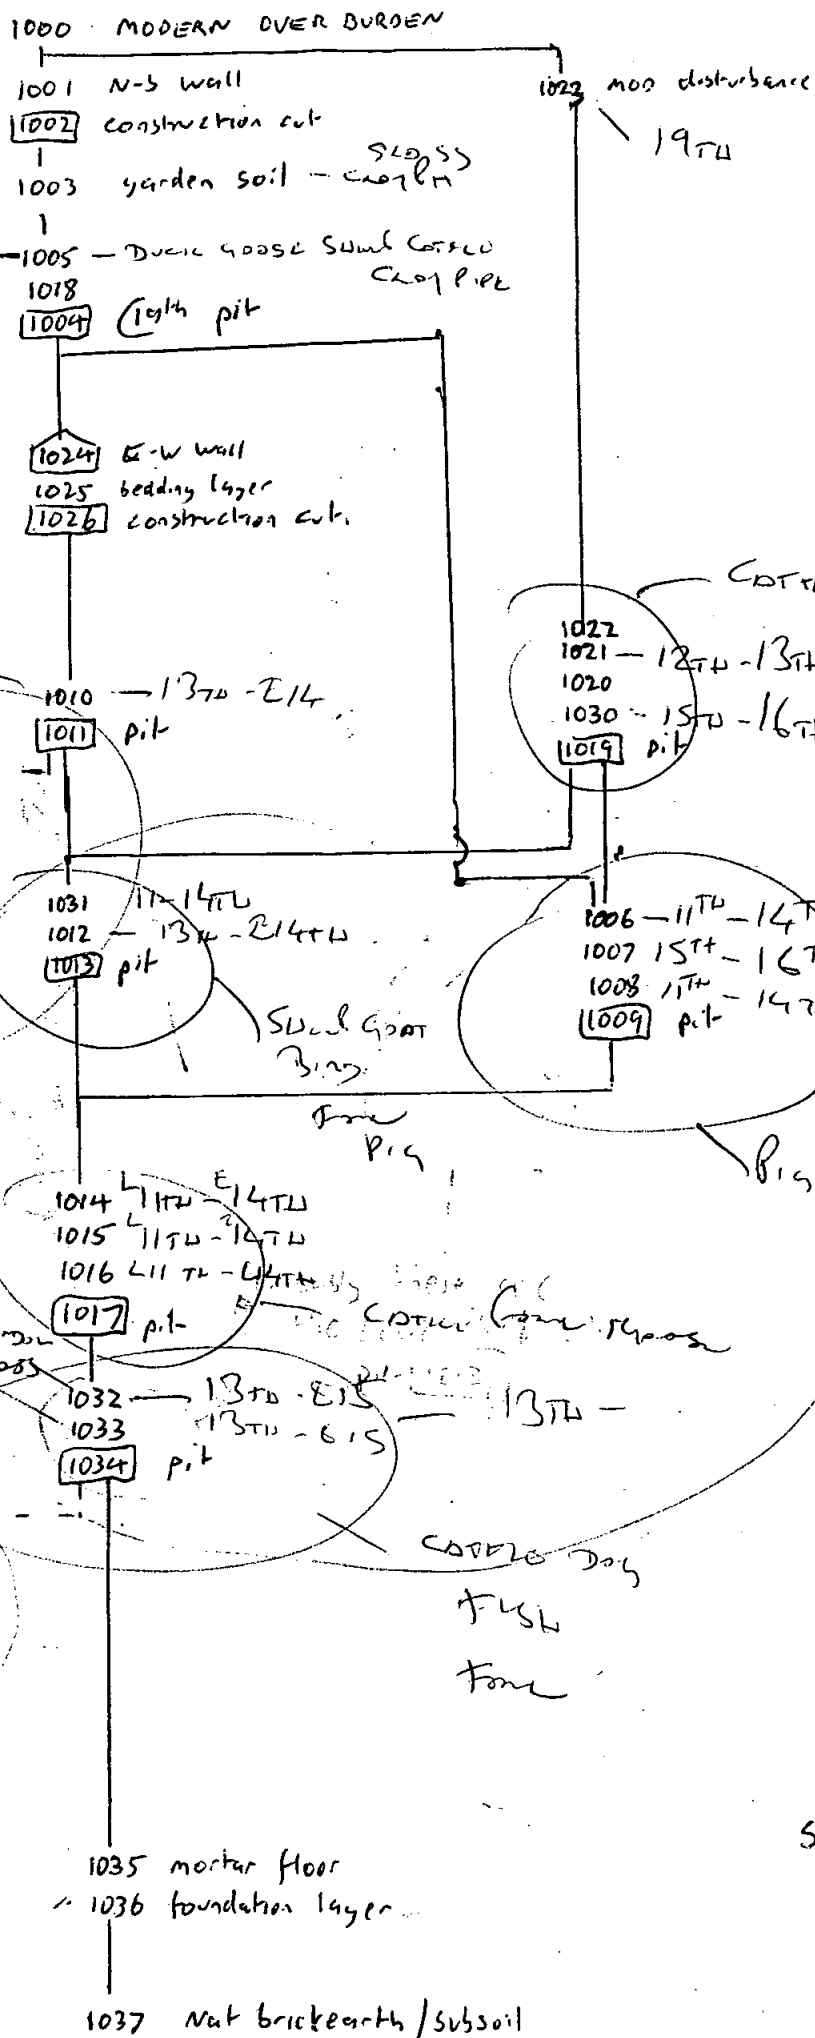
OXTRABRII Lift shaft matrix

POST
MED

MED

(16-17th)

18th

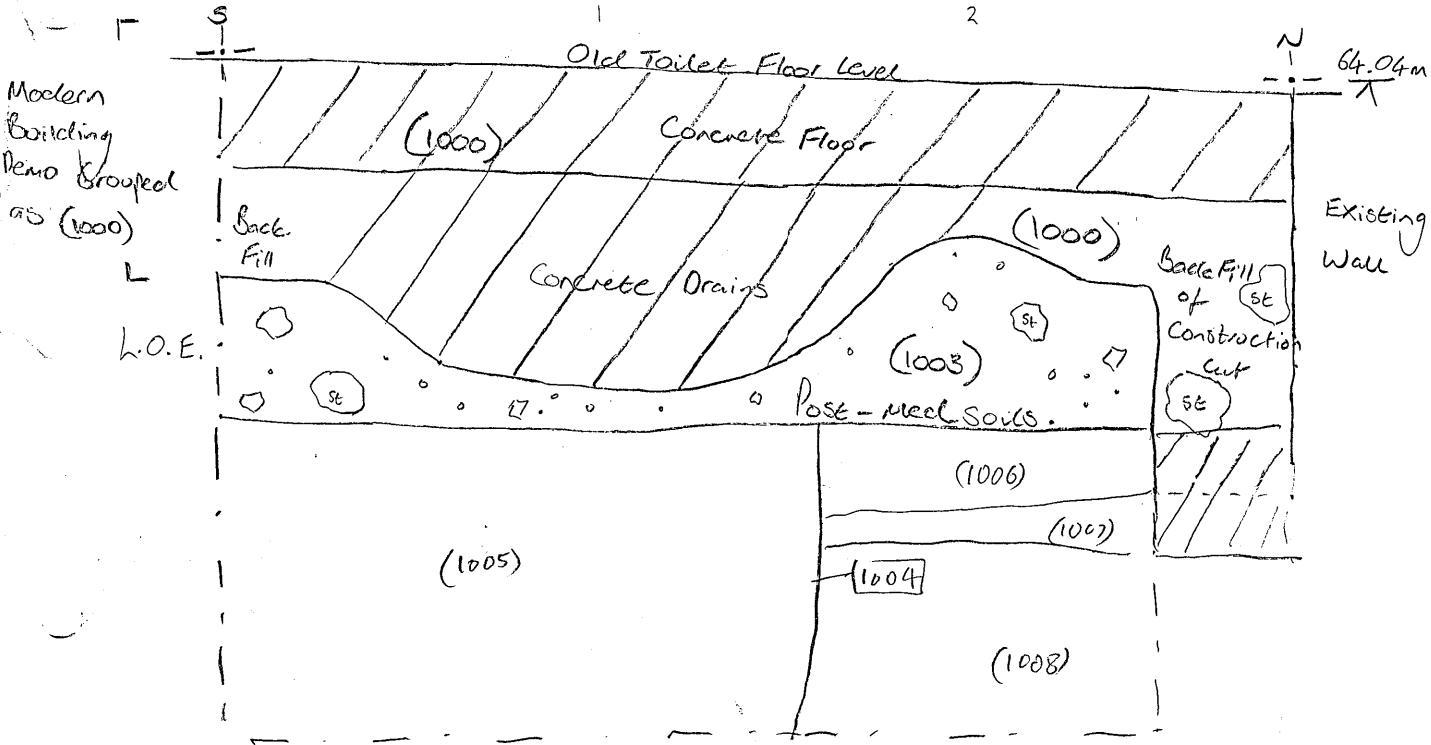
OXTURB11
Section 1
Scale 1/20

SE - Stone

/// - Concrete

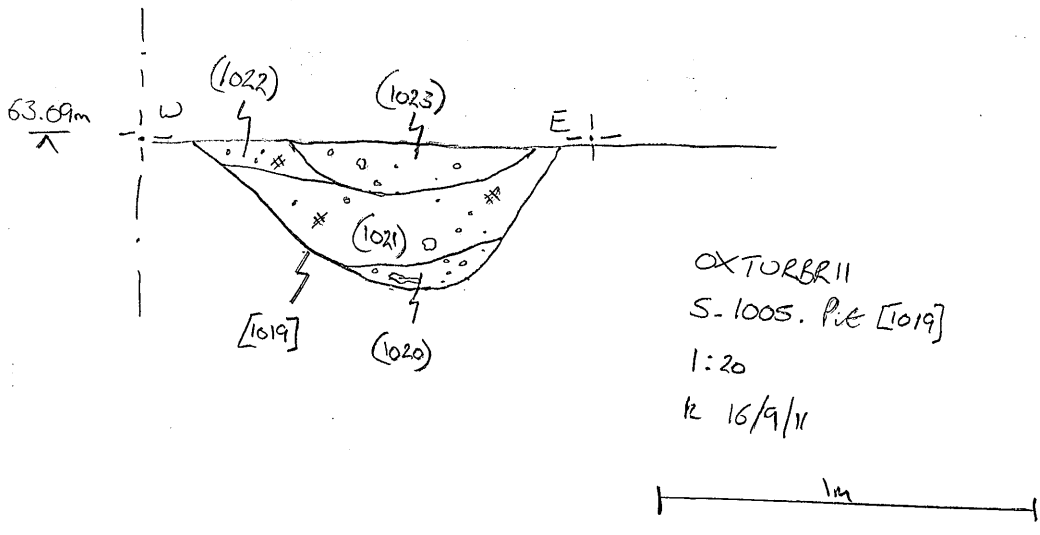
OXTORBR11
S-1005. Pit [1019]
1:20
12/16/9/11

Redrawn
as
Sect. 1007

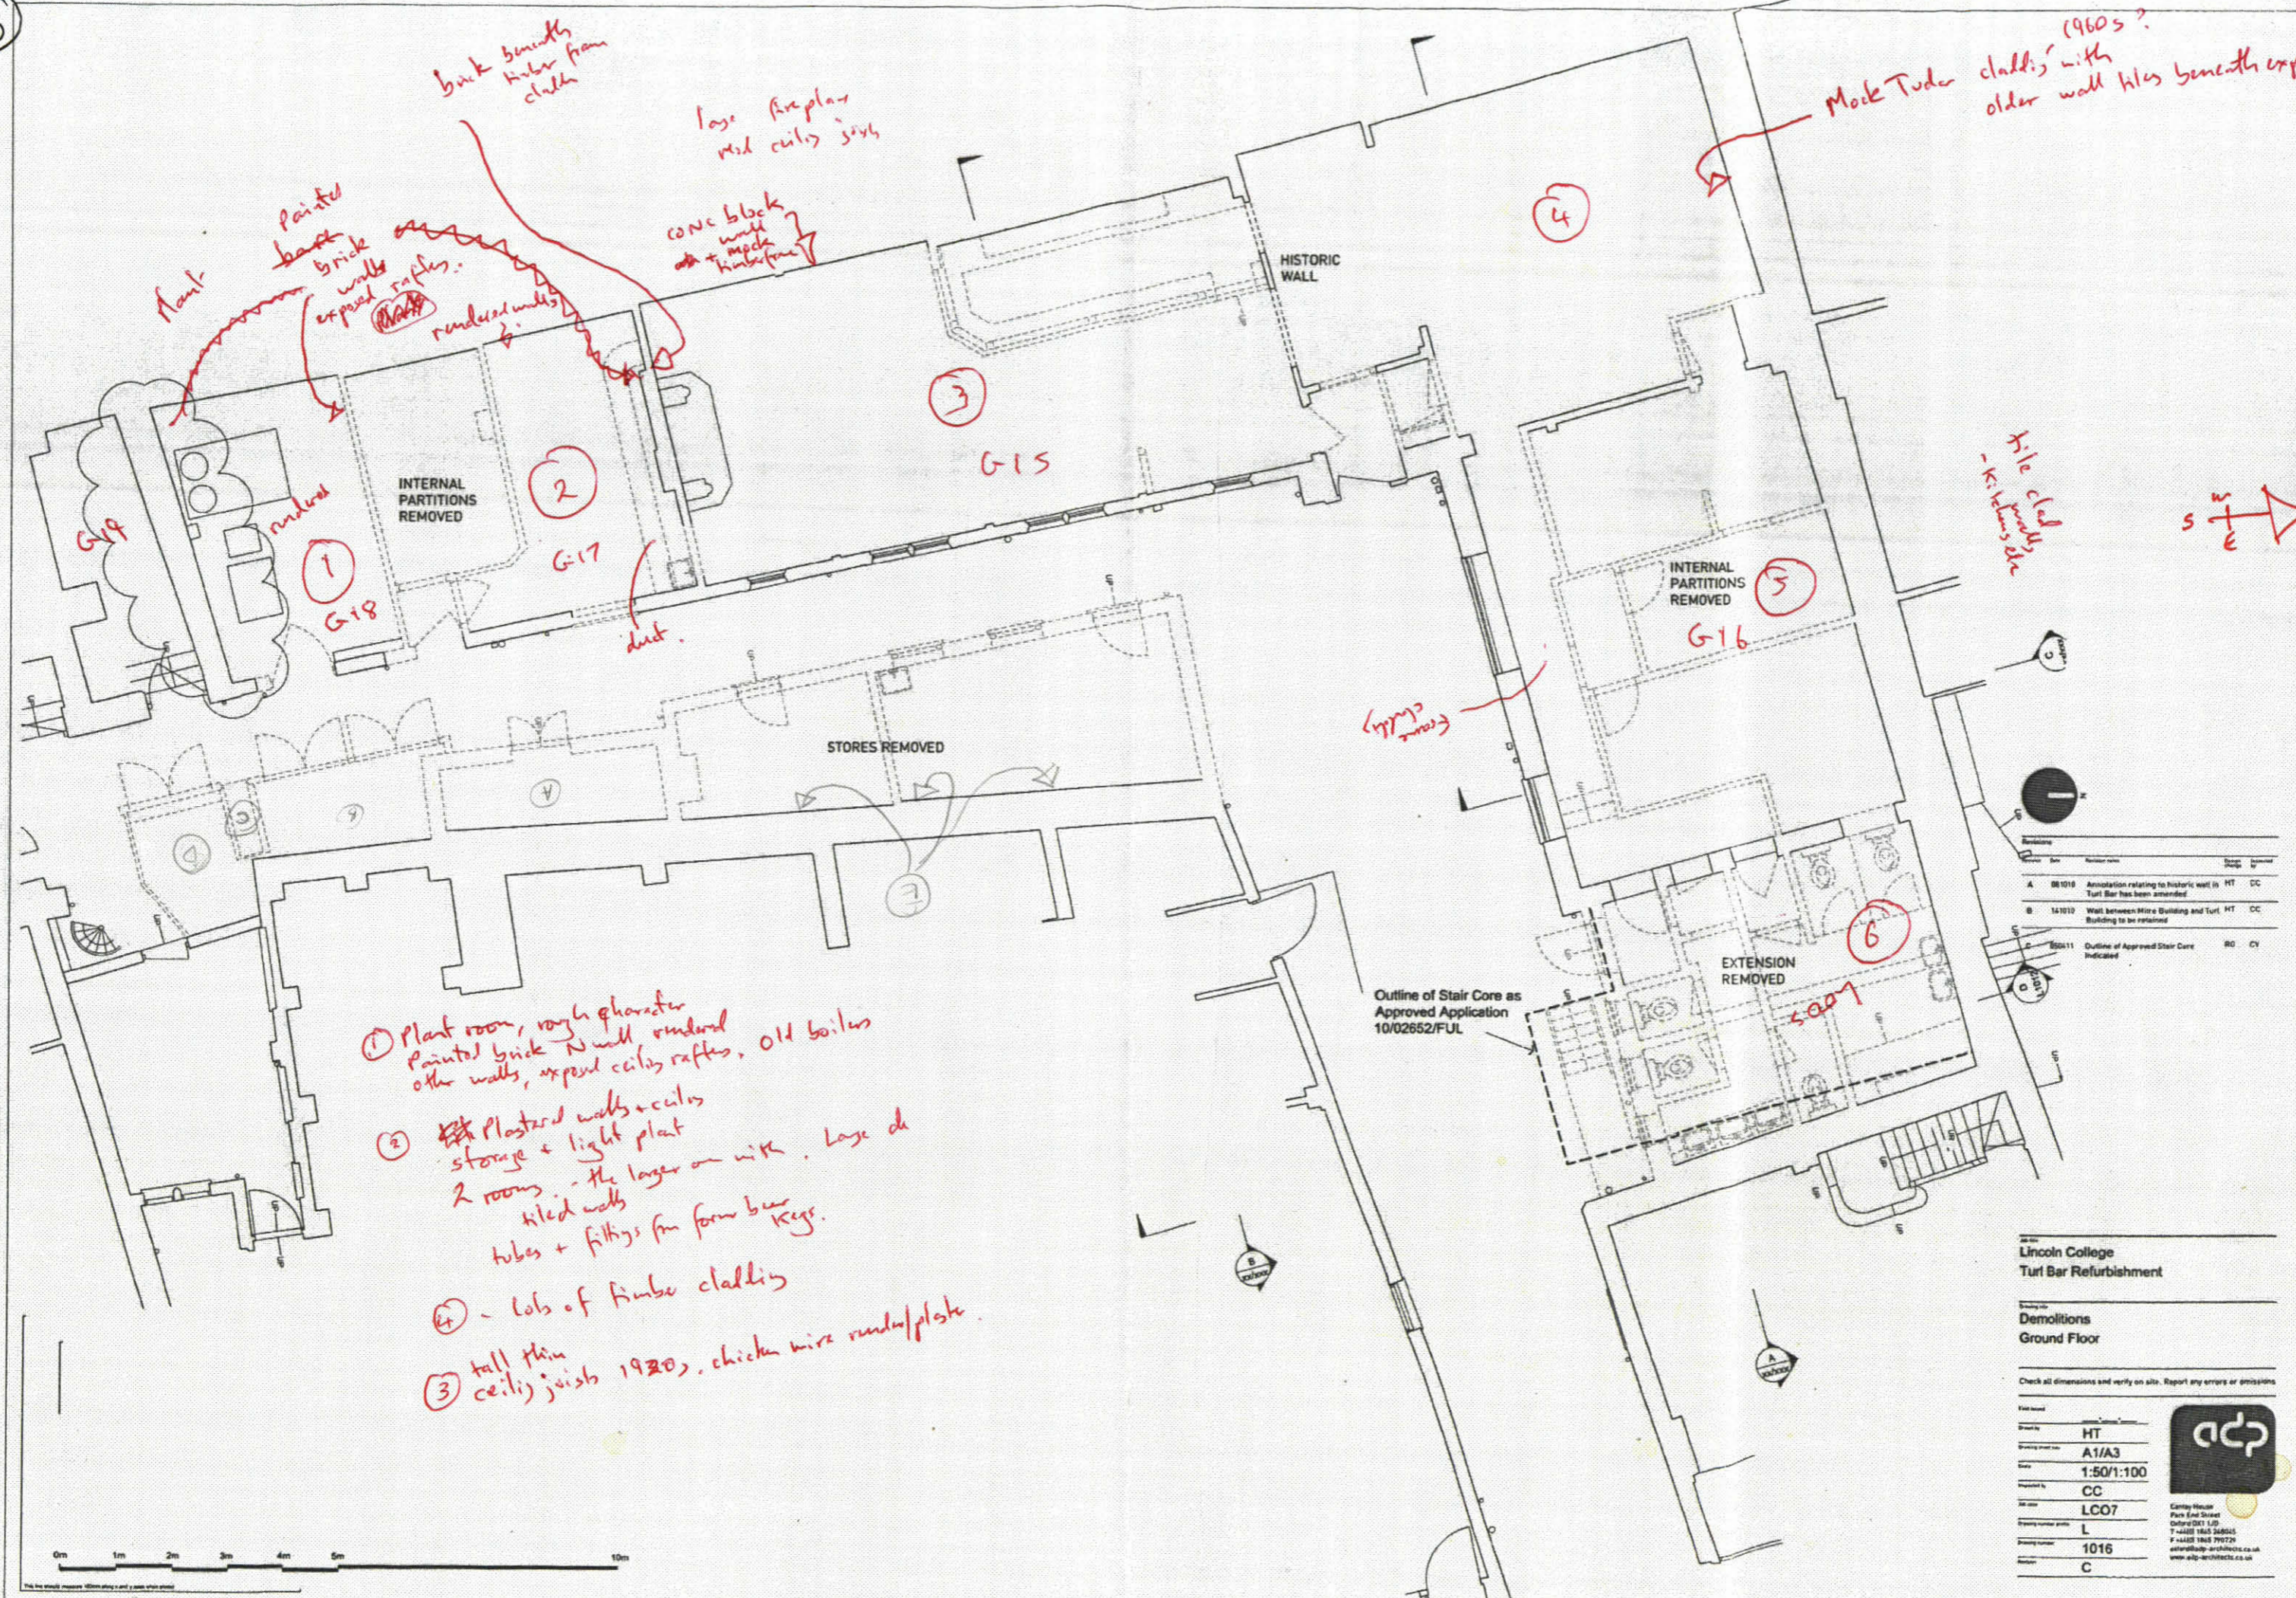
- ① Plant room, rough character painted brick N wall, rounded other walls, exposed ceiling rafters, old boilers
- ② Plastered walls & ceiling storage & light plant 2 rooms - the larger on north tiled walls tubes & fittings for former beer kegs.
- ④ - lots of timber cladding
- ③ tall thin ceiling joists 1920s, chicken wire round/plate.

Mock Tudor cladding with older wall tiles beneath exposed (1960s?)
