Historic building recording at the former British Legion Headquarters, Bardwell, Suffolk

Historic Building Recording

February 2014

OA East Report No: 1583

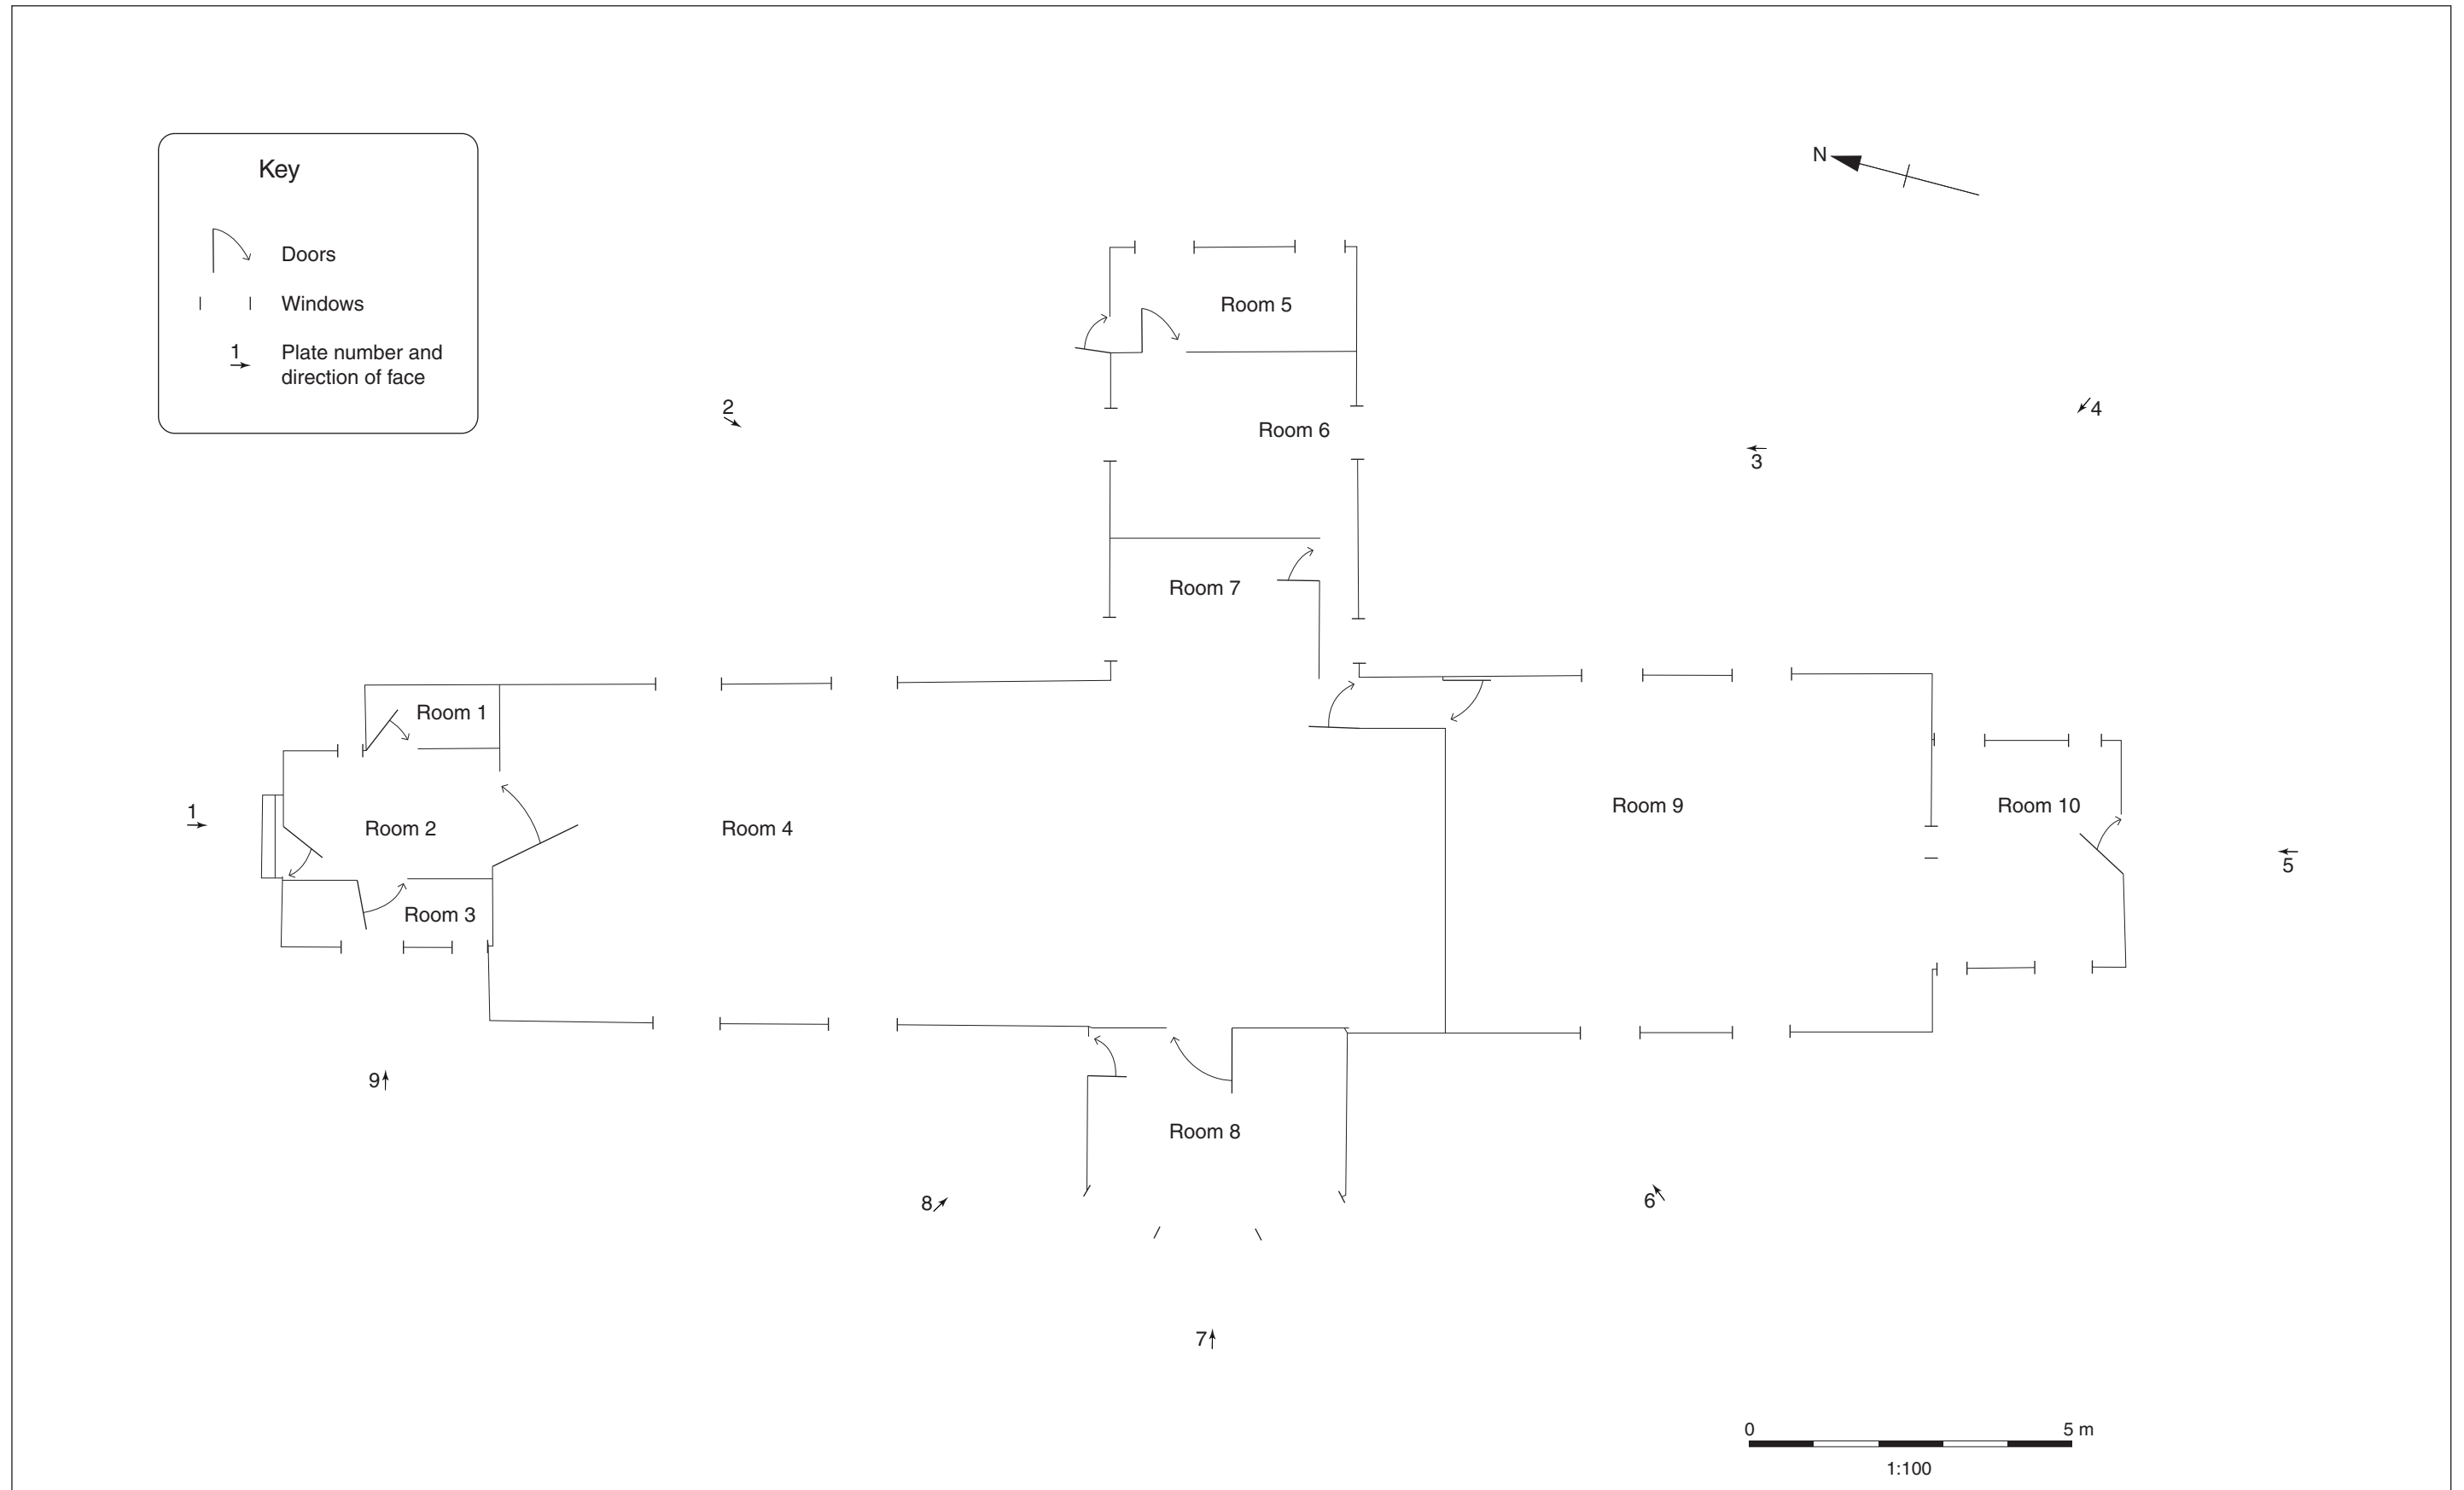
Figure 2: Floor plan and direction of report plates

- 3.5.1 This was a later addition to the building and is presently used as a male wash room. The room measured 2m x 1.2m.

- 3.5.2 This was used as an entrance lobby with access to rooms 1, 3 and 4. It is unclear if this was the original entrance to the building when used as an isolation hospital as a double width doorway would have most likely existed. The internal measurements were 3.5 x 1.8m.

- 3.5.3 Room 3 was used as a female wash room accessed from room 2. This room retained some original tongue and grooved pine panelling to the walls and roof. The room measured 3.5m x 1.2m.

- 3.5.4 This would have been the main body of the building when used as an isolation hospital. When used as such it would have measured approximately 22.5m x 5m. The addition of a partition to create a snooker room has reduced the measurements to 15m x 5m. This area would have most probably been used as the hospital ward and had access to rooms 8 (an office) as well as rooms 7 and 10 (storage areas). A modern suspended ceiling obscured the roof structure which most probably would have been open to the rafters.

- 3.5.5 This area would have originally been used as a storage area and had internal measurements of 6.5m x 3.75m. Some original features remained in the shape of two shelves and internal tongue and grooved panelling. Latterly the room had been subdivided into a further storage area (room 6) and bar area (room 7)

- 3.5.6 This room is an internal division of room 5 and would have been constructed after its relocation to its present site. It measured 3m x 3.75m and was most recently used for storage.

- 3.5.7 This area is located in the footprint of room 5 and served as the bar for the British legion club. It measured 2.2m x 3.75m.

- 3.5.8 This was recently used as the kitchen area but originally would have been an office. Three windows were located on a bay to the east and an external door to the north. Original panelling here survived on walls and ceiling, (plate10). Room 8 measured 3.2m x 4m.

- 3.5.9 Room 9 was originally part of the main ward area of the isolation hospital but was most recently used as a snooker room. This was created using a modern wooden partition giving the room dimensions of 7.5m x 5m.

- 3.5.10 This area is another store room measuring 3.5m x 3m. Originally it would have been accessed directly from the ward area but now is accessed from the snooker room (room 9).

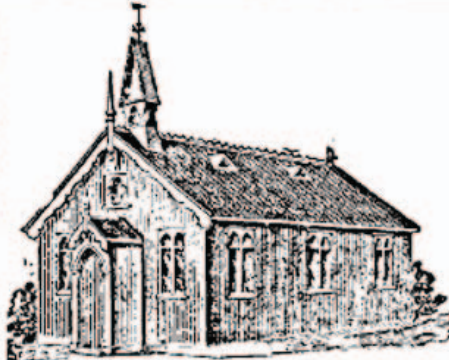
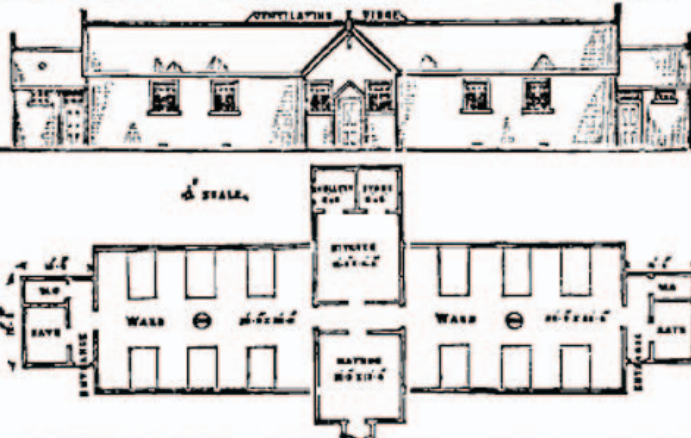
Figure 3: Humphreys' advertisement

- 3.3.1 The type of building at Bardwell is often known as a tin tabernacle. This stems from the use of these prefabricated iron buildings as temporary churches and places of worship. These were mostly paid for by public subscription or by wealthy benefactors. The use of these buildings were not confined to religious houses. There were many and varied uses such as schools, meeting rooms and as in the case at Bardwell it was originally constructed as a Isolation hospital and erected at Fornham before being dismantled and re-erected in Quaker Lane. The need for these buildings in the Victorian era stemmed from a growing population and a need for cheap easily erected temporary buildings and with the technique of galvanising the corrugated iron sheets becoming economically more sustainable there was a rise in manufacturing and manufacturers from the last quarter of the 19th century. Pattern books and set prices were produced with an option to alter any design for a cost. One such manufacturer Humphrys Ltd of Knightsbridge produced an advert around the turn of the twentieth century shows an illustration remarkably like the building at Bardwell, and advertised as an Isolation Hospital. (Figure 3).

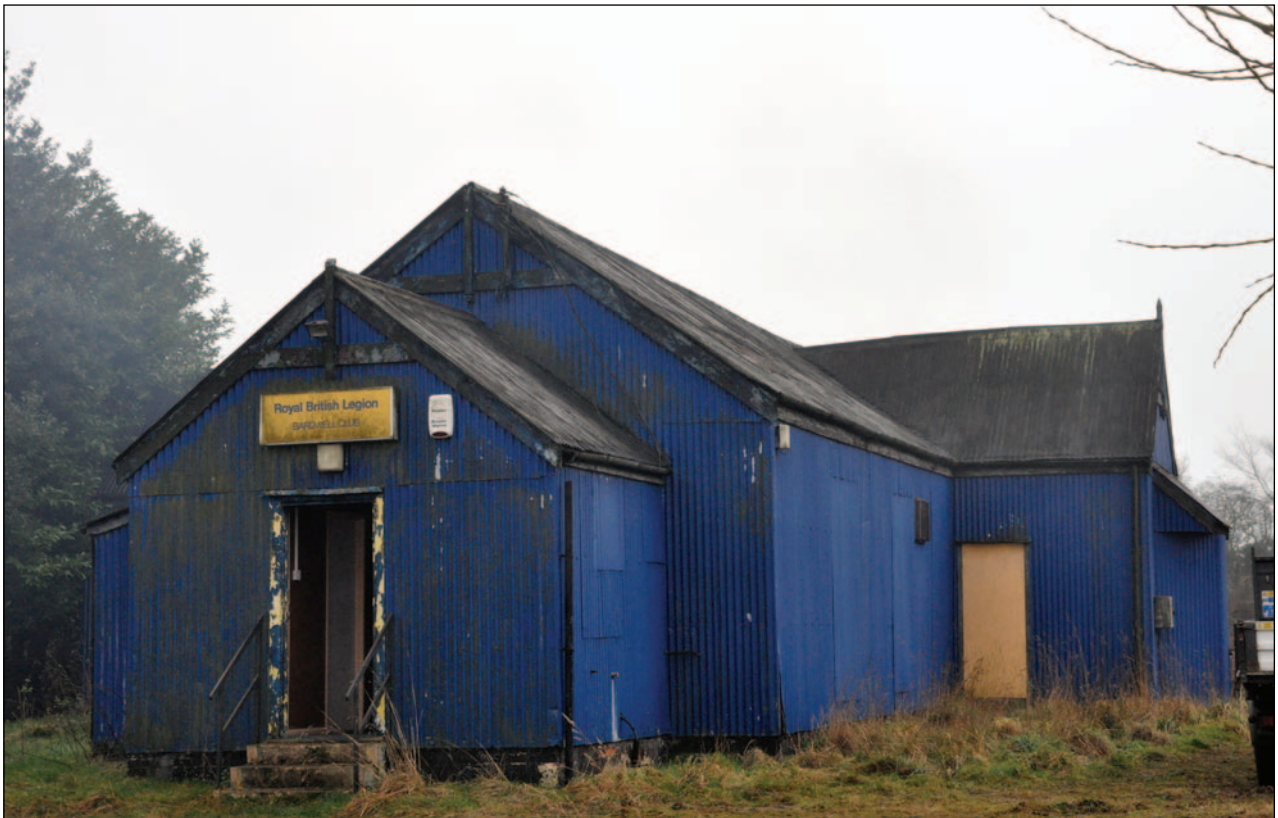
Plate 1: Northern elevations

3.4.2 The north facing elevation consisted of an entrance porch measuring 3.2m x 3m and had a single door accessed by concrete steps leading to an entrance lobby and male and female toilets. Wooden fascia boards met at the apex and were finished with a simple wooden pointed finial. A modern sign, light and intruder alarm were located above and right of the entrance.

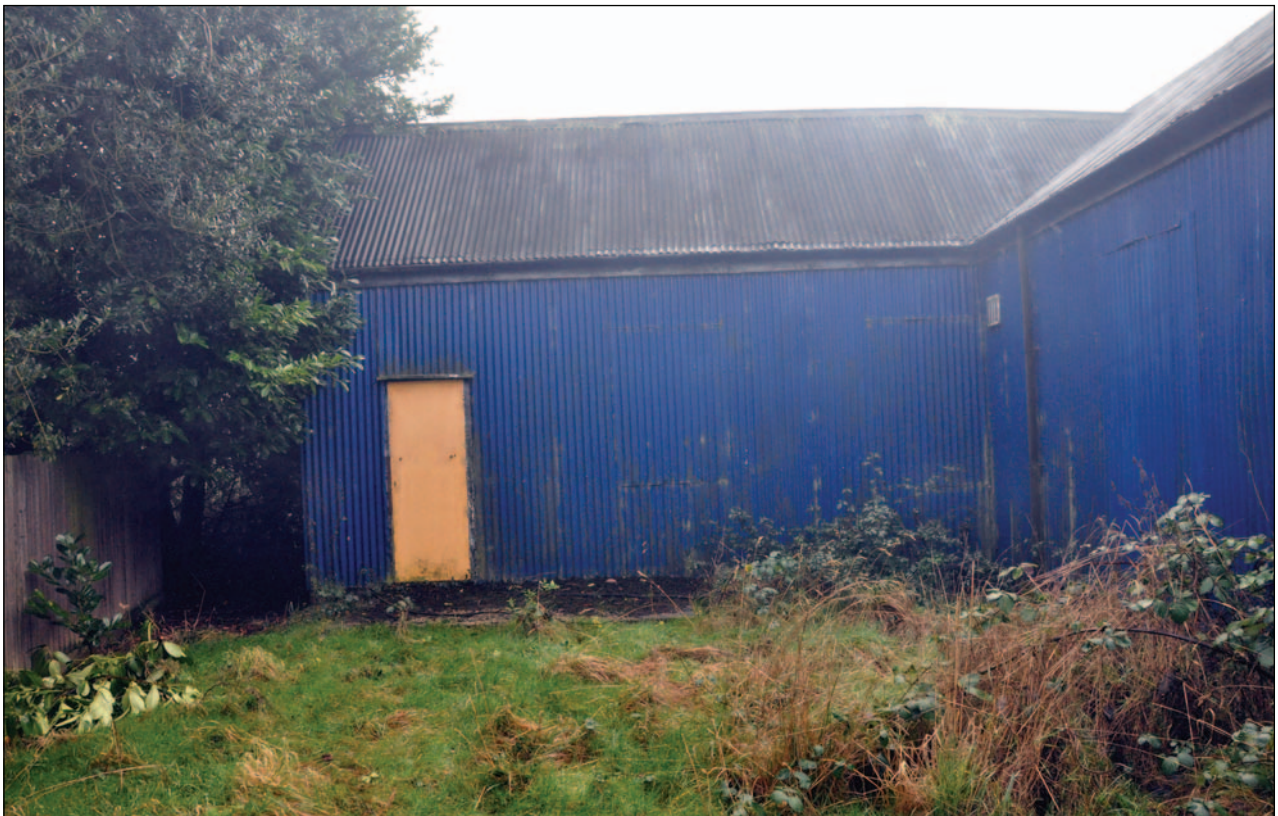
Plate 2: Eastern wing from the north

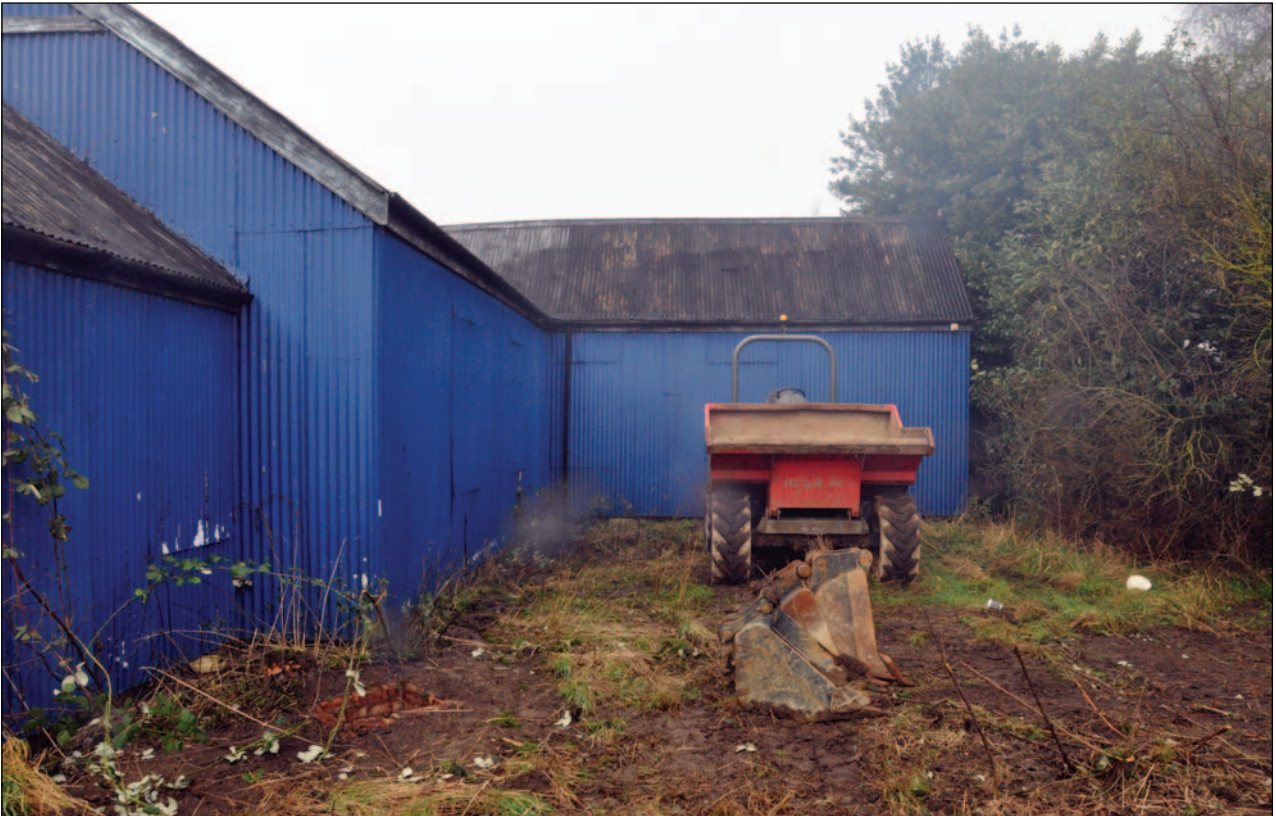
Plate 3: Eastern wing from the south

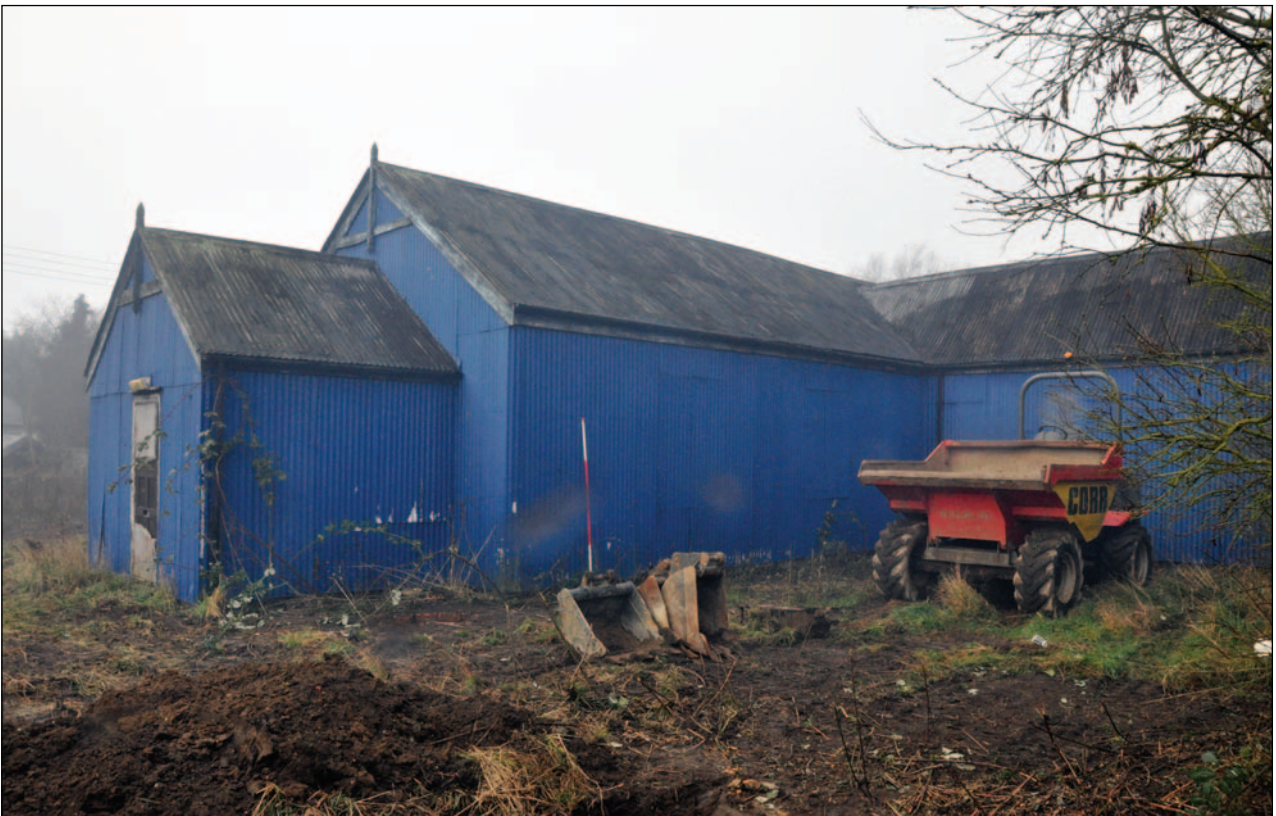
Plate 4: Eastern elevation

- 3.4.6 Access to the eastern side of the building was hampered due to the close proximity of the plot boundary and to plant machinery. It was noted that the eastern side of the building mirrored that of the western aspect other than the fact that the wing located on this side of the building was larger than that of the opposing office wing and measured 6.5m in length and had a width of 3.75m. Six blocked windows were noted on the wing with two on the northern side, two on the southern side and two smaller windows high on the east of the extension. The four larger windows measured 1.36m x 0.95 and the smaller windows 1.07m x 0.80m. External access was obtained by a single doorway located on and to the rear of the northern side of the wing. Internal observation suggest this wing was used as a storage area.

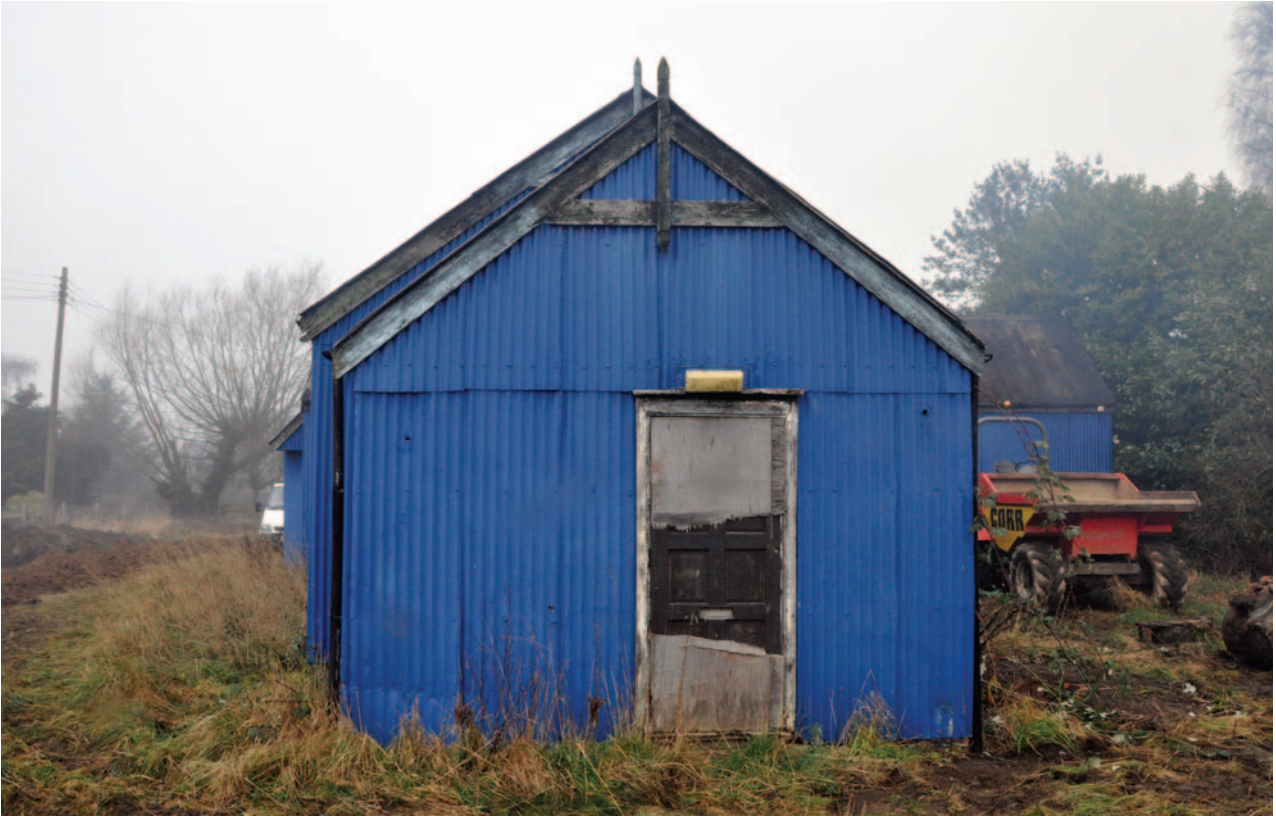
Plate 5: Southern elevation

3.4.5 The southern aspect of the building consisted of the small storage extension measuring 3m x 3.2m and is described above.

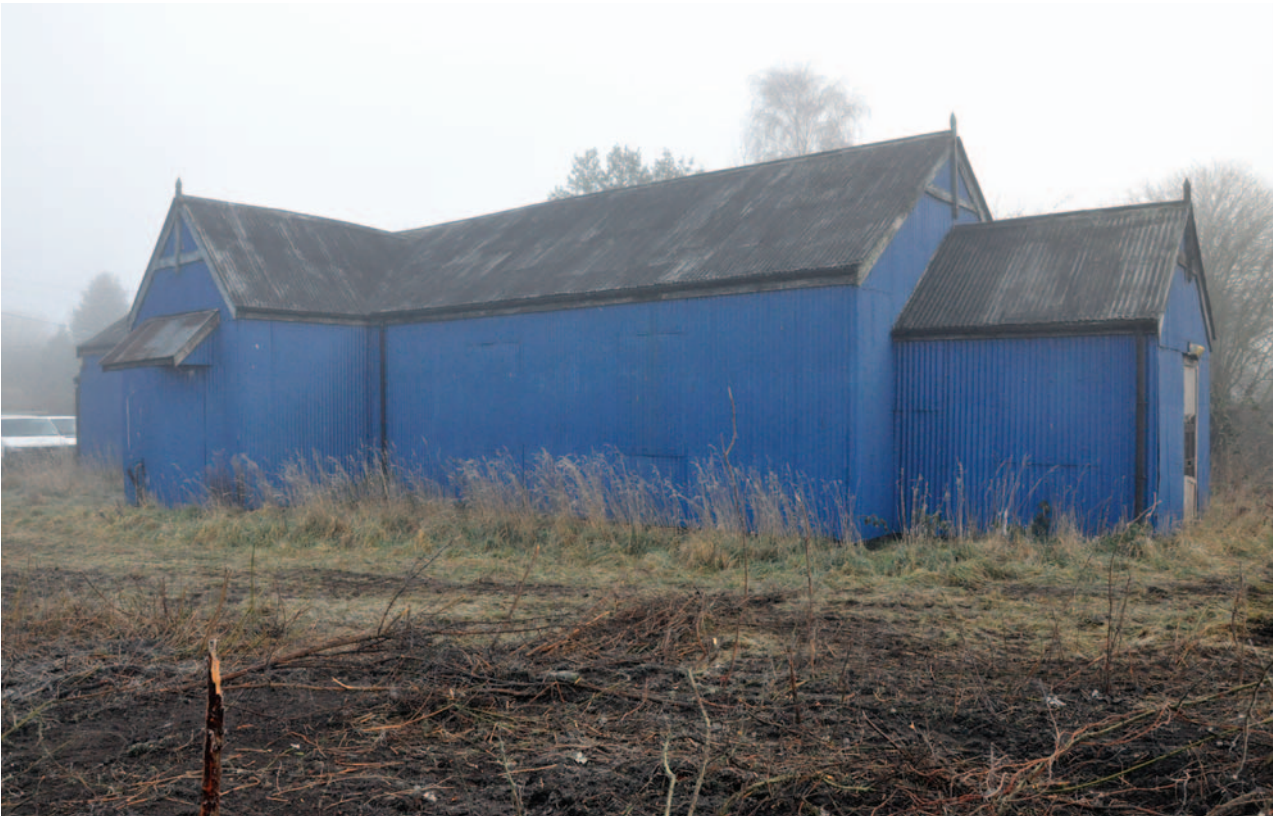
Plate 6: Western elevation

3.4.3 The western aspect comprised of the main body of the building with what was originally an office wing and now a kitchen located centrally. This office/kitchen area measured 4m x 3.2m. Again window openings had been blocked but it was possible to see that the office had three bay windows that each measured 1m x 0.95m. A sloped roof existed above the windows and the same simple wooden boards and finial were present at the roof apex. Two further windows existed either side of the office extension, these were located at equal distances between the end of the main building and the office structure. Internally window measurements were 1.49m x 1.5m. A single door located on the northern aspect gave external access to the office. This door had been removed and blocked with a modern wooden board.

3.4.4 At the southern end of the main building another small extension existed that was most probably a storage room. Two small windows were located on the eastern and western sides. Again these had been covered and measurements were impossible to take externally or internally due to light and access issues. A door had been added to the southern aspect at a later date and was located off centre. Similar facing boards rising to a wooden pointed finial at the apex of the roof were noted here as on all the other ends of the building. The probable use in the original building for this extension was as a storage area which did not require external access.

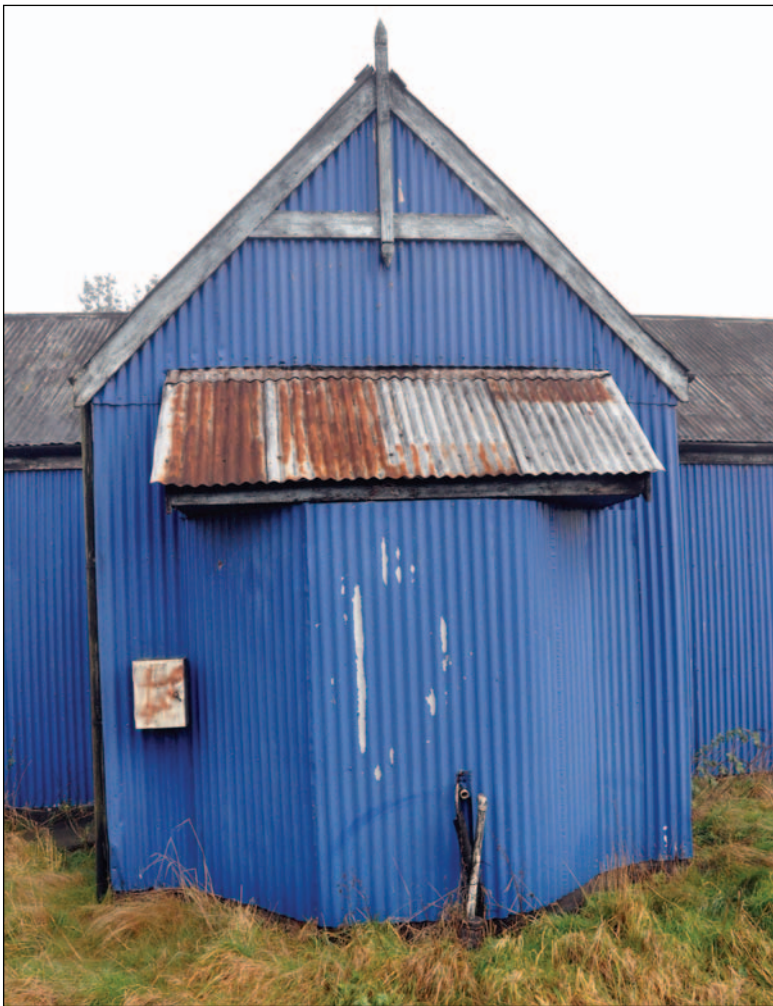
Plate 7: Western office wing

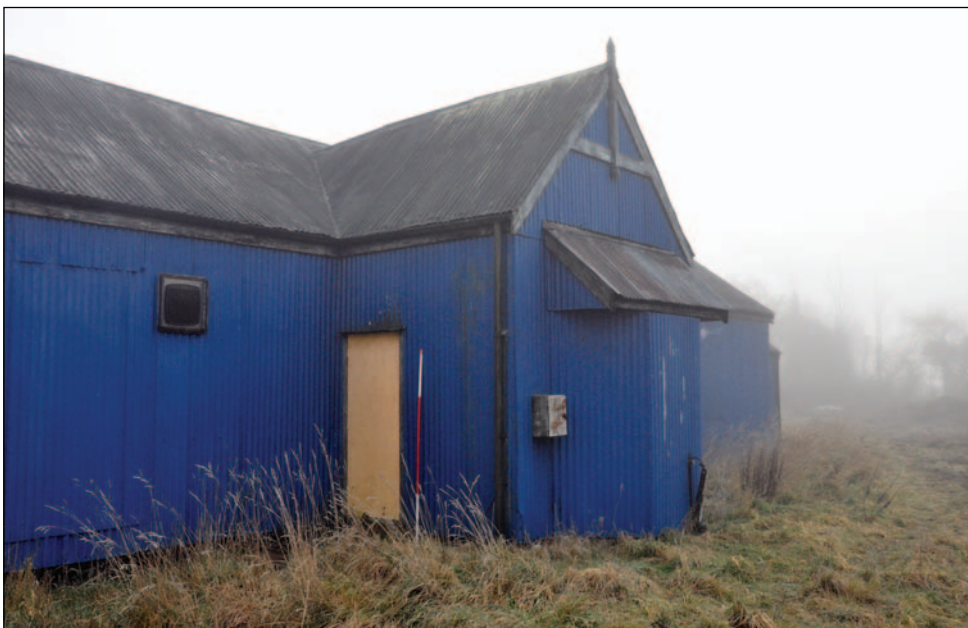
Plate 8: Western office wing showing doorway

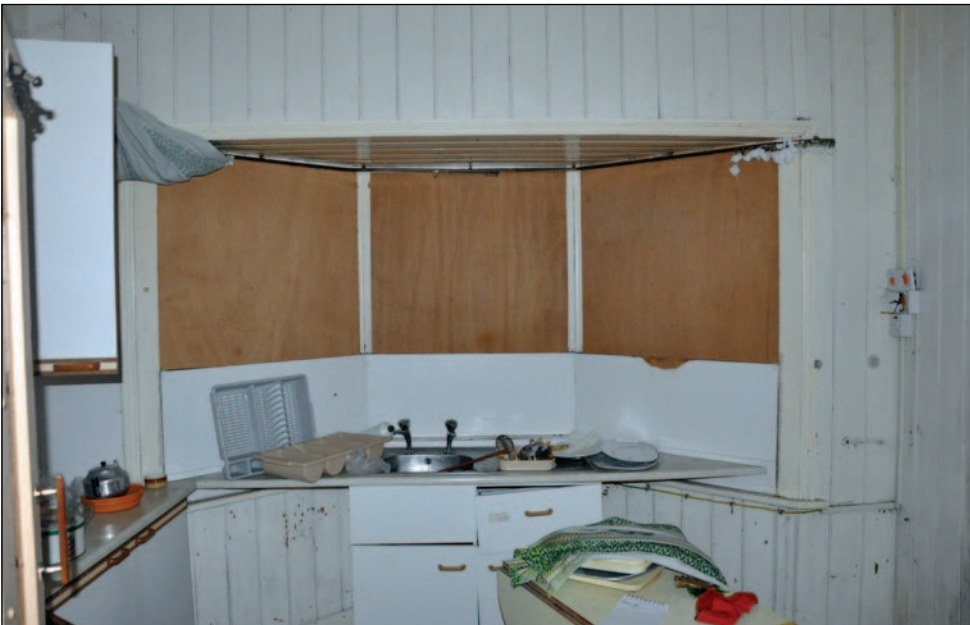
Plate 10: Kitchen area showing tongue and groove panelling
