**Willot Hall,
Wilmslow Road,
Prestbury,
Cheshire**

**Archaeological
Watching Brief,
Phase 2**

Oxford Archaeology North

April 2014

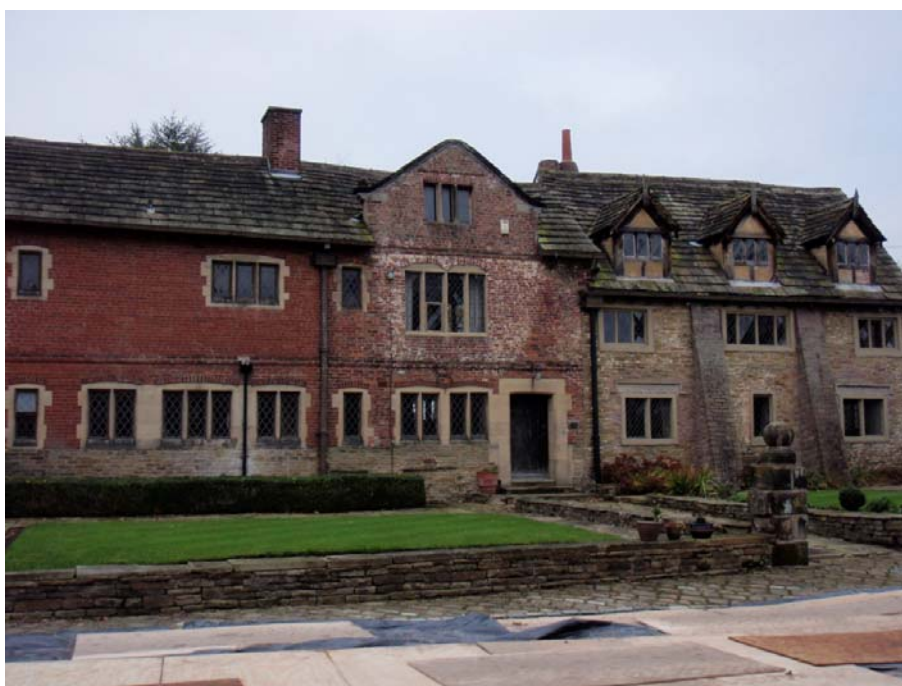
- 1.3.2 Willot Hall is a Grade II* listed building built in the fifteenth century. It was originally a medieval timber-framed hall, converted to a farmhouse, and now a private residence. It underwent extensive renovation in the seventeenth century when it was encased in stone, along with repairs and brick additions of a service wing in the late seventeenth century. The building underwent a major restoration, with extension of the solar, in 1939. The current building consists of sandstone rubble and brick, with a stone-slate roof. The interior plan of the hall, solar and the passageways survive, and the medieval hall has been re-opened to the roof (*ibid*).

Plate 1: View of the facade of Willot Hall, showing the varying phases of construction

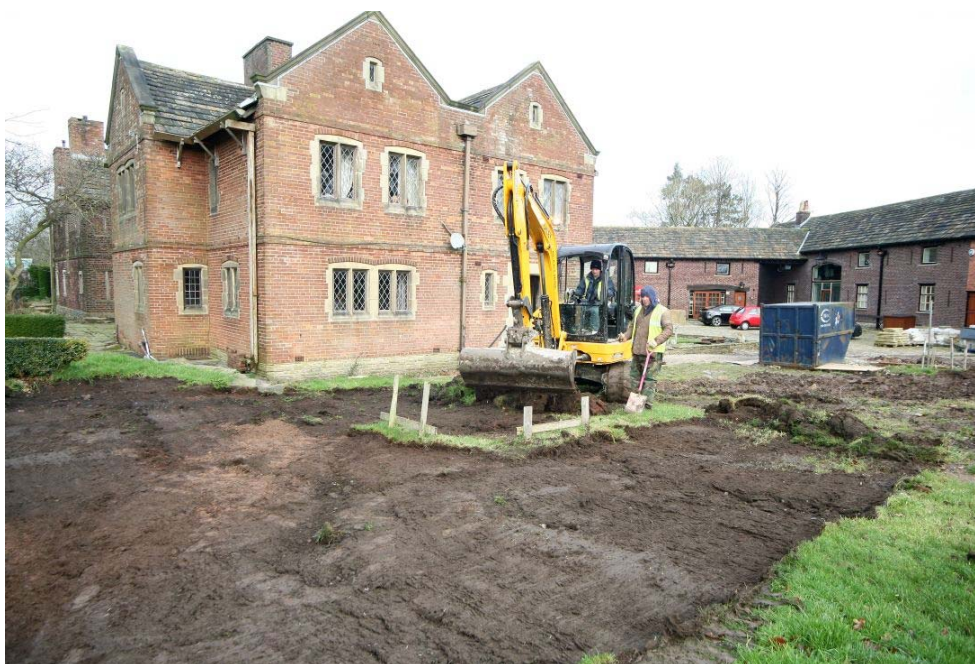
3.2.1 The area of groundworks measured 9.5m by 5.5m (Plate 2). It was covered in a dark brown silty topsoil, **1**, with a thickness of up to 0.45m, containing approximately 5% to 10% well-rounded stones and was similar in appearance to that recorded during Phase 1. The topsoil deposit overlay a layer of demolition/rubble material, **2**, which consisted primarily of clinker and 10% crushed brick. For the most part this was between 0.2m and 0.3m thick and sealed the natural geology, **3** (although this undulated), which was a combination of orange-yellow sands and brownish-yellow boulder clay. An area of yellow-orange sand, **9**, was present as a strip running down the side of the main house. An area of clinker and ash was present at the east end of the site, **10**, which was cut into the natural geology.

Plate 2: View northwards across the excavated area

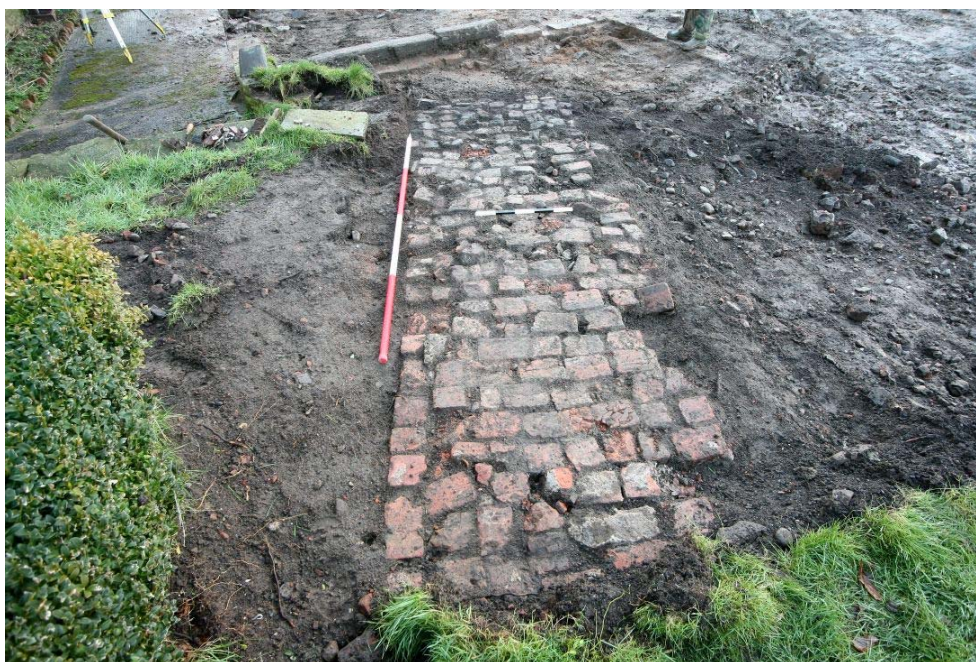
3.2.2 In total, four structures were revealed during the excavations, **4**, **5**, **6** and **8** (Fig 2). Structure **4** was the remains of a brick floor/surface approximately 1.13m long by 0.39m wide made up of red handmade brick, the average size of which measured some 0.15m by 0.13m by 0.07m (Plate 3). They were laid in straight courses with a row of headers at the northern end. The surface was a single course deep, and lay directly below the topsoil, **1**, and was constructed

the demolition/rubble material **2**. It appeared to be truncated at the southern end and may have extended further.

Plate 3: Structure 4, facing east

- 4.1.2 Structure **4**, the brick surface, may represent a walkway or similar such feature leading towards a formal garden at the rear of the hall. It was placed directly on top of demolition rubble/ash, **2**. Structures **5** and **6** represent probable small structures/buildings situated to the south of the current hall. Interestingly, they are aligned on a slightly different axis to the main building and it is entirely possible that they once continued further to the north as they are truncated at the northern end by a cut containing a deep layer of sand, **9**, that appears to be associated with the 1930s extension to the hall.

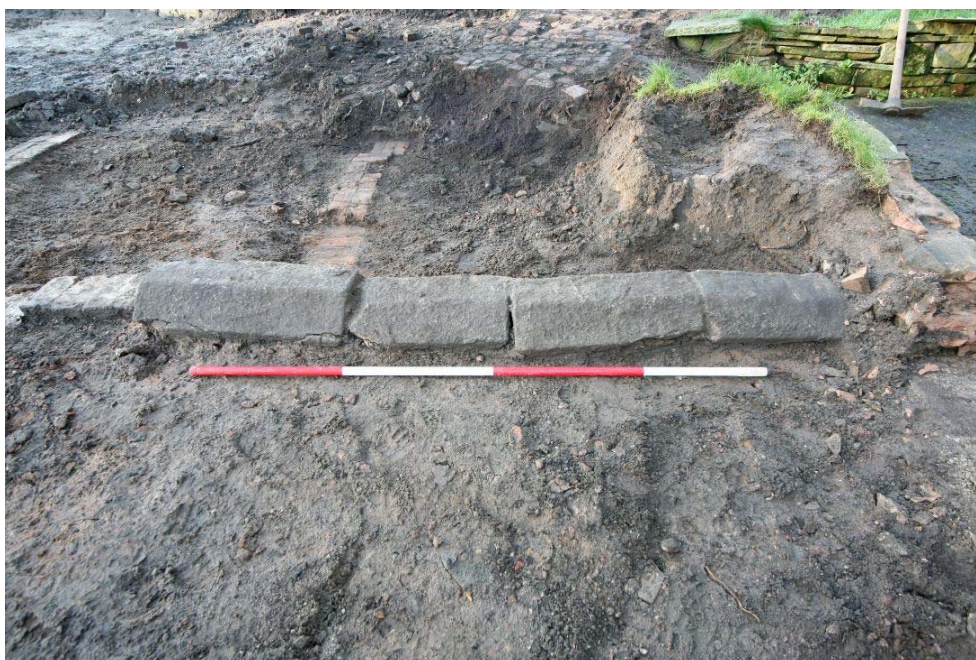
3.2.3 Structure **5** consisted of a single row of re-used stone copings partially sited on top of a brick wall, **6** partially overlapping deposit **2** (Plate 4). The copings were of grey sandstone and each one measured some 0.76m by 0.30m by 0.26m. They were chamfered on one side and were laid on an approximately north-west/south-east axis for a length of 2.55m (Fig 2).

Plate 4: Structure 5, facing west

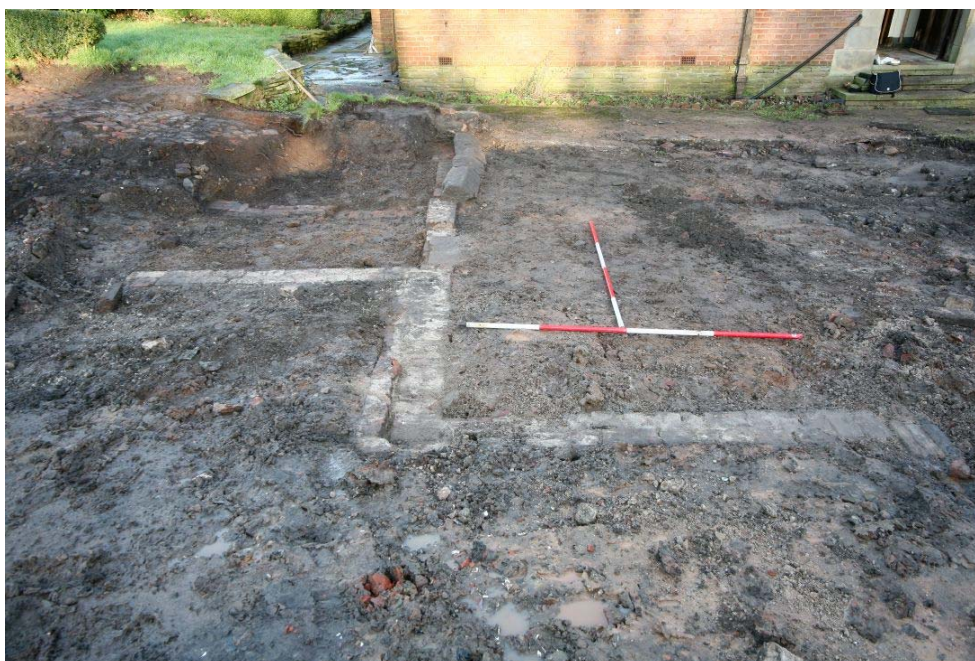
3.2.4 Below structure 5 a rectangular arrangement of brick walls, 6, was present (Fig 2, Plate 5). These probably formed the foundations of some sort building/s and each of the walls was cut directly into the natural geology, 3 and sealed by deposit 2. The walls were two or three courses deep and bonded with lime mortar, laid in stretcher bond, the walls aligned on a north-west/south-east axis being 0.36m wide, whilst those on an north-east/south-west axis were 0.23m wide, probably indicating external and internal walls. The bricks were handmade and had average dimensions of 0.23m by 0.11m by 0.08m. No trace of any internal floor surface was visible, although a possible sandstone threshold was present within one of the north-west/south-east aligned walls (Fig 2). The northern end of the walls are truncated by a cut containing a layer of sand, 9, probably associated with the 1930s extension to the hall.

Plate 5: Structure 6, facing north

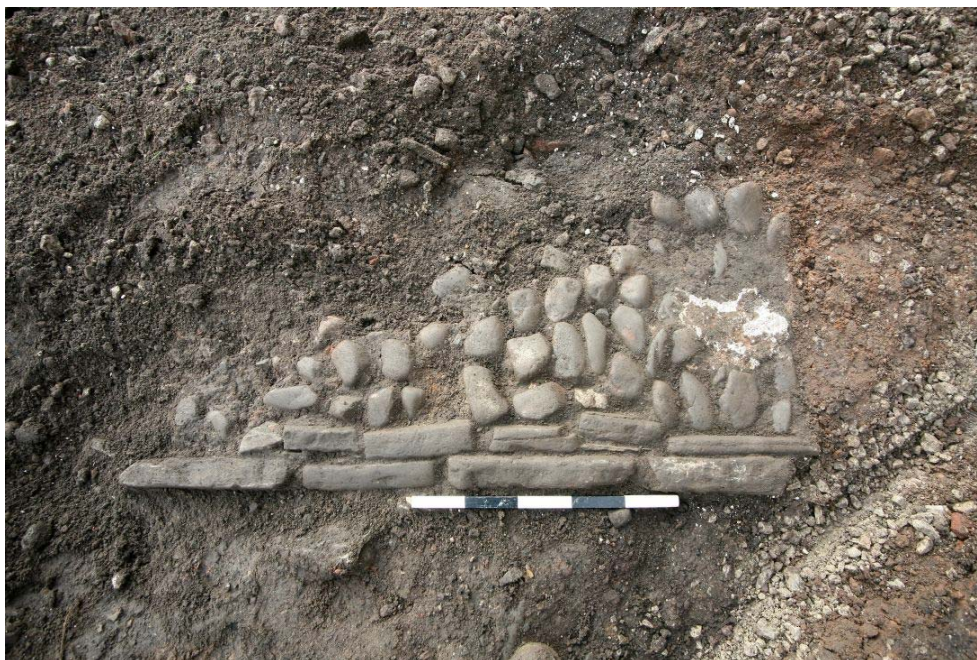
3.2.5 Further to the north-east of Structure 5, a fragment of cobbled surface was present, 8 (Plate 6). This was quite limited in extent, measuring no more than 1.4m long by 0.7m wide at the maximum extent. The cobbles were rounded, each being approximately 0.1m in diameter and were laid on edge directly into the natural geology, 3. The cobbles were defined on the eastern edge by a sandstone kerb consisting of two rows of individual sandstone blocks measuring approximately 0.25m by 0.3m by 0.03m. These were all laid on edge, directly into the natural geology, 3.

3.2.6 During the excavation, a concrete slab was lifted that appeared to be a continuation of the cobbled surface 8. This sloped to the north-east towards a culvert/drain of twentieth century appearance. To the north-east of this a pit, 10, was cut into both the natural geology, 3 and deposit, 2. This pit contained ash and rubble and was probably a rubbish pit.

Plate 6: Structure 8, facing west

- 4.1.3 To the east of the brick walls, **6**, a small fragment of cobbled surface, **8**, possibly mainly replaced with a later concrete slab, may represent a yard or other such space.
