# Archaeological Investigation at No.1 Ditton Walk Cambridge

## Archaeological Evaluation Report

OA East Report No: 1570

## **Archaeological Investigation at No. 1 Ditton Walk, Cambridge**

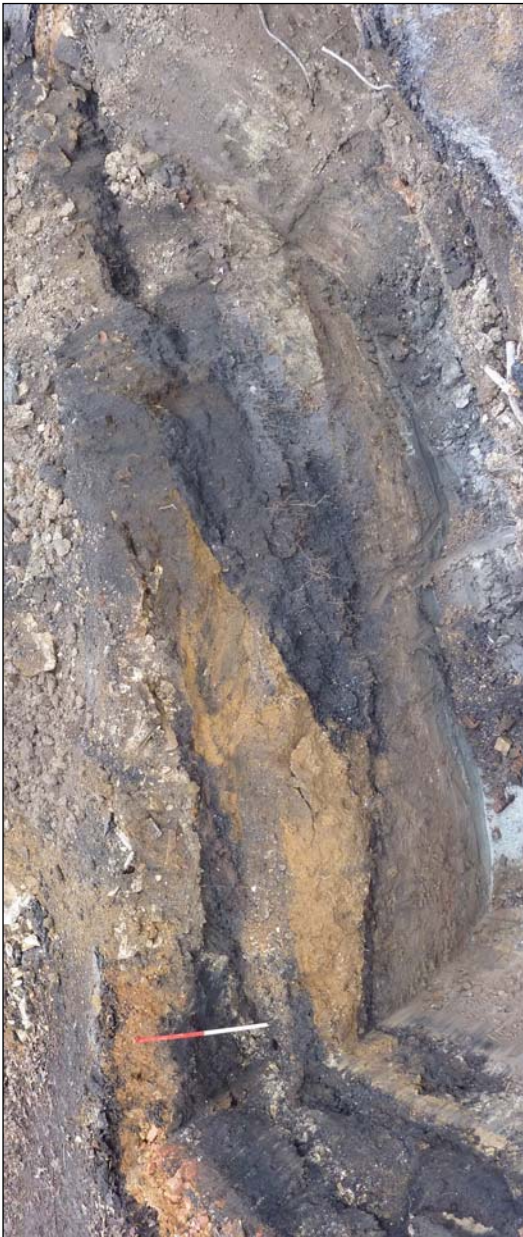
Plate 1: Section of Trench 1, looking west (1m scale)

3.2.5 Above this was a series of tipped layers making up ground from 1.6m to 0.4m below surface (see Plate 1). In order of deposition, these consisted of redeposited chalk marl, followed by clinker, coarse sand, more clinker and hardcore.

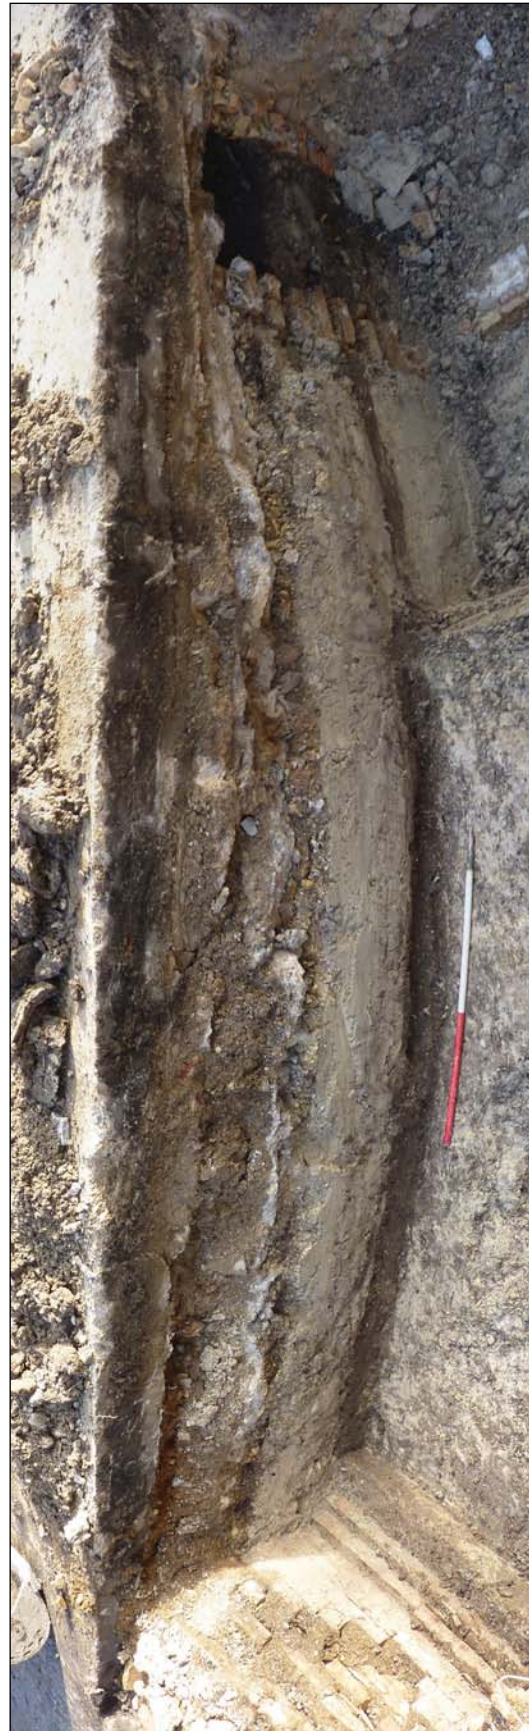
Plate 2: Section of Trench 2, showing 19th-century and later build-up, looking east (1m scale)

3.3.3 Across much of the north of the trench, the natural marl was covered by a thin soil (104; see Plates 2 and 4 and Fig. 4) extending into the eastern baulk, 0.15m thick. This contained only 19th-century material, primarily brick and tile fragments, but no indication of the nature of any associated activity. The lack of any interface layer with the natural marl below the soil shows it built up after an earlier terracing/truncation event i.e. that even here the natural chalk marl was truncated to a depth of 1.5m (5.95m OD) in the 19th century.

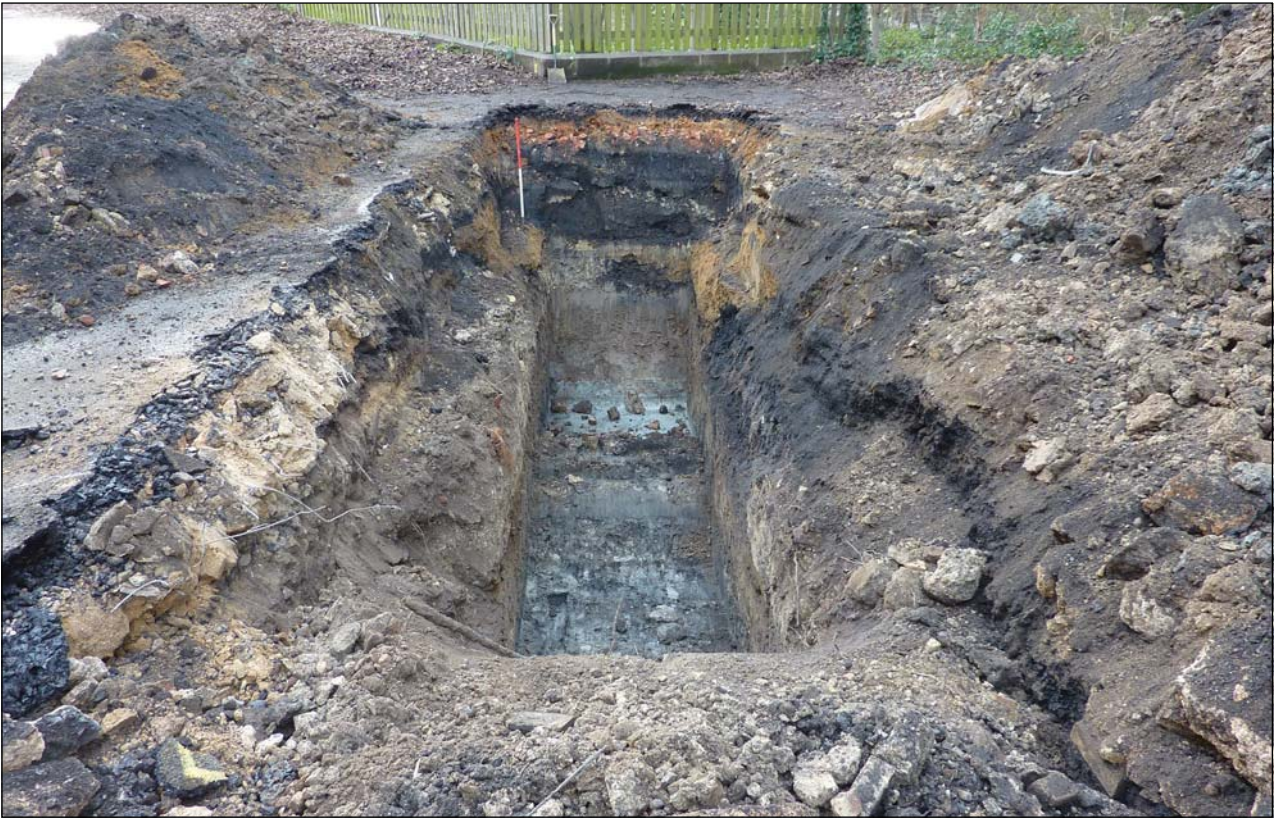
Plate 3: Trench 1, looking south (1m scale)

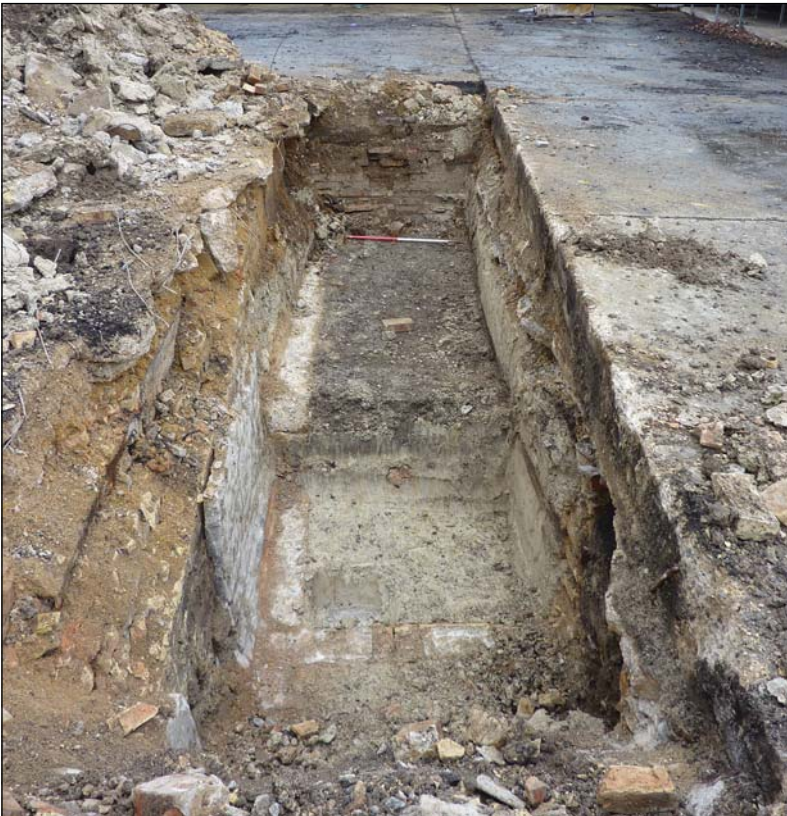
Plate 4: Trench 2, showing soil layer 104 prior to excavation, looking north (1m scale)

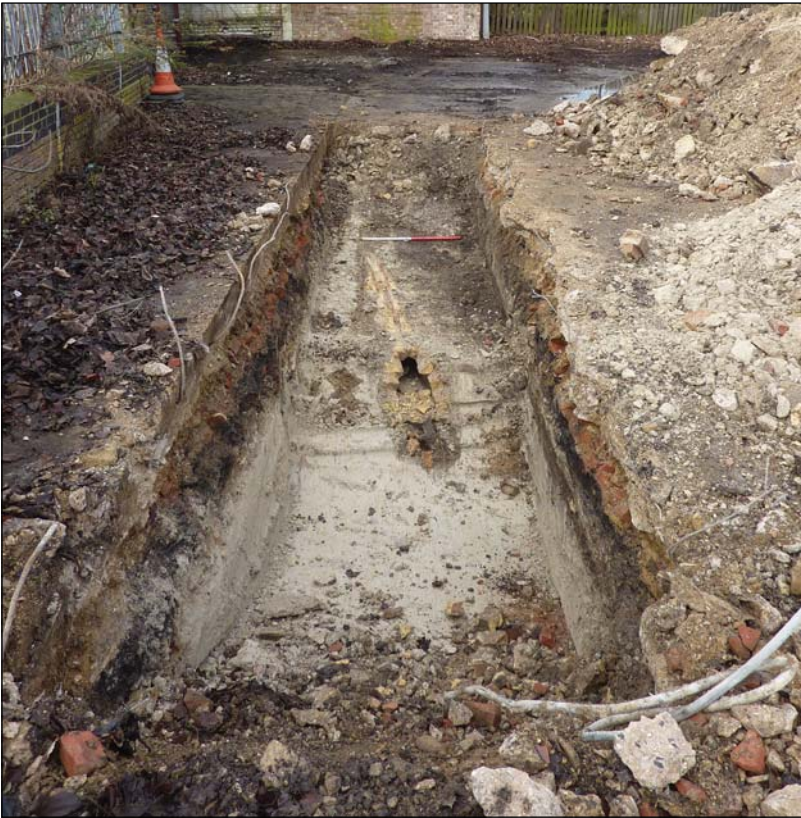
Plate 5: Trench 3, looking west (1m scale)

3.4.1 Parallel with the southern boundary, Trench 3 ran southeast-northwest for 8m at 1.6m wide. The natural deposit of chalk marl was encountered at a depth of 0.8m (6.70m OD) and tested with a machine sondage at the eastern end to 1.5m (6.00m OD). It was very firm with no inclusions. This had evidently been truncated with no evidence of any soil surviving above it.
