12a Friars Entry Oxford

Archaeological Excavation and Watching Brief Report

Excavation and Watching Brief Report

Historic Building Record Level 2

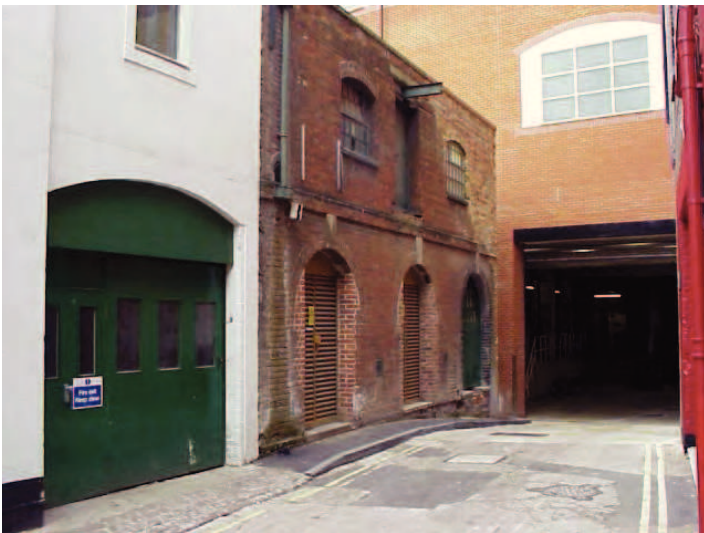
Photo EX01: South elevation to Red Lion Square, looking towards Debenhams delivery yard

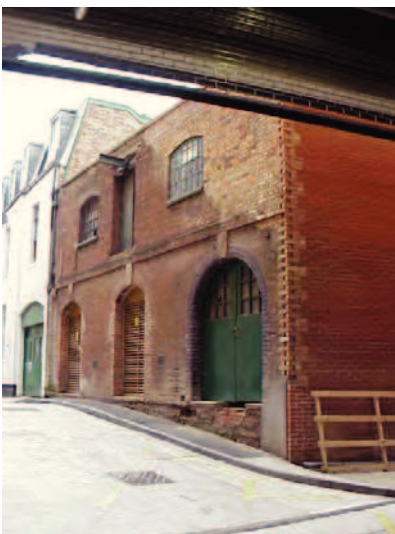
Photo EX02: South elevation to Red Lion Square as seen from Debenhams delivery yard

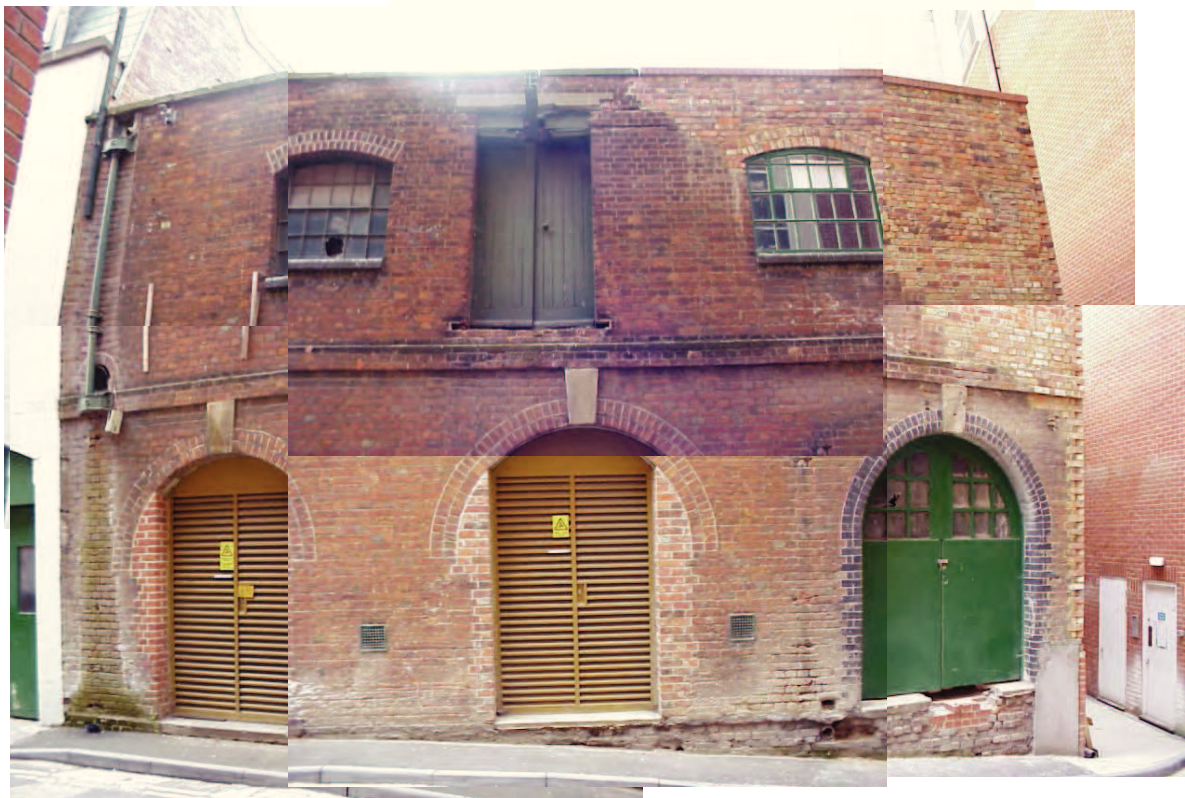
Due to the site restrictions it was not always possible to take all photographs perpendicular to the elevations and in the case of a south (principal) elevation a photomontage was produced.

South elevation to Red Lion Square photomontage

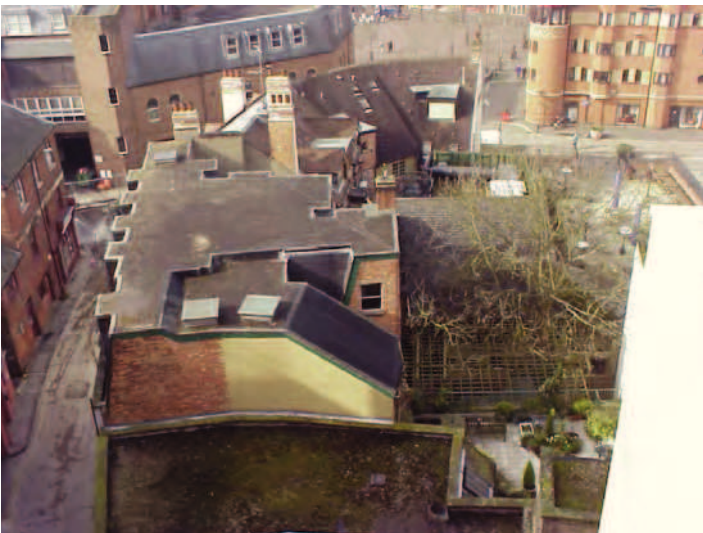
Flat roof seen from Debenhams building

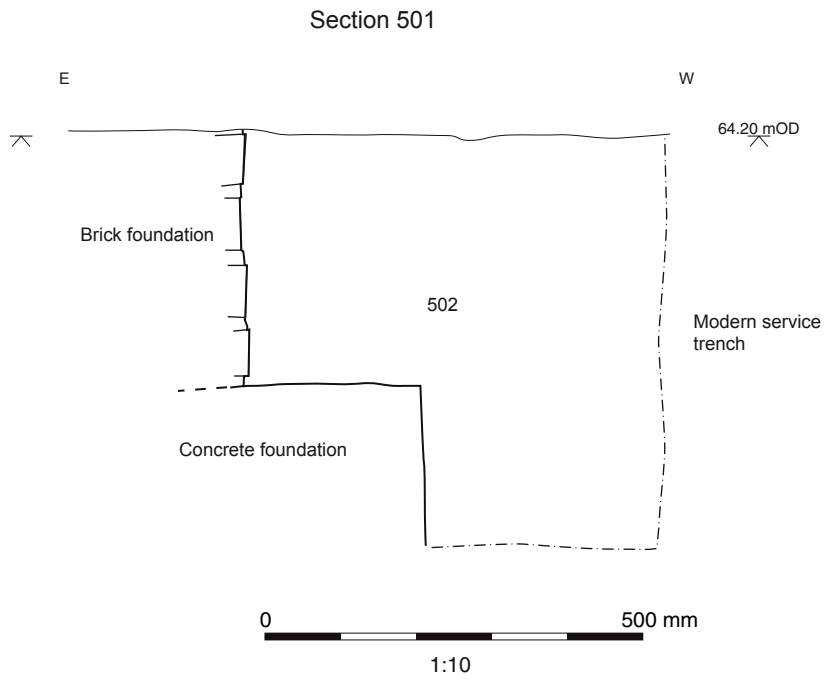
Figure 3: Test Pit 5: Section 501

3.9.1 This trench was 1.2m x 0.7m and 0.55m deep. The stepped brick and concrete foundation for the adjacent shop was overlain by modern made ground (502), more than 0.55m thick, consisting of sandy clay and building rubble (Fig. 3). A modern plastic doll pierced with nails was recovered from deposit 502 (Plate 1).
