New Water Feature Thame Park Thame Oxfordshire

Archaeological Evaluation Report

December 2006

Issue N^o: 1
OA Job N^o: 7018
NGR: SP 7166 0375

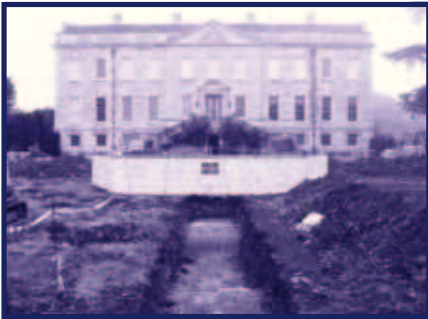
Cover Plate: View of the front of Thame Park with Trench 7 in foreground.
