The Church of St Peter and St Paul, Olney,  
Buckinghamshire

ARCHAEOLOGICAL WATCHING BRIEF REPORT

Oxford Archaeological Unit

May 1998

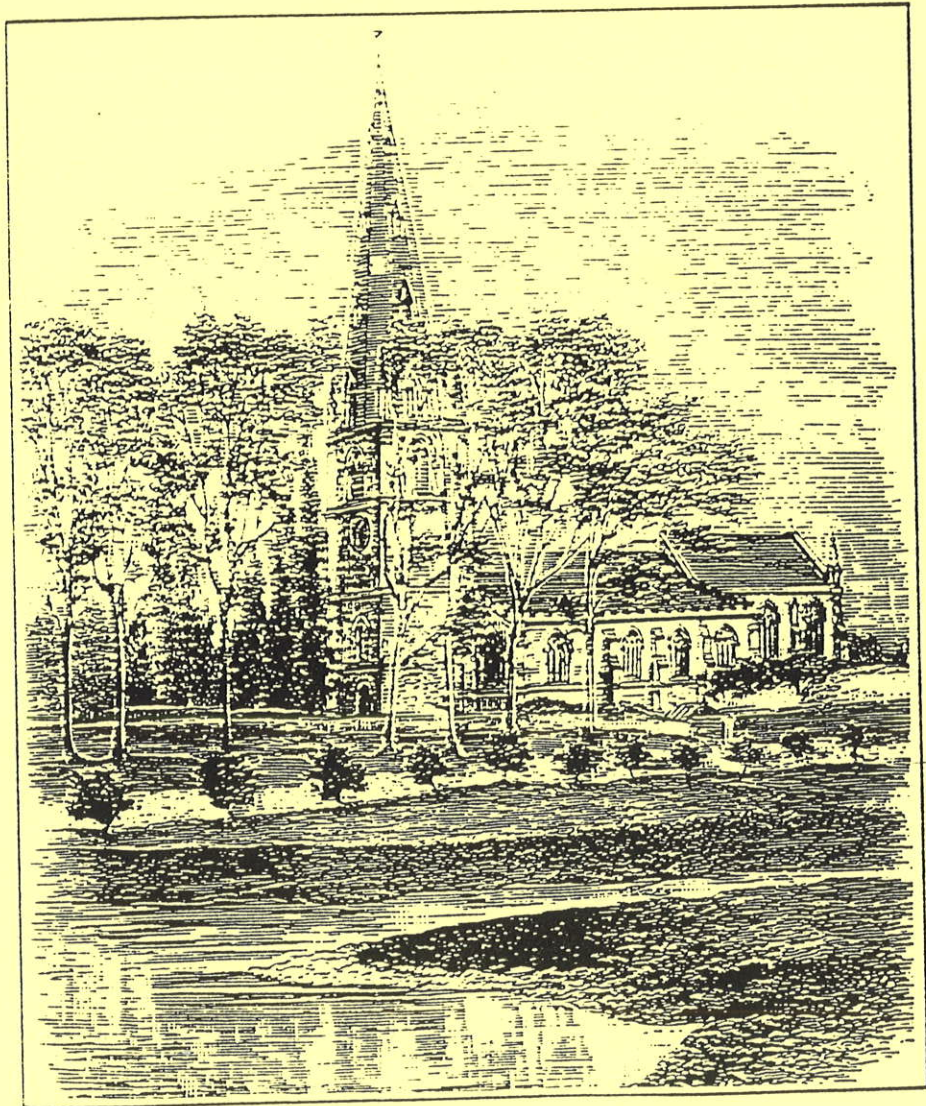
The church of St Peter and St Paul lies at the south end of the town of Olney. The present building is believed to contain elements of a 12<sup>th</sup> century structure, but mainly dates from the 14<sup>th</sup> century. At this time the chancel was rebuilt and enlarged, the north and south aisles added and also the distinctive tower and spire.

The south aisle was almost completely rebuilt at the end of the 19<sup>th</sup> century, and the entire building was extensively restored in the 19<sup>th</sup> and 20<sup>th</sup> centuries.
