Site/Project Name: **St Peters and St Pauls Church, Olney**

Site Code: OLPP95

Site/Project Type: Watching Brief

WATCHING BRIEF RECORD		
Site Code OLPP	Site Name ST PETER AND ST PAULS CHURCH, OLNEY	
NGR	County BUCKS	Date 21/9/95
Previous visit: 18/9/95	Visit by: BOB WILLIAMS	
Start time 9.00 am	Time finish 11.30 am	
Mileage None - very close to home.		
Type of 'construction' work Excavation of 250mm wide trench c. 300 - 650m deep across SW corner of Tower probing c. 6 metres into ground at West of Tower.		
Contacts made: Vince - builder. Ted Carter - Churchbridge Foreman?		
Archaeology present? Yes.		
Yes	Medieval / Post-medieval floor levels	
No	/	
Undated	/	
Other	? late medieval shield fault in burnt layer representing top of late medieval floors?	
COMMENTS		
Following telephone call from builder to say had started digging some trenches in tower unable to record work - only trench across SW corner of tower completed - other trench still being dug. One long section of trench including 6.2 m length outside W end of tower cleaned up and drawn/described. Layers are very similar to those recorded in the stratigraphic pits although at no point was the trench deep enough to have reac

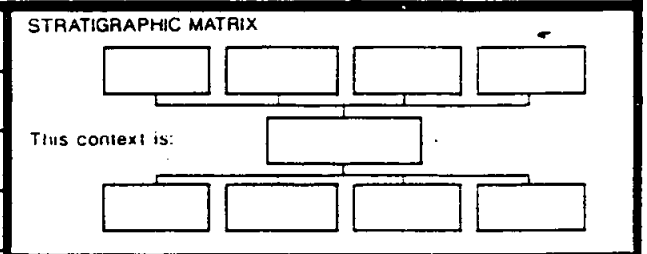
①	Hard
②	cream coloured
③	lime 'putty'
④	none.
⑤	
⑥	
⑦	
⑧

Interpretation/Discussion: Very thin lens of lime putty sealed beneath the three floor levels ⑥

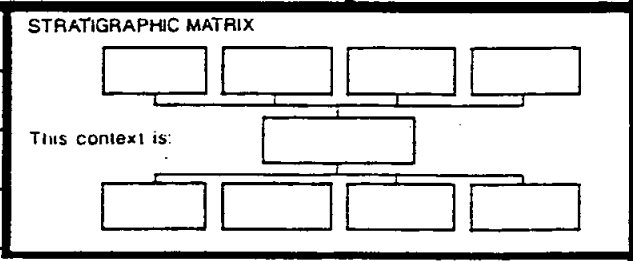
Interpretation/Discussion: *Reconstruc Yorkstone kerb set into floor of tower.*

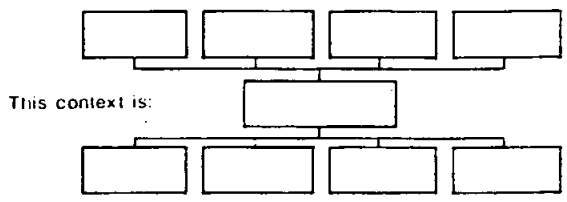
<p>This context is:</p>
Interpretation/Discussion: Localised lens of clayey mortar lying on top of floor levels ⑥ and sealed beneath later floor make up.

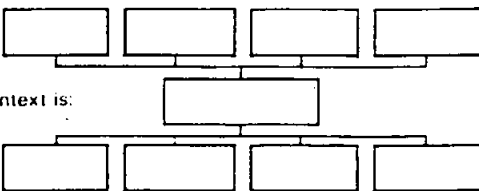
Description (See check lists):	STRATIGRAPHIC MATRIX
① Medium brown.

② compact	This context is:
③ clayey silt	
④ fragments of burnt clay + few small	
⑤ fragments of limestone	
⑥	
⑦	
⑧

Interpretation/Discussion: Layer of more clayey redeposited chuckyard soil overlies a thick deposit - Layer ② of mortar containing fragments of limestone

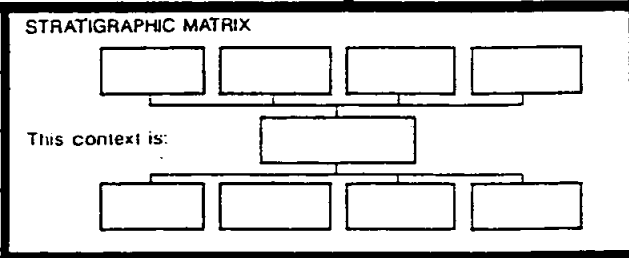
Interpretation/Discussion: Very thin dark layer - probably remains of the ash/dust deposit noted in the other pits - only survives over top of flint stone tower foundation

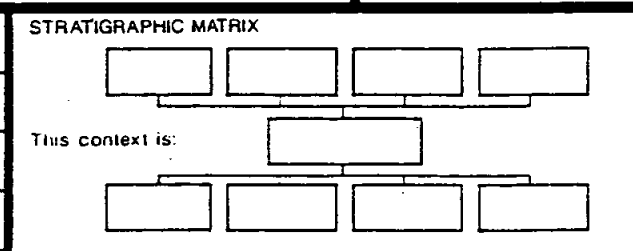
Interpretation/Discussion: Offset tower foundation built of large mainly coursed rectangular roughly cut limestone blocks up to 500mm + long and 150mm thick - one piece shows evidence of narrow chisel tooling.

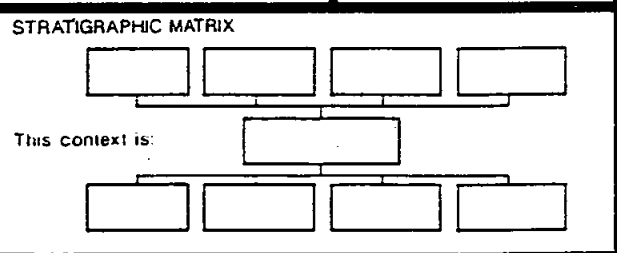
Service trench dug across SW inner corner of Tower tunnelled under large stone threshold slab of W door of Tower and excavated 6.2 m into the ground to the west of the tower to join manhole connection with Trench 3 - see dug 1. Trench is 250 mm wide in tower and 300 mm outside. Base slopes from 300 mm below inner floor level at SE end to 650 mm below tarmac surface at NW end. NE facing section cleaned by hand and entire section drawn at 1:20 - Dug 8.

Section shows build up of probable later medieval and post medieval floor levels/houses mainly consisting of compacted mortar although at 200 mm below modern floor is a thin layer averaging 20-25 mm thick of finely laminated ash/dust and soot overlying a clean mortar layer. The ash/dust layer contains localised areas of greater soot concentration and one area of more intense burning reddening the layer beneath.

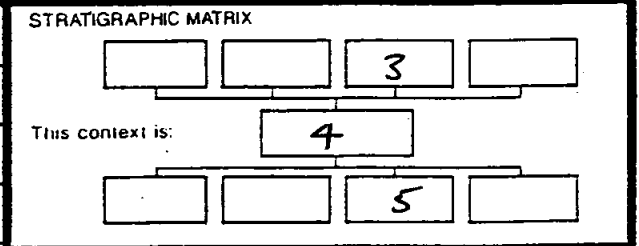
Description (See check lists):	
①	Firm
②	Creamy yellow
③	fine mortar/plaster
④	None.
⑤	Up to 20mm
⑥	Max width 750mm.
⑦	_____
⑧	Only visible in section

Interpretation/Discussion: Thin lens of plaster overlying dusts floor 5 - either remains of lime floor worn away elsewhere or more likely localised area of lime plaster deposit.

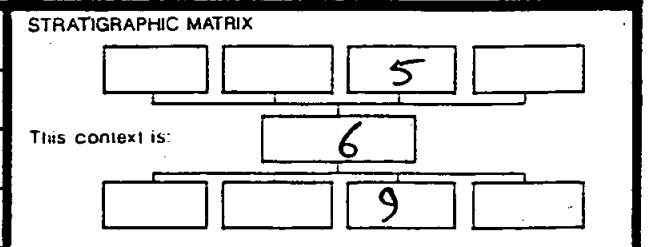
Description (See check lists):	
①	Firm
②	Creamy yellow
③	fine mortar/plaster
④	None.
⑤	Up to 35 mm thick
⑥	Extends up to 800 mm from S. wall of Tower
⑦	/
⑧	Only visible in section:

Interpretation/Discussion: This lens of creamy coloured fine mortar/plaster abutting the south wall of the tower. - is sandwiched between the geyser basin mortar 'floor' layer ② and the dusty floor deposits ⑤. Maybe remains of an intervening floor which has been almost entirely unexcavated apart from here it is very close to the tower walls

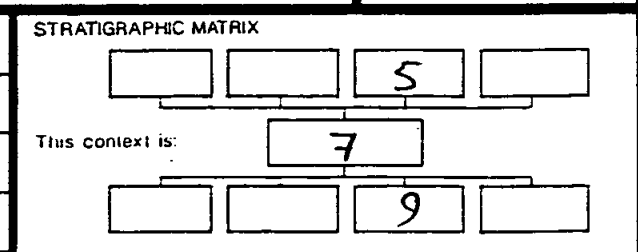
①	Loose.
②	Reddish brown.
③	Burnt mortar
④	None.
⑤	Up to 28mm thick
⑥	Maximum width 650mm
⑦	/
⑧	Only seen in section.

Interpretation/Discussion: Localised area of greyish brown mortar 'floor' - Layer ⑧ which has been fire reddened by intense burning above as indicated by the greater concentration of soot on it in the layer above - Layer ⑤

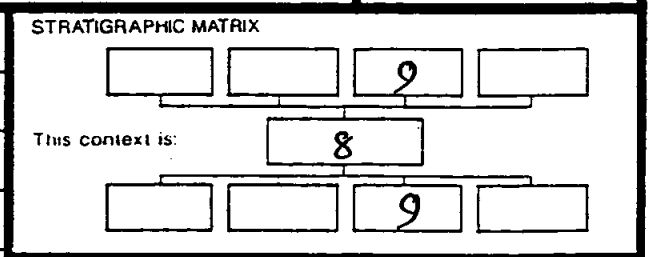
- Description (See check lists):
- ① Compact
 - ② Medium brown
 - ③ Clayey loam
 - ④ creamed mortar fragment
 - ⑤ Up to 15mm thick
 - ⑥ Maximum width 500mm
 - ⑦ /
 - ⑧ Only seen in section

Interpretation/Discussion: Thin lens of brown clayey soil noted within the thicker mortar 'floor' ② - almost certainly a trample layer of an area of clayey soil of similar type to Layer ⑪

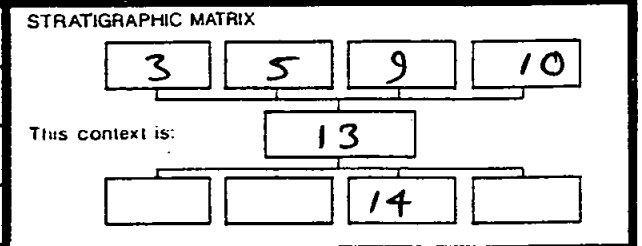
Description (See check lists):	
①	Very loose.
②	Orange brown
③	Sandy gravel.
④	80% gravel > 20mm across
⑤	Up to 100mm thick
⑥	Almost 2m wide
⑦	—
⑧	Only seen in section

Interpretation/Discussion: Orange brown sandy gravel mainly underlying the large limestone threshold slab but also spread out over the top of the stone footings beneath and to either side - clearly a levelling up layer on which the slab was laid at an unspecified date.

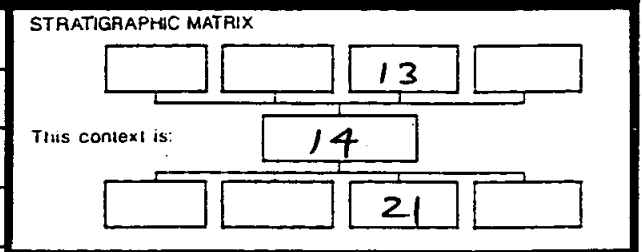
①	limestone blocks
②	Up to 400 mm across
③	Randomly laid.
④	" - "
⑤	—
⑥	—
⑦	—
⑧	—

Interpretation/Discussion: Large random limestone features for tower beneath threshold of west door with geyser basin mortar matrix same as that noted in the offset features recorded in Pits 1 and 5 - Contributor trench **[21]** with crantide.

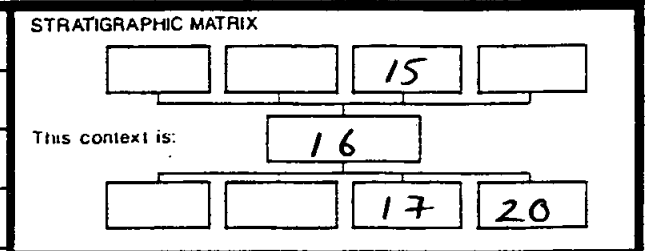
Description (See check lists):	
①	Loose
②	Angled beam
③	clayey gravel
④	Card up to 20mm across
⑤	Up to 180mm thick
⑥	Extends from West door of Tower some distance to W.
⑦	—
⑧	—

Interpretation/Discussion: Thick layer of clayey gravel forming former footpaths around Western side of the tower - not possible to see individual layers but probably represents a number of paths of 18th - 20th century date.

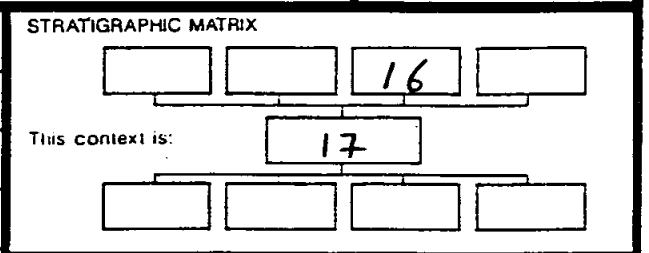
Description (See check lists):	Firm
①	
②	Medium brown
③	clayey loam.
④	Small amount of gravel + few human bones.
⑤	400mm +
⑥	Vubble in trench outside of tower - not seen inside church tower
⑦	—
⑧	—

Interpretation/Discussion: Churchyard soil sealed beneath post medieval gravel and tarmac paths - contains few small fragments of human bone. Cut by 20th century drain - Cut/19

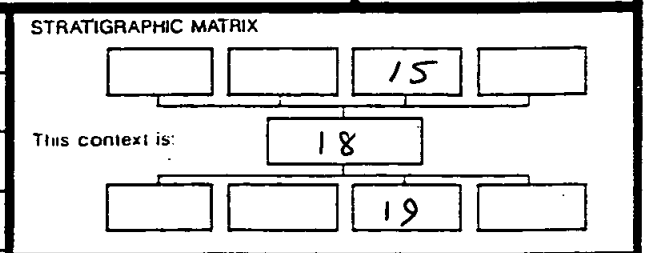
Description (See check lists):	
①	Relatively loose
②	Dark brown
③	gravelly loam
④	30% gravel.
⑤	—
⑥	—
⑦	—
⑧	Only seen in section

Interpretation/Discussion: Full of drain cut overlying 6" soft-glazed pipe cut through gravel paths but sealed beneath terrace surface.

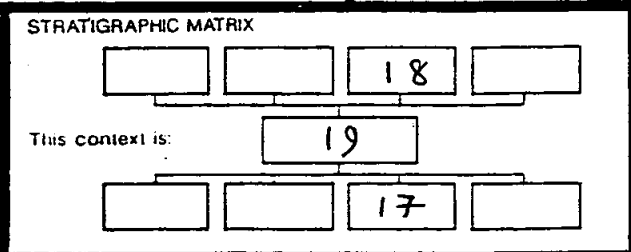
Description (See check lists):	
①	Not seen - but parallel sided
②	Steep sided
③	400mm top, 250mm wide base.
④	10/
⑤	None.
⑥	Filled by 18 and 6" sabbled pipe.
⑦	—
⑧	—

Interpretation/Discussion: Cut for late 19th / 20th century storm drain pipe
 runs N-S across west of Tower.

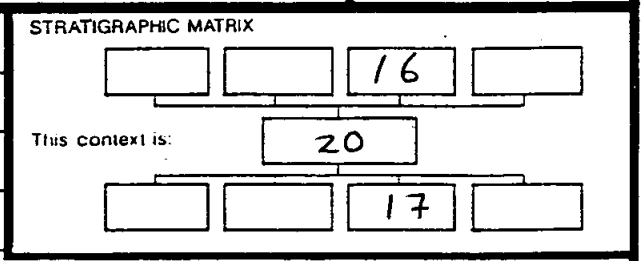
①	Firm
②	Medium brown
③	clayey gravel.
④	20% gravel.
⑤	c. 600 mm wide
⑥	300 mm + deep.
⑦	—
⑧	Only seen in section

Interpretation/Discussion: Filled construction trench for Tower - not visible inside tower.

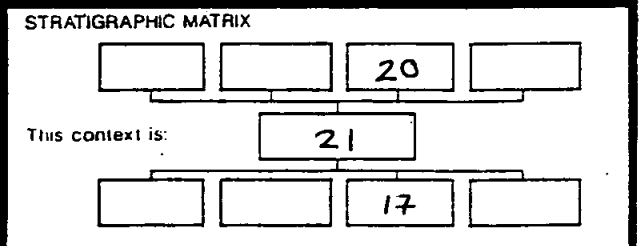
- (5) *Cut away on W. side by modern drain - [19]*
 - (6) *Filled by (20)*
 - (7) *—*
 - (8) *—*

Interpretation/Discussion: *Cut of construction trench of tower foundation.*

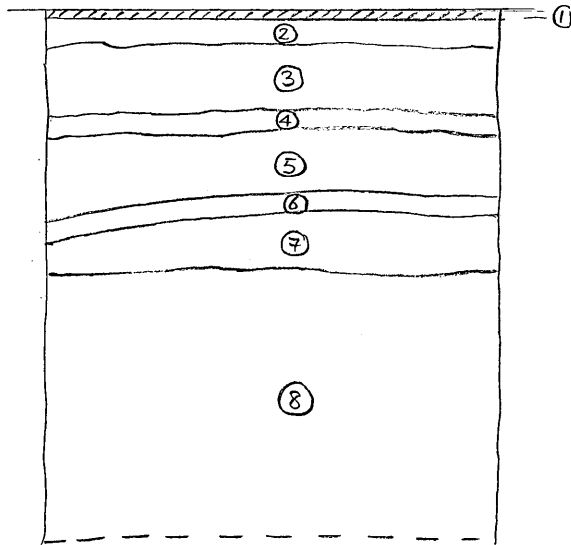
E - FACING

SECTIONS OF PIT 6 (SEE PLAN FOR LOCATION)

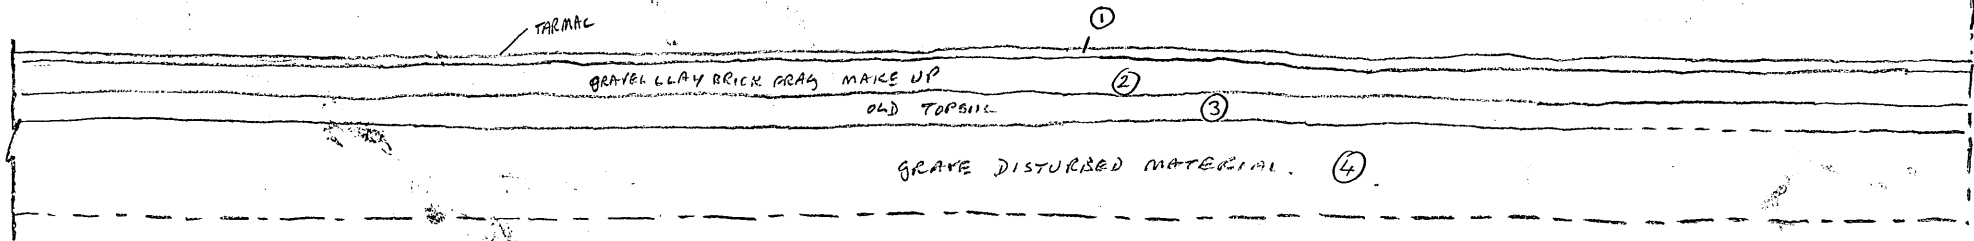
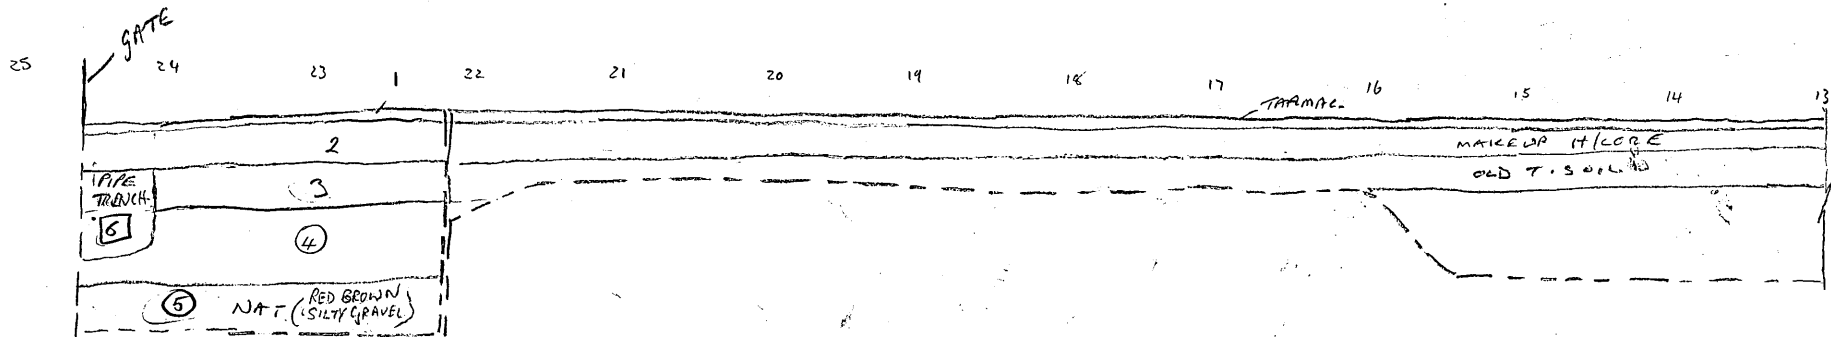
OLNEY. OLPP 95.
1:50 SECTION No. 10

Trench 3

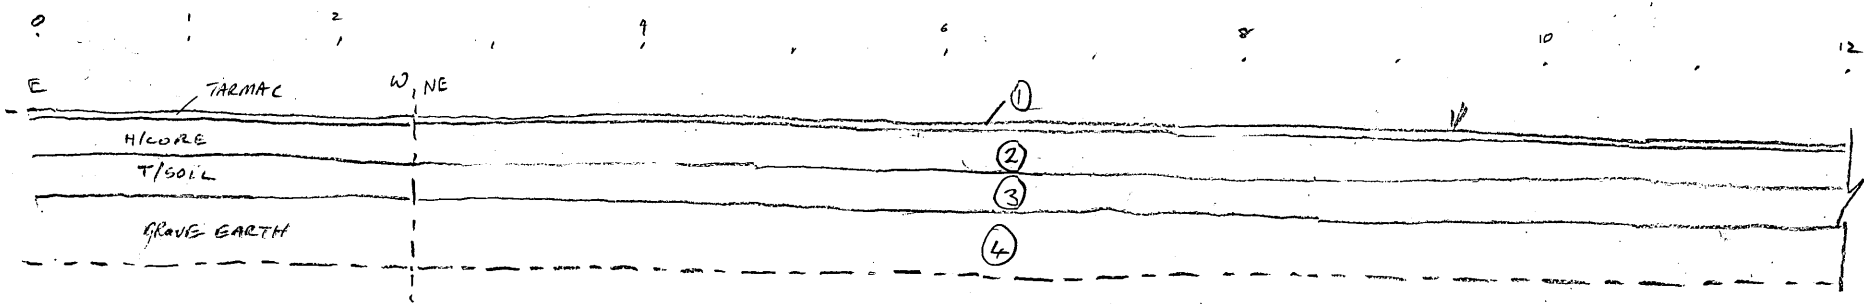
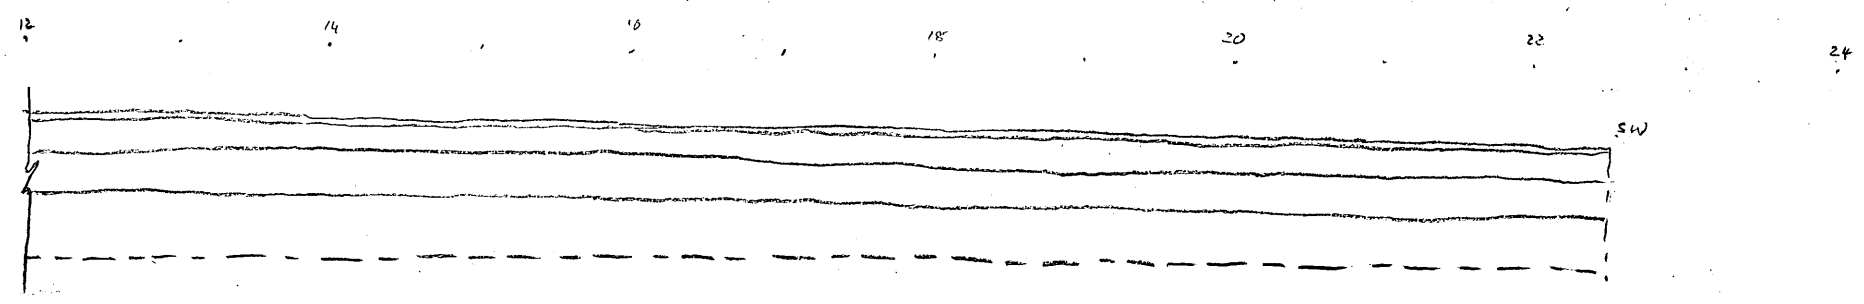
1:50
SECTION II

Trench 4.

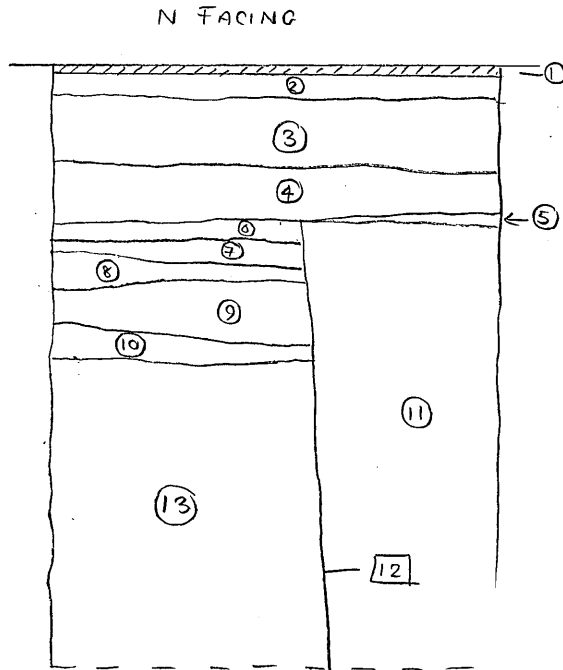
W-Facing section similar to east end of N-Facing section

S-Facing section consists of very large coursed limestone blocks same as in Pit 5

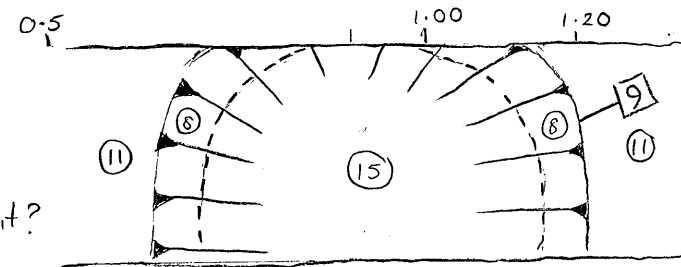
DETAILED PLAN OF PIT 9

SCALE 1:10

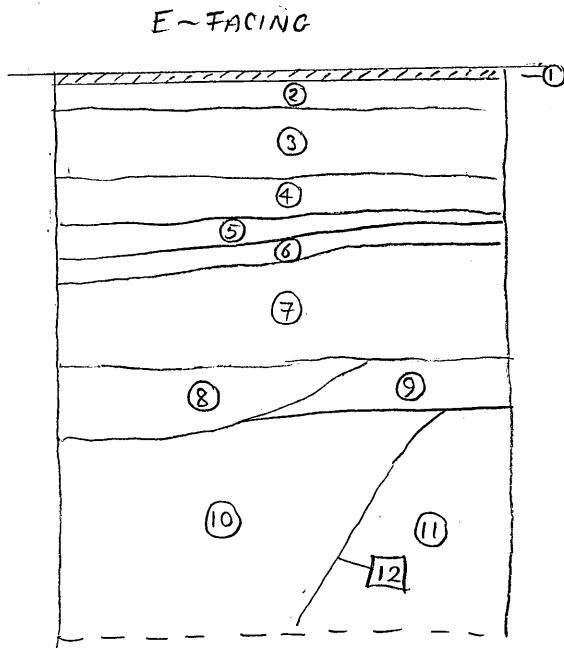
DWG 9

Other faces broadly similar
sequence but impossible to
clean up properly or examine
in any detail owing to confined
access to pit
