Hampton Court Palace Banqueting House Wall

Historic Building Investigation and Recording

November 2011

Client: Historic Royal Palaces

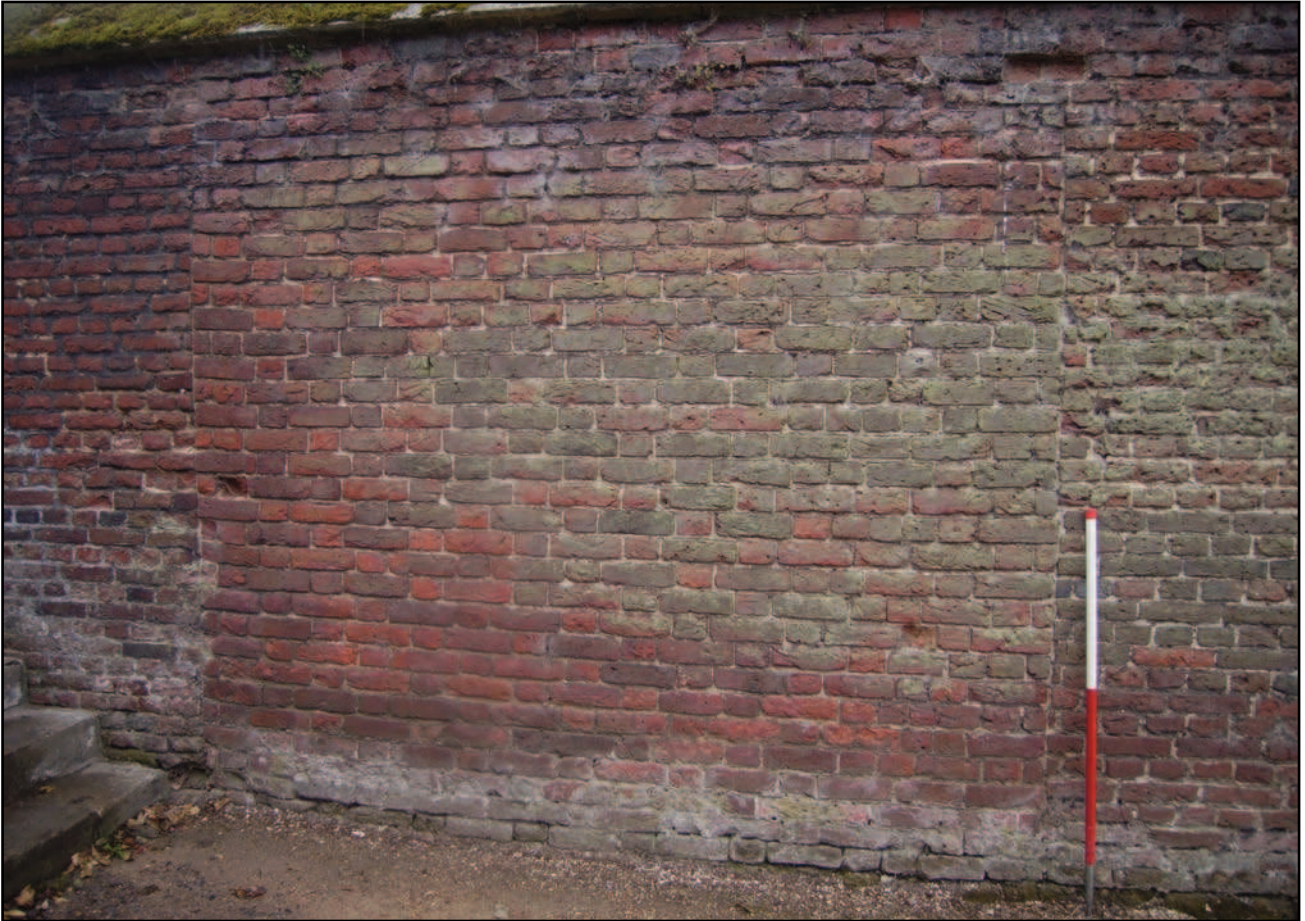
Plate 5: Infilled opening adjacent to south west garden stairs

- 3.2.3 There is a large area of infill bricks beside the stairs leading down from Queen Mary's Terrace at the south of the wall. These bricks are brown/orange in colour and measure 220-224 x 102-110 x 64-70mm with an arris to arris measurement of 292-296mm. The bricks are not uniform shape but the arrises are sharper than the adjoining Tudor brickwork and the mortar is dark cream in colour with

lime inclusions and friable to touch. The bricks are laid in a Flemish bond. The infill area is 2.68m wide with clear straight joints which is approximately the same size as the blocked window openings on this elevation. The straight joint continues to floor level on the northern jamb, however, suggesting this may be a former doorway rather than a window. The bricks are most likely **Type F**, a stock brick of the mid 17th century.

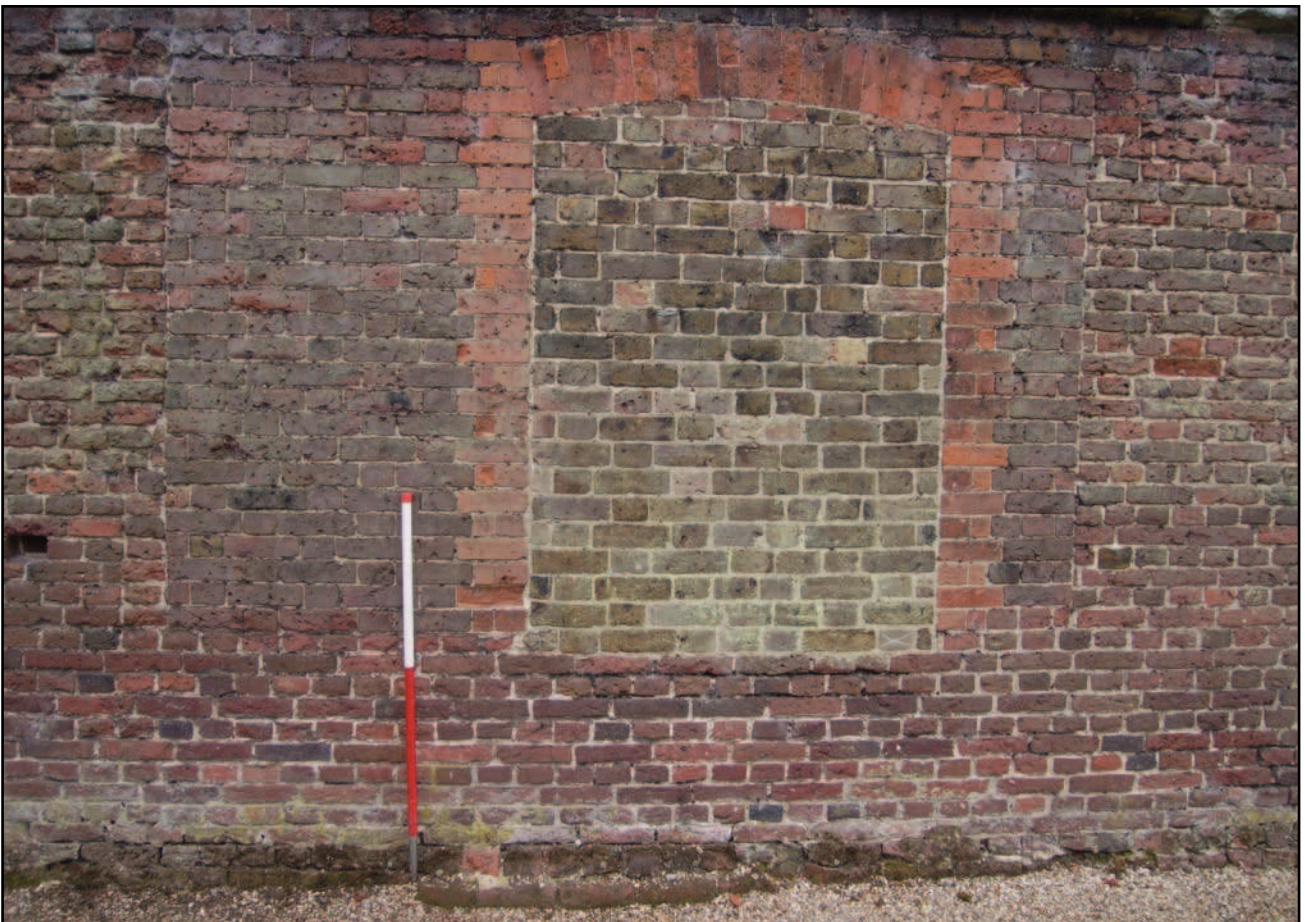
Plate 6: Infilled window opening on south west elevation of wall

- 3.2.5 The five blocked windows on this elevation of brickwork are clearly situated on the site of earlier larger window openings which may correspond with the openings depicted in Wyngaerde's drawing of 1558. The larger openings have been partly infilled with **Type H** bricks and the work probably carried out at the same time as the construction of the Banqueting House in 1701. The windows would have allowed views down into the aviary and orchard gardens from the raised walkway surrounding the former pond garden. The bricks used to form the jambs and arched lintels of the new window openings are red in colour with sharp arris and small stone inclusions within the clay mix. The pointing is very finely gauged with a pale cream coloured lime mortar. The bricks used are possibly **Type L**, a Wren Kentish ornamental stock brick which are used for detailing within brickwork during this phase. The same brick detailing around windows can be seen on the banqueting house itself.

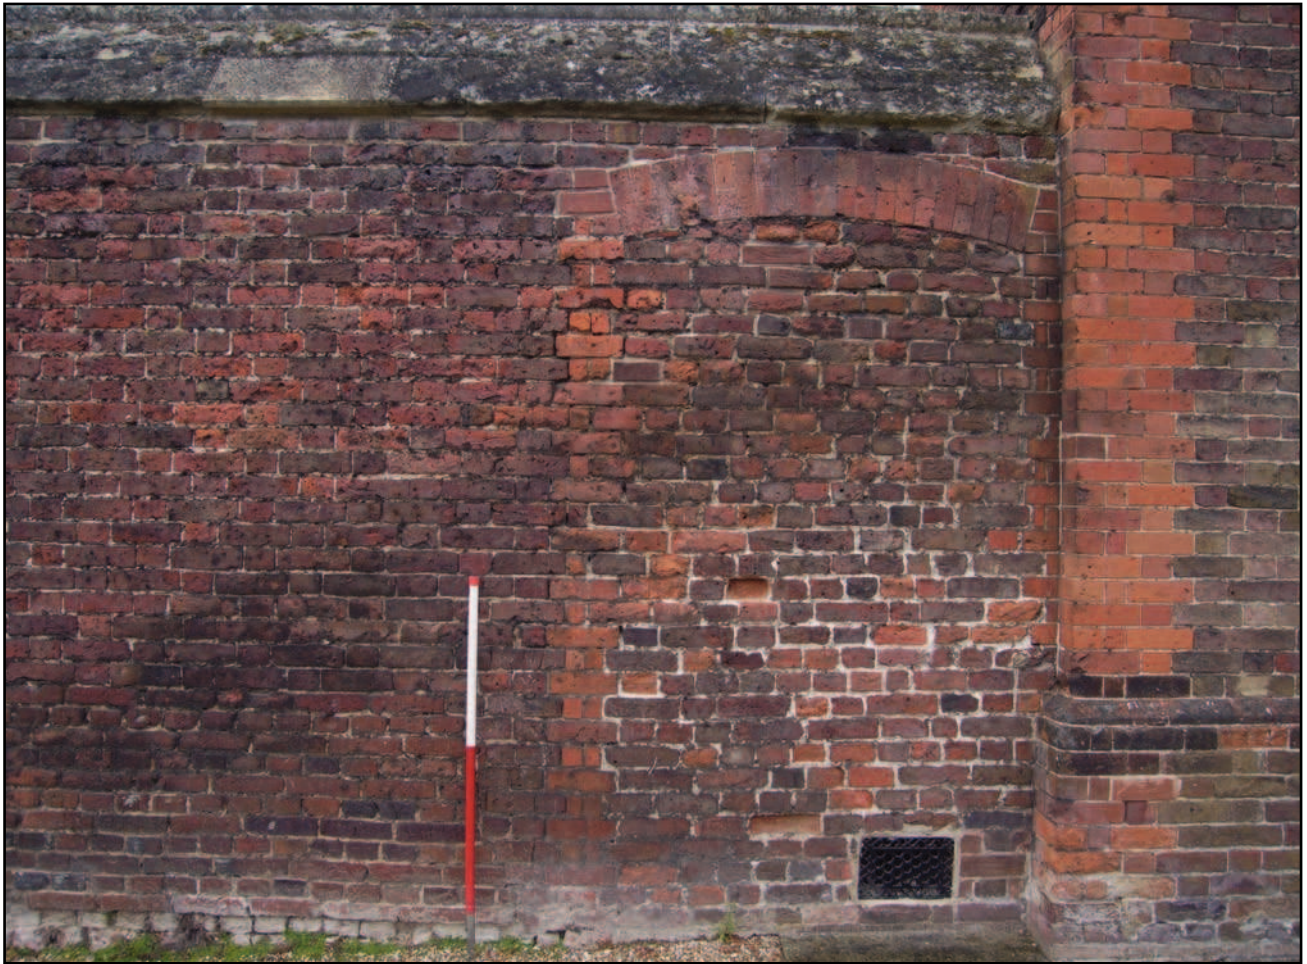
Plate 7: Infilled doorway on south west elevation of wall

- 3.2.7 A small blocked doorway is situated adjacent to the banqueting house on the southern section of wall. This doorway has rubbed brick jambs and arch lintel and dates to the early 18th century and was probably inserted at the same time as the windows. The doorway may have provided access from the raised walkway to the aviary garden. The infill bricks however also appear to be of 18th century date suggesting its use as a doorway was short lived. The bricks and mortar are most consistent with the **Type H** bricks used to infill the larger openings and for the construction of the Banqueting House.

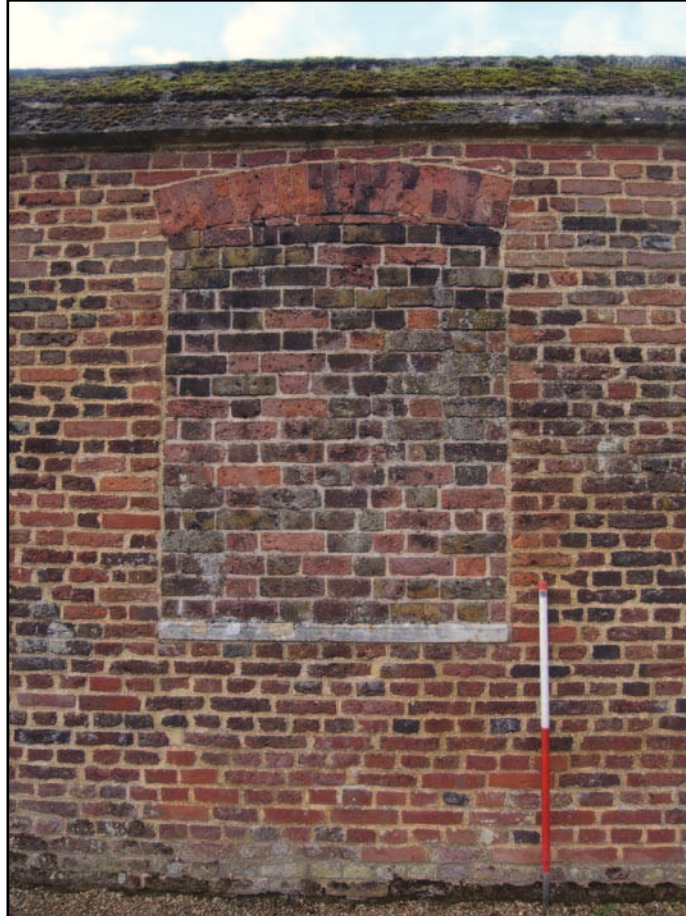
Plate 10: Infilled window opening with stone sill on north west elevation of wall

- 3.3.2 The northernmost blocked window has a stone sill which remains in situ. The stone is a pale coloured sandstone with roll moulding to the upper arris. The majority of the blocked openings show some infill pointing at a lower level than the red brick jambs suggesting the presence of an earlier sill. It is unknown why only one stone sill was left in situ on this elevation during the blocking up of the openings however a similar stone sill remains in place on a blocked window within the northern wall of the orchard garden and this suggests the remaining windows also had stone sills of the same type as seen here. All the remaining blocked windows have infill bricks at the same level as the insitu sills suggesting all windows had stone sills which have since been removed.

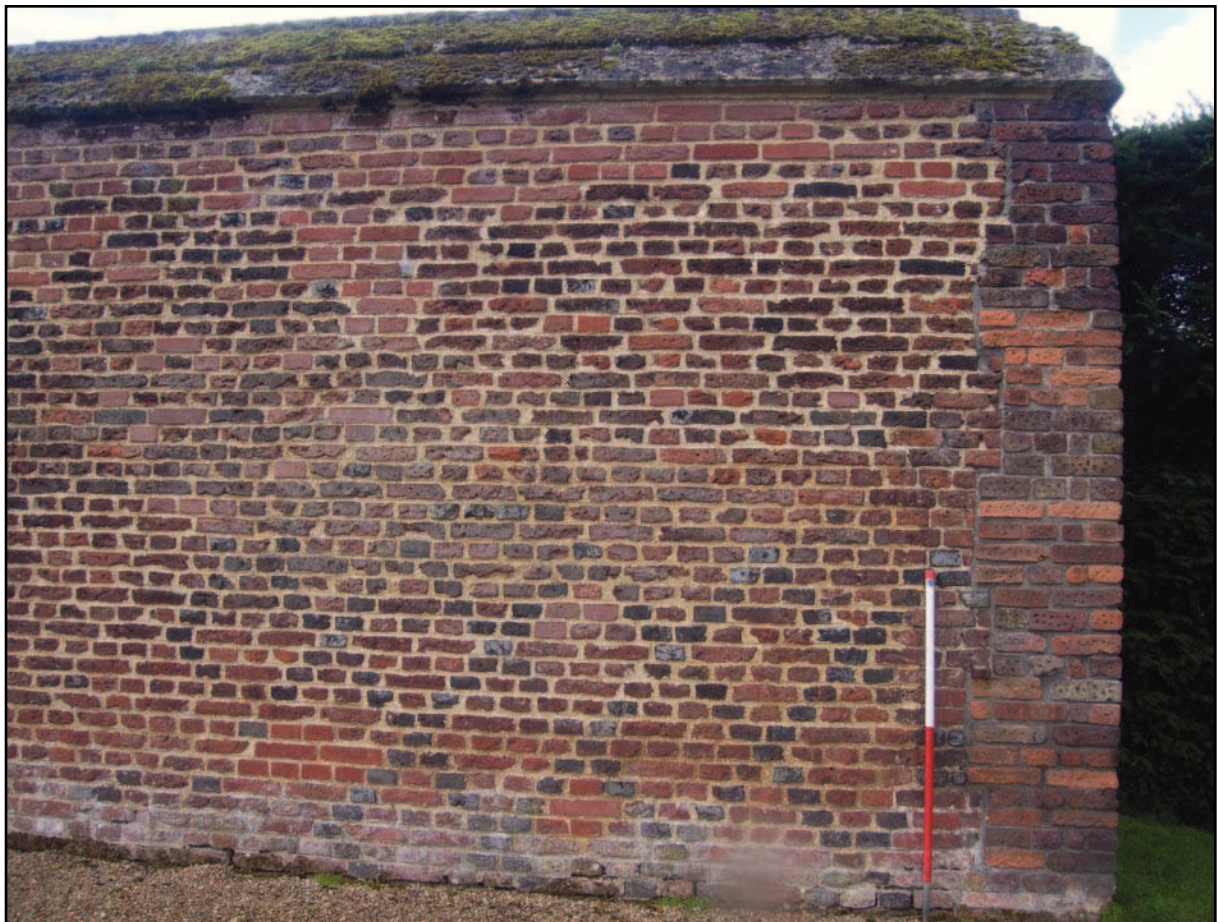
Plate 12: Tudor diaperwork and later rebuilt corner on north west end of wall

- 3.2.2 On the lower northern section of the north west elevation a fragment of diaperwork in the Tudor brickwork can be clearly seen. This is a section of open lozenge diaperwork. The open lozenge design is a typical design for later diaperwork (Smith 1992, 24) and this style can be seen throughout Hampton Court. The presence of a small section of diaper decoration does not suggest that the pattern initially covered all of the elevation at the time of construction, areas of partial diaper pattern can be seen throughout the palace. White (2005) has argued that the diaperwork was laid out using available vitrified bricks and the patterns ended when available bricks ran out. The finished elevation may have had diaperwork painted on covering the brickwork underneath the painted surface. Several examples of painted decoration have been found at Hampton Court, the most preserved being the east elevation of the chapel which was enclosed by the Wren rebuilding works in the late 17th century. No evidence for painted decoration was found during the survey, however it is possible that this surface was initially painted as it would have been visible from the palace grounds.

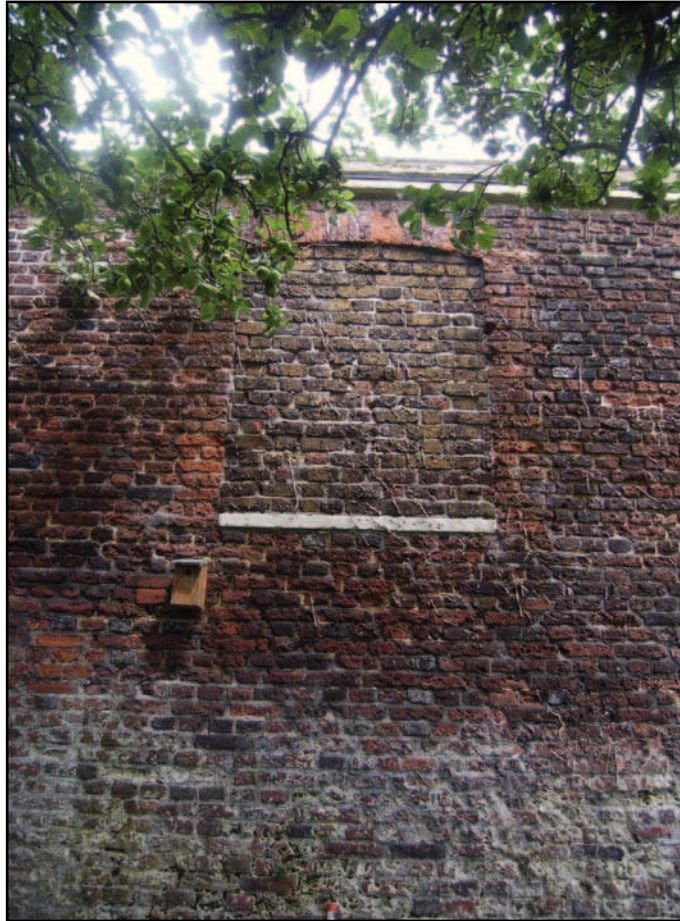
Plate 15: North east elevation detail of infilled window with stone sill

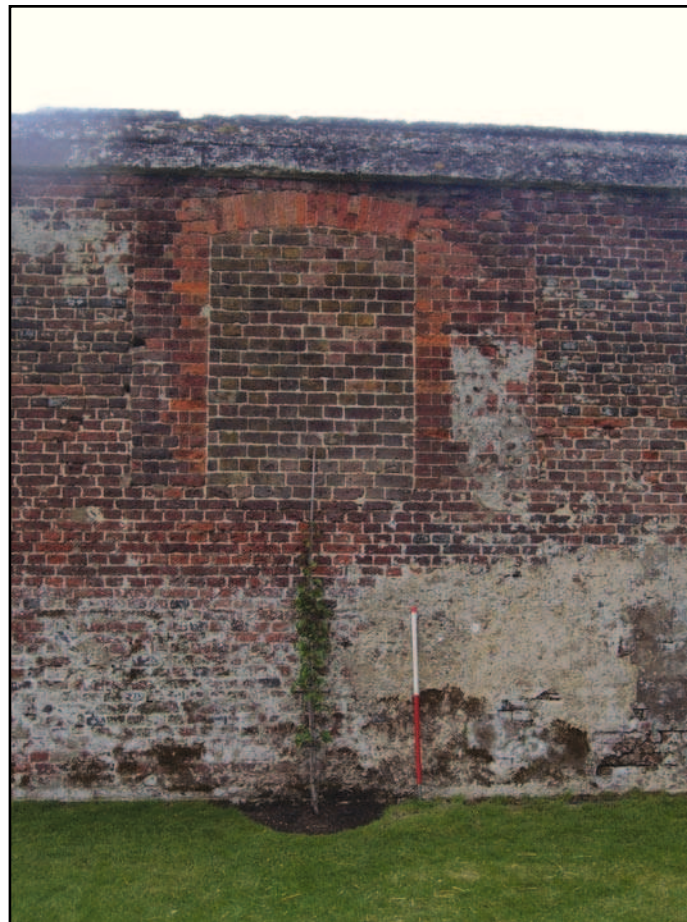
Plate 20: South east elevation detail of infilled window

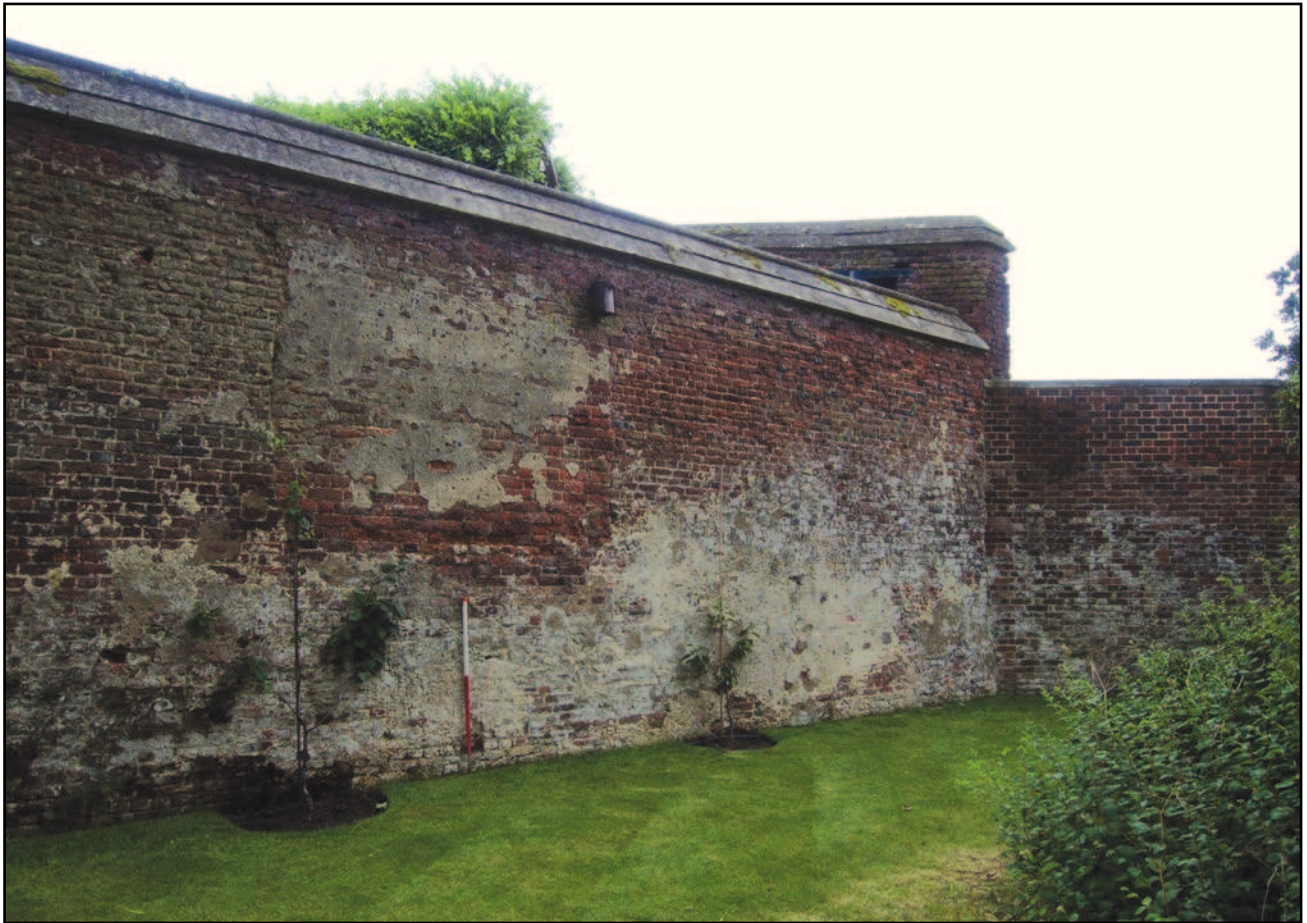
Plate 21: View of large infill patch on south east elevation and southern garden wall

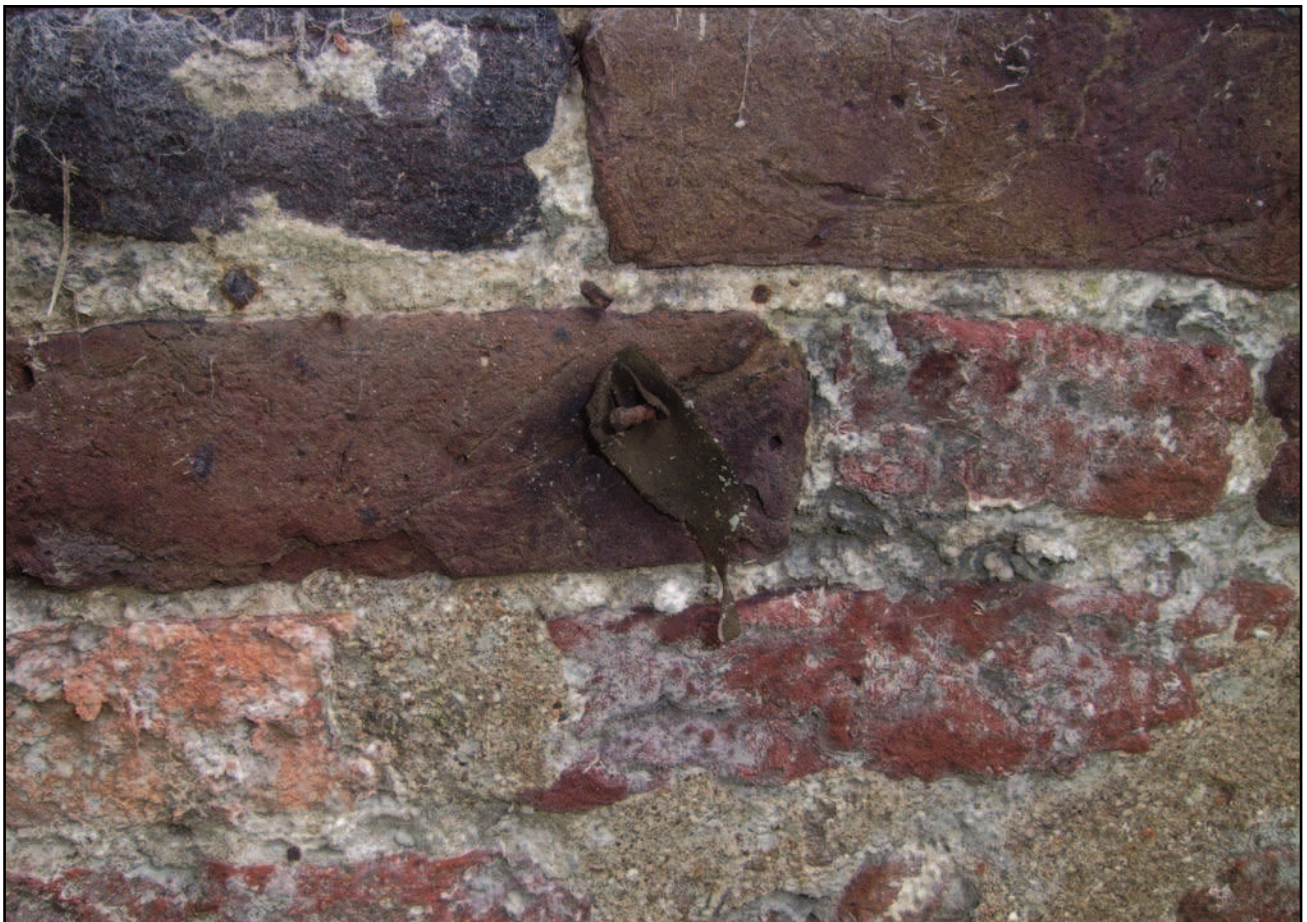
Plate 22: Detail of leather strap plant fixing on south east elevation

- 3.1.1 The wall is constructed of brick with stone coping. The north east elevation has been extensively repointed with a heavy brown coloured mortar with lime inclusions. The brickwork on all elevations shows evidence of former foliage and other planting with many nail holes and occasional survival of leather straps used for plant fixing.

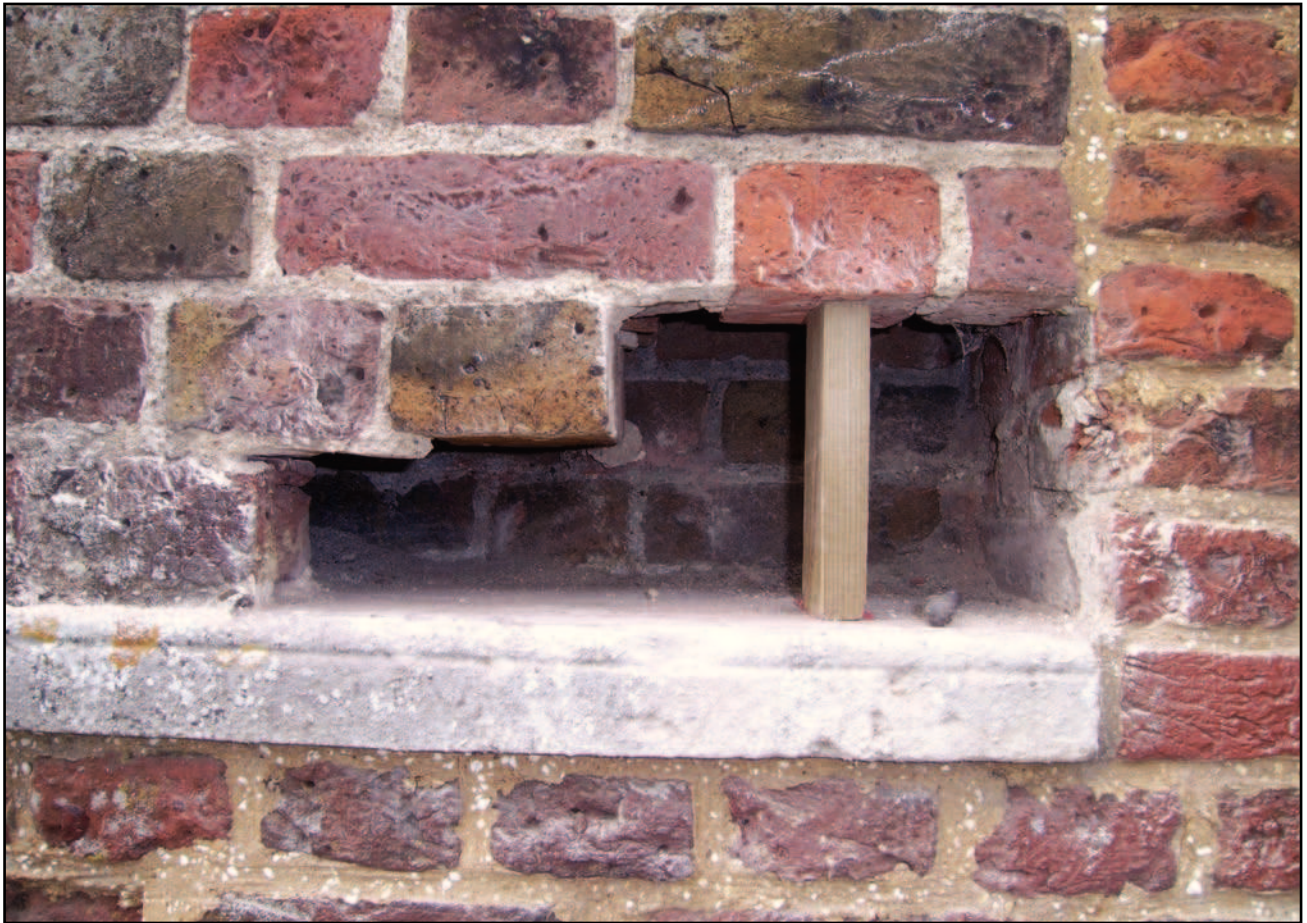
Plate 23: Opening up of lower infill brickwork on north west elevation

- 3.4.2 Initial removal was carried out on the northernmost blocked window which differed from the other windows as a stone sill remained in situ. Two small areas of removal were chosen, one to access the upper face of the stone sill, the other to access the underside of the ornamental lintel.

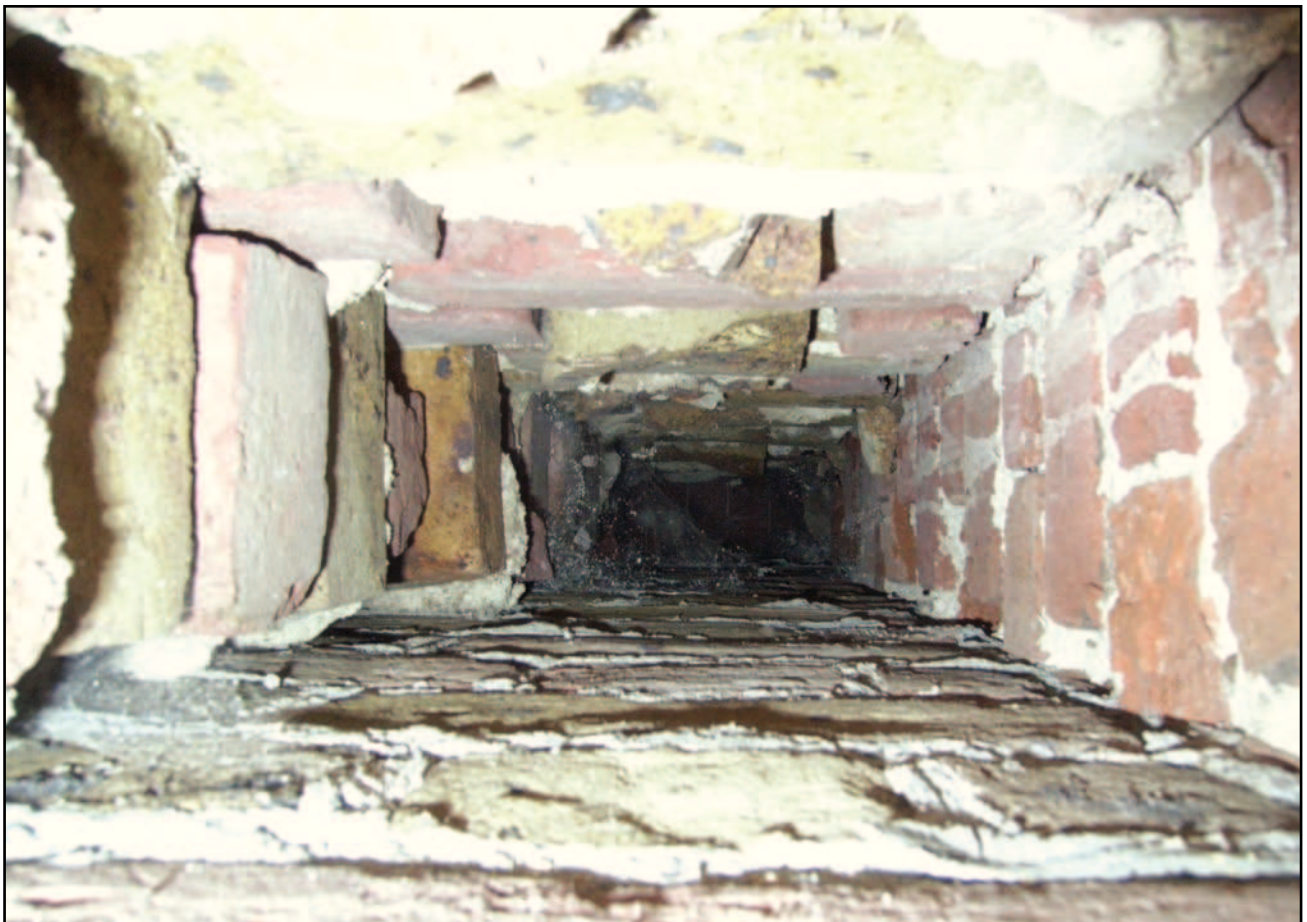
Plate 24: Internal view of void behind infill brickwork

- 3.4.3 The infill brickwork is only one skin deep in places leaving a void approximately 24cm deep. The header bricks seen on the face of the infill brickwork were found to be half bricks. Two areas of secondary brickwork in the form of rough piers were evenly spaced behind the outer skin and were probably included to provide support to the face bricks. The rear infill brickwork has some evidence of scoring in the pointing suggesting the openings were infilled from the eastern elevation first. It may be that the openings were left as decorative alcoves for a short period as there is some sign of possible weathering on the rear brick face of the

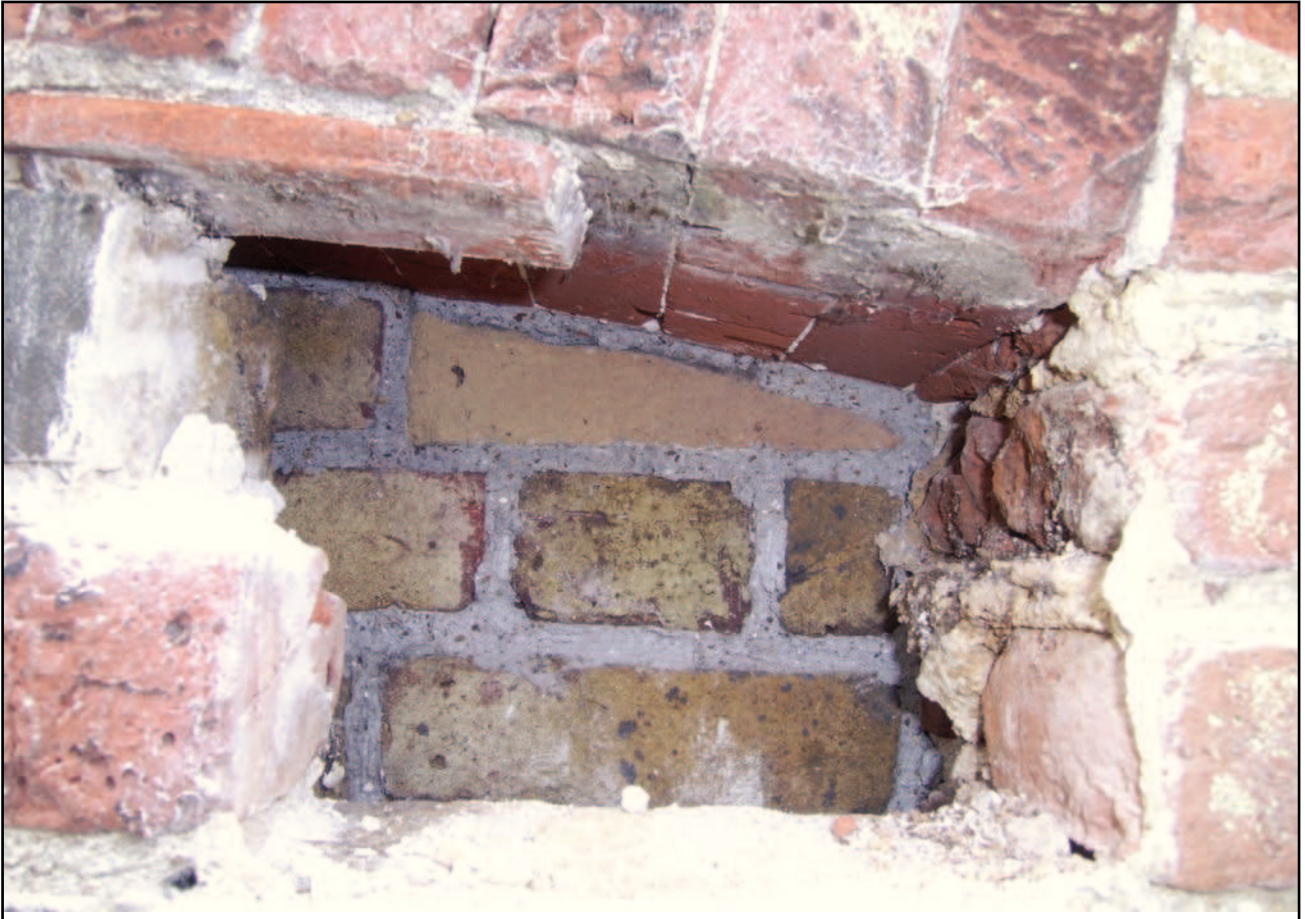
Plate 25: Opening up of upper infill brickwork on north west elevation

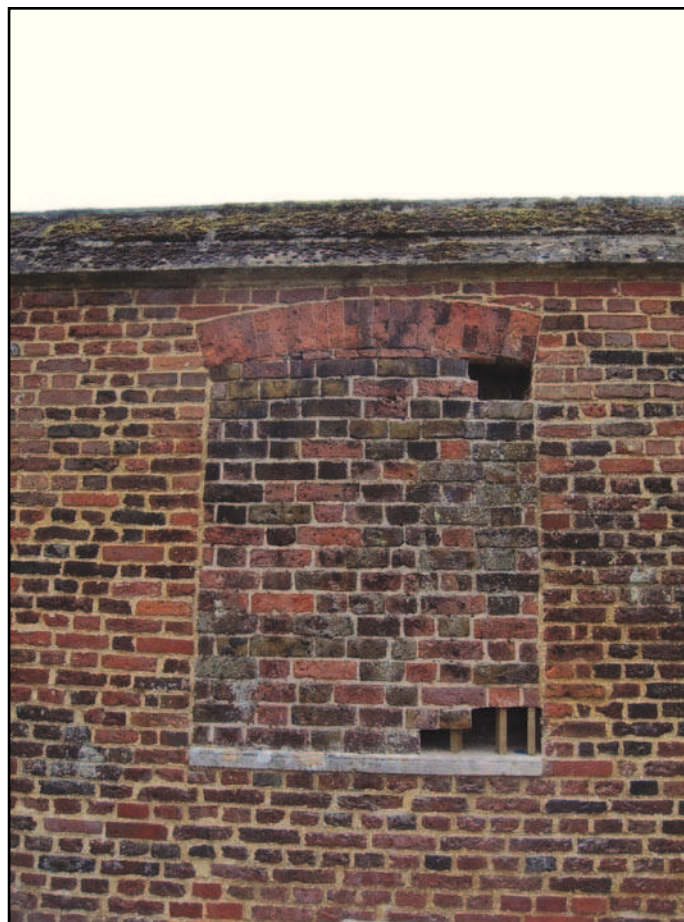
Plate 26: View of infilled window following opening up on north west elevation

infill, however it is more likely that the openings were simply blocked in one phase as the same bricks are used for both elevations and the scoring automatically added by the bricklayer. The pointing on the jamb is very rough which would be unusual for such a visible detail, however the mortar on the jamb is very patchy suggesting it was a repair and this may account for the roughness. The upper face of the stone sill was smooth and without indentation or rebating for screen or bars.

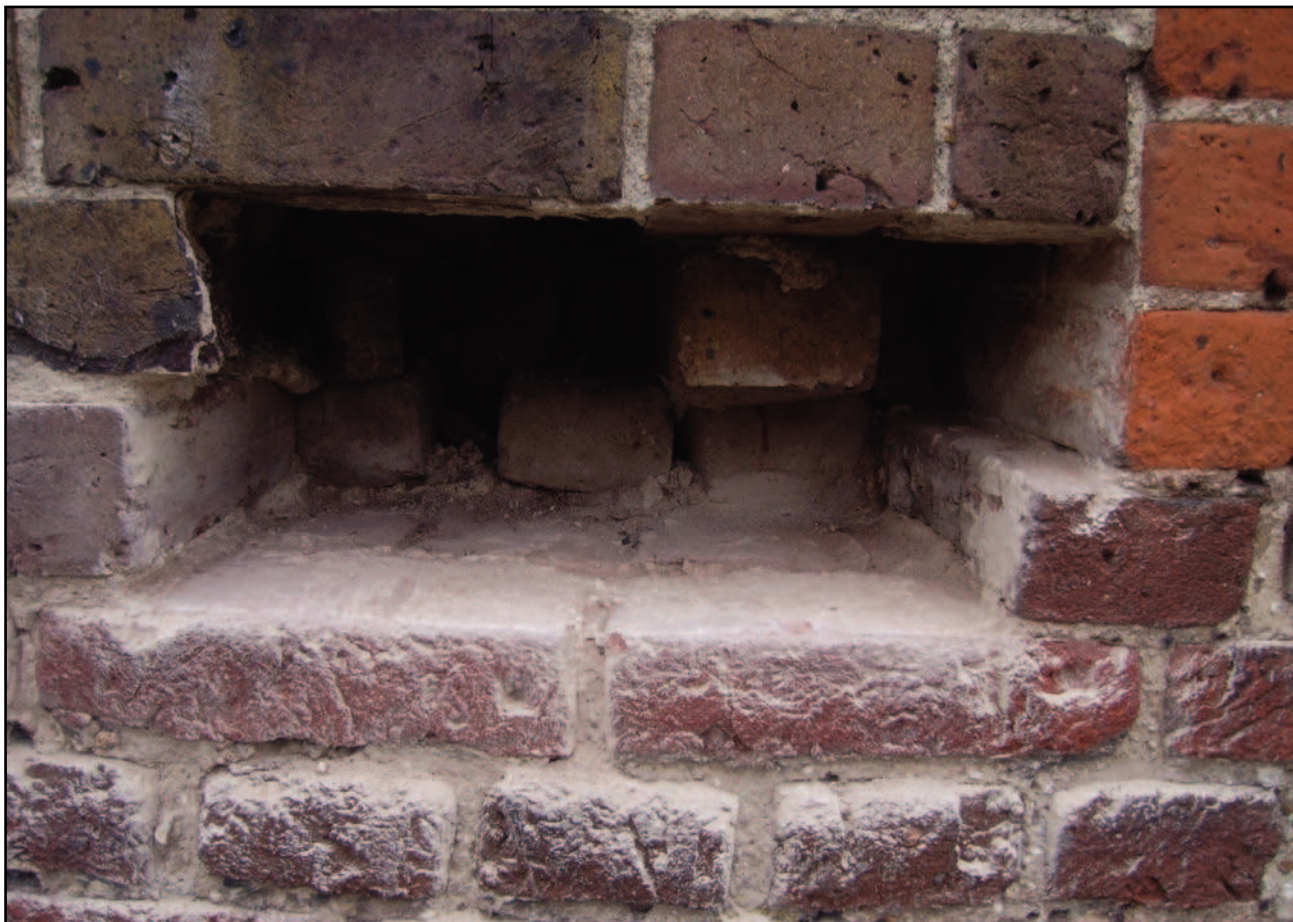
Plate 27: Opening up of lower infill brickwork on south west elevation

- 3.4.4 A small quantity of lower infill bricks were removed from a blocked opening on the south west elevation of the wall. This revealed a large amount of loose rubble, brick and mortar infill. As with the north west elevation a rough brick pier could also be seen. The brick jamb had finer quality pointing than seen previously and the mortar was lighter in colour with a larger amount of lime inclusions. Unlike the opening up on the north west elevation this window opening does not have a stone sill. The lower brickwork was therefore exposed and the upper face consisted of bonded brick with large areas of a pale cream lime mortar.
- 3.4.5 Removal of a small quantity of brick revealed no evidence for any kind of screen within the openings either on the stone sill or within the brick jambs of the blocked windows.

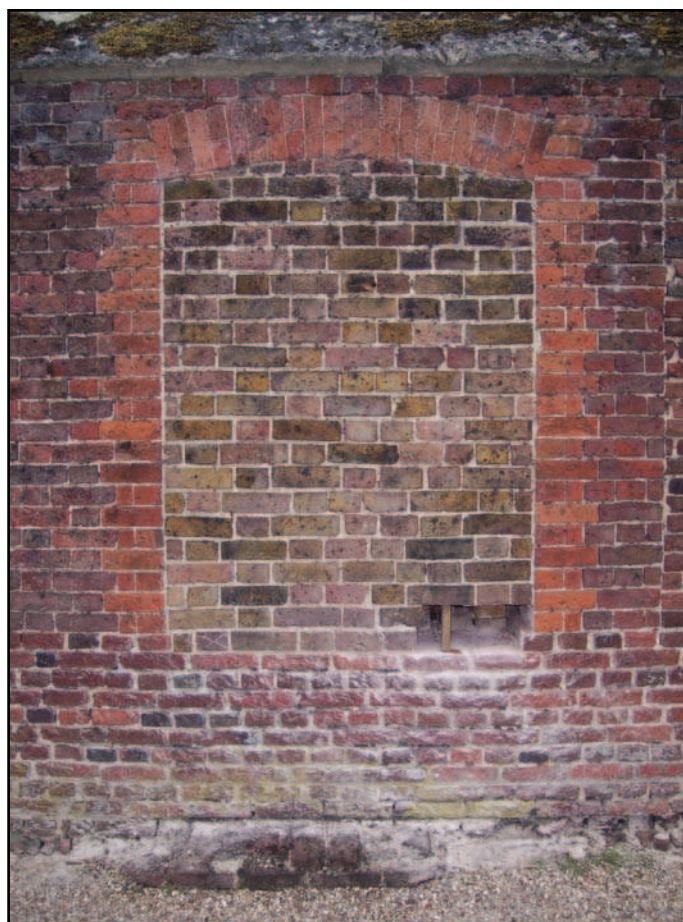
Plate 28: View of infilled window following opening up on south west elevation
