The Kya Ludgershall Buckinghamshire

Historic Buildings Recording and Watching Brief

Document Type: Historic Building Recording and Archaeological Watching Brief
Issue Number: 1

HISTORIC BUILDING RECORDING AND ARCHAEOLOGICAL WATCHING BRIEF

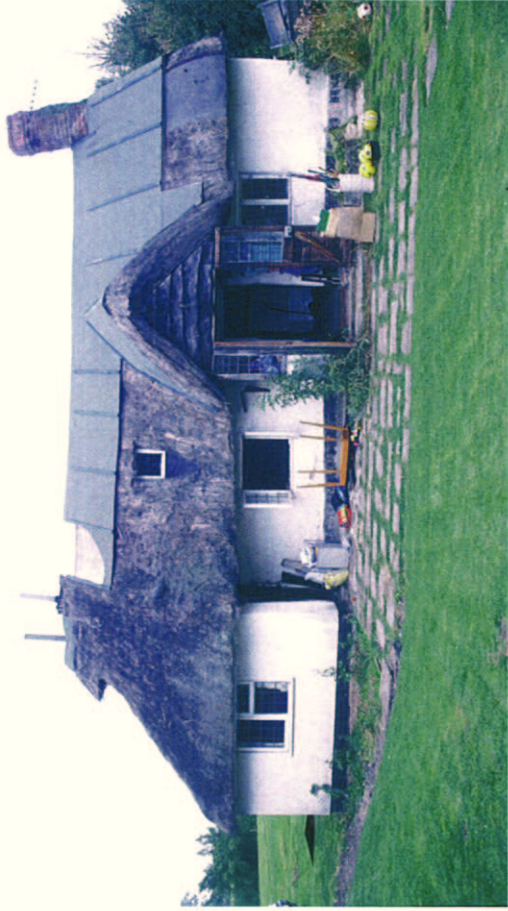
Plate 1 : View of The Kya from the South East

- 3.1.2 The *south-east elevation* (front, see Pl. 1) of the house was c.2 m tall and was of white-washed cob (see 3.2 below for discussion of cob construction). There was a plinth of bricks (later 19th or early 20th century) laid against the base of the cob. From other evidence (detailed below) it is apparent that this wall was a secondary rebuild of the front of the house and that the original wall was outside the current line of the wall. The main entrance to the house was towards the centre of this wall and was enclosed by a simple 20th-century porch with glazing on each side on brick foundations. There were two

windows to the elevation, one on each side of the porch, each of which was a simple timber casement of probable 20th-century date.

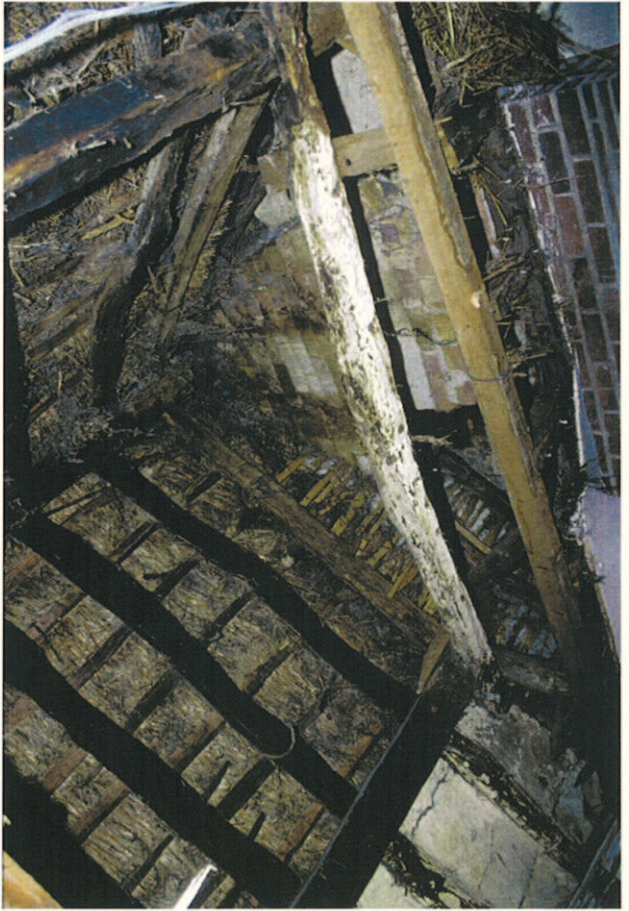
Plate 3 : Roof space and chimney stack at the North East end

- 3.4.4 The removal of the ceiling above G1 also revealed that the upper part of the chimney in the north-east wall survived from an earlier larger fireplace. The brickwork of the modern fireplace only extended up to the tongue and groove ceiling and immediately above this was a narrow brick shaft (probably 19th-century brick) which had been created within one side of the original wider shaft. The brickwork of the original shaft survived towards the roof ridge and above it but the lower section had been substantially removed only leaving the smoke blackening from the former wider shaft on the surviving brick gable.

- 3.4.5 This shaft and chimney was immediately behind a partially surviving truss at this end of the building. This truss consisted of a slightly cambered collar which clasps the purlins to each slope but the rafters at this point were no larger than the other common rafters. The purlins were each supported by a low queen post adjacent to the collar but supporting the purlin directly rather than indirectly via the collar. The posts were supported by a secondary softwood joist contemporary with the tongue and groove ceiling and presumably replacing a lost earlier one.

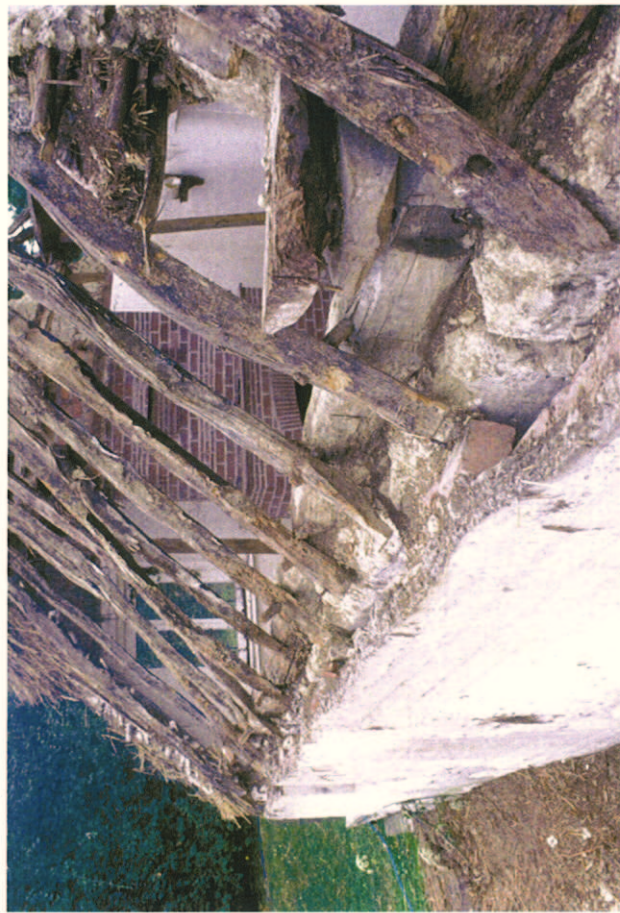
Plate 7 : Rafters and wall plate on the rear wall

- 3.4.7 The removal of the thatch also revealed that the wall plate on top of the cob front (SE) wall was machine sawn softwood (8 cm tall x 18 cm wide) and was 1.97 m above the floor height. The lower wall plate on top of the rear wall was of older elm (12 cm tall x 10 cm wide) and was 1.44 m above the ground floor. The rafters to the front were nailed to the softwood plate and were sawn off immediately below it whereas those to the rear were pegged to the lower

elm plate. This appears to confirm that the front wall had been rebuilt and stepped back from its original line and that the front would originally have been at the same low height as the rear.

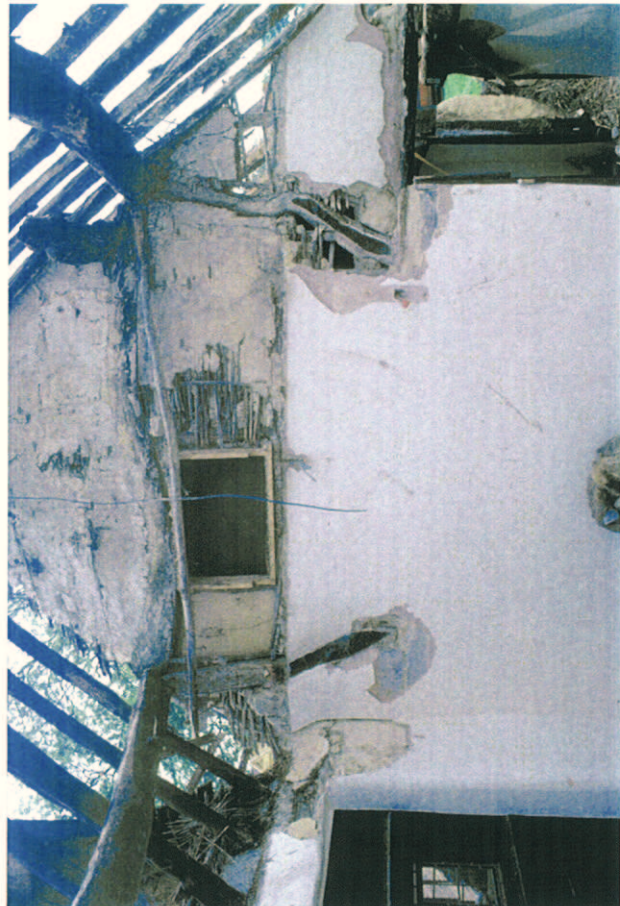
Plate 8 : Central wall viewed from North West

- 3.4.2 The full-height cross wall which divided G1 from G2 (and F1 from the unusable loft space) would originally have been of wattle and daub but the lower section (below c.1.5 m) had been replaced by concrete blockwork presumably to provide support for the inserted first floor above F2. Above the concrete block was a thin (7 cm tall x 18 cm wide) tie beam (presumably split and reused from a previously thicker beam) which supported two rough raking struts and wattle and daub up to the roof line. The raking struts, which supported the purlins with birds-mouth ends immediately beneath the collar, were thin, waney pieces of wood which had not been squared (Pl.8). Although the struts were not tenoned to the purlins they appeared to be integral with the wattle and daub and were probably primary. A rough collar spanned between the purlins (clasping the purlins) and there were six small posts between this collar and the tie around which the wattle staves had been woven. Daub had been applied to both sides of this along with modern plaster beneath the height of the modern ceiling (2.05 m). The tie-beam was roughly propped up at its north-west end on top of the low wall plate in a way which suggested that it had been raised when the concrete block was inserted to allow a taller doorway between the rooms (Pl. 7).

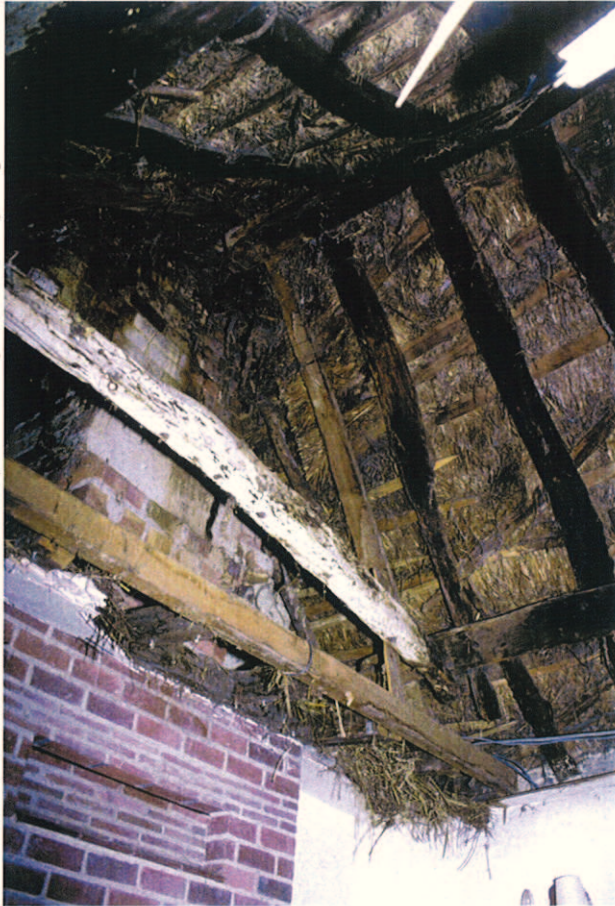
Plate 9 : Rafters on the South East slope at North East end

- 3.4.6 Once the thatch had been fully removed from the roof it was possible to see that the common rafters to the north-eastern half of the building (and one in the south-west half) were of thin waney oak whereas those to the south-western half were of more regular, machine-sawn elm. All the rafters were pegged in a broadly similar way suggesting that although the elm rafters were secondary replacements the vernacular construction techniques continued from one phase to another. Alternatively it may suggest that all the rafters were from the original construction of the building and that the older oak rafters had been reused from a previous building.

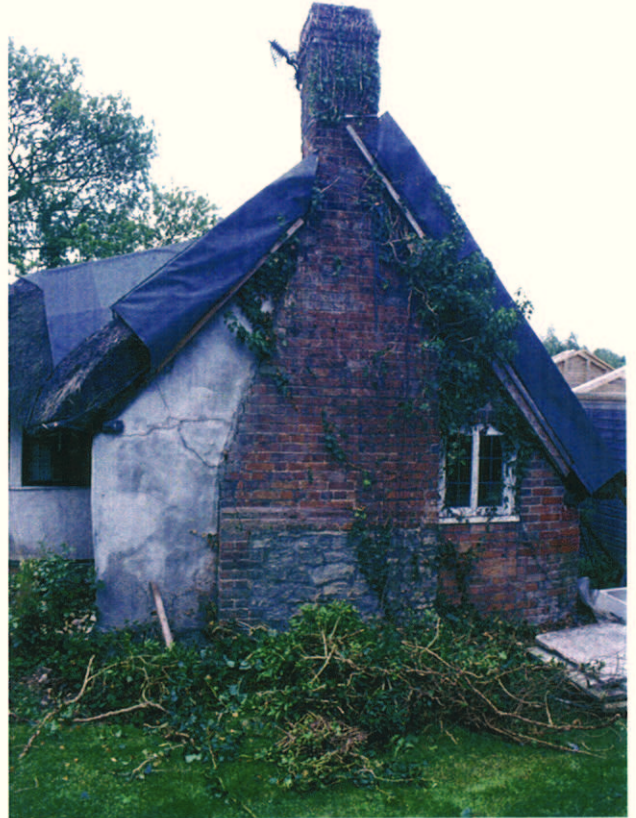
Plate 10 : North East gable

- 3.1.4 The *north-east elevation* (Pl. 10) was dominated by a chimney stack which projected from the centre of the elevation. The lower section (beneath 1 m) of the stack was constructed of limestone rubble and the upper section (above 1 m) was of brick (probably of later 18th-century date). Immediately to the north-west of the stack was a former doorway which had been blocked in 20th-century brickwork (with concrete block to the inner face) beneath a casement window.

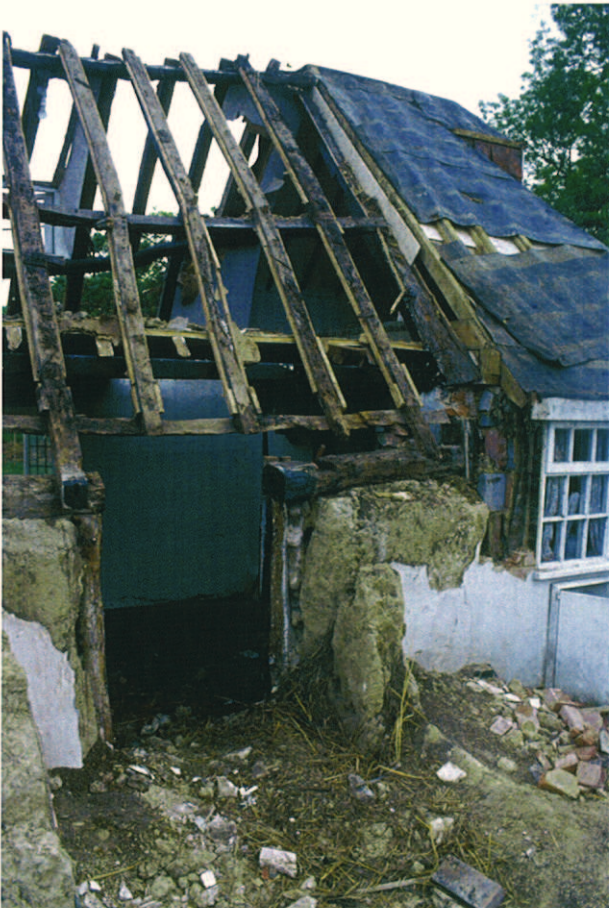
Plate 11 : Doorway in North East elevation

- 3.3.7 The low wall plate on the rear wall had been truncated towards the northern corner of the room to allow a doorway through to the cob-built extension (Pl 11). Reused posts had been inserted to each side to support the wall plate and flank the doorway. The rafters at this point had also been truncated immediately below the modern bearer (supporting this end of the first floor) to allow a greater clearance beneath the doorway.

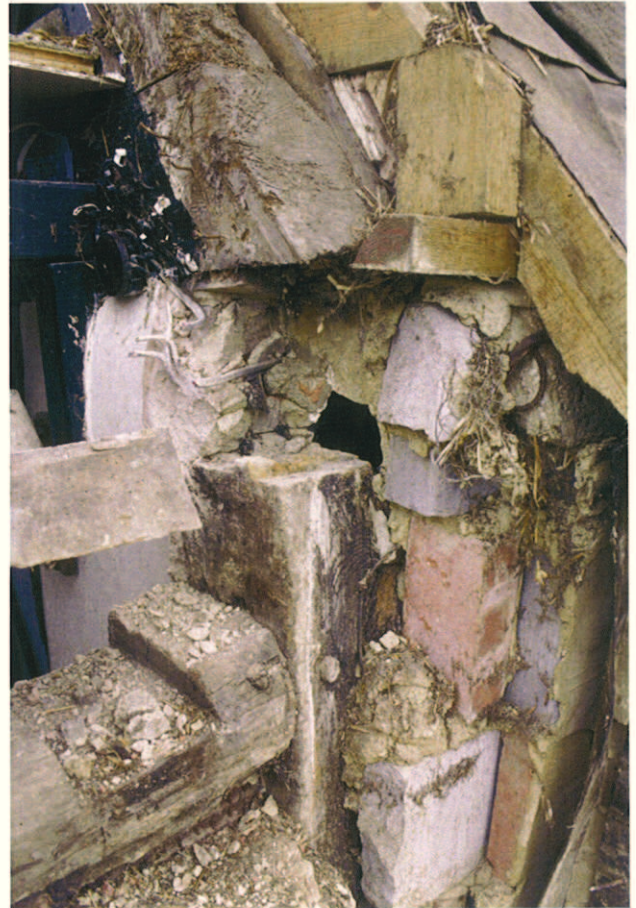
Plate 12 : Primary wall plate, post and tie at West corner of house

- 3.4.9 At the north-west end of this wall (ie the west corner of the main house) an elm post (16 cm x 18 cm) was revealed by the demolition works (Pl. 12). The primary wall plate (1.44 m above the floor) was tenoned into this post but the post continued up 15 cm above this and terminated with a vertical tenon (partially surviving) in its top. Above the top of the post (c.20 cm above) was the end of the tie-beam and the space between the post and the end of the tie had been filled with brick packing (hand-made bricks, lime mortar, possibly 18th century). Presumably this brick infill replaced a wall plate between the post and tie and secured to the post by the tenon. However the top of this previous plate would have only been c.35 cm above the height of the surviving wall plate and must therefore have extended south-west from the post and acted as the wall plate of the adjacent previous building.
