Notley Abbey Long Crendon Buckinghamshire

Archaeological Watching Brief Report

Oxford Archaeology

October 2003

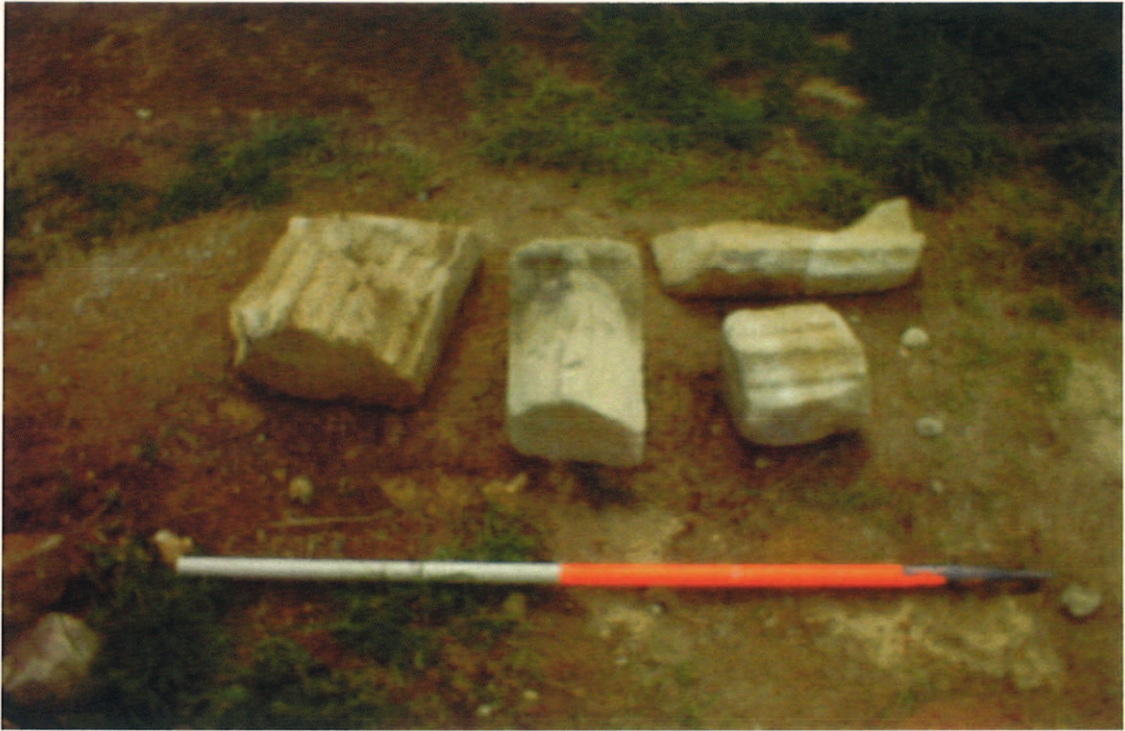
Two fragments measuring 0.28 m x 0.16 m x 0.12 m and 0.20 m x 0.22 m x 0.12 m which fitted together to form a moulded base of a window light.

Three fragments of moulded window mullions measuring 0.3 m x 0.18 m x 0.24 m, 0.22 m x 0.18 m x 0.14 m and 0.42 m x 0.32 m x 0.19 m.

Plate 1 View of the five fragments of worked stone recovered from the wall.

These fragments were all dated to the medieval period and are thought to be from the church building, except one of the mullion fragments, which was dated to the late 16th century to early 17th century. The fragments of worked stone were kept on site.

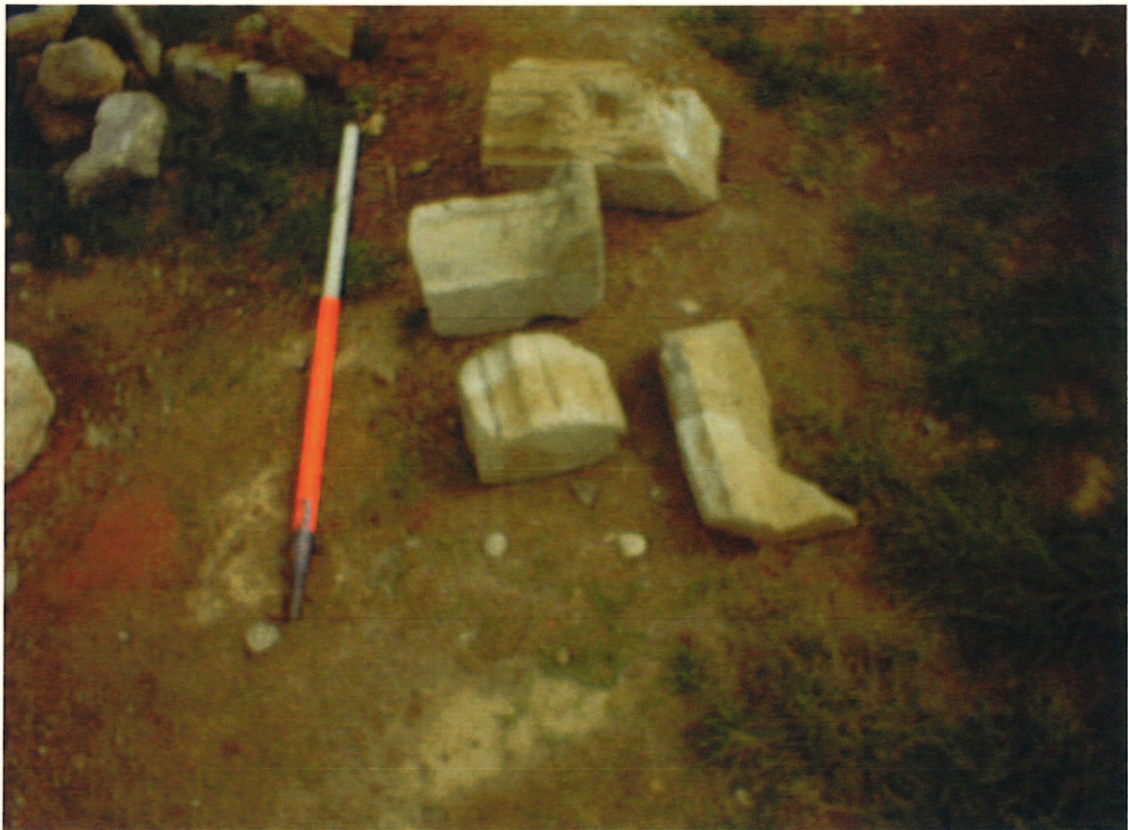
Plate 2 View of the five fragments of worked stone recovered from the wall.
