Hollingworth High School, Rochdale, Greater Manchester

Archaeological Desk- based Assessment

Oxford Archaeology North

May 2009

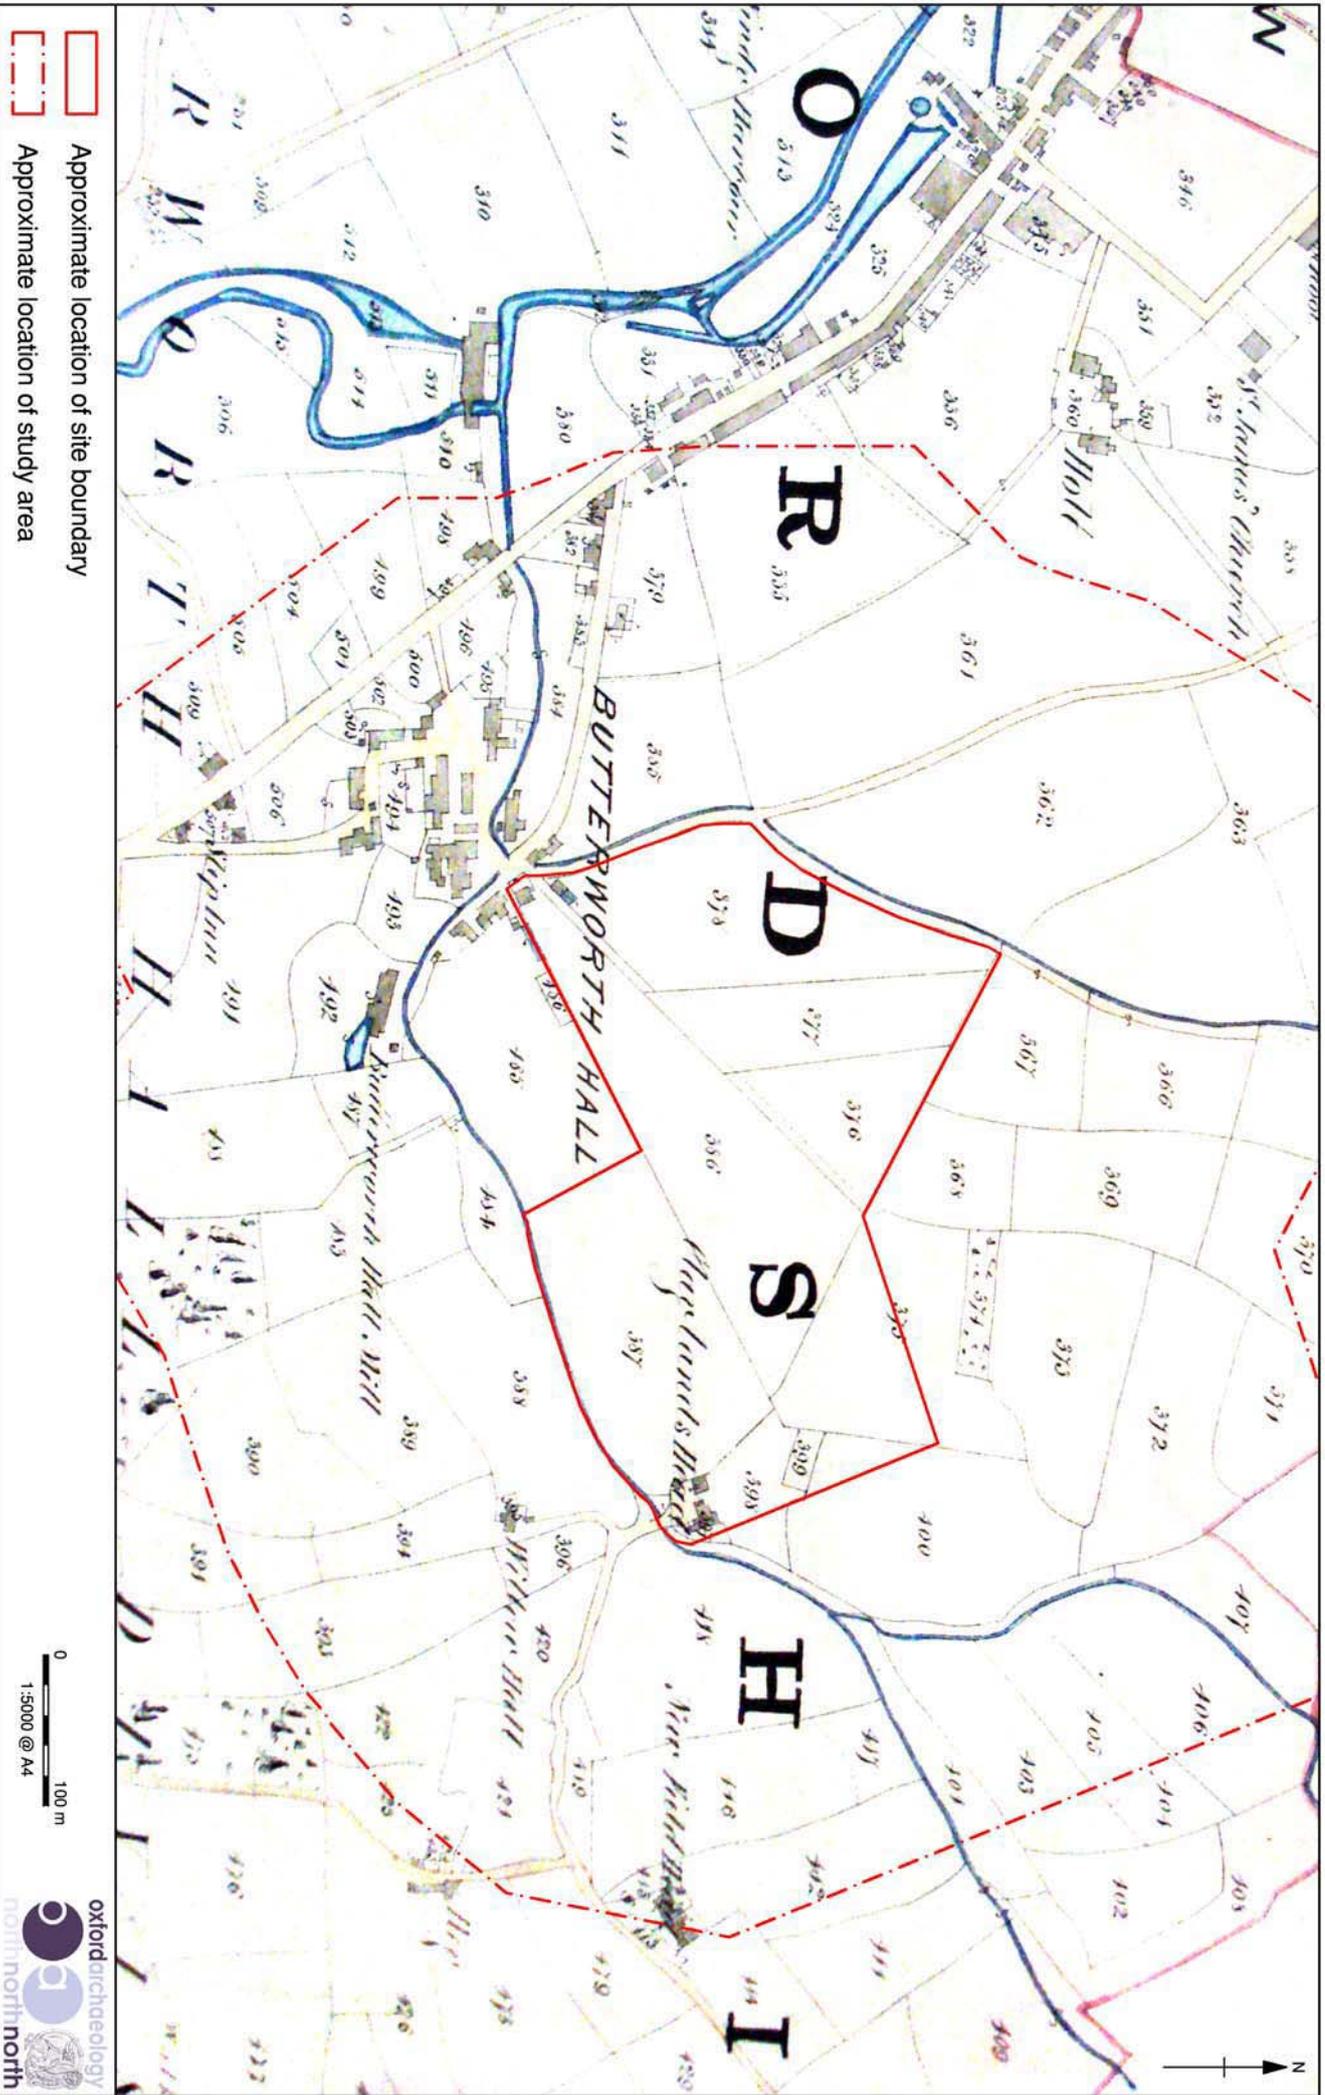
Figure 5: Extract from Buterworth Tithe, 1846

- 3.3.4 **Butterworth Tithe map, 1846 (Fig 5):** this is the first detailed survey of the study area (DRM 1/27), which depicts the layout of the structures within the settlement, annotated as Butterworth Hall (Site 07). Butterworth Hall Mill (Site 14) is named on the map, comprising a large, single structure with a reservoir. Newfield Head is also shown, to the east (Site 03). 'Holt' is marked and presumably relates to Holt Hall (Site 02) and Willow Hall (Site 12) is shown, as is Claylands Head (Site 13). The tithe apportionment was also consulted revealing that the majority of the land within and around the study area belonged to the Butterworth estate. However, it appears that the apportionment is not complete and no field names were included, which are often used in determining former land use and potential archaeological remains. The land to the north of Butterworth Hall comprises large, regular fields with straight boundaries, possibly reflecting a period of post-medieval enclosure. The fields in the immediate vicinity of Butterworth Hall are generally smaller, strip fields, or fields with more irregular boundaries, which tends to reflect field patterns of greater antiquity. Three early nineteenth century houses, along what is later named Charles Lane to the west of the village core, are shown on the tithe map (Site 05). There are also structures in similar positions to those on Hennet's map, on the south and north sides of Water Lane.

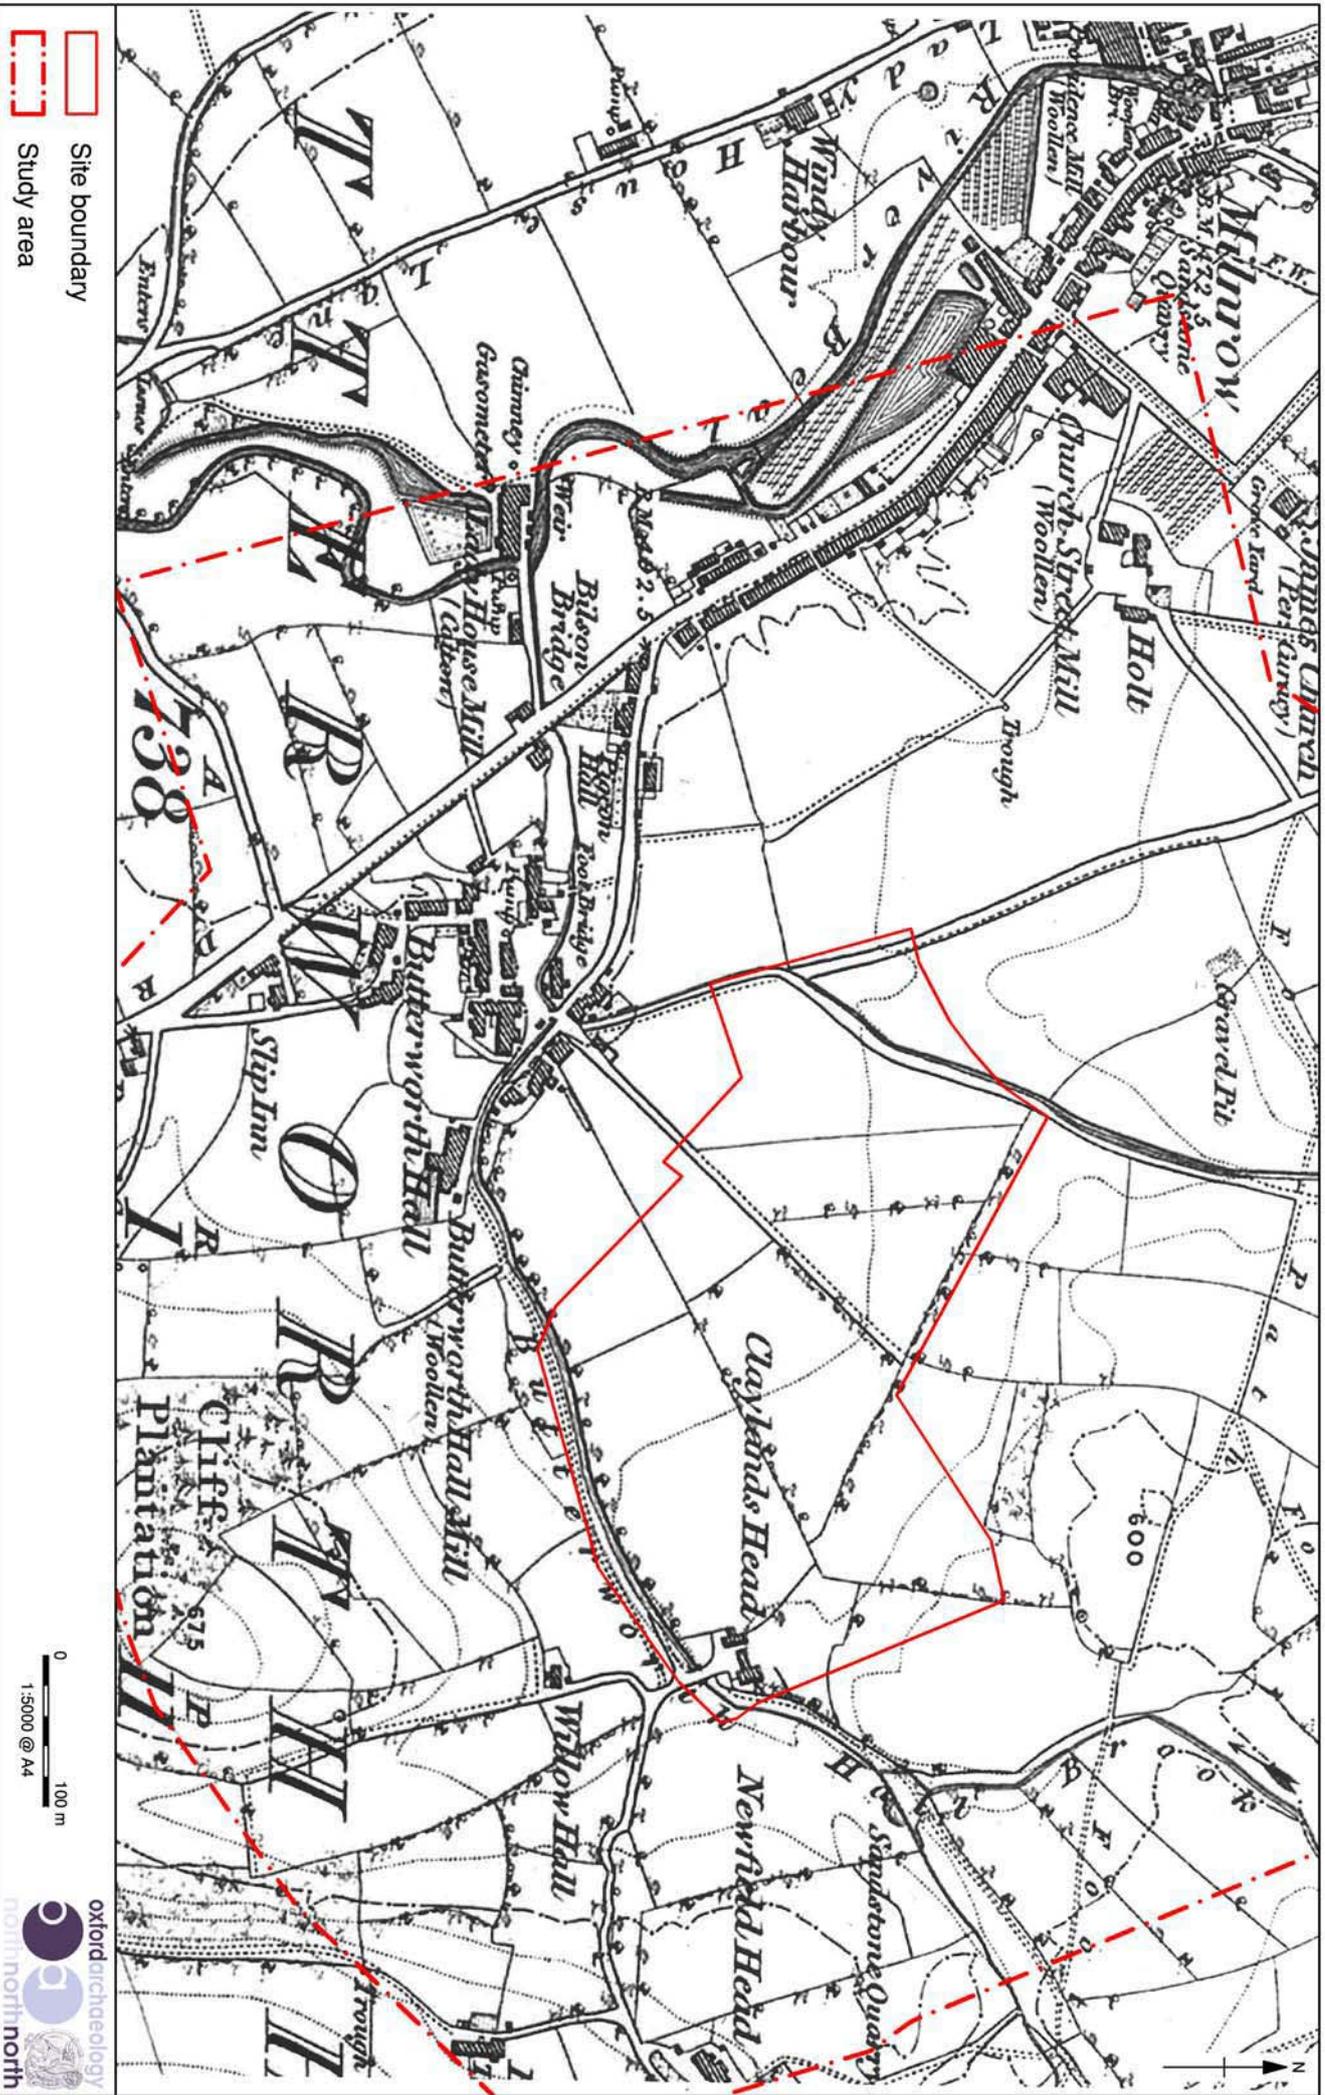
Figure 6: Extract from the First Edition Ordnance Survey, 6" to 1 mile, 1851

- 3.3.5 **Ordnance Survey First Edition 6" to one mile map, 1851 (Fig 6):** the layout of the buildings within Butterworth Hall (Site 07) is unchanged. Butterworth Hall Mill (Woollen) is marked (Site 06), as is Newfield House (Site 03), Claylands Head (Site 13) and Willow Hall (Site 12). The most obvious change within the village core is the annotation 'Ruins' adjacent to the site of Butterworth Hall (Site 04). The building on the north side of Water Lane appears to be marked as 'Pigeon Hall, which may have been present from at least 1786. There is a footbridge marked across Butterworth Hall Brook. Further north in Milnrow, the primary industry is evident; tenter fields are shown adjacent to Providence Mill and Church Street Mill. The three structures on Charles Lane, shown on the tithe map, are also clearly shown on the first edition map (Site 05).

1828, 115). In 1851, an old half-timbered house at Butterworth Hall was burned down. These may be the 'Ruins' marked on the Ordnance Survey map of 1851 (Fig 6). For many years the property had been let as a farmhouse (Plate 2), and was partially pulled-down and rebuilt in 1868 although the old porch was left intact. The property, owned by the Chadwick family, became a Doctor's home where in 1869 Dr John Chadwick held his first surgery (Robertson 1889).

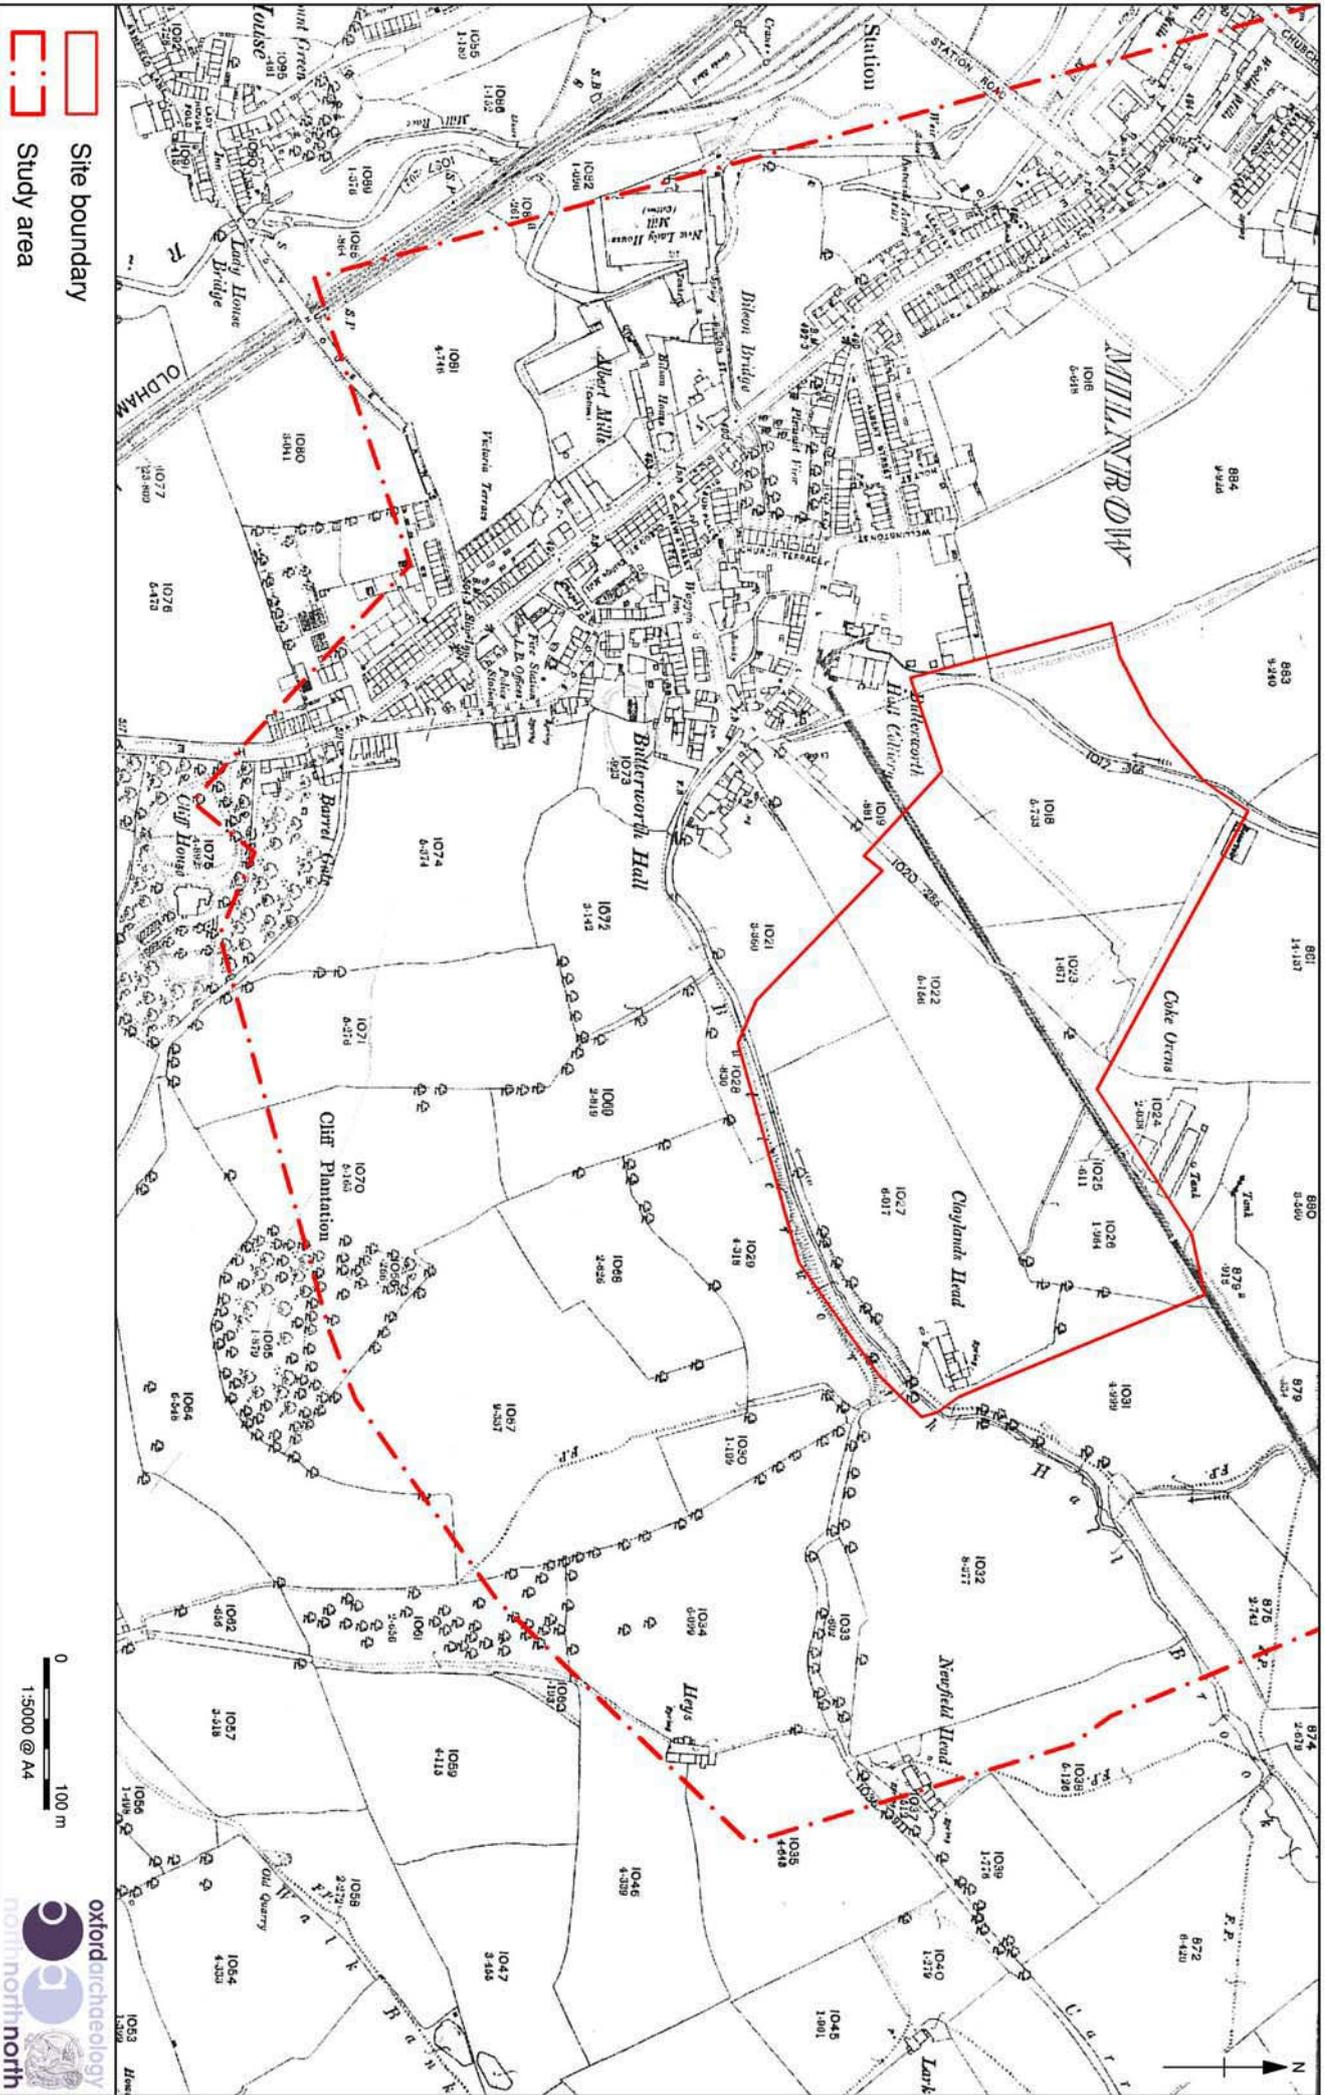
Figure 7: Extract from the Ordnance Survey 25" to 1 mile, 1890

- 3.3.6 **Ordnance Survey 25" to one mile map, 1890 (Fig 7):** there were some immediately obvious changes to the study area since the 6" first edition map was produced. Both settlements of Milnrow and Butterworth Hall have expanded, with an increased number of mills, both woollen and cotton, and terraced housing. Within Butterworth Hall, a fire station, Local Board offices and police station are marked. Waggon Inn is named in the centre of the village. Butterworth Hall Woollen Mill is possibly shown but is not named (Site 14). A further mill is also named on the map, but it is not possible to read the name (Site 08), and along New Hey Road is part of Albert Mills (Cotton) but the extant building is on different alignment and is a later addition (Plate

12). Butterworth Hall Colliery is now marked on this map (Site **01**), comprising several pit head buildings, with a tramroad running in a north-easterly direction past the ‘Coke Ovens’ (Site **11**), comprising three structures and a tank. Claylands Head (Site **13**) and Newfield Head (Site **03**) are named but Willow Hall (Site **12**) appears to have been demolished. Site **09** is shown as ‘Bilson Bridge’. To the west of Butterworth Hall, the Oldham to Rochdale Branch of the Lancashire and Yorkshire Railway has been constructed, with stations at Milnrow and New Hey.

3.2.13 Butterworth Hall Colliery, opened in 1862, (Site 01; Fig 7) was a deep mine colliery and comprised the site of pit-head buildings with the line of a former tramroad (Fig 7; Site 10) running east across a golf course to Higher Tunshill (Ashmore 1982, 116). An article in the Manchester Times in 1876 (Issue 963) describes the case of a check-weigher who had been charged with interfering with the management of the colliery by altering the 'tare'. He was subsequently removed from the mine. A list of mines worked in 1869 shows that the colliery was owned by Richard and William Stott (www.cmhrc.co.uk). In 1890, an article appeared in the Manchester Times describing the case of a manager of the mine being fined following an explosion in which one man died and his brother was injured (Issue 1734). In 1882 Butterworth Hall Colliery was purchased by Messrs Platt. The Platt brothers submitted plans in 1892, 1895 and 1907 to the borough surveyor for alterations or extension of the coke ovens at Butterworth Hall Colliery (MW/LA/D/2/2/A/2/1/5, MW/LA/D/2/2/A/2/1/6 and MW/LA/D/2/2/A/3/18; held at Rochdale Local Studies Centre), although it is not clear whether these refer to the coke ovens within the colliery complex or those adjacent to Tunshill golf course. The colliery was eventually closed in 1928. Between 1880 and 1928 the Mines Inspector Reports, and Mine Inspectors Records of Accidents (post-1914), recorded a total of twenty accidents at Butterworth Hall Colliery causing death or injury to workers between the ages of ten and sixty (www.cmhrc.co.uk).

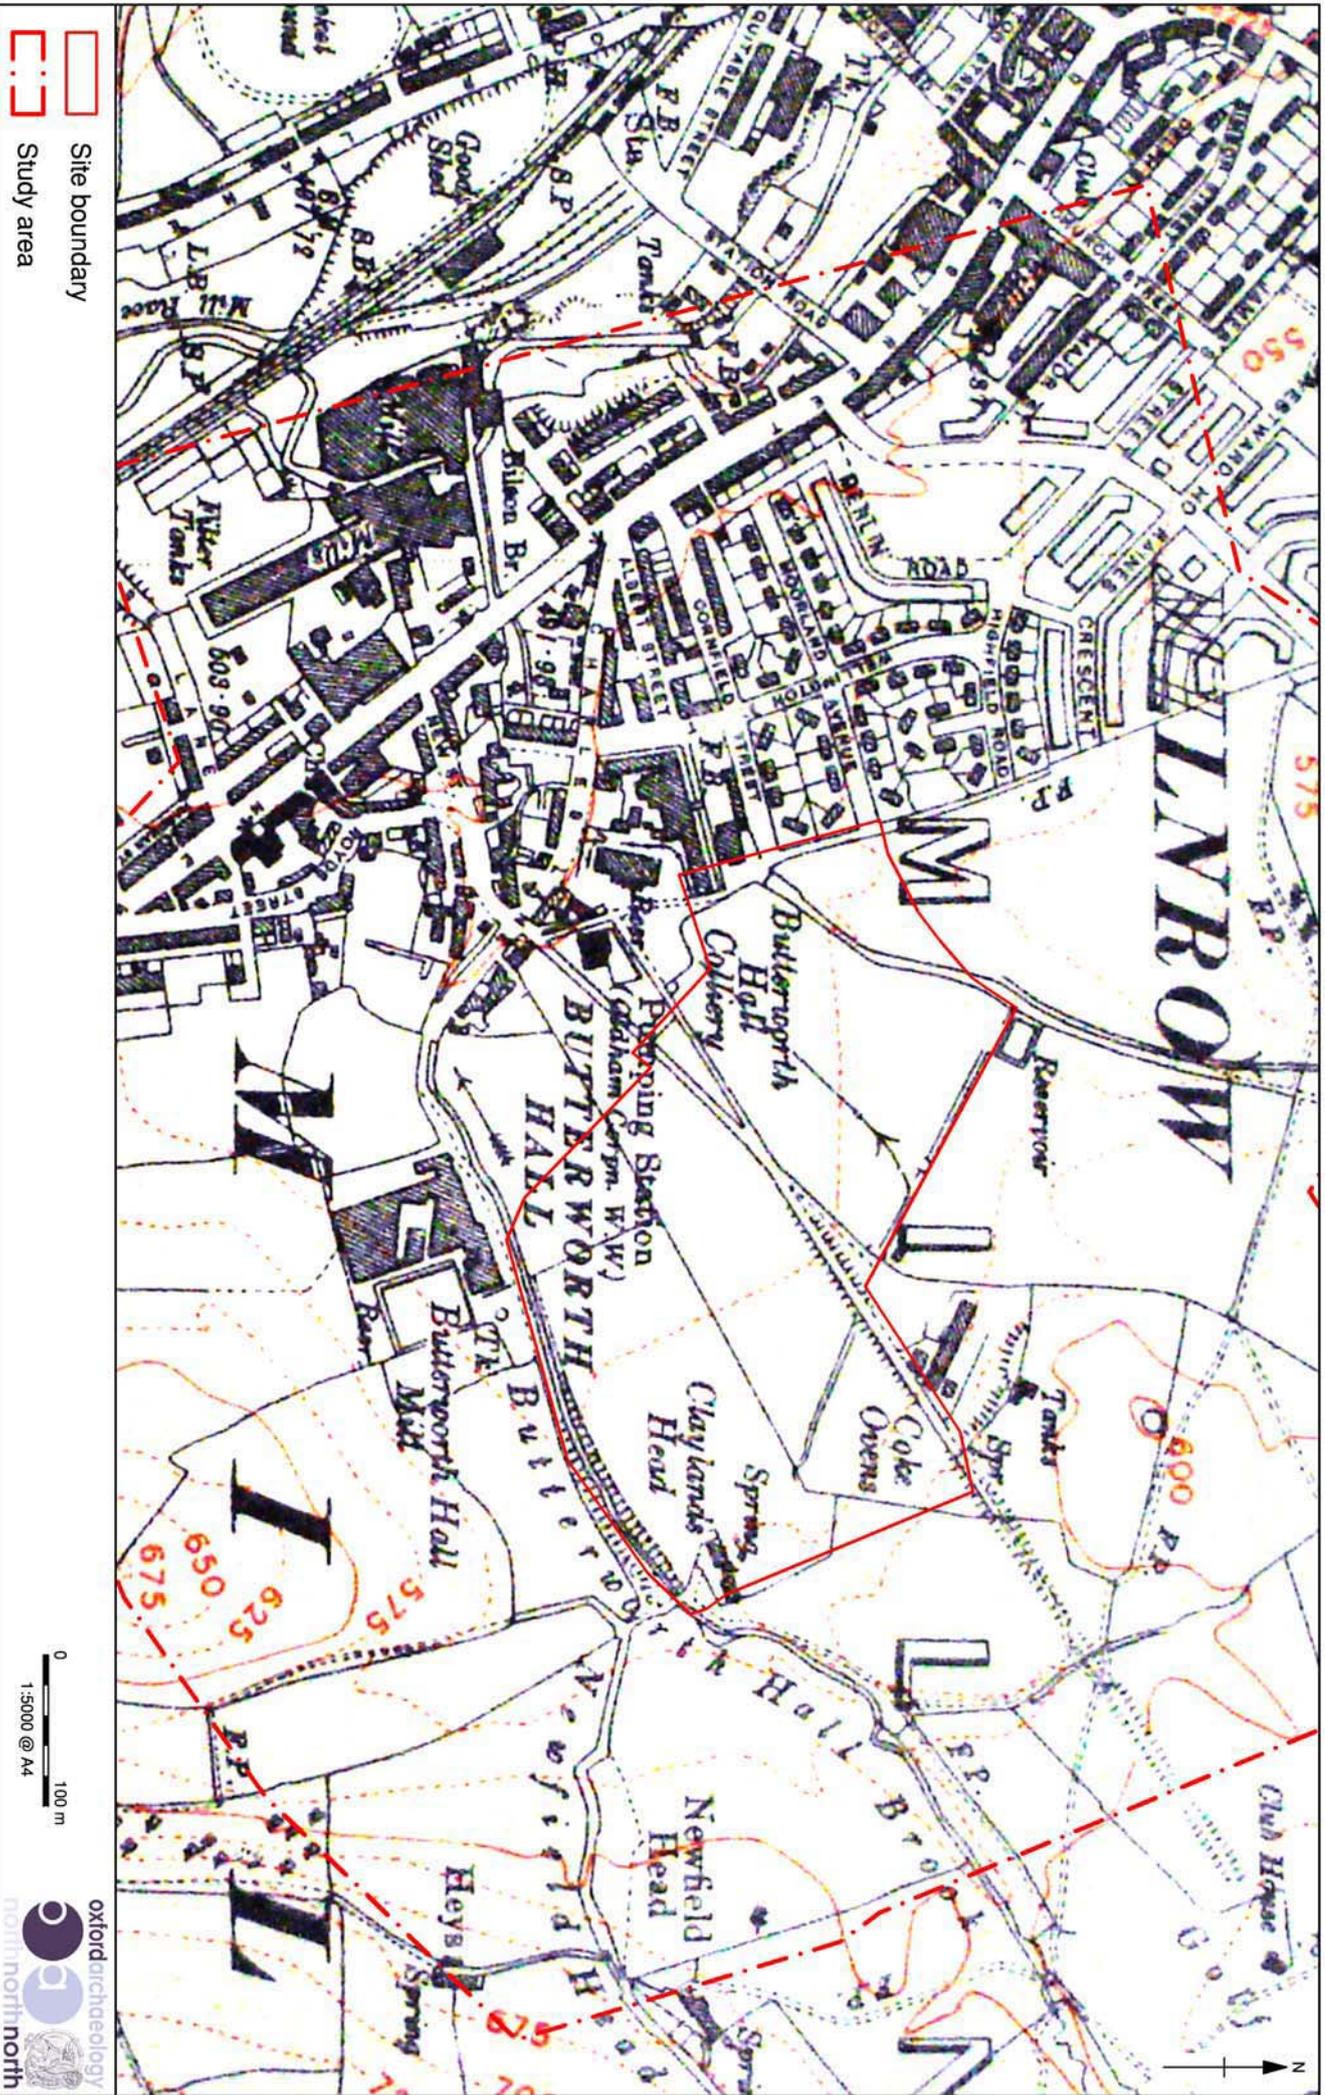
Figure 9: Extract from the Ordnance Survey 6" to 1 mile, 1928

3.3.8 **Ordnance Survey 6” to one mile map, 1928 (Fig 9):** between 1910 and 1928 the residential area to the north of Butterworth Colliery was altered substantially, when terraced housing and open areas were replaced by semi-detached houses. Butterworth Hall Colliery (Site **01**) is still marked, and the structures within the site remain unchanged. However, it is known from documentary sources that the colliery, which opened in 1862 was closed in this year and, subsequently, used as a source of water for Oldham Corporation's reservoirs in the hamlet of Ogden, as demonstrated by a pumping station marked on the map as ‘Oldham Corp. W.W.’. A large mill complex to the south of Butterworth Hall Brook is marked on the map as Butterworth Hall Mill (Site **06**), which is a cotton spinning mill and not to be confused with the woollen mill of the same name (Site **14**). However, there were no structures present at this location on the earlier 1910 map, which suggests that this mill had been constructed sometime between the two on the site of the earlier woollen mill (Site **14**). Residential areas within Butterworth Hall (Site **07**) and Milnrow have extended to such a degree that the two settlements now merge, with no discernible boundaries. Within the village core (Site **07**) the boundaries of the narrow plots in between Royd Street and Water Lane have been removed to create a larger, more open area. Tunshill golf course, to the east of the study area, is also shown on the map, along with the club house.

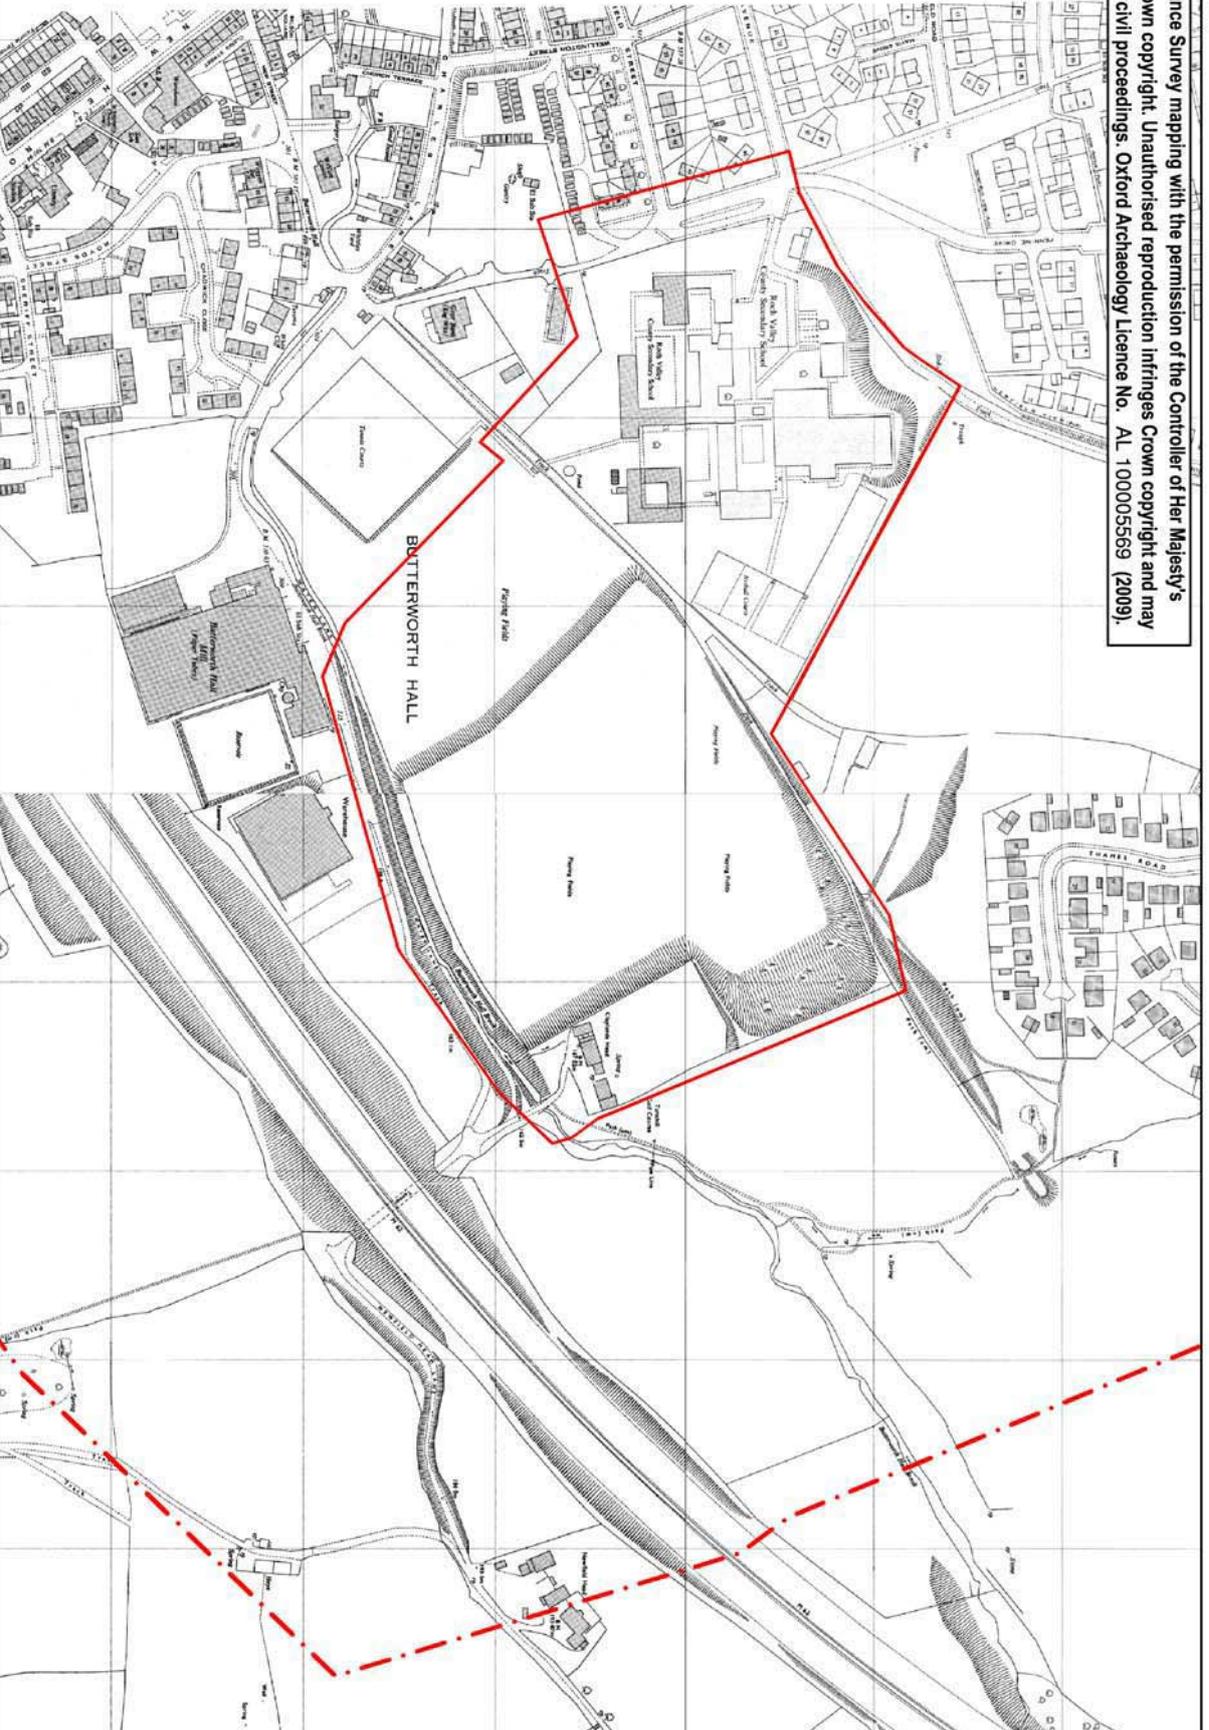
Figure 13: Extract from the Ordnance Survey 1:1250, 1968-1977

- 3.3.12 **Ordnance Survey 1:1250 map, 1968-1977 (Fig 13):** in a previously open, undeveloped area, on the football ground shown on the previous map, a school has been constructed, named 'Roch Valley County Secondary School'. This was the precursor to the present school and closed in 1990. The layout of the buildings is very similar to the present complex, including a tennis court marked within the 'playing fields'. Butterworth Hall Farm is no longer shown within the school playing fields, having been replaced by the tennis courts. The area of allotment gardens within the village core, between Royds Street and Chadwick Close (Site 07) has been built over with housing. Butterworth Mill (Site 06) is shown as a 'Paper Tubes' manufacturer. By 1977 the M62 had been constructed, and a warehouse had been built adjacent to Butterworth Mill (Site 06). There is also a small engineering works to the north-west of the tennis courts.

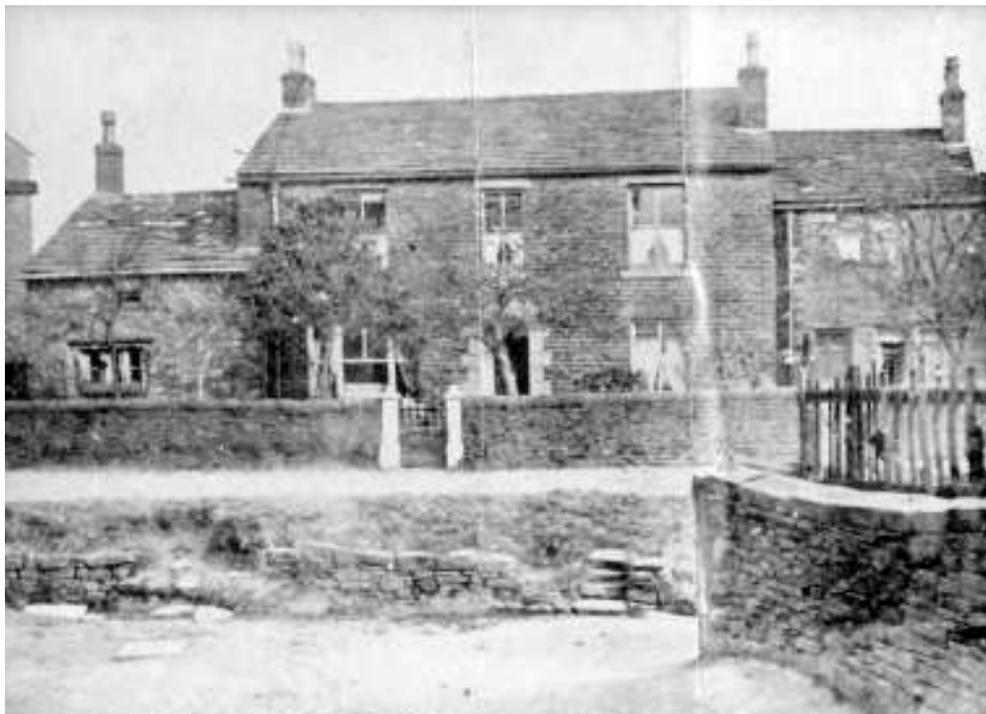
Plate 2: Butterworth Hall Farm with possible remains of Butterworth Hall in foreground

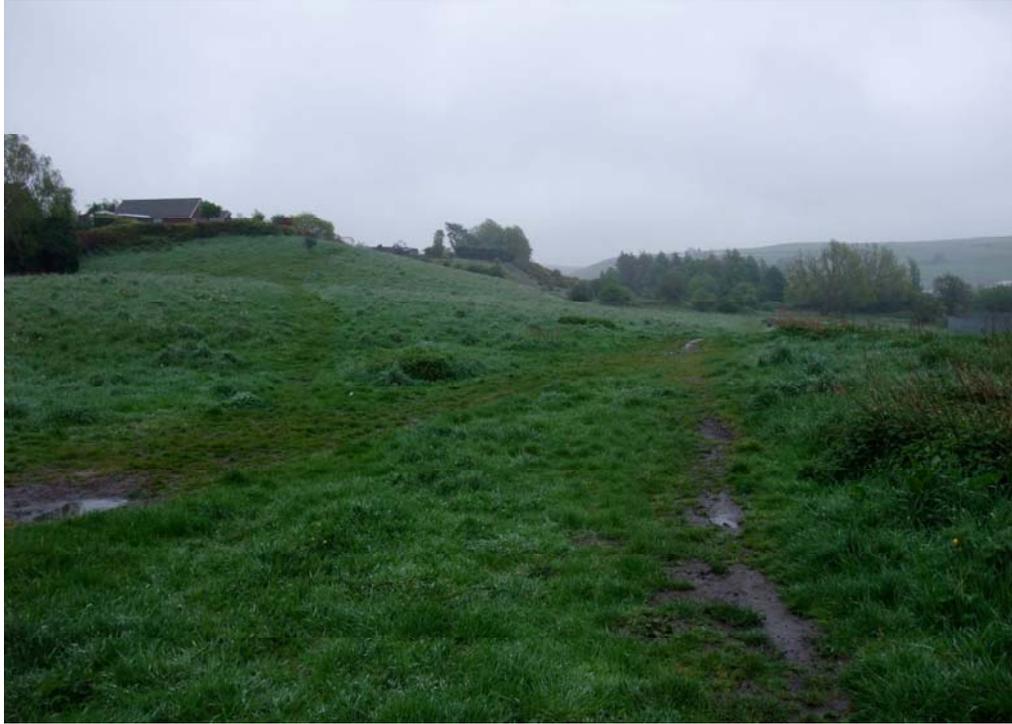
Plate 5: Looking south-west towards the site of the former coke ovens (Site **11**) and tramroad (Site **10**) from Newfield View

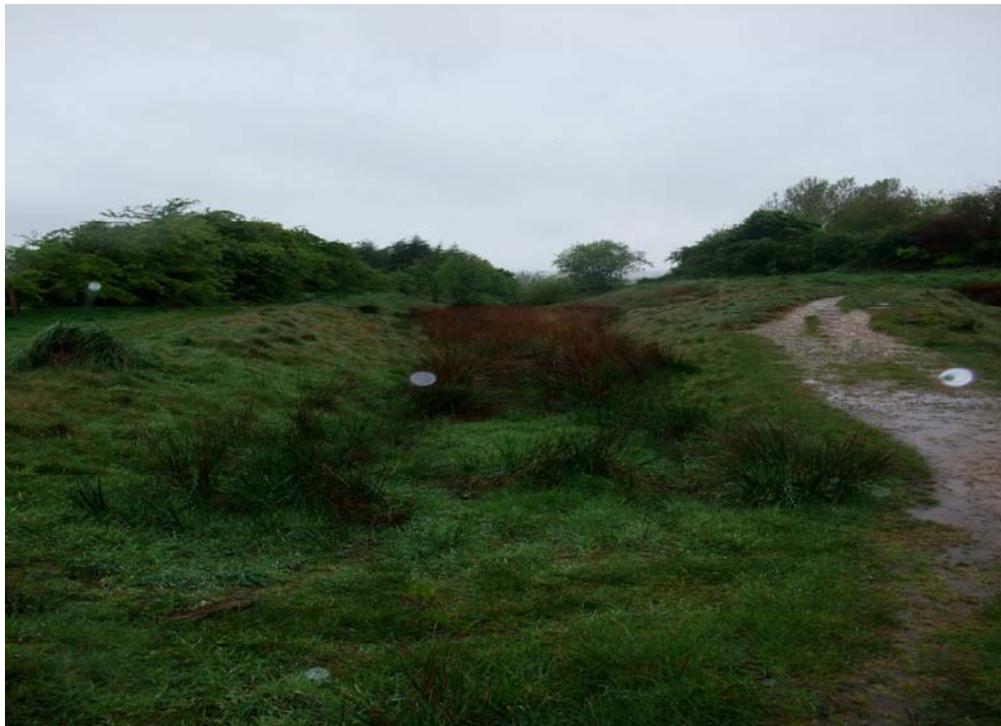
Plate 6: Line of the former tramroad (Site **10**) looking west towards the school from the perimeter of Tunshill Golf Course

7.2.1 Of the three known sites within the proposed development area, only one (Site **10**) appears to be in an area that may be impacted. Site **13**, which is the site of a post-medieval farmhouse, should not be impacted upon by the development, and no further work is recommended for this site. Any remains pertaining to the colliery (Site **01**) could prove to be of regional significance resulting in addition to the HER. It is therefore recommended that a watching brief is carried out during groundworks undertaken within the south-west corner of the school complex, if groundworks are to extend into the site of the former colliery. This work should be carried out in consultation with Greater Manchester Historic Environment Service (GMHES), who would provide a project brief. It is also recommended a watching brief is carried out on any groundworks undertaken in the area of the former tramroad (Site **10**) also in consultation with GMHES, who would provide the project brief.

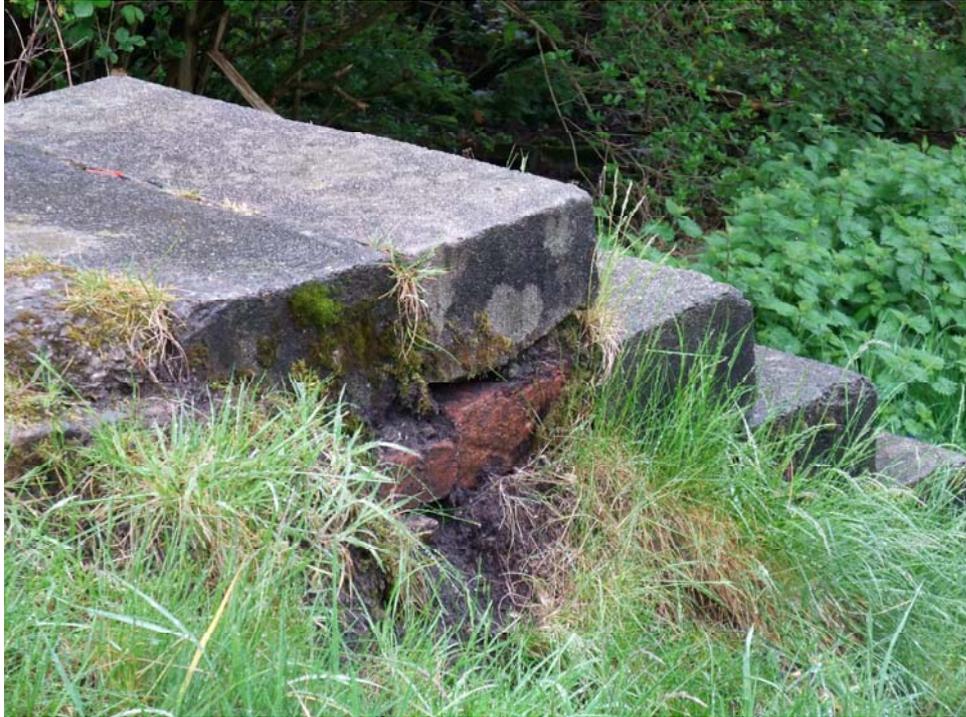
- 3.4.3 To the west was a surfaced lane that followed the fencing directly to the rear (south) of the school buildings. In this area, to the south of the track, some steps were observed (Plate 7). These were not associated with any extant structure, although there were traces of rubble in the adjacent undergrowth. There are several small structures shown in a similar location on the 1936 Ordnance Survey map (Fig 11). The large red brick pithead buildings of the nineteenth century Butterworth Hall Colliery (Site 01) are clearly visible on the northern side of this lane (Plate 10). Part of the red brick boundary wall of the colliery runs along the northern side of the lane (Plate 9) to a cobbled entrance-way. Across the playing fields, to the south, was the site of Butterworth Hall Cotton Mill (Site 06; Plate 13), which was demolished in the late 1990s (www.geograph.org.uk), and the area built over with housing (Plate 8). Following the public footpath along the western and north-western

Plate 7: Steps (Site 15) adjacent to the former tramroad (Site 10)

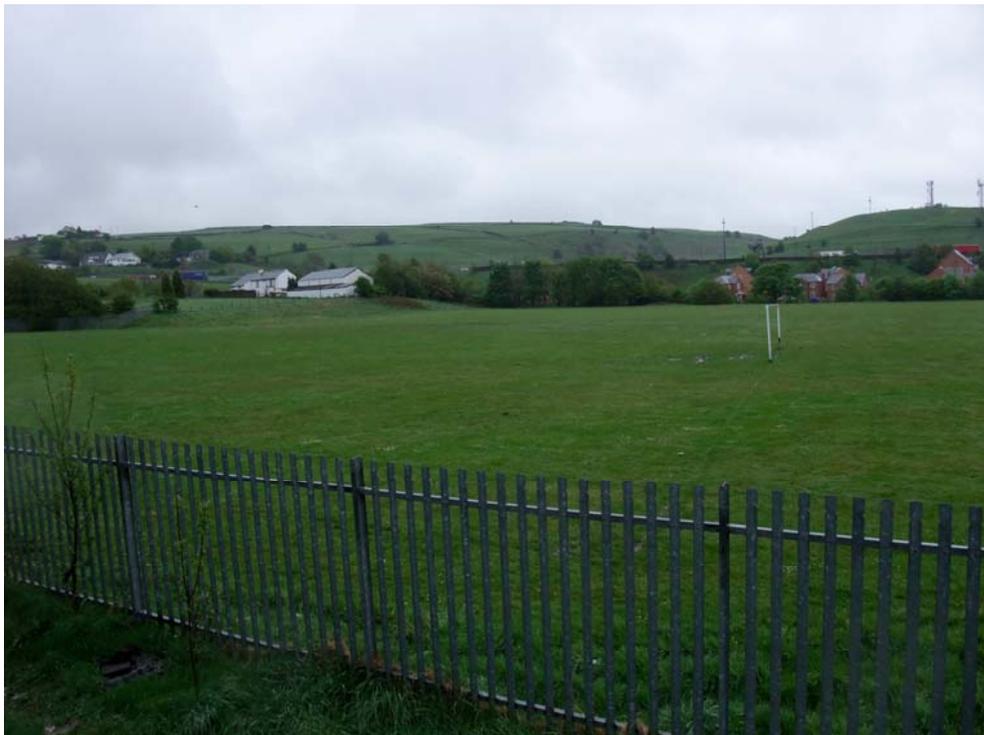
Plate 8: Looking south-west across the school playing fields towards Claylands Head (Site 13), and the site of the former Butterworth Hall Mill (Site 06)

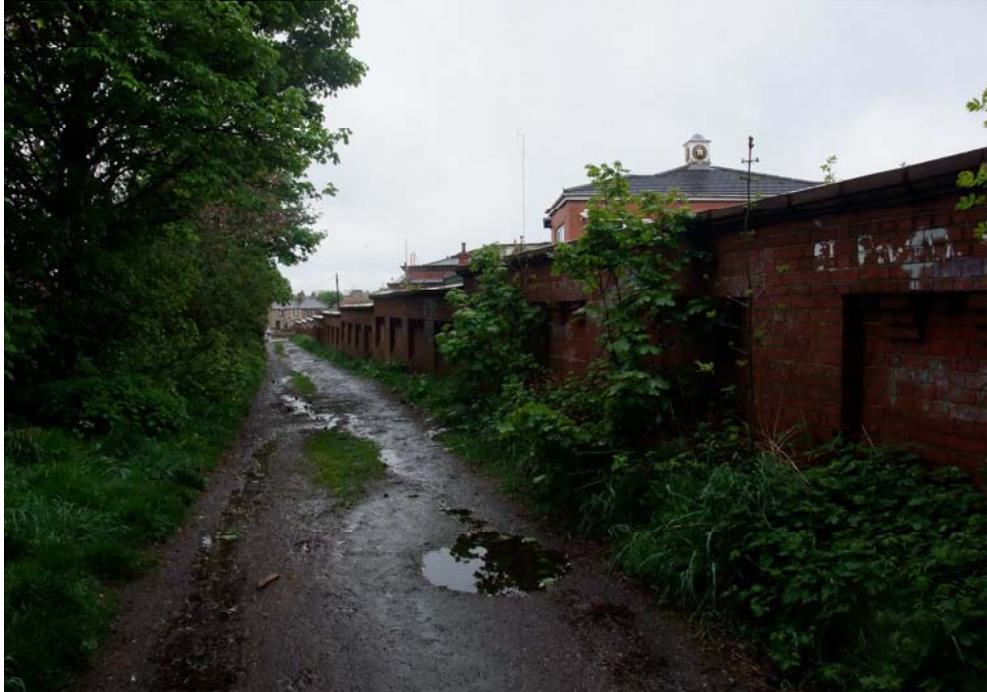
Plate 9: Boundary wall (Site **16**) of the former Butterworth Hall Colliery (Site **01**) adjacent to a track forming the southern boundary between the school and playing fields

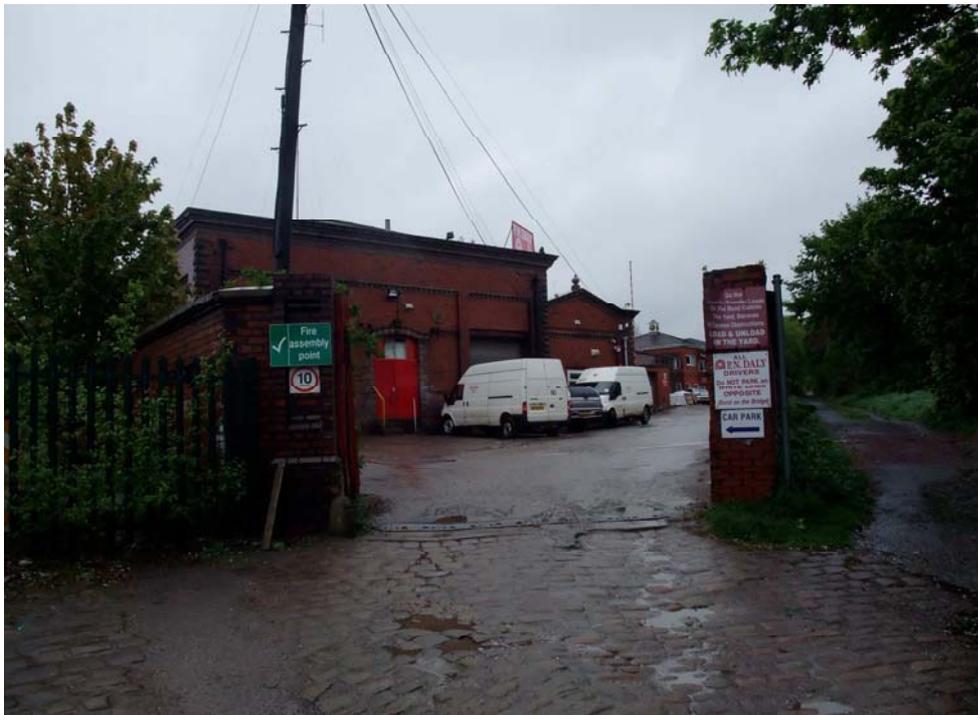
Plate 10: Former colliery buildings (Site **01**) and cobbled entrance

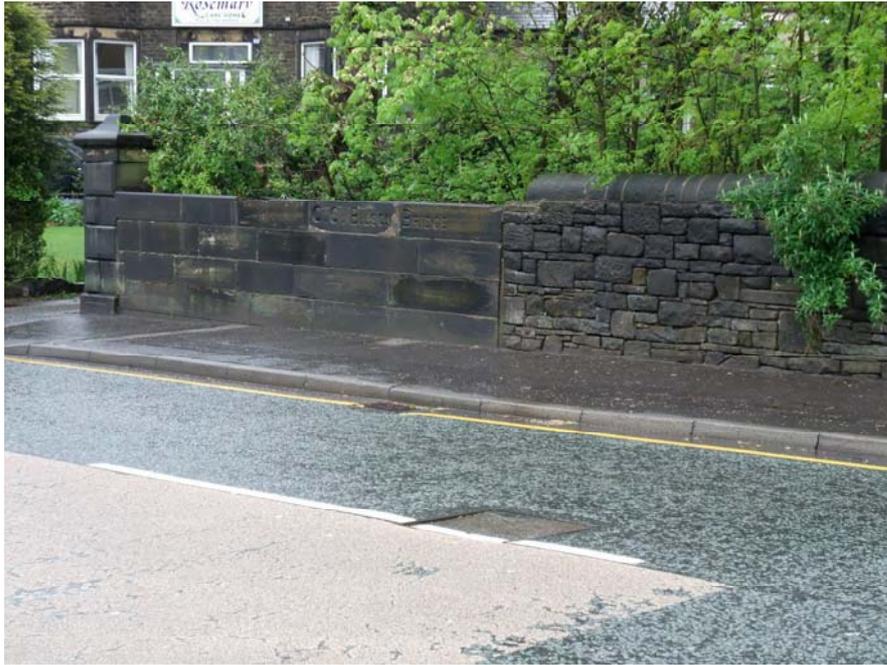
- 5.2.10 Butterworth Hall Mill (Site **06**) was demolished in the late 1990s and the area has since been built over, although the associated reservoir has survived. Some light industrial units have replaced the mill, possibly resulting in some survival of below ground remains. The former Butterworth Hall Woollen Mill (Site **14**) was demolished before 1890 and, subsequently, built over. It is unlikely that remains of this mill survive. Willow Hall (Site **12**) was demolished sometime between 1851 and 1890, although this site is now covered by the M62 and there is little chance of any surviving below ground remains. Newfield Head Farm (Site **03**) and Claylands Head Farm (Site **13**) are still shown on modern mapping; Site **03** appear extant, the condition of Site **13** is not known, although the buildings are again extant. The bridge (Site **09**) also survives in a good condition (Plate 11).

Plate 11: Bilson Bridge (Site 09), Butterworth Hall
