Hollingworth High School, Rochdale, Greater Manchester

Archaeological Desk- based Assessment

Oxford Archaeology North

May 2009

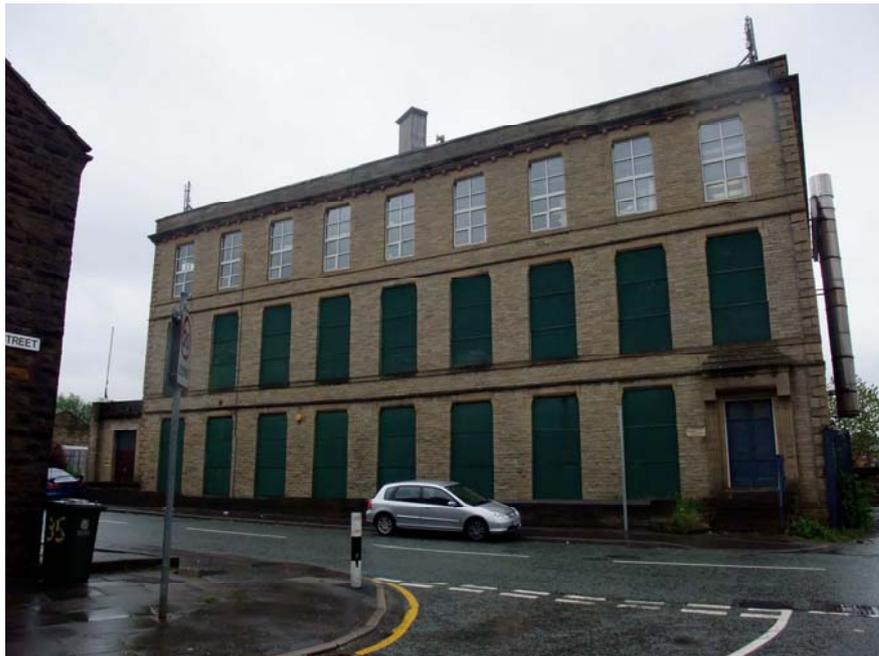
Description A three-storey sandstone building of nine bays. The mill is thought to be of nineteenth century date but with much twentieth century repointing. Until recently, the building was used as a greetings cards manufacturers. However, the property is currently vacant and the windows blocked. The extant building represents the larger north-eastern block of the mill shown on the present 1:10,000 map. The other part has been replaced by modern housing. The north-west wall has three large loading bay doors, one on each storey. The river flows directly under the original site and, at its emergence, the north of the mill is supported by a modern steel and brick structure, possibly resting on earlier stone foundations.

Plate 12: Former Albert Mill (Site 08) used more recently as a greeting cards manufacturer, but now boarded up

perimeter of the development site, further sections of red brick boundary wall were visible. Also, within the wider study area Site **08**, the mill of nineteenth century date listed in the HER as still operating as a greeting cards manufacturers, is now been boarded up (Plate 12). Bilson Bridge (Site **09**) was identified on the opposite side of the road, but no date stone was observed (Plate 11).

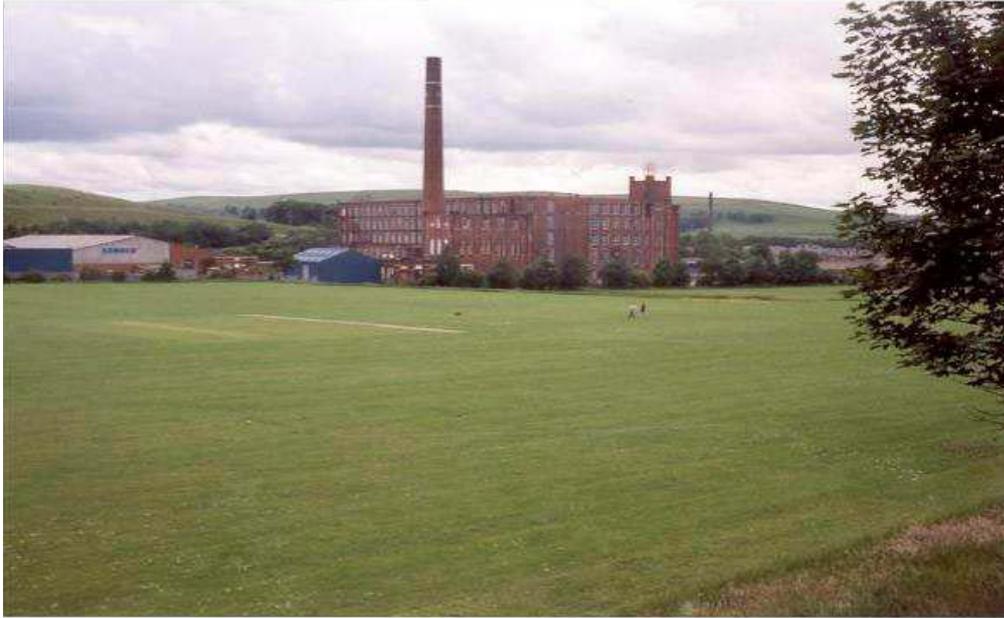
Plate 13: Photograph of Butterworth Hall Cotton Mill (Site **06**), taken just before its demolition in the late 1990s. Reproduced with kind permission from Paul Hogg, photographer (copyrighted but licensed for reuse; source www.geograph.org.uk)
