**Pioneer Mill,  
Lodge Street,  
Middleton  
Greater  
Manchester**

**Archaeological  
Building  
Investigation**

**Oxford Archaeology North**

**December 2007**

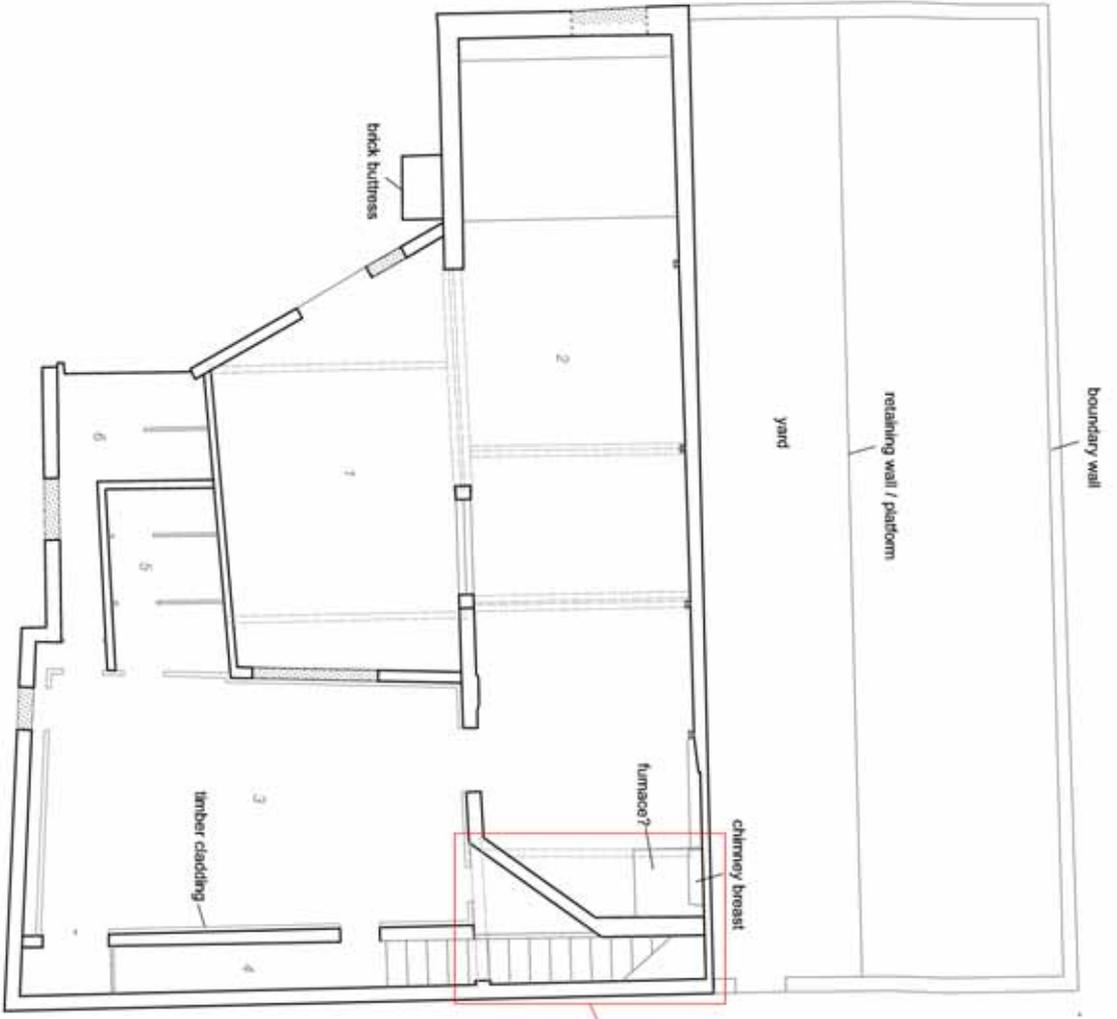
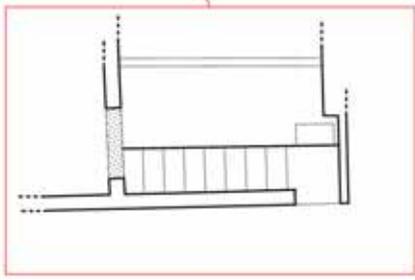
Figure 2: Ground Floor plan

4.2.2 There are two single-storey outshuts located at the front of the building, which are roofed separately. The ground floor comprises six rooms (Fig 2), and there four on the first. A single staircase allows restricted access to part of the first floor (Fig 2).

- 4.5.1 The ground floor comprised six rooms (Rooms 1 to 6) five of which were contained in the outshuts (Fig 2). Room 2 alone was part of the original brick structure. As previously stated, access into the building was via the western outshut, the interior of which comprised Room 1. Access to all of the other rooms was via Room 2. A staircase located in Room 4 provided access to part of the first floor.

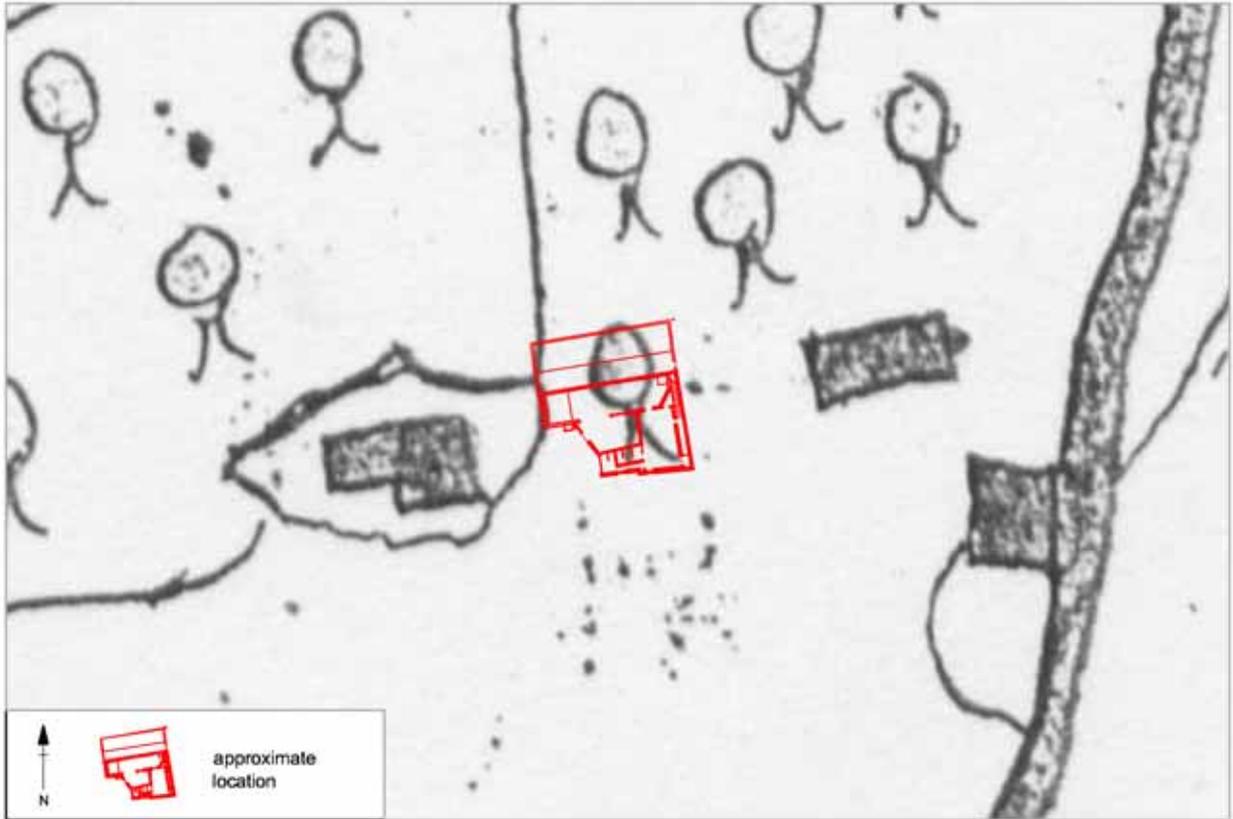
Figure 3: Extract from "A Survey By Hugh Oldham", 1767

- 3.1.10 The first plan to show the part of Middleton where the site is located in any detail was drawn from a survey by Hugh Oldham in 1767 (Fig 3). This depicted the town as a sparse rural community lying in a narrow strip of land between Rochdale Road/Long Street, to the west, and the River Irk and Whit Brook, to the south and east, respectively. The dispersed settlement was dominated by Middleton Hall, and surrounding gardens, orchards, and parklands, to the south, and the church currently called St Leonard's, to the north. The presence of one mill was suggested by the field-name 'Mill Meadow' at the south-west of the area. There were buildings depicted on this plan that appeared to be located immediately to the east and west of the building being studied, however, the present site appeared to be lightly wooded.

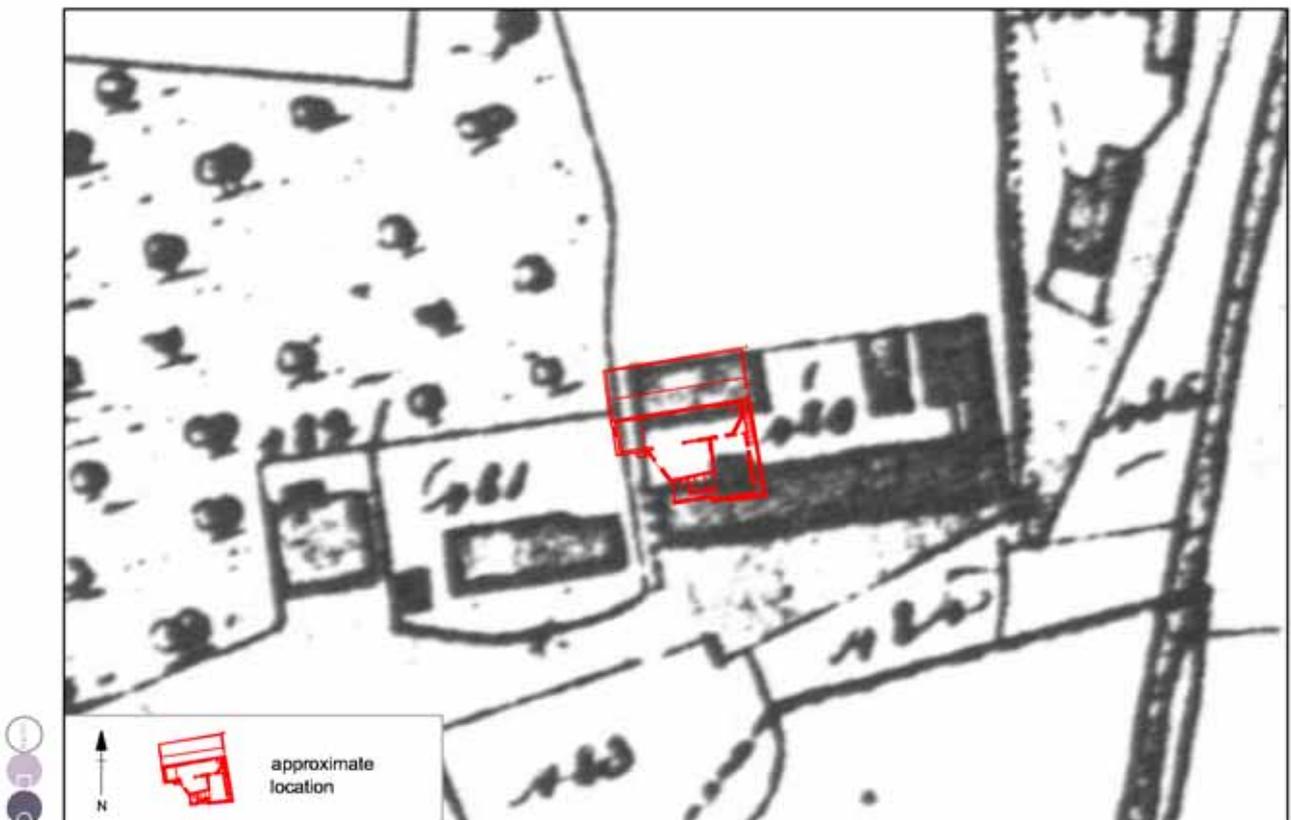
Figure 4: Extract from the Middleton tithe map, 1839

- 3.1.11 When the Middleton tithe map of 1839 (Fig 4) was published, 72 years later, the town had changed dramatically. The increase in domestic development, including the construction of weavers houses, and industrial expansion in the late eighteenth century (Garratt 1973) led to the transformation of the northern and western parts of the town, where nucleated blocks of terraced housing were depicted with conspicuous ribbon development along Long Street and Wood Street. Lodge Mill, to the south of the building under study, was depicted on this map for the first time and the numerous mills that would dominate the Lodge and Townley Street areas in later periods were not yet present. A building was shown on this map that corresponds exactly to the position of the current site, with two strips of buildings fronting Lodge Street and Morton Street sharing the same rectangular plot. There is some suggestion that at this time the building was semi-detached, although the dividing line is not very clear. This plot was named on the accompanying tithe apportionment as 'building land' occupied by John Andrew Ward 'and others' and owned by Lord Suffield. The arrangement of buildings might suggest that the building under study was an ancillary structure associated with domestic terraces. The elevated area to the north-west of the building included a restricted area described as a 'new burial ground' in the tithe apportionment, while the rest of this area was depicted as lightly wooded and described as a pigtle, or small enclosure, and garden. The area directly behind the building was named as 'Sandy Brow Waste'.

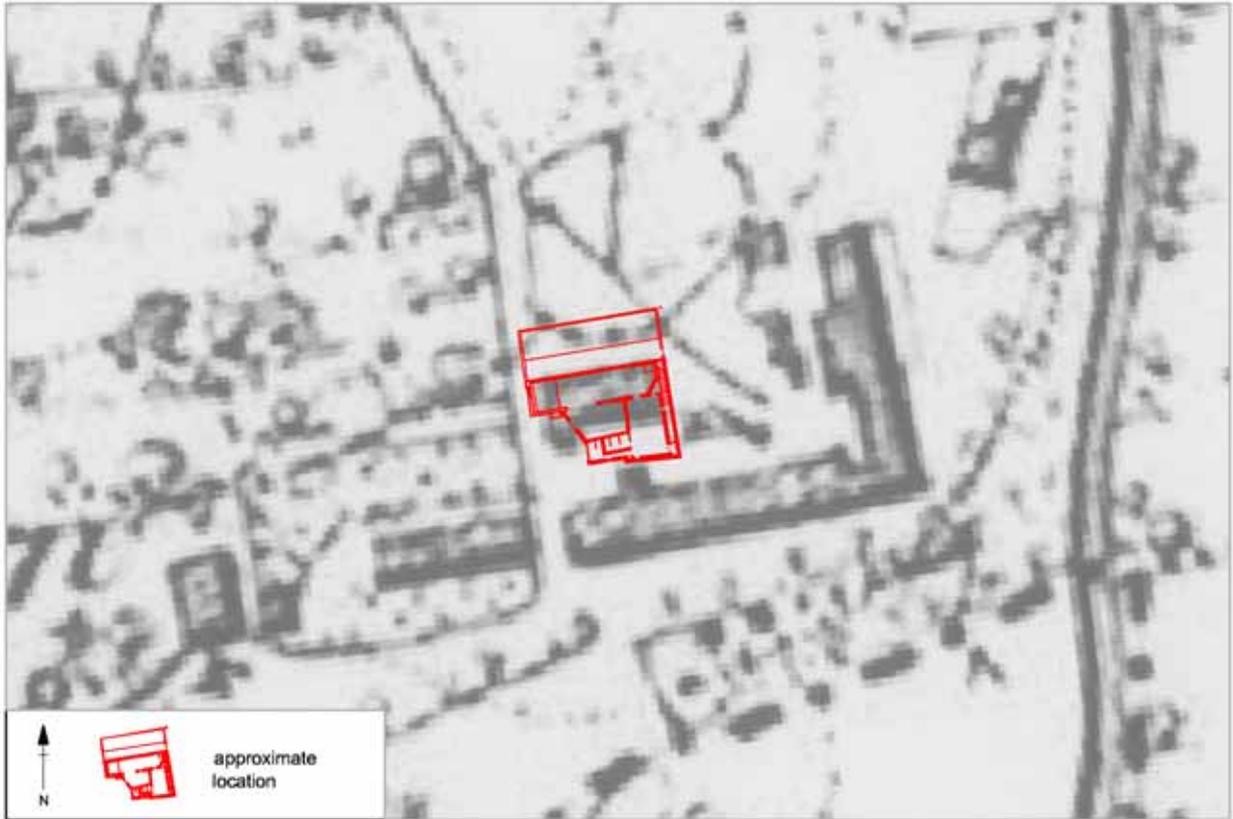
Figure 5: Extract from the Ordnance Survey map, 1848

- 3.1.13 The Ordnance Survey produced a map of Middleton in 1848 (Fig 5), at a scale of five feet to one mile. This map showed the area with a much greater degree of detail and accuracy than the earlier maps. The same buildings were depicted in the immediate study area as had been shown on the tithe map of 1839. The building under study was depicted as one unit, with two walled yards to the rear and a small outshut at the western end of the front (south) elevation. A terraced row to the south of the building, fronting Lodge Street, and a second portion of terraced buildings to the west of this, were named 'The Lodge' and

the strip of buildings fronting Morton Street was also shown to have been divided into several properties. The area behind the building was named as 'The Warren' and was shown as lightly wooded with the same, well-defined, cemetery area as had been depicted on the tithe map. Lodge Mill was named as a cotton mill on this map.

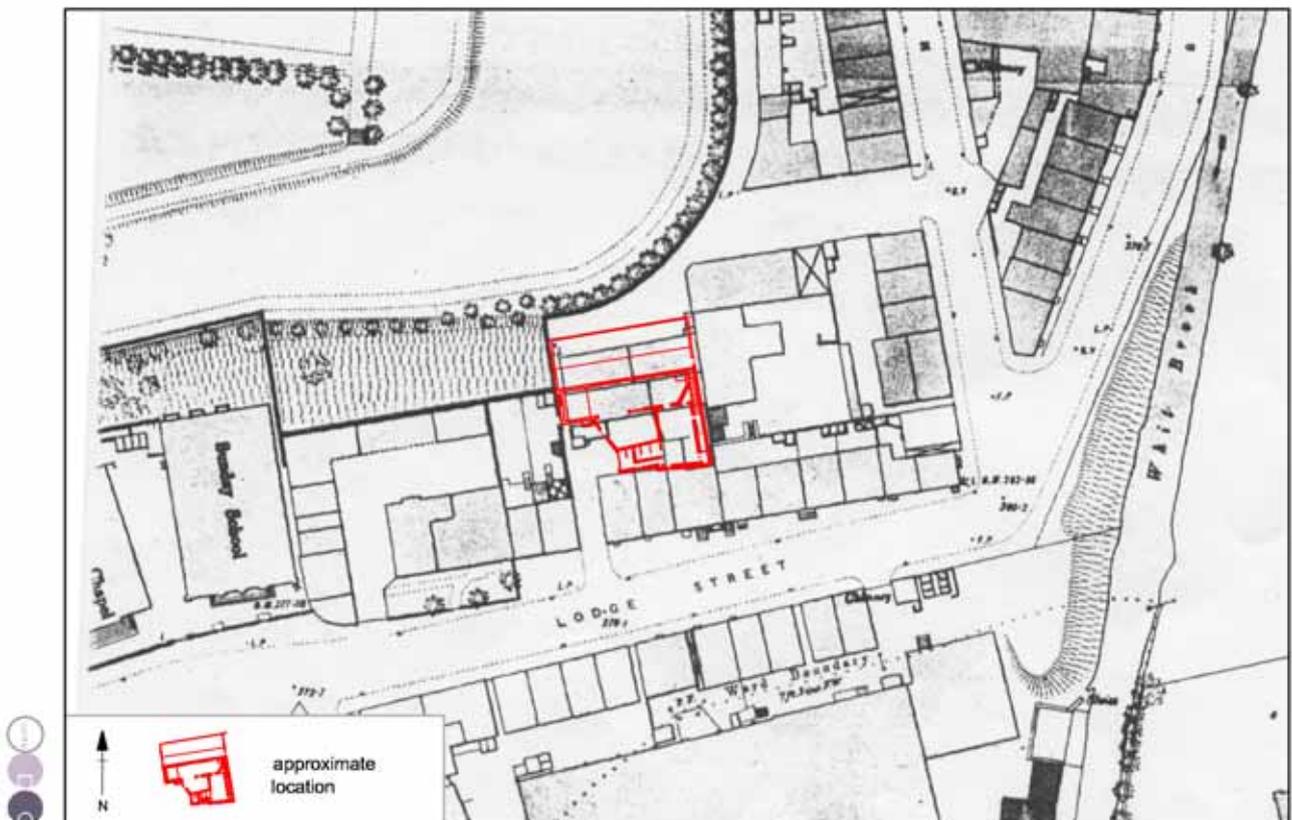
Figure 6: Extract from the Ordnance Survey map, 1891

- 3.1.14 The Ordnance Survey map of 1891 (Fig 6) was drawn at a scale of ten feet to one mile and showed the study area in considerable detail. The building under study was depicted as two subdivided units of a rectangular building with two contiguous yards to the rear. Two additional structures, similar to those on the map of 1848, were also depicted at the western end of the southern face of the building. The immediate locale was depicted as more intensively developed than the earlier maps had suggested, with numerous buildings lining Morton Street and Lodge Street. The southern part of the town had become entirely urbanised by this time, with the former estate of Middleton Hall being dominated by an industrial landscape of mills and associated housing. The cemetery area, to the north-west of the study area, had also increased in size and a monument to Samuel Bamford, a local weaver and radical (Garratt 1973), had been raised in the area formerly named 'The Warren'. Brookside Mill, to the south of the study area, was depicted for the first time on this map and named as a cotton mill. Other nearby mills included Park Mill, Mikader Mill, Albany Mills, Lodge Mills, and Townley Mill. The rail link from Middleton Junction, completed in 1857 (Pimlott 1997, 131), was depicted for the first time on this map.

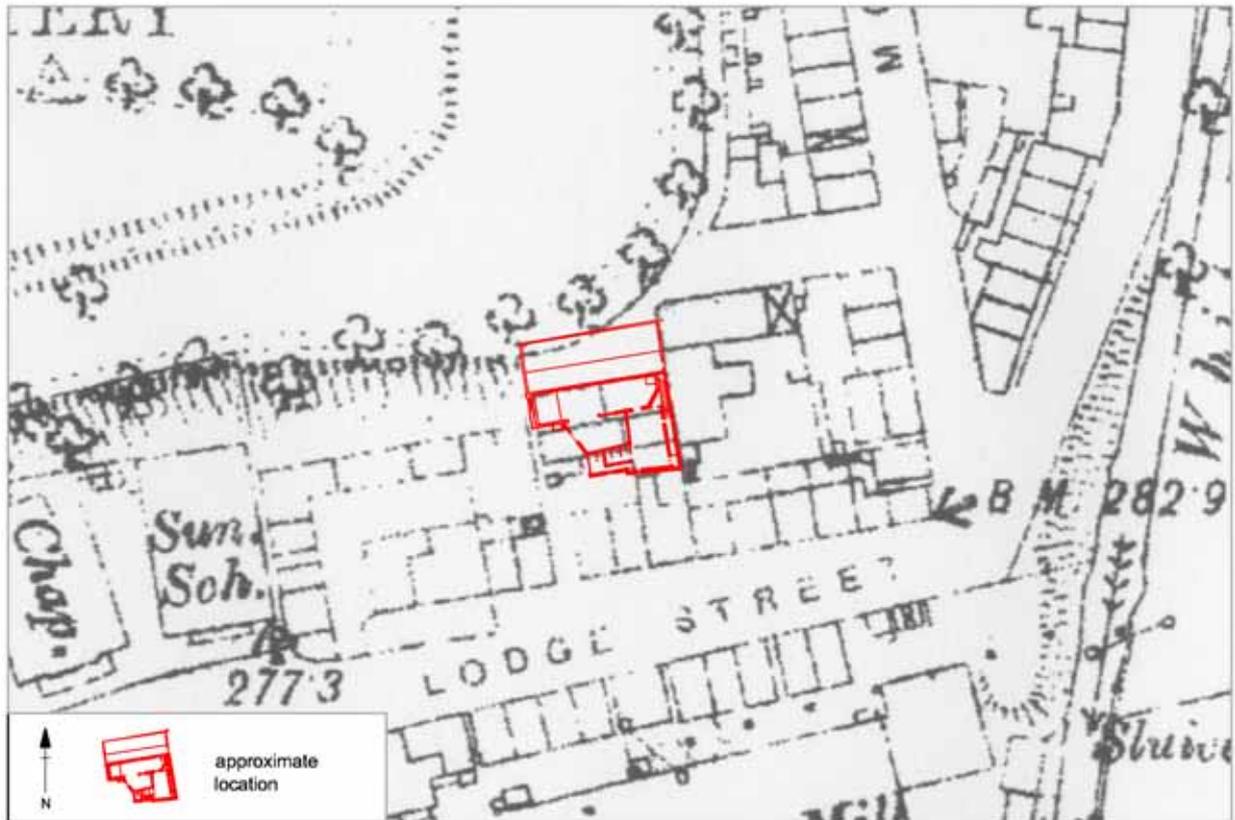
Figure 7: Extract from the Ordnance Survey map, 1893

- 3.1.15 The Ordnance Survey map of 1893 (Fig 7), at 25 inches to 1 mile, and the Ordnance Survey map of 1894, at 6 inches to 1 mile, showed the area as it was depicted on the map of 1891, but with less detail.

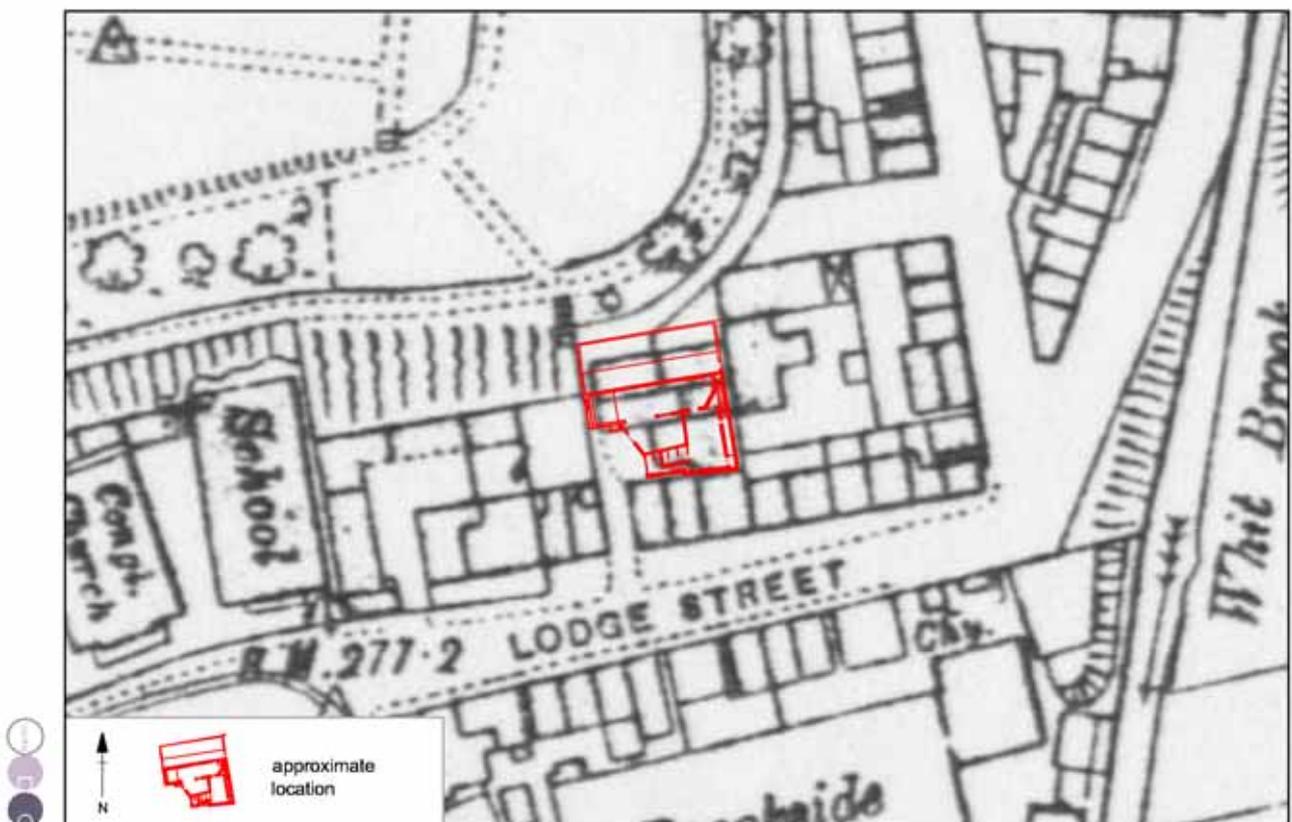
Figure 8: Extract from the Ordnance Survey map, 1907

- 3.1.16 The Ordnance Survey map of 1907 (Fig 8), at 25 inches to 1 mile, depicted few changes to the maps of the 1890s, however, the western outshuts were no longer depicted and an L-shaped structure was shown abutting the eastern part of the southern side of the building. The area occupied by the cemetery appeared to have increased to occupy the whole of the eastern part of the raised area behind the study area.

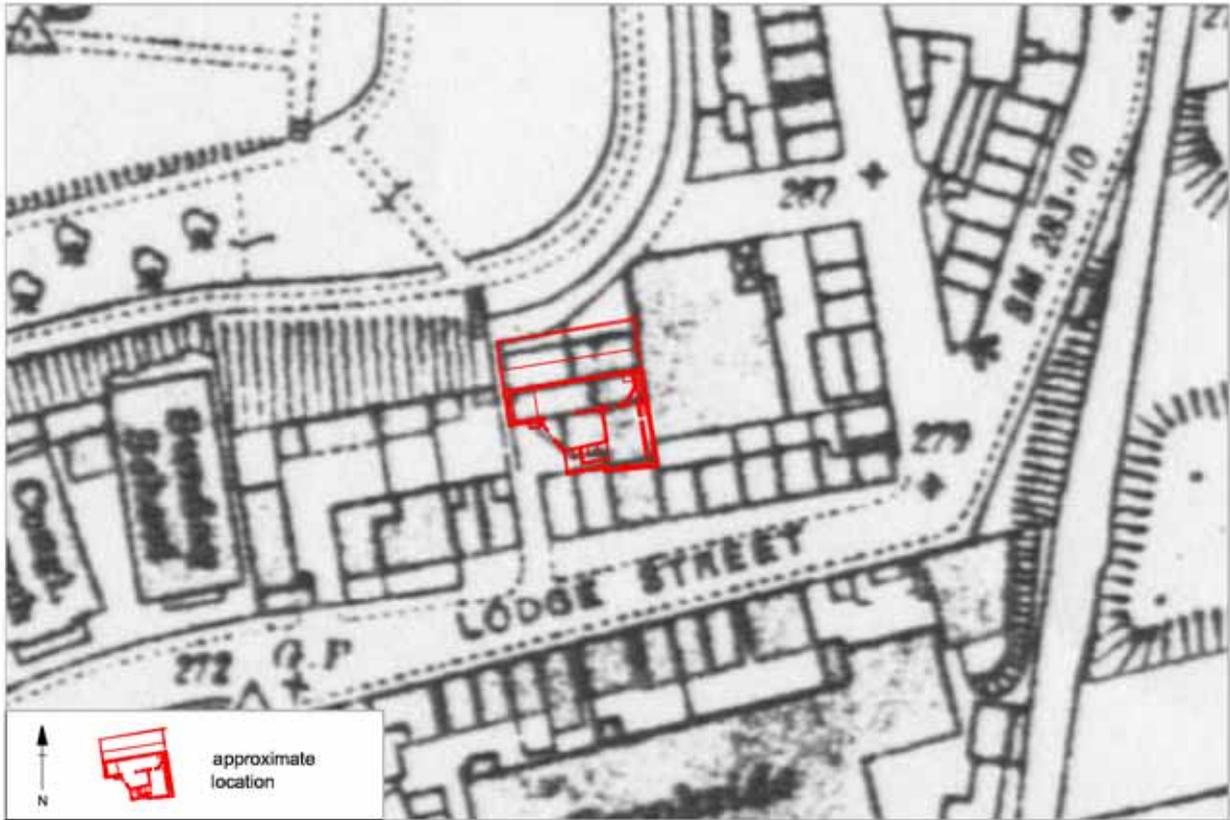
Figure 9: Extract from the Ordnance Survey map, 1932

- 3.1.17 The Ordnance Survey map of 1932 (Fig 9), at 25 inches to 1 mile, showed that the present angled wall of the westernmost outshut had been constructed. This map also appeared to depict a single large roofed structure adjacent to the south and west of the building under study, where previously several independent units had been shown.

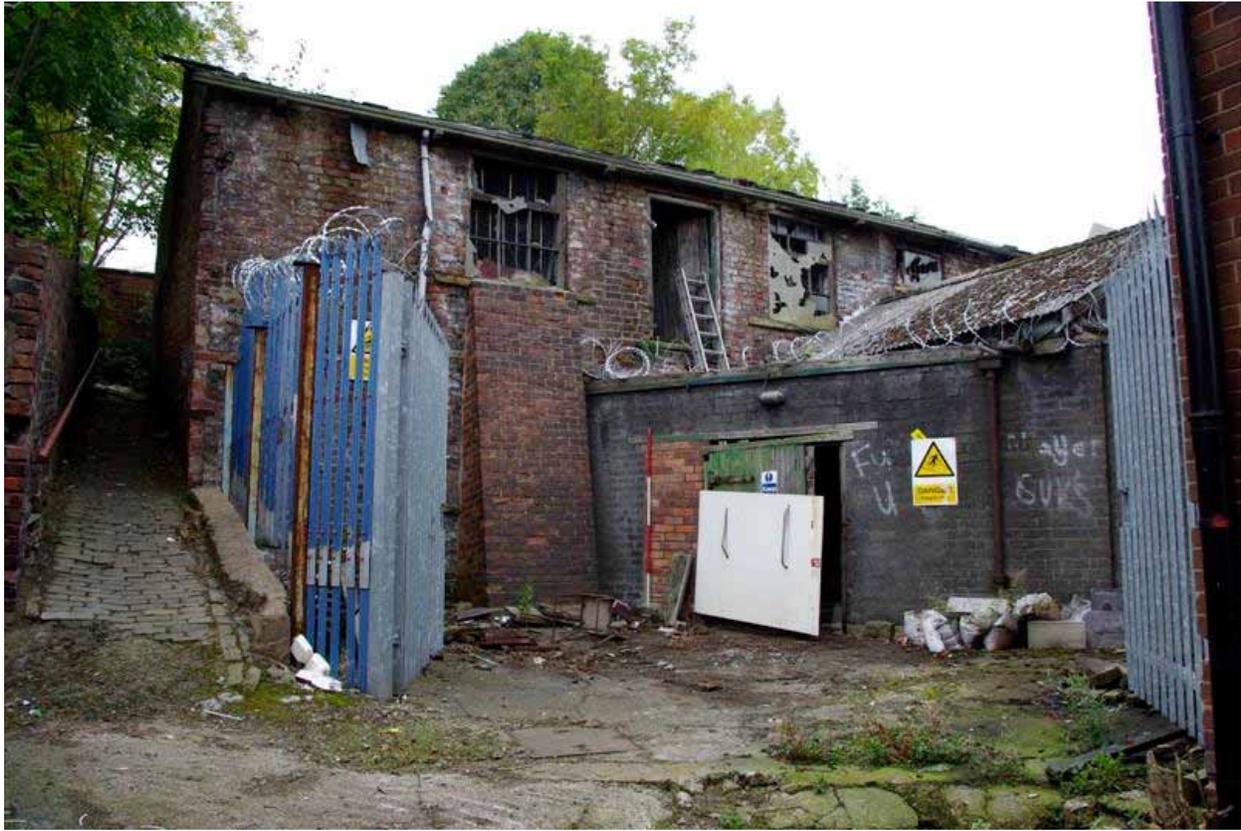
4.3.1 The main part of the building is of handmade brick construction (Plate 3) (average size 9 ¼ inches x 4 inches x 2 ½ inches) laid mostly in English garden wall bond, with predominately cement mortar, although lime mortar is evident in some places. Some repair and patching has been carried out using modern grey brick. The windows are all timber casements with timber lintels and yellow sandstone sills.

- 4.4.1 ***The South (Front) Elevation:*** this is the front of the original brick two-storey building, and housed what was the original doorway into the building (Plate 3). Part of the elevation is hidden from view by the later, more modern outshuts. A join in the brickwork in this wall appears to represent two phases of construction, and the eastern side of the building differs slightly in that it is of stretcher bond rather than English garden wall bond. The east end of the brickwork appears earlier than that to the west.

Plate 3: The front elevation

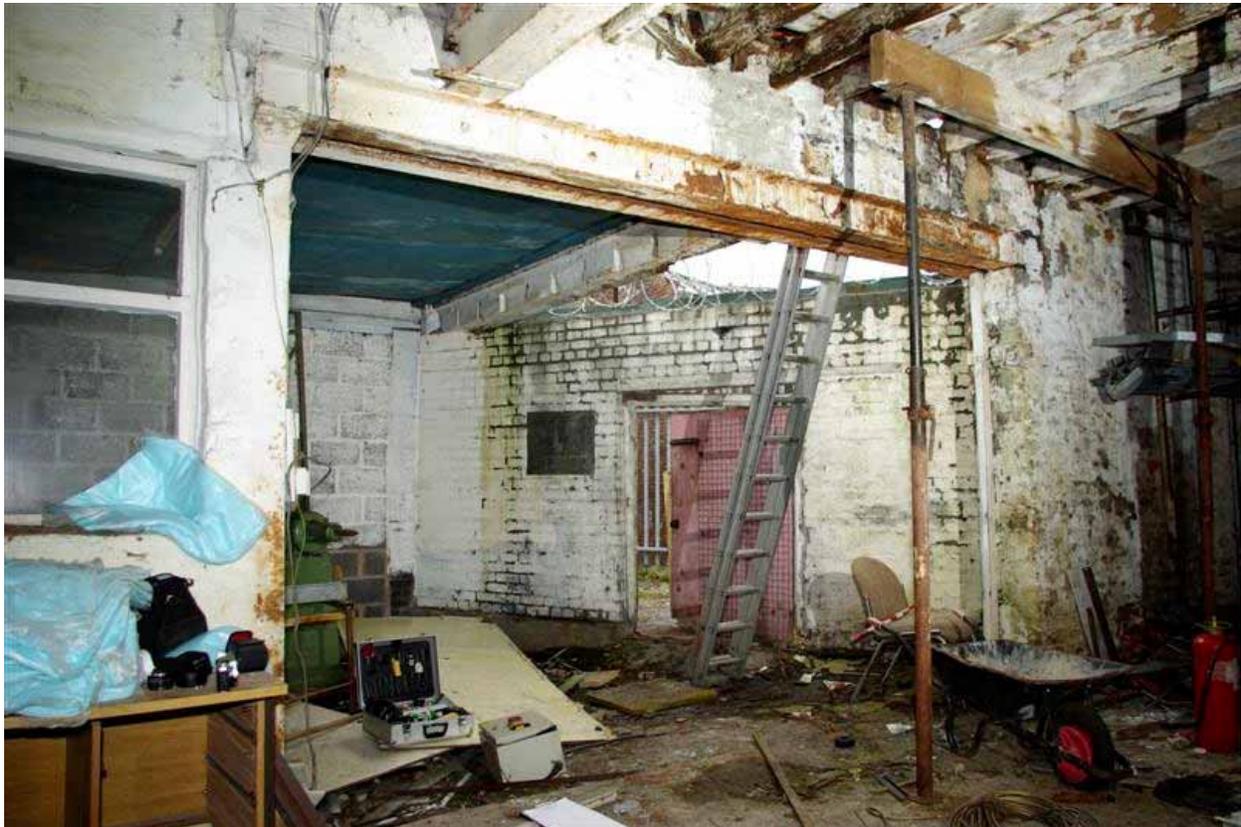
- 4.4.2 A single wide doorway allowed access to the ground floor. This appeared to be later in date than the wall itself, and was beneath a twin RSJ lintel (Plate 4). Adjacent to this doorway was a wide window opening containing a modern casement. This also appeared to be a later insert, and may have replaced an earlier arrangement.

Plate 4: Internal view of the main entrance in Room 2

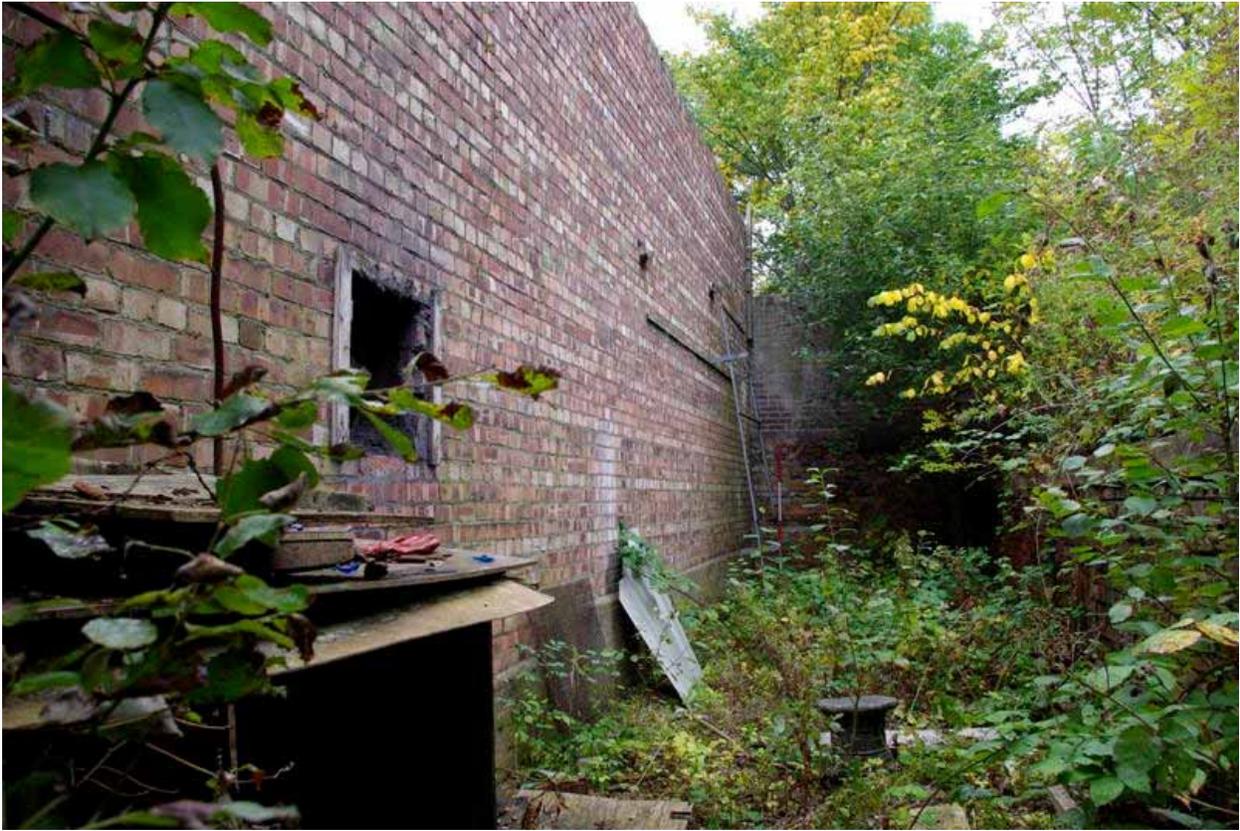
- 4.4.6 ***The North (Rear) Elevation:*** this elevation was also plain and appeared to have been rebuilt, probably in the late twentieth century (Plate 4). It was constructed of brick laid in English garden wall bond, with a rendered plinth. Access to the rear of the building was only possible via a rear door in the adjoining property. No windows were present in the back of the building, although a small square vent was present to the right of the doorway.

Plate 5: View of the North (Rear) elevation

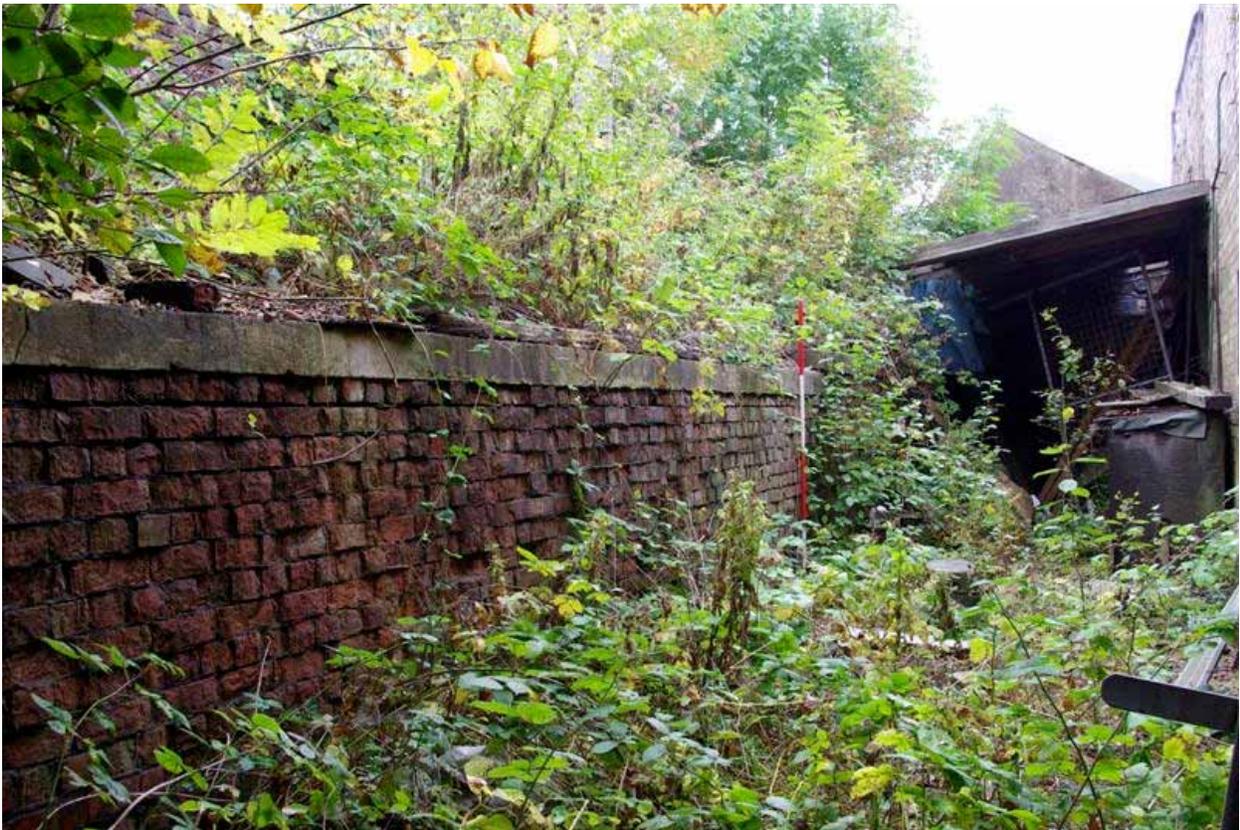
- 4.4.7 **The Rear Yard:** the yard is small and access was limited at the time of survey due to the dense growth of vegetation (Plates 5, 6, and 7). It was enclosed by a high brick wall, which was topped with razor wire. Approximately 3m to the south of this, and on the same alignment, was a lower brick wall with large sandstone coping stones. Its function was unclear but it could have served as either a working platform or retaining wall.

Plate 6: The rear yard area.

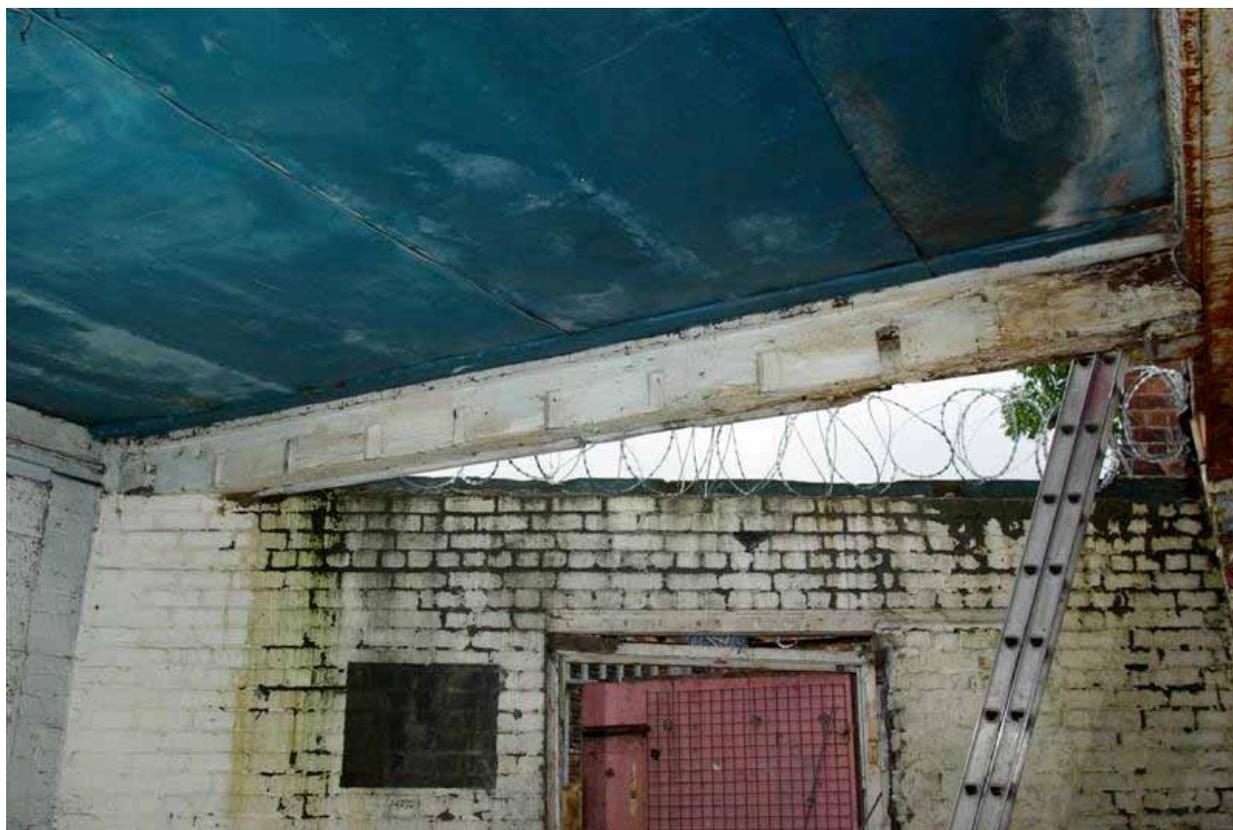
- 4.5.3 The ceiling was lined with chipboard and was supported on a RSJ and a reused timber beam (Plate 8). This beam had joist slots cut into both faces and was almost identical to another beam embedded vertically into the south wall (Plate 10). The provenance of these beams is impossible to deduce but they are both clearly reused.

Plate 8: Reused beam and partially open roof in Room 1

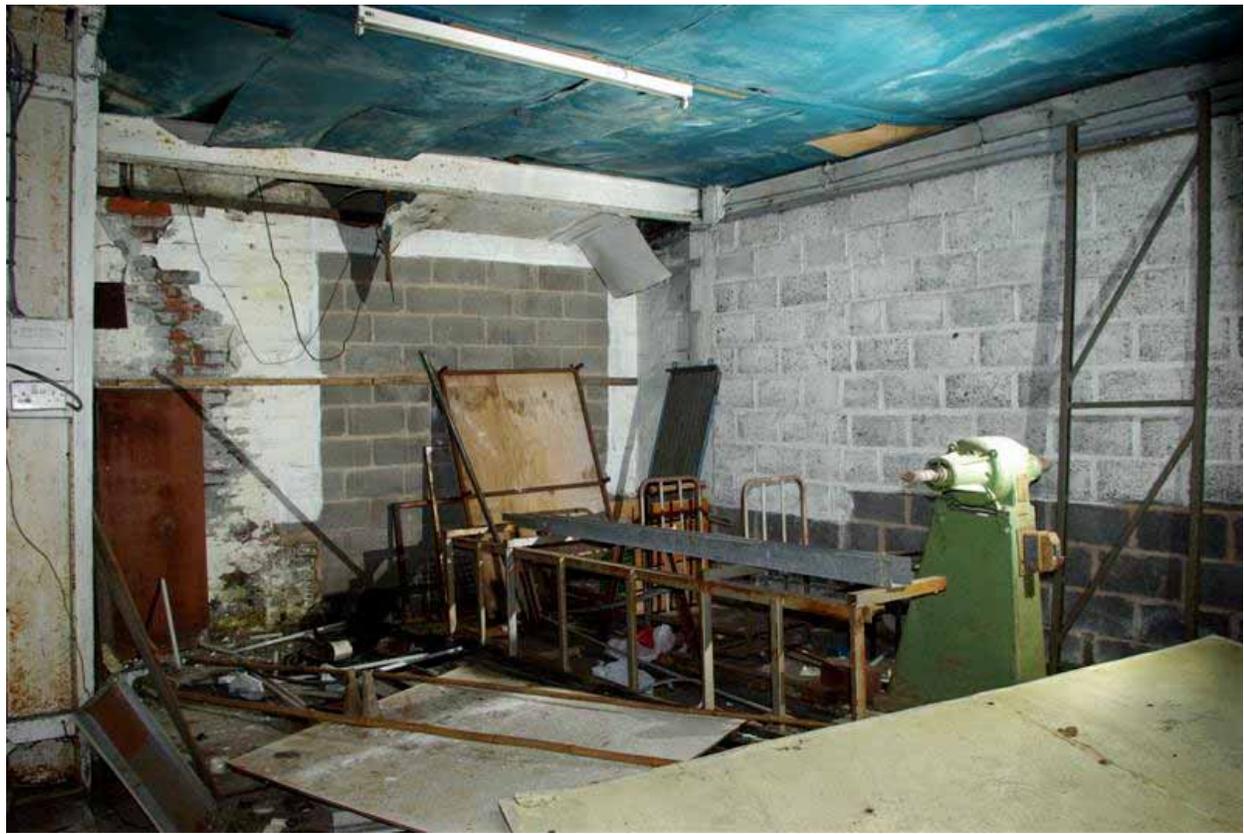
- 4.5.2 **Room 1:** this room was constructed mainly from cinder block (Plate 9) and entry was via a modern doorway from the small yard to the front of the building. It appears to originally have been rectangular in plan but a grey brick wall has been added at an oblique angle at the western end. All the walls were plain and partly painted. Some earlier brick was evident in the east and south walls. The floor was laid to concrete. The room contained machinery and metal, which restricted access.

Plate 9: General view of Room 1

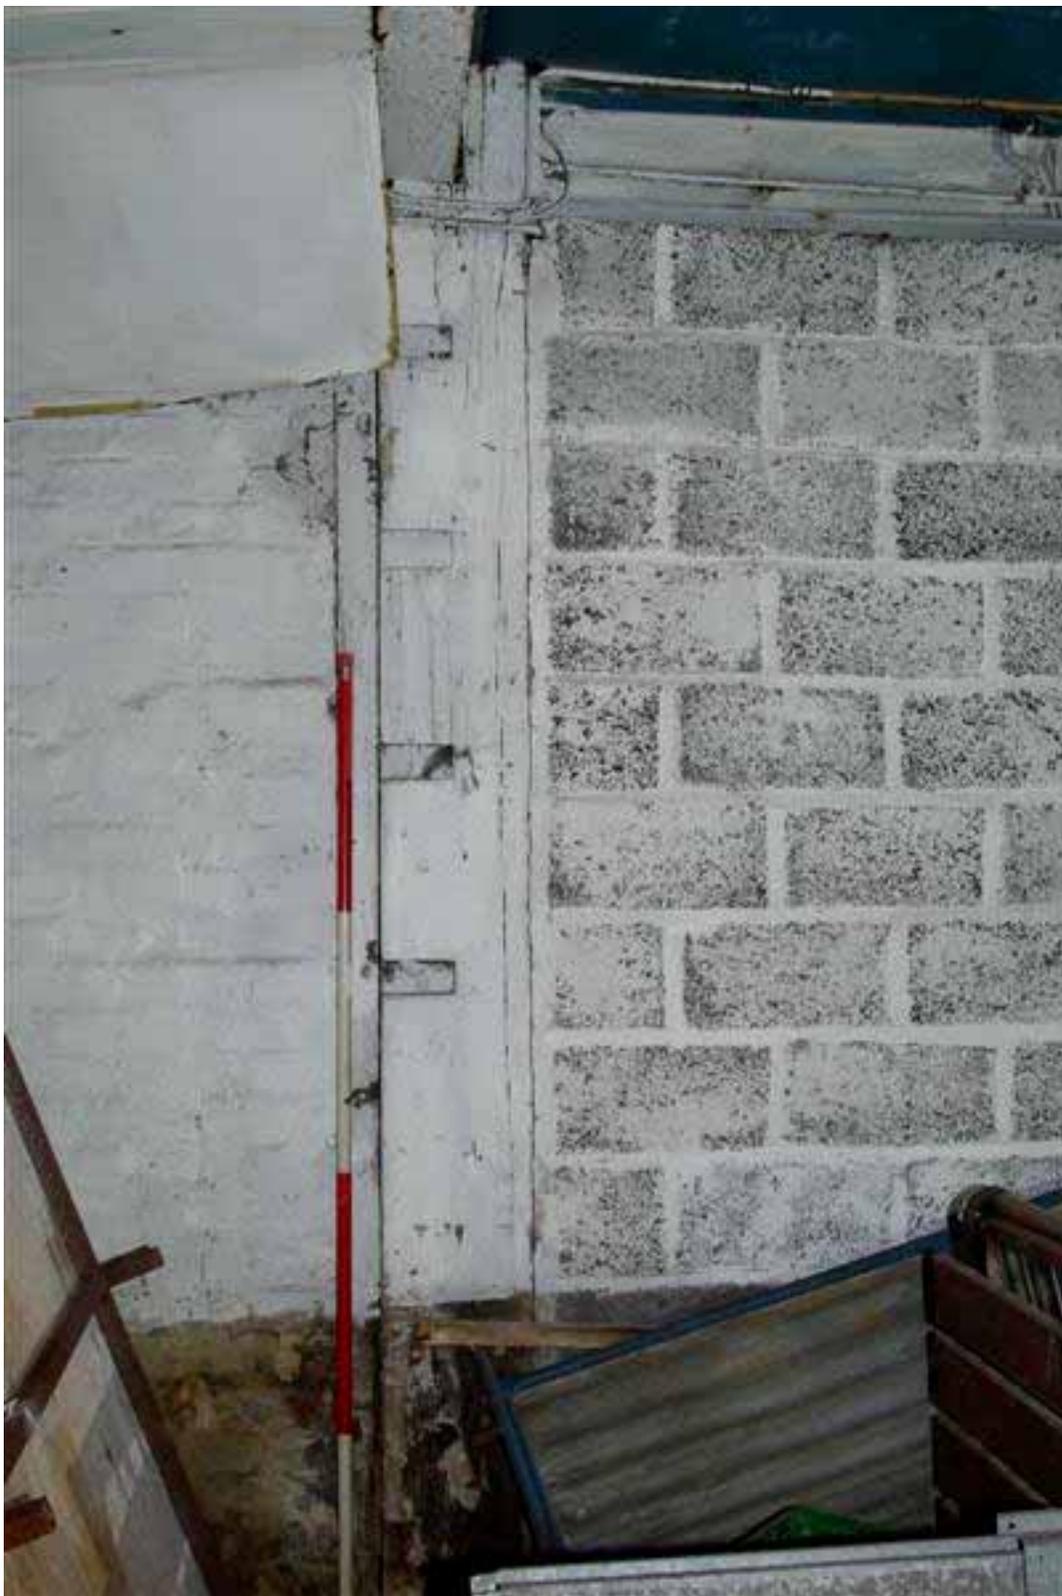
Plate 10: Reused beam embedded into the south wall of Room 1

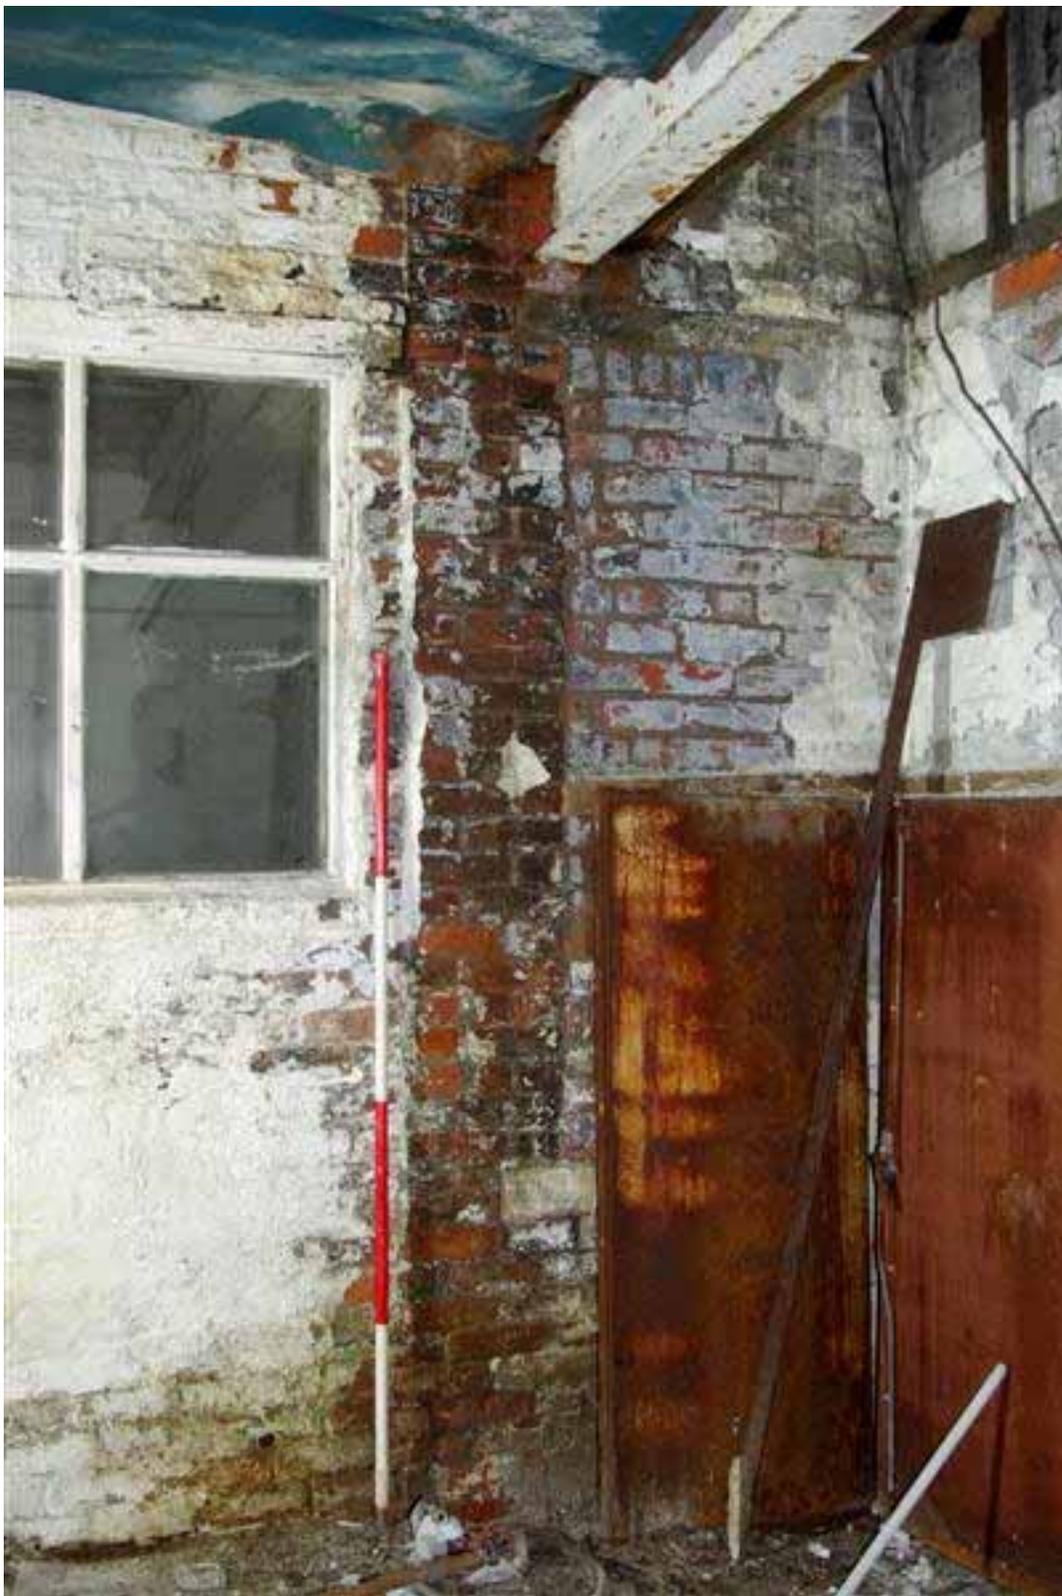
- 4.5.4 The north wall comprised the original external face of the south wall of the main building. This wall was of brick construction and a vertical butt joint indicated that it may be of two phases (Plate 11), or that an earlier opening had been reduced in size. In the north-east corner, there was a tall blocked window in brick, whilst a modern, wide window and doorway were also present. The latter provided access into Room 2.

Plate 11: Vertical butt joint in the north wall of Room 1

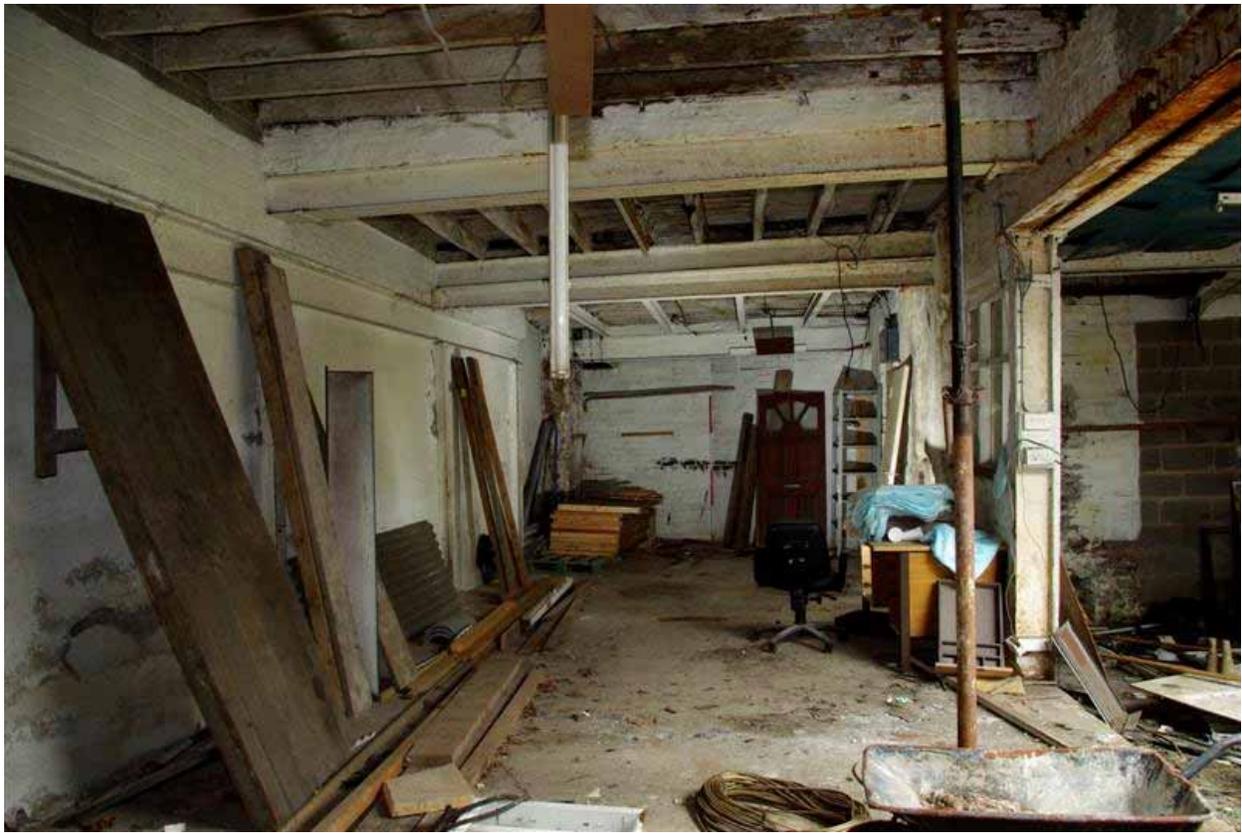
- 4.5.5 **Room 2:** this room encompassed the whole of the ground floor of the main building (Plate 12). The south wall and part of the north walls were the original brickwork, and were lime plastered and whitewashed. The east wall appeared to have been either inserted or rebuilt and part it is at an oblique angle. Most of the north wall, and the full extent of the west wall, have been rebuilt or lined in later brick (the blocked window visible on the west external elevation is not

Plate 12: General view of Room 2 facing east
