**Pioneer Mill,  
Lodge Street,  
Middleton  
Greater  
Manchester**

**Archaeological  
Building  
Investigation**

**Oxford Archaeology North**

**December 2007**

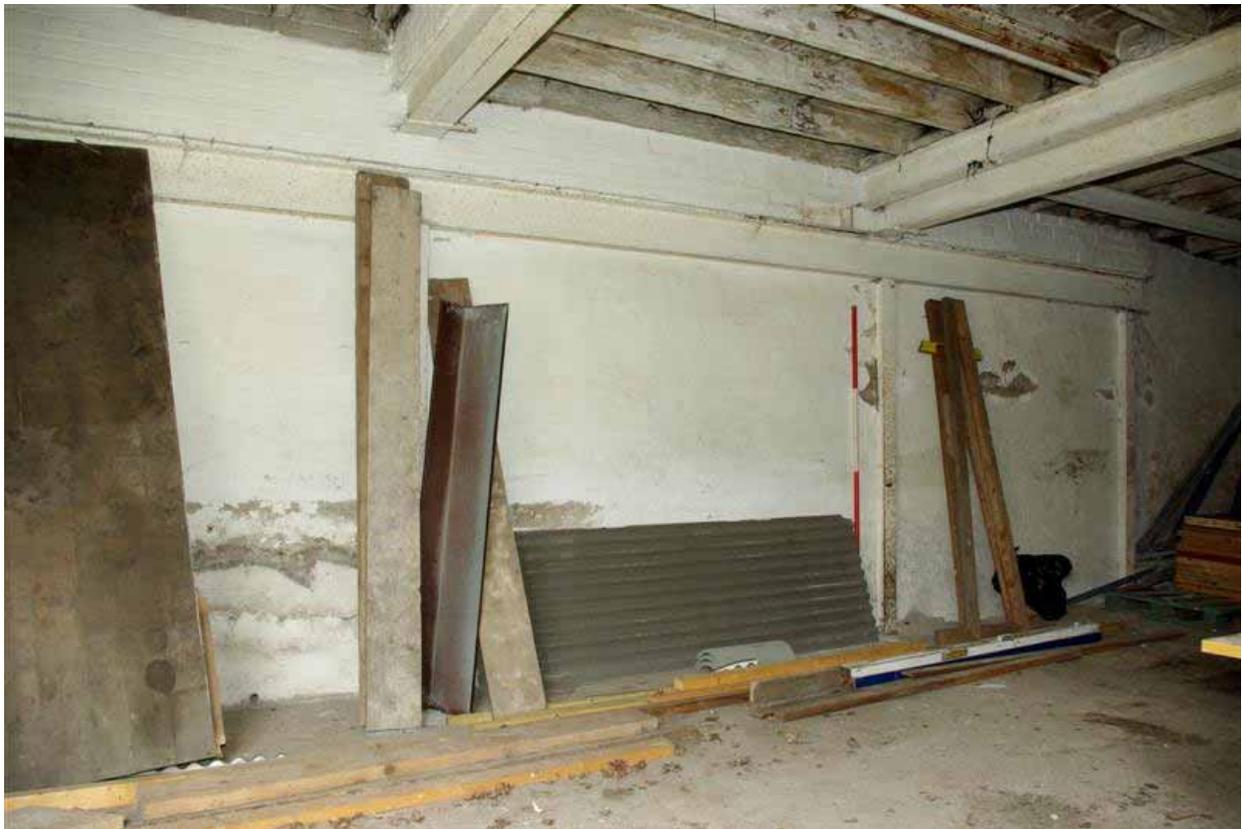
evident). The north wall contained vertical and horizontal RSJs, which support both the brick work above and the ceiling RSJs (Plate 13).

Plate 13: Rebuilt north wall in Room 2

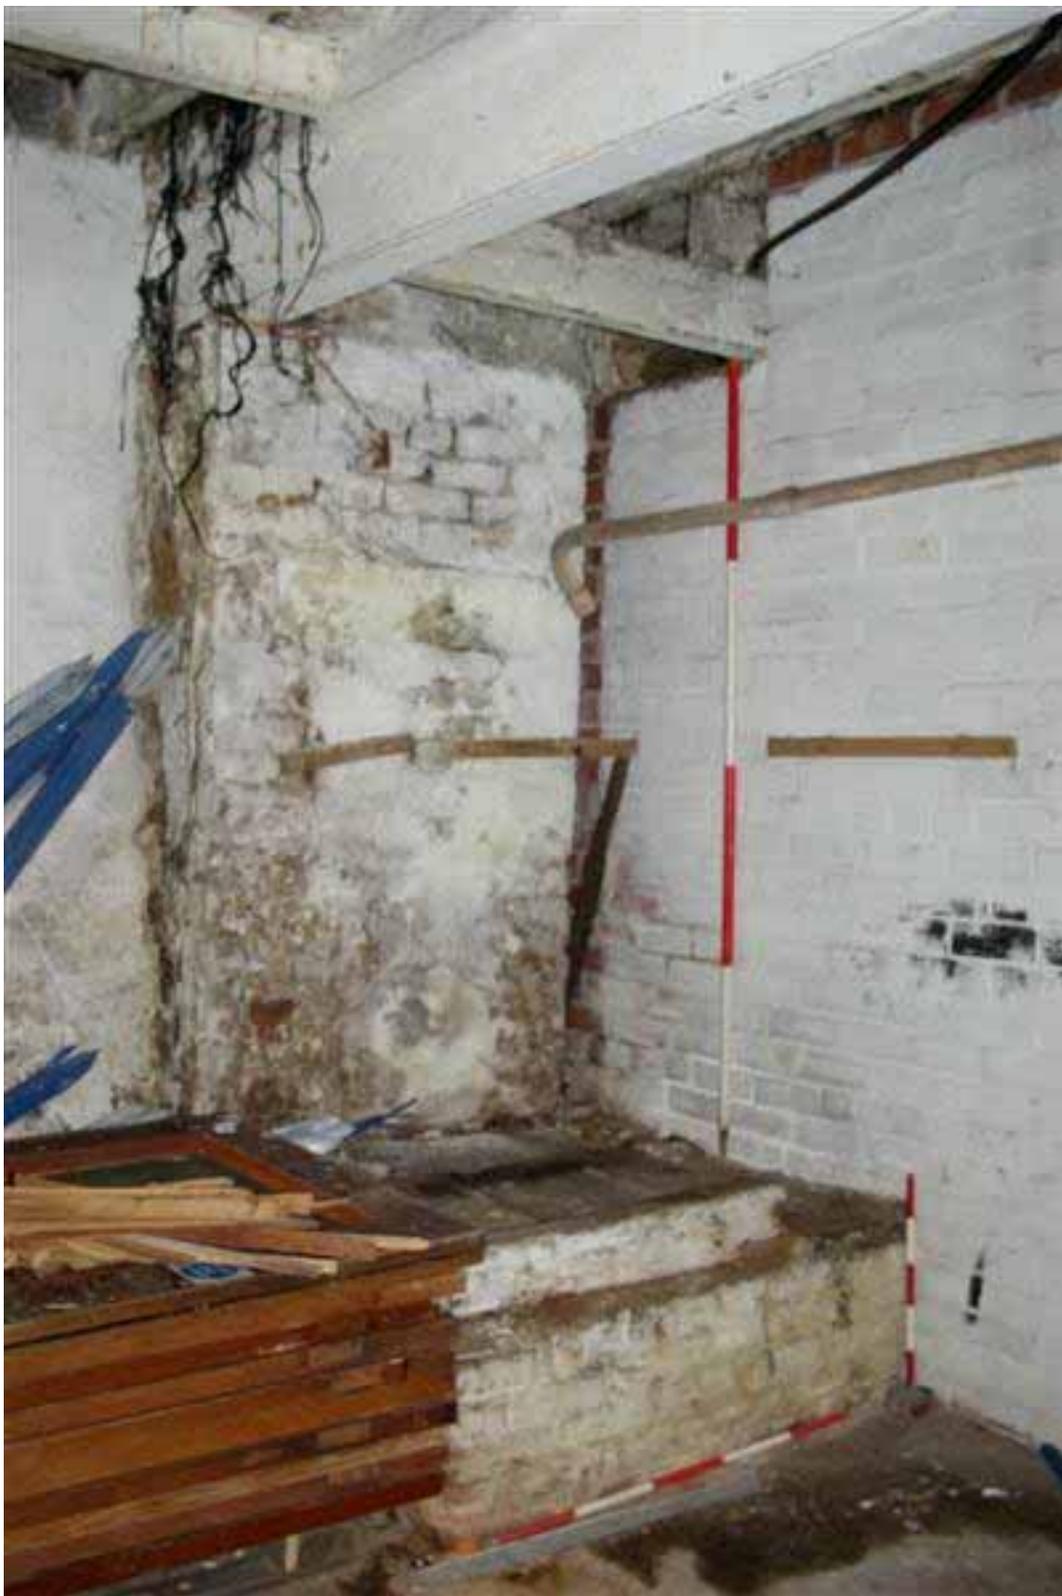
- 4.5.7 A single brick flue was located in the north-east corner of the room; this had a brick base or hearth (Plate 14). A blocked aperture with sandstone lintel was visible leading into the flue. The height of the stone base or hearth suggests this may have functioned as a small furnace-type feature.

Plate 14: Flue and base in the corner of Room 2

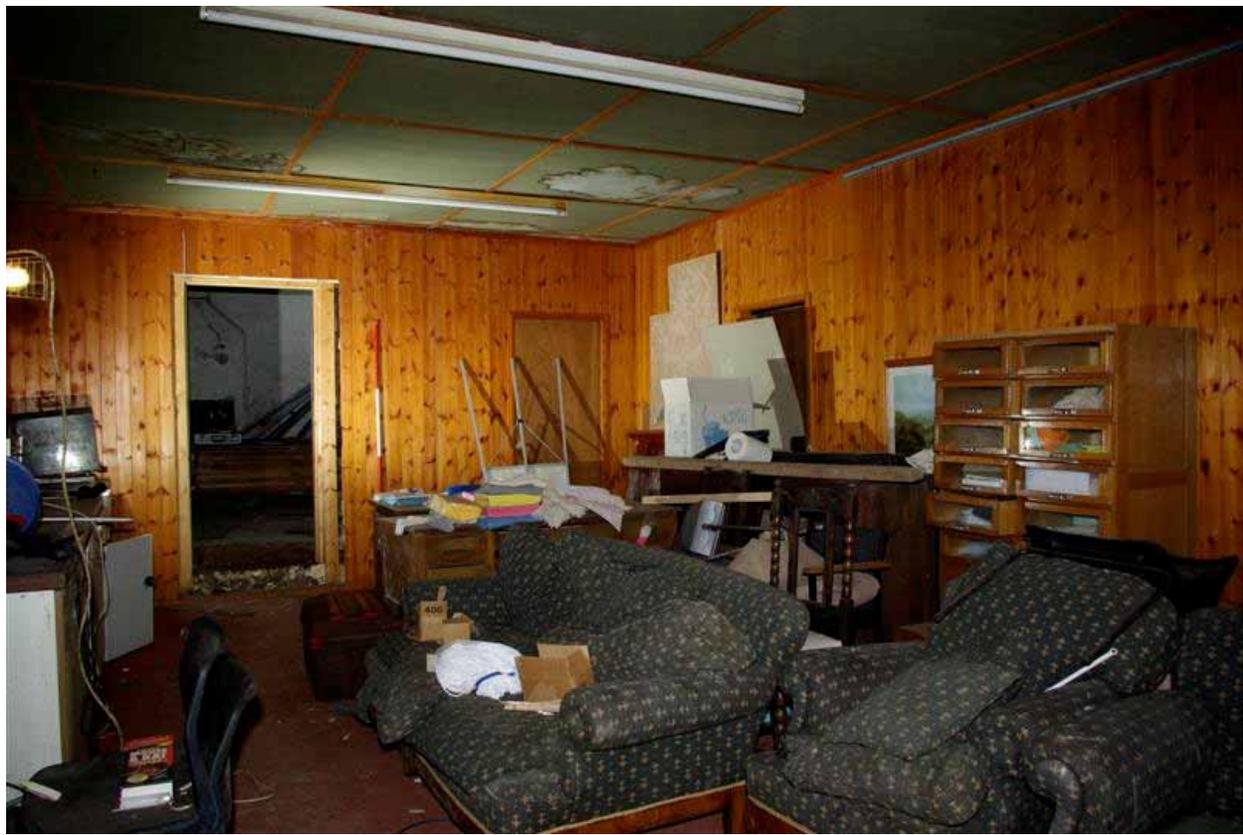
- 4.5.8 **Room 3:** this room was entirely modern in appearance. The walls were lined with wooden panelling, obscuring the wall fabric (Plate 15), and the ceiling was suspended. A small section of cinder block wall was visible at the south end, where a doorway, now blocked, once led in to the adjacent building (Fig 2). The floor was of timber and at a slightly higher level than Room 1.

Plate 15: General view of Room 3 facing north-east

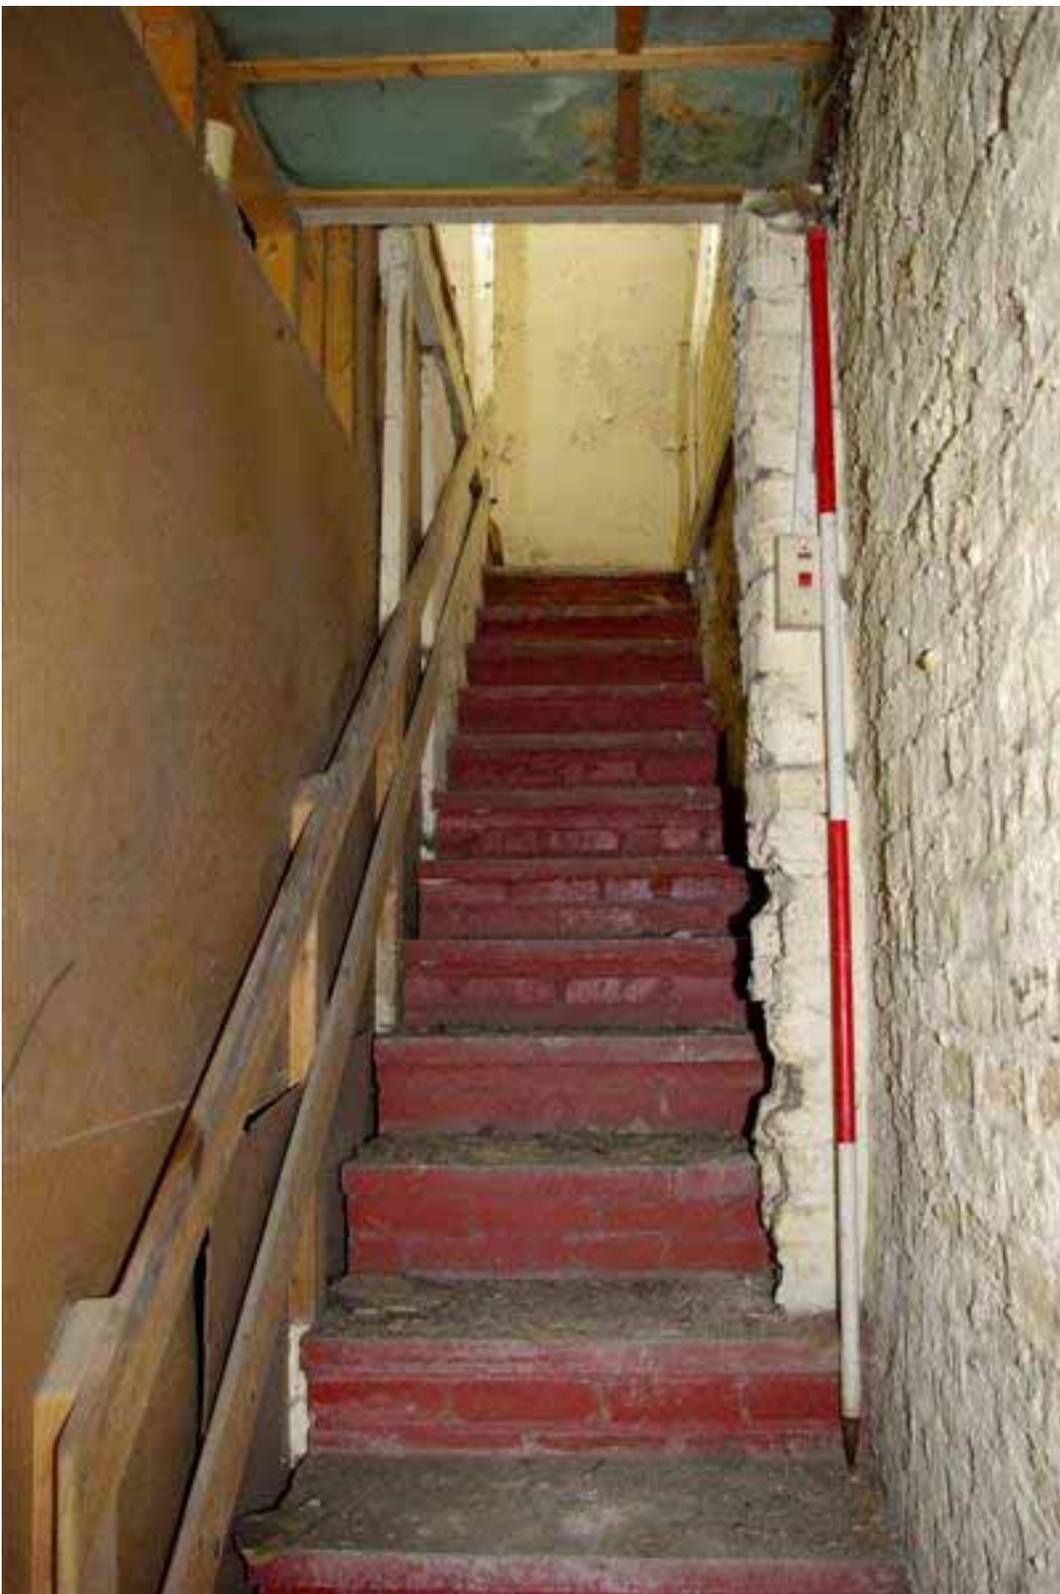
- 4.5.9 **Room 4:** this narrow room to the east of Room 3 served as a cupboard to the south and housed a stairway at its northern end (Plate 16), which led up to the first floor of the main building. The stairway was modern in appearance and it was apparent that the south wall of the main building had been modified to accommodate the staircase (Plate 16), with reinforcing RSJs having been inserted. The west wall was partly of brick with timber partitions, and the east wall was entirely of brick construction (all whitewashed).

Plate 16: Staircase in Room 4 leading to the upper floor (Room 7)

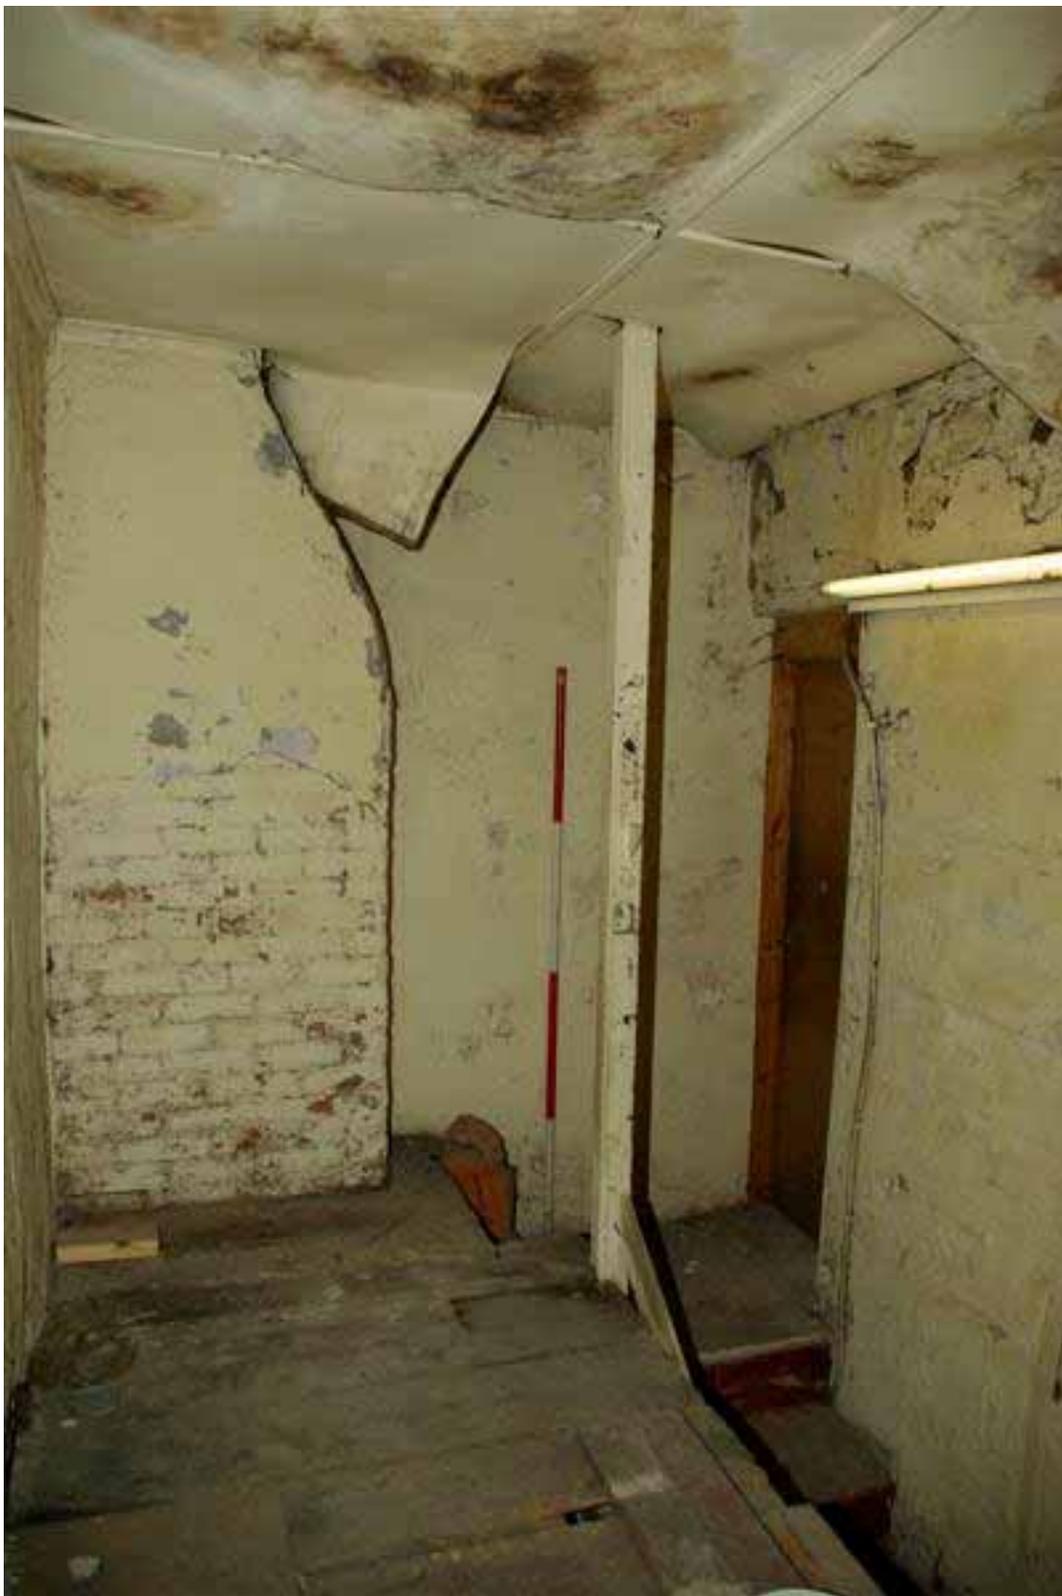
- 4.5.11 **Room 7:** at the top of the stairway leading from Room 4 a small landing was present (Plate 17). This room is plain plastered and served no obvious purpose other than to allow access via a modern door into the adjacent property to the east. The wall to the west, dividing the landing from the remainder of the upper floor, contained no obvious evidence of a doorway. There was, however, a blocked window in the south wall, and evidence of blocking in the east wall (Fig 2). The flue described in *Section 4.4.4* passed through this room (Plate 17). The floor was laid down to 12 inch wide boards and the ceiling was covered with fibreboard.

Plate 17: Small landing area on the upper floor facing north-east (Room 7)
