Sewer Ejector Replacement Round Kitchen Court Hampton Court Palace

Archaeological Watching Brief Report

January 2013

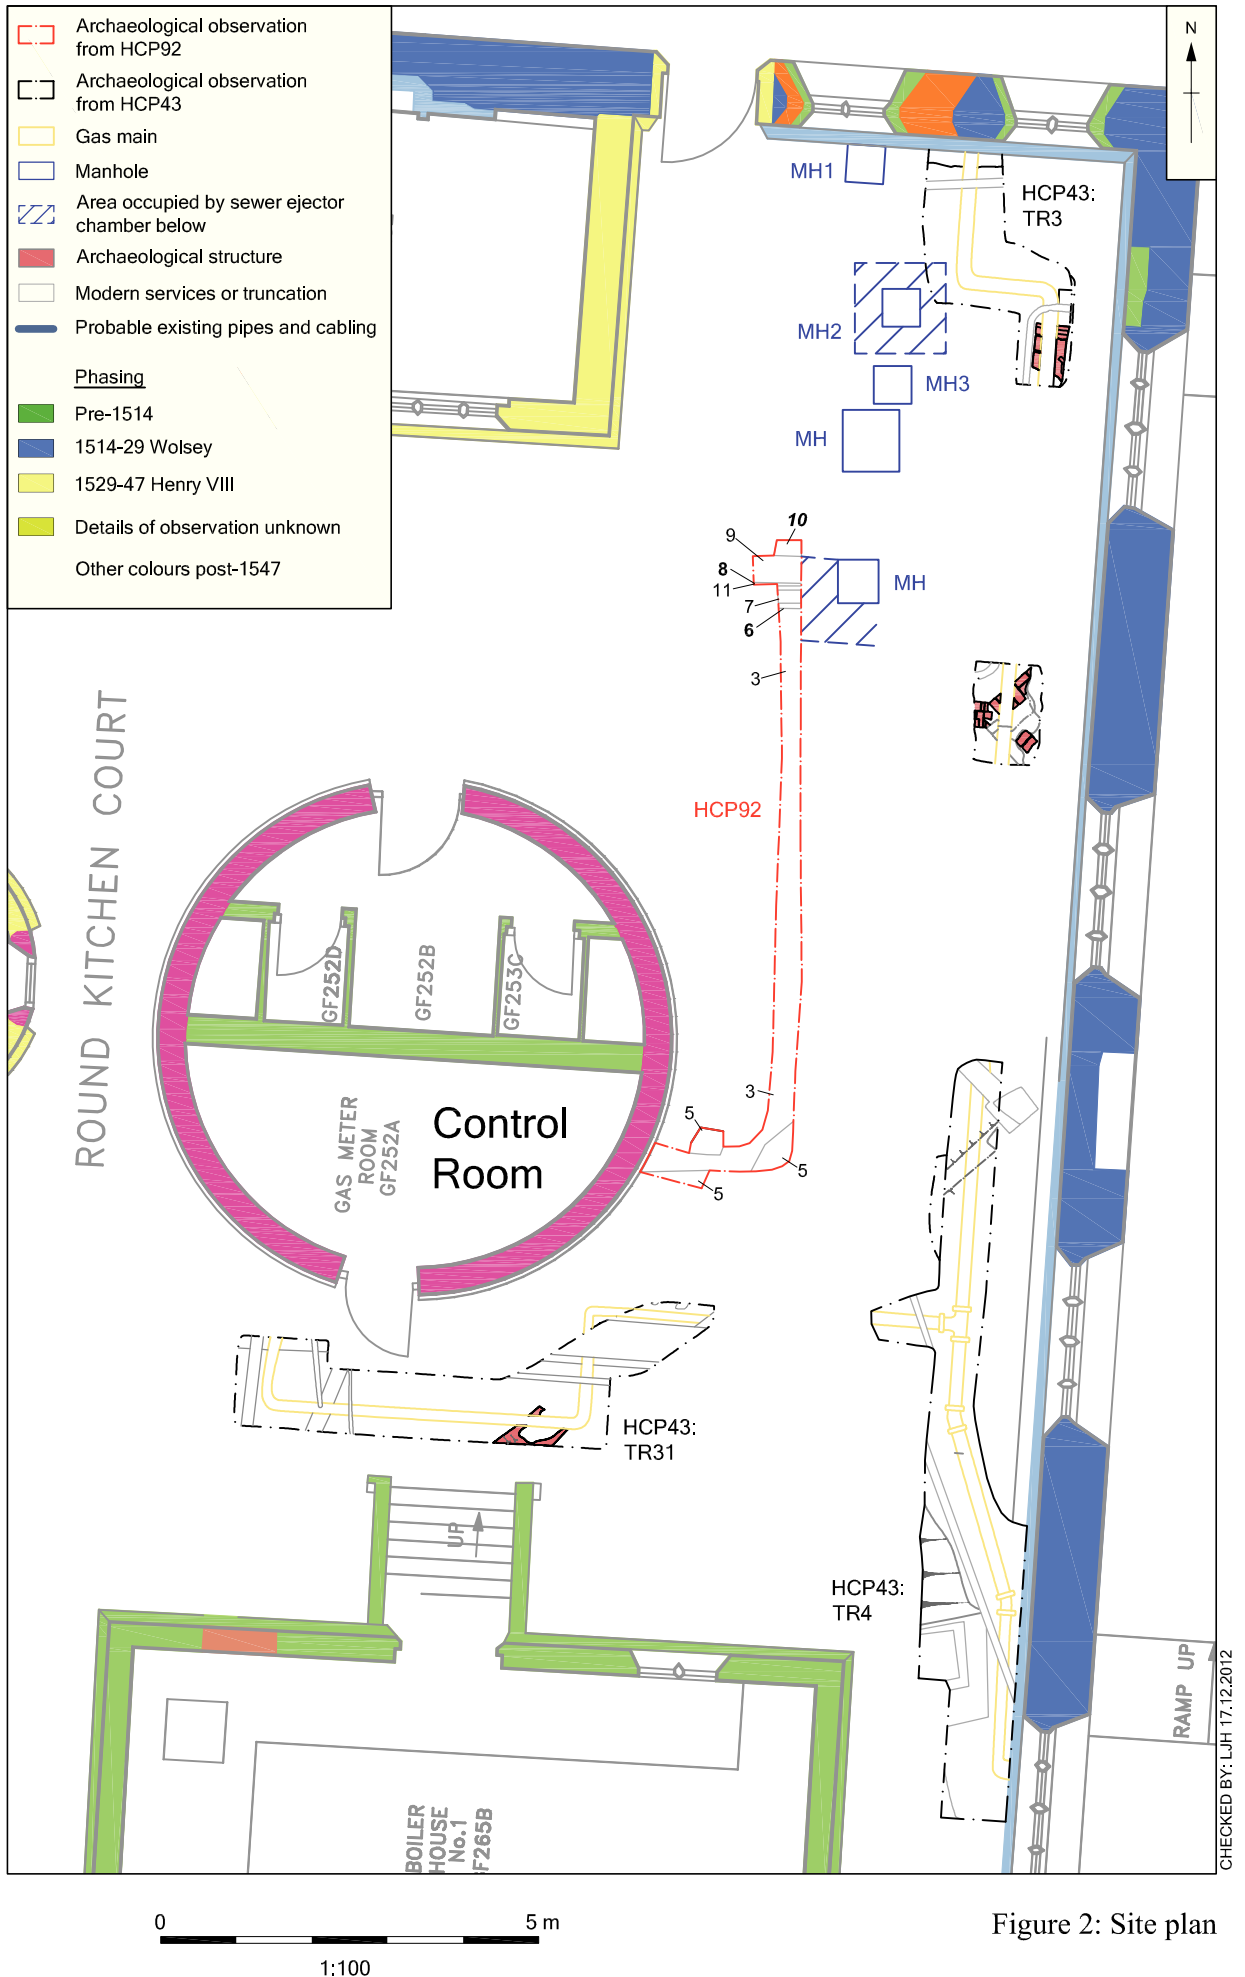
Figure 2: Site plan

- 1.3.3 Four locations (Trenches 3, 4, 30 and 31) were observed and recorded in Round Kitchen Court as part of an Archaeological Watching Brief during the renewal of the pipework for the palaces main gas supply, archive code HCP 43, (OA, 2004). The results of these trenches are repeated, in full, below and are shown in relation to the results of the 'close' Watching Brief on Figure 2.

- 3.1.1 No significant archaeological deposits were observed during the close watching brief.
- 3.1.2 The majority of the base of the excavation and the south and east facing sections remained within the backfill of the original service trench. A large amount of 'modern' disturbance was noted along the length of the trench, especially next to the Control Room and the manhole MH2. Only two archaeological deposits were observed, as discussed below.

- 3.1.3 Layer 5, a firm light red/brown silty sand containing frequent charcoal, CBM and mortar flecks and pockets of grey silt, was observed along the length of the excavations, and was observed mostly in the west facing section and occasionally at the base of the trench. This deposit was located between 0.42 -0.56 m below current ground levels and was 0.15 m+ thick.

- 3.1.4 Layer 11, a soft light brown/pink silty sand with moderate CBM flecks and frequent sub-angular gravel, was localised to the east facing section at the north end of the excavations. This layer was located at 0.45 m below current ground levels and was 0.04 m+ thick. Layer 11 was heavily truncated by modern service pipe trenches 6 and 8, which also obscured the relationship between layers 5 and 11.
