Site/Project Name: **Oxford Magdalen College Old Bursary**

Site/Project Type: Watching Brief

Project name	Oxford Magdalen College Old Bursary
Short description of the project	In July 2009 Oxford Archaeology (OA) carried out an archaeological watching brief during investigatory floor slab removal within the Music Room/Store, Linen Room and Lobby of Magdalen College, Oxford. In the Music Room/Store a short stretch of stone wall/foundation aligned NE-SW was found, and probably relate to the medieval infirmary of the Hospital of St. John the Baptist at Oxford. These remains were overlain and abutted by foundations and floor make-up deposits relating to the current college buildings. Only service runs, pipework, modern wall foundations and modern floor make-up deposits were observed in the Linen Store and Lobby. No dating evidence was retrieved during the works.
Project dates	Start: 17-07-2009 End: 27-07-2009
Previous/future work	Yes / Not known
Any associated project reference codes	OXMDALN09 - Sitecode

Title Old Bursary Opening-up Works, Madgalen College, Oxford

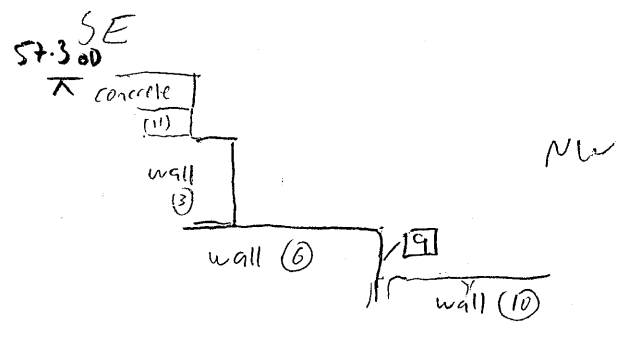
sect 2 1:20
Profile across walls

it has a short stretch of NW-SE return wall keyed into it. wall (3) sits directly on it (but is at a different angle). The return wall has been cut [9] (for wall (10) + possibly cut at the SW for wall (4)).

A short stretch of NW-SE wall foundation wall (4) sits directly on it (10 is offset 0.21) it appears to be in cut (9) (cut through wall (6)) Is it part of the foundations of the standing wall? or is it an earlier wall?
