Site/Project Name: Somerton, St James Church

Site/Project Type: Watching Brief

Title New Drainage Works St James Church Somerton Oxfordshire, Archaeological Watching Brief Report

WATCHING BRIEF RECORD

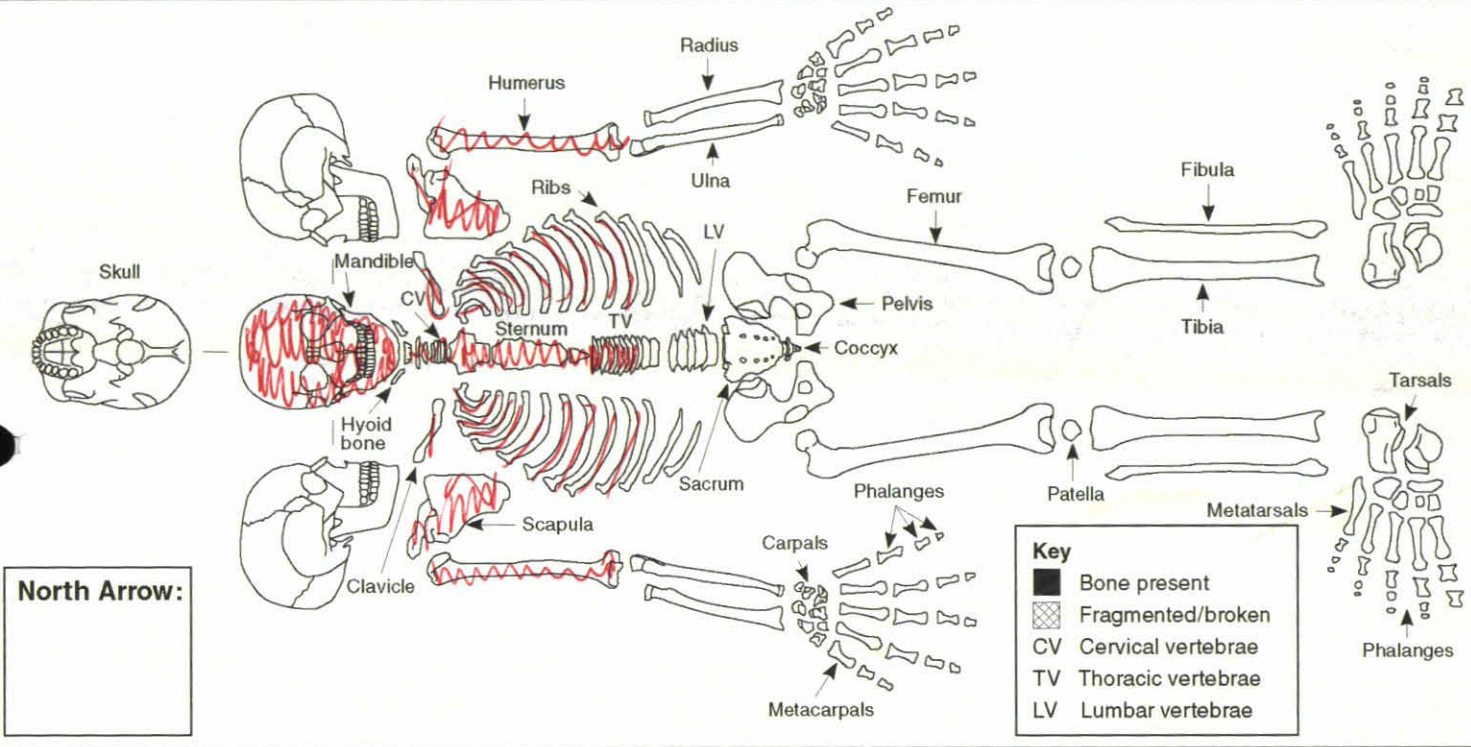
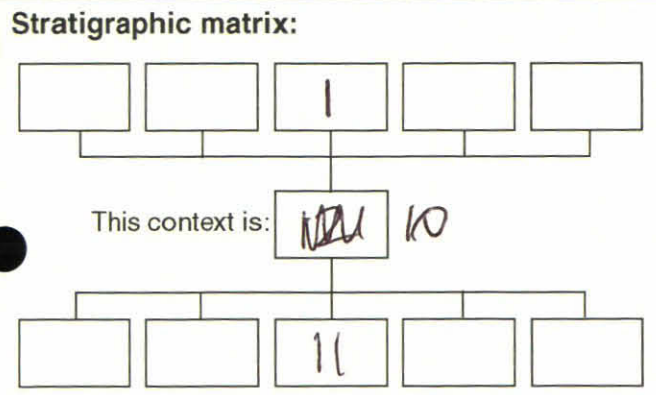
Skeleton no: 10

Site code: <u>SOSTICH 08</u>	Site Subdiv:	Group:	Plan no:)
Grave cut:	Fills:	Coffin: <u>N</u>	Additional sheets:
Age:	Sex:	Body position: <u>Supine</u>	Orientation: Head at <u>W</u> end

Supine burial head to west
Arms by side.
Bones in good condition

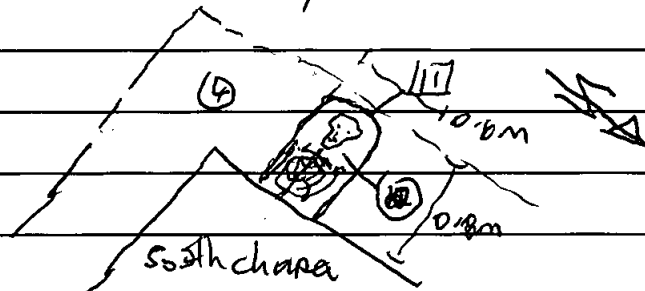
- 1) *Rectangular*
- 2) *Vertical sided / flat base*
- 3) *0.6m wide, 0.8m deep*
- 4)

- 5) *Eastern end cut by foundation trench for south chapel*
- 6) *Filled by (12)*

Grave cut, predates 14th south chapel
