The Orangery at Knole Sevenoaks

**Historic Building Recording
and Investigation**

Document Title: The Orangery, Knole House, Sevenoaks

Document Type: Historic Building Recording and archaeological investigation

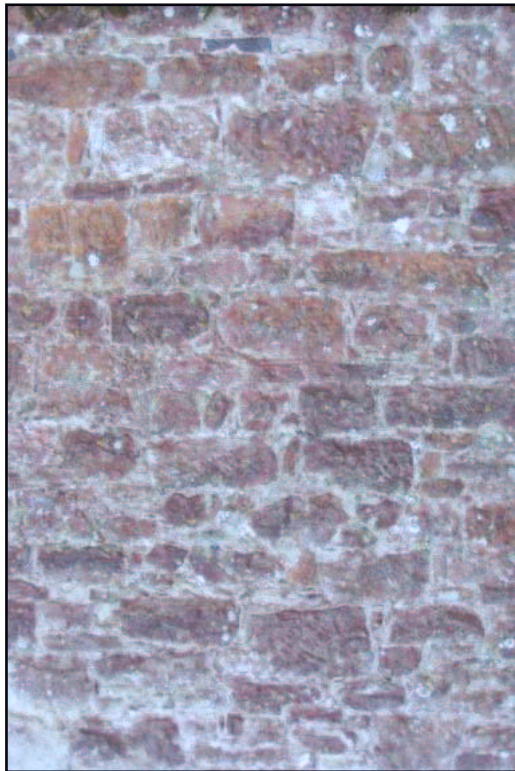
- 3.2.3 *Masonry:* The wall is constructed with large irregular ragstone blocks with galleting set in joints. The galleting largely uses fragments of the Kentish rag stone, probably left over after the carving work of the bigger blocks, but it also incorporates small elements of bricks. The composition of the mortar is sandy lime and it frequently has very small pieces of charcoal. This seems to be the original one and it does not appear to have been repointed. The colour tends to be light grey. However, it varies depending on the distance to the downpipes, to areas where vegetation has existed or still exists and even sometimes it has been 'tinted' in red by the weathering out of the stones due to rain.

Plate 6: Main fabric, eastern end of the north facade

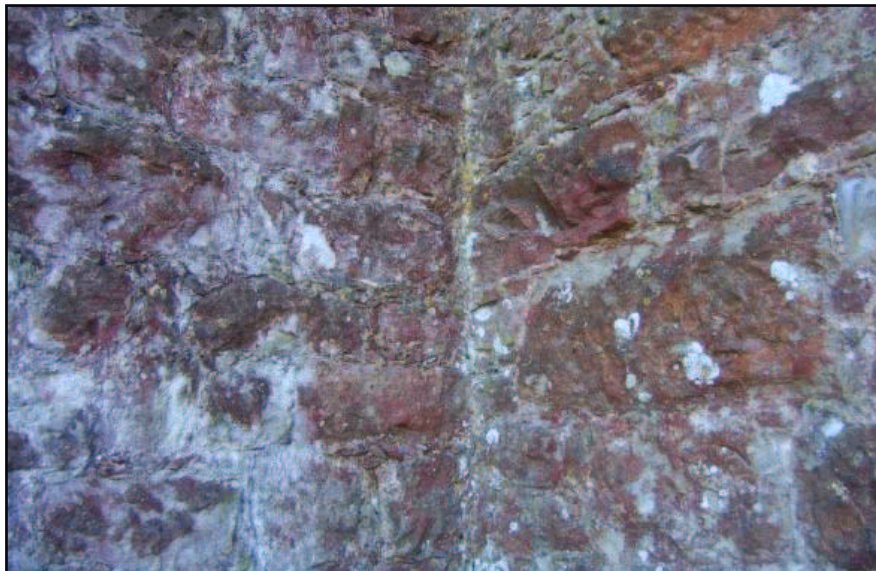
- 3.2.2 At first glance the elevation appears relatively uniformly built with slightly irregular courses of rough stones. This façade appears to be earlier than King's Tower, at the south end of the eastern range, whose fabric abuts the wall of the southern range of the court. This tower is also later than the rest of its range³ (Plate 7).

Plate 7: The southern end of the east range

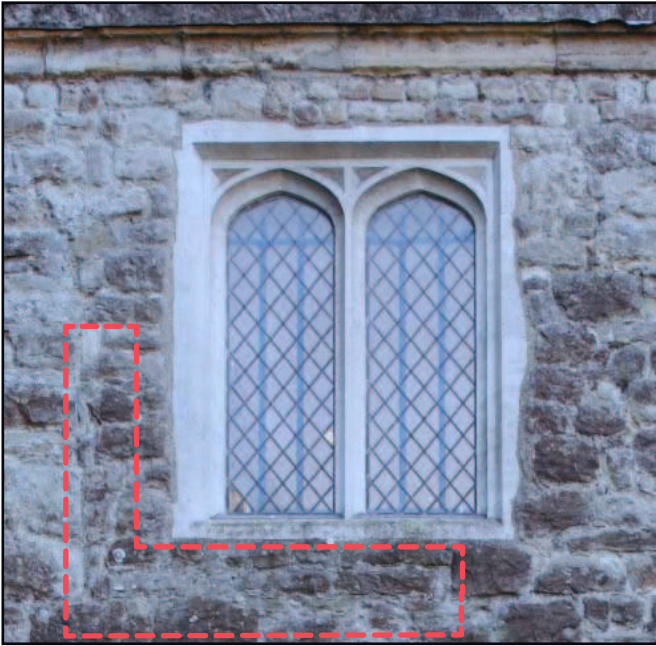
Plate 8a: Straight joints in the eastern end of the north facade (first floor) suggesting alterations to the fenestration. Easternmost window

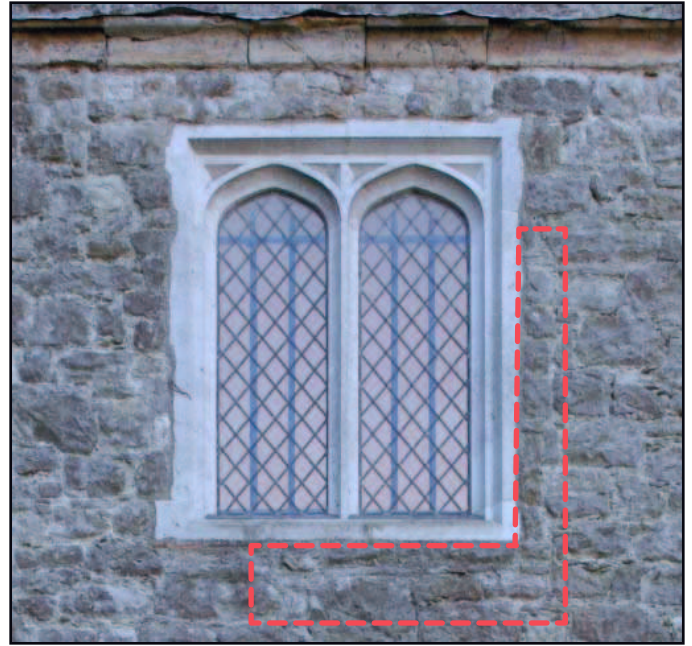
Plate 8b: Second easternmost window. Image taken from rectified photographic survey undertaken by The Downland Partnersip.

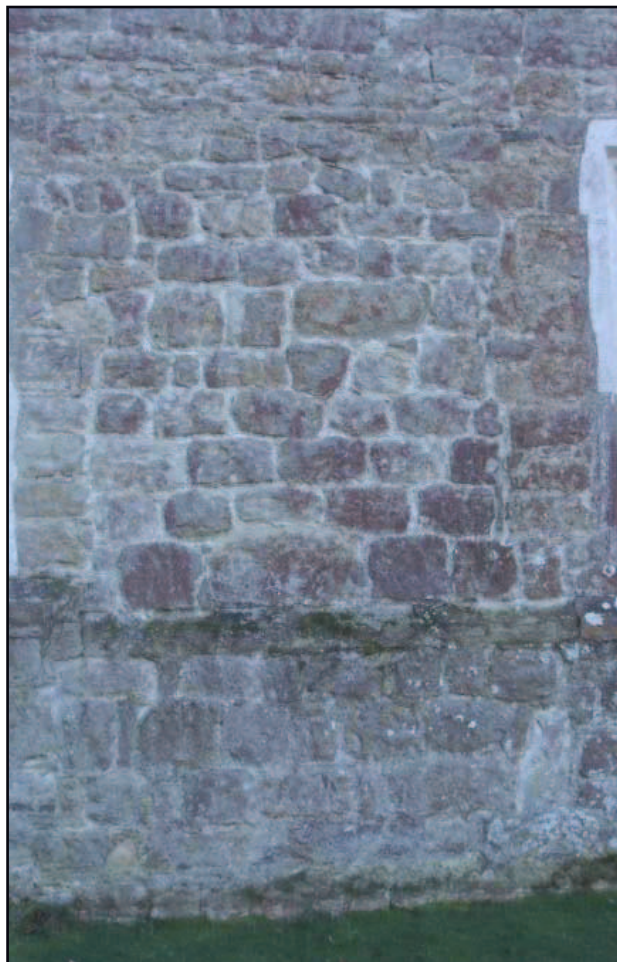
Plate 9: Blocked doorway in the north facade (west)

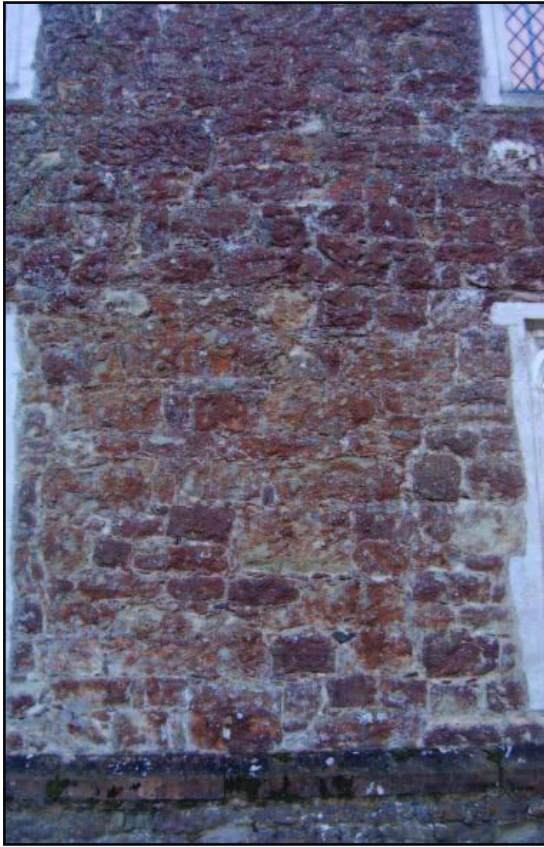
Plate 10: Phasing in north facade from insertion of windows

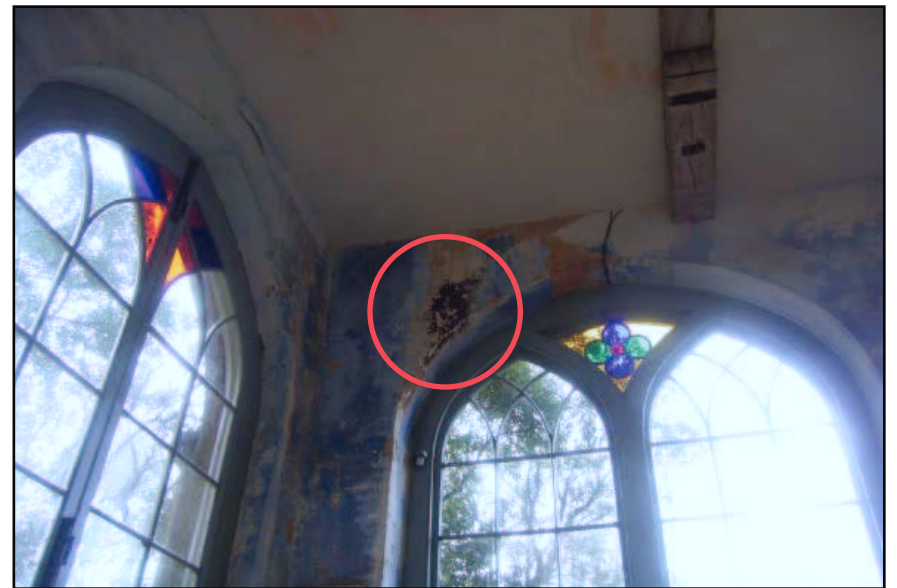
- 4.3.1 The south elevation also has some areas of wall exposed where the plaster is coming away, revealing brick. The wall surface in this part of the elevation is painted in pink and this colour is also located where the blue paint was largely rubbed away. Some of the intrados of the arches of the tall windows have also been recently re-plastered probably at the same time as the ends of the tie beams and the windows' lintels on the first floor in the inner northern elevation. The white plaster is evident especially in the two westernmost arches. The easternmost however, has a dark stain that looks like blackened plaster/paint by fire (Plate 21).

Figure 21: Black stain , probably due to fire in the inner arch of the easternmost window of the south wall

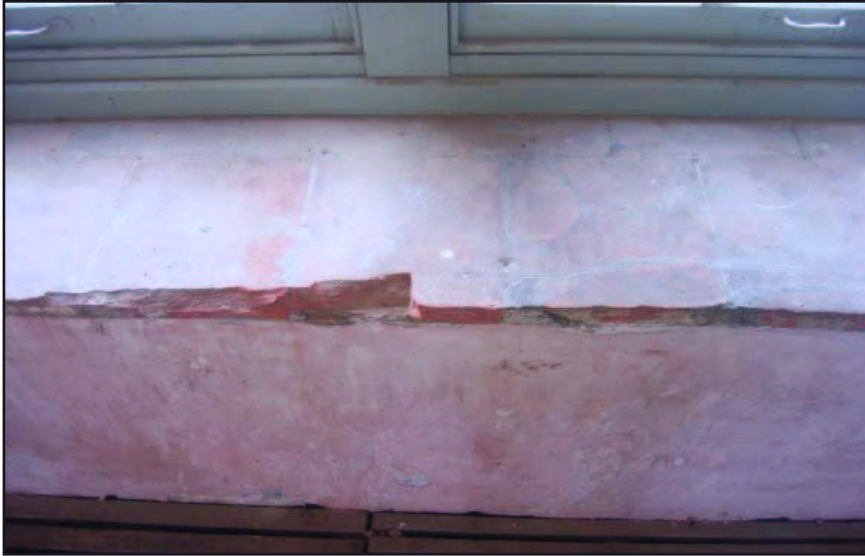
- 4.3.2 The window sills are made of 0.3m square brick tiles which have been inserted probably in the 20th century (Plate 22). Some of them have been repaired whereas others have damaged later and have been left in-situ. The windows also appear to be from the 20th century as the details of hinges, bolts, etc. suggest.

Figure 22: Sill of a window with some broken and some repaired tiles.
South wall

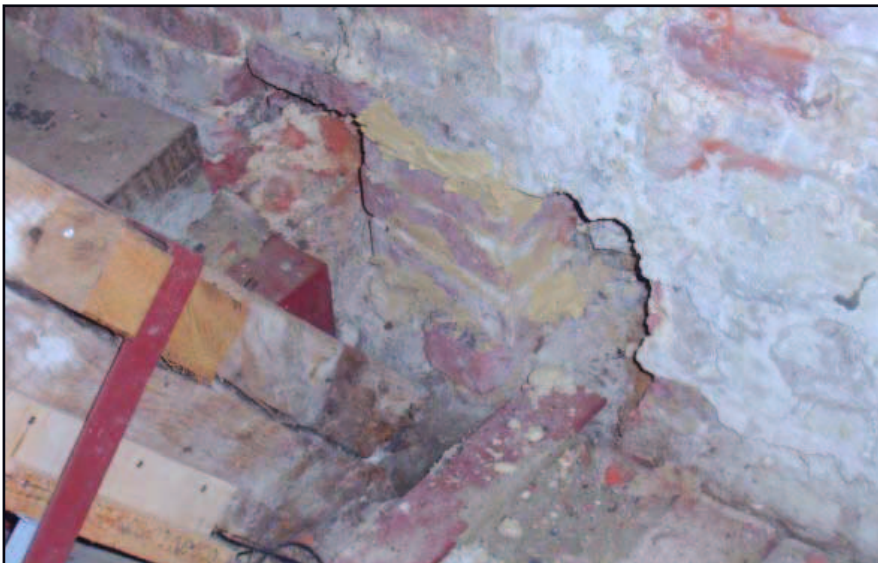
supported at each end by c.1.25 m long timber corbels (or bolsters) set into the wall and bolted to the undersides of the tie-beams. These corbels are similar to others in this situation at Knole. The tie-beams are bolted to the corbels. The only east to west member in the ceiling is a centrally set binder in the central bay. It is likely that the subdivision of this bay is an indication of a former staircase and central chimney stack. The ceiling is painted light beige although some parts are plastered in white possibly at the same time as the ends of the tie-beams were repaired (Plate 26).

Figure 28: Recent metallic bracing for the tie beams and sockets in the wall

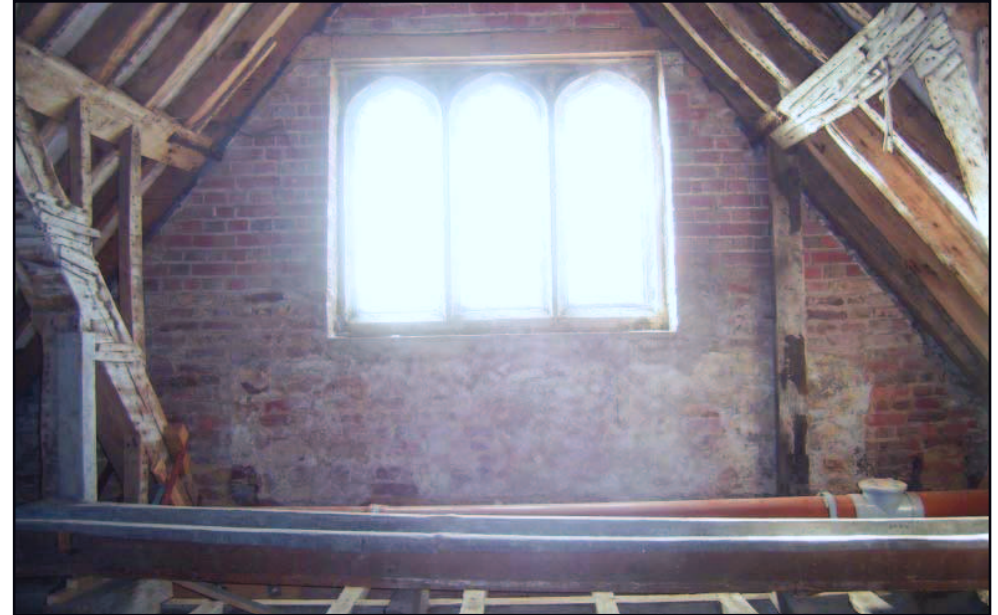
- 4.7.13 *Gables to south wall*
- 4.7.14 There are three gables within the south side of the roof which were heavily altered in 1823 and they now have internal brick faces together with later repairs. These are in bays 2, 5 and 8 (from the west end) and there is a further gable at the east end of the structure. In each of these bays the main purlin is raised above the height of the others to incorporate the gable structure.

Plate 31: Central gable from the inside south wall

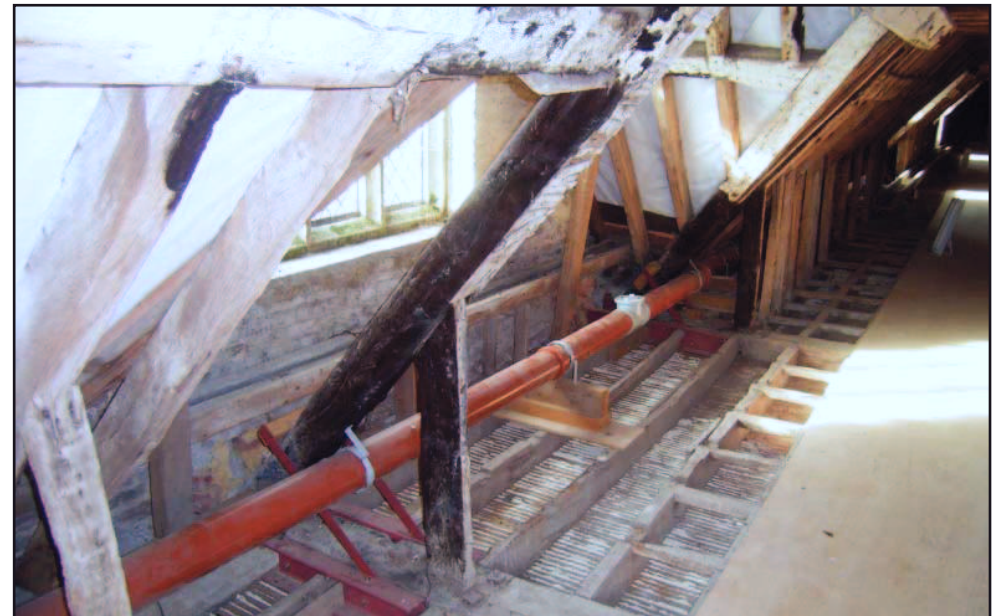
- 4.7.16 A further feature which is worthy of note is related to the dark stain produced by fire that we have previously referred to above. The timbers of the roof structure of the western gable on the south façade above the stain are also all blackened by a fire (Plate 33). Apparently this fire affected the wall below although there are no traces of that in the current ceiling so the fire happened before it was built. The blackened timber do not seem to be very affected and seem to preserve the core intact.

Plate 33: Blackened timbers due to fire

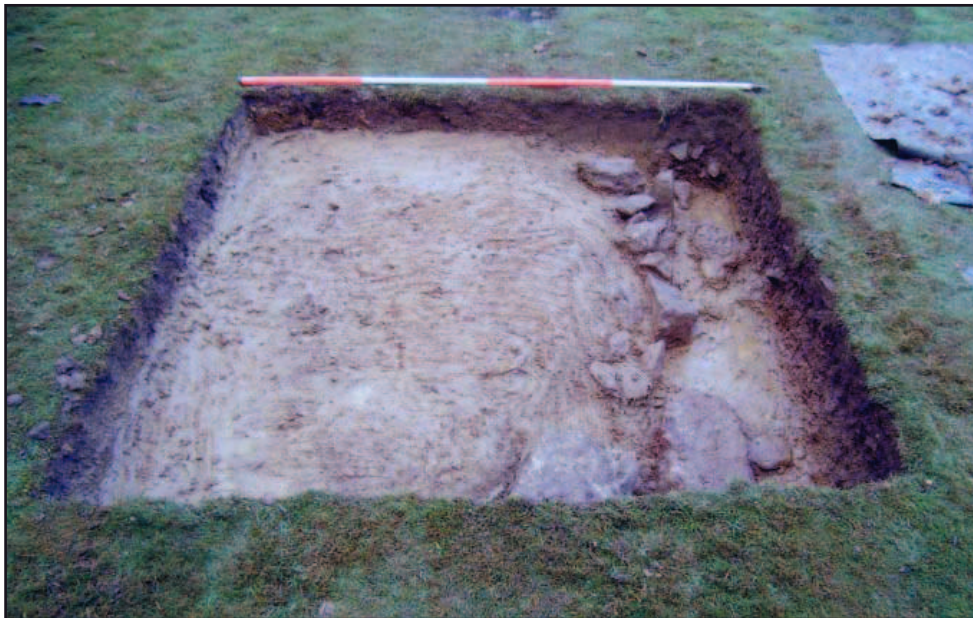
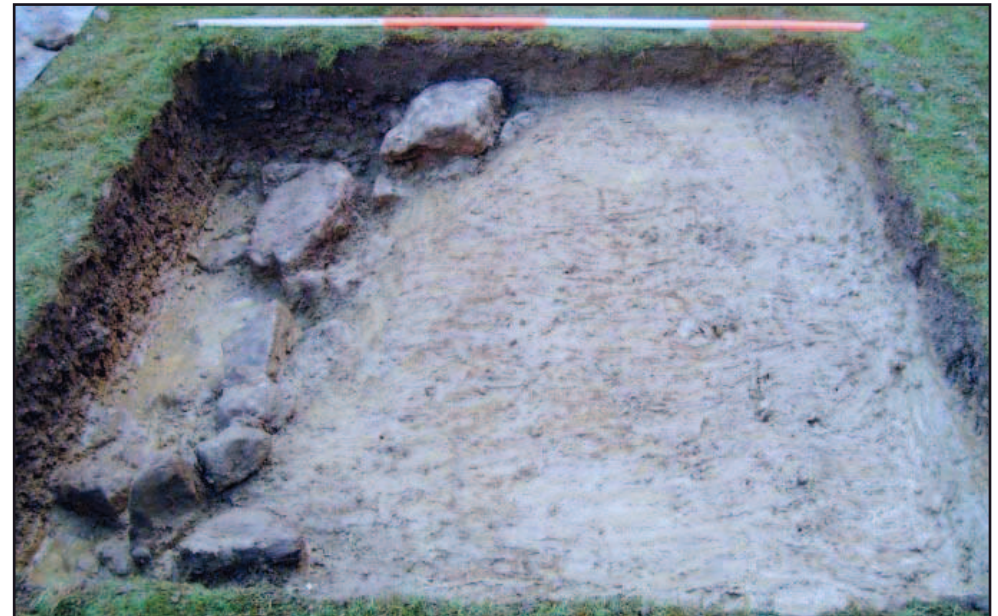
Plate 36 : Wall foundation **205**

Plate 37: Wall foundation **205**

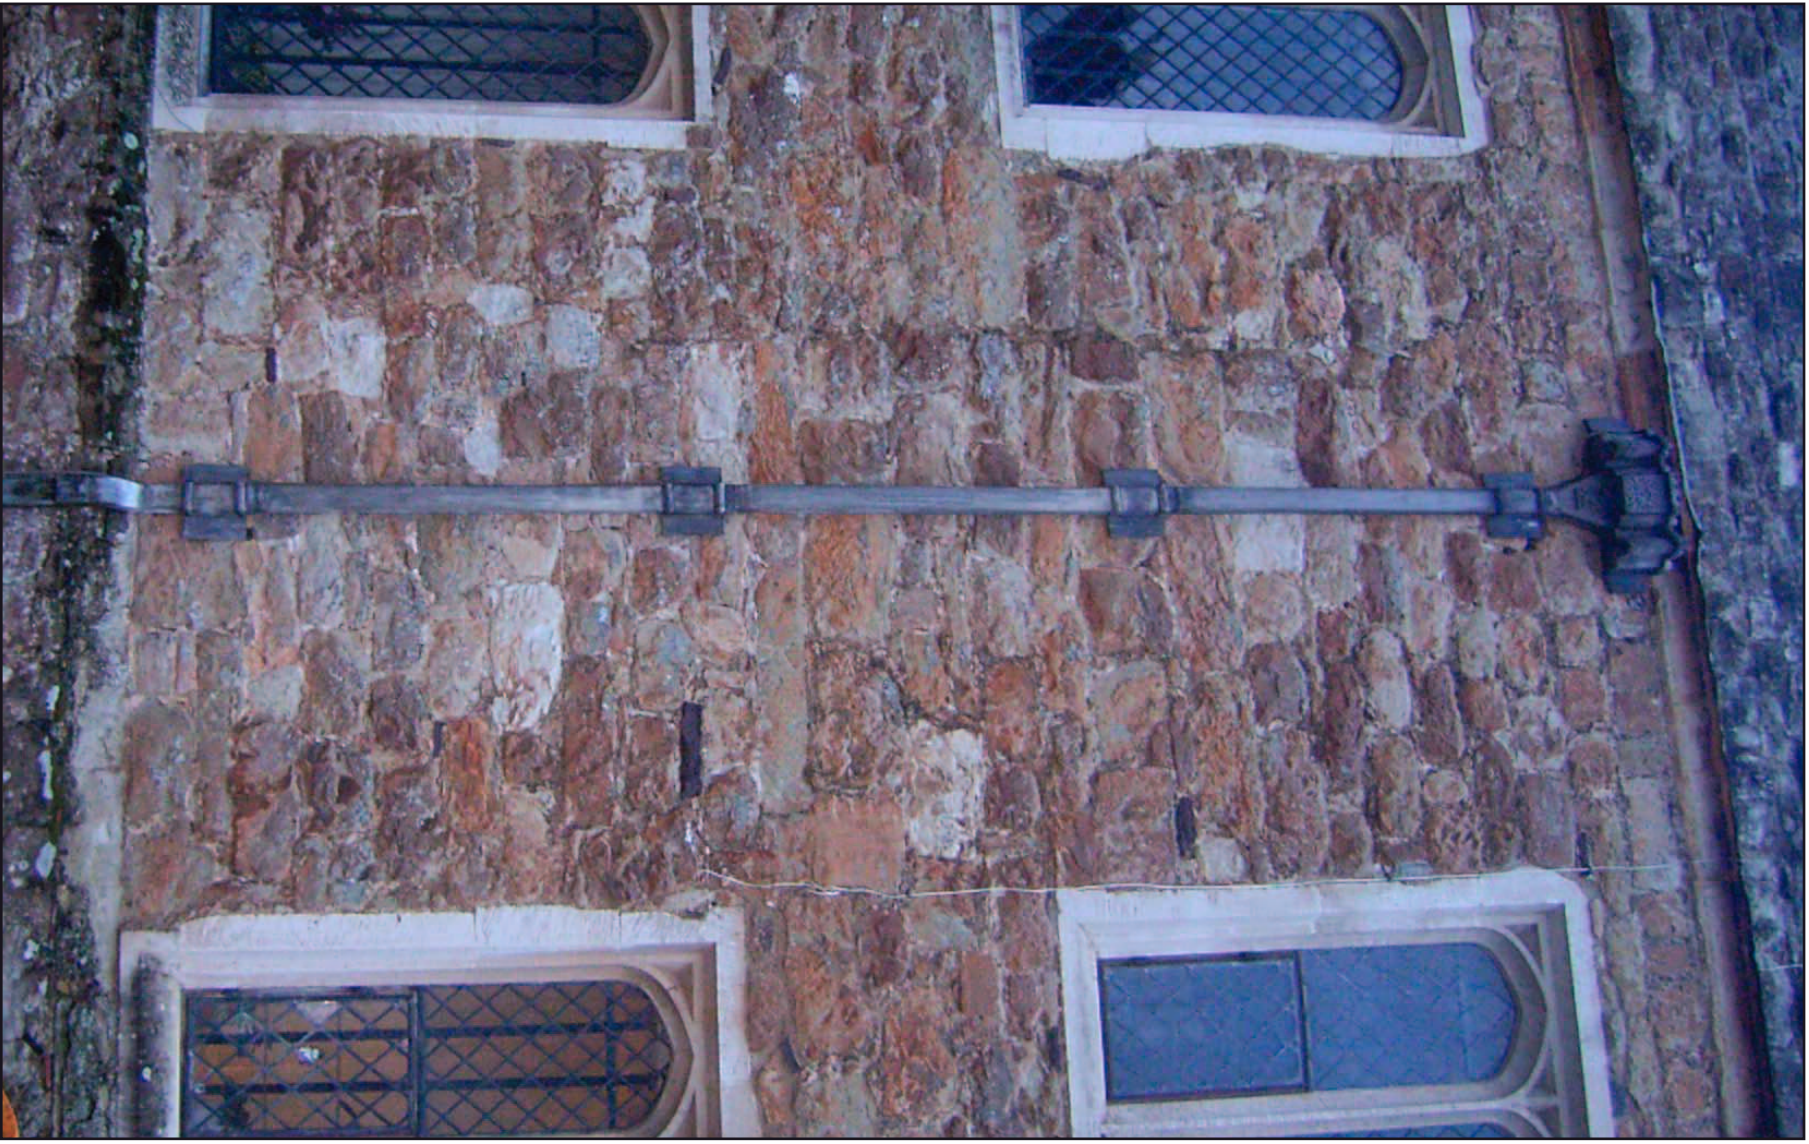
Plate 38. Vertical scar of a break in the east wall of the western range in Green Court

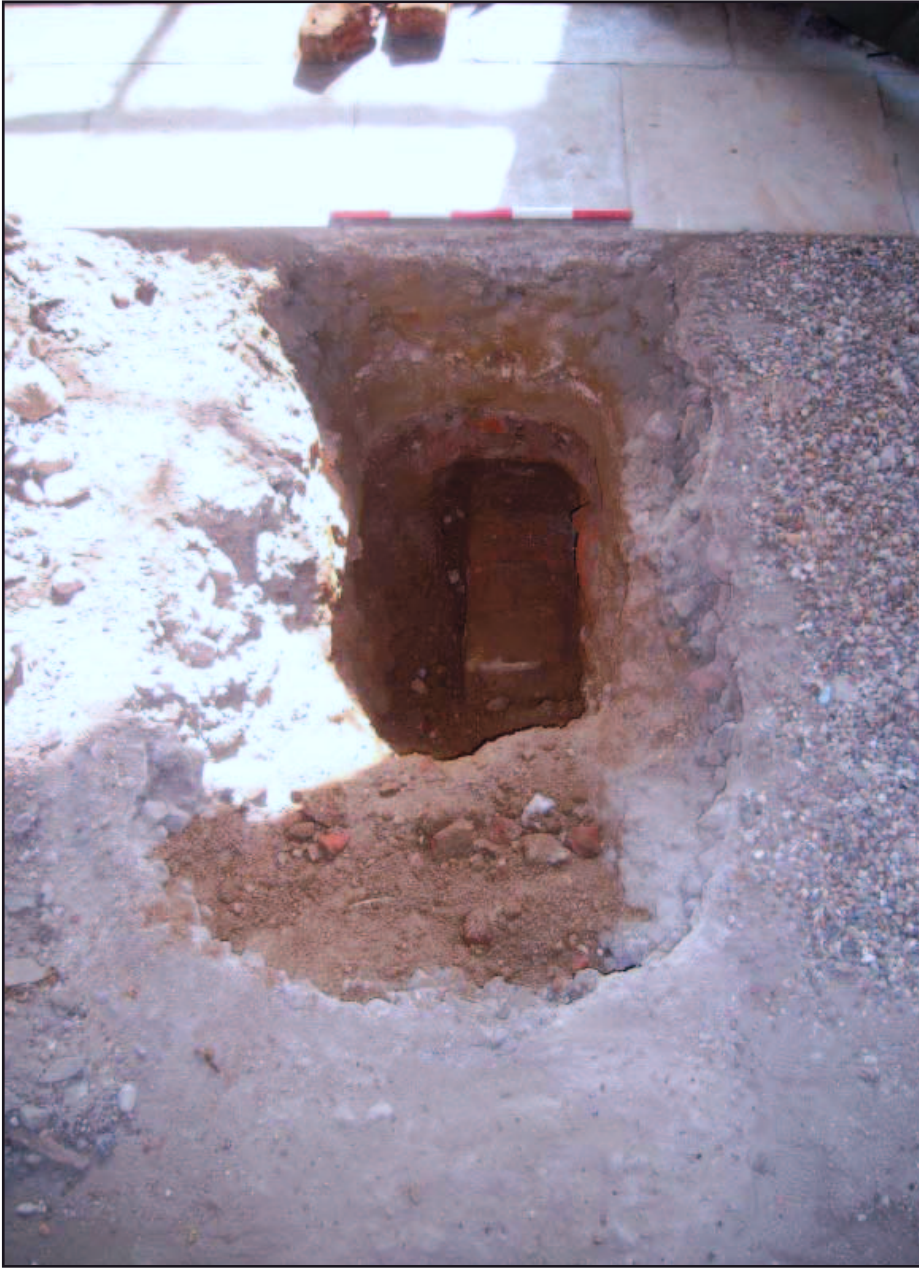
Plate 39: Trench 3 within Orangery showing surviving footings from former partition

- 7.1.4 Two targeted trial trenches have been opened within the Orangery close to the centre of the building. These found no evidence of any former chimney stack (corroborating the documentary evidence) but two sections from a primary east-west partition were located on the west side of the central bay. The top of the footing from this wall was exposed at the same height as the primary floor level (65 cm below the current floor) and this wall was clearly pulled down to ground level before the new raised floor was constructed.

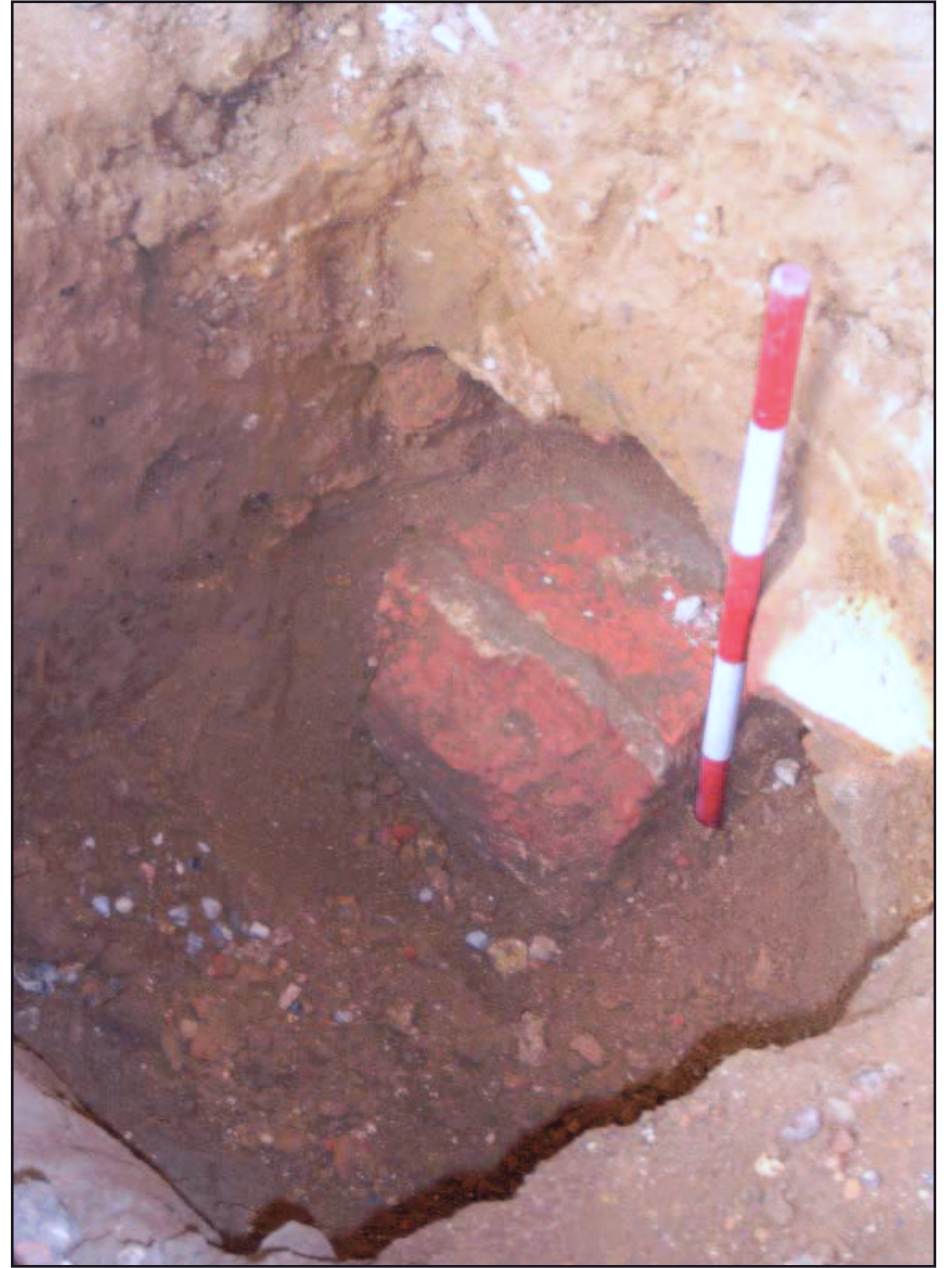
Plate 40: Trench 4 within Orangery showing partition footings

- 6.3.6 **Test Pit 4** was aligned with TP3 but on the south side of the stone-paved walkway. This pit was rapidly reduced to the level of the footing found in Test Pit 3 and the layers were generally similar although there were occasional charcoal flecks. At 66 cm below the height of the stone paving two east-west orientated in-situ bricks were exposed and this aligned with the footings exposed in Pit 3 showing that the footing almost certainly continues beneath the walkway. The southern end of the visible stub appears to have been truncated.

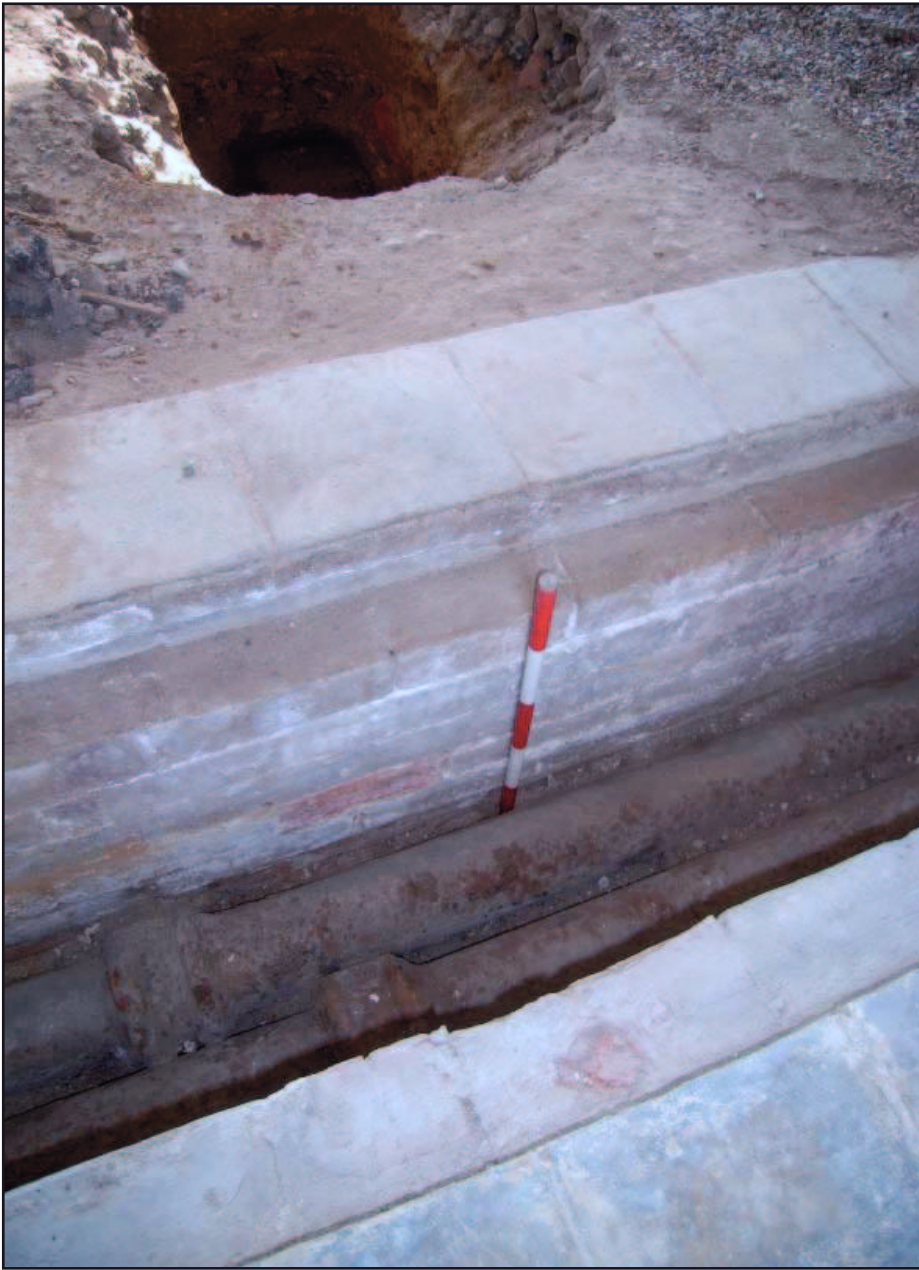
Plate 41: Heating pipes within duct/trench along north wall of Orangery

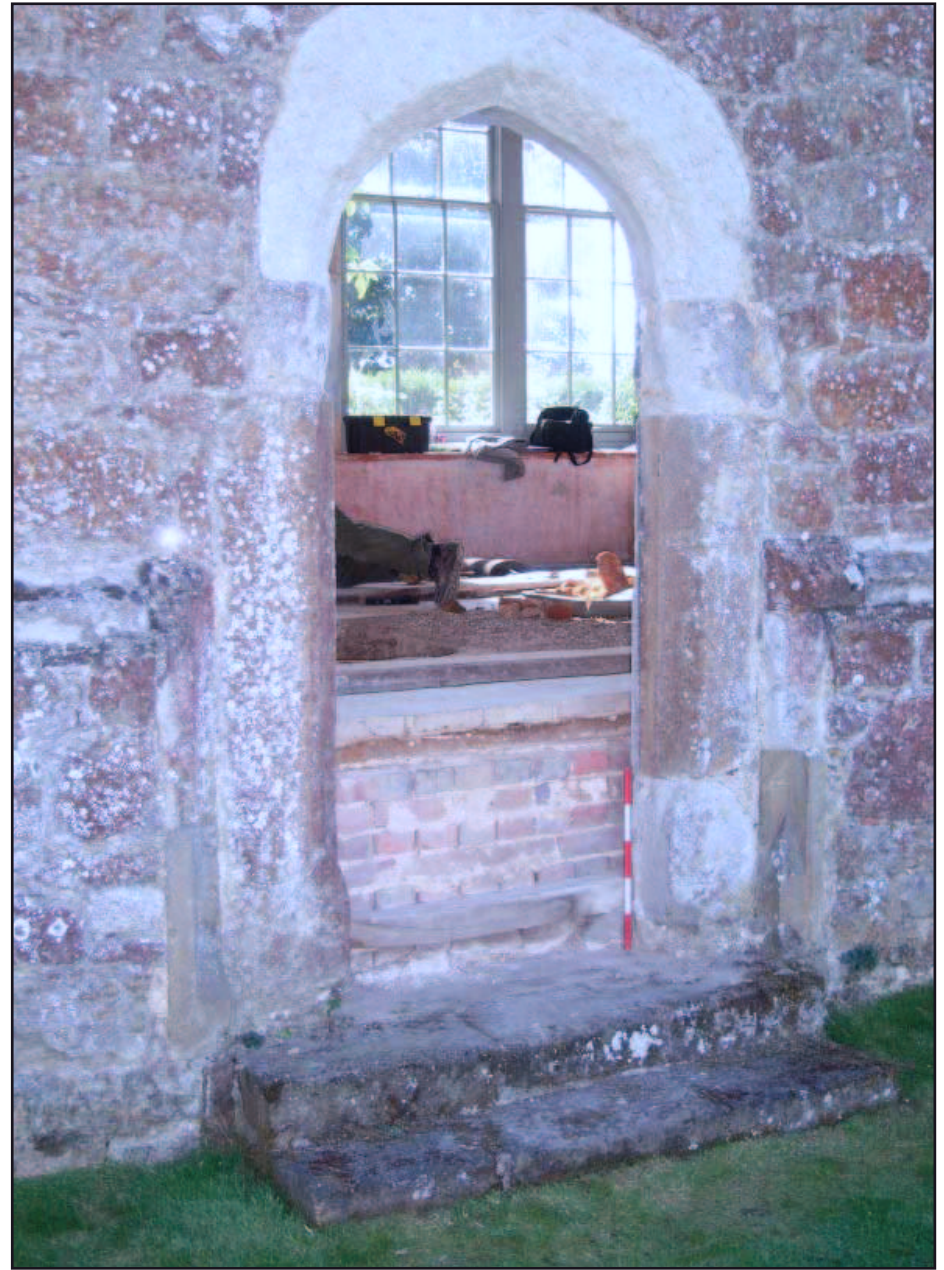
Plate 42: Former doorway in north wall showing raised floor level

- 6.4.1 The results of these internal trenches show that the floor level was significantly raised to form the Orangery floor and heating system, and that the earlier floor level still survives at a depth of around 65 cm. This may of course be truncated, and no indication of flooring material (or stair base) was found, but the brick foundations, probably of a partition, were located.
- 6.4.2 The trenches were positioned to encounter the footings of any fireplace or chimney stack located (like others in Green Court) opposite the doors. No trace of any foundations was found, and this may tend to support the evidence of early views that there was no stack in this position.
