Archaeological Monitoring at Langley Abbey Norfolk

Archaeological Watching Brief Report

February 2010

OA East Report No: 1149

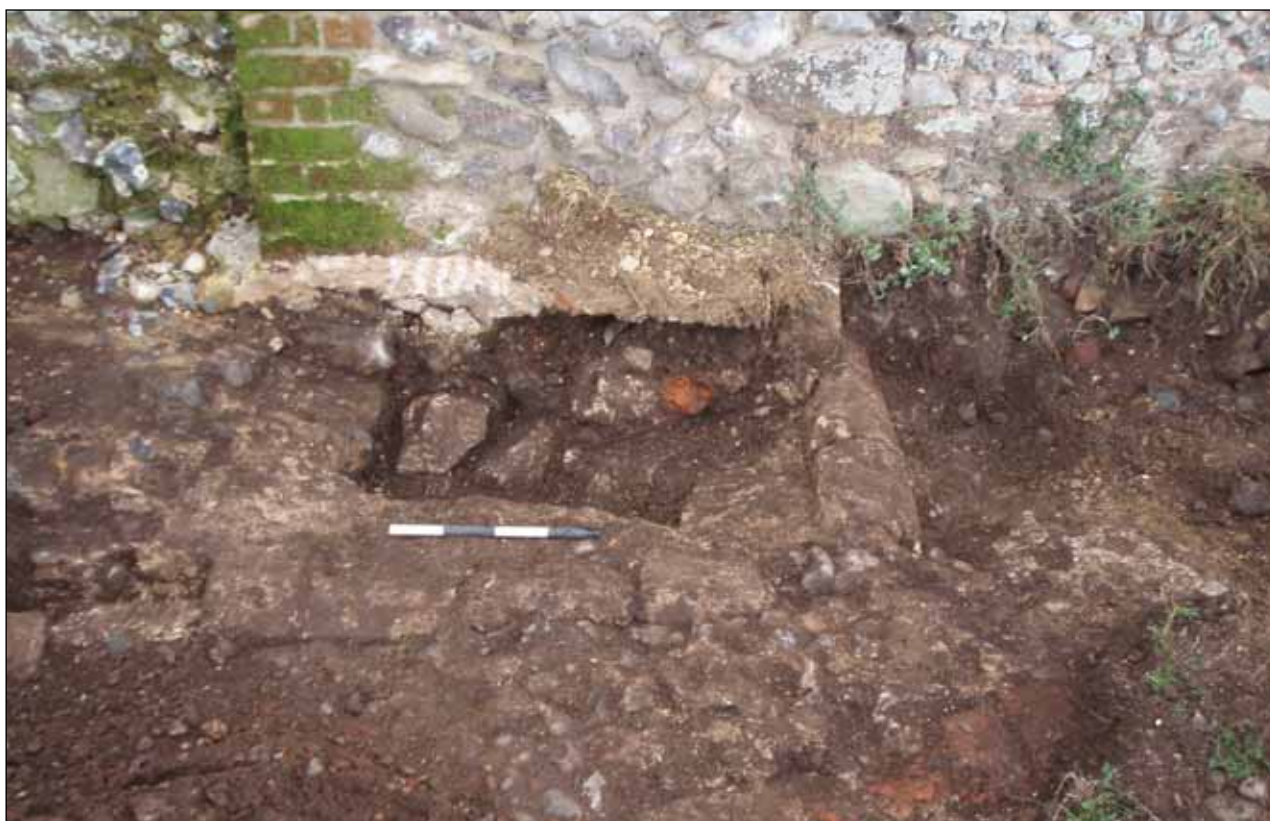
Plate 1: Medieval butters foundation (13) and (14), from north

- 4.1.1 The excavation of the drainage trench revealed masonry, at a level of 3.06m above ordnance datum (AOD), located at the junction of the north-western corner of the barn/western range and the gatehouse and immediately below the present ground level (see Fig. 4 and Plate 1). The masonry **14** comprised a single course of faced limestone, bonded with lime mortar and set in a foundation of mortar bonded flint nodules. On the rough inner surface some brick was also observed set into the foundation. The central part of the feature behind the masonry comprised loose dark earth with some faced limestone rubble. The masonry extended out of the excavated area towards the east.

- 4.1.2 This feature was considered to represent the remains below ground level of the pre-existing buttress indicated on the historical ground plan of Langley Abbey (Erwood 1922). This feature would appear to confirm the present wall immediately over the buttress was part of the original later 13th century western range as indicated by the historical ground plan. This is also born out in the orientation of the northern wall of the present gatehouse which has an appreciable change in direction from a point above the western edge of the revealed buttress. It must be noted that the present fashioning of the juncture of the barn/western range gives the misleading impression that the entire wall at this point is part of the 14th century gatehouse.

- 4.1.3 A mass of flint nodules set in lime mortar **13** was observed to extend around the northern side of the buttress and this was partly faced on the northern side with red brick (see Plate 1). This material was observed to lie partly over the slanting face of the limestone blocks comprising the buttress and appeared to spill over the top of the buttress at its north-western corner. This was considered to represent a later feature than the original buttress. This feature appears to be at variance with the information given on the historical ground plan (Erwood 1922) which indicates an older, early 13th century, line of masonry abutting the northern side of the uncovered buttress.

- 4.1.6 The natural ground comprised loose pale yellow silty sand with much flint gravel.
- 4.1.7 On-site discussions between representatives of OA East, Donal McGarry and contractors resulted in the archaeology encountered being left 'in-situ' without any further disturbance by the drainage works.

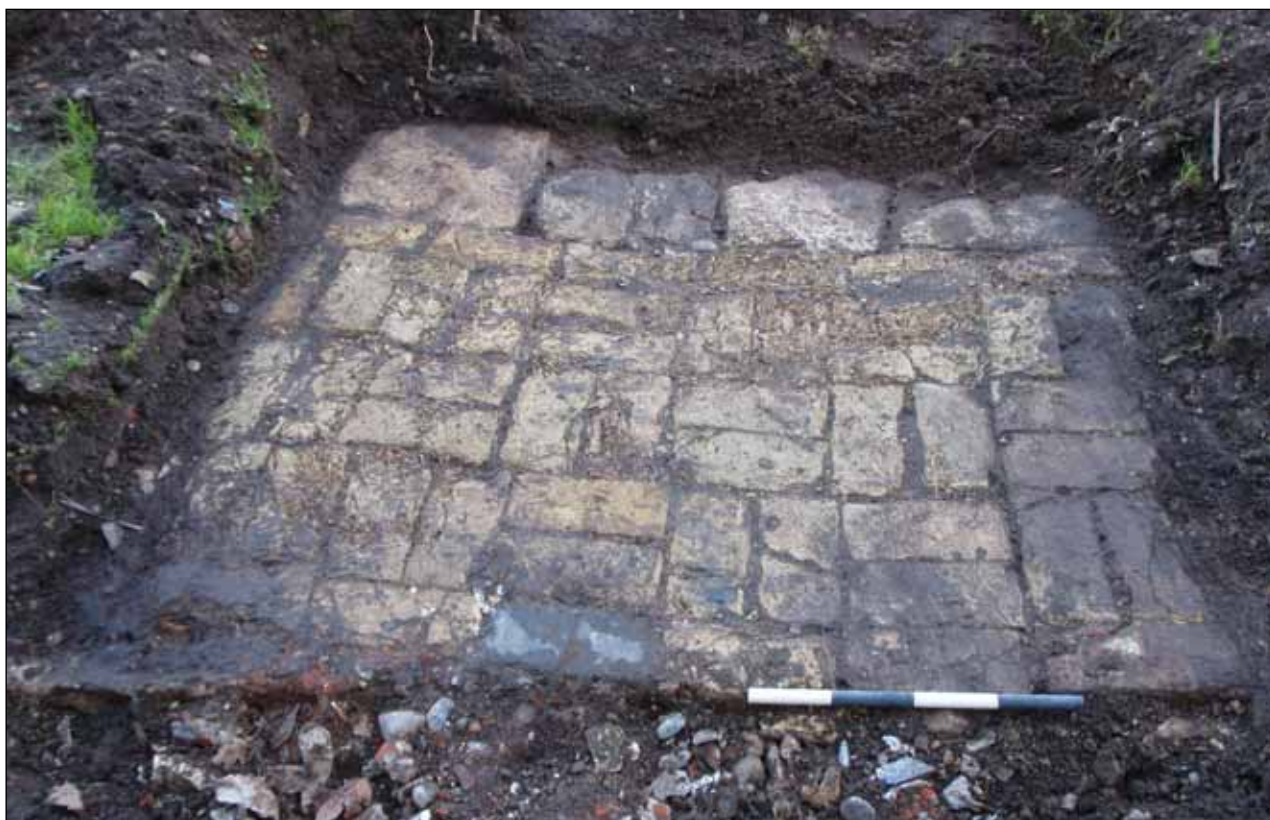
Plate 2: Brick and limestone construction (7) and (8), from west

- 4.2.1 Elements 1 and 2 of the monitoring brief did not encounter any archaeology.
- 4.2.2 Element 3 revealed a paved surface **7, 8** approximately 1.3m square and in line with a doorway through the eastern wall of the barn/western range (see Fig. 4 and Plate 2). The paved surface lay at a level of 2.33m AOD. The paved surface comprised yellow brick set into the topsoil with no bonding. The eastern end was edged with limestone blocks with flat upper surfaces. This feature may represent part of a porch for the door in the barn/western range to the west, or it may simply be a surface construction which utilised those faced blocks that were freely available. The feature appeared to have been truncated towards the door by the modern concrete surface the current work had removed. This feature was considered to be post-date the dissolution of the abbey. Discussion with the contractor on-site formed the opinion that the feature was at a level that could be turfed over without further disturbance.

The Archaeological monitoring identified features in the barn/western range that post date the dissolution of the Abbey. The remains of the porch leading from the door in the eastern wall are to be turfed over without further disturbance. The retaining wall

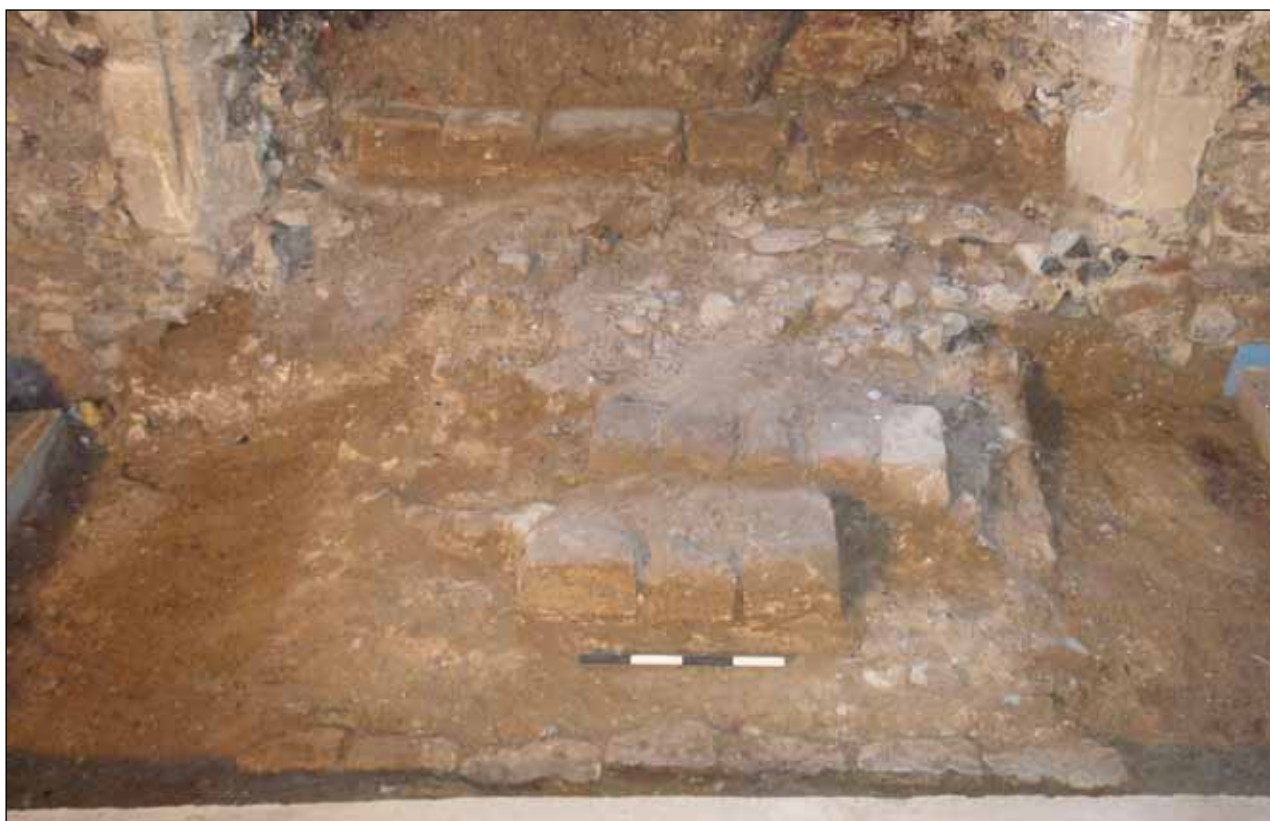
Plate 4: Heavily truncated stair (10) and foundation (11), from east

- 4.2.5 Element 5 involved the preservation through record of what appeared to be a heavily truncated staircase up to the adjacent doorway in the western wall of the barn/western range (see Fig. 4 and Plate 4). On-site discussions between representatives of OA East, Norfolk Landscape Archaeology and Donal McGarry formed the opinion that the staircase lead down to a level inside the barn/western range that post-dated the dissolution of the abbey and could therefore be excavated by archaeological methods. The evidence for this conclusion lay in the level of the footing of the internal limestone arch of the doorway being at a higher level than the base of the staircase at 1.97m AOD. The footing indicates the original internal floor level of this chamber of the Cellarium/ western range being 2.49m AOD.

- 4.2.6 The two courses of set stone **10** were composed of re-used faced limestone blocks set with lime mortar. These were set into a foundation **11** of flint nodules and lime mortar.

The eastern end of the foundation was edged with further re-used limestone blocks at the pre-existing ground level.

- 4.2.7 The two courses of limestone blocks were removed including the upper portion of the foundation. On-site discussions between the representative of OA East and contractors resulted in the lower portion of the foundation and the limestone eastern edge of the feature being left 'in-situ' without further disturbance.

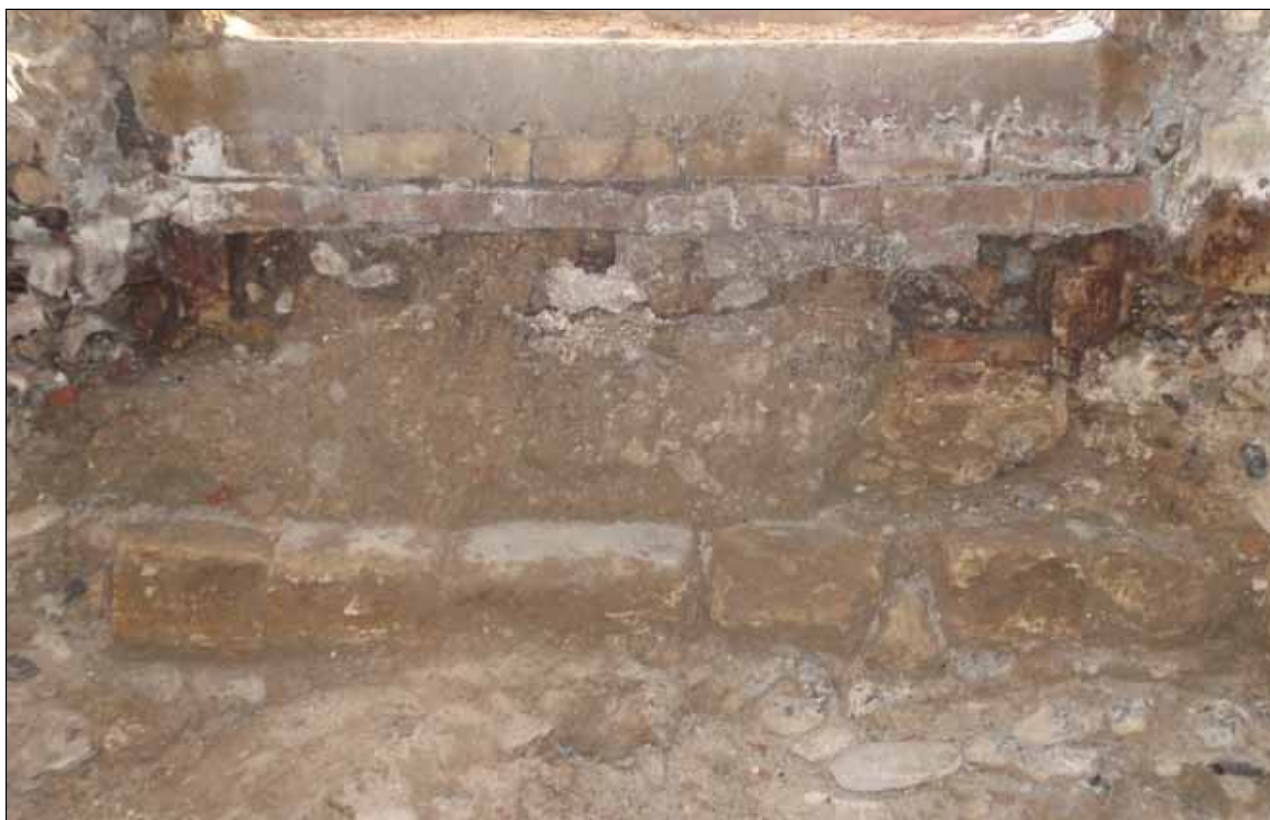
Plate 5: Base of architrave in doorway above stair (10), from east

- 4.2.8 During the course of these works the stone architrave base for the original medieval doorway was revealed at 2.92m AOD (see Plate 5). This feature in association with the footing of the limestone arch on the inside of the doorway at 2.49m AOD indicated the original relative height between the higher external ground level and the lower internal floor level of the cellarium/ western range at the time of construction in the later 13th century (a difference of 0.43m). The internal floor level in the northern part of the cellarium/ western range was later reduced by 0.52m, probably in the post-dissolution period, necessitating the installation of the staircase replacing perhaps originally two steps. Subsequently the doorway itself went out of use and the majority of the limestone blocks were removed. The present external level of the doorway, to the west of the barn/ western range, lies at 3.41m AOD.
