# Mill Road Cemetery Mortuary Chapel an Archaeological test pit Evaluation

## Archaeological Evaluation Report

OA East Report No: 1150

## **Mill Road Cemetery Mortuary Chapel; an Archaeological test pit Evaluation**

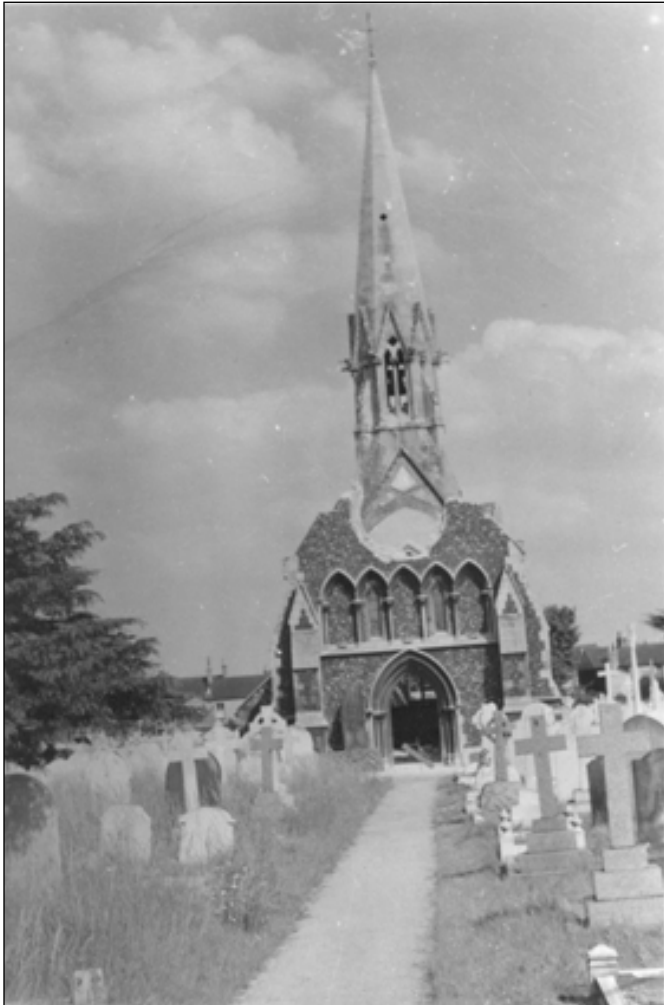
Plate 1: The Mortuary Chapel during demolition, viewed from the west (Courtesy of the Cambridge Collection)

3.3.1 This test pit was positioned over a separate room on the north side of the chapel. This is shown on a photograph of the chapel (Plate 1) with a lower roof than the main building. Test pit 1 revealed the corner of this side chamber and also showed that it had a considerably lower floor than the rest of the chapel building. This was excavated to 0.96m below current ground level, although the faced wall continued beyond this depth.

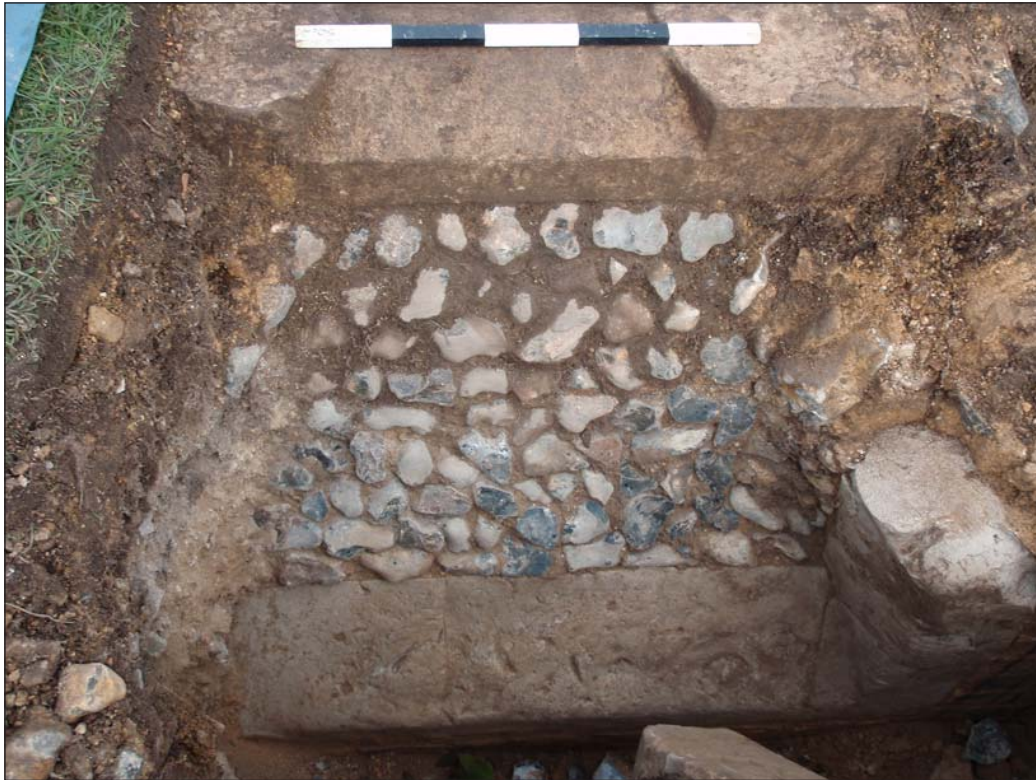
Plate 3: Test pit 1 after excavation

3.3.2 This sunken floored area had been backfilled with rubble during demolition, but remained in good condition. The internal facing was of brick at the corners and flint cobbles elsewhere. The sill of a splayed window still remained in place. The window frame was of sandstone with a carved clunch architrave (plate 3).

- 4.2.1 On the north side of the chapel a protruding room was shown to have a lower floor level than the rest of the chapel. This had resulted in the survival of at least 0.96m of wall which had been faced internally with brick and flint. Set into this was a window, the base of which, as well as part of the architrave survived. The floor surface of this area may have survived, however, it was not possible to reach this in the test pit excavated.

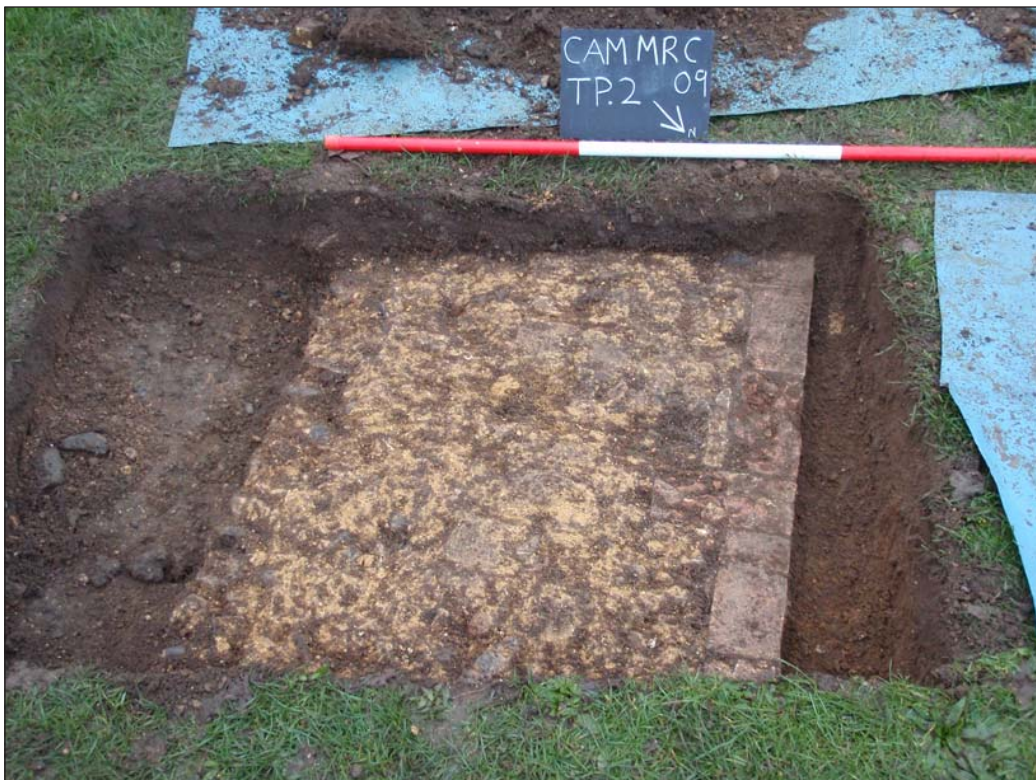
Plate 4: Test pit 2 after excavation

3.4.1 This was positioned over the foundation of the apsidal eastern end of the chapel. It revealed a wall foundation 0.10m below the present ground surface. This wall was 0.98m wide, with an internal brick facing, a core of mortar with flints and an exterior of flints with mortar.
