President's Lodgings Wall Magdalen College Oxford

**Archaeological
Watching Brief and
Building Recording**

January 2010

Client: Magdalen College

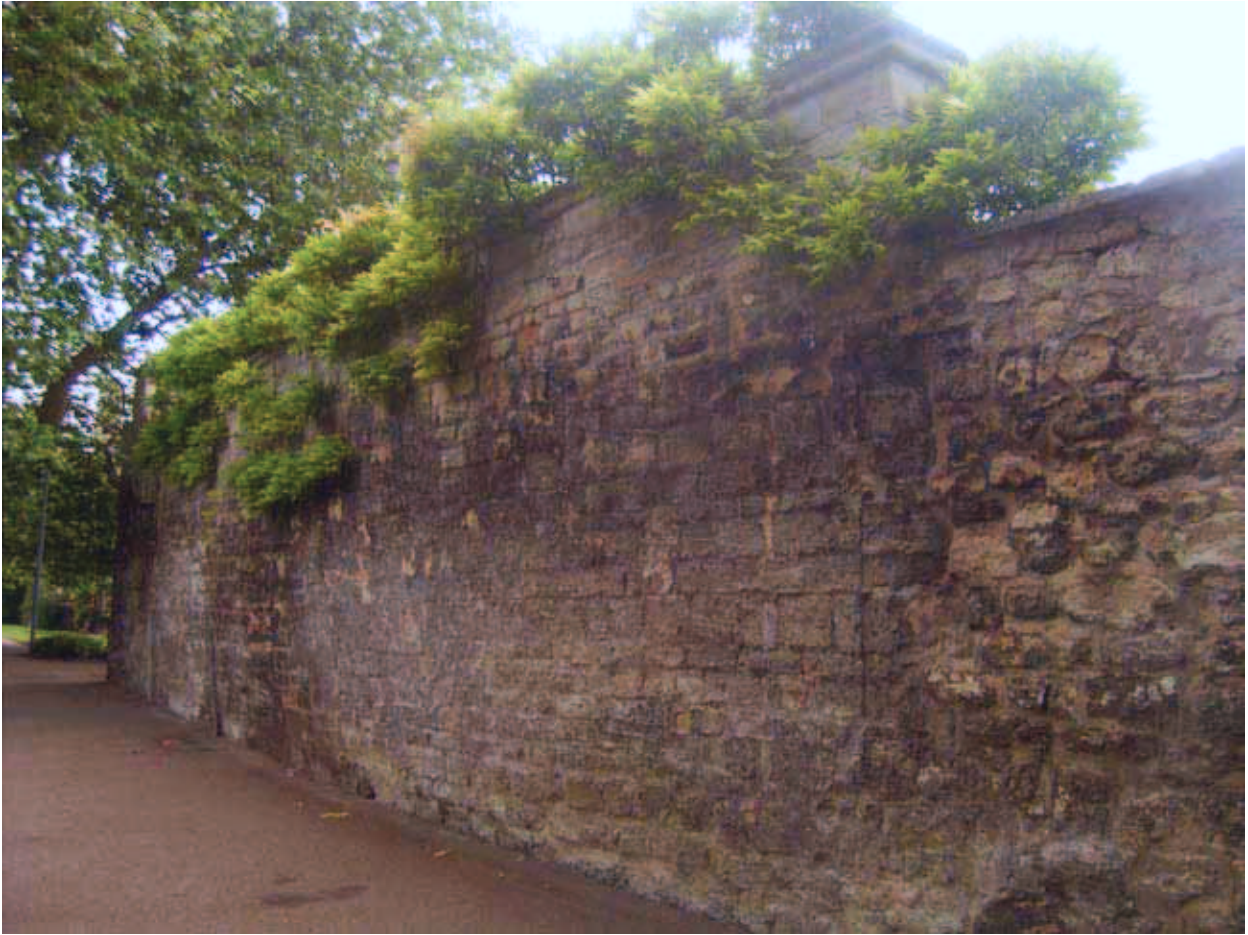
- 3.1.3 Section 2, the subject of this report, which is to be demolished and rebuilt, is 14.4m in length and 3.62m in height on the north (outer) side before reducing by 0.86m where it meets section 3 on the west side (Plate 1). It is approximately 0.4m wide and 2.28m in height on the south (inner) elevation as it retains approximately 1.34m of raised ground inside the garden.

Plate 1: President's Lodgings Wall, Magdalen College: View of north face, looking south east

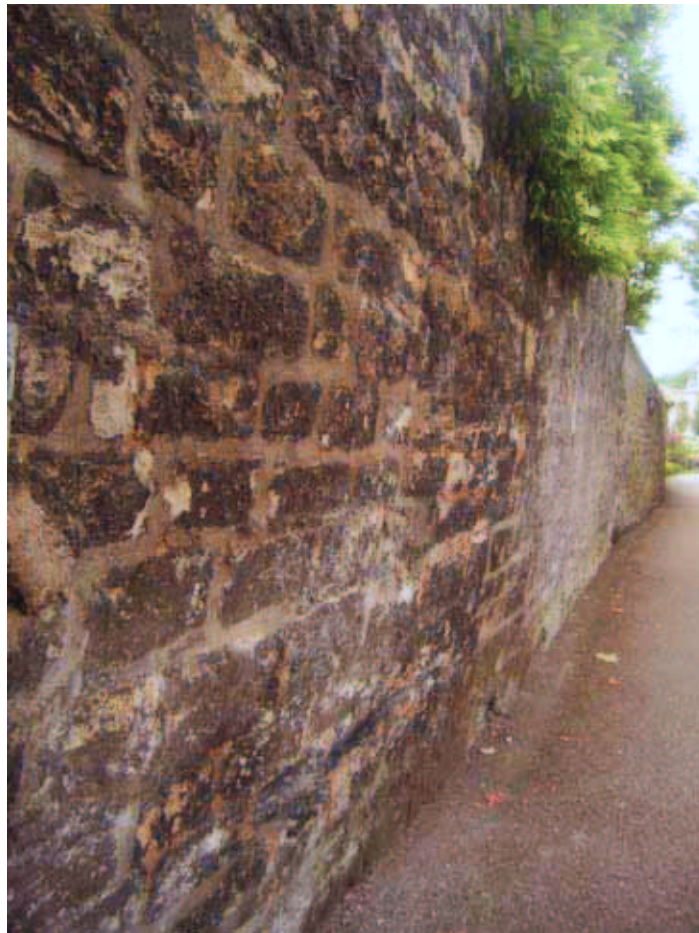
- 3.1.4 Over the past 130 years, section 2 has begun to lean forward and bulge visibly towards the north. It may have deflected by up to 255mm. The wall was subject to some repairs 6 years ago but since then, the wall has moved up to 15mm. The bulge in the middle of the wall appears to be caused by outward pressure, or inadequate bearing capacity of the foundations.

- 3.2.1 The wall bulges outward considerably in the centre of the north facing side (Plate 2). Where it meets section 1, it has moved forward and out of line by approximately 80mm. Cement repair has been applied here at the interface between section 1 and section 2, but as it has bulged forward, this thick layer of cement has cracked and is coming away from the east wall, showing that the wall has moved since the repair was made (Plate 3). Underneath this cement repair is the evidence of similar incompatible repair work over the years.

Plate 2: President's Lodgings Wall, Magdalen College: Bulge in north face, looking west

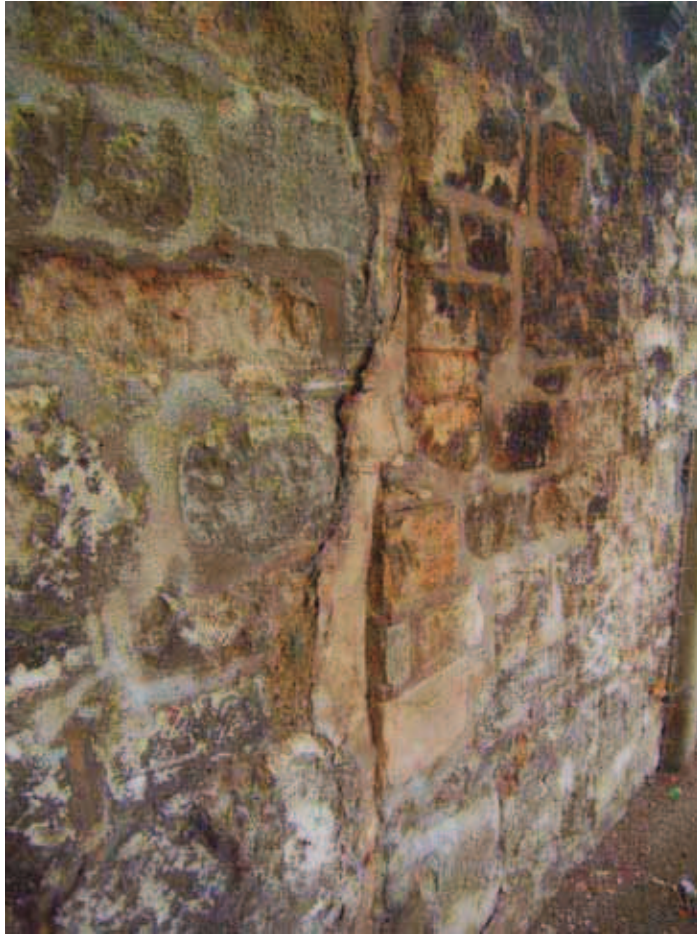
Plate 3: President's Lodgings Wall, Magdalen College: Crack in north face, looking south west

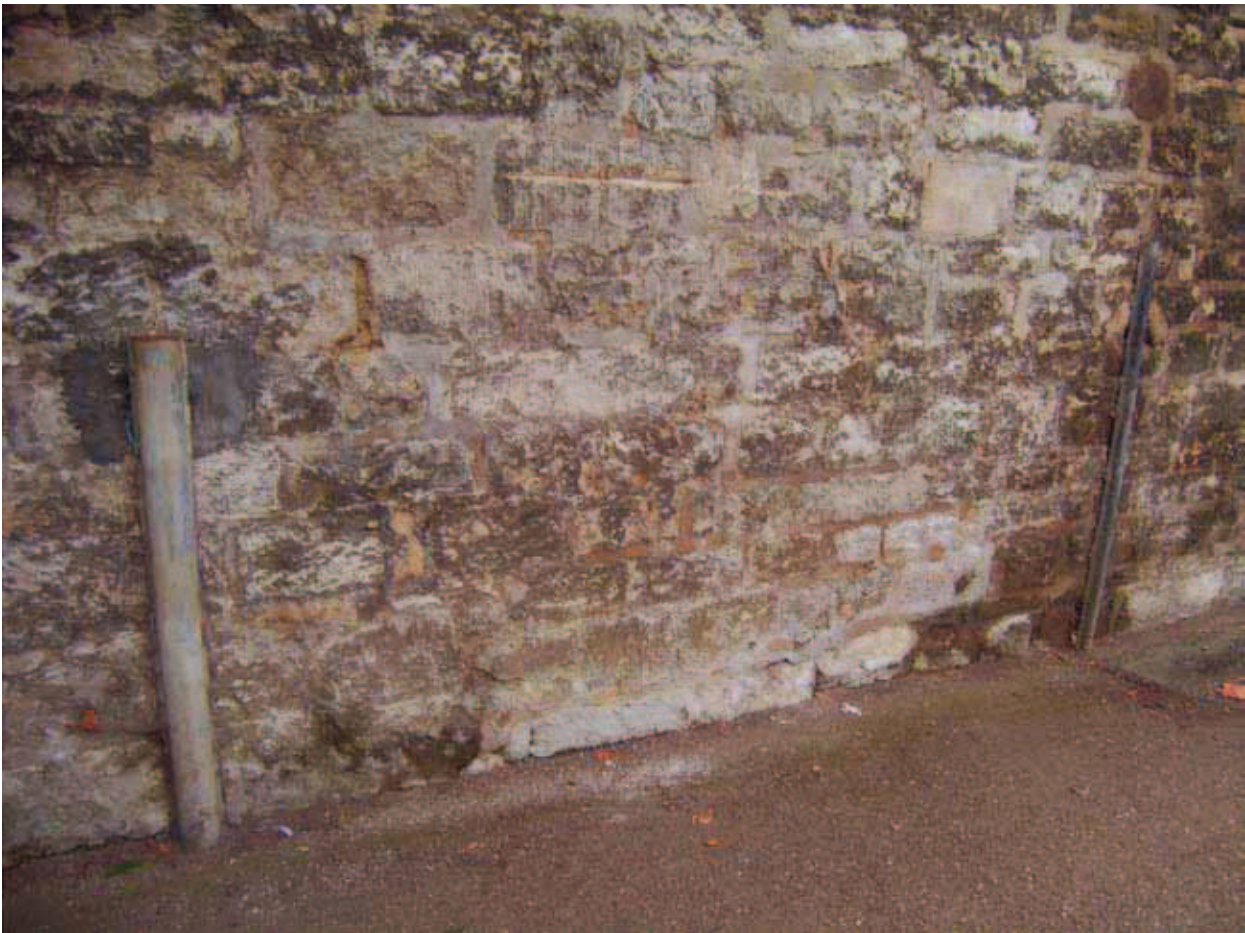
- 3.2.2 There are two steel supports built against the wall towards the west side. These may have been put in place to support the wall (Plate 4).
- 3.2.3 The face of section 2 is obscured by pollution and lichen but most stones appear to be large rectangular dressed stones (Plate 5). Some courses are narrower than others but this seems to be part of the construction rather than an indication of different phasing. However, phasing can be identified in some parts, most notably the latest phase, which is approximately 1m thick along the top (Plate 6). This makes up 5 courses underneath the coping stones and although the stones are smaller they appear to be the same stone as the rest of the wall. It is largely pointed with a modern cement ribbon pointing but is in better condition than the lower masonry. Where cement repointing has fallen off, a distinctive yellow, sandy mortar pointing can be seen.

Plate 4: President's Lodgings Wall, Magdalen College: Steel supports on north face, looking south

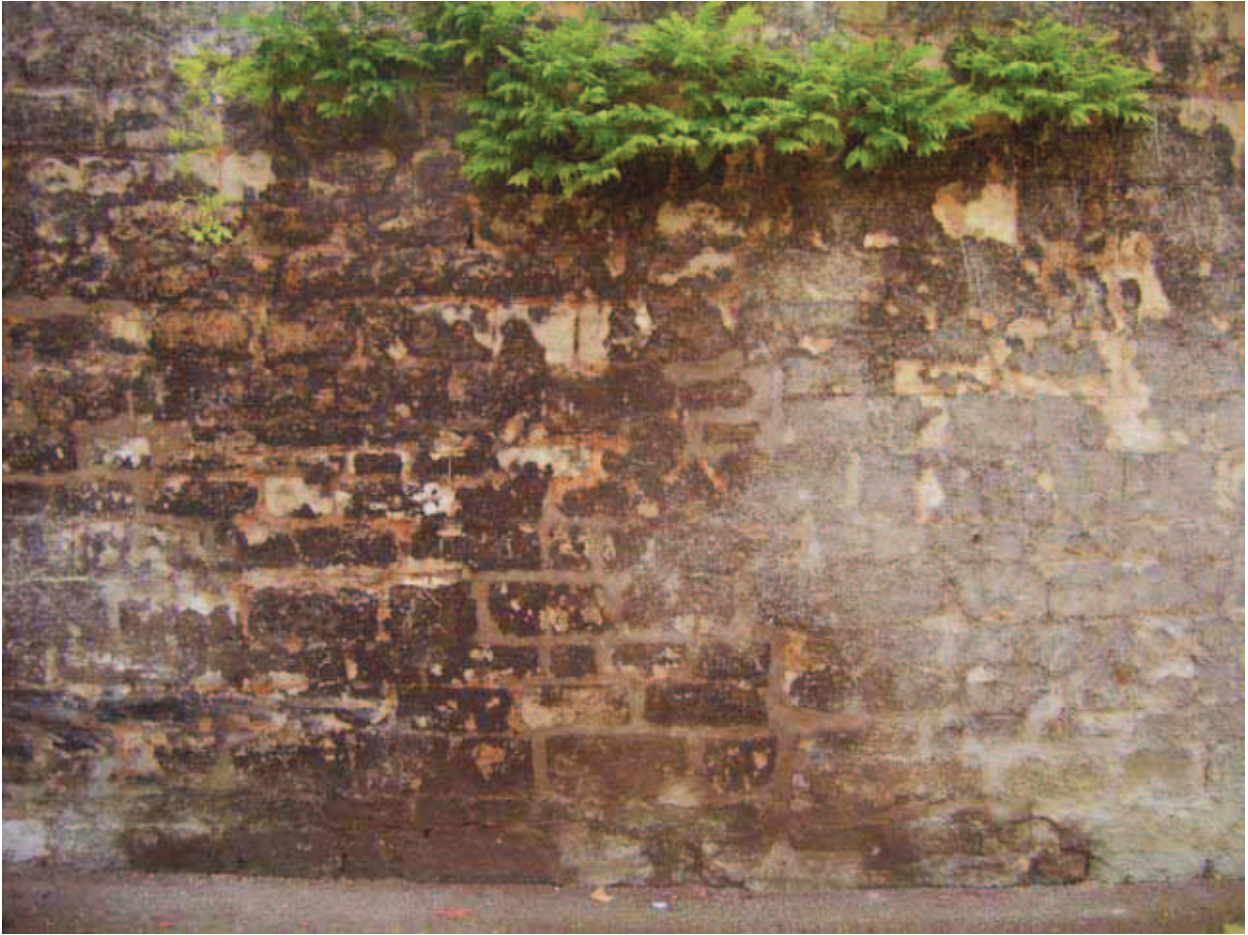
Plate 5: President's Lodgings Wall, Magdalen College: Coursing on north face, looking south

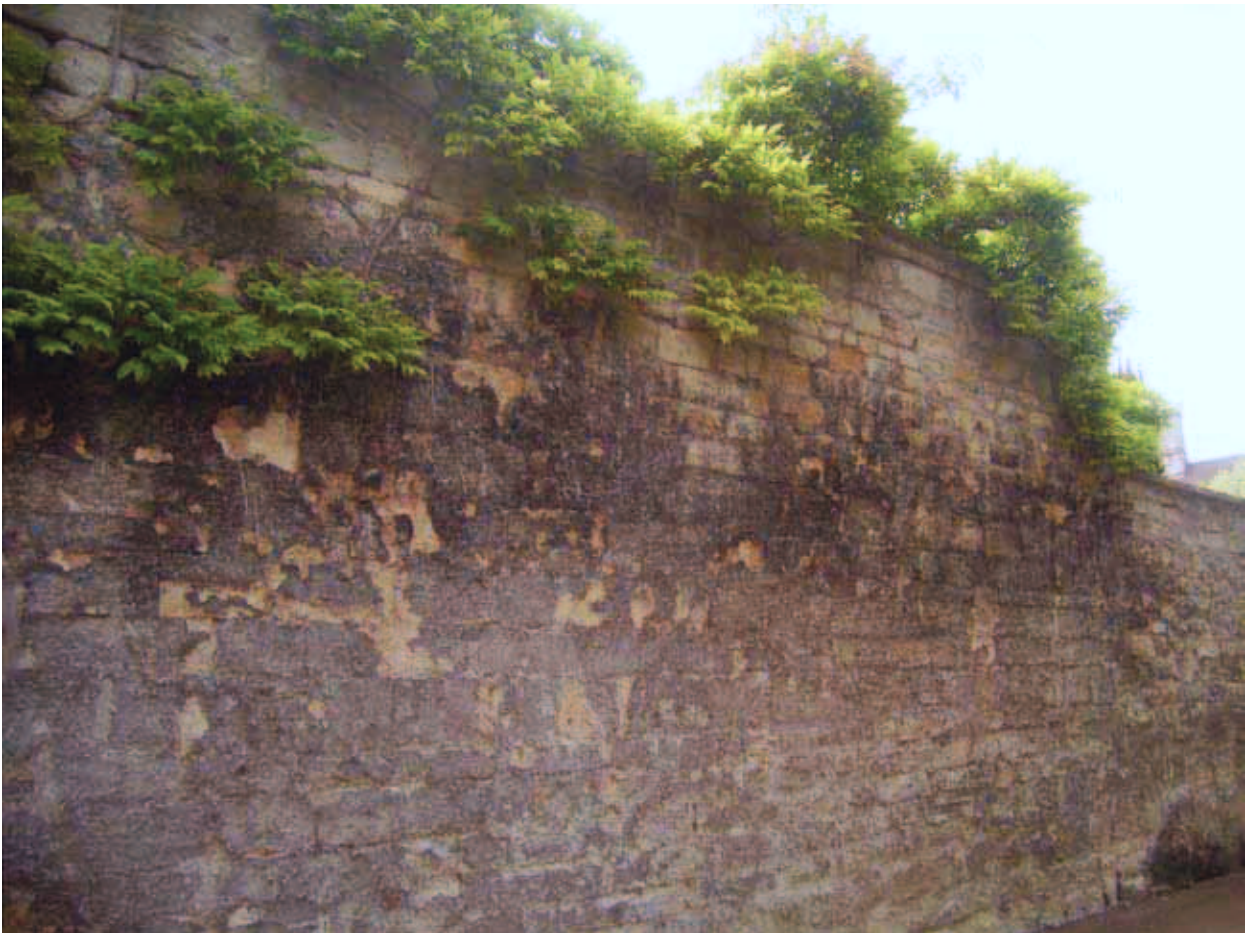
Plate 6: President's Lodgings Wall, Magdalen College: Coursing on north face, looking south west

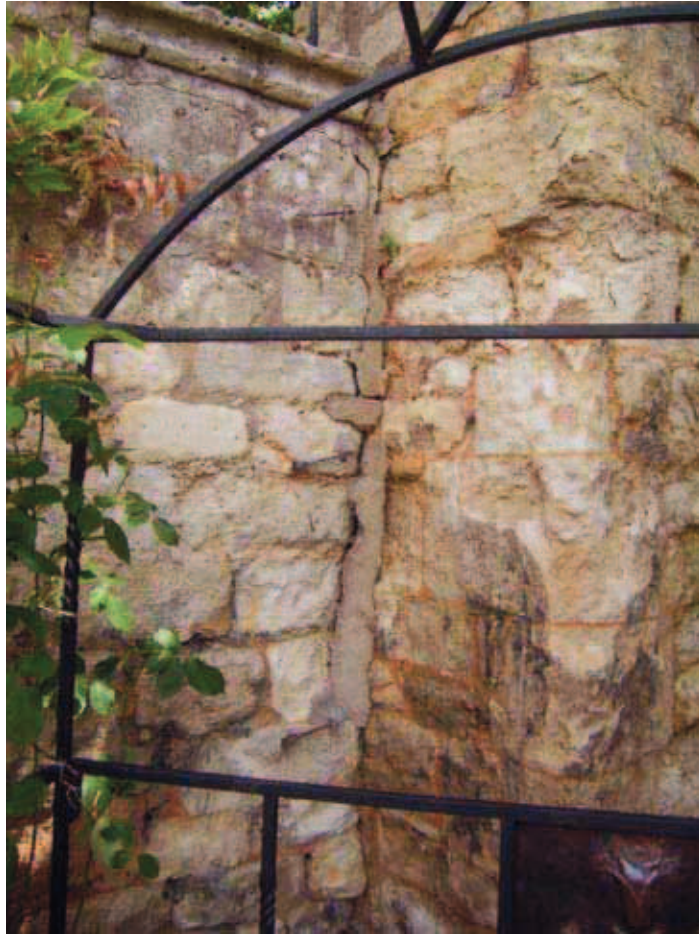
- 3.3.2 On this side of the wall is a low stone seating which was presumably built against it. There is now a gap of up to 10cm between the wall and the seat (Plate 7). Where the wall meets the west wall, the concrete repairs have cracked off and the wall has moved away from them (Plate 8).

Plate 7: President's Lodgings Wall, Magdalen College: Cement repairs on south face, looking north east

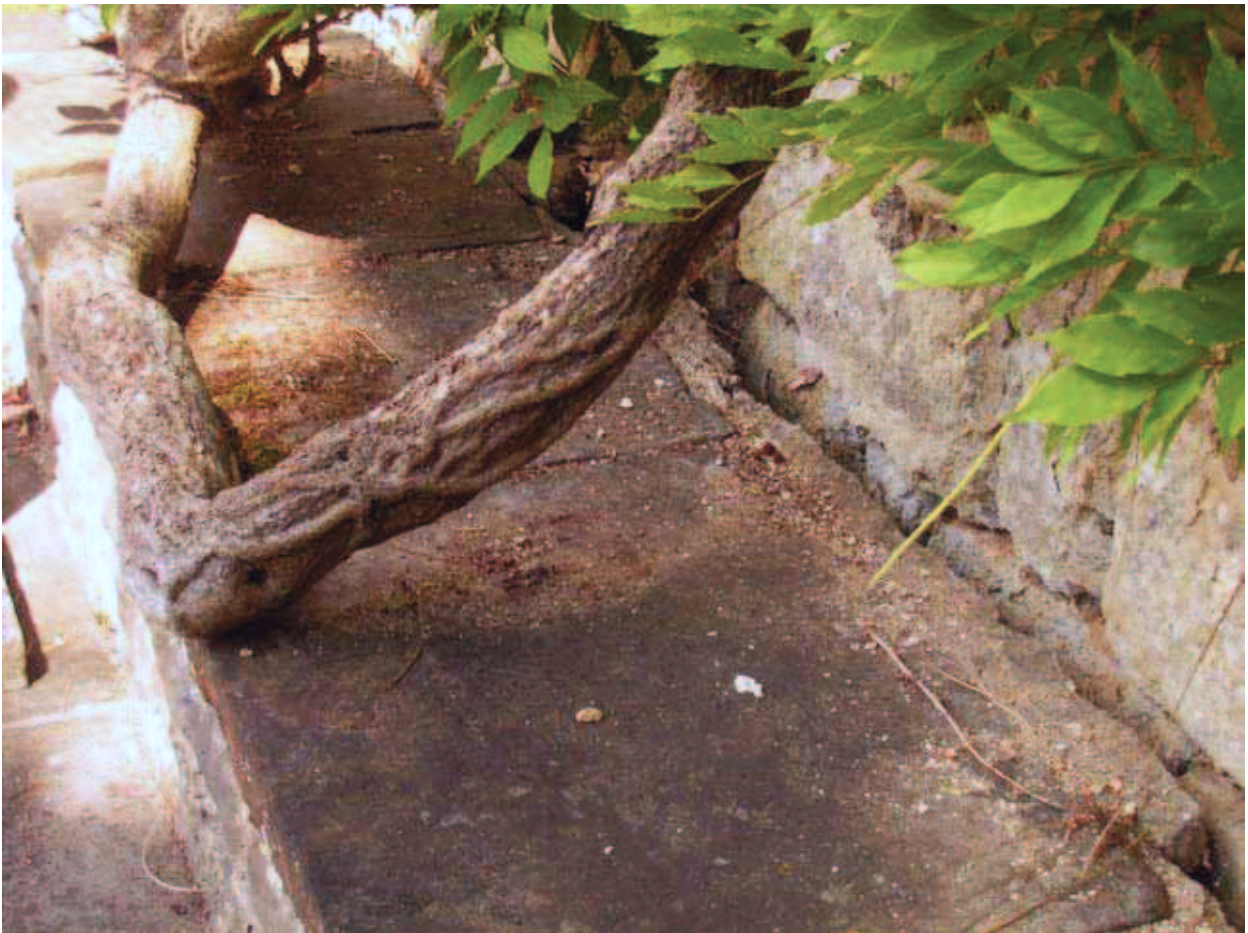
Plate 8: President's Lodgings Wall, Magdalen College: Evidence of movement on south face

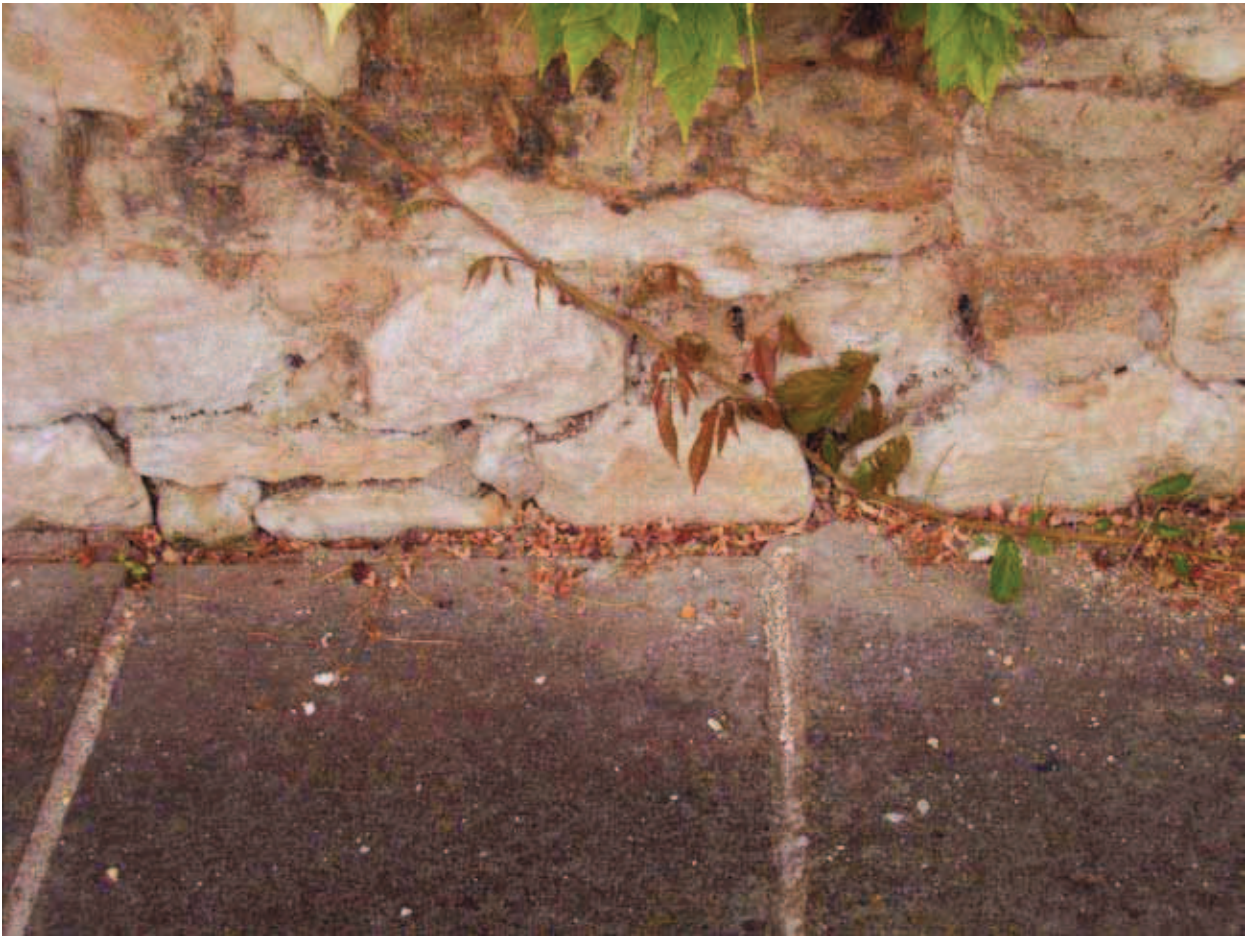
- 3.3.3 Mortar and cement pointing appears to be failing in parts of the wall visible through vegetation. Other areas have been painted with cement. Towards the bottom where the wall meets the garden flower bed, the stone is in very poor condition (Plate 9).

Plate 9: President's Lodgings Wall, Magdalen College: Foot of wall at south side, looking northwards

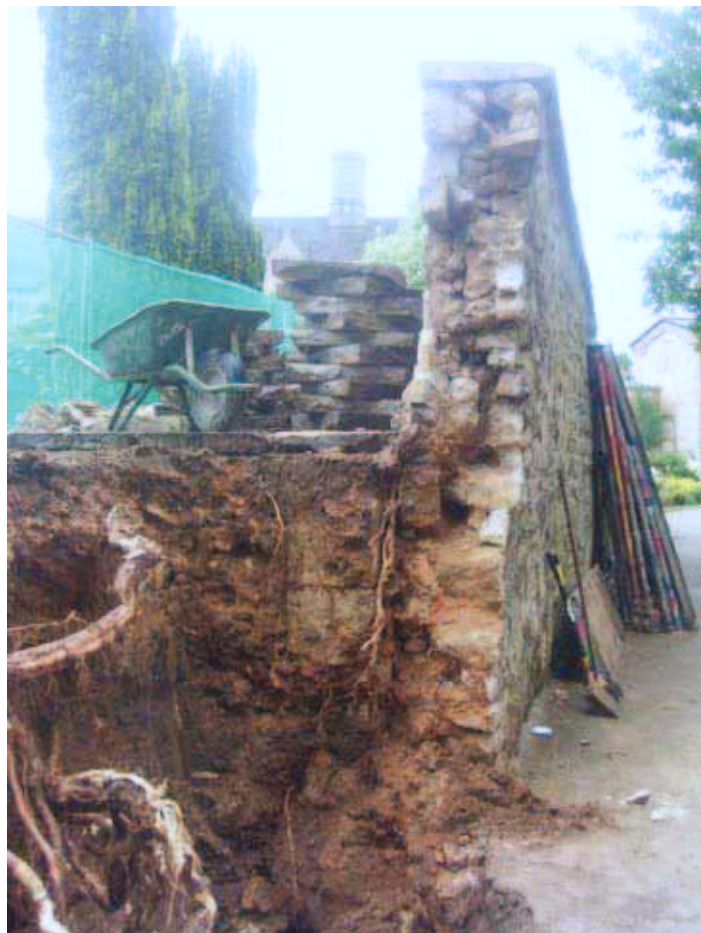
- 4.1.1 After the wall had been dismantled, the foundations became visible. On the east side, approximately 0.4m below ground level, the foundation seem to be a smooth level surface of packed yellowish mortar and large stones (Plate 10). Towards the west side of the trench, this foundation has been removed. Although the masonry in section 3 differed to that of section 2, because it is a different phase of construction, there was no clear break and where section 2 has been removed, the edge of section 3 is quite jagged and broken.

Plate 10: President's Lodgings Wall, Magdalen College: Section of wall after dismantling, looking west

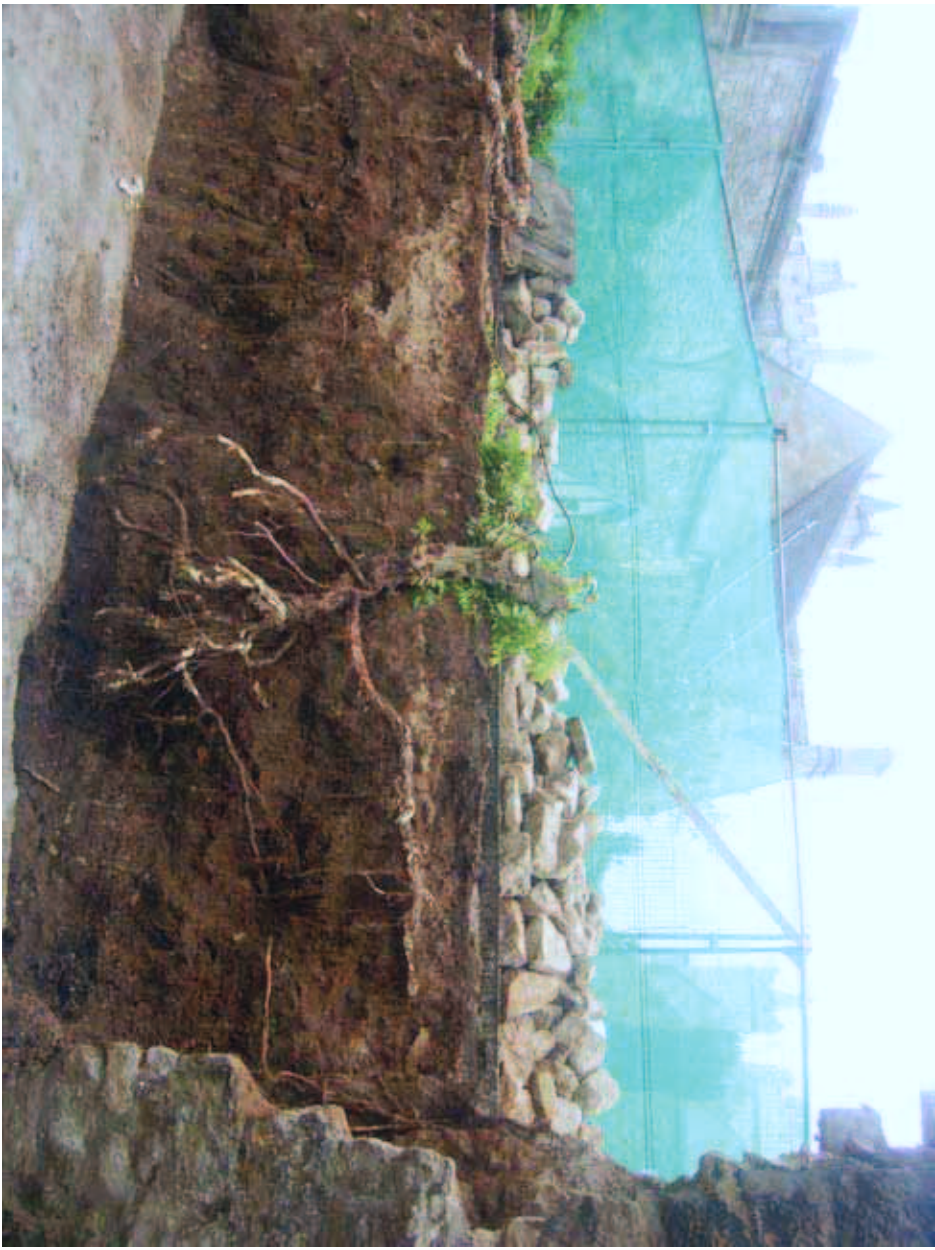
- 4.1.2 There is a retaining wall on the south side of section 3 below ground level of the garden (Plate 11). Three courses of large squared stones are visible beneath the York stone paving. This section shows a clear break in masonry where it would have come into line with the interface between section 2 and section 3.

Plate 11 : President's Lodgings Wall, Magdalen College: area of wall after dismantling, looking south
