Tithe Barn  
Church Lane (South)  
Sydling St Nicolas  
Dorset  
DT2 9PA  
Scheduled Monument No. SM  
DO 105; HA 1003209

**Archaeological  
Evaluation Report**

**An Archaeological Evaluation Report**

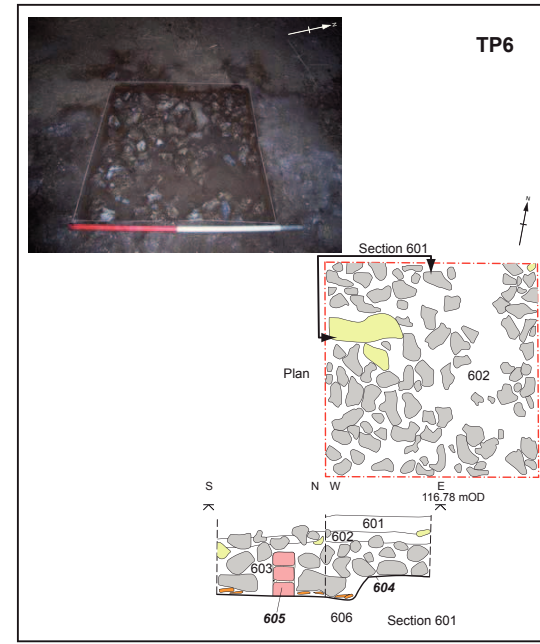
Figure 2: Test Pit location plan -showing plan of first significant archaeological horizon with photograph, and example section for each Test Pit

3.1.1 The evaluation consisted of six Test Pits which were distributed evenly within the barn (Fig. 2). Each Test Pit shared a number of general aims, which were to establish the condition, nature, date, and use of any historic floor level[s], deposit[s] and structure[s] encountered, and in addition aimed to:

- 7.2.2 Historic floor surfaces were present in three out of six of the test pit locations, and were observed elsewhere within the footprint of the barn. No effort was made to reveal their full extents, as they were covered by varying thickness's of humic overburden but where visible they were planned (Fig 2, plan of barn), and general photographs taken.

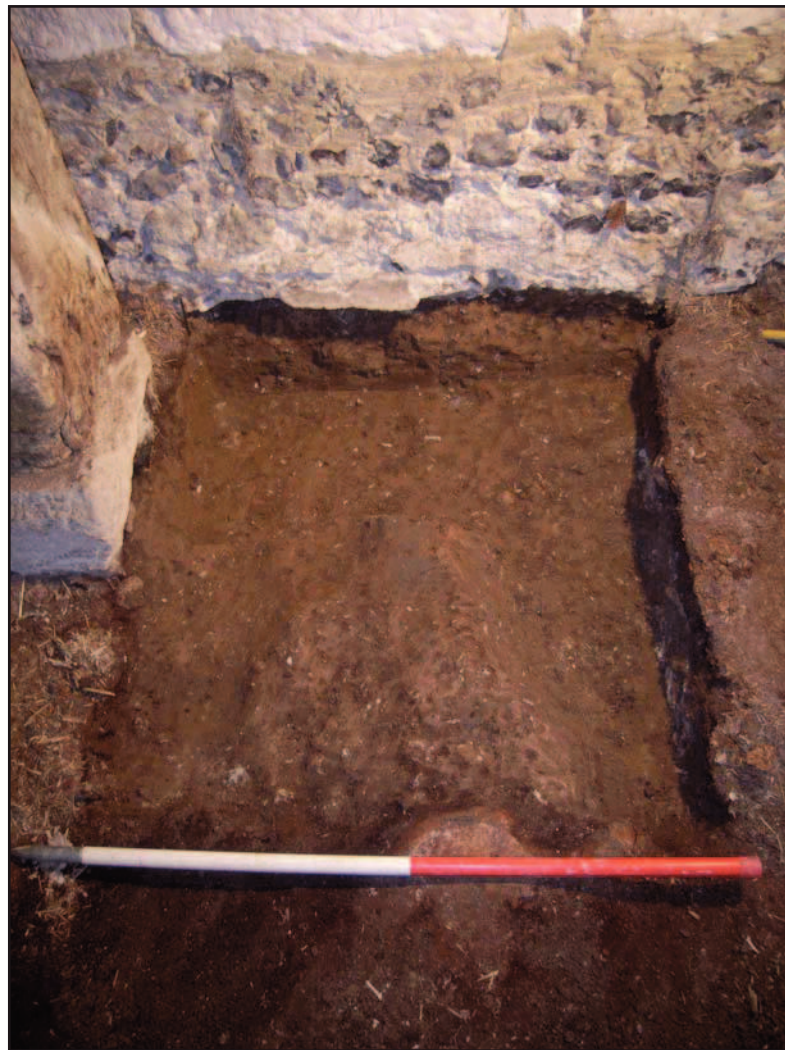
Figure 4: Test Pit 3 - Plan and photograph after excavation completed

- 5.2.5 Test Pit 3 was located against the eastern gable end wall of the barn and the north-easternmost aisle post and measured 1 m x 1 m (Fig 2), a sondage measuring 0.5 m x 1.0 m was located in its western half .

- 5.2.6 An uneven mid brown clay deposit (304) was encountered at 116.66 m OD, between 0.1 m – 0.15 m below current ground level, the sondage confirmed that it was sterile and probably of geological origin. At the southern edge of the test pit a shallow feature (306) was partially revealed, it measured 0.60 m E-W by 0.5 m N-S but extended beyond the southern baulk, and was 0.10 m deep. This was filled with a grey brown silt clay with chalk inclusions (305). This feature had been truncated by an east-west aligned shallow linear (303 filled by 302) whose eastern terminus respected the extant barn wall and then extended 0.96 m westwards to continue beyond the limits of the trench.

- 5.2.7 Both the extant eastern wall to the barn and the extant post pad sat directly on the clay natural with no construction cuts observable or any discernible foundations, and with no relationship to the features 303 and 306 described above.

- 5.2.8 The overburden consisted of a mid-dark brown, humic-rich silt deposit (301), this overlay the entire test pit and abutted both the wall and post-pad. No *in situ* stone floor surface was present, and in places the overburden immediately overlay the natural geology.

Test Pit 3 - View to the east

- 7.4.6 The eastern gable end and the isle posts were all constructed directly on the natural geology; chalk bedrock to the west, and degraded chalk and sterile clays to the east. The eastern gable end wall is suffering subsidence and there are cracks between this and its jointing with the side walls – this lack of foundation could have contributed to this situation.

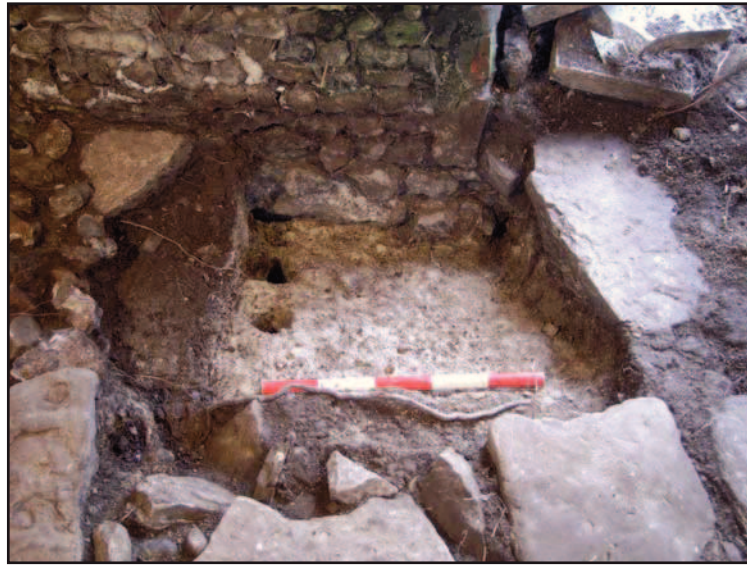
Figure 5: Test Pit 4 - Plan and photograph after excavation completed

- 5.2.10 The natural chalk horizon (401) was only exposed within the sondage, at 0.15 m below current ground level at 116.48 m OD. This had been truncated by an east-west aligned construction cut (409) for the existing vertical mortared flint foundation (408) to the southern wall of the barn. The foundation appeared to utilise larger less tightly packed flint than the wall above.

- 5.2.11 A pair of stake/post-holes (404) and (406) cut the chalk and were aligned perpendicular to the foundation/wall. Sealing the chalk natural and the features, was a friable dark grey brown clay silt (402) which was overlain by a surface comprising limestone flags and flint cobbles (401) at 116.70 m OD. This surface abutted the extant barn wall but extended beyond the limits of the test pit (its observable extent was planned and is shown on Figure 3, it does however extend beyond its' observable limits but was covered by overburden).

- 5.2.12 The corner to the entrance to the barn had been modified/repaired with brick.

Test Pit 4 - View to the south

- 7.4.12 Two types of surface were observed, those that predominantly consisted of limestone flags and those of flint nodules (dressed and undressed).
- 7.4.13 The flagstone floor observed in Test Pit 4 (Fig. 2) and elsewhere (Fig. 3 plan of barn) is probably the earliest, and possibly original, floor surface of the barn. Such an important

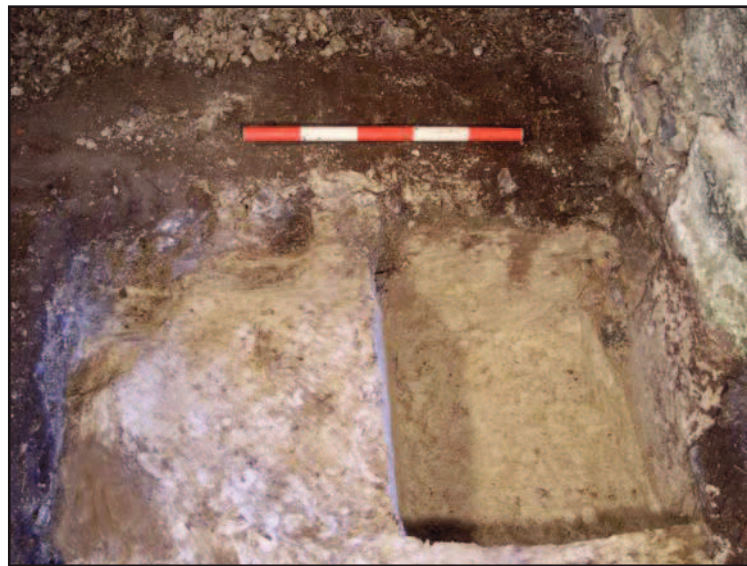
Figure 6: Test Pit 5 - Plan and photograph after excavation completed

- 5.2.14 Natural degraded chalk and clay (517) was recorded at 116.60 m OD, some 0.10 m below current ground level. At this horizon three postholes (503), (507) and (513) as well as four closely positioned stake holes (505), (509), (511) and (519) were revealed. No dating evidence was found in the similar brown silt fills of these features. A pair of north-south aligned wheel ruts were recorded at this level at the eastern extremity of the test pit aligned with the edge of the entrance way into the barn.

Test Pit 5 - View to the west

- 7.4.8 There is a similar case to be made for the post/stake holes in Test Pit 5. Several of the post holes and stake holes revealed in Test Pit 5 apparently cut the backfilled construction cut of the original northern wall and are also partially sealed beneath a layer of chalk and flint rubble (502) which contained the 19<sup>th</sup> century pottery. It is possible that this rubble derives from stone dressing for on site wall repairs, in the 19<sup>th</sup> century, carried out from scaffolding that was set into these post and stake holes. A number of these could also form an internal division of bay.

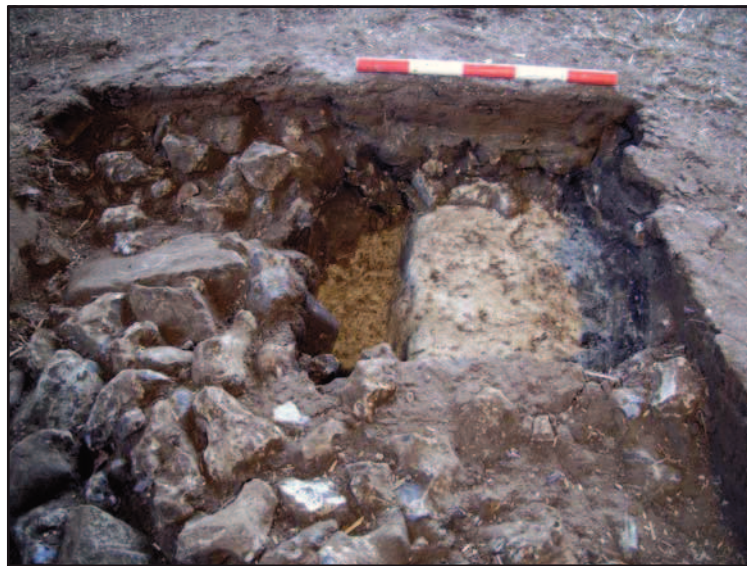
Figure 7: Test Pit 6 - Plan and photograph after excavation completed

- 5.2.18 Natural chalk bedrock had been cut at the western side of the sondage by a north-south aligned linear feature (604) which was 0.10m in depth. A lime mortared brick structure was constructed on the base of the cut, it was 3 courses high and one brick header wide (top level at 116.56 m OD) it was aligned perpendicular to the cut on an E-W axis. The flat base of the feature was lined with pottery sherds, all dating from the 19<sup>th</sup> century which lay at the base of a thick deposit of loosely packed dressed flint nodules within a compact dark brown calcareous silt matrix (603). This deposit filled the cut, abutted the brick structure on both its sides and sealed the natural chalk horizon to its east. The feature probably acted as some form of drain. Overlying (603) lay a rough flint cobbled surface (602) at approximately 116.60 m OD. This was overlain by (601), a similar dark brown humic-rich deposit as seen elsewhere within the barn.

Test Pit 6 - View to the north

- 7.4.11 The linear cut in Test Pit 6, aligns well with the eastern sides of the westernmost entrance. The brick divide[?] and the loose flint nodule fill suggests a drainage function below a resurfaced flint floor. The loose flint nodule fill of linear (102) in Test Pit 1 is similar and may share a similar function. This could suggest a difference in use of the western end of the barn.
