# The Roman Car Dyke Billinghay Skirth Lincolnshire

## Archaeological Evaluation Report

OA East Report No: 1125

## **The Roman Car Dyke, Billingham Skirth, Lincolnshire**

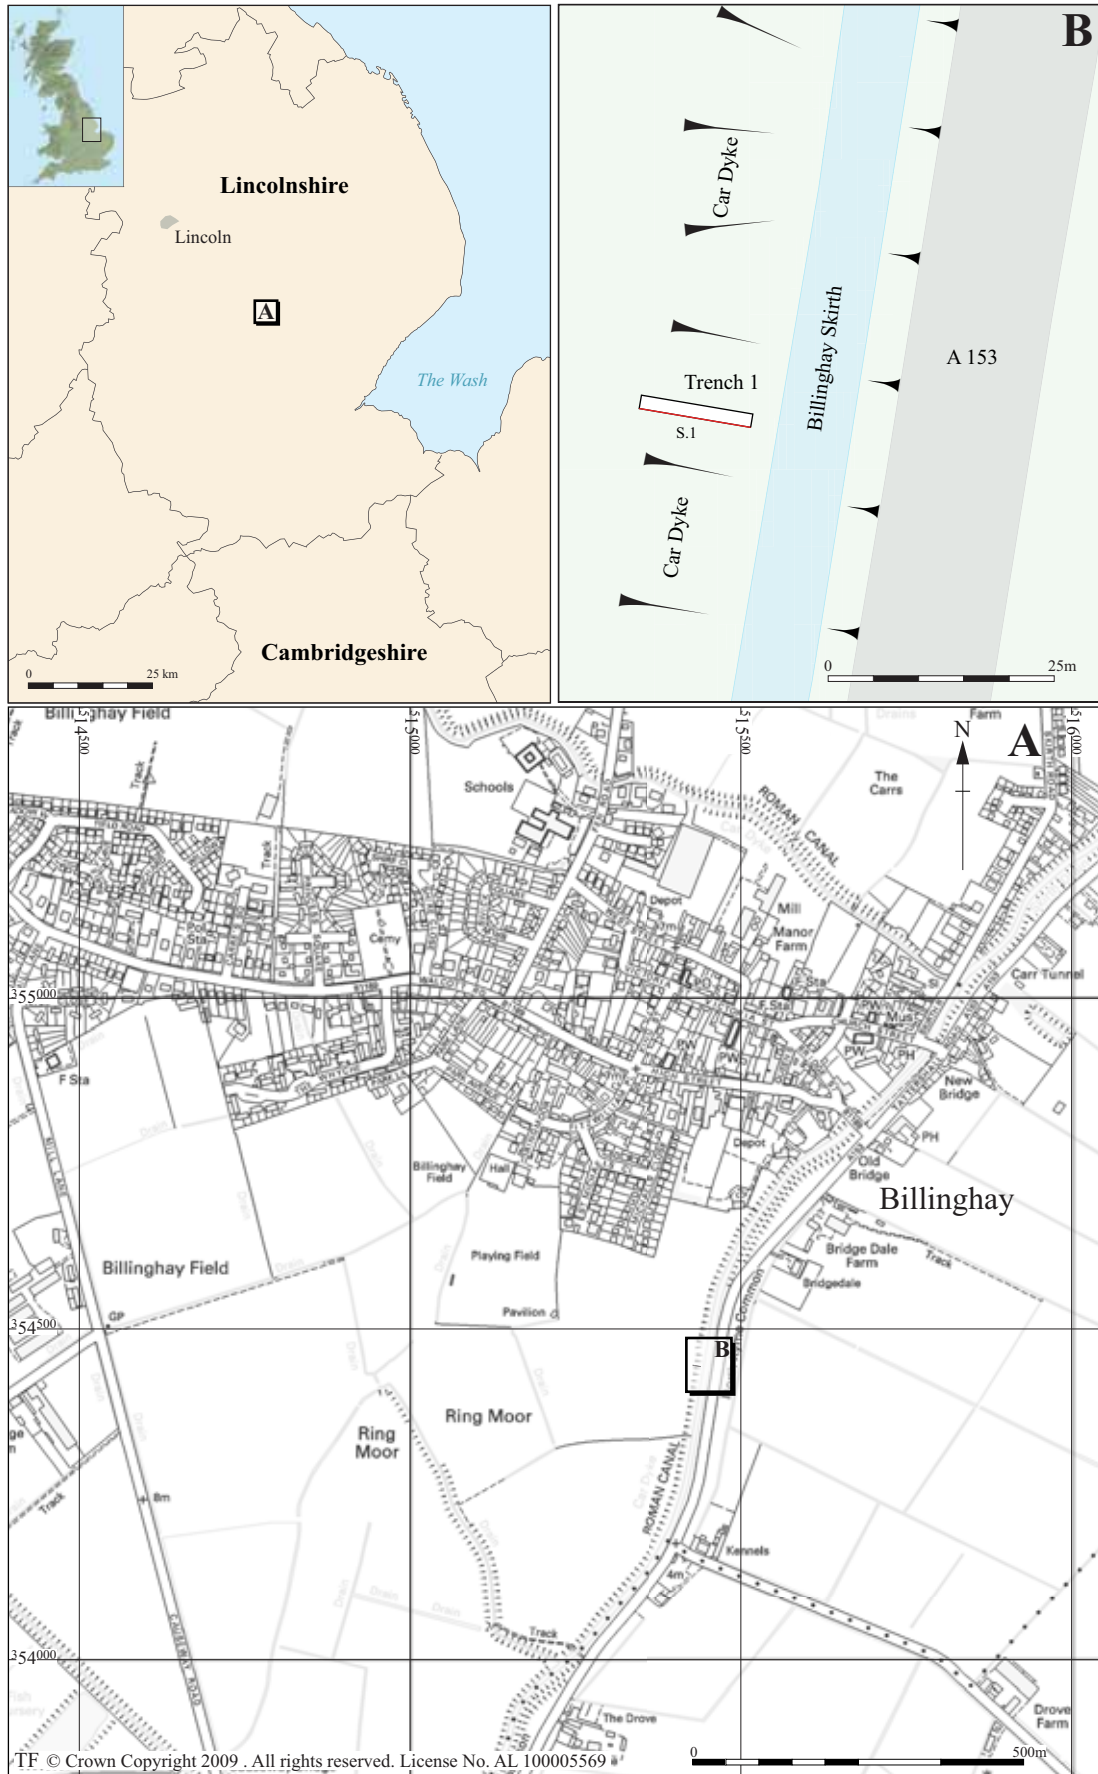
Figure 1: Location map (A) and trench plan (B)

- 1.1.1 An archaeological evaluation was conducted adjacent to the Billingham Skirth, an extant watercourse, that runs near the village of Billingham in Lincolnshire. A single 13m long trench was excavated through the west bank of the watercourse (TF 15436 54443; Fig. 1).

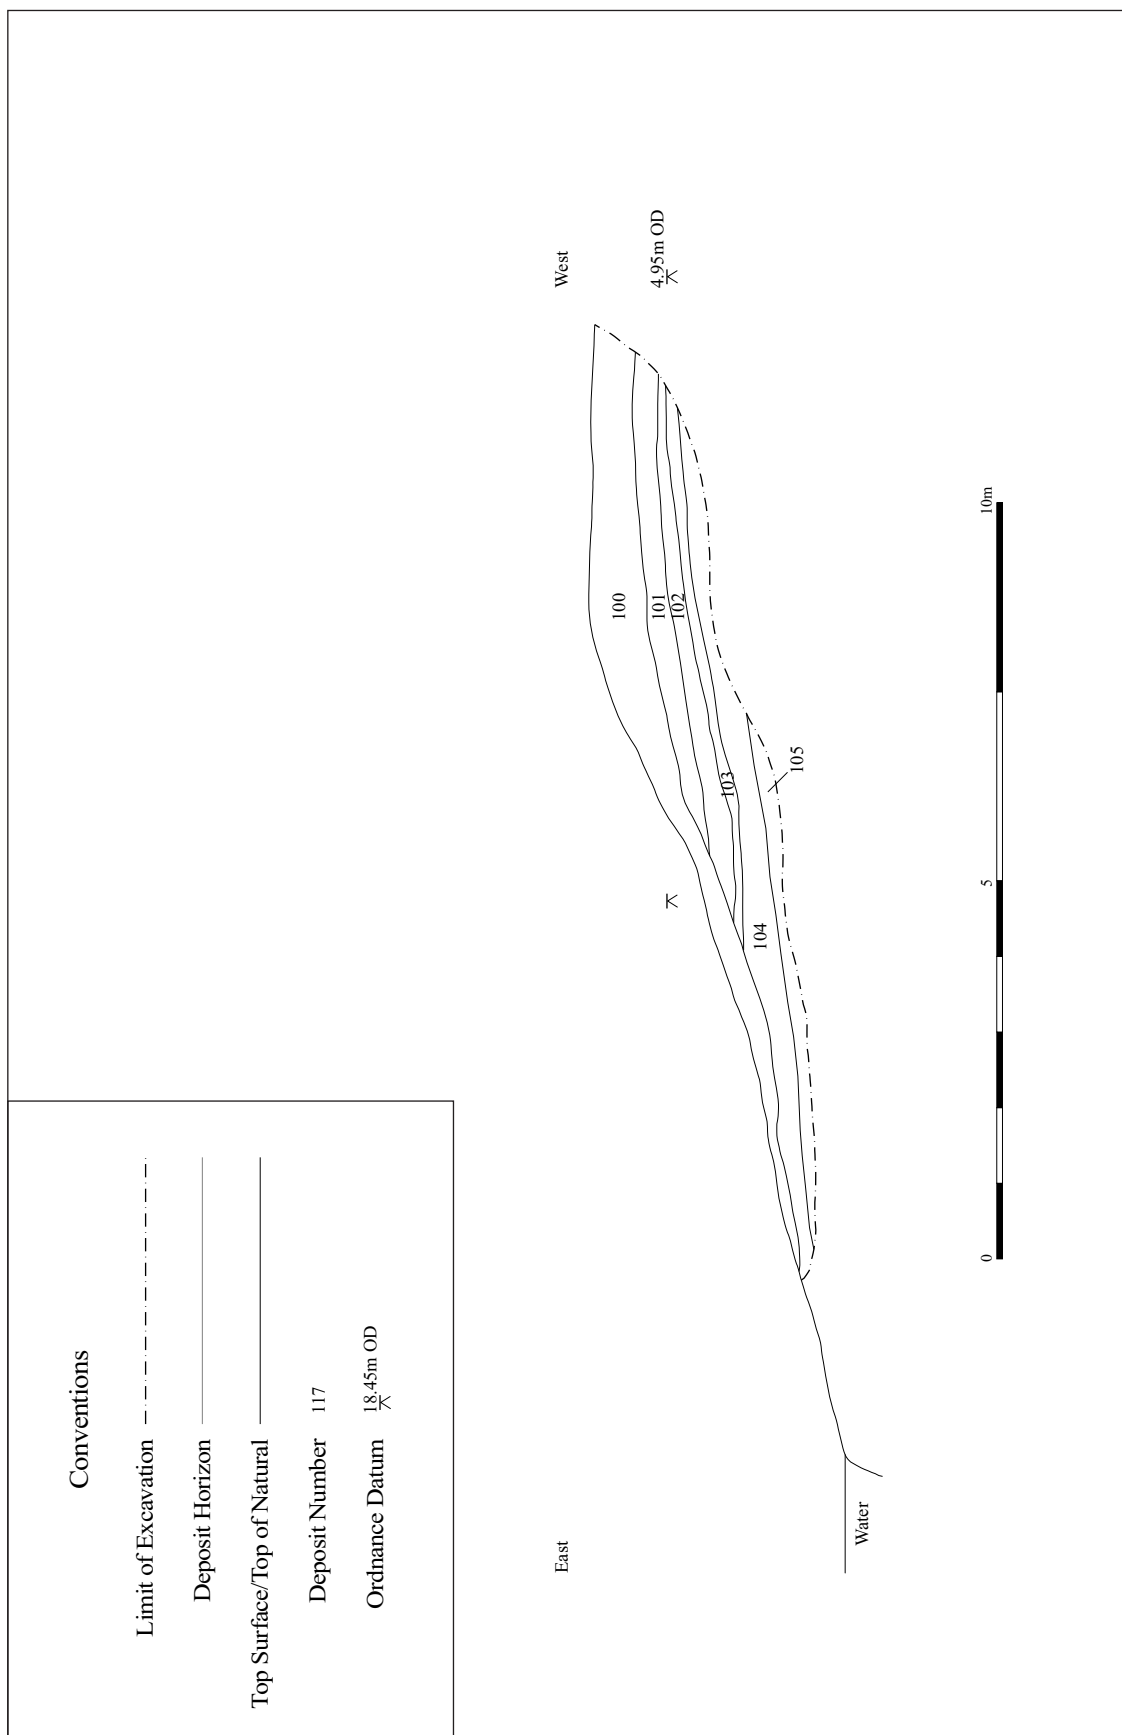
Figure 2: Section 1

- 1.2.2 The Billingham Skirth was once navigable but now acts mainly as a drain leading into the river Witham to the north. The watercourse follows an approximately south to north orientation at the evaluation trench with a water level of 2.6m AOD. The western bank/berm forms a slope of just under twenty degrees over a distance of approximately 8m from the edge of the watercourse steepening to 30 degrees for about 3m before levelling out at a height of 5.65m AOD (Fig. 2) at the top of the bank.

#### 3.1 Trench 1 (Fig. 2)

- 3.1.1 The earliest deposit comprised a mid to dark blue grey clay (105) that gently sloped down to the watercourse. This was sealed by a band of yellow brown clay sand with some patches of yellow white chalk (104). This deposit was up to 0.5m thick and may be redeposited natural upcast to form the base of a bank. Above it was a 0.2m thick band of mid grey brown clay silt flecked with charcoal (103). The presence of charcoal suggests that this layer may represent an old land surface (buried soil). Above it was yellow/orange brown chalk with clay silt up to 0.30m thick, probably redeposited natural (102). This was sealed by a mid grey brown clay silt (101). The upper layers may represent another phase of bank material. The entire sequence of bank deposits (101-104) was approximately 1.5m from base to top.

- 3.1.2 Sealing layer 101 was topsoil (100) which was only 0.1m thick near the water's edge deepening to up to 0.80m thick at the top of the slope on the western side. It comprised a dark grey brown loam. No artefacts were found from any of the layers within the trench.

- 4.1.1 The evaluation has found buried deposits which may represent a bank associated with a watercourse now known as the Billingham Skirth. The section excavated has some similarities to a section excavated across the Car Dyke at Helpringham where a buried soil layer was found sealed beneath bank deposits (see section 1.3.6 above). Whilst at Helpringham the section showed one phase of bank deposition, that at Billingham appeared to show two phases.
