St Cross Church Oxford

Archaeological Watching Brief Report

Client: Balliol College, Oxford

Job No: 4625

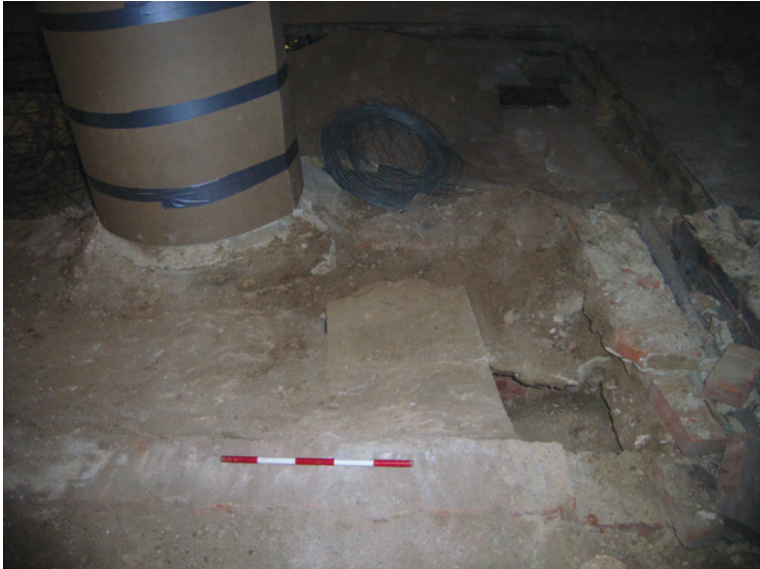
Plate 1: Burial 8, facing north

3.2.3 An additional two burials and a third possible burial were found in the north east corner of the aisle. One of these was immediately adjacent to the eastern most pillar separating the aisle from the nave on the south side (**Burial 8**). On the surface, it consisted of three large slabs fixed with a hard, compact white lime mortar. The centre slab appeared to be a broken Ogee topped headstone and has the initials 'MB' inscribed in it (Plate 1). The east and west stones were much rougher and appeared to be undressed from the surface. A hole at the east end of the burial allowed for photos of the interior to be taken. It is a red brick, coffin shaped chamber, orientated east west with the head towards the west, the base of which is obscured by debris but pieces of coffin timbers and fixtures can be seen. The brick is laid in a stretcher bond and the base of the stones appeared to be dressed (Plate 2).

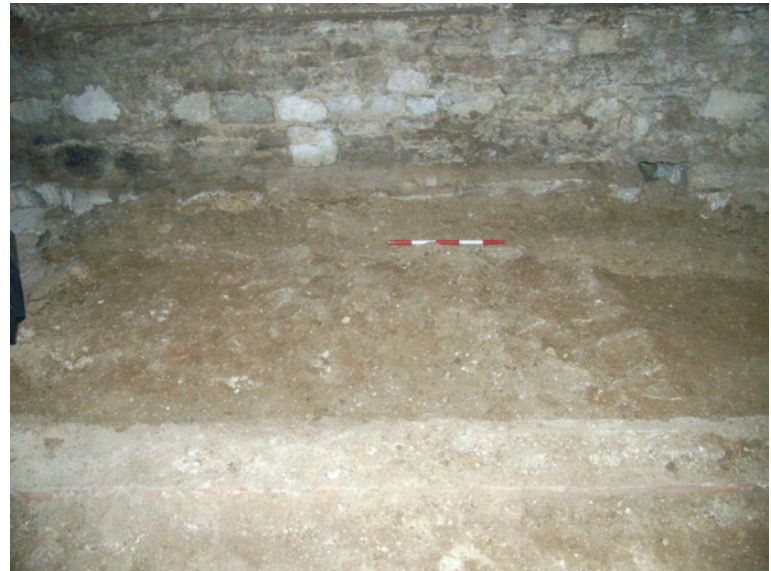
Plate 4: Possible robbed out wall in south aisle, facing south

3.2.5 Immediately south of the possible burial described in 3.2.1, and running alongside the south wall of the aisle, there is a feature which is possibly a robbed out wall. It measures approximately 2.35m x 0.7m and it is orientated east to west (Plate 4). It consists of large stones, packed into the earth within a darker context than the rest of the aisle and stops abruptly at the west end. It is slightly irregular and not quite parallel with the south wall of the aisle, therefore it may simply be some packing that was laid down to create an even ground surface.

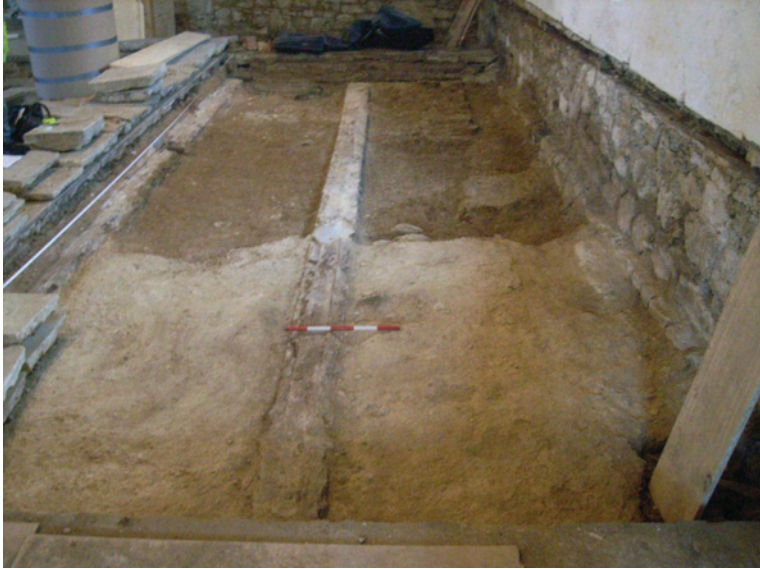
Plate 5: South aisle, facing east

3.2.6 The western half of the south aisle (immediately east of the font area) was packed with a very hard, compact white lime mortar surface (Plate 5). Within this were areas of large packing stones. The area is approximately 3.15m x 2.5m within the south aisle area and is deeper than the required 300mm below datum.

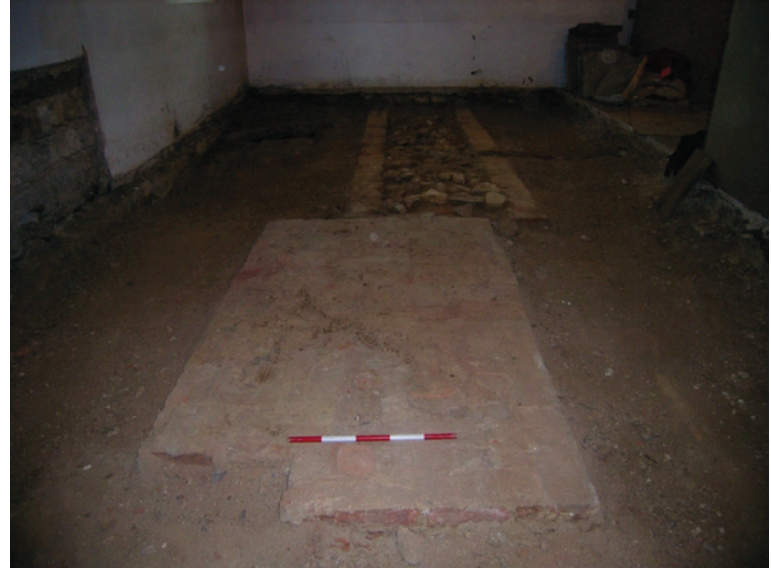
Plate 6: Red Brick plinth for font in south aisle, facing west

- 3.3.1 Before the limestone floor was removed from this area, the large 19th century font was removed and placed in the chancel while works commenced. Beneath the limestone floor, the ground was loose and friable around a large red brick plinth, constructed as a base for the font (Plate 6). This consisted of three courses of solid brick with a hollow, most likely a font drain, in the centre.

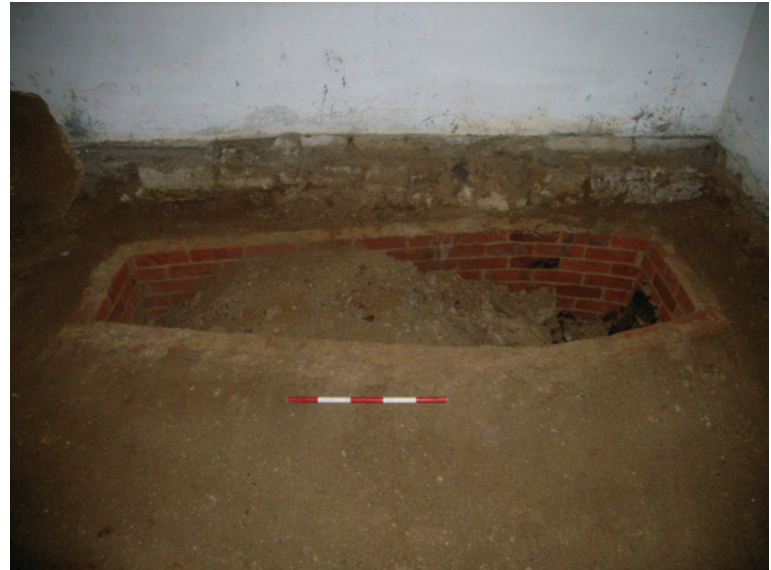
Plate 8: Burial 11, facing south

- 3.3.4 In the south west corner of the church, another burial was found (**Burial 11**) slightly out of line with the south wall of the south aisle (Plate 8). On the surface, it consisted of three large rough slabs fixed with a hard, compact white lime mortar. These slabs were removed as they lay above the level of necessary floor reduction. Beneath was a red brick coffin shaped chamber, orientated east west with the head towards the west, 2.18m in length and 0.73m in width at its widest. The base is obscured by debris including pieces of coffin timbers and fixtures. Some human remains were visible. The brick is laid in a stretcher bond and the base of the stones appeared to be dressed. It was not necessary to disturb the red brick chamber or the remains and it was covered over with strong wooden ply board to protect it from the floor surface, which was to be inserted.

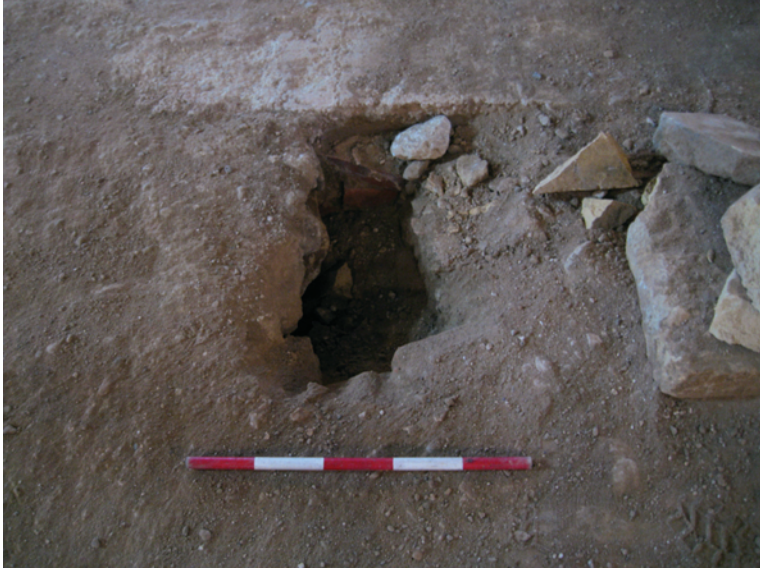
Plate 9: Burial 12, facing north

- 3.4.1 The removal of the limestone causeway in the central nave revealed four more burials. Excavation was unnecessary as all were below the level of floor reduction. The first is in the very centre of the nave (**Burial 12**) and only two rough partially buried slabs were exposed after the reduction. There is a wide gap between the slabs where part of one has crumbled and visible below was part of the the red brick lined chamber (Plate 9). Inside, debris was visible with some broken coffin timbers towards the west end.

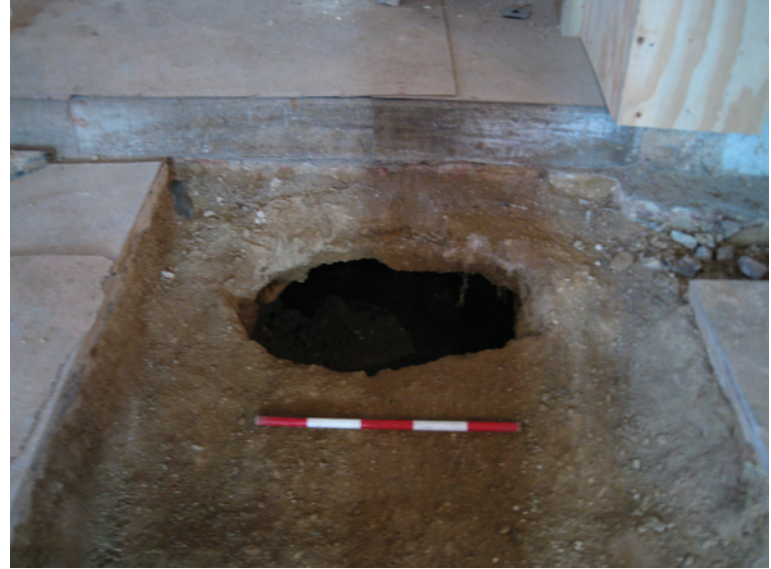
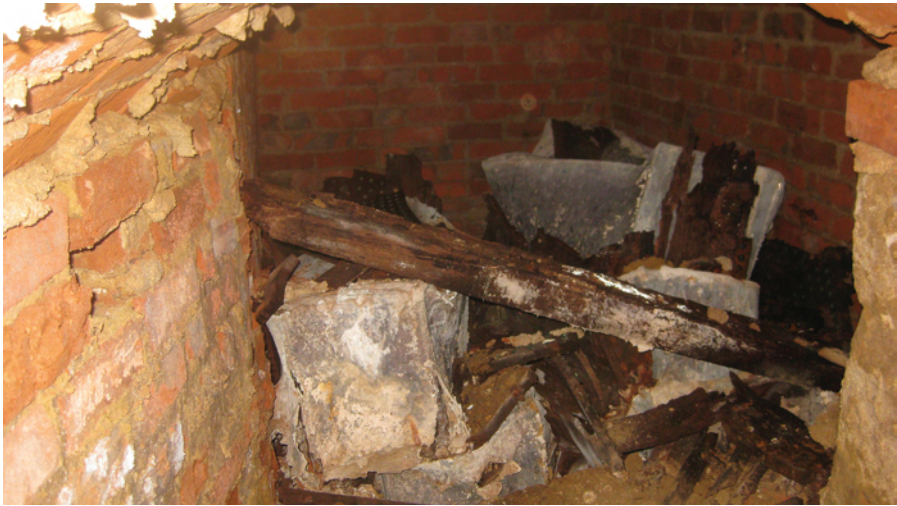
- 3.4.2 At the east end of the nave, at the south side of the entrance to the chancel, a hole was uncovered over a small brick lined passage leading east to a larger chamber under the chancel (**Burial 13**). It is a deep brick lined chamber and at least three decayed coffins can be identified (Plates 10 & 11).

Plate 10: Entrance to Burial 13, facing east

Plate 11: Interior of Burial 13, facing east

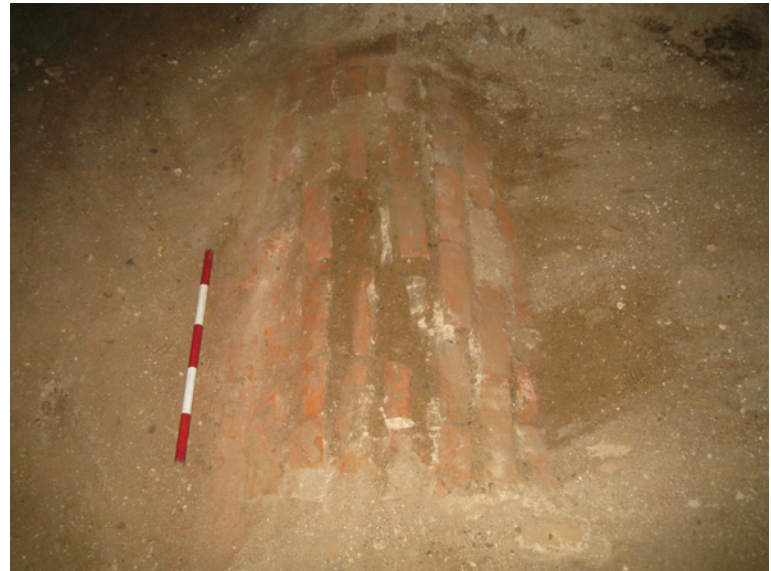
Plate 12: Burial 6, facing south

- 3.4.3 About a metre south west of this hole is an almost fully exposed red brick vault (Plate 12). It is orientated east west and the bricks of its convex, vaulted covering are laid in rows east to west with no distinguishable bond. It is approximately 56cm wide and 1.15m in length where exposed. This was identified as **Burial 6** (See *the Archaeological Recording of the floor at St. Cross, OA 2009*).

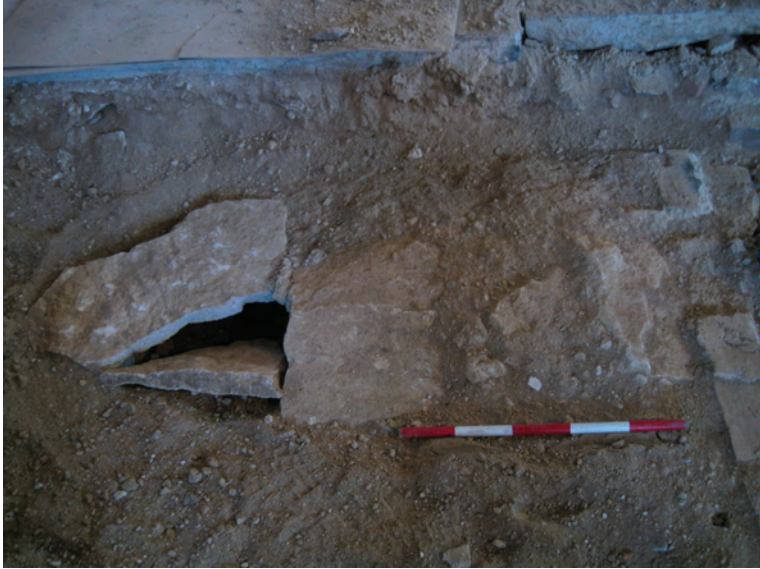
Plate 13: Burial 14, facing south

- 3.4.4 In the north east corner of the nave is a further burial, orientated east west, covered with approximately three large rough stone slabs fixed with a very compact pale lime mortar (**Burial 14**). The eastern most slab is broken in two pieces and was too precarious to allow a camera inside without the risk of further damage (Plate 13).

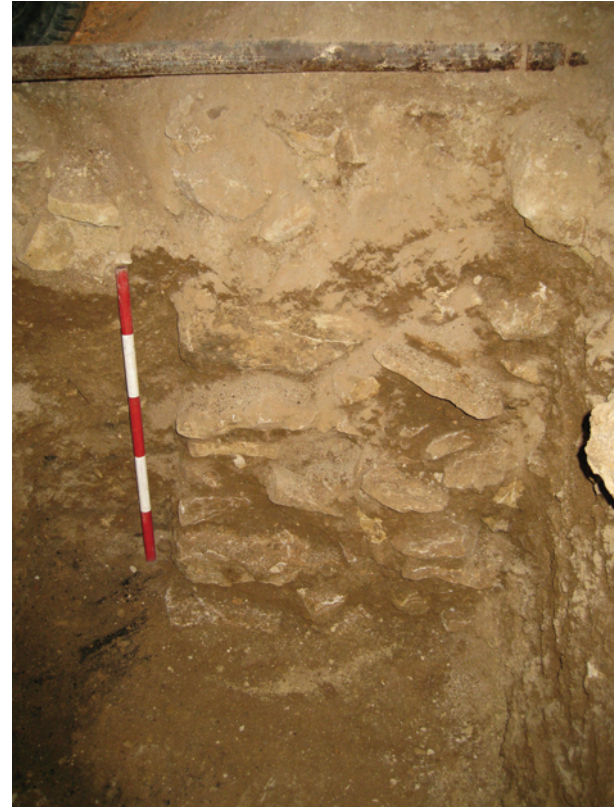
Plate 15: Test Pit 2, Area under tower

- 3.5.2 In the northern test trench (**Test Pit 2**), which was approximately 1.5m x 1m and 70cm deep, the first 10cm layer constituted a powdery mortar and mixed limestone rubble (**A**) making up a post Victorian levelling. Below this, 19th century activity was exposed in a moderately friable, orange brown sandy silt with 3-6% small stones (**E**). A lead pipe runs north west to south east and underneath it, a red brick wall runs in line with it (Plate 15). The wall is one brick in thickness (11cm) and two and a half courses were exposed. Another line of bricks was exposed on the immediate north east side of this wall but only the top of the bricks were visible at 70cm. In the south east corner of the trench, both the pipe and the wall turn in a straight southerly direction.

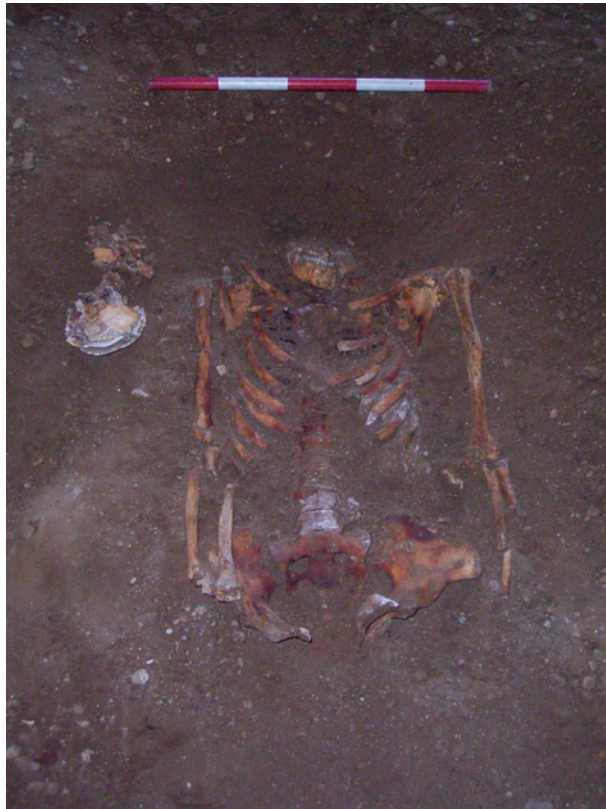
- 3.6.8 One articulated skeleton was found in the service trench to the south side of the church (**Burial 16**). The skeleton was revealed as far as the pelvis but it was decided to leave this in situ and divert the service trench accordingly. The skeleton appeared complete (as far as the pelvis), apart from the skull which may have been disturbed during the installation of drains and may have been one of the three skulls found in the trench to the west, although this was not proven.

Plate 16: Burial 16, showing truncated remains of adult female skeleton

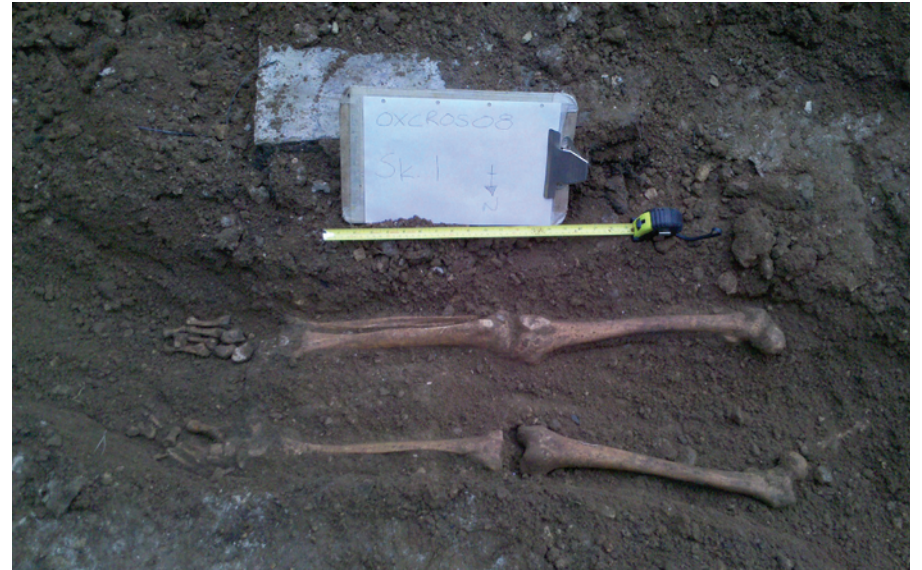
Plate 17: Burial 17, Showing extra-mural truncated human remains

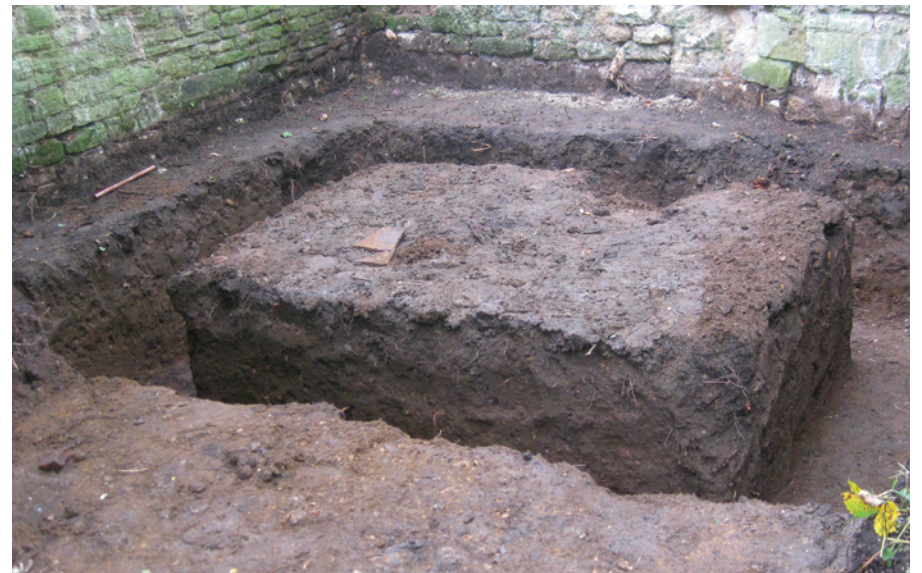
Plate 18: Excavation for Argonite store in Holywell Manor garden

- 3.6.9 *Argonite Store* A rectangular trench was dug in the garden of Holywell Manor garden, which is immediately north of St. Cross Church (Plate 18). The trench was dug at the south side of the garden adjacent to the boundary wall of St. Cross church for the purposes of foundations for an Argonite store. The trench is 900mm deep and approximately 400mm wide and traces the footprint of the Argonite store, which is 3.3m north to south and 2.1m east to west.

- 3.6.10 The trench was dug with a spade and under the grass is a dark brown loamy topsoil, which was relatively easy to remove. At a depth of about 75cm, a harder grittier layer of brownish yellow natural soil was exposed and remained consistent to the depth of 900mm.
