# St Cross Church Holywell Oxford

## Historic Buildings Assessment

February 2009

Client: Balliol College, Oxford

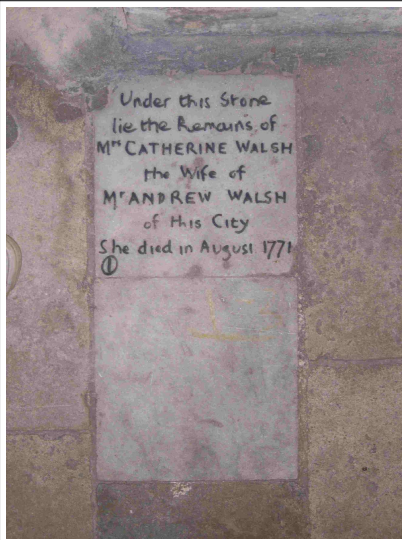
No:	1

Object	Inscription on a floor slab	
Location	the slabs are south of the southeast tower pillar, in line with the southern most corner of the pillar. The slab has a 0.05m gap between the pillar and the top edge of the slab.	
Description	'UNDER THIS STONE LIE THE REMAINS OF MRS CATHERINE WALSH THE WIFE OF MR ANDREW WALSH OF THIS CITY SHE DIED IN AUGUST 1771'	
Material	The slab looks in good condition, it is a uniform pail white fine grained stone, it could be marble?	
Size	0.3×0.3m slab. Only applicable to the top slab.	
Potential impact	This floor memorial will either be covered or removed to allow for the the controlled environment unit in the South Aisle.

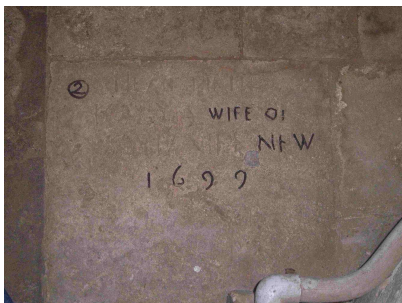
No:	2

Object	Stone slab inscription	
Location	The slab is molded round the southwest pillar of the tower, round the north corner of the of the pillar. The slab butts inv.no A1 slab which runs the length of the west tower wall to the door and is in line with the south door frame of the west door and the edge of inv.no A1.	
Material	The slab is similar to the surrounding slabs, gray /brown color.	
Dimensions	0.57×0.56m, the bottom right corner of the slab had the corner reworked to the molding of the pillar.	
Potential impact	Should not be impacted by development	
Description	The slab is very worn making the inscription very difficult to read, the only words that are legible are 'WIFE' and the date '1699' it is possible that the name of the wife begins with a 'K'. The inscription is facing the wall meaning that the slab has been moved at some point in time, it is likely that the original position of the slab was an area where a high volume of traffic passed for the extent of the ware to have occurred.

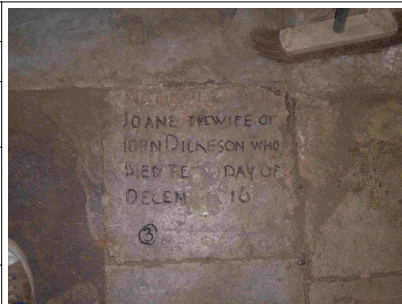
No:	3

Object	inscription floor slab.	
Location	The slab is near the west door set in the west tower, the slab is 0.1m south of the door arch and 0.5m east of the same point.	
Description	'JOANE THE WIFE OF JOHN DICKESON WHO DIED FE..... DAY OF DECEN..... 16....' there is a line of eligible writing along the top of the slab, it is most likely to be 'HERE LIETHY THE BODY' or something similar.	
Material	The stone slab is similar to the surrounding slabs and it is most likely that the stone is local or was chosen to be in keeping with the church.	
Dimensions	0.36×0.4m, square slab.	
Impact	Should not be impacted by development

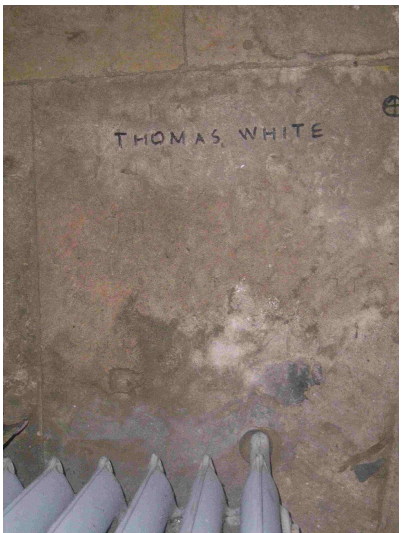
No:	4	
Object	Inscription on a floor slab	
Location	The slabs is north of the west door, with the bottom edge of the slab butting with the west wall of the tower. The inscription faces west

making it possible to read the inscription when entering the through the west door.

Description	The only part of the inscription that can be made out is a name, 'THOMAS WHITE', it is unknown whether the slab is dedicated to this individual or if this is the husband or who dedicated it, as with some of the others that have been mentioned.	
Material	stone slab, the same material is the same as the surrounding slabs.	
Dimensions	0.91x0.65m	
Impact	Should not be impacted by development

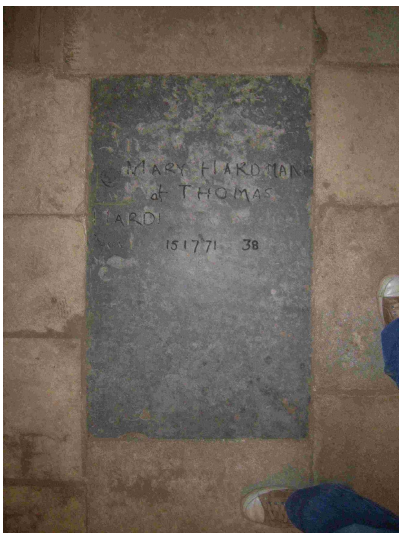
No:	5

Object	Inscription floor slab	
Location	The slab is 3.04m away from the center of the west door way, the location is central to the door so that anyone who enters from the west passes over the inscription. The slab is 2.29m from the south tower arch to the corresponding edge and 1.8m to the north tower arch from the alternative edge. Although the slab, in plan, is not truly central to the west door the surrounding smaller slabs give the impression that it is central.	
Description	'MARY HARDMAN OF THOMAS HARDI..... \\ \ 1517 71 38'	
Material	stone slab, faded black stone	
Dimensions	1x0.69m, rectangular.	
Potential impact	Should not be impacted by development

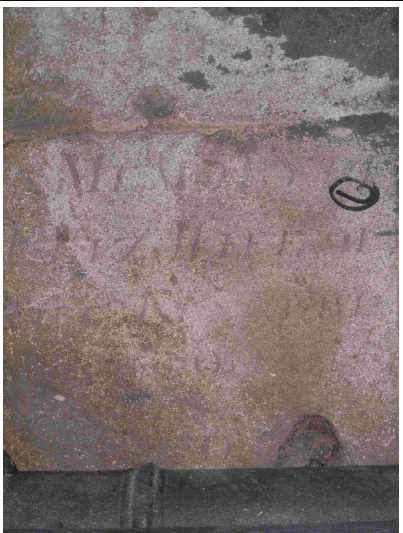
No:	6

Object	Floor slab inscribed	
Location	in the south aisle central to the southeast window and butting the south elevation.	
Description	Floor slab with memorial inscription. The inscription faces south into the wall, the slab is very worn on the lower half nearest the wall. 'In memory of ELIZ         ( ).....' Sound condition but worn	
Material	Stone, same as most which make up the floor of the church.	
Dimensions	0.38x0.38m	
Potential impact	Should not be impacted by development

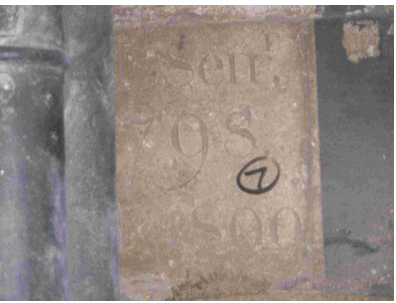
No:	7

Object	Floor slab inscribed	
Location	along the south elevation, below the southeast window, in the south aisle. The slab butts the south elevation on its right side this makes the identification of the letters difficult because of the radiator pipes which run the length of the elevation.	
Description	the slab faces east and it has a small simple boarder. The top of the boarder is missing identifying that it has been moved and relaid. 'H + T SEN 1798 RT 1800' good condition, the inscription is clear and wear seem to be minimal.	
Material	Stone, has more of a yellow colour which makes it appear lighter than most of the other slabs which have been inscribed.	
Dimensions	0.26x0.28m	
Impact	Should not be impacted by development

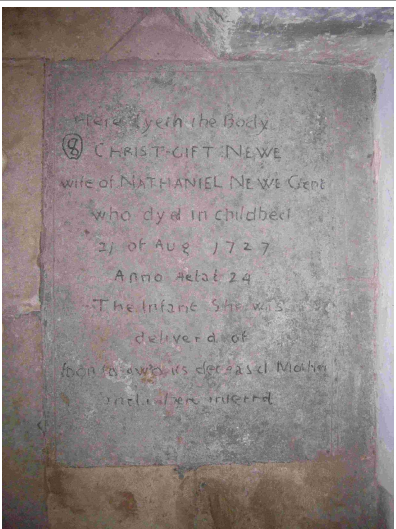
No:	8

Object	floor slab inscription	
Location	The slab butts perpendicular to the east Nave wall north of the arch into the chancel. The slab finishes about 0.3m before the arch, this coincides with the finish of the plaster on the wall. The top of the slab also butts the conjoined pillar which supports an arch into the north aisle.	
Description	<p style="text-align: center;">'HERE LYEITH THE BODY CHRIST GIFT NEWE WILE OR NATHANIEL NEWE GENT WHO DIED IN SHILD BED ANNO A E T A T 24 THE INFANT SHE WAS DELIVERED OF LOON W ' O ITS DECEASED MOTHER'</p> <p>The final line is faded and is difficult to make out a coherent group of words. The slab has a boarder inscribed round three of the sides, the bottom side has the boarder missing and could indicate that the bottom has been reworked. The slab is aligned facing south and is butted up against a wall on its right side. Good condition, some erosion to the bottom of the slab and the reworking damage</p>

Material	Dark faded black stone, not in keeping with the surrounding slabs.	
Dimensions	1.2x1m, the boarder has a 0.05m margin.	
Impact	Should not be impacted by development

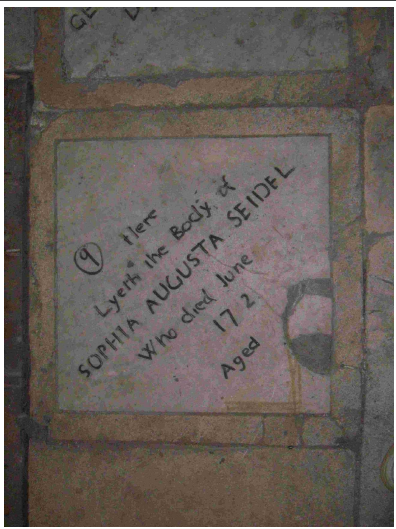
No:	9

Object	Floor slab with inscription.	
Location	bellow the center of the northeast arch leading from the Nave to the north aisle. The slab is 1.65m from the east wall of the nave, measured from the bottom corner.	
Description	<p>the floor slab is made up of a central plaque, which contains the inscription, and a boarder which encompasses the plaque. The two elements are made up of two different materials, the plaque of white marble and the boarder of a brown stone. Along the bottom right edge if a chip which as been filled with the broken segment and cement as well as the the boarder having multiple cracks to the bottom corner. The inscription is offset so that the slab is laid at an angle to get the inscription level. The slab is aligned so that the inscription faces the chancel arch, this does not mean to say that the slab does not fit the order of the surrounding slabs, it just means that they chose to lay the slab in a specific place.</p> <p style="text-align: center;">' Here lyeth the body of SOPHIA AUGUSTA SEIDEL who died June 17 2 Aged (hidden by chip)'</p>

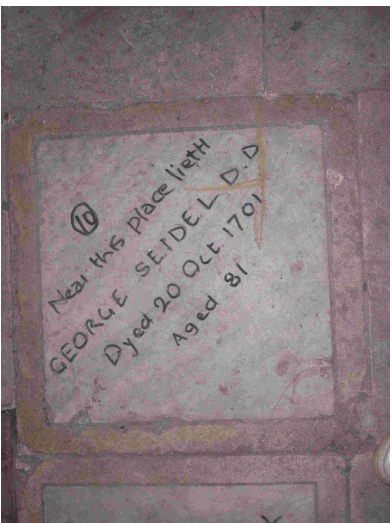
No:	10

Object	Memorial floor slab inscription	
Location	bellow the center of the northeast arch leading from the Nave to the north aisle. To the north of inv.no9 and butts inv.no 9 with the bottom edge.	
Description	<p>Description: inscribed floor slab with a simple boarder of different stone. The inscription is diagonal across the face of the slab and the slab is aligned so that the inscription faces the chancel arch. The location of the slab, so that the inscription faces the chancel arch, does not seem to be a consequence as it is pared with inv.no 9, which is the neighboring slab. The identical material and design of the boarder suggests that these were a pair. Out of the pair this slab is slightly larger than inv.no 9 by 0.004m, it could be that the boarder has been reworked when it was laid.</p> <p style="text-align: center;">'Naer this place lieth GEORGE SEIDE D.D dyed 20 Oct 1701 aged 81'</p> <p>Condition: Good some damage to the bottom edge.</p>

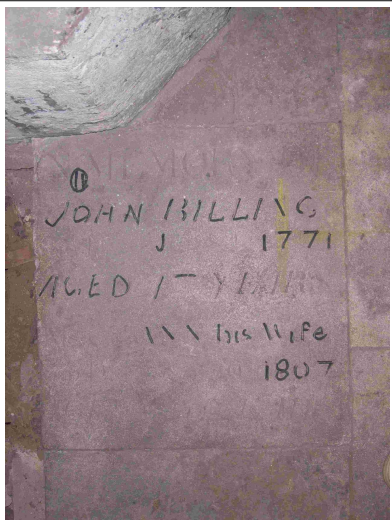
No:	11

Object	Inscription on a floor slab	
Location	Butted against the northeast pillar supporting the arch to the north aisle. The slab is on the east side of said pillar with a third of the west edge of the slab in contact with the pillar and the other two thirds extending north.	
Description	<p style="text-align: center;">'IN MEMORY OF JOHN BILLING ..... 1771 AGED..... YEARS ..... HIS WIFE .....1807'</p>	
Material	Stone slab, it is the same colour as the surrounding slabs.	
Dimensions	0.56x0.55m, square slab.	
Impact	This floor memorial will be covered or removed to allow for the bookstack/archive racks adjacent to the North Aisle

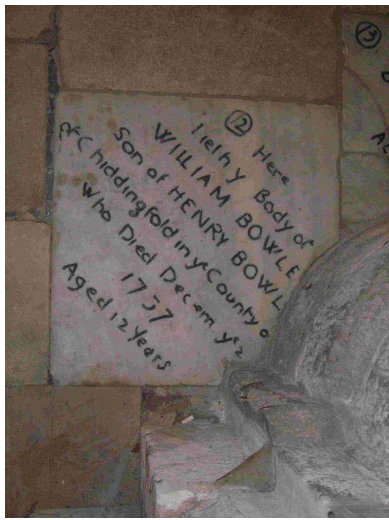
No:	12

Object	Inscription on a floor slab	
Location	the slab is located on the west edge of the northeast tower pillar. The slab is butted up against the west side of the tower pillar, to fit the molded pillar the northeast corner of the slab has been reworked. The slab is orientated with the letters facing the south making it possible to easily read the inscription.	
Description	'HERE LIETHY BODY OF WILLIAM BOWL SON OF HENRY BOWL OF CHIDINGFOLD IN Y <sup>e</sup> COUNTY O..... 1737 AGED 12 YEARS' The letters which remain are easy to read and are not worn, it is possible that the slab has never been positioned where a constant flow of traffic would wear it away.	
Material	the slab is an opal color, it is possible that the material is marble.	
Dimensions	04.8x0.47m, square slab, it looks to have been moved because some of the inscription is missing and edges reworked.	
Potential impact	Should not be impacted by development

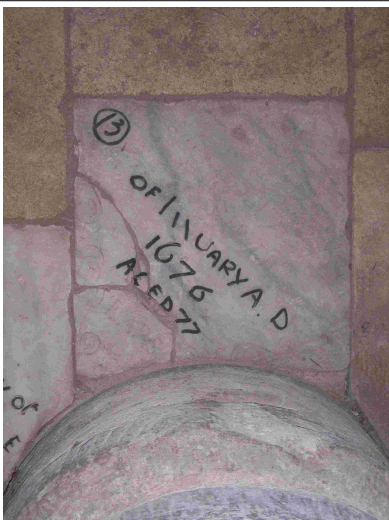
No:	13

Object	Inscription on a floor slab	
Location	the slab butts the northeast tower pillar on the west side, while also butting the north edge of inv.no 12, the slab is positioned central to the pillar. The lettering is orientated so that it is possible to read the inscription from the south of the slab.	
Description	Description: 'OF   \ \ UARY A.D 1676 AGE 77 YEARS' The inscription has a scroll border, it looks to encompass the whole of the inscription.	
Material	Opal color slab with fine grains, possibly marble.	
Dimensions	0.36x0.36m, originally the slab would have been square. Some of the slab is missing it looks to have been moved and refitted. The east edge of the slab is molded round the pillar that it butts	
Impact	Should not be impacted by development

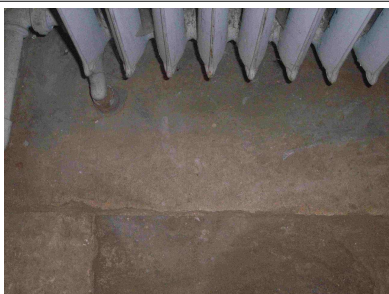
No:	14

Object	inscribed floor slab	
Location	Long the west elevation to the south of the tower door running parallel with the wall it butts against. The slab is practicably the length of the wall it butts.	
Description	'HEARE YETH THE BODY OF MARY SOVC..... ...OHN SO..... DECE..... OF.....' The inscription has been 75% eroded, most of the erosion has occurred in the lower half of the slab and surprisingly the top two lines are very clear and easy to read. There is also damage due to the placement of a radiator which not only has damaged some of the inscription but also obscures half of the slab. The alignment of the slab is to the north and is butted along a wall, not the most desirable position for a memorial inscription, so it is most likely that this slab was repositioned some time before the instillation of the radiators. The erosion to the slab backs up this idea as in its current location the amount of traffic would not sustain the level of erosion to the lower half of the slab. Condition: fairly faded, a more extensive analysis can be made once the

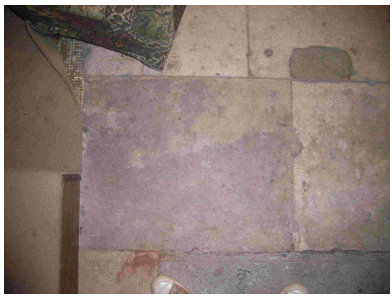
No:	15

Object	Inscription on floor slab	
Location	The slab is located near the east wall of the Nave, to the north of the chancel arch, it butts inv.no 8 to the east but the south edge of the slab is in line with the chancel arch. The slab is therefore offset by 0.3m in relation to inv.no 8.	
Description	The floor slab is completely eroded only hits that there was ever and inscription remain. It cannot be said the direction which it is facing but if the surrounding inscriptions are anything to go by than it will face the chancel arch. Condition: Very faded	
Material	the stone slab is darker than the surrounding slabs but it is the same colour.	
Dimensions	0.73×0.61m. the corner nearest the chancel arch is 1m from the east wall of the Nave.	
Potential impact	Should not be impacted by development

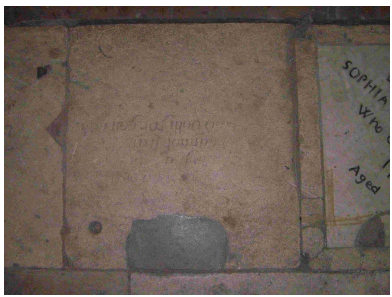
No:	16

Object	floor slab inscription	
Location	the slab is located in the north east of the Nave a quarter of a meter south of the east arch into the north aisle, c.2m from the east wall of the nave to the south east corner of the slab.	
Description	The slab is heavily eroded and none of the inscription can be made out. However the lettering used in this slab is unlike the majority of the slabs with in the church, the letters are more curved and flow. The slab faces west and is damaged on the east side, this has been repaired with some cement, it could have been a large chip or brake. The damage could have originated from a earlier function of the slab which was recycled and used as a floor slab. In the southeast corner of the slab is a drilled hole it would seem that the hole was created after the laying of the slab in its current location. The logic behind the ideas is that the hole must have had a function for it not to have been filled in. The arrangement of the slab many indicate that it was heavily eroded before it was laid in its current position as its alignment is not representative of the surrounding inscriptions, which face east towards the chancel. Condition: poor, highly damaged, but functional.

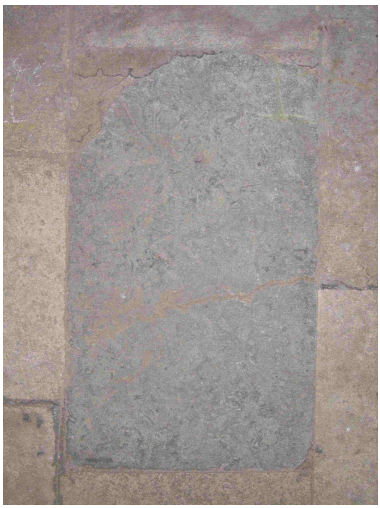
No:	28

Object	Stone floor slab with inscription	
Location	the slab is located within the South Aisle, between the font and the southeast pillar for the tower. It is nearly central between the two.	
Description	the slab has damage to the top left corner, filled with cement. The inscription faces south towards the font. The inscription cannot be made out, a rubbing may prove best for recording what is left. The slab has been arranged with the inscription facing south.	
Material	stone, the slab is black and is unlike the stone used within the church.	
Dimensions	0.76×0.46m	
Potential impact	This floor memorial will be covered or removed to allow for the foundations of the controlled environment unit in the South Aisle.

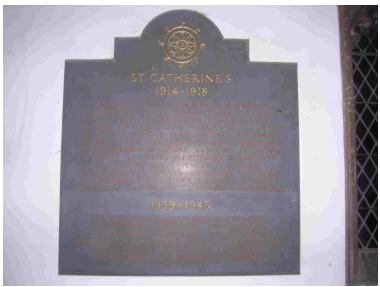
No:	29

Object	memorial panel	
Location	the panel is located on the south aisle south elevation at the west end, before the final window on the same elevation, facing the font.	
Description	the panel lists the men which died in the grate war and the world war. The panel is square with a semi-circular raise in the top. Within the top edge is a symbol, a ships wheel with left facing spokes instead of handles, this must be representative of the military. The panel has St Catherine's below the list of names. The panel has a decorative boarder which sets up to the face of the panel, Hollow chamfer stepped moulding (Morris 1992).  Condition: very good	
Material	Green polished marble with gold inlay into the inscription.	
Dimensions	1.14×1.03×0.03m , the hight of the panel from the floor to the center is 2.47m	
Potential impact	All wall panels will remain in-situ but only visible from a 87.5 cm wide corridor adjacent to wall so some may be hard to read from ground..

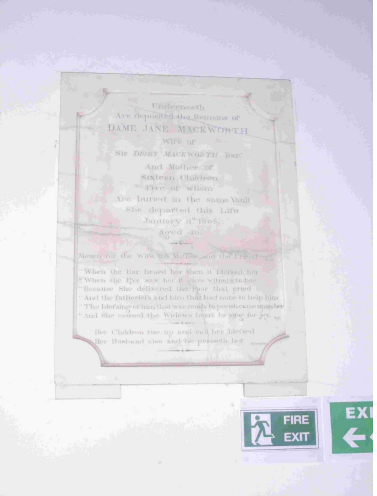
No:	33

Object	Memorial panel,	
Location	along the west wall of the north aisle between the west door and window on the corresponding wall.	
Description	<p>panel which is in memory of Dame Jane Mackworth as with inv.no A19 the panel sits on two legs. These are the same material as the panel, unlike inv.no A19. With these legs it is more difficult to determine whether they are apart of the panel or set into the wall for support. The panel is flush with the pegs, also unlike inv.no A19 which over hangs, the legs also have a recess on the inner side.</p> <p style="text-align: center;">'Underneath Are deposited the remains of DAME JANE MACKWORTH wife of SIR DIGBY MACKWORTH BAR<sup>T</sup>. And mother of sixteen children five of whom are buried in the same vault she departed this life January 11<sup>th</sup> 1808 aged 40 ----- Mourn for the wife, the mother and the friend D.M  "when the ear heard her then it blessed her "when the eye saw her it gave witness to her "because she delivered the poor that cried "and the fatherless and him that had none to help him "the blessing on him that was ready to perish come upon her "and she caused the widow's heart to sing for joy. Joh. ----- "her children rise up and call her blessed "her husband also and he praiseth her <i>proverbs.</i>' -----</p> <p>Condition: good, needs a clean.</p>

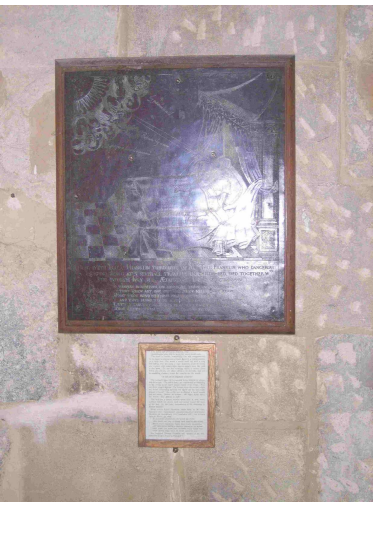
No:	36

Object	Brass engraving	
Location	central to the south east tower pillar, on the south west side. Below the engraving is a small frame with the information about the engraving on it.	
Description	the engraving depicts a woman in bed with children, three are dead, one is alive. It is mounted on a wooden frame. Condition: there is some corrosion to the face of the brass plaque.	
Material	Brass and wooden frame.	
Dimensions	0.47×0.41×0.025m (wooden frame), 0.425×0.37×0.005 (brass engraving) the height from the floor to the top right corner is 1.95m	
Potential impact	All wall panels will remain in-situ but only visible from a 87.5 cm wide corridor adjacent to wall so some may be hard to read from ground.

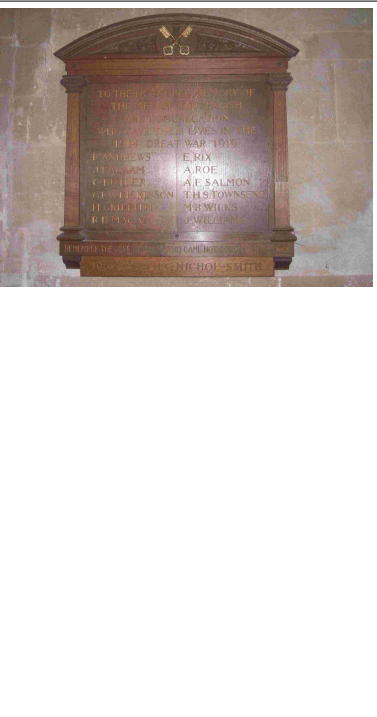
No:	37

Object	wooden panel	
Location	on the North east tower pillar, on the south side, central to the pillar wall.	
Description	Memorial for the dead in both World Wars  <p style="text-align: center;">'To the Honored memory of the men of this parish and congregation who gave their lives in the 1914 Grate War 1919 R.Andrews    E.Rix J.Balaam    A.Roe C.Butler    A.F.Salmon G.R.W.Dickinson    T.H.S.Townsend H.Griffith    M.B. Wilks R.B. Magan    J.Williams Remaenber the love of them who came not home from the war 1939-1945 H.C.Nichol – Smith</p> Condition: fair	
Material	wood, oak? Inlay with gold into the carving	
Dimensions	0.93×0.81×0.05m	
Potential impact	All wall panels will remain in-situ but only visible from a 87.5 cm wide corridor adjacent to wall so some may be hard to read from ground.

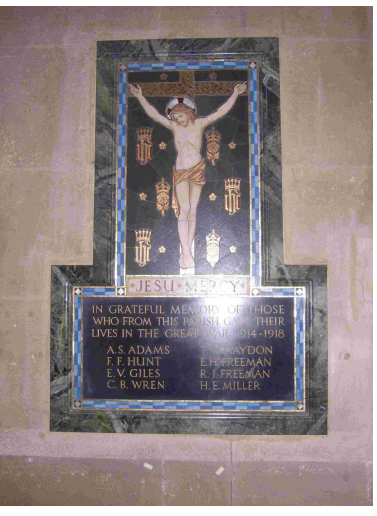
No:	38

Object	Memorial panel	
Location	on the south east tower pillar, on the north side, central to the wall it sits on. Both inv.no 24 and 25 have to be walk passed if entering through the west door and walking down the Nave to the chancel.	
Description	Description: Memorial panel listing men that died in the two world wars.  <p style="text-align: center;">'Jesu Mercy In Grateful memory of those who from this parish gave their lives in the Grate War 1914-1918 A.S Adams    T.W Haydon F.F Hunt    E.H Freeman E.V Giles    R.J Freeman C.B. Warn    H.E Millar'</p> The panel contain the image of Christ on the cross with the names below Condition: good.

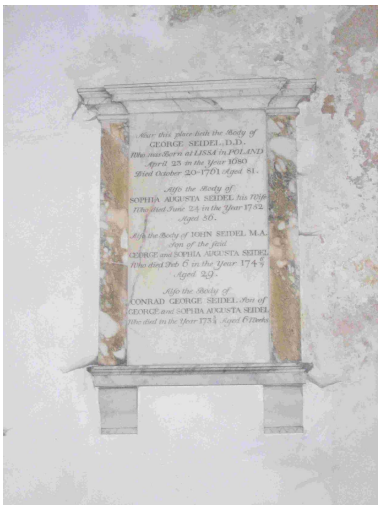
No:	43

Object	Memorial plaque; aedicule	
Location	in the north wester corner of the north aisle, on the north elevation. Central between the window and the corner of the elevation. The height was similar to inv.no 21, allowing for dimensions differences.	
Description	<p>list of a families deaths. The architrave has two hollow chamfers with a set separating the two (Morris 1992). The aedicule has columns, square, capital and base.</p> <p>' Near this place lieth the body of GORGE SEIDEL .D.D. Who was born at Lissa in Poland April 23 in the year 1680 died October 20 1761 aged 81</p> <p>Also the body of SOPHIS AUGUSTS SEIDEL his wife aged 56 also the body of JOHN SIEDEL M.A. Son of the said GEOGE and SOPHIA AUGUSTA SEIDEL who died Feb 6<sup>th</sup> in the year 174 <sup>6</sup>/<sub>7</sub> aged 29 Also the body of CONRAD GEORGE SEIDEL son of GEOGE and SOPHIA AUGUSTA SEIDEL who died in the year 173 <sup>3</sup>/<sub>4</sub> aged 6 weeks'</p> <p>Condition: good.</p>

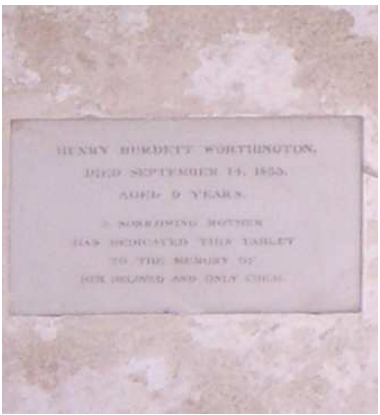
No:	45

Object	Memorial plaque	
Location	bellow inv.no 30, c.1.5m from the window in the northwest of the north elevation.	
Description	'HENRY DURDETT WORTHINTON died September 14 1835 aged 9 years a sorrowing mother has dedicated this tablet to the memory of her beloved and only son'  Simple rectangular tablet. Condition: Good	
Material	white marble	
Dimensions	c.0.3×0.5×0.04m	
Potential impact	All wall panels will remain in-situ but only visible from a 87.5 cm wide corridor adjacent to wall so some may be hard to read from ground.

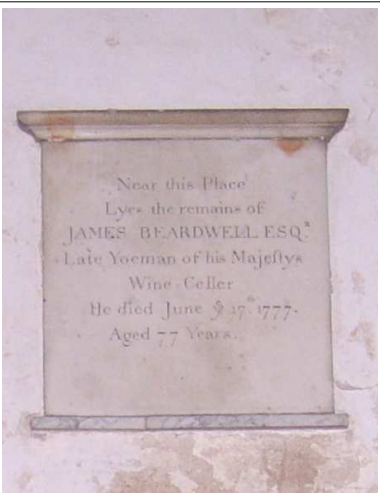
No:	46

Object	Memorial panel	
Location	on the North Aisles north elevation, central between the first window and second window, from the west of the elevation.	
Description	very nearly a square plaque with a top architrave, quadrant then hollow chamfer moulding (Morris 1992), and a base.  'Near this place lyes the remains of JAMES BEARDWELL ESQ <sup>R</sup> late yeoman of his majesty's wine celer he died June y <sup>e</sup> 17 <sup>th</sup> 1777 aged 77 years'  Condition: good, some water marks, unable to investigate further because of the lack of a floor.	
Material		
Dimensions	c1×1×0.07m	
Potential impact	All wall panels will remain in-situ but only visible from a 87.5 cm wide corridor adjacent to wall so some may be hard to read from ground.

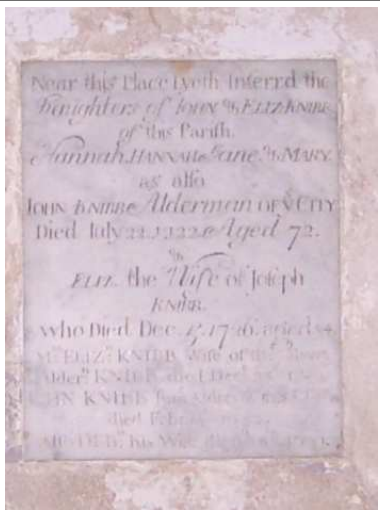
No:	46

Object	Memorial Plaque	
Location	central between the first window and second window, form the west, on the north elevation in the north aisle.	
Description	Description: family history. A simple rectangular marble plaque.  'Near this place lyeth interred the daughters of IOHN & ELIZ KNIBB of this Parish HANNAH. HANNAH JANE & MARRY & also JOHN KNIBB Alderman of y <sup>e</sup> city died July 22 1722 Aged 72 & EIIZ. The wife of JOSEPH KNIBB who died Dec 5 1726 ages 34 Mrs ELIZ <sup>H</sup> KNIBB wife of the above ALDER <sup>N</sup> KNIBB died Dec <sup>r</sup> 23 <sup>rd</sup> 1740 JOHN KNIBB JUN <sup>R</sup> ALDER <sup>N</sup> of this c... died Feb 14 <sup>th</sup> 1754 Also DEB <sup>H</sup> his wife died 18 <sup>th</sup> 1755'

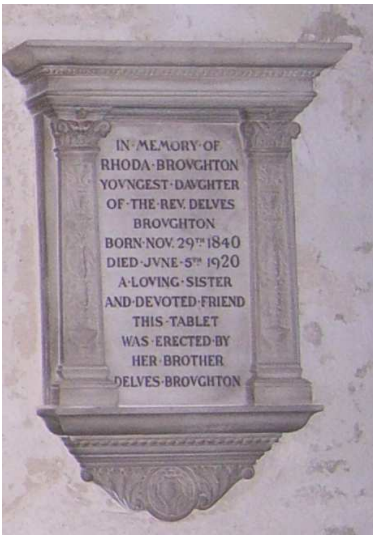
No:	50

Object	Memorial plaque; Aedicule	
Location	along the north elevation of the north aisle, between the first and second window, working away from the northwest of the elevation. The plaque is hung to the east of the wall, nearest the second window, c.0.5m from the second window.	
Description	<p>Identical to inv.no A36 in design (Cocke et.el 1996). This plaque has many spelling mistakes replacing U with V.</p> <p style="text-align: center;">           'In memory of            RHODA BROVGHTON            youngest daughter            of the REV DELVES            BROVGHTON            born Nov 29<sup>th</sup> 1840            Died JVNE 5<sup>th</sup> 1920            a loving sister            and devoted friend            this tablet            was erected by her brother            DELVES BROVGHTON'         </p> <p>Condition: Good.</p>	
Material	white marble plaque and pale stone frame	
Dimensions

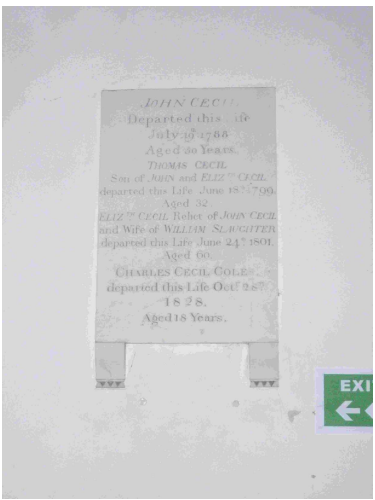
No:	51

Object	Memorial plaque	
Location	located on the north elevation of the north aisle, between the second and third window from the northwest end of the elevation. The plaque is off center, nearer the west and the second window, c.0.5m from the left edge and the second window. The hight of the plaque was unattainable but it was hung central to the window next to it.	
Description	<p>Simple rectangular marble plaque with two decorative legs for support of the same material. The feet are flush with the edges of the plaque. The feet taper down from the plaque downward facing triangles for decoration.</p> <p style="text-align: center;">           'JOHN CECIL            departed this life            July 19<sup>th</sup> 1788            Aged 50 years            TOMAS CECIL            son of JOHN and ELIZ<sup>th</sup> CECIL            Aged 32            ELIZ<sup>th</sup> CECIL relict of JOHN CECIL            and wife if WILLAIM SLAUGHTER            departed this life June 24<sup>th</sup> 1801            Aged 60            Charles CECIL COLES            departed this life Oct<sup>r</sup> 28<sup>th</sup>            1828            Aged 18 years'         </p> <p>Condition: Good</p>

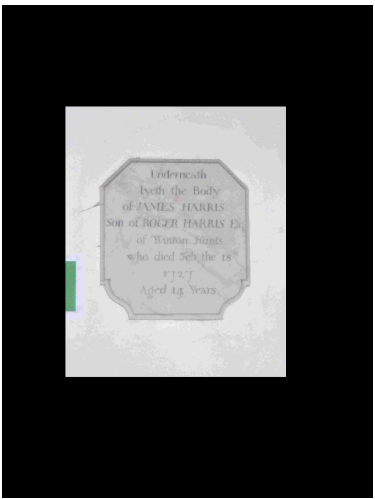
No:	52

Object	Memorial plaque	
Location	located on the north elevation of the north aisle, between the second and third window measured from the northwest. The plaque is nearer the third window about 0.3 to the west. The plaque is hung just above the central point of the window.	
Description	<p>the plaque is just off square, with the corners trimmed to make an irregular octagonal. The edges of the plaque have been beveled to produce the effect of two levels. The top two corners have simply been trimmed at 45°, while on the other hand the bottom two corners have a protruding curve.</p> <p style="text-align: center;">'Underneath lyeth the body of JAMES HARRIS son of ROGER HARRIS ESQ of Winton Hants who died Feb the 18<sup>th</sup> 1727 Aged 14 years'</p> <p>Condition: Good</p>	
Material	white marble, with gray clouding.	
Dimensions	estimated c.0.5x0.5x0.05m	
Potential impact	All wall panels will remain in-situ but only visible from a 87.5 cm wide corridor adjacent to wall so some may be hard to read from ground.

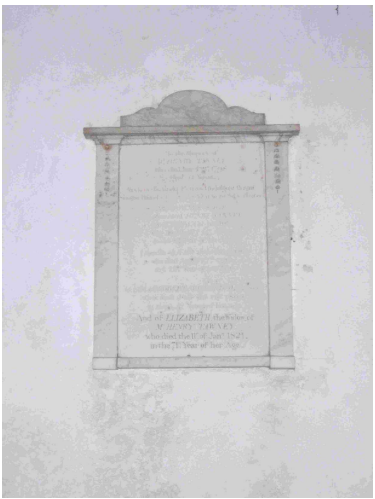
No:	53

Object	Memorial plaque; aedicule	
Location	along the north elevation of the north aisle, between the third and fourth window from the northwest end of the aisle. The plaque is hung on the west of the wall that it is hung on, c0.5m east of the third window.	
Description	<p>The inscription was very dirty and some of it could not be read. The plaque is rectangular with columns flanking the sides, along the top of the plaque is an architrave and crown supported by the rectangular columns and capital. On the top of the ledge is a pediment with no decoration.</p> <p style="text-align: center;">'And of ELIZABETH the widow of M. HENRY TAWNEY MIL. who died the 11 of Jan 1821 MIL. in the 71 year of her Age'</p> <p>Condition: Good, but dirty which has made the inscription faded</p>	
Material		
Dimensions		
Potential impact	All wall panels will remain in-situ but only visible from a 87.5 cm wide corridor adjacent to wall so some may be hard to read from ground.

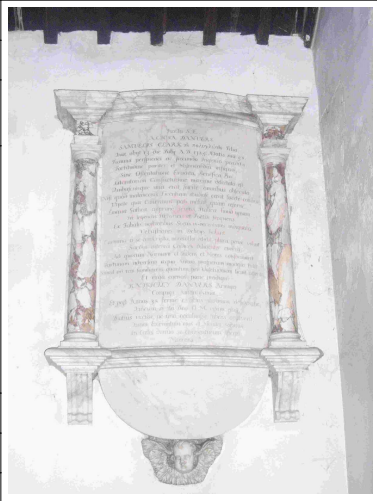
No:	55

Object	Memorial and Short Biography; aedicule	
Location	located on the north elevation of the north aisle, at the northeast end of the elevation. The plaque is c.0.5 m smaller than the width of the wall.	
Description	Memorial of Alicia Danvers Samuels Clark who died on July 13 1725. The inscription is in French, the plaque takes up most of the wall it occupys and it is made of marble which suggests that this woman is was very wealthy. The plaque is framed by columns volute supporting the architrave. The face of the plaque is concaved projecting to the hight of the columns. The columns are of white and brown marble wile the rest of the plaque is white marble. At the bottom of the plaque is a apron with a face surrounded by leafs (Cocke et.el 1996). Condition: good	
Material	white and brown marble.	
Dimensions		
Potential impact	All wall panels will remain in-situ but only visible from a 87.5 cm wide corridor adjacent to wall so some may be hard to read from ground.

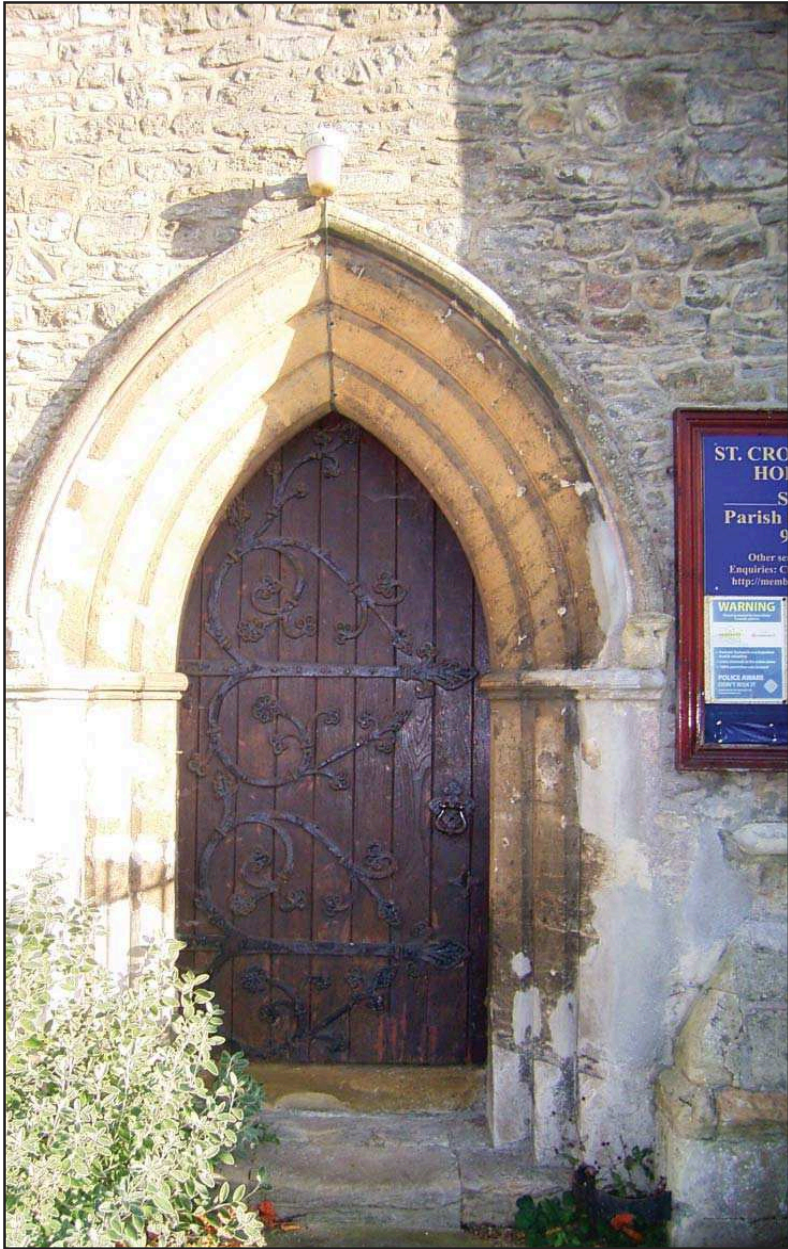
Plate 1: Primary 13th-century doorway in west wall

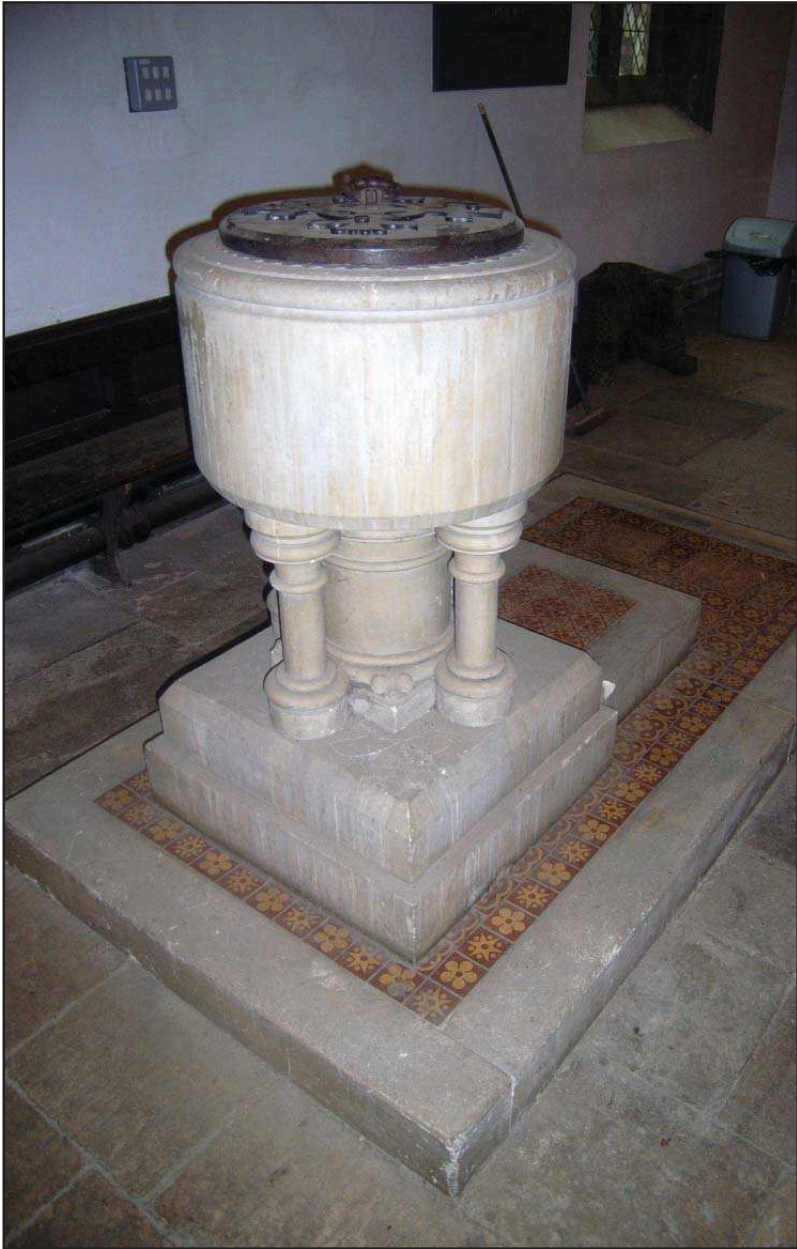
Plate 15: Font in South Aisle

*The other principal direct impact of the development is the removal of several visible features. These include a late Victorian organ, a Victorian font from the south aisle (which will be repositioned to the north of the chancel arch), and fittings from the vestry (again Victorian). In addition there are six floor memorials which would be impacted by the proposed bookstacks. These would either have to be removed to allow for the foundations of the controlled environment units or covered over for standard shelving.*

- 3.2.8 Towards the western end of the south aisle is a stone font on plinth with Victorian tiled surface.
- 3.2.9 The **Vestry and organ chamber** is an L-shaped block which was added to the north of the chancel in 1876. The vestry has a simple common rafter roof braced by collars, a stained glass window to the north gable and a parquet-block covered floor. The vestry has robe hooks, tongue and groove panelling and other furniture but there are no visible monuments.
