# Footpath construction at St Peters and St Pauls Church, Steeple Morden, Cambridgeshire

## Archaeological Monitoring and Recording

OA East Report No: 1285

*Date of Works: 14/7/11 and 18 /7/11*

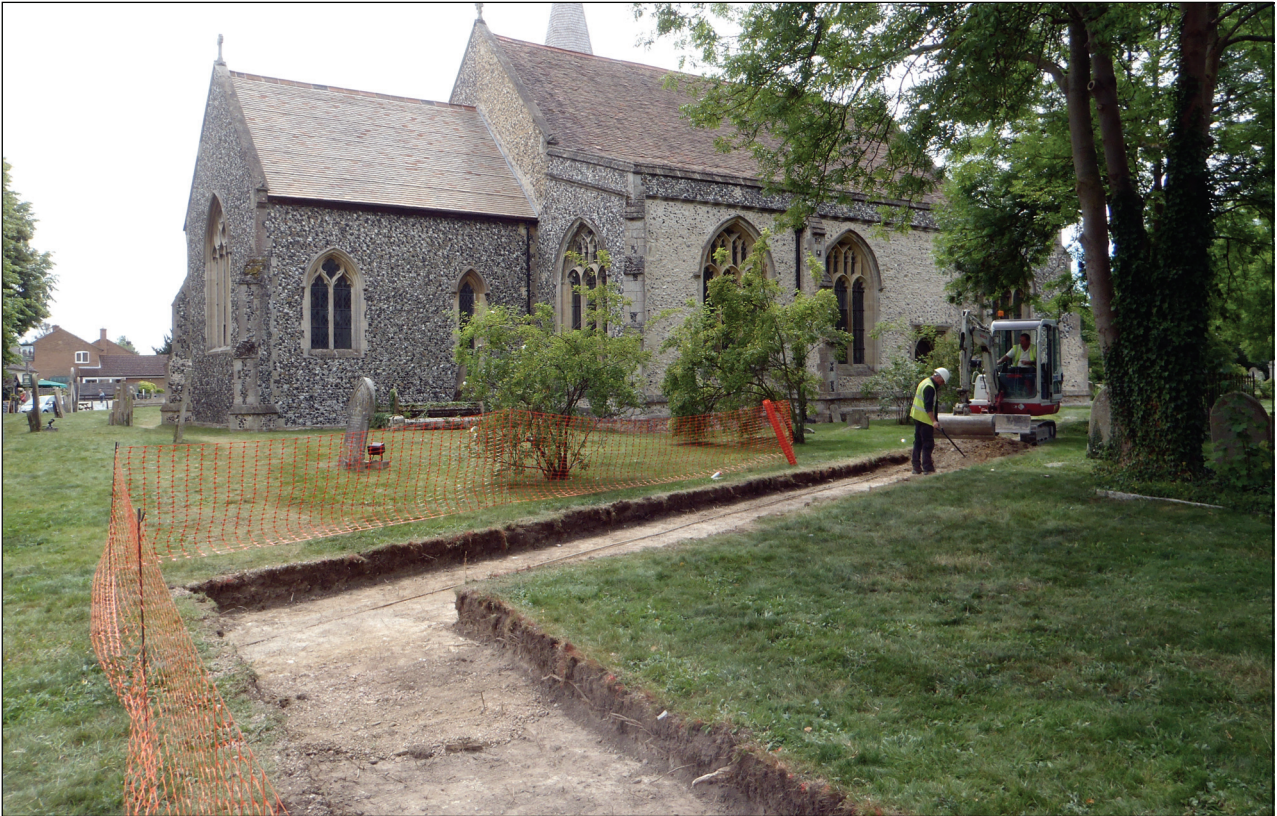
- 4.1.1 The area of the footpath was stripped to a depth of around 0.25m, depth was relatively constant following the minor changes in topography along the proposed footpaths route within the northern side of the churchyard. For the most part this merely constituted the removal of top soil only, the north-east arm of the path revealed a steel pipe at the aforementioned depth.

Plate 1: North east arm of footpath, taken from the north-east.

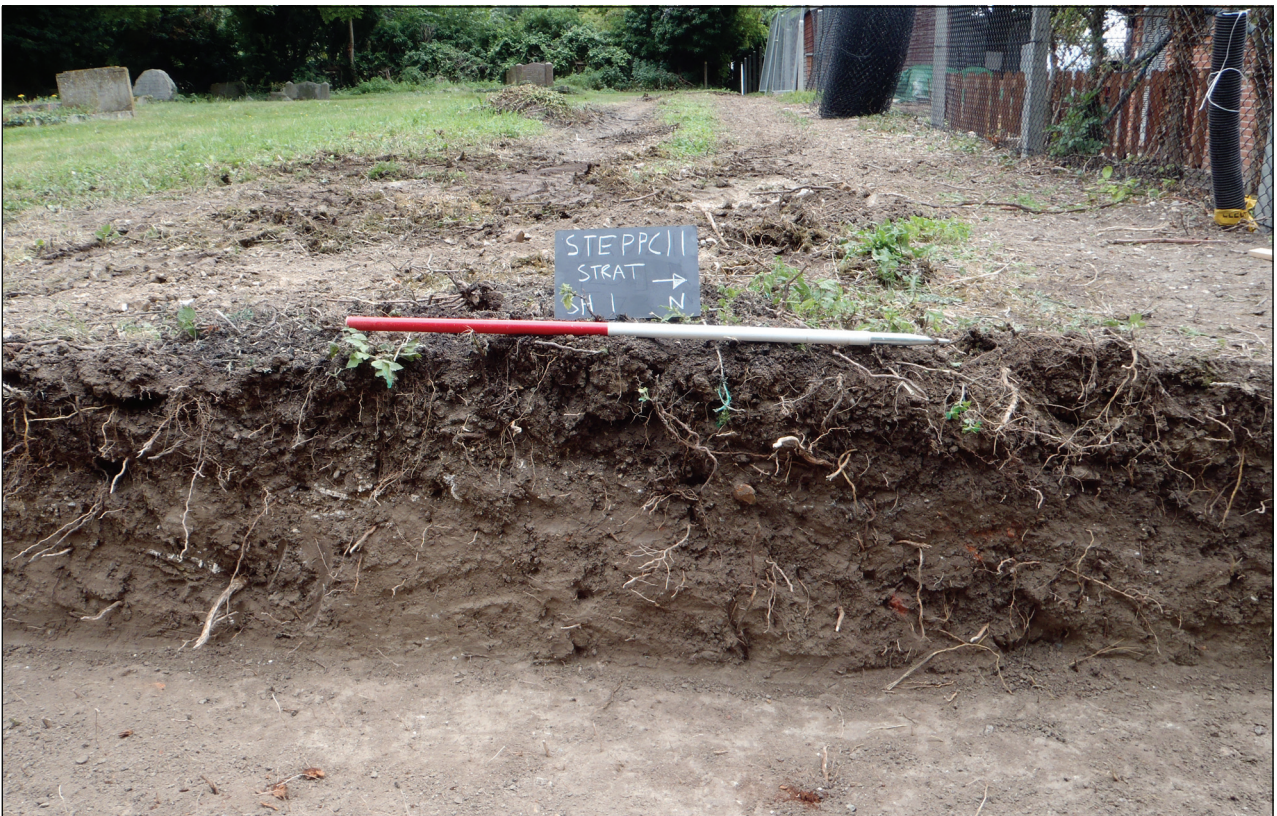
- 4.1.2 Areas of ground depression were observed along the northern boundary of the church yard, the lower ground meant the footpath was dug considerably deeper at the point where the north west arm of the footpath from the church connected to the school gate (figure 2, section 1, Plate 2). The gate and school grounds sit at a lower level to the church yard, so deeper excavation was required to match up the levels. Further ground reduction was required within this area to grade into the proposed final level of the footpath. The footpath footing was dug to a depth of 0.8m, this cut through what appeared to be relatively recent deposits, with pottery of late 19th century to 20th century date.

- 4.1.3 The earliest deposit (103) was not bottomed, the deposit was a dark grey brown, silty sand sub soil. The next layer observed in the sequence was a light greyish brown, sandy silt deposit (102), the deposit was seen at the southern end of the section and had a high frequency of chalk inclusions, the deposit measured 0.14m in depth and thinned to the north. Overlying this deposit was a typical top soil material (101) measuring 0.17m. The uppermost layer (100) was only seen at the northern end of the section, the deposit was a sandy silt, greyish brown with a high frequency of chalk inclusions the deposit measured 0.12m thinning to the south.

Plate 2: Stratigraphy through footpaths deepest impact, taken from the east.

- 5.1.1 The thicker deposits at the north west end of the footpath are likely to represent an incidental levelling of the churchyard, the depressions observed partially along the north boundary of the churchyard may indicate a former boundary ditch, or a result of its use as a footpath. In either case it appears that the area of lower ground level has been raised whether as part of purposeful levelling or levelling as a result of the frequent digging of graves in recent centuries, with excess spoil being dumped in lower areas at the churchyard boundaries.
- 5.1.2 As expected the ground has been disturbed and seen continued use, the only finds seen were of 19th century or modern date. The groundworks for the church path did not impact on any archaeological features or deposits.

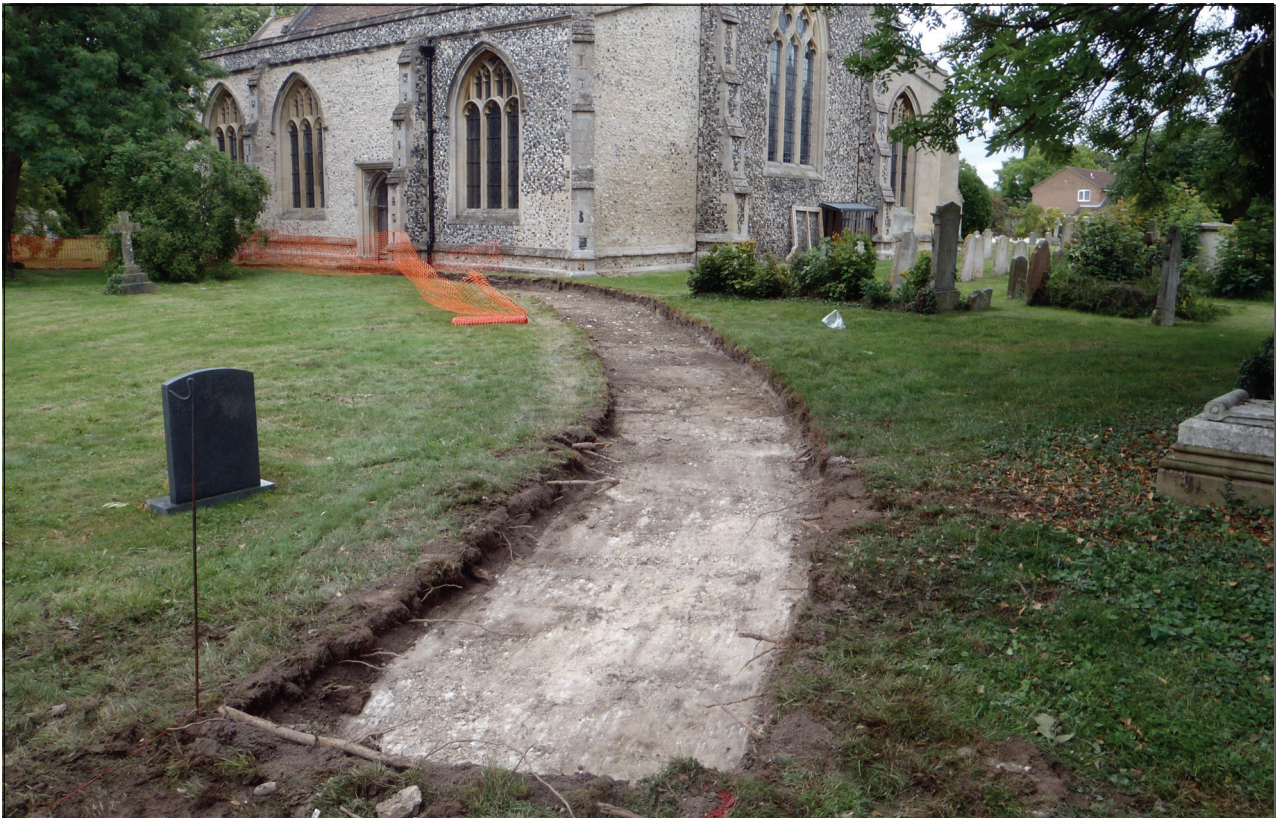
Plate 3: North west arm of footpath, taken from the north-west.

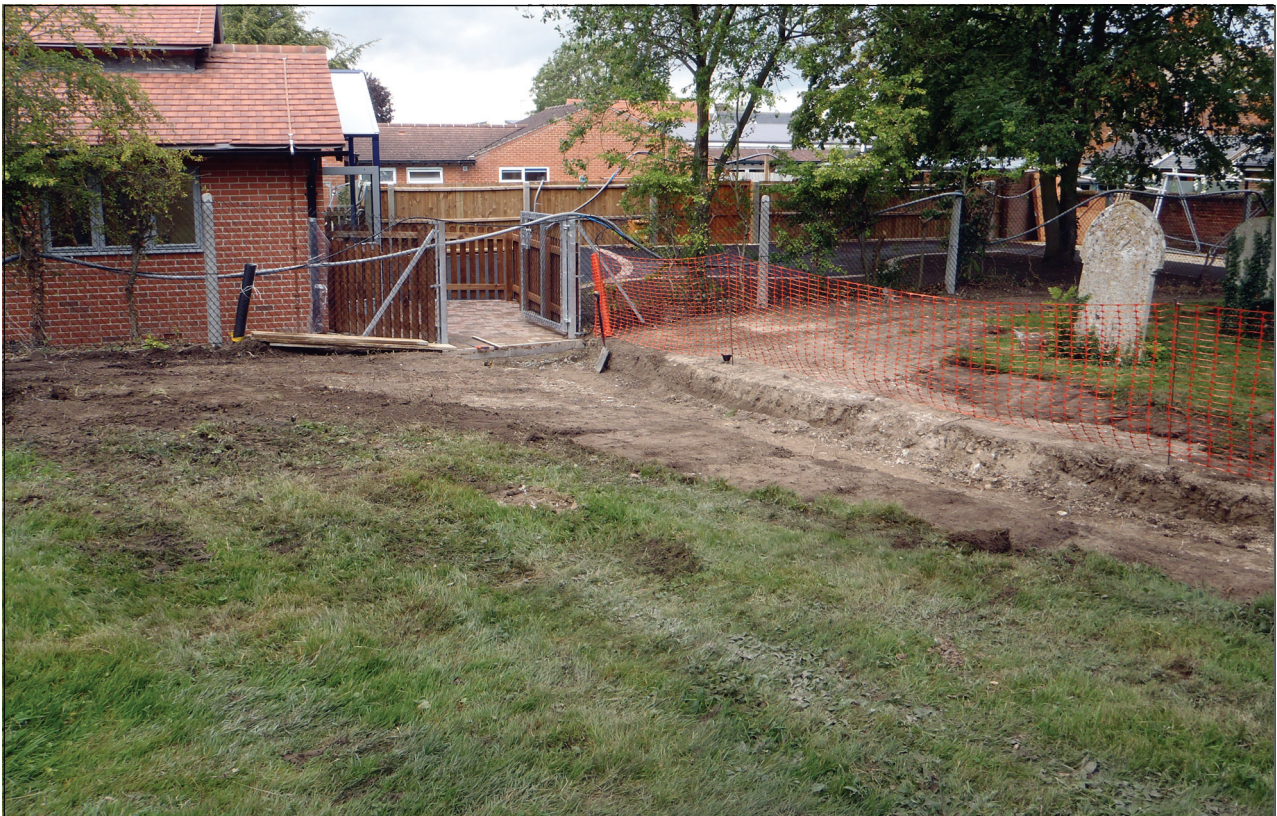
Plate 4: Area of ground reduction and grading of footpath, taken from the south-west.
