South Holland (Spalding Power Connection)

Archaeological Evaluation Report

OA East Report No: 1347
OASIS No: oxford3-120613
NGR: 550450 326350

Archaeological Evaluation at South Holland (Spalding Power Connection)

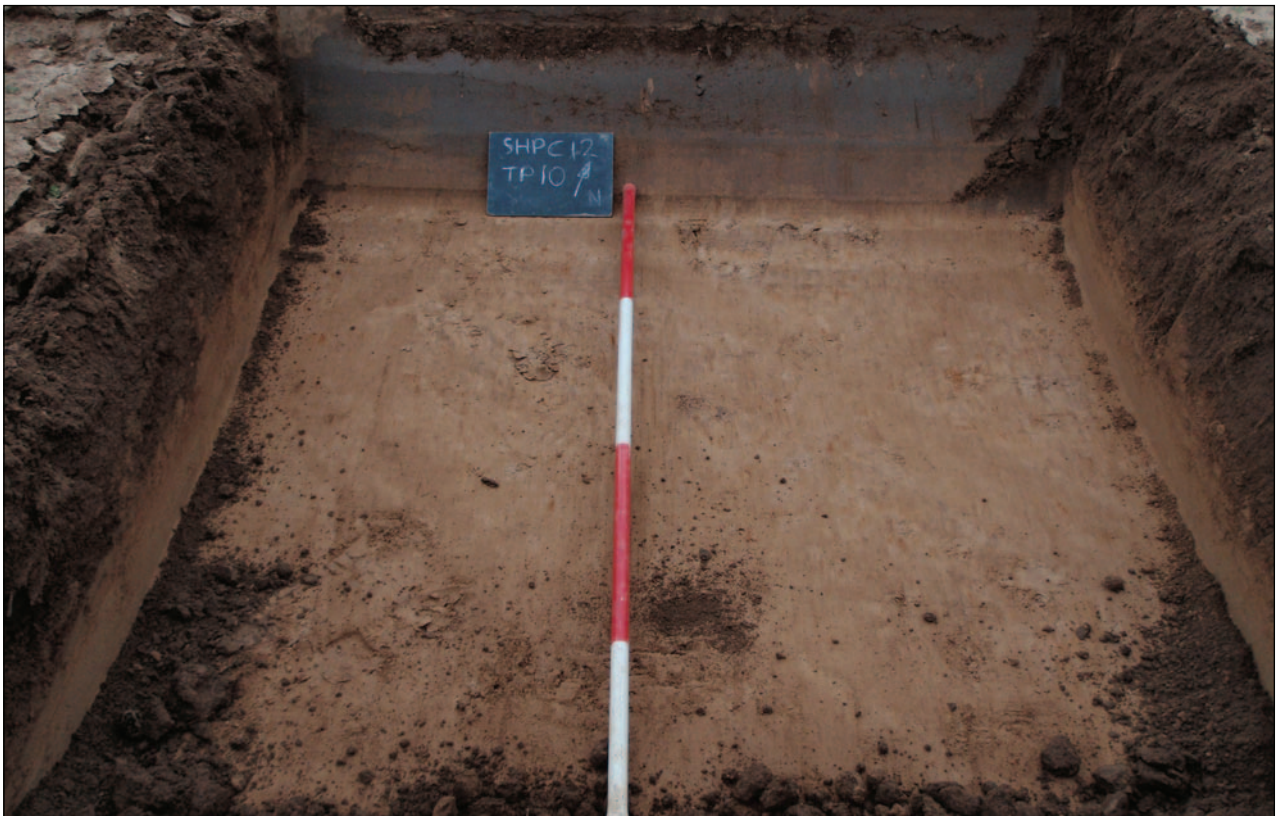
Plate 4: Test pit 10

3.5.1 Test pits **2,3,4,5,6,7,8,9** and **10**. were excavated on the line of the underground cable route starting at the southern and progressing in numbered order northwards . Each consisted of a water deposited silt (102) overlain by a light brown silty subsoil (101). This was capped by the silty sand plough soil (100). The depths of these layers were consistent throughout the test pits. With the subsoil layer having an average depth of 0.40m and the plough soil layer (100) having an average depth of 0.40m. No archaeological features or finds were recorded in any of the test pits.

Test pit 10						
General description					Orientation	NE-SW
Test pit 10 was devoid of archaeology					Avg. depth (m)	0.8
					Width (m)	1.8
					Length (m)	2
Contexts						
context no	type	Width (m)	Depth (m)	comment	finds	date
100	Layer	1.8	0.3	Topsoil	-	-
101	Layer	1.8	0.3	Subsoil	-	-
102	Layer				-	-
