Showsley Grounds

Easton Neston

Historic Building Recording

Historic Building Survey

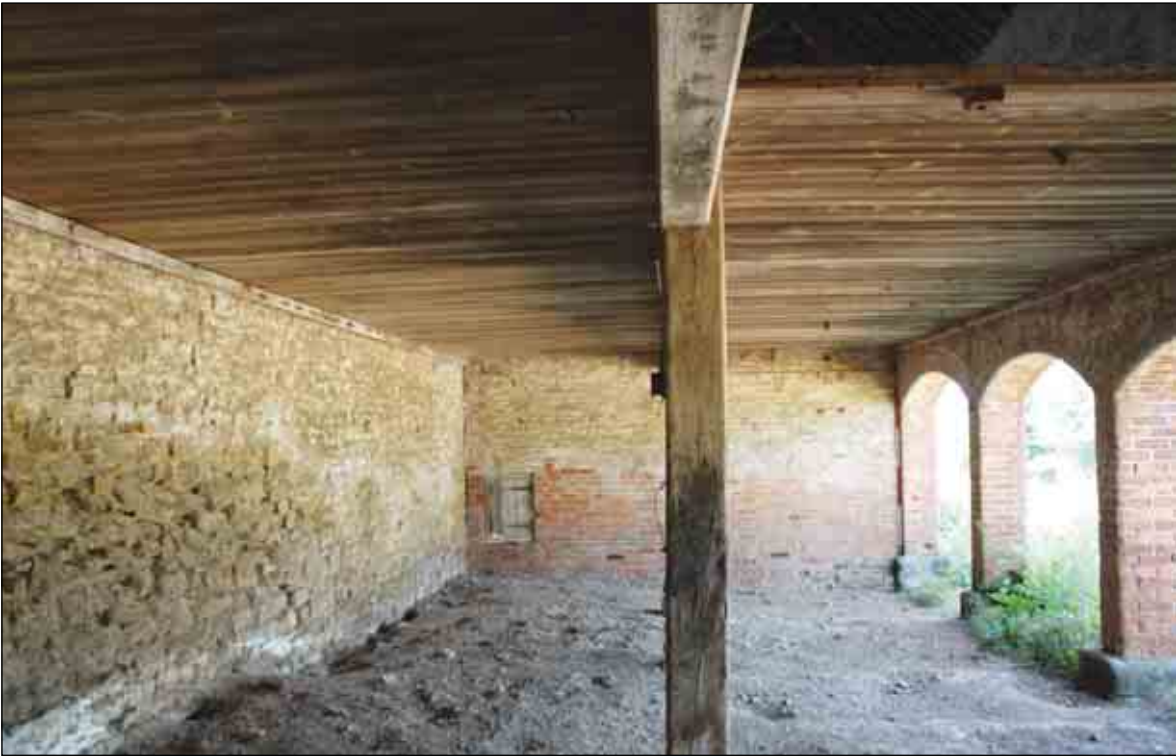
Plate 19: Interior view, Building B (ii)

- 4.2.23 At the southern end, the internal wall has been partially constructed using red brick (Plate 19). This wall is not tied into the rear wall which may suggest it is either repair or a later insertion. It is possible this partition wall was added to subdivide the original space allowing the access stairs leading to a new first floor to be created on the other side. Within this wall there is also a small doorway/hatch with a single door comprising three vertical tongue and groove panels secured with iron strap hinges (Plate 20).

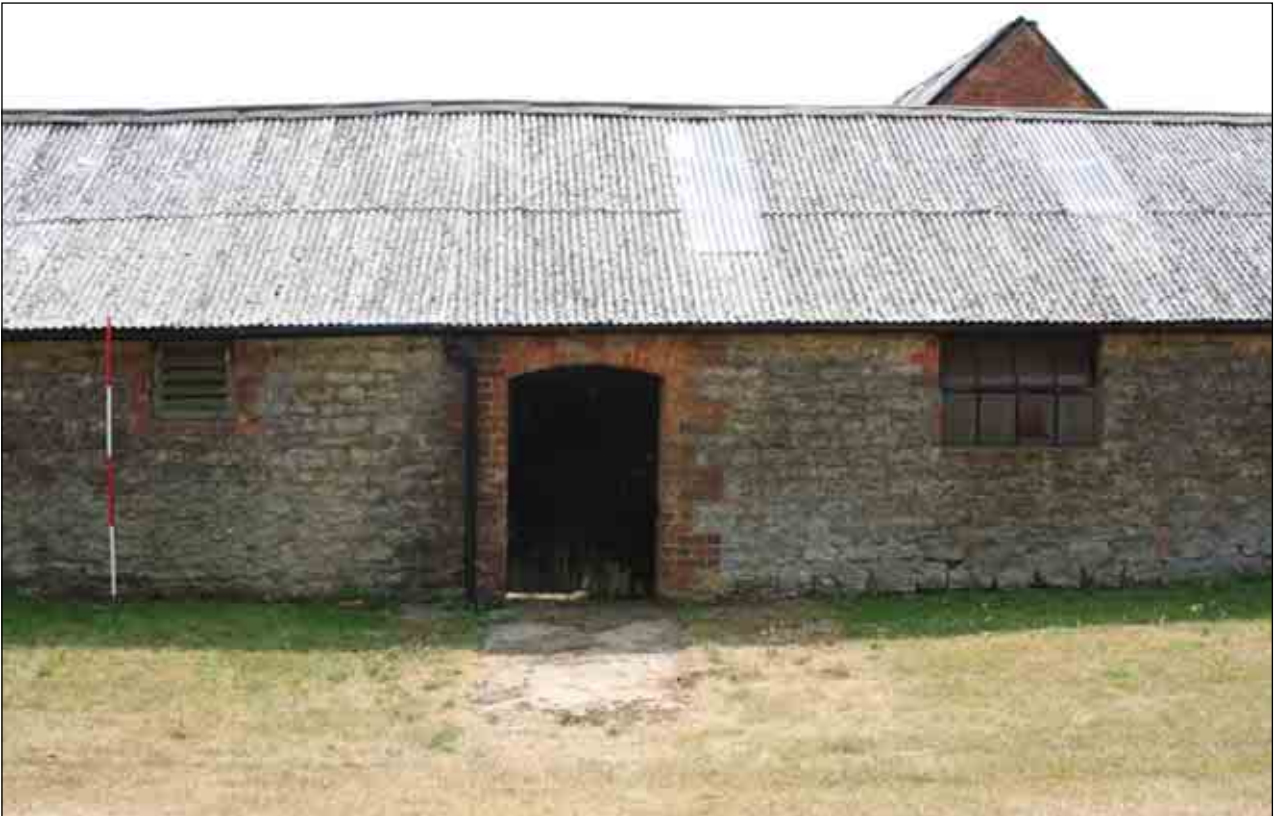
Plate 32: Doorway, window and ventilation opening on Building D, north-facing elevation

- 4.4.4 Centrally located along this elevation is a doorway (Plate 32). With a quoinstone effect brick surround and arched brick lintel. The bricks used on either side and within the archway have either been replaced, repaired or re-pointed as they appear slightly different in colour.

- 4.4.5 To the west/right of the door is an eight-pane, steel framed casement window which probably dates to the mid 20th century (Plate 32).
- 4.4.6 At the western end of this elevation are two smaller windows/openings which appear from the brick surrounds to be original (Plate 33). These openings have bull-nosed brick surrounds and cill and have brick surrounds on either side comprising headers and stretchers which match the quoinstone effects as noted on the other contemporary buildings. The shutters inside are recorded on the internal description. At the very end of this elevation, the wall continues beyond the brick quoinstone detail which is expected to be found at the end of the structure (Plate 33). Cartographic evidence indicates that this building was originally longer, but shortened when Building C was constructed.

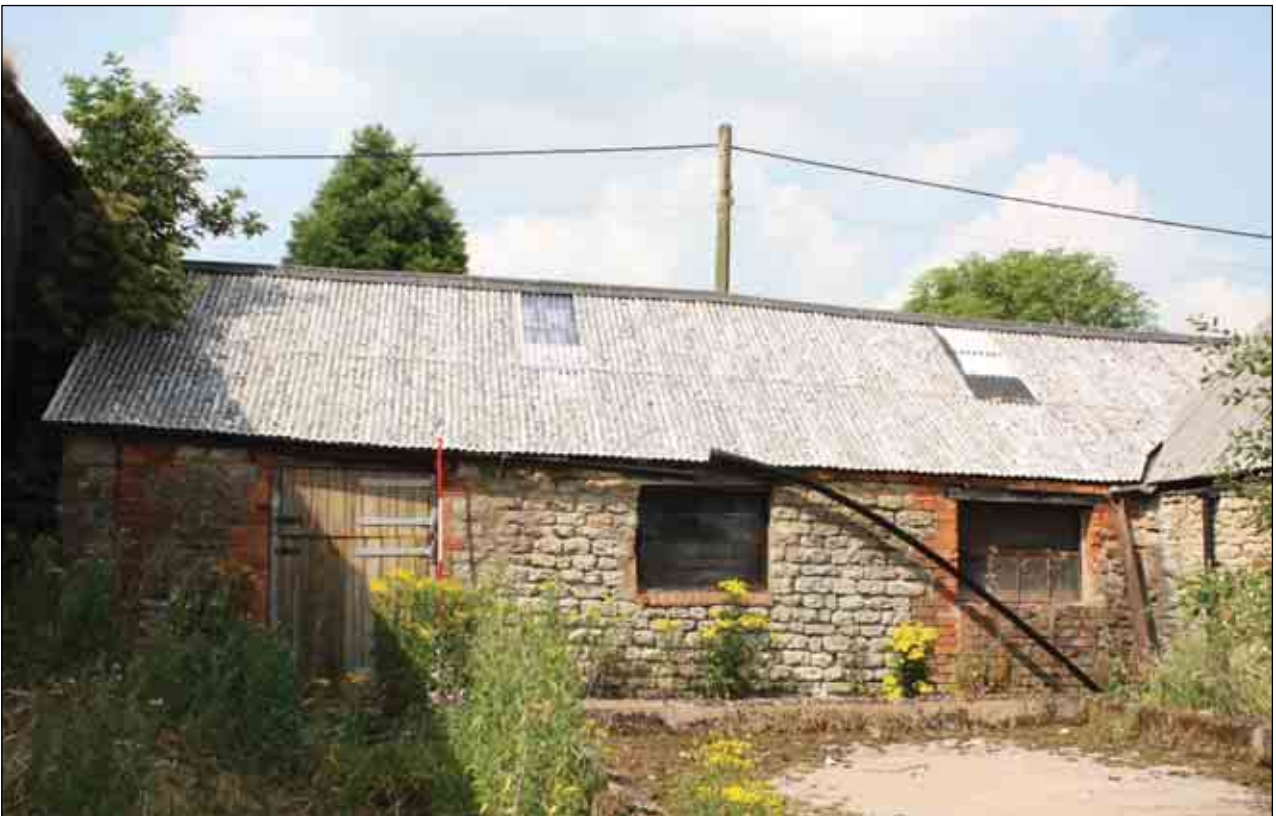
Plate 37: Building D, western end of south-facing elevation

- 4.4.13 The western end of this elevation has the same stone end beyond the brick quoin stones at the very corner of the building, as noted on the opposite elevation (Plate 37). It has a replacement two-part stable door with heavy modern strap hinges and a boarded up window opening. To the right of this is another wider eight pane window with modern metal frame, probably 20th century in date. This has been inserted into a former door opening which has been bricked up at the lower part with nine courses of red brick (Plate 38). The brick used appears to be earlier than the 20th century window and may have been re-used.

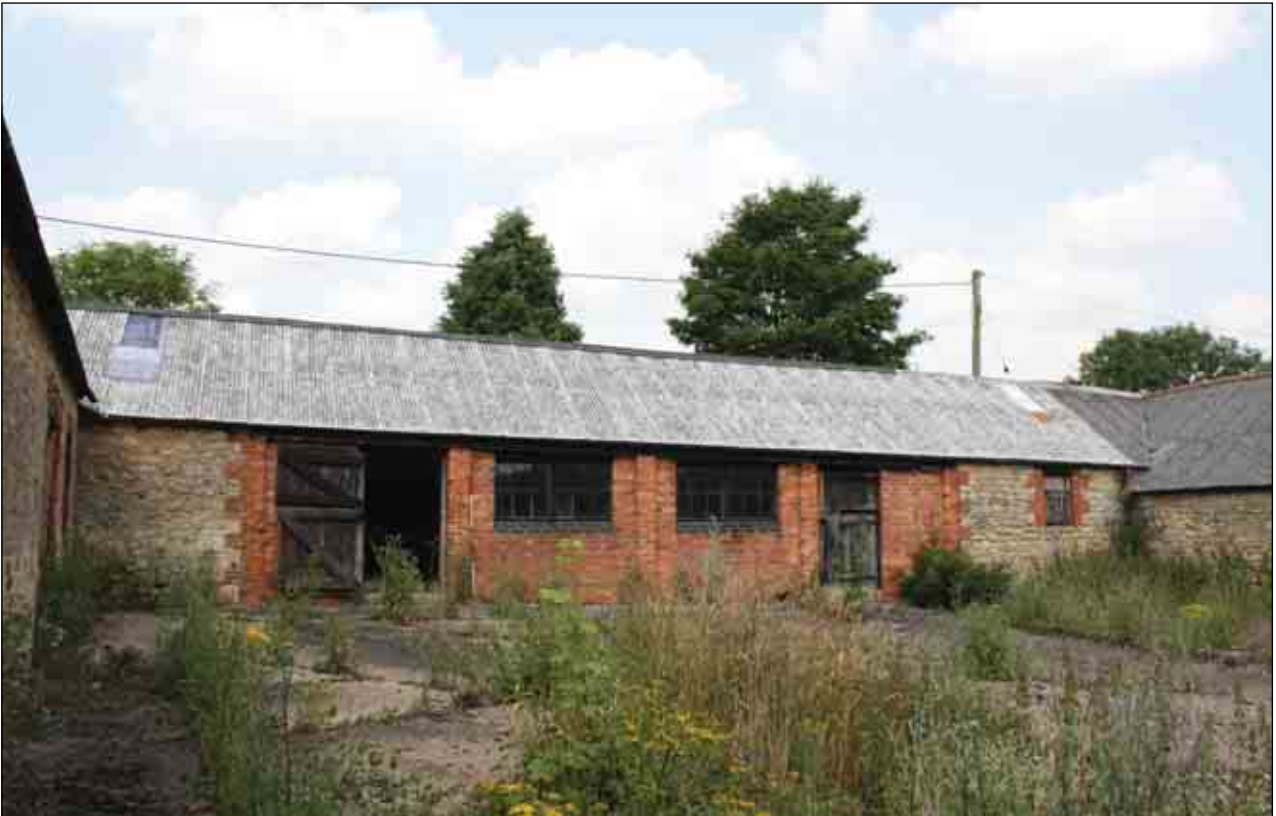
Plate 40: Building D, eastern end of south-facing elevation

- 4.4.15 The eastern element of this elevation on the east-west range comprises a red brick in-fill incorporating what appear to be mid 20th century windows and replacement two-part stable doors (Plate 40). The windows comprise 12-pane casement windows with metal frames and grey brick cills below (Plate 41). the brick used within this in-fill is a lighter,

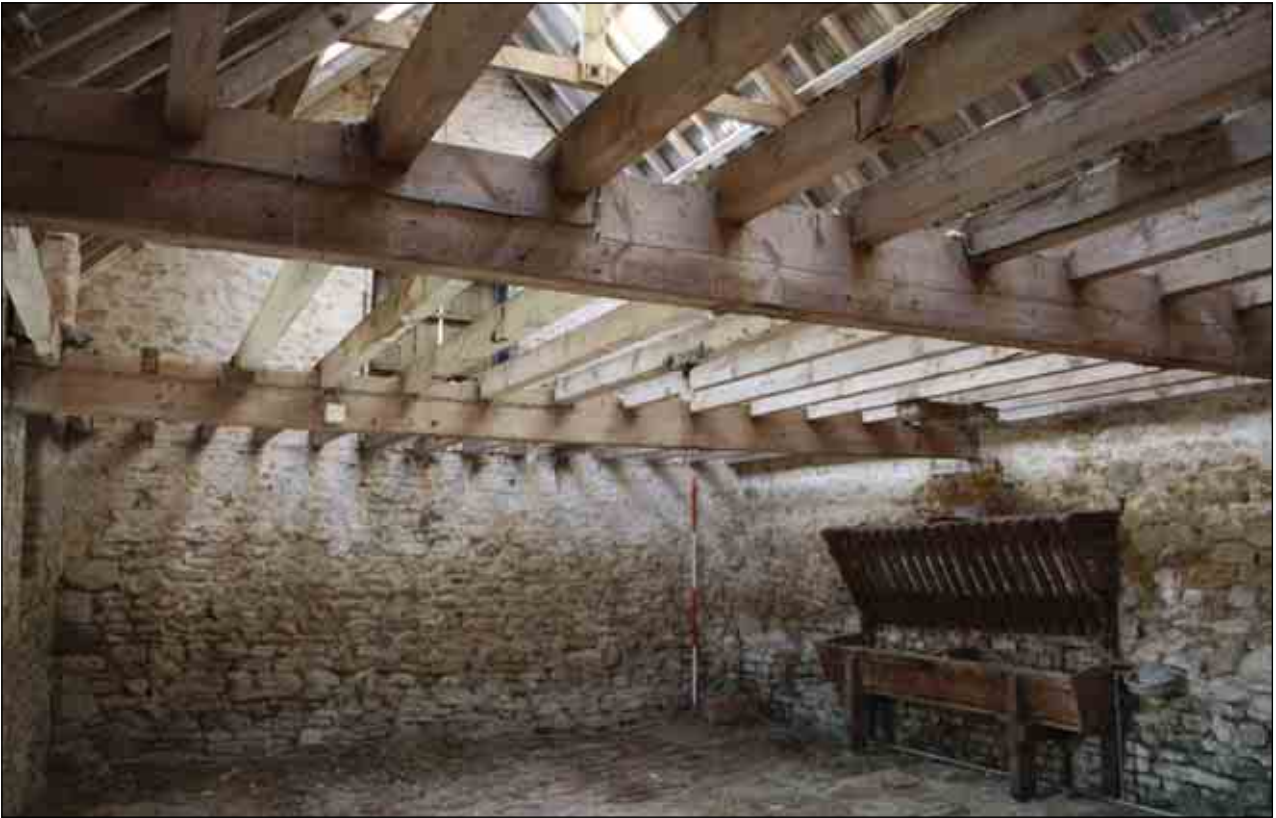
Plate 44: Interior view, Building D (i), southern end

- 4.4.18 The southern-most part of this range has exposed stone walls and exposed ceiling joists and plates which had presumably supported a ceiling and first floor storage area (Plate 44). Access for loading/unloading could be gained from the external first floor door noted on the south-facing elevation. The ground floor surface is created using brick with a slight incline towards a drainage channel which spans the length of the room (Plate 45). Within the floor are the remnants of a series of posts which may denote the location of former stalls. Set within concrete, these were either replacement posts or not contemporary with the original construction. The wall which subdivides the northern and southern areas of this part of the building (Plate 45) is constructed from red brick and is an obvious later addition, possibly constructed in the mid-late 20th century.

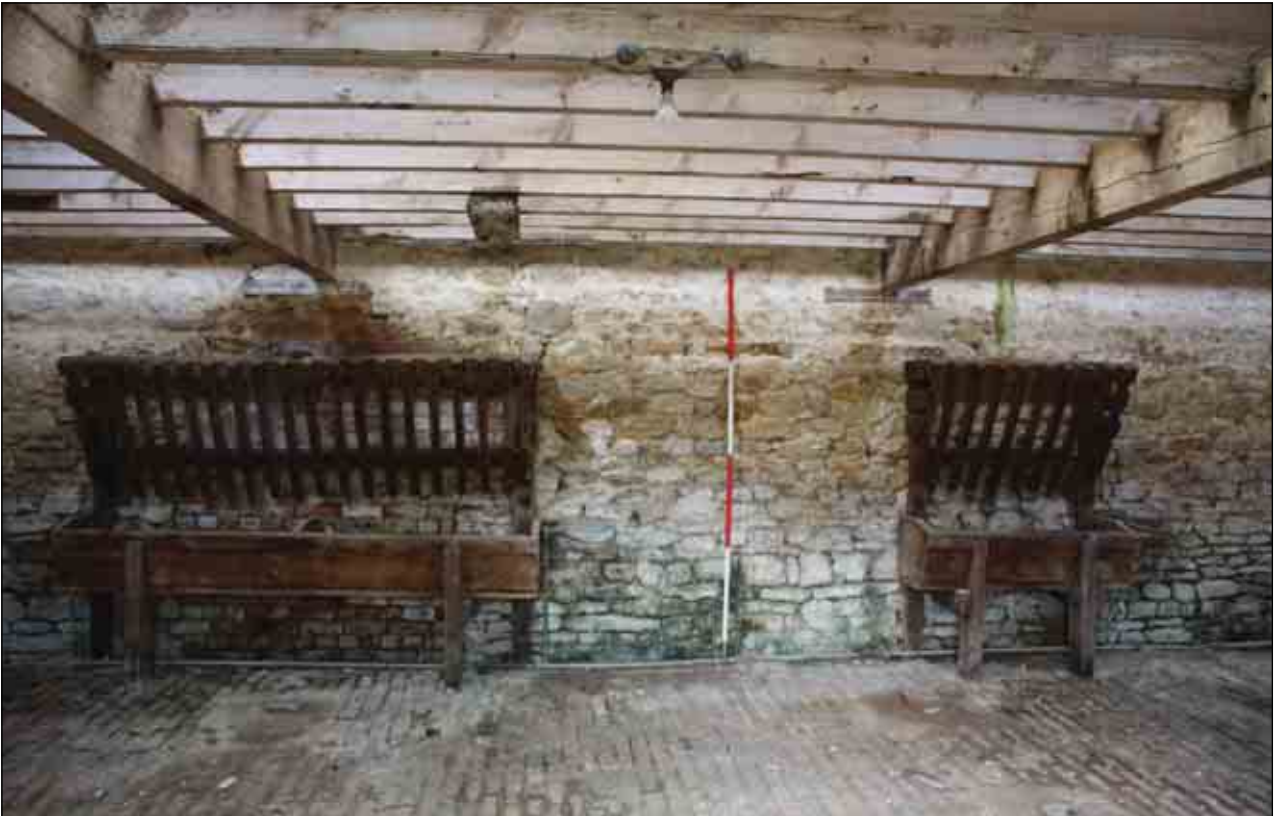
Plate 46: Wooden feeding troughs, Building D (i)

- 4.4.19 Located on the rear wall are two wooden feeding troughs (Plate 46). The remnants of posts between these indicated they were located within separate stalls. To the right of each trough is a water bowl (Plate 47) which is connected/plumbed into a water supply piped into the building. The stainless steel water troughs are marked "Fordham SelfFill Mk 2". Fitted with a float ball to ensure constant supply of water, similar models are still manufactured today for sows and pigs (www.hendersons.co.uk/pigequip/pigbowl.html). This indicates that at least the most recent use of this part of the building was to accommodate pigs. Also on this rear wall is a blocked up window as noted on the external elevation.

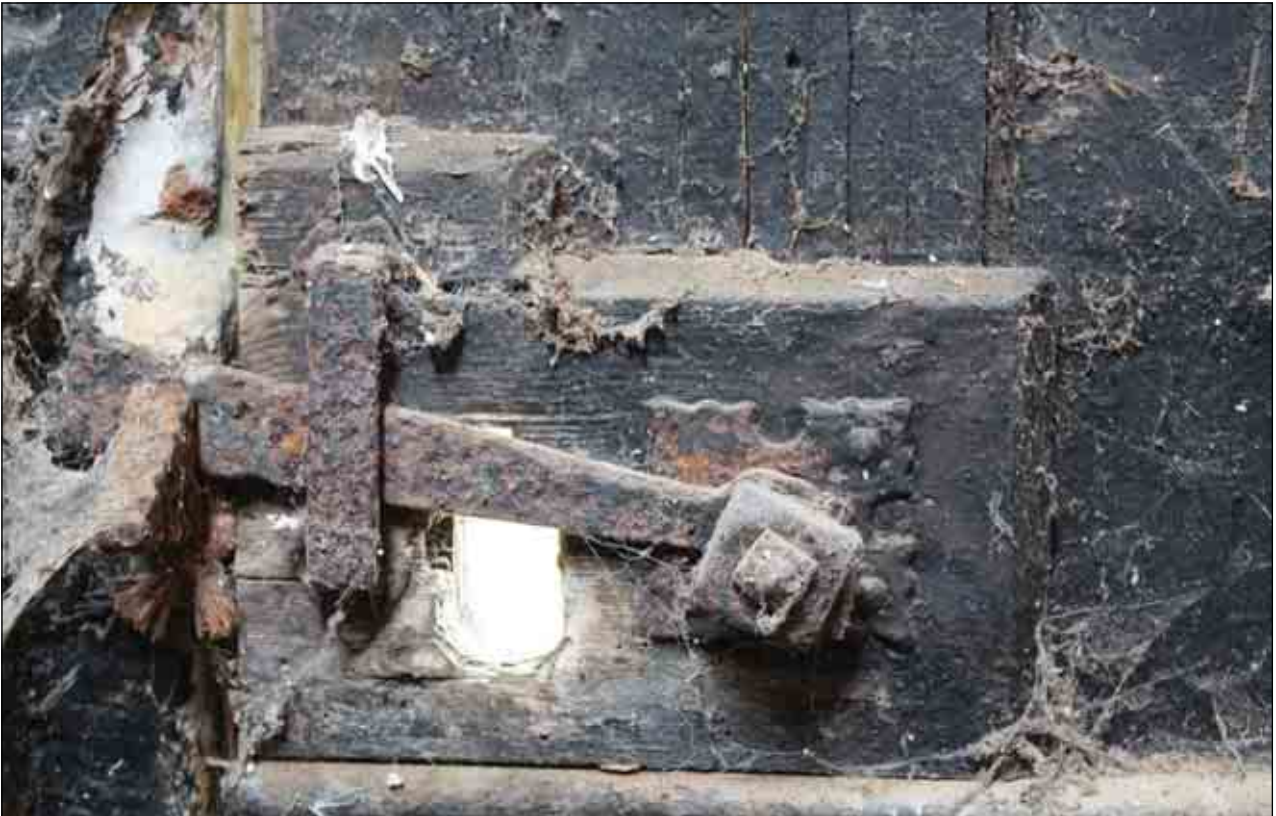
Plate 54: Detail of iron door latch, Building D (iii)

- 4.4.29 The access door, as noted on the north-facing elevation, comprises six vertical timber boards secured by three horizontal moulded batons (Plate 53). It is arched at the top and held on iron hinges with long, square-ended iron strap hinges. The door is held closed with a drop latch which can be opened from the outside through a hole (Plate 54). The pivoting latch backplate is decorative but not closely datable (Plate 54).

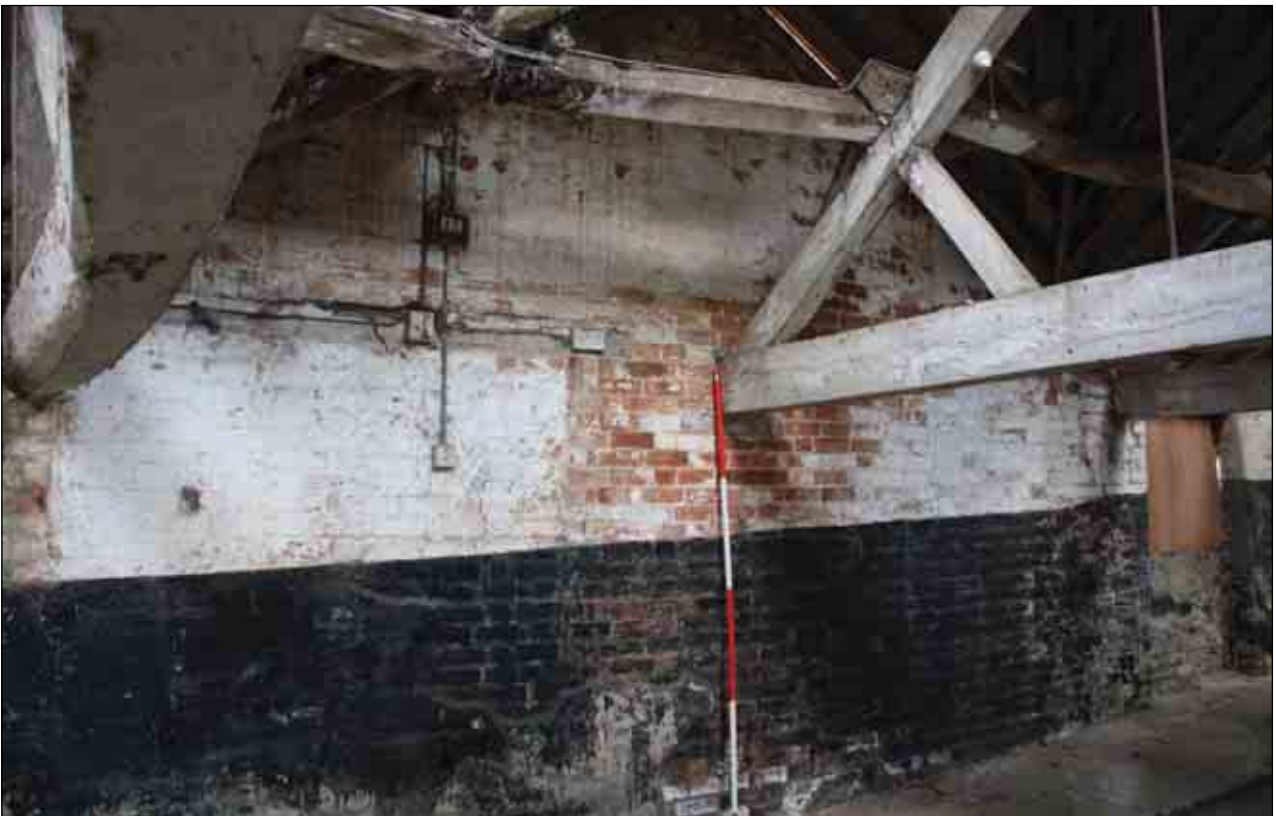
Plate 55: Blocked-up opening, Building D (iii)

- 4.4.30 The brick in-fill between this area and D(i) can be viewed although much of the brick has been painted over (Plate 55). A machine sawn tie-beam has been inserted within the in-fill that differs from the rest of the tie beams in this area which are all hand sawn and have a slight curve. There have been a number of repairs and alterations where the roof structures of these two parts of the building meet.

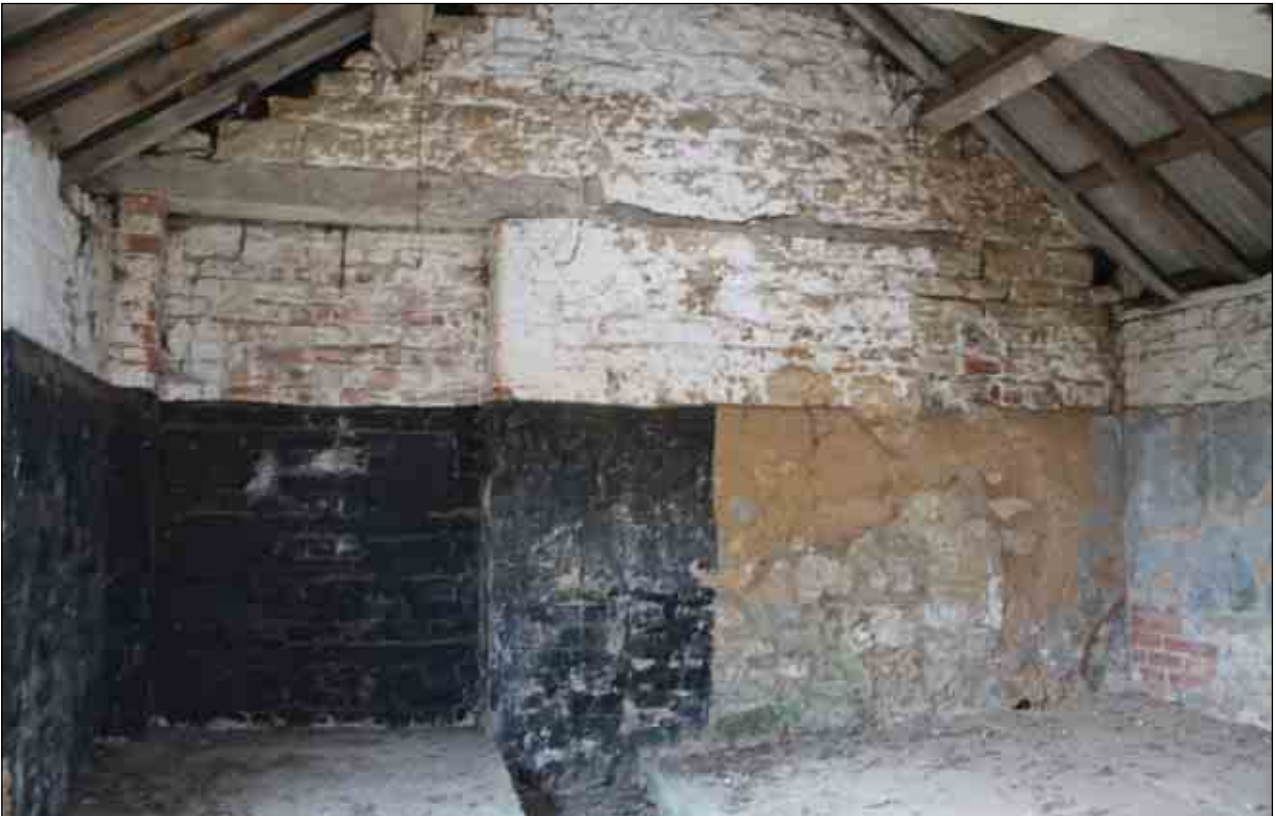
Plate 57: Blocked-up doorway, western end of Building D (iii)

- 4.4.32 At the western end of this part of the building is a blocked-up doorway (Plate 57). As noted from cartographic evidence, this building originally extended further westwards and this may represent an internal doorway which once led into another part of the building.

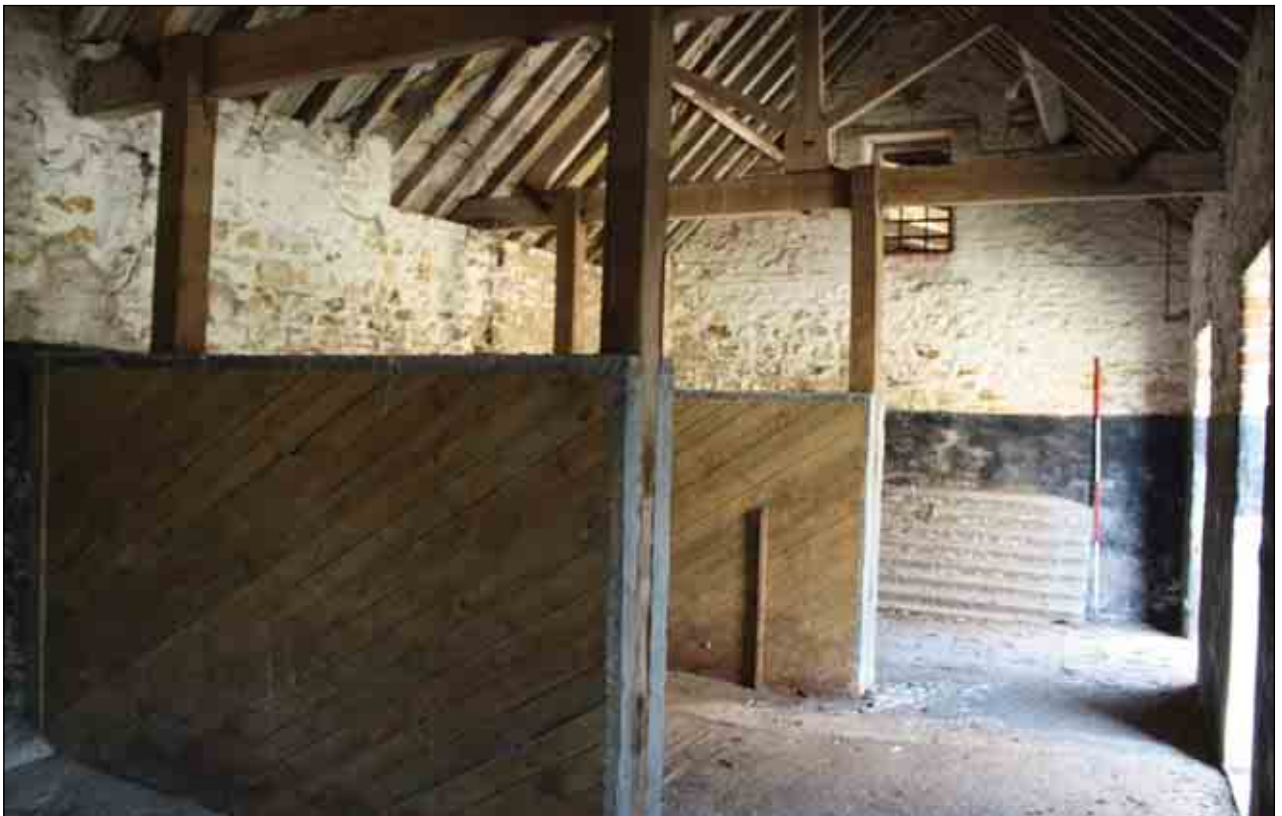
Plate 63: Interior view, Building E

- 4.5.9 The walls all consist of exposed brick and stone. Timber upright partitions sub-divide areas recently used as stalls (Plates 63 and 66). There is a ventilation opening at the the western end as noted on the external elevation and the replacement asbestos cement roof covering is supported by a series of king-post roof trusses.

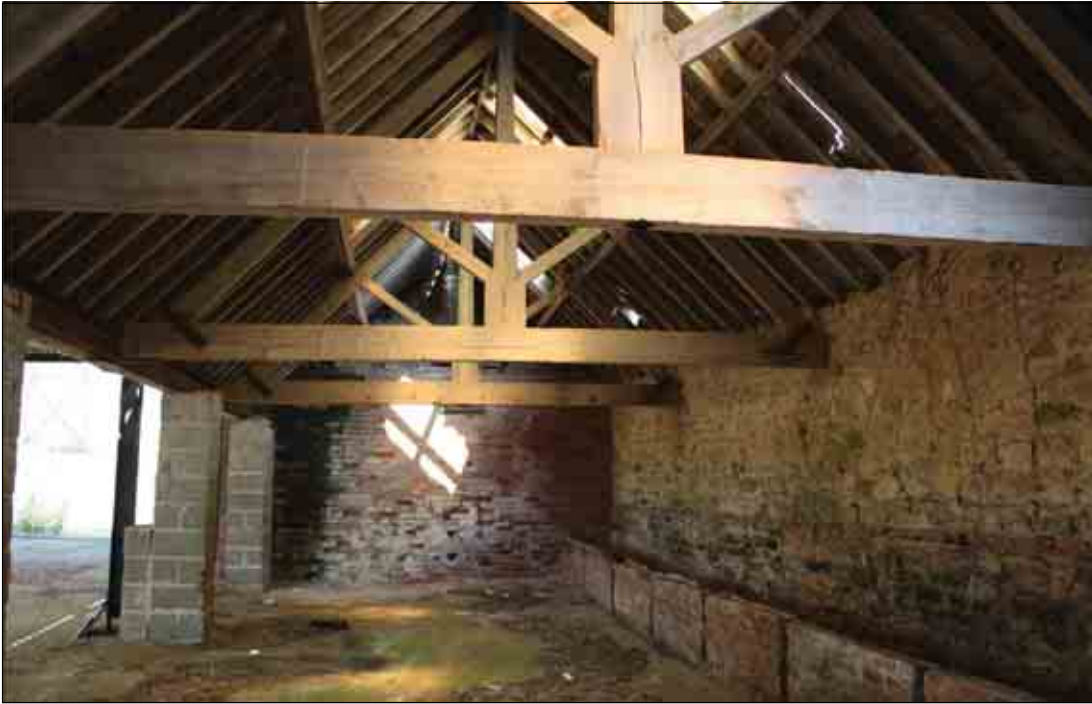
Plate 68: Interior view, Building E (ii)

- 4.5.15 The open-fronted side of the building is supported by breeze block pillars. These pillars support the replacement roof structure of machine sawn timber king post trusses (Plate 68). Although these pillars are clearly modern and are thought to have been inserted when Building F was constructed, the 1884 Ordnance Survey Map (Figure 5) clearly depicts this part of the building with an open-fronted access.
