The Jennie Lee Centre,
Wednesfield,
Wolverhampton

**Historic Building Recording
and Desk-Based Assessment**

August 2013

OA East Report No: 1514

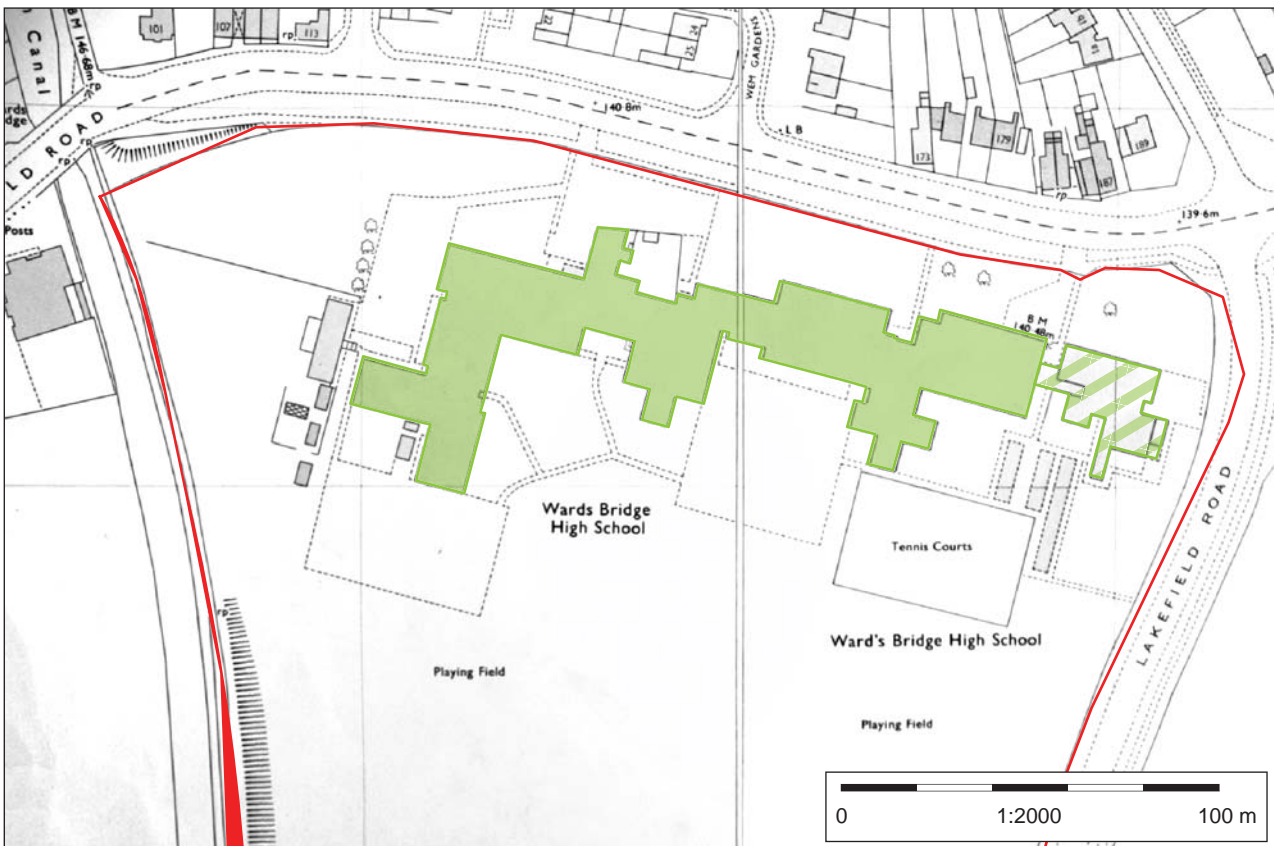
Figure 5: Extract from 1975 Ordnance Survey Map (1:2500) showing location of buildings surveyed

4.2.34 On entering this area from the conference rooms corridor (81) there is a large open reception area (111) with a separate reception office within the corner (110) (Plate 57). The floor of this area is covered with carpet and the walls are all painted. The ceiling is also plain and painted, with modern ceiling lights and an elevated skylight which allows natural daylight into the area. On the northern side of the reception area are the modern doors and windows as noted on the external elevation (Plate 58), this entrance first appears on the Ordnance Survey Map dated 1975 (Figure 5).

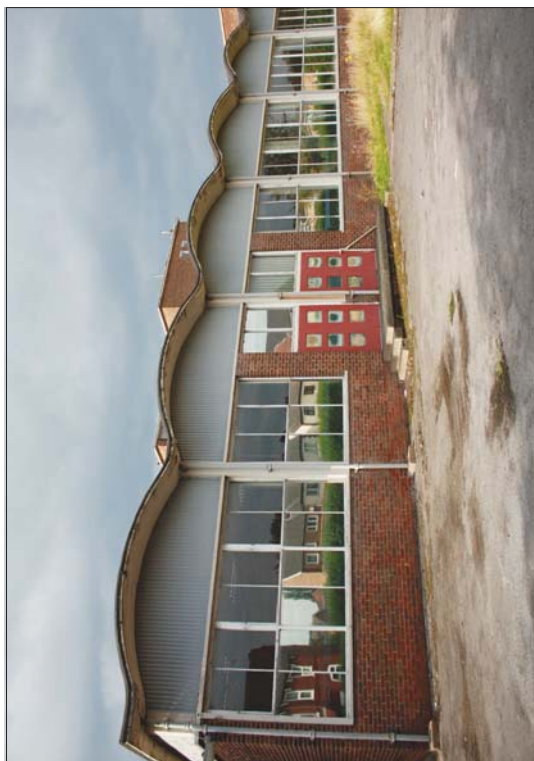
Plate 2: North-facing elevation of the original eastern end of the school

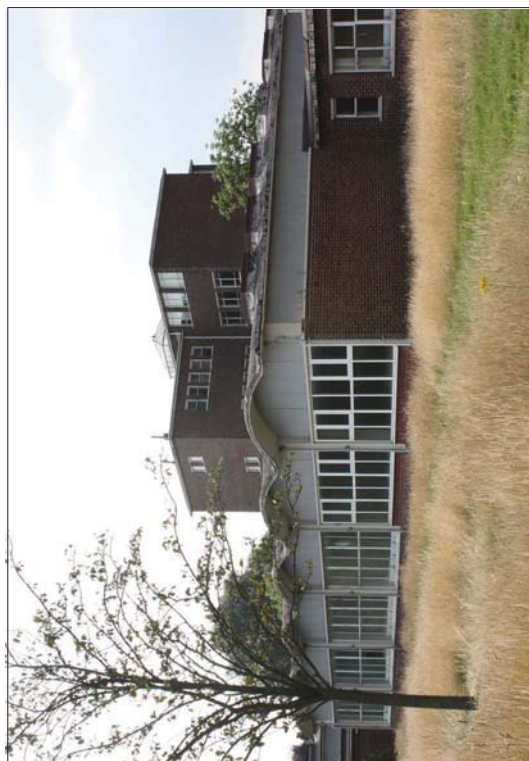
- 4.1.5 The next part of the building comprises another six-part component as noted in 4.1.3 with wavy roofline and elevations comprising two rows of large windows (Plate 4). These windows would allow significant amounts of light to enter the rooms making the most of their north-facing aspects. Within the roofline are small raised skylights allowing additional light into the rooms. The last two section of windows on the right are recent

replacements using UPVC frames and cills. Replacement brickwork beneath confirms that the original windows were the same length as those to the left.

Plate 4: North-facing elevation of med-section of building with Tower 2 behind

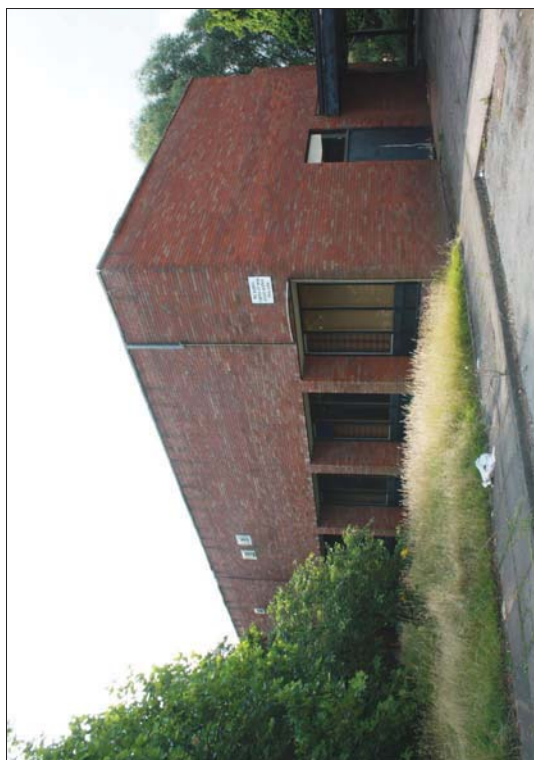
- 4.1.2 At the far eastern end of the site is the later extension which was not accessible for internal inspection (Plate 1). It is constructed from a dark reddish coloured brick in a stretcher bond with a row of tri-part windows at ground floor level and a flat roof. It appears that the windows have been replaced within the last 30 years as this side of the building is shown in the photograph taken in 1986 (Figure 19b) where the windows comprise four panes, the outer two of which appear to open outwards. The extension is connected to the original part of the building via an open-sided covered walkway.

Plate 1: North-facing elevation of the eastern extension

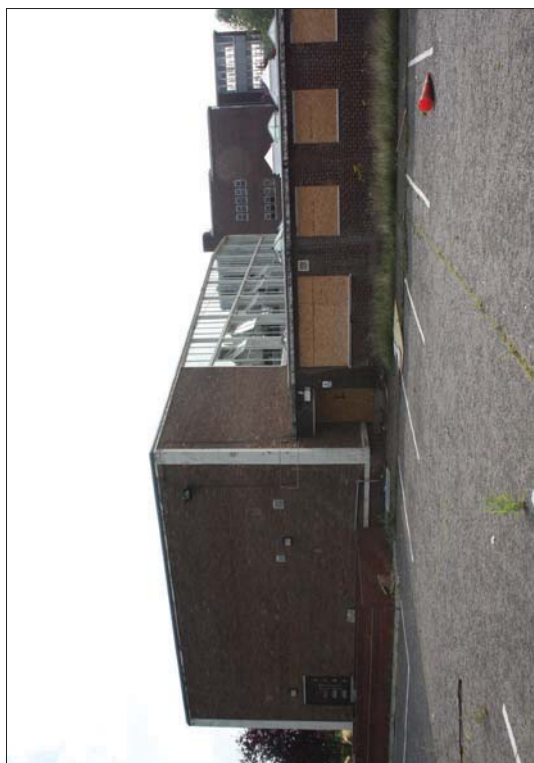
Plate 9: West-facing elevation of hall and north-south block

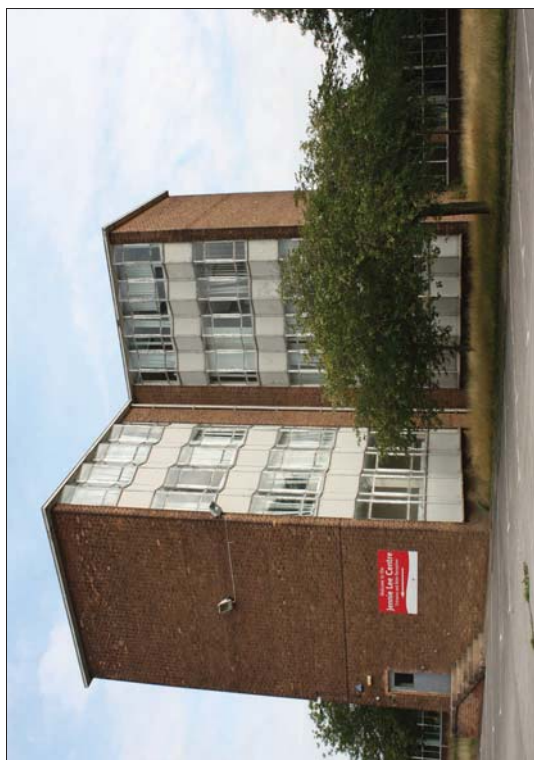
Plate 17: Tower 1 as viewed from car park at south of the building

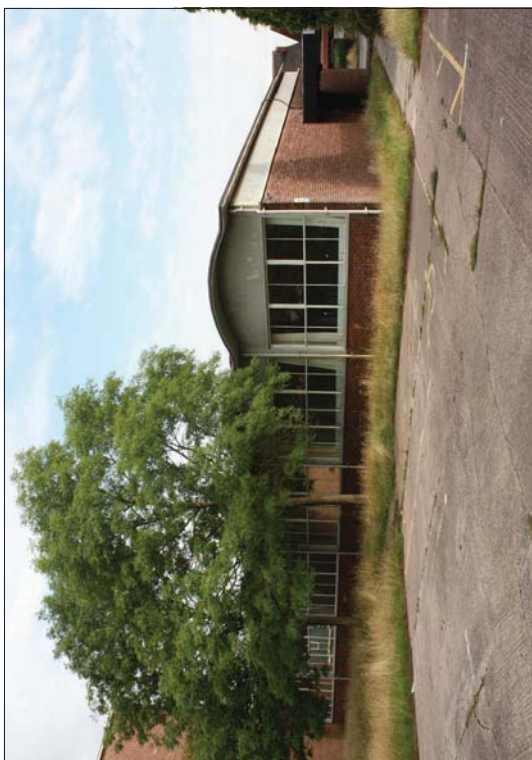
- 4.1.18 Positioned between the two towers and on the eastern end of the range are the south-facing sides of one of the sections of the building with the wavy designed roof as noted on the north-facing side (Plates 20 and 21). As with the north-facing elevation, they comprises six sections with large steel framed windows and downpipes between each section.

Plate 21: South-facing elevation of the original eastern end of the school

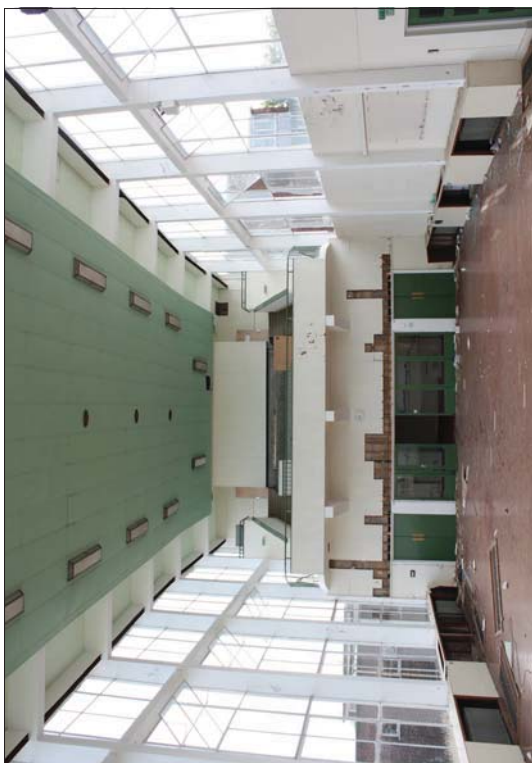
- 4.2.6 At the eastern end, above the entrance is a balcony which is accessed from the stairs noted within the lobby area. The balcony itself (218) comprises rows of concrete steps for seating with green painted metal handrails at the front and a set of access steps on either side (Plate 30).

Plate 29: balcony at eastern end of hall (28)

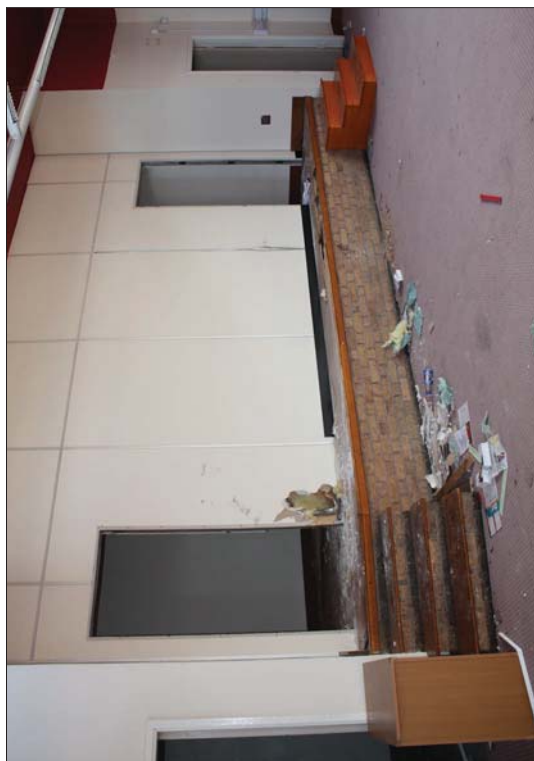
windows noted in the gym and hall. At one end there is a stage (55) with four small store rooms, two on either side (rooms 54, 56, 57 and 57) (Plate 42).

Plate 42: Stage/storage areas at eastern end of dining hall (39)

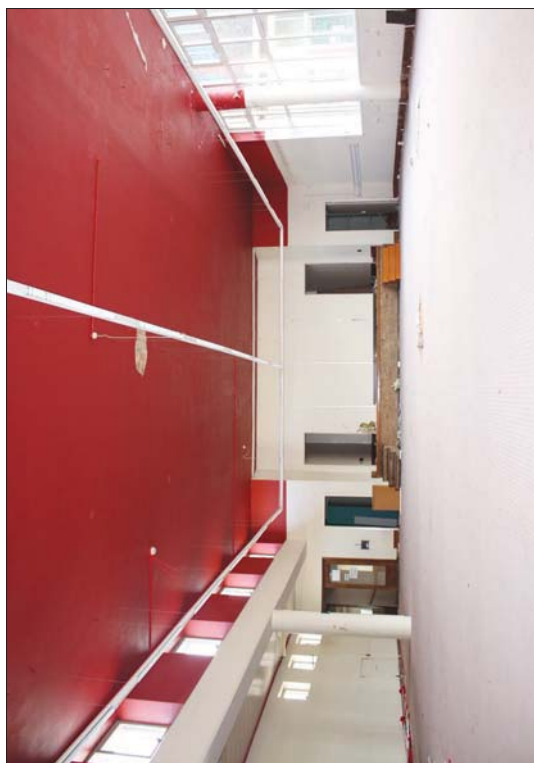
- 4.2.19 Further along the short corridor (40) and on the right is a large open room (39) which is thought to be the original dining hall (Plate 41). This room is carpeted with white painted walls and red ceiling. There are two pairs of structural support pillars on either side of the room allowing the corridor on the left to be opened up and additional light to be let into the area. Any original light fittings in this area have been removed and replaced by rows of strip lights suspended from the ceiling. On the south side of the room there is a large window reaching to ceiling height with plastic frames and glazing bars; this has the same winding opening mechanism as the earlier steel framed

Plate 41: General view of dining hall (39)

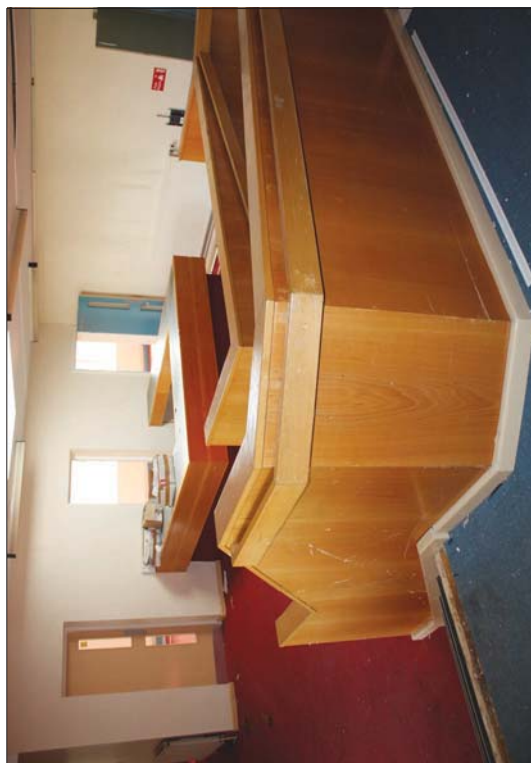
- 4.2.21 The first room (68) has a set of steps as well as a ramped access leading down to a reception desk area (Plate 43). From this area there are doors leading to the stairwell (66), a library room (69) and access to the north side of the building via the set of original double doors as noted on the north-facing elevation (Plate 44). These doors, as well as an elevated skylight (Plate 45), allow plenty of light into this area.

Plate 43: General room view of library reception area (68)

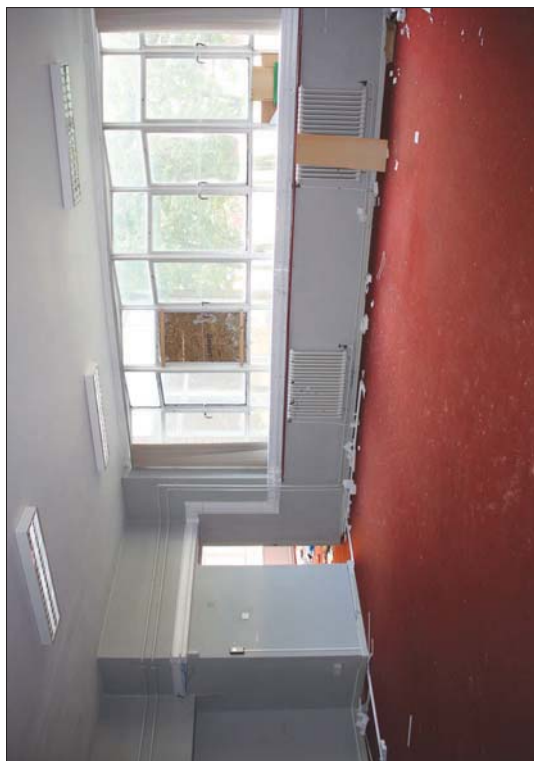
- 4.2.23 Rooms 60 and 61 are two more former library rooms, both of which have red coloured carpets and plain grey painted walls. Room 61 has the same concertina windows on both east and west elevations as noted in room 69, as does the southern elevation of room 61. Other than the windows, there are no other original fixtures or fittings of note in these rooms (Plate 50).

Plate 50: General room view of library (61)

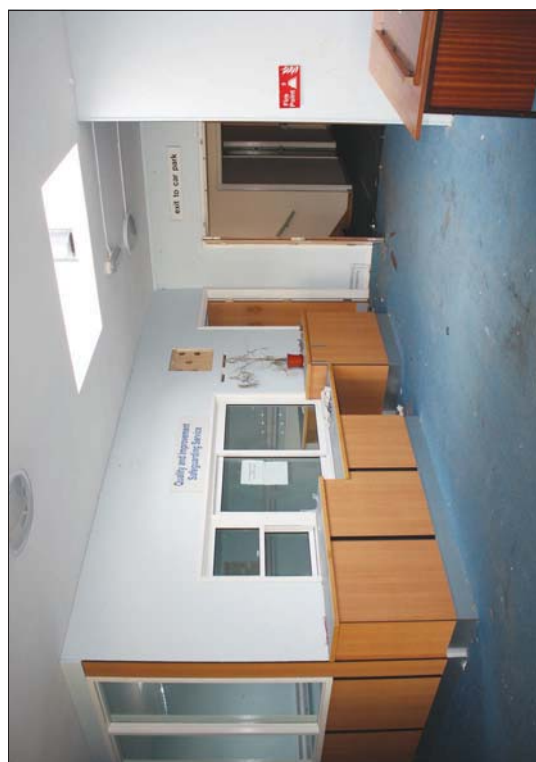
Plate 57: General view of reception area (111)

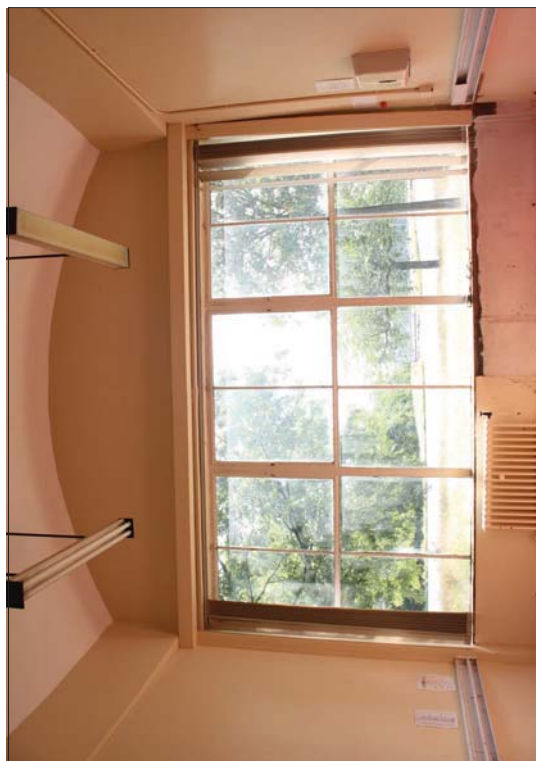
Plate 66: Original window and arched ceiling in office (117)

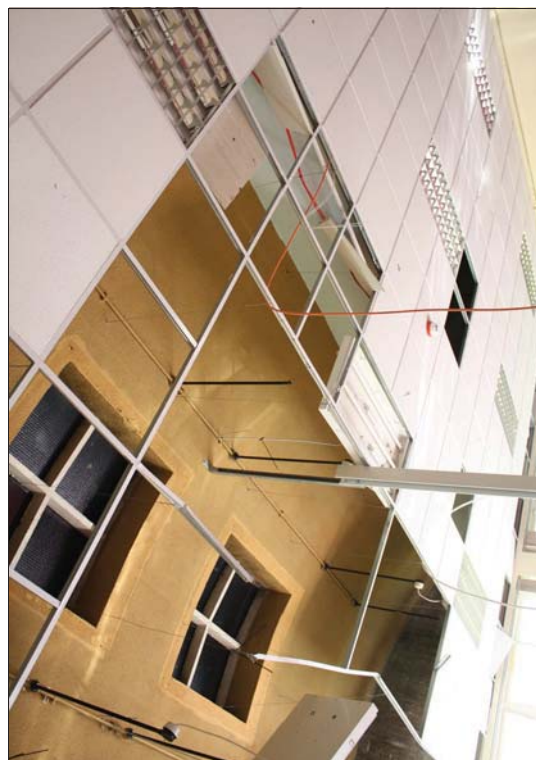
- 4.2.40 Room 115, like 114, is a large square shaped room which had not been sub-divided up as part of the 1990s alterations. However, the arched roof/ceiling had been concealed beneath a suspended ceiling comprising white ceiling tiles and flush strip lights and at the eastern end of the room, two modern inserted doors provide access into rooms 116 and 117 (Plate 64). Where parts of the suspended ceiling have been damaged, the original ceiling can be seen with the row of skylights in each arched section as noted in room 114 (Plate 65).

Plate 65: Detail of original ceiling (115)
