Archaeological
Monitoring and
Recording at
Pulloxhill Water
Treatment Works

Archaeological Watching Brief Report

Client: Anglian Water

OA East Report No: 1466 OASIS No: oxfard3-149352

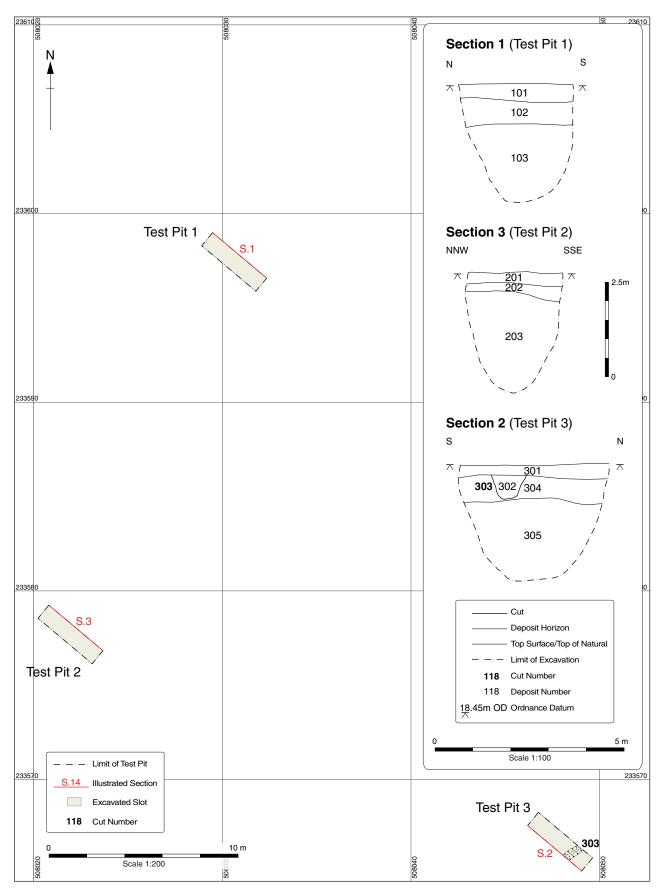
Figure 4: Plans and sections

4.4.1 Test pit 3 was located to the south of the building and close to the rear boundary of the water treatment works. I measured 3m x 0.75m x 3.75m. An underlying natural geology of firm blue grey gault clay (305) was overlain by a light yellowy brown silty clay subsoil (304). Cutting into this layer a small but reasonably deep linear feature thought to be a ditch, was noted (303) running on an east-west orientation. It had steeply sloping sides and a flattish bottom. The fill of the feature (302) was similar to 304, and differentiated only in being of a slightly darker hue. The contents of the feature were carefully examined but no evidence was found to date the feature. It did however lie below the ridge and furrow cultivation and must pre date the medieval ploughing. The test pit was capped by a dark grey silty top or plough soil (301) and a turf line.

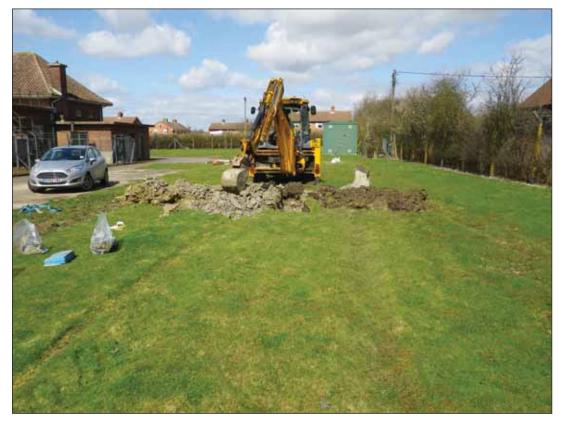
Plate 1: Test pit 1

4.2.1 Test pit 1 was situated to the east of the existing building and on the ridge of the extant ridge and furrow cultivation. It measured 3m x 0.45m x 3m. A natural geology of firm blue grey gault clay (103) was overlain by a light yellowy brown silty clay subsoil (102) that contained a moderate amount of small stones and flint. The test pit was capped by a dark grey silty top or plough soil and turf line (101). A moderate amount of bitumen and modern brick was noted within this layer. Given the amount of truncation occurring close by. This would have originated from the 20th century construction work carried out on the site.

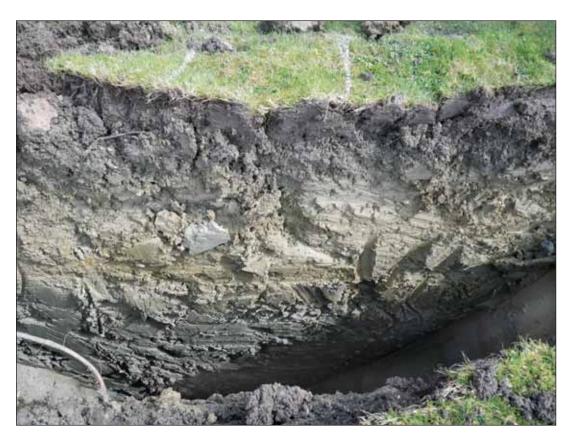
Plate 2: Test pit 2

4.3.1 Test pit 2 was located To the south of the building and adjacent to access road. It measured 2.5m x 0.75m x 3m. The test pit was devoid of archaeology and consisted of a natural geology of firm blue grey gault clay (203) overlaying a light brown silty lay subsoil that contained a moderate amount of stones and flint. (202). The test pit was sealed by a dark grey silty top or plough soil (203) and turf line.

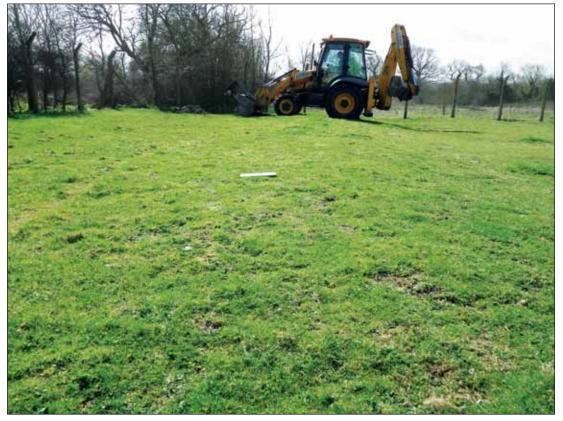
Plate 4: Working shot showing extant ridge and furrow cultivation strip
