Stable Block Area Mentmore Towers Buckinghamshire

Archaeological Evaluation Report

Document Title: Stable Block Area, Mentmore Towers, Mentmore,
Buckinghamshire

Document Type: Evaluation

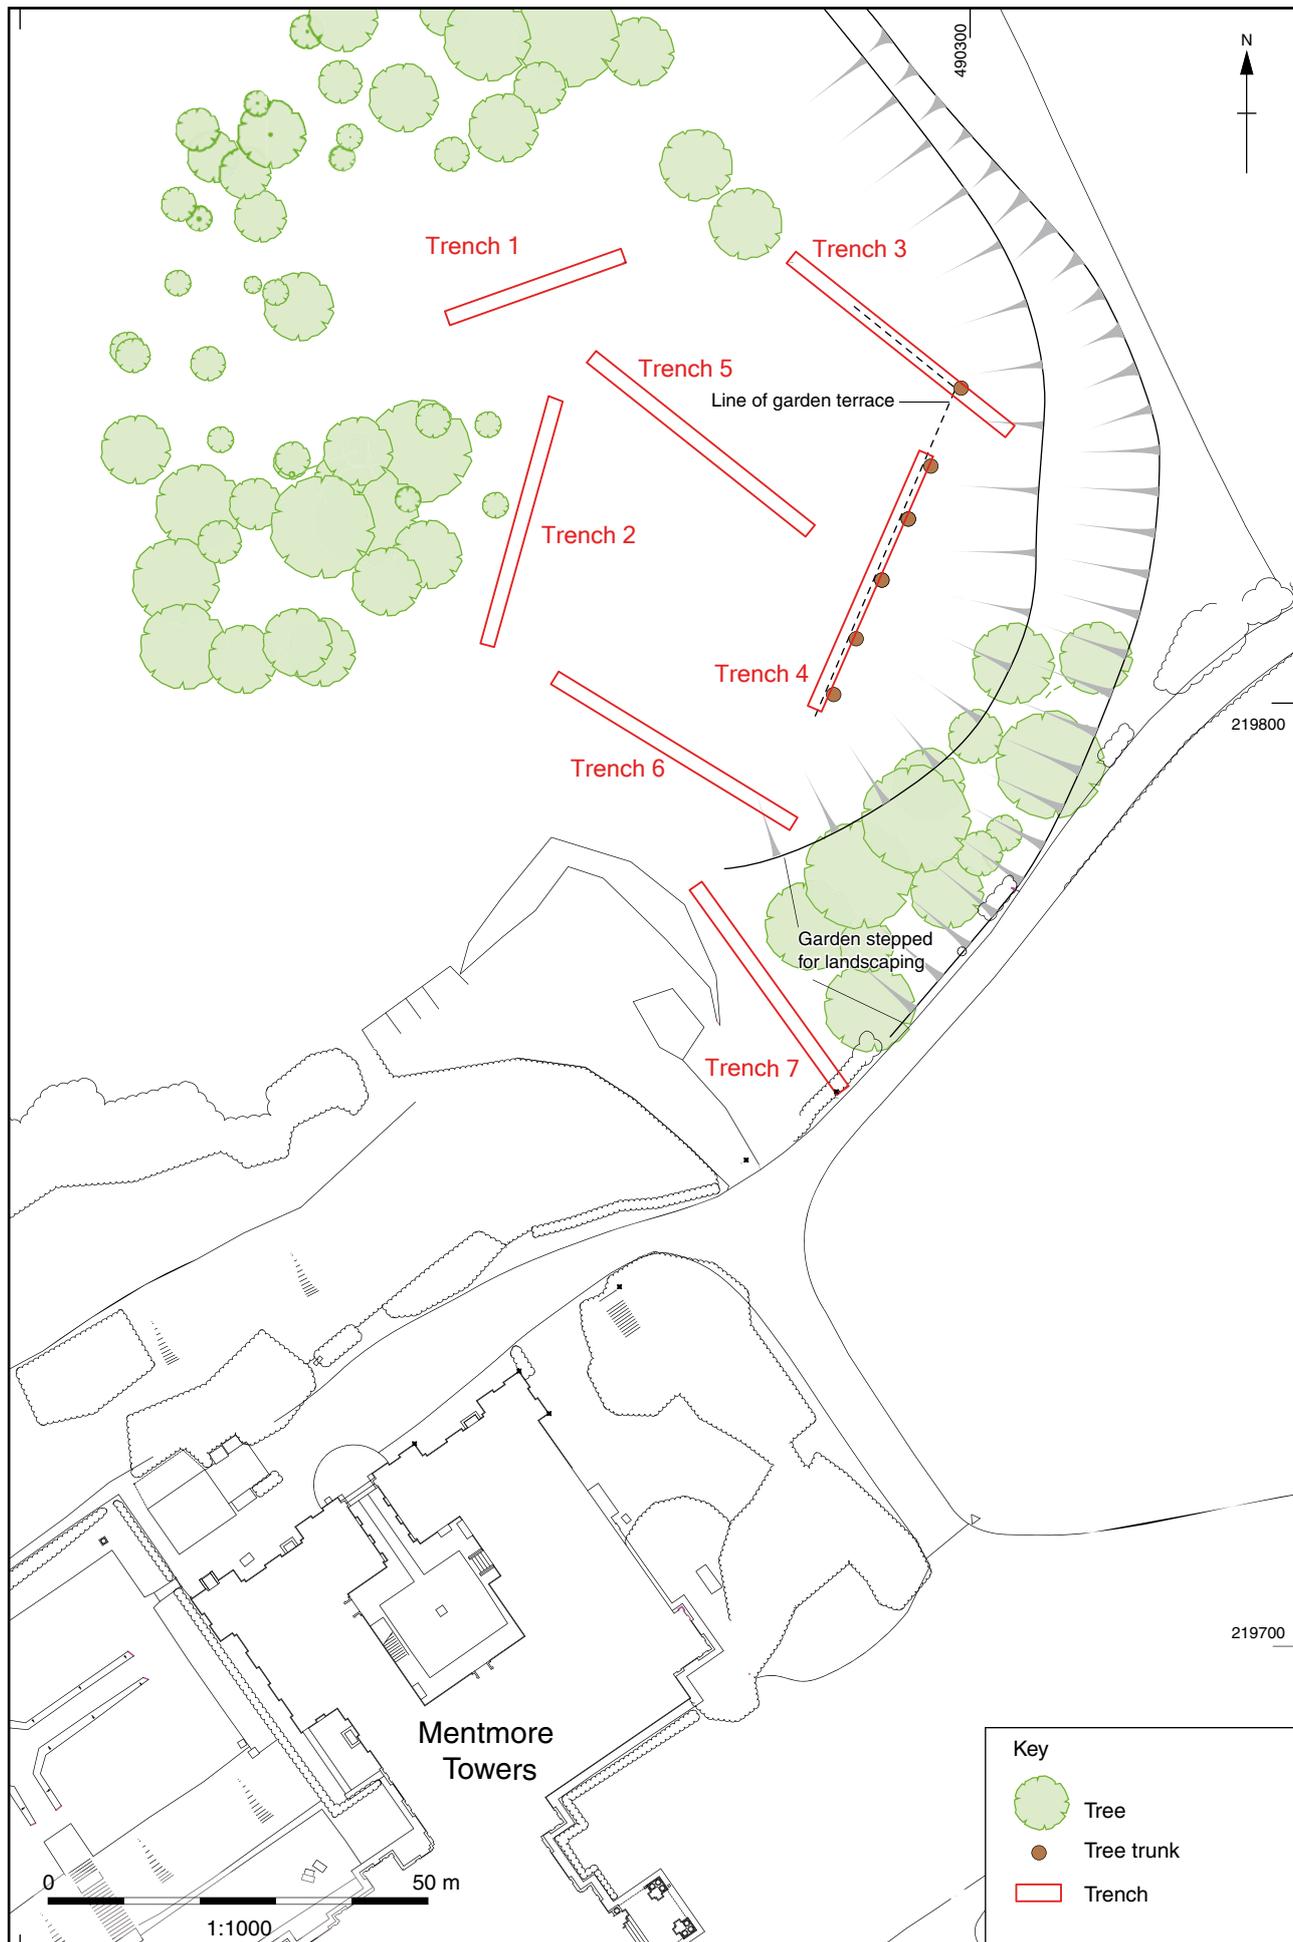
Figure 2: Trench location plan

- 3.1.1 The evaluation consisted of seven trenches of which six measured 30 m x 1.9 m wide and one measured 20 m x 1.9 m wide (Fig. 2). The overburden was removed under close archaeological supervision by a 360° mechanical excavator fitted with a toothless bucket.
- 3.1.2 The trenches were cleaned by hand and the revealed features were sampled to determine their extent and nature, and to retrieve finds and environmental samples. All archaeological features were planned and where excavated their sections drawn at scales of 1:20. All features were photographed using colour slide and black and white print film. Recording followed procedures laid down in the *OAU Fieldwork Manual* (ed. D Wilkinson, 1992).

- 5.1.4 This trench was aligned north east to south west and measured 30 m long and 1.9 m wide a 2 m section was machined at the south end and exposed the light brown silty clay (3045) natural. This was sealed below 0.24 m thick dark brown silty clay (3044) which was quarry in-fill material. This was sealed below a re-deposited natural (3042) forming a terrace step with more dark grey silty clay (3043) in-fill. This was all sealed below a 0.10 m 0.50 m thick reddish brown silty clay (3041) cultivated soil. This had been cut by a line of trees along the line of the terrace (Fig.2). The trench was sealed by a 0.20 m thick very dark grey brown silty clay (3040) topsoil.

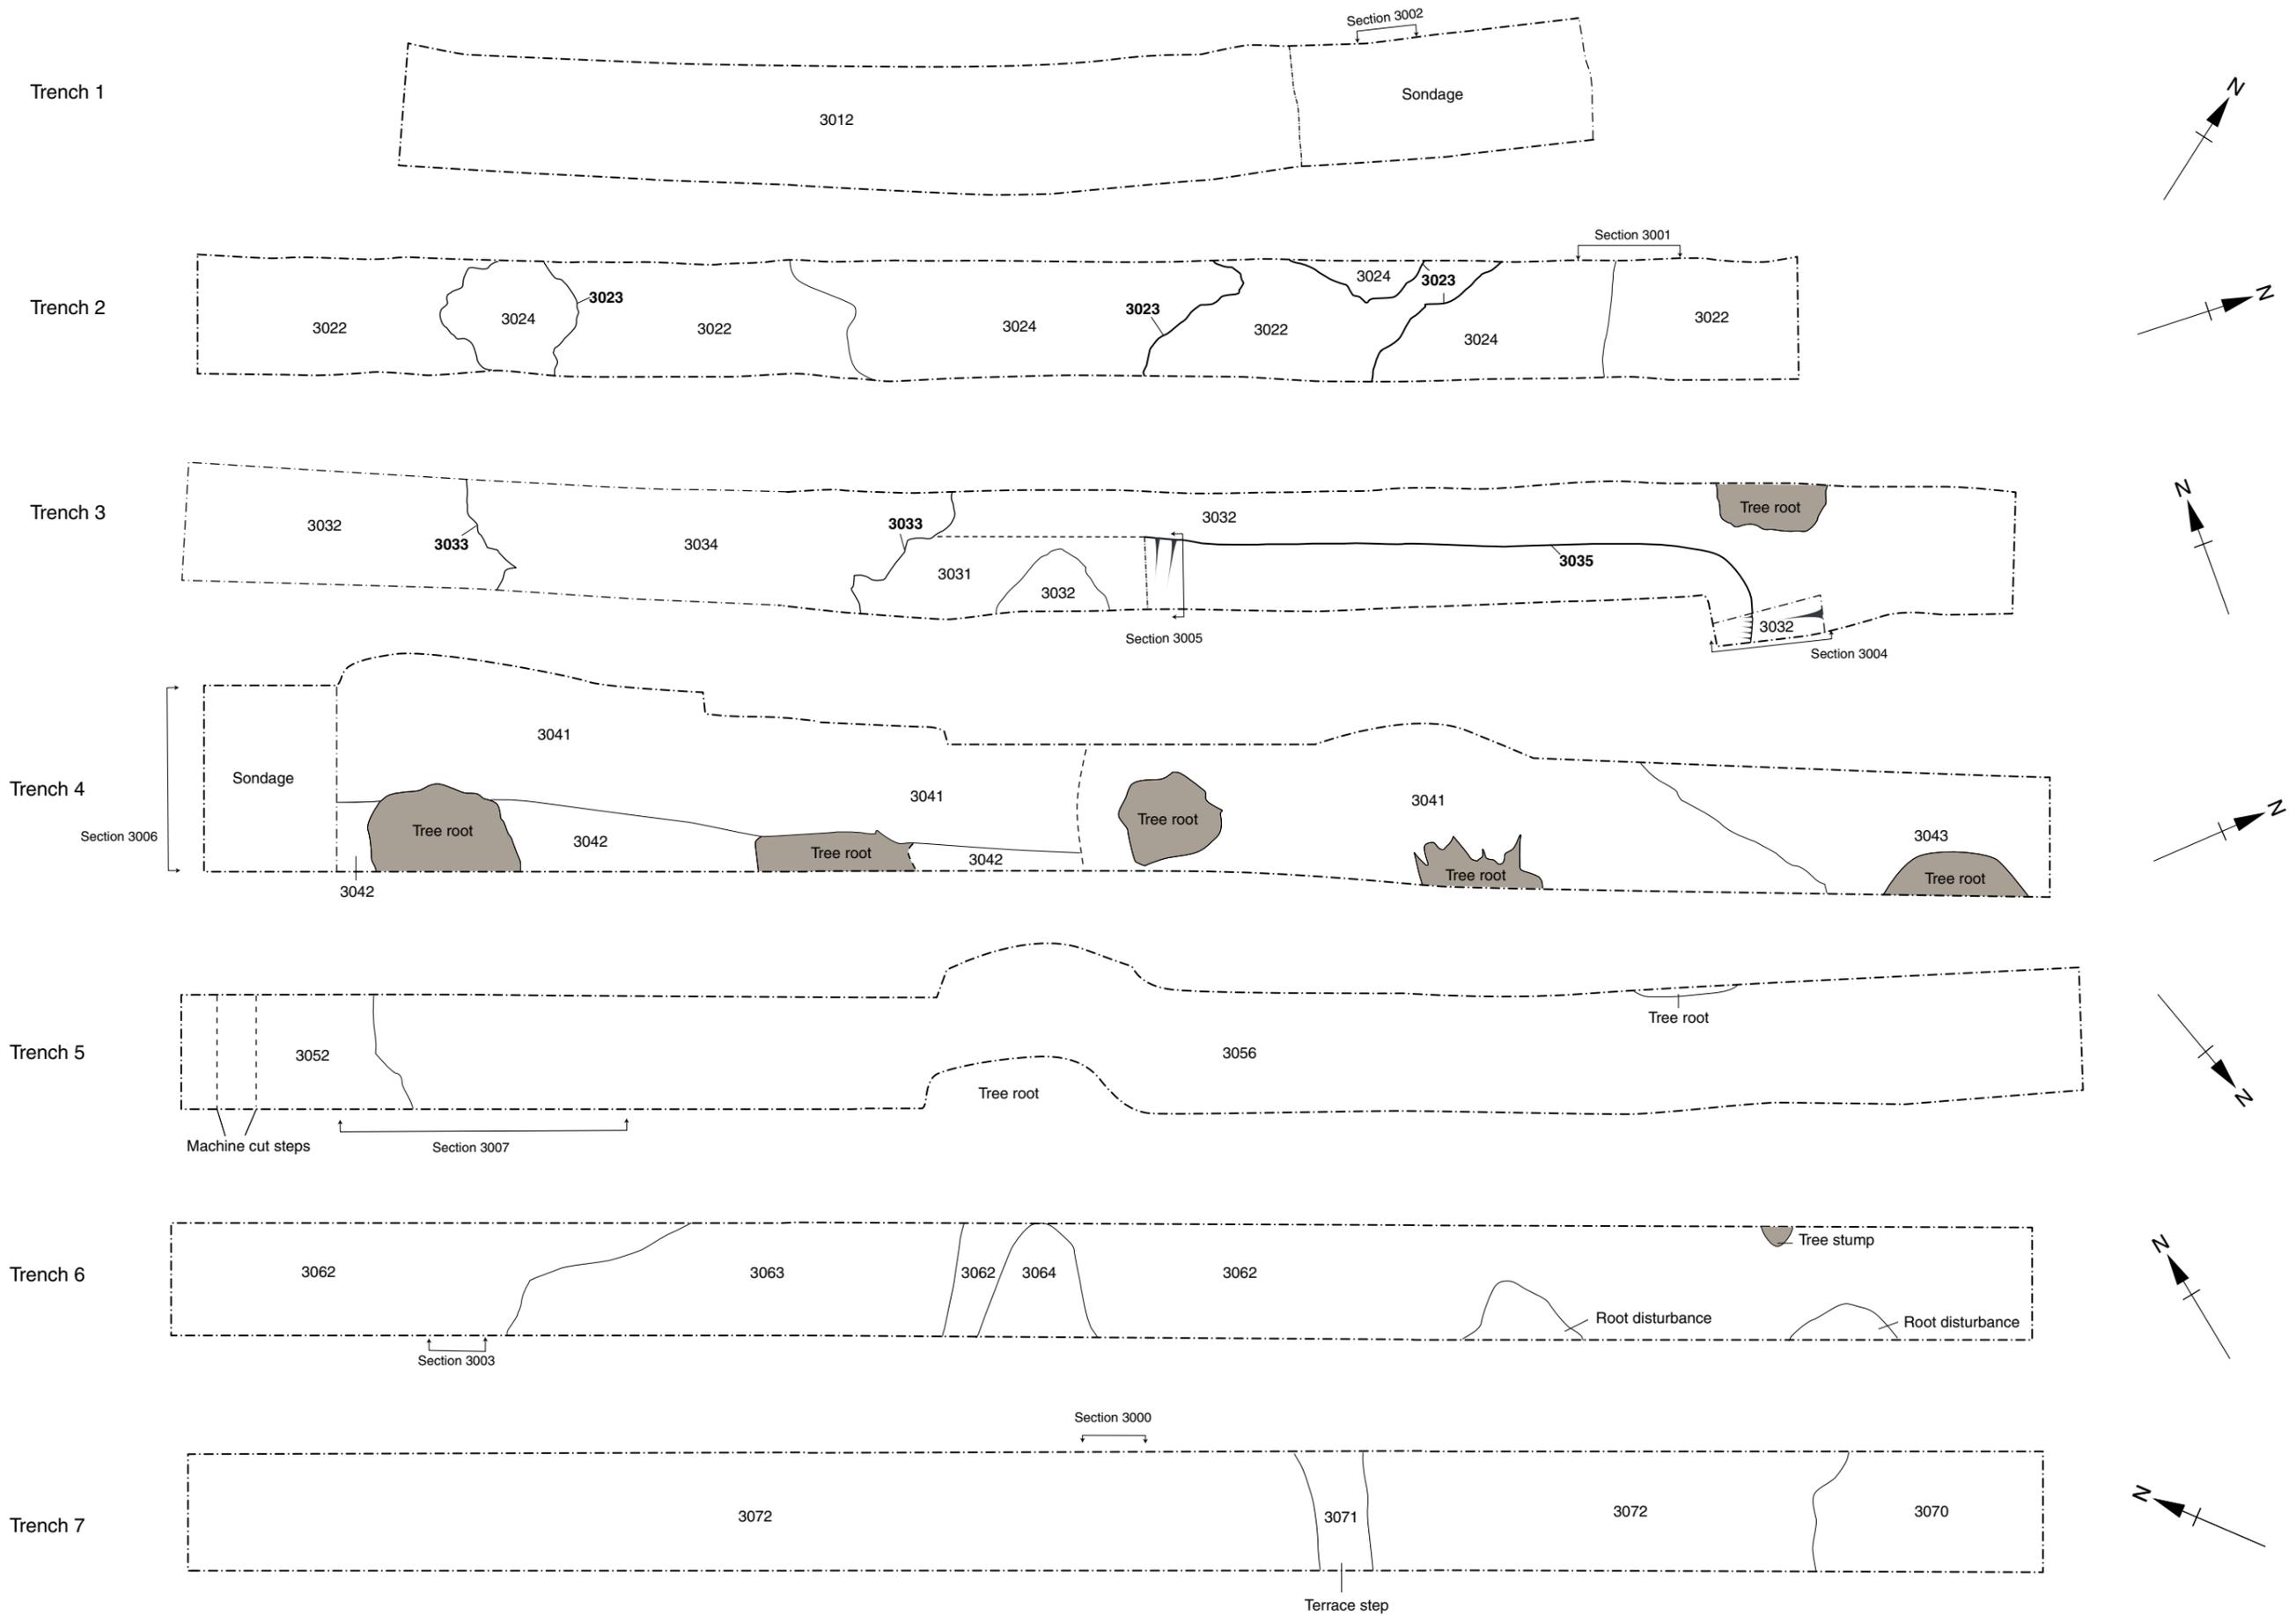
Figure 3: Trench plans

- 5.1.1 This trench was originally aligned north to south and was moved to the east and realigned from its proposed position due to trees still standing on the site. The trench measured 20 m long, 1.9 m wide and 1.4 m in depth. A 4.5 m long section at the north-east end of the trench exposed the natural light brown silty clay (3013). This had been sealed by a 0.55 m thick grey brown silty clay (3012) colluvium hill wash forming at the base of the slope. Overlying this was a 0.60 m thick reddish brown silty clay (3011) with a 0.20 m very dark grey brown silty clay (3010).topsoil

- 5.1.2 This trench was aligned north-west to south-east and measured 26 m long and 1.9 m wide and was excavated to a depth of 0.40 m onto the natural of light brown silty clay (3022). This was sealed by a 0.25 m thick reddish brown silty clay (3021), which was cut by a number of root holes (3023) filled by dark grey brown silty clay with reddish patches (3024). Sealing these was a 0.20 m thick very dark grey brown silty clay (3020) topsoil.

- 5.1.3 This trench was aligned north west to south east and measured 30 m long and 1.9 m wide and was excavated to 0.60 m onto top of natural. This was light brown silty clay (3032) and had been cut by a shallow sloping cut (3035) which ran along the trench and turned south-east at the eastern end of the trench. This was part of the 19th century landscaping of the quarry, the corner of which was marked by a large tree stump. The cut was covered with a 0.20 m - 0.35 m thick layer of reddish brown silty clay (3031), which was cut by tree root holes (3033) with a fill of dark grey brown silty clay (3034) and sealed by a 0.20 m thick very dark grey brown silty clay (3030) topsoil.

- 5.1.5 This trench was aligned north west to south east and measured 30 m long and 1.9 m wide and was excavated to 1.2 m in depth onto top of a light brown silty clay (3052) natural. This was sealed below a series of layers starting with a 0.6 m thick dark reddish brown silty clay (3056) in-fill, then a re-deposited natural (3054) and a mid-reddish brown silty clay (3051). These were sealed by a 0.20 m thick layer of reddish brown silty clay (3053) cultivated soil, which was sealed by a 0.20 m thick very dark grey brown silty clay (3050) topsoil. This had been cut a large tree root hole (3055) which had disturbed the layers below.

- 5.1.6 This trench was aligned north west to south east and measured 30 m long and 1.9 m wide and was excavated to a depth of 0.40 m on to the light brown silty clay (3062) natural. This was sealed below a 0.20 m thick layer of reddish brown silty clay (3061) cultivated soil, which was sealed by a 0.20 m thick very dark grey brown silty clay (3060) topsoil. This had been disturbed by a tree roots (3063) and (3064) in the trench.

- 5.1.7 This trench was aligned north west to south east and had been moved to the west to avoid cutting the road surface. It measured 30 m long and 1.9 m wide and was excavated to a depth of 0.50 m on to the light brown silty clay (3072) natural. A small terrace step 1 m in width was seen near the east end cut into the natural slope.

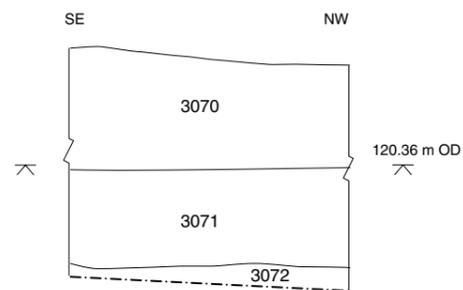
Trench 7
Section 3000

The natural was sealed below a 0.30 m thick layer of reddish brown silty clay (3071) cultivated soil. This had been cut by a root hole (3073). The trench was sealed by a 0.20 m thick very dark grey brown silty clay (3070) topsoil.
