**7 – 9 Lower  
Hillgate,  
Stockport,  
Greater Manchester**

**Archaeological  
Investigation**

**Oxford Archaeology North**

November 2011

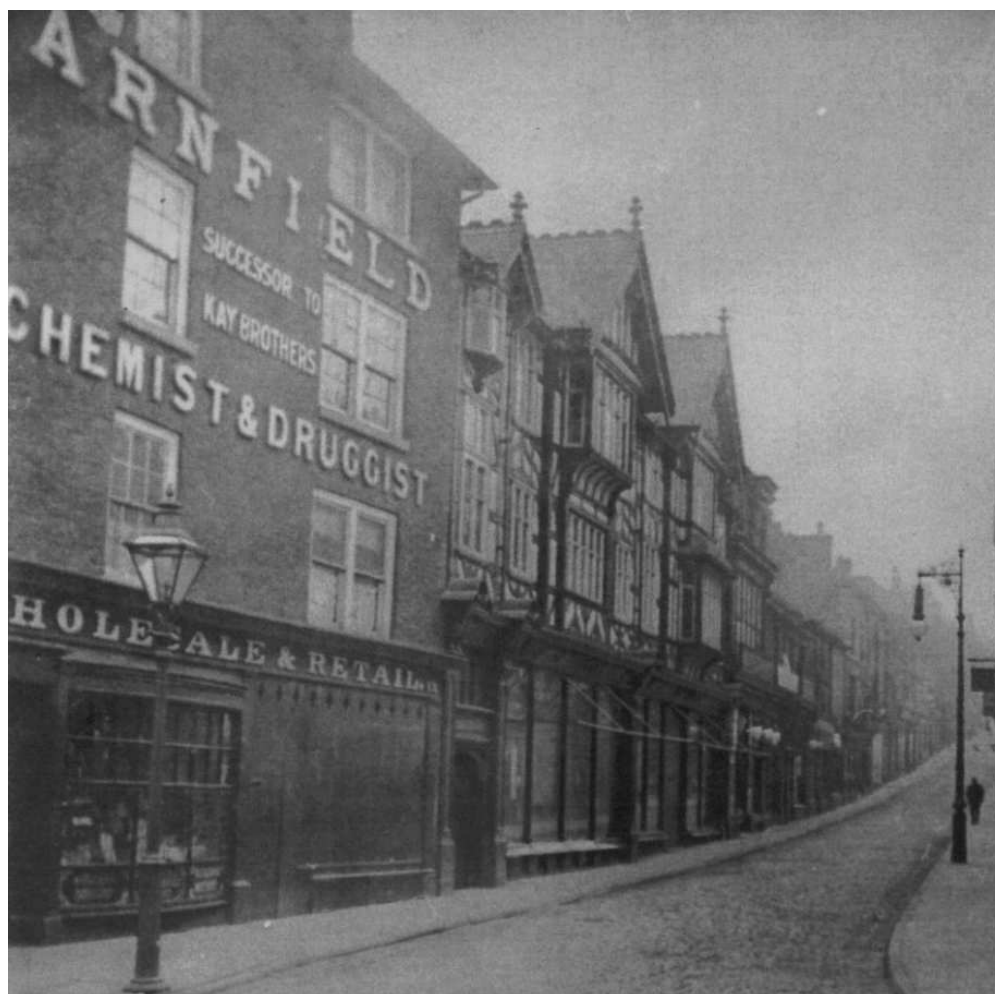
Plate 8: Photograph showing 7-9 Lower Hillgate in 1901-2

- 3.2.7 The buildings occupying the Lower Hillgate frontage at this date are depicted in an historic photograph, dating to 1901-2 (Plate 8). This shows 7-9 Lower Hillgate to have comprised a four-storey building occupied by JC Arnfield, a manufacturing pharmaceutical chemist. The ground floor of the building incorporates a shop window frontage, indicative of its use as retail premises.

- 6.3.5 The chemists' shop itself quite probably dates to this period of rebuilding of the Rostron Brow frontage, and was certainly constructed in a style typical in the region in the mid-nineteenth century, with vertical sash windows and little or no architectural embellishment above the ground floor (Plate 8).

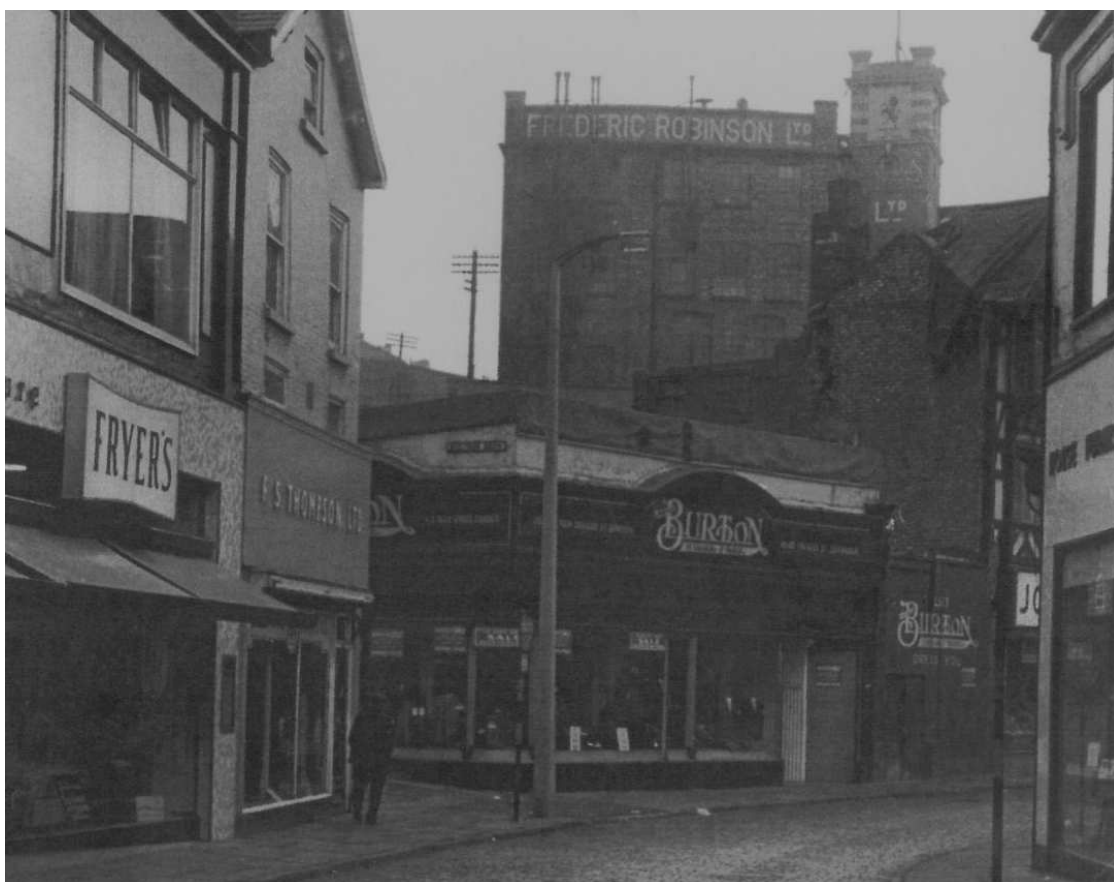
Plate 11: 7-9 Lower Hillgate in 1963, showing the upper floors of the building removed

- 3.2.10 The next available edition of Ordnance Survey mapping, published in 1959 (Fig 7), shows a similar layout of buildings, although the structure between 9 and 11 Lower Hillgate, incorporating the narrow passage from the street frontage to the rear of the property, appears to have been rebuilt. A photograph of the building taken in 1963, however, shows the upper floor of 7-9 Lower Hillgate to have been demolished, leaving a single-storey shop (Plate 11). Whilst the fabric of the surviving ground floor is likely to have been the vestiges of the eighteenth-century building, a new shop-front window is shown to have been installed, further reducing the historic integrity of the building.

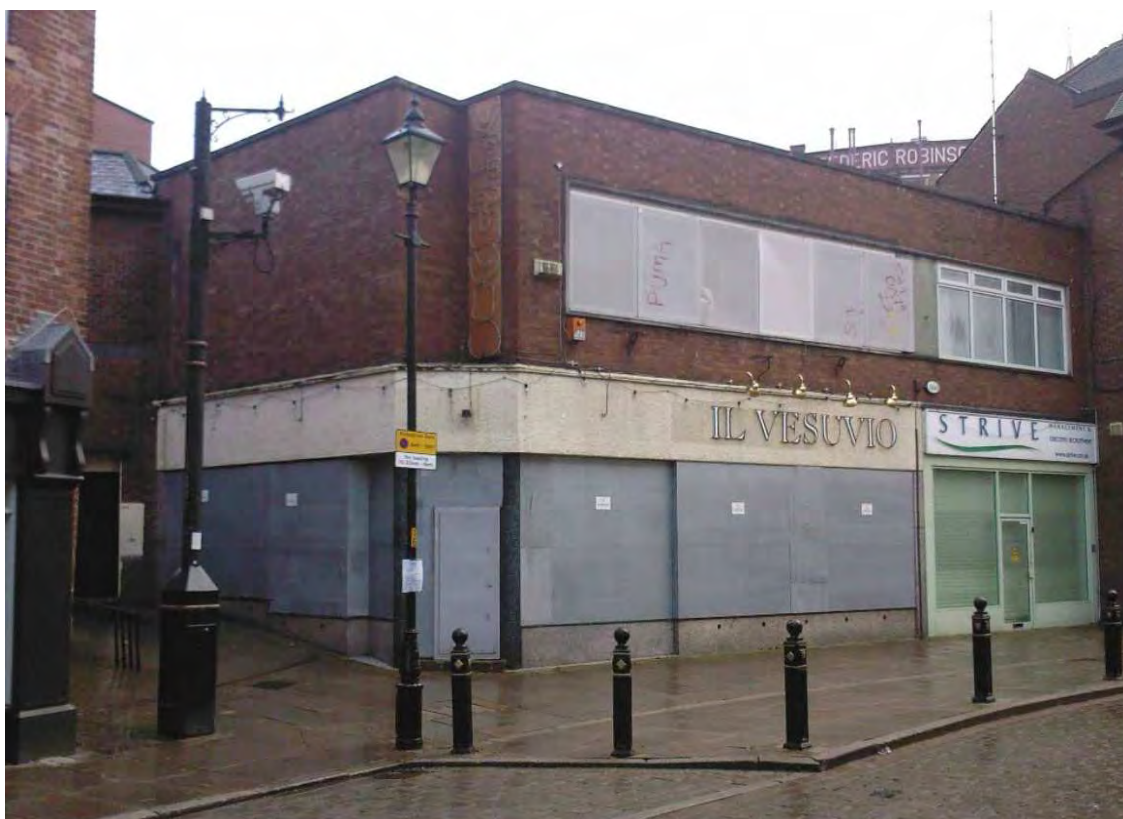
Plate 12: Recent view of 7-9 Lower Hillgate prior to demolition in 2011

- 3.2.11 The subsequent edition of Ordnance Survey mapping, published in 1972, shows further remodelling of 7-9 Lower Hillgate (Fig 8), involving the construction of a new building. This redevelopment extended to the rear of the street frontage, along Rostron Brow, creating the structure that occupied the Scheme Area until 2011, when it was demolished. This building was occupied in the 1970s by the Newhall Discount Stores and, more recently became a restaurant and offices for a recruitment agency (Plate 12).

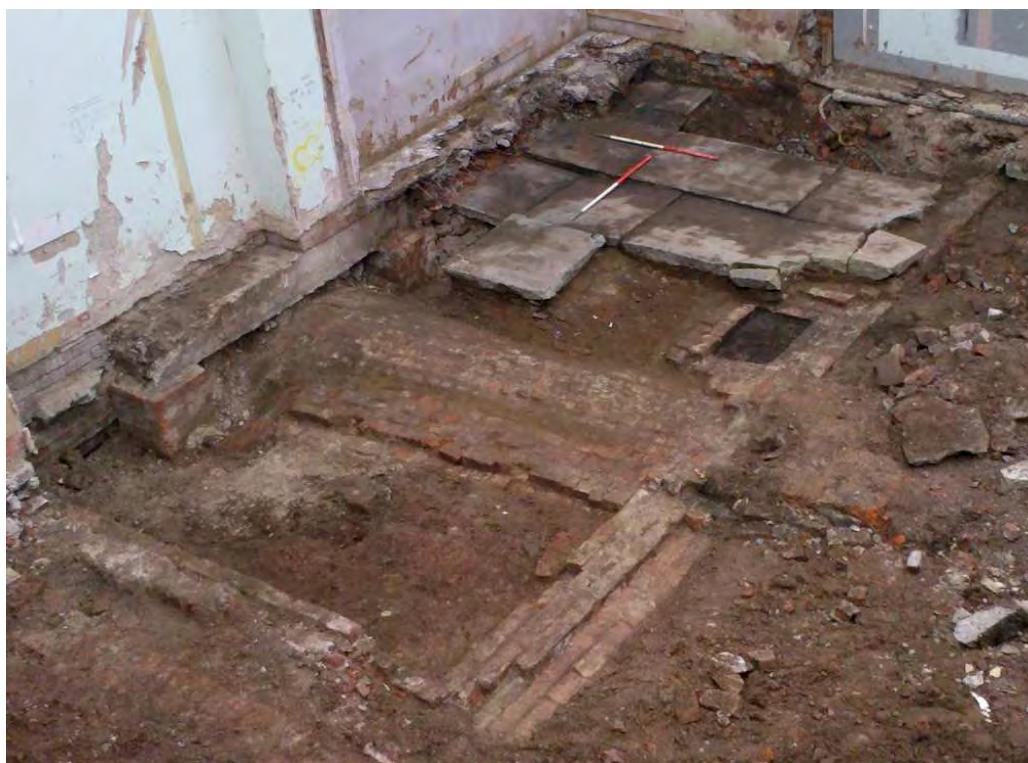
*Plate 13: Pre-excavation overview of the excavation area, facing south-west. The culvert (**106**) runs across the centre of the site.*

- 4.1.2 The area to the west of the culvert was occupied partially by a stone wall (**107**), which reduced the space within which a mechanical excavator could operate and precluded the reduction of the exposed demolition infill to the level of the underlying natural deposits. This area was too deep to allow further reduction by hand, and the proximity of standing structures presented a risk of undermining.

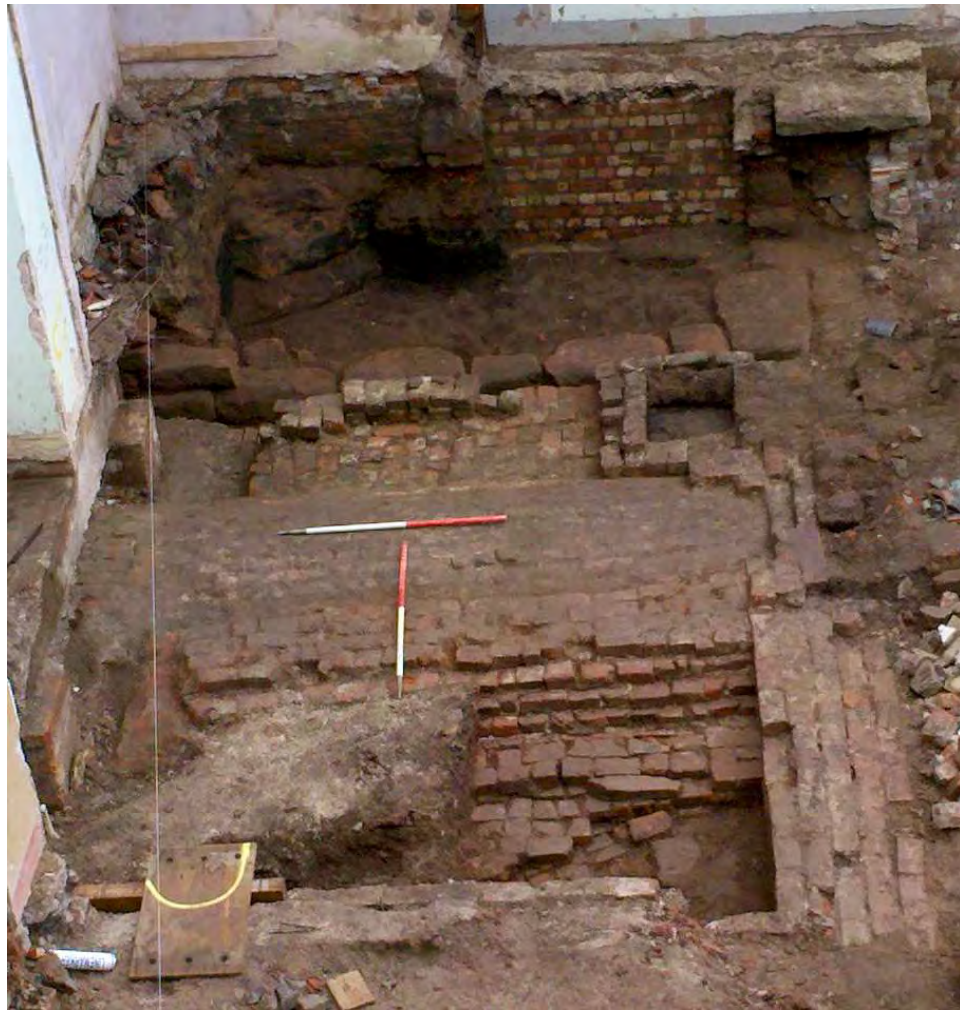
Plate 14: Post-excavation overview of the excavation area, facing west.

- 4.2.5 **Culvert 106:** a south-south-east/north-north-west-aligned culvert that contained flowing water was exposed across the centre of the excavated area (Plates 14, 20, and 21; Fig 10). This comprised vertical walls supporting a barrel-vaulted capping, and was constructed largely of hand-made bricks, with some limited use of sandstone, and was bonded with lime-based mortar, consistent with an eighteenth-century construction date. The culvert 3.96m wide and was exposed for a distance of 8m. The external faces of the walls had been obscured entirely by brick-built retaining walls. A rectangular aperture set into the crown of the culvert, exposed at the southern edge of the excavation area (Plate 21), is likely to have been an inspection chamber. The aperture had been blocked with a stone slab, over which lay a discrete deposit of clinker that had been used to infill the top of the chamber.

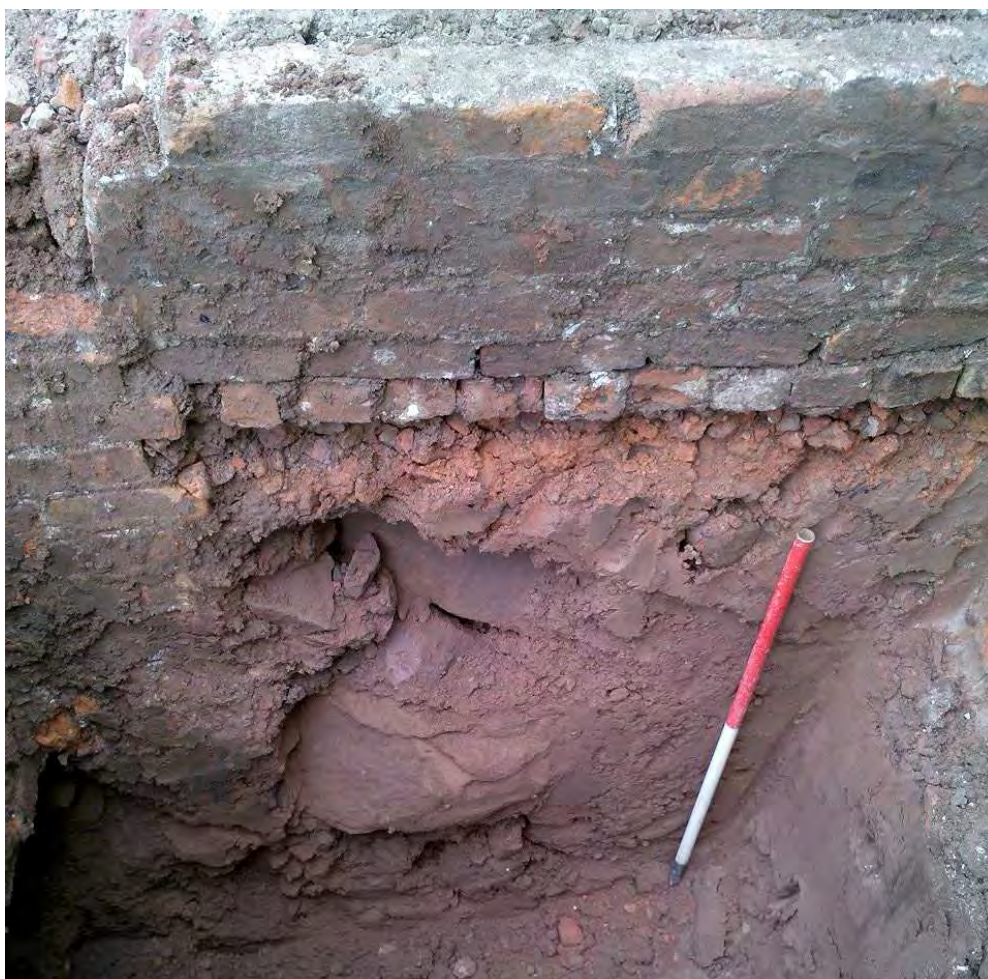
*Plate 15: Mixed sand and sandstone underlying the eastern part of the site*

4.2.1 **Natural deposits:** natural geological deposits were encountered in the eastern part of the excavated area (**108**; Fig 10), and comprised greyish-pink sandstone and sand (Plate 15). These deposits consisted of loose and mixed sand and stone, which might have resulted from disturbance or weathering, that overly directly solid and earthfast bedrock. Portions of solid sandstone bedrock were also exposed at the south-western corner of the excavation area (Fig 10; Plate 16).

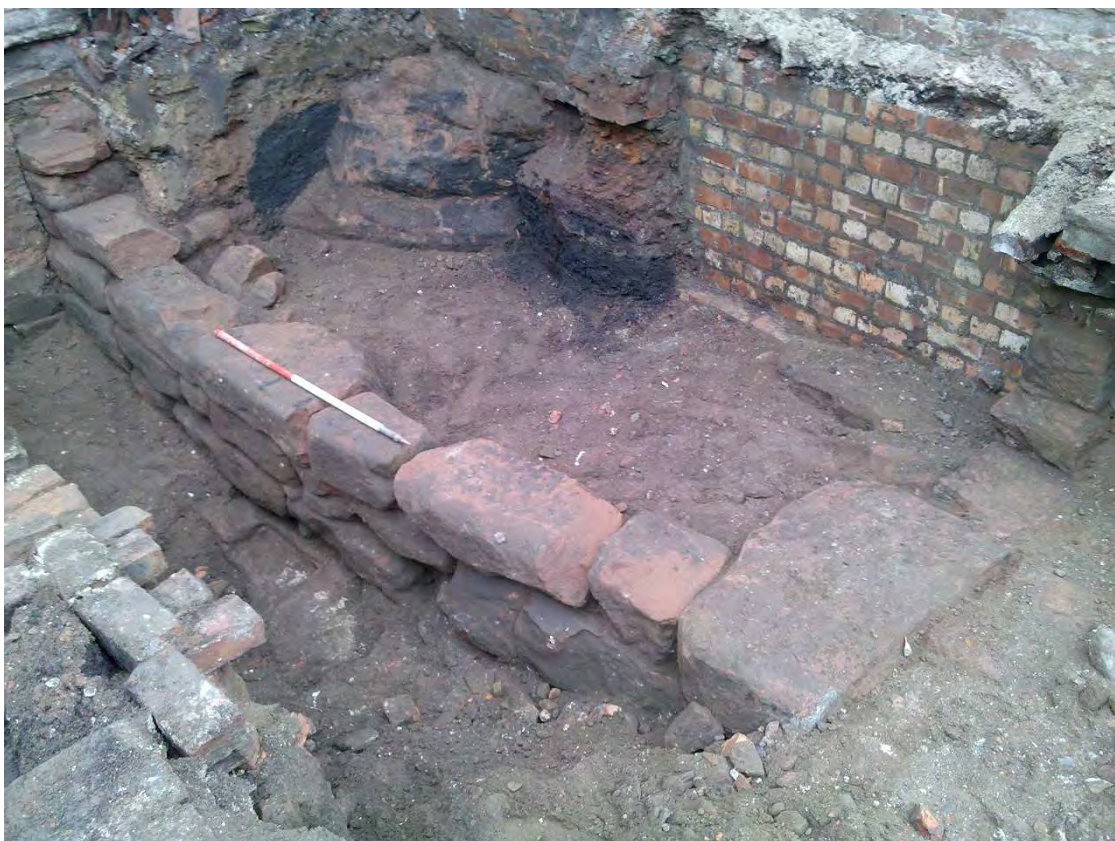
*Plate 17: Wall 107 looking south-west*

4.2.2 **Stone Wall 107:** a sandstone wall (**107**) was encountered at the western side of the site (Plates 17 and 18; Fig 10). This wall comprised large, roughly squared, sandstone blocks that each measured up to 1m long by 0.56m wide and 0.4m high. Portions of two sides of the wall were exposed that measured, in total, 5.5m long, a maximum of 0.56m wide, and 1.77m high. The two sections were orientated north-north-west/south-south-east and east-north-east/west-south-west, and had been incorporated into the lower walls of the structures standing to the south and west (Plates 17 and 18). Parts of seven courses of the wall were exposed.

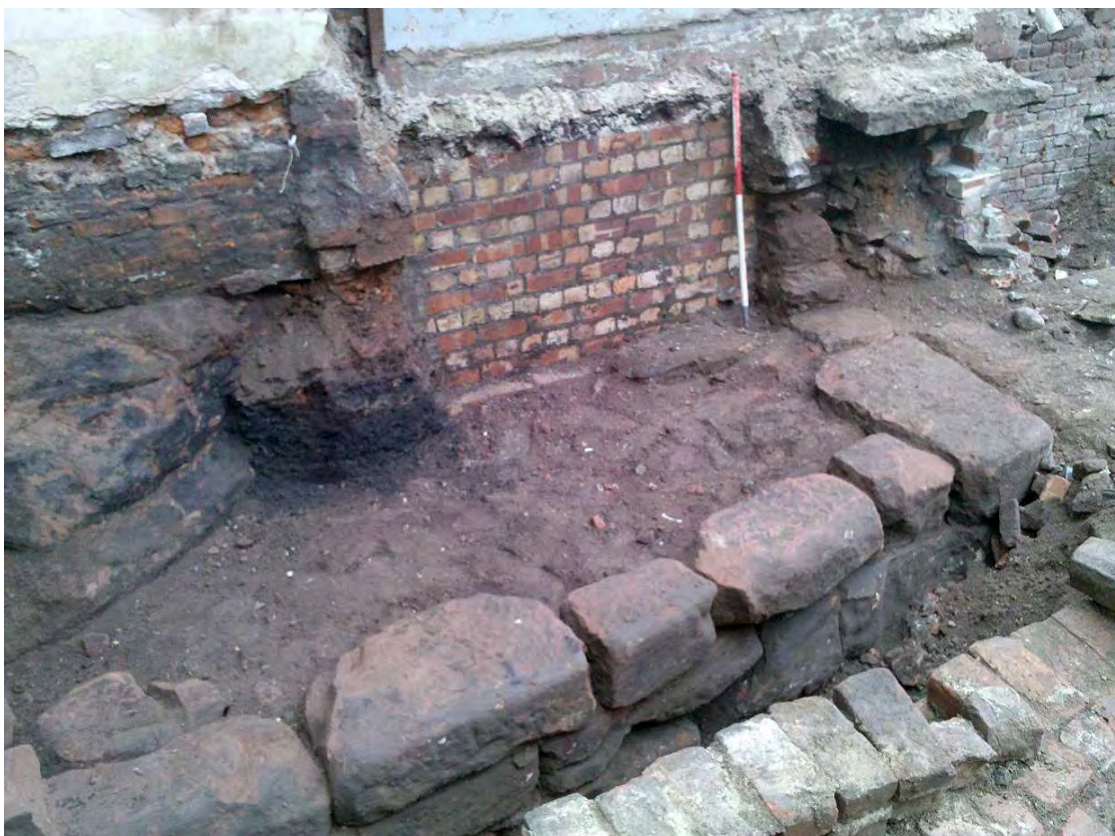
*Plate 18: Wall 107 looking west*

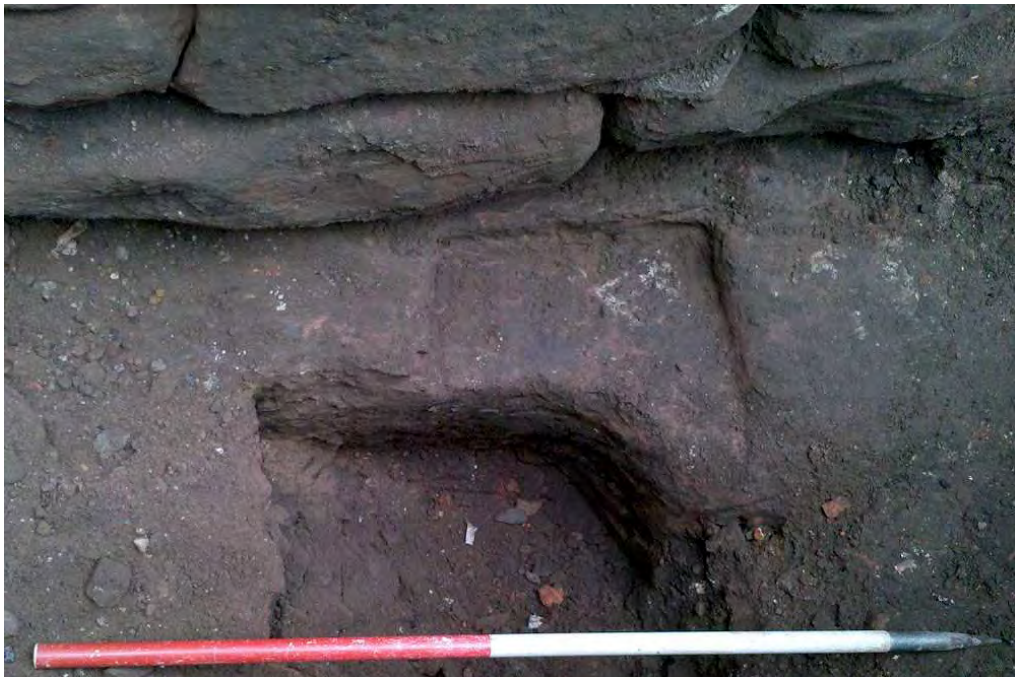
Plate 19: A worked stone stepping out at the base of wall 107

- 4.2.3 The wall foundations were not exposed entirely for health and safety considerations, although a sandstone block encountered at the base of the excavated section almost certainly represented a stepped foundation (Plate 19). The block appeared to have been reused from an earlier structure, as it featured a square recess, measuring approximately 0.4m square and 30mm deep, that had apparently been made redundant by the shaping of the block to form an approximate rounded right-angle. The shape of the recess was consistent with the profile of a large structural timber, and could perhaps have been intended to support the base of a timber upright. This may have formed part of a timber-framed superstructure, or an internal feature such as a gate or doorway, although corroborating evidence was lacking.

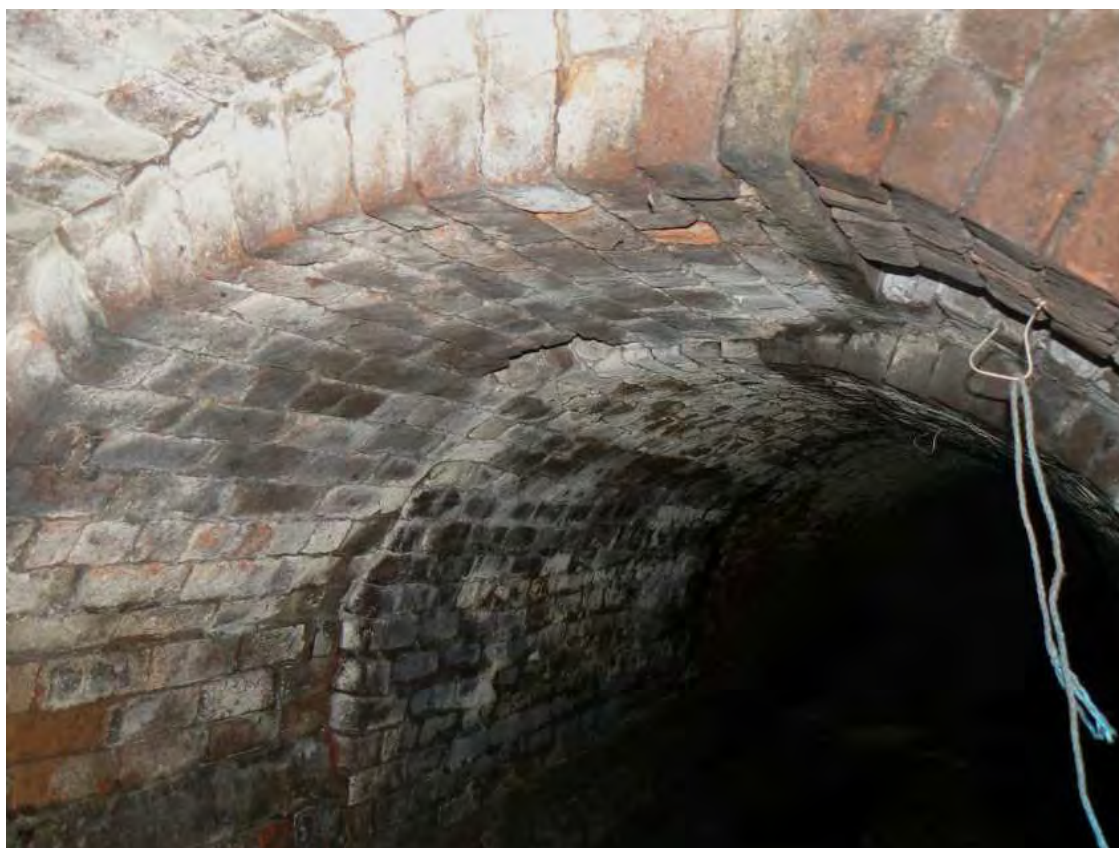
*Plate 20: View of the interior of Culvert 106*

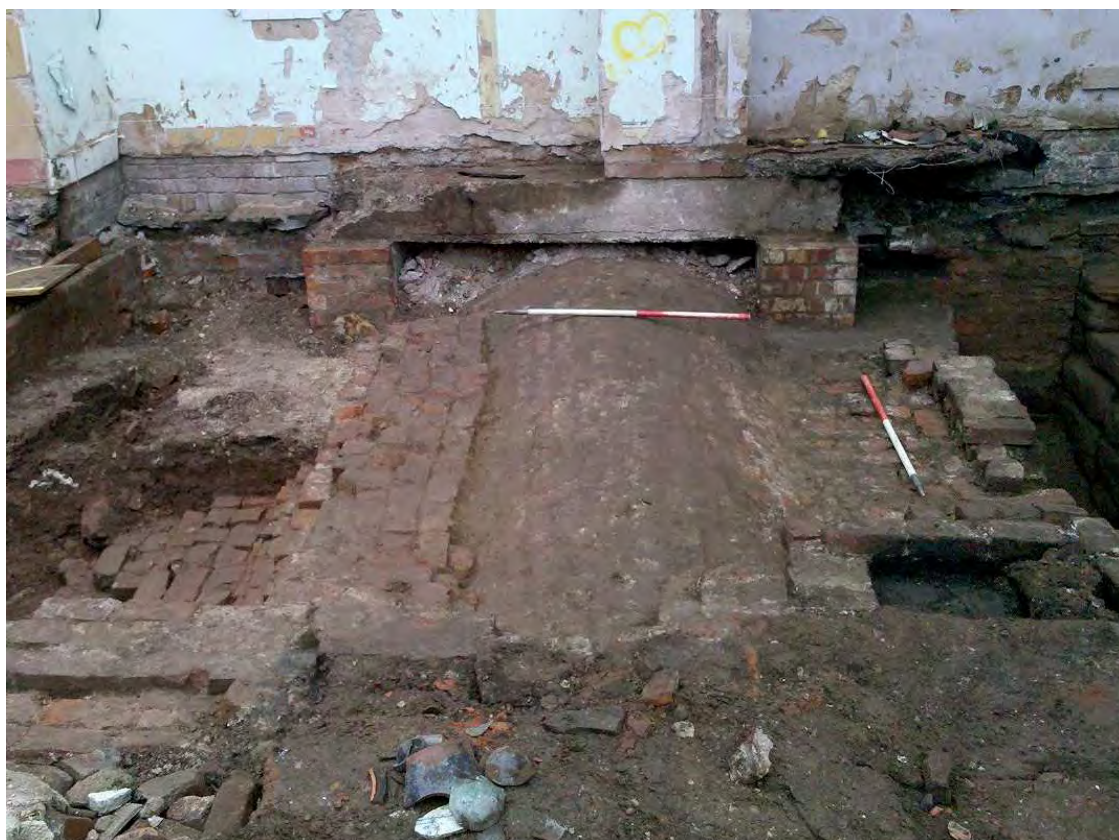
*Plate 21: The brick-built capping of culvert 106 and the associated retaining walls, looking south*

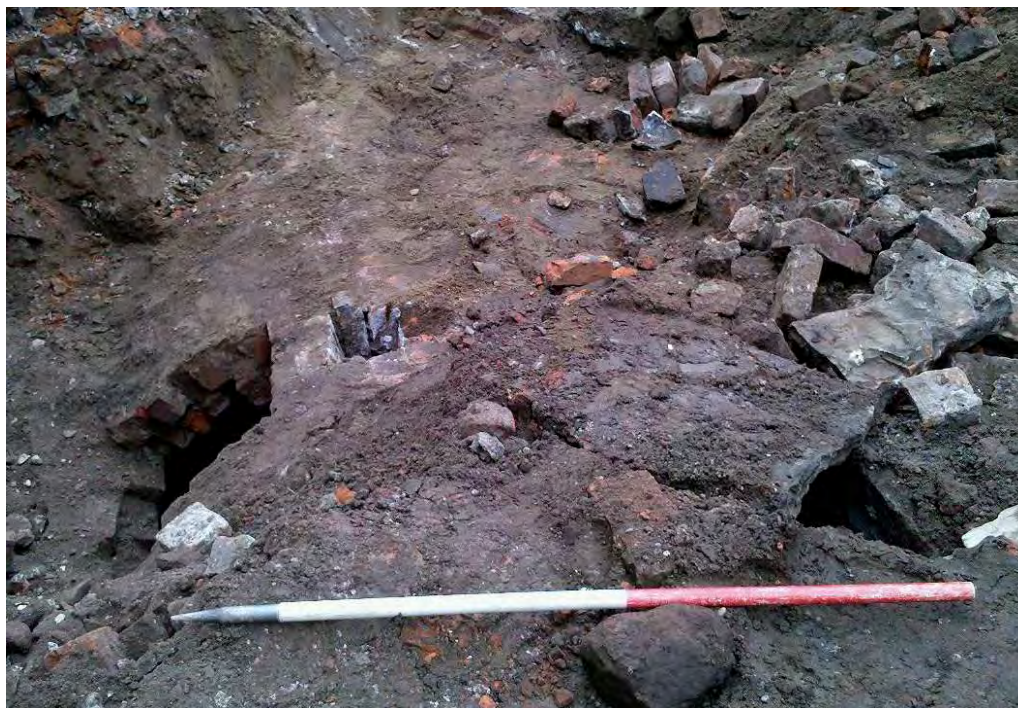
*Plate 22: An additional section of culvert 106 extending northwards from the excavation area, looking north-west*

- 4.2.6 The mechanical removal of demolition debris from beyond the area targeted for archaeological excavation exposed an adjoining section of the culvert. This ran at a slight angle from the northern end of the excavated section, and was aligned north-west/south-east (Plates 22-3).

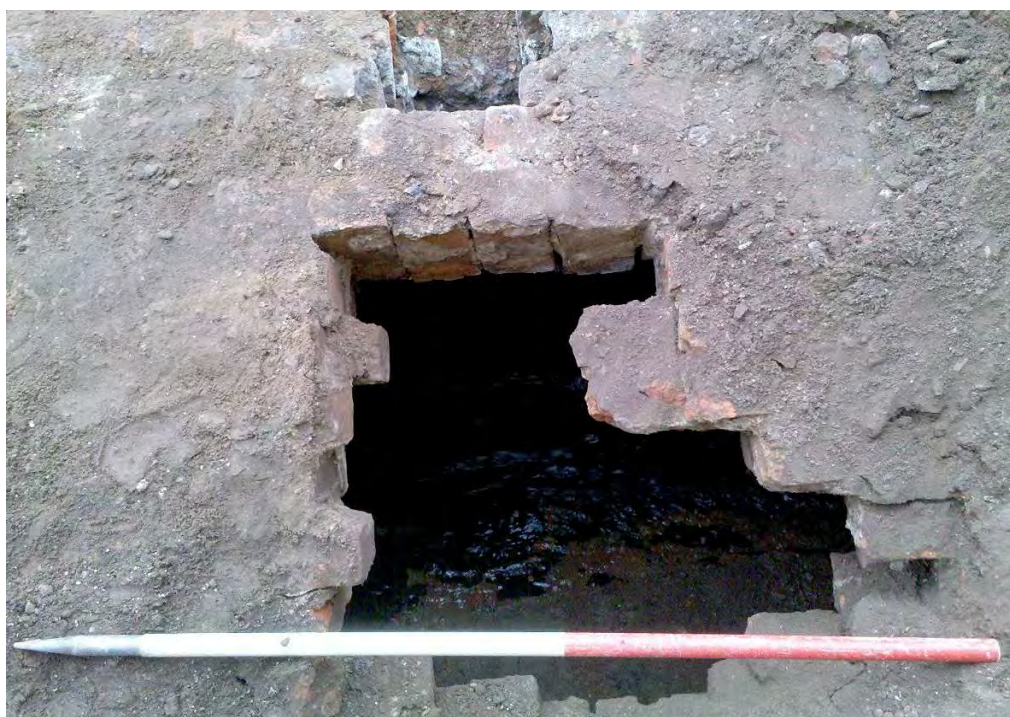
*Plate 23: View through an aperture within the culvert revealing flowing water within*

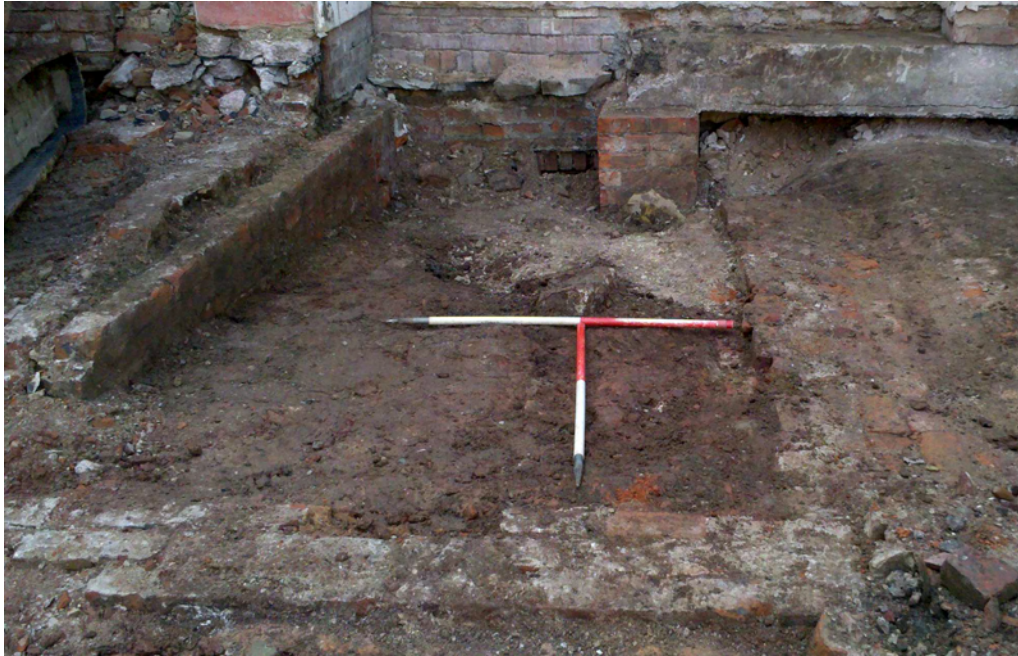
Plate 24: Soil deposit 104 overlying the eastern side of culvert 106, looking south-south-east

- 4.2.7 **Soil deposits 104 and 105:** the lower levels of brickwork that formed the buttresses of the culvert (106) were overlain by deposits of silty clay and sandy silt that formed a mixed mineral soil (Plate 24; Fig 9).

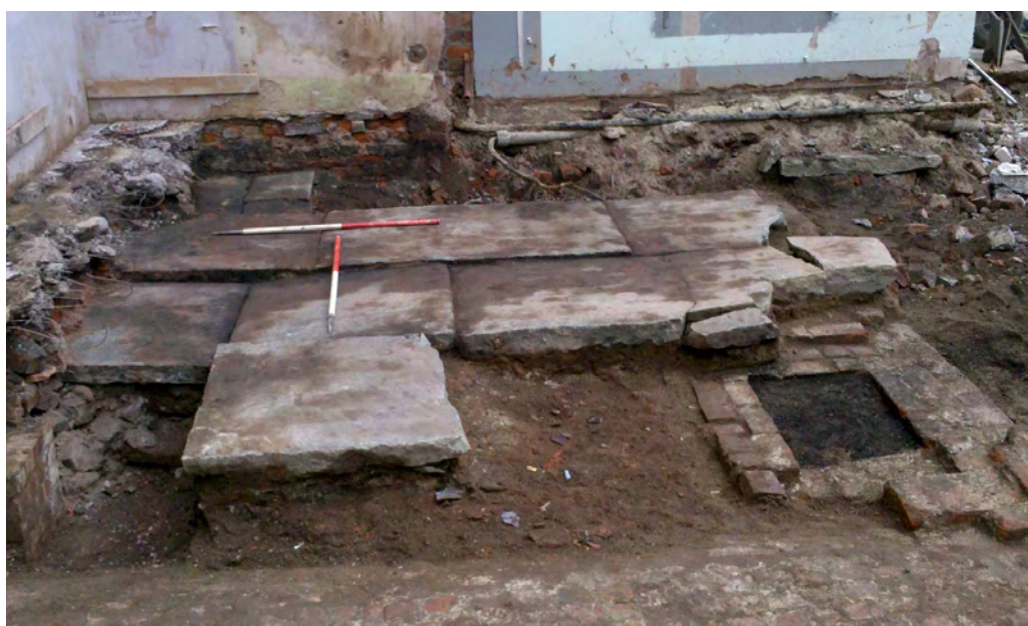
Plate 25: Stone flags 101, in the foreground and 102 to the rear of the image. Looking west

- 4.2.11 **Flagstone surface 101 and 102:** the demolition infill (109), mixed soil (106), and the western side of the culvert were all overlain by a layer of sand (103), which provided a bedding layer for two portions of flagstone flooring (Plates 13 and 25; Fig 9). The two surfaces were at a similar level and lay contiguous with each other, suggesting that they were contemporary, or that the difference in materials might have reflected modifications during the use of the surface. The larger flags (101) were very substantial slabs and measured up to 1.5m long and 0.92m wide, by 140mm thick. Conversely, the smaller flags (102) measured up to 0.48m long by 0.36m wide and 50mm thick. The overall area occupied by the surface, as exposed during the excavation, was approximately 10.85m<sup>2</sup>.

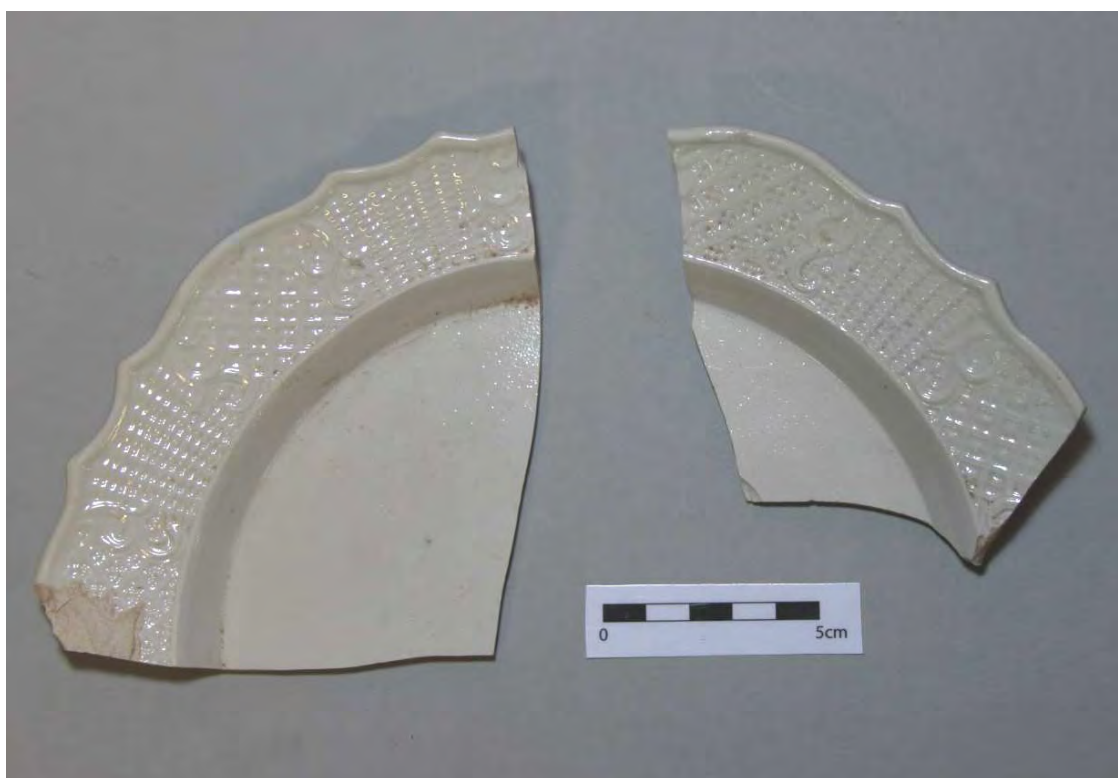
*Plate 31: Fragments of a salt-glazed press-moulded plate*

- 4.3.7 Two large fragments of a salt-glazed press-moulded plate, also unstratified, might date to around the 1740s, and are typical of Staffordshire production (Plate 31). In general terms, white salt-glazed stoneware was one of the Staffordshire kilns most successful wares, competing and supplanting tin-glazed earthenware (Barker 2008), and it is quite likely that the vessels from this site are Staffordshire products. Several other fabrics were also recovered, comprising Yellow ware, Agate ware, Creamware and Whieldon ware, with the last two dating the to the 1760s to 1780s (Barker 2008; Draper 1984).

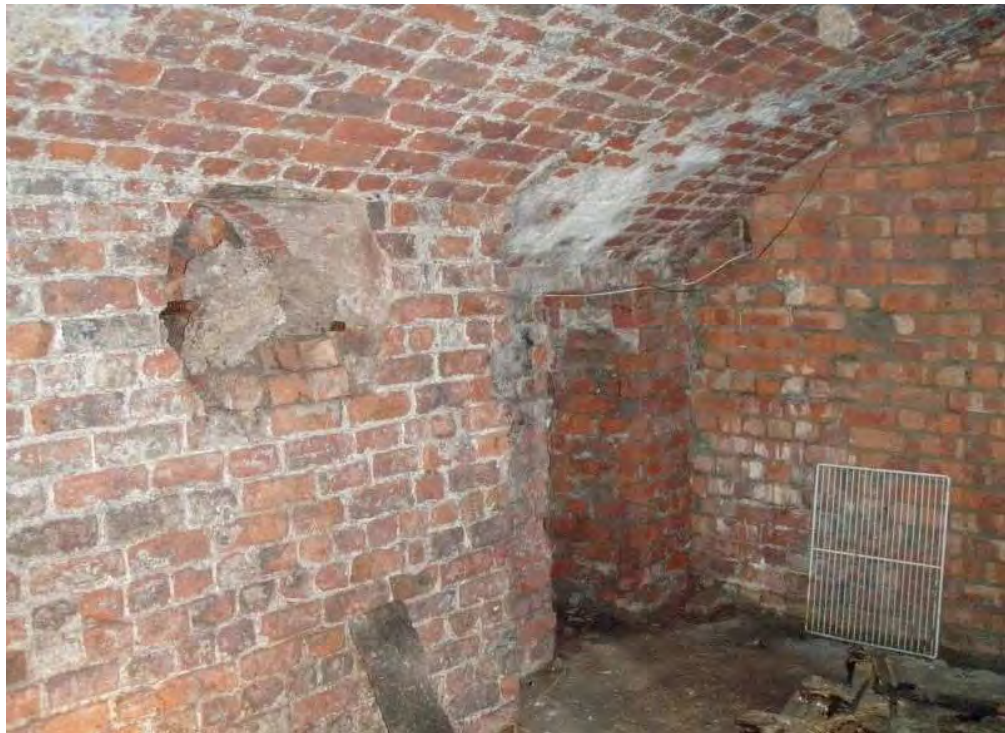
*Plate 32: Hand-made brick construction of vaulting, with blocking wall and inserted entrance*

- 5.2.2 Approximately 18ft (5.49m) from the extant southern end of the undercroft, which coincided with the point where the vaulting survived intact following demolition of the associated structures, the vaulting sloped towards the north-east (Plate 33). What little remained of the crown of the vaulting to the south-west of this point appeared to form part of a single construction to that within the sloping section of the undercroft to the east (Plate 33). The crown formed a slightly irregular segmental arch of single-brick thickness (Plate 33), comprising entirely headers in the sloping eastern section, but seemingly constructed in an approximation of English bond (comprising alternate courses of headers and stretchers) in the level western part of the undercroft. A rough joint, with broken-brick infilling was observed within the south wall at the interface between the level and sloping elements of the undercroft (Plate 34). To the east, the wall sloped on a similar angle (approximately 20°) to the crown above (Plate 34), and the irregular junction between the two elements of the wall probably simply reflected the simplest way to accommodate the change in angle of the wall. All elements of the vaulting were bonded in a mortar type similar to that described above, and several sections of the walls and vaulting retained patches of limewash (Plates 32-34).

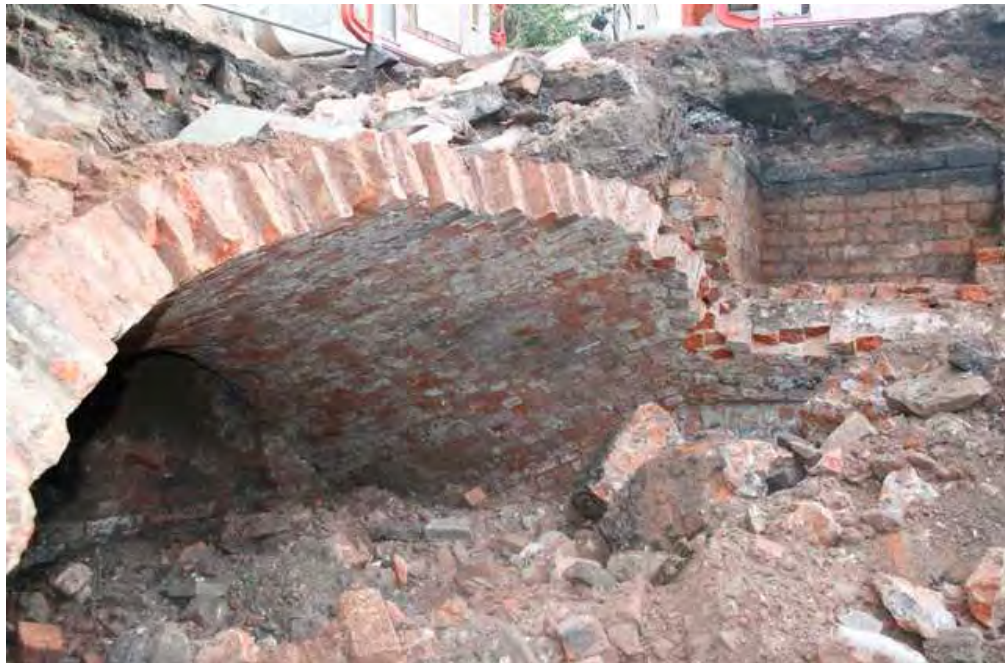
*Plate 33: Sloping vault of undercroft observed during groundworks*

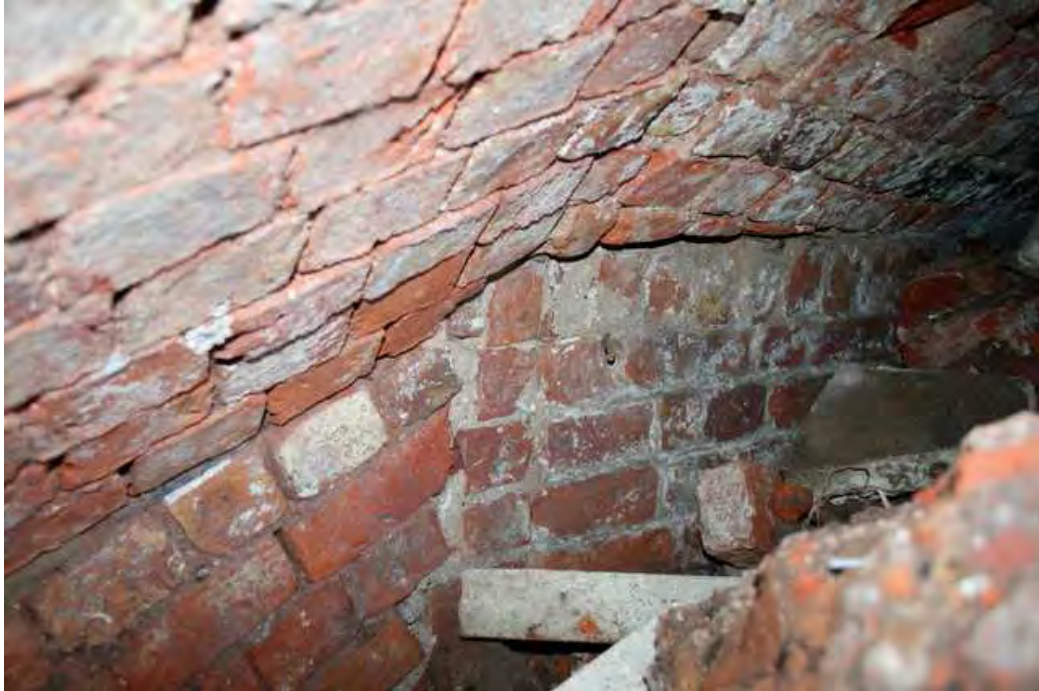
*Plate 34: Irregular joint between sloping and level sections of vault side wall*

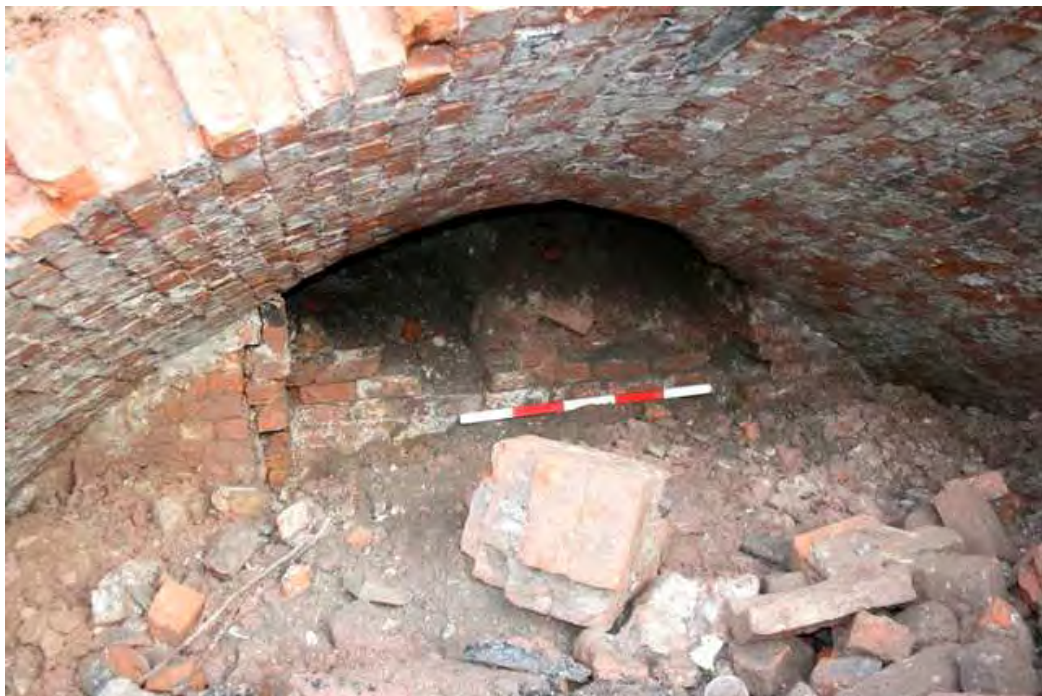
*Plate 35: Inserted aperture in eastern end wall of undercroft*

- 5.2.3 The sloping element of the undercroft measured only 6ft 6in (1.98m) long, culminating in a substantial brick return at its eastern end (Fig 11). This was of three-bricks thickness (32in (0.81m)), and was of similar construction to the other elements of the structure. It had been cut centrally to form a 6ft (1.83m) wide aperture (Plate 35), which possibly formed a window or cellar light, although no framing for such a feature was observed. The aperture was infilled with a single-skin brick wall, to within 29in (0.74m) of a flat external brick

lintel, bonded in a white lime mortar. The open area below the lintel was filled with demolition rubble, typical of the early to mid-twentieth century.

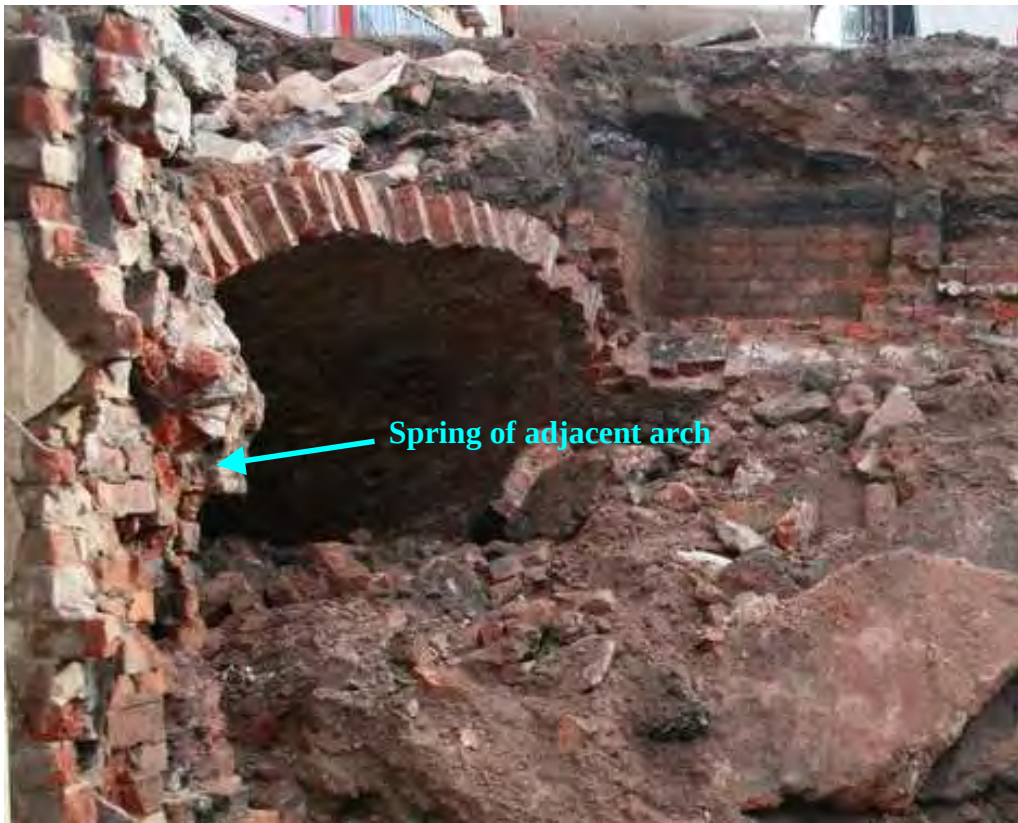
*Plate 36: Broken north wall of vaulting, with stub of adjacent vault identified*

demolition of this undercroft, the dividing wall between the two structures was butted by two walls of full-brick thickness, bonded in pale brown sandy cement mortar, and continuing above the height of the earlier crown (Plate 36).

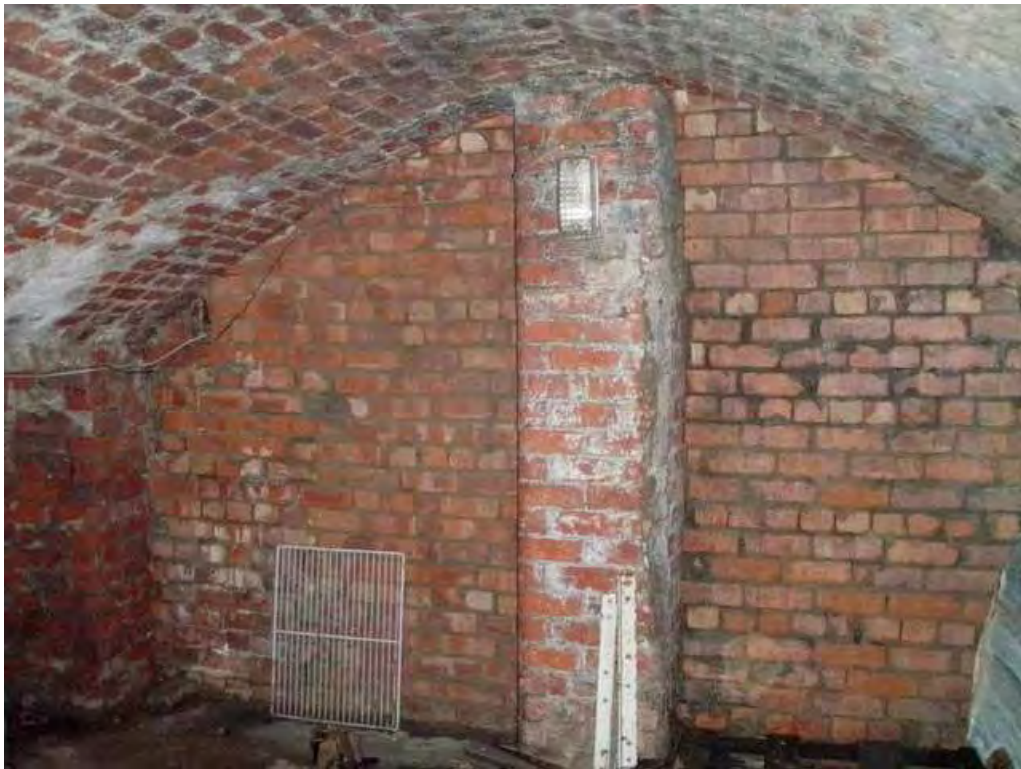
*Plate 37: Inserted brick pillar, blocking walls and rebuilt vaulting at west end of undercroft*

- 5.2.5 At its western end, the undercroft had a centrally placed, two-brick square, pillar (Fig 11; Plate 37). This was constructed using similar brick to that used within the vaulting, but was bull-nosed around each corner, and bonded with a wider bed of pale cement-based mortar (Plate 37). The end of the undercroft was blocked either side with brick walls, each of  $1\frac{1}{2}$  brick thickness, but apparently of different date. That to the north of the pillar was constructed using a majority of salt-glazed brick, built in three-stretcher English Garden Wall bond, and with oozing beds of dark grey, cement-based mortar (Plate 37), suggesting that it had been erected from the western side. To the south, the blocking wall comprised more orangey, machine-made brick, bonded in a paler, mid-grey cement mortar, in five-stretcher English Garden Wall bond (Plate 37). This wall contained an inserted and subsequently blocked 2ft (0.61m) wide low aperture at its southern end, the blocking being undertaken with re-used hand-made brick in a combination of English and English Garden Wall bond (Plate 37).

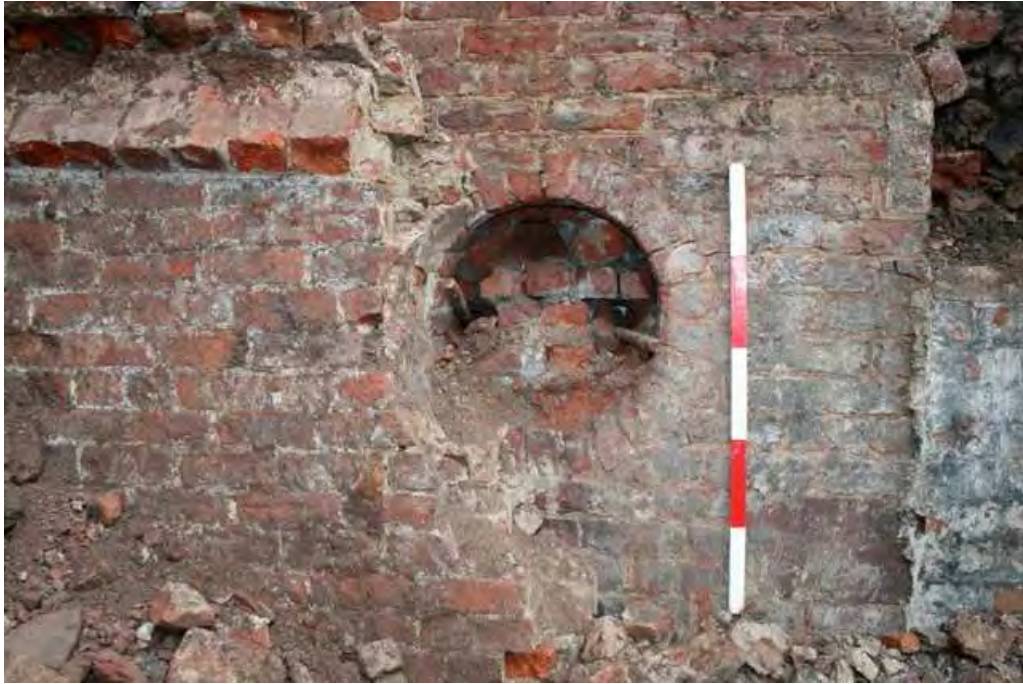
*Plate 38: 'Oeil de boeuf' aperture behind later vault wall, with arched door jamb to right, including sandstone pad near exposed base*

sandstone block, and was truncated during the construction of the vaulting of the undercroft. A single-skin brick floor between these two north-west/south-east-aligned walls dated to the construction of the vaulting, being bonded in similar mortar, and almost certainly representing a structural capping of the joint between the vault wall and the earlier wall behind it.
