**7 – 9 Lower  
Hillgate,  
Stockport,  
Greater Manchester**

**Archaeological  
Investigation**

**Oxford Archaeology North**

November 2011

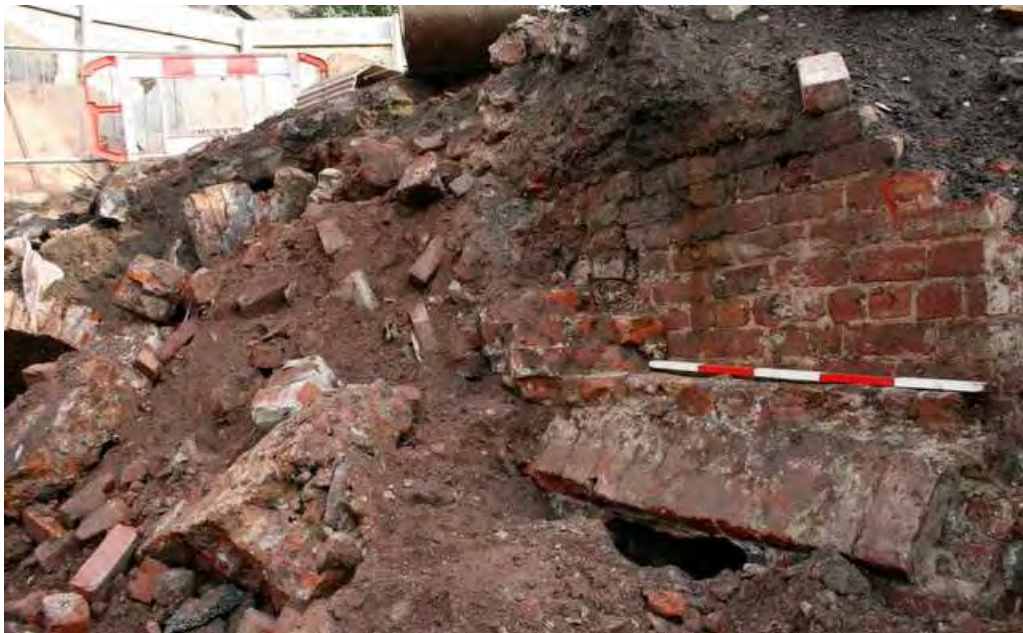
*Plate 39: Earlier wall extending above undercroft vaulting, with brick infill between*

sandstone block, and was truncated during the construction of the vaulting of the undercroft. A single-skin brick floor between these two north-west/south-east-aligned walls dated to the construction of the vaulting, being bonded in similar mortar, and almost certainly representing a structural capping of the joint between the vault wall and the earlier wall behind it.

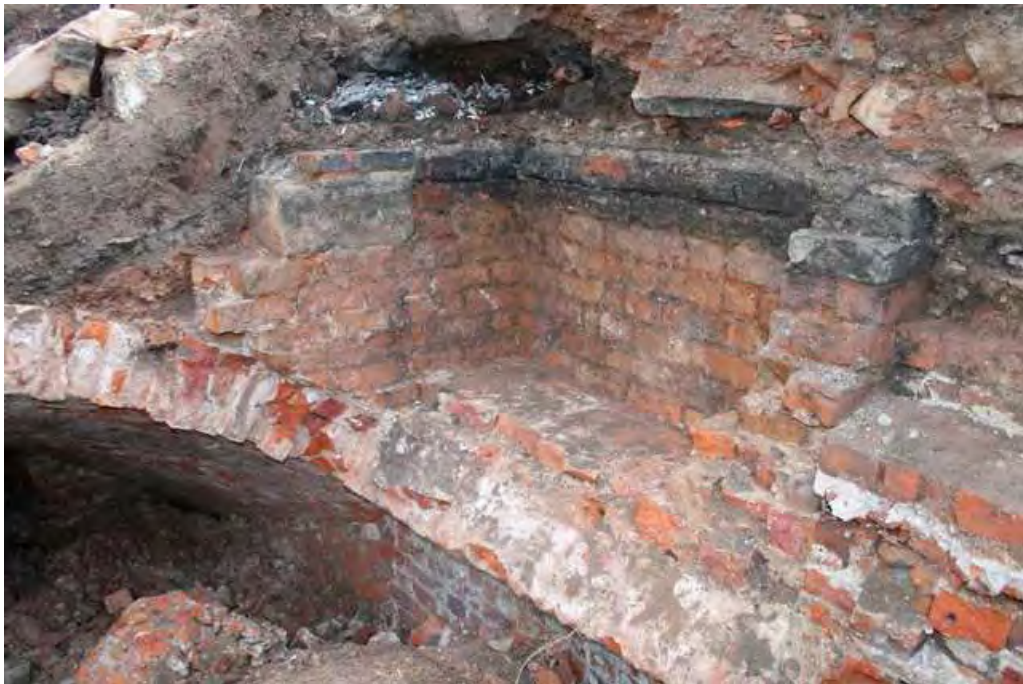
Plate 40: Truncated returns of earlier walls above undercroft vaulting

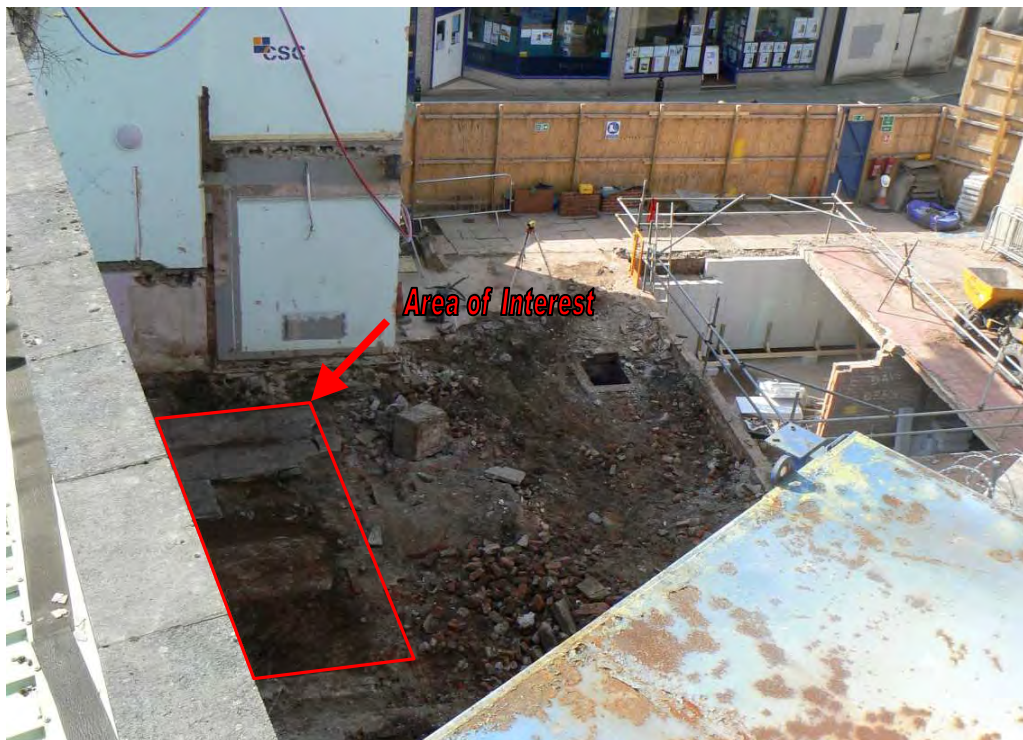
Figure 1: View across the development site, marking the location of the excavation area

3.2.1 **General Methodology:** it is proposed that an area measuring approximately 6 x 3m along the south-eastern boundary of the development site is subject to full archaeological excavation and recording (Fig 1). The archaeological potential of this area was identified during the demolition and clearance of modern buildings, when a buried soil horizon and fragments of seventeenth- and eighteenth-century pottery were identified.

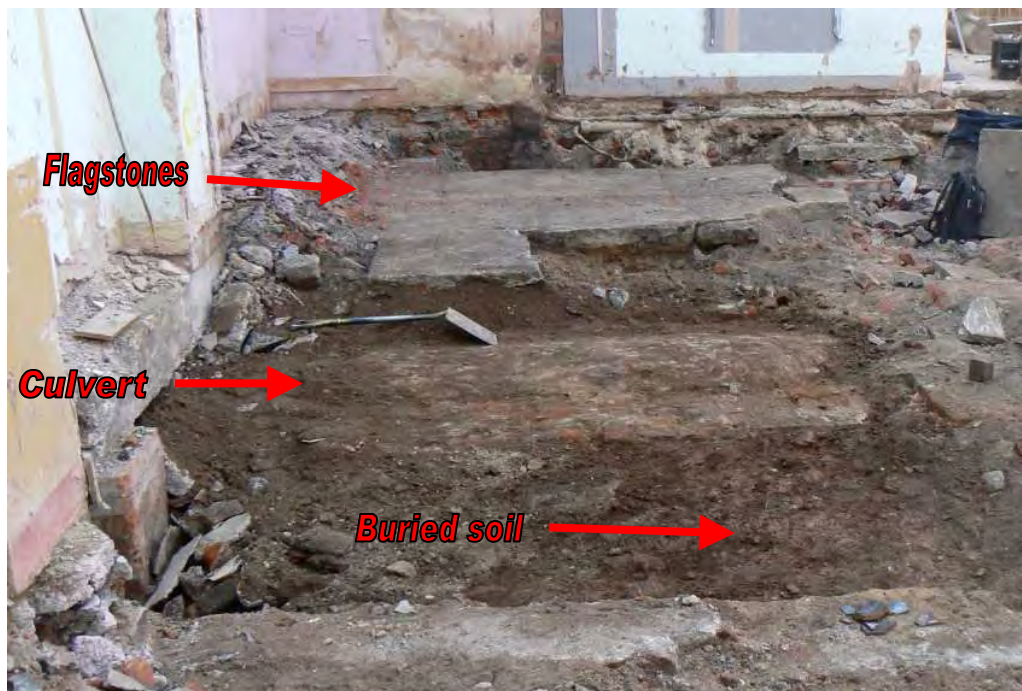
Figure 2: View across the proposed excavation area

3.2.2 Whilst a mechanical excavator will be required to remove a series of flagstones along the western part of the excavation area (Figure 2), all excavation will be carried out subsequently using exclusively manual techniques. Excavation will continue to the level of natural geological deposits, enabling a detailed record to be compiled of all overlying deposits and archaeological features.

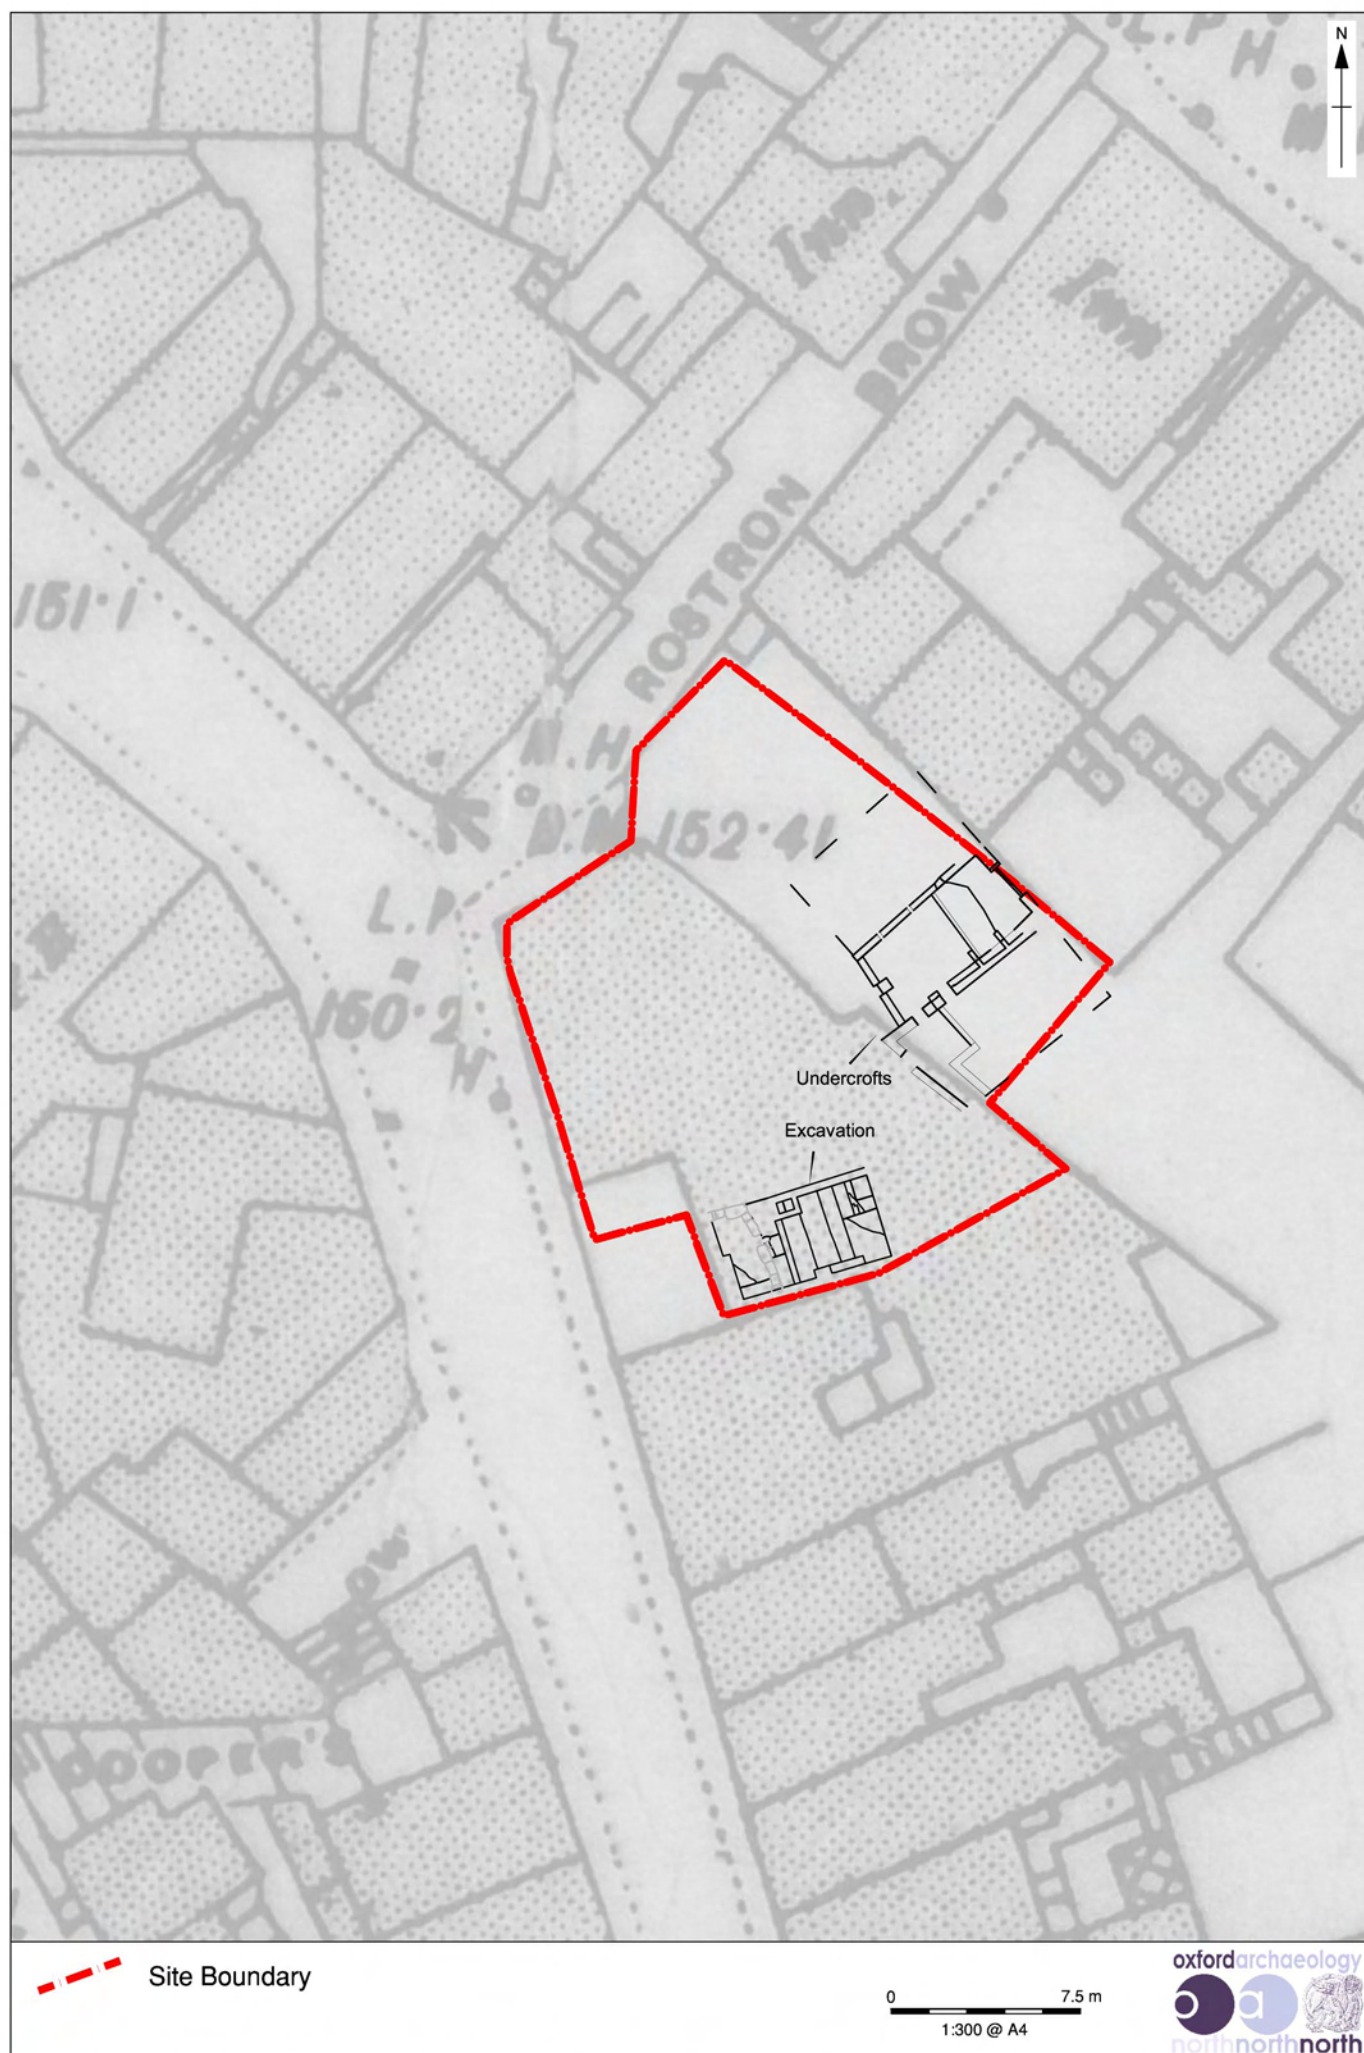
Figure 4: Site boundary superimposed on an extract from the Ordnance Survey map of 1895, showing location of the excavation area and undercrofts

- 3.2.6 The configuration of buildings within the Scheme Area is shown as largely unchanged on the next edition of detailed Ordnance Survey mapping, surveyed in 1873 and published in 1882 (Fig 3). The subsequent edition of Ordnance Survey mapping, however, surveyed in 1893 and published in 1895 (Fig 4), shows that the Scheme Area had been subject to considerable remodelling. Whilst the footprint of 7-9 Lower Hillgate remains largely unchanged except for the infilling of the covered passage from the street frontage, the adjacent building in the south-eastern corner of the Scheme Area is shown to have been demolished. Similarly, the buildings to the rear of the Lower Hillgate frontage have also been cleared, together with the covered alley leading to Crooked Passage. This was presumably in preparation for the creation of Harvey Street, which is named on the Ordnance Survey map of 1910 (Fig 5). The detail provided by this map shows some slight changes to the buildings within the Scheme Area, focused on the southern boundary of the site.

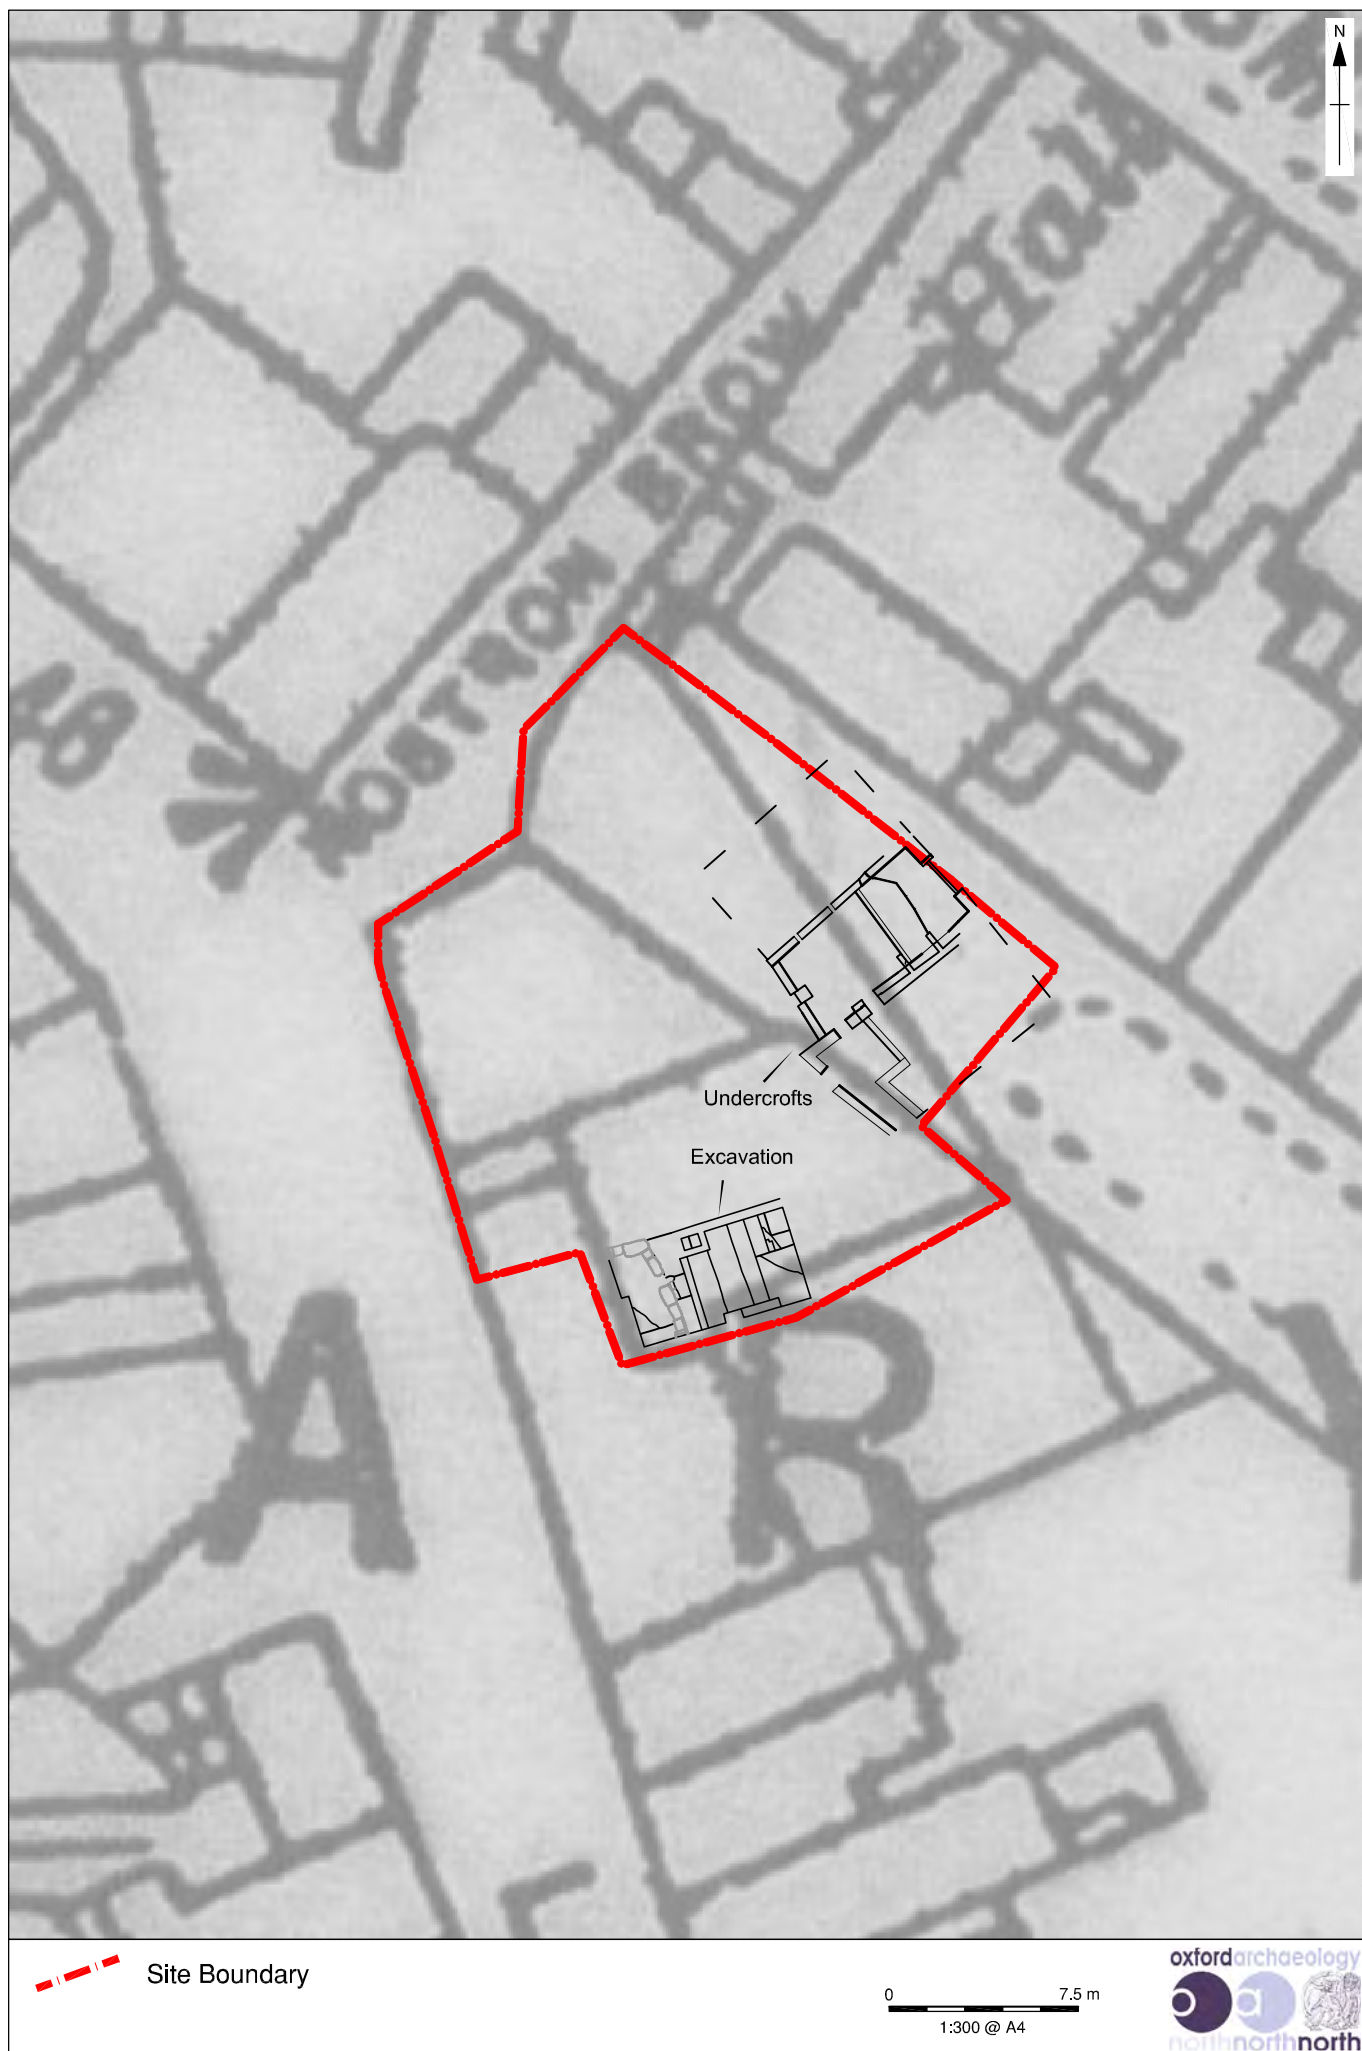
Figure 6: Site boundary superimposed on an extract from the Ordnance Survey map of 1936, showing location of the excavation area and undercrofts

- 3.2.9 Burton's remained as the occupants of 7-9 Lower Hillgate until the later 1960s, and was responsible for considerable remodelling of the building during their period of ownership. The detail provided by the Ordnance Survey map of 1936 (Fig 6) suggests that the southern part of the bank to the rear of the Lower Hillgate Street frontage was demolished, retaining only a boundary wall along the eastern side of the property. Access was seemingly afforded via a narrow passage from Lower Hillgate.

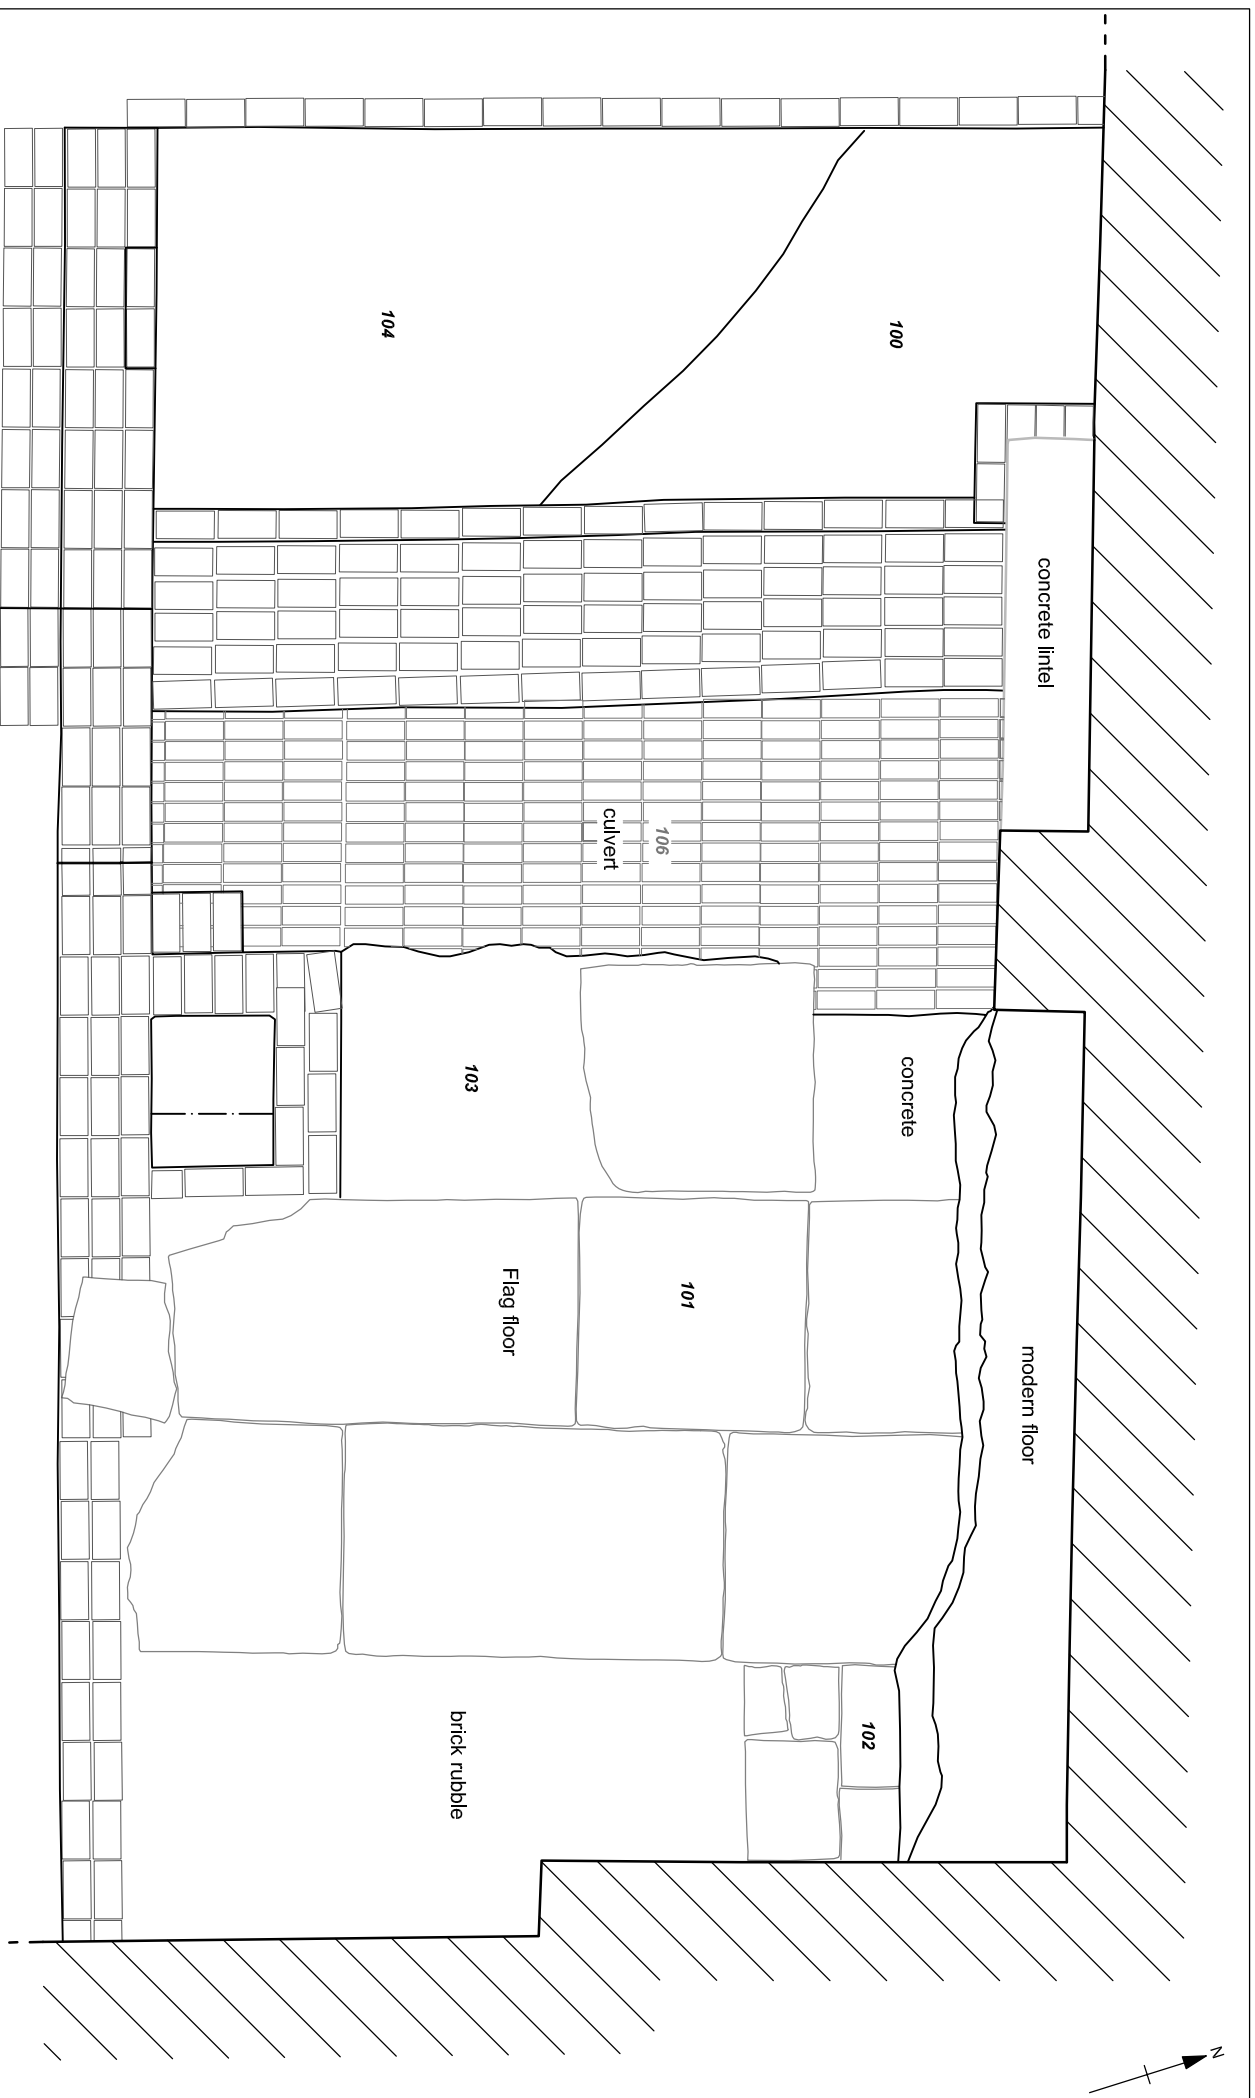
Figure 9: Plan of the excavation area following the removal of modern concrete surfacing

- 4.2.7 **Soil deposits 104 and 105:** the lower levels of brickwork that formed the buttresses of the culvert (106) were overlain by deposits of silty clay and sandy silt that formed a mixed mineral soil (Plate 24; Fig 9).
