BARN CONVERSION, HANKINSON'S FARM, MOSS SIDE LANE, STALMINE, POULTON-LE-FYLDE, LANCASHIRE

Archaeological Building Investigation

Oxford Archaeology North

June 2008

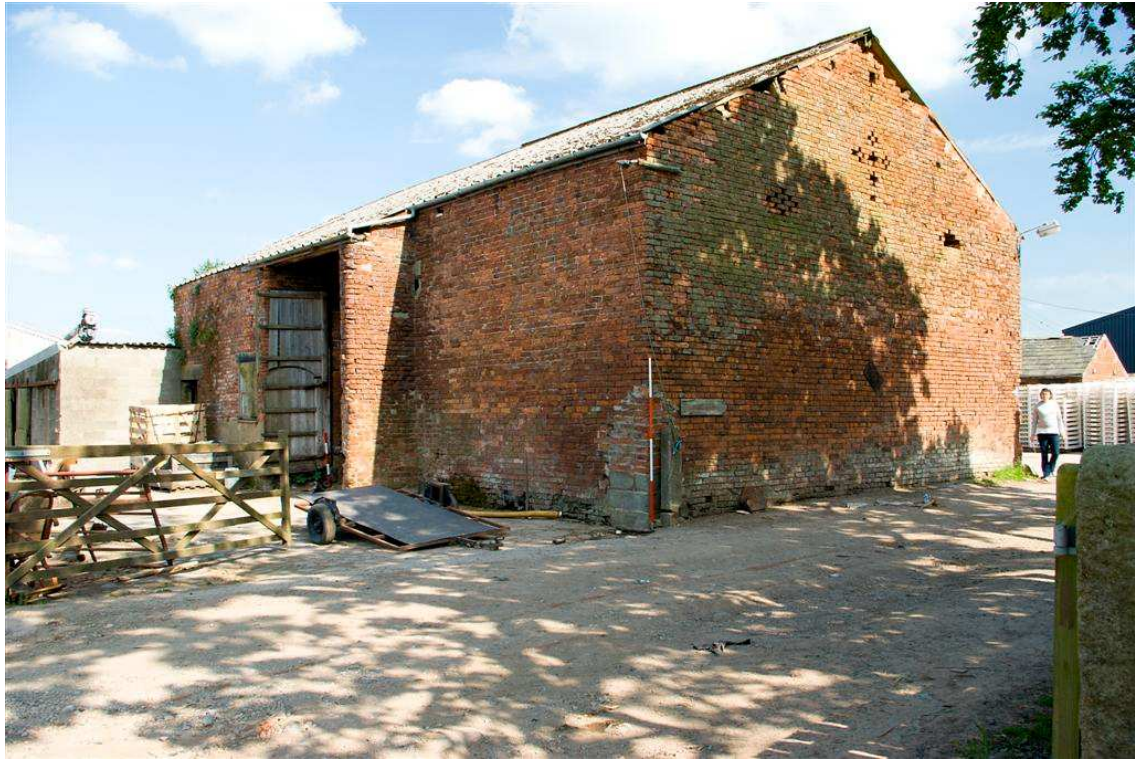
Plate 1: The barn at Hankinson's Farm, from the north-west

4.2.1 **Appearance and Layout:** the building is a small T-shaped rectangular structure, some 46feet (13.7m) long by 41feet (12.2m) wide (at the maximum extent of each projecting wing), the roof lying on a general east/west axis (Plates 1 and 2, Figs 9-11). It is of a single storey with a ground floor shippon, with loft space above at the east end. The main part of the barn consists of a high open space. The barn has a full height opening with porch at the north side. The building was being used as a general storage area at the time of the investigation. Two additional structures have been added to the main body of the barn that are of later phases. Inspection of both the barn and adjacent milking parlour revealed no evidence that they were previously connected.

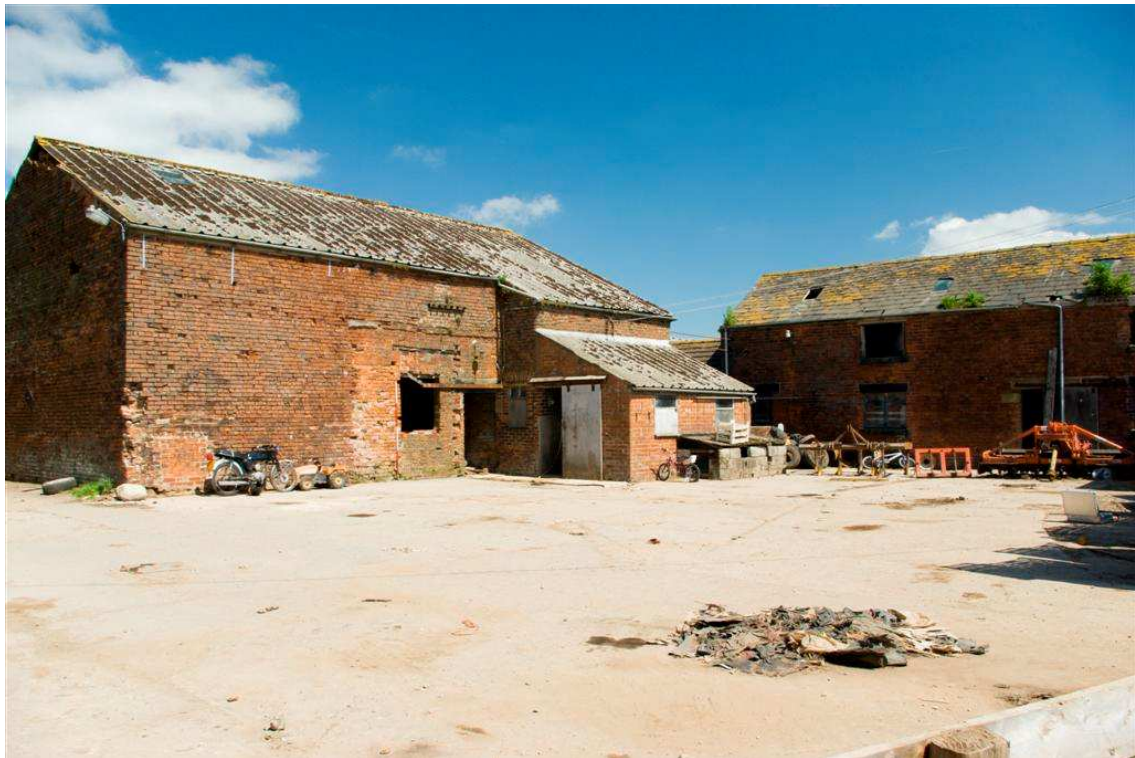
Plate 2: The barn at Hankinson's Farm, from the south-west

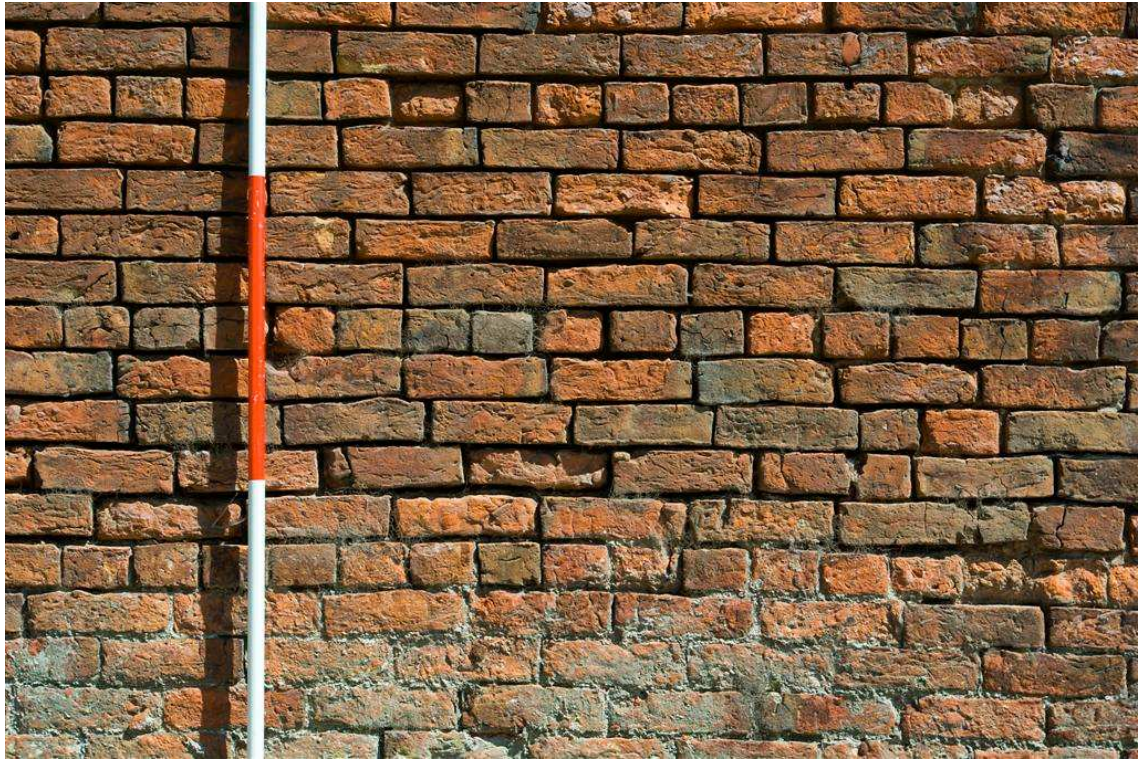
Plate 3: Example of the fabric of the barn showing the brick bond

4.2.2 **Fabric:** the whole of the core of the building is constructed from red hand-made brick (the clay probably sourced locally) of approximately 9¾ inches long by 2¾ inches deep and 4½ inches wide (Plate 3). The whole brick fabric is laid in variable English garden wall bond and the corners of the porch and south wing are of bullnosed brick. The mortar is lime, which is highly weathered in some places.

- 5.2.1 As far as is practicable, it is recommended that most of the hand-made brick fabric of the barn be retained during any conversion works. The internal cross wall in particular is interesting and should be retained. Also, it is suggested that the layout of the barn be unchanged since this has survived relatively intact since its construction. The south outshut and north-east cinder block structures are of no historical value.

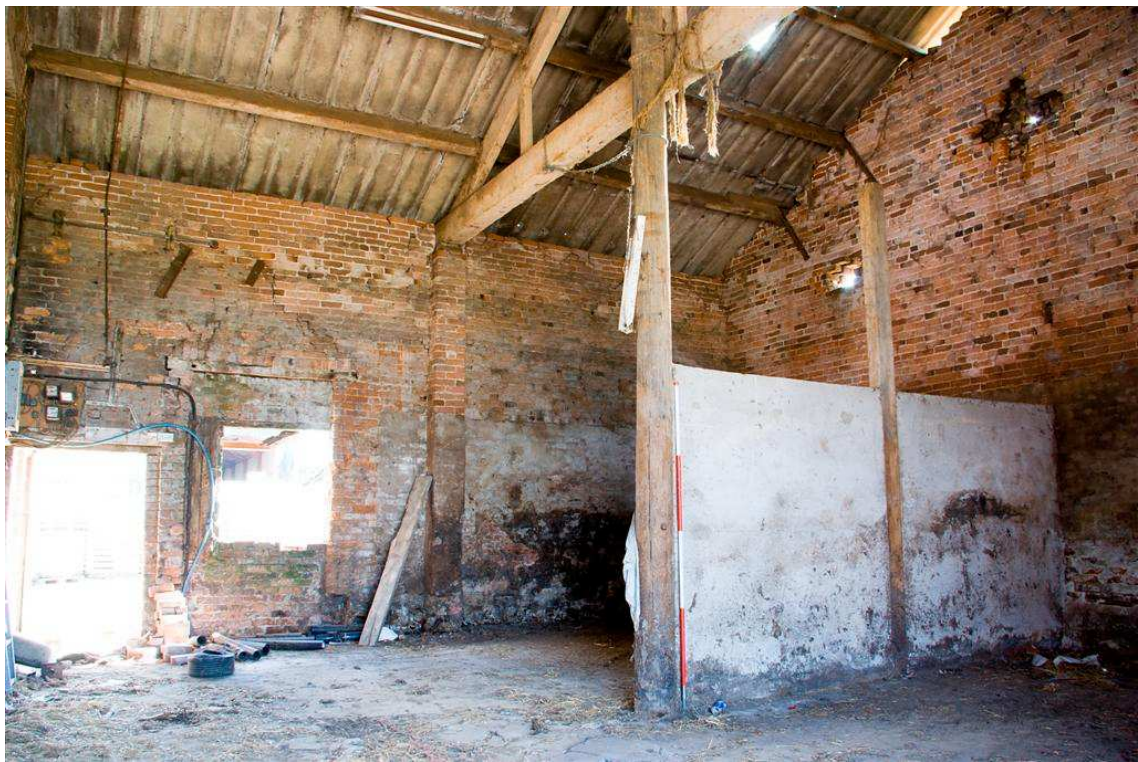
Plate 4: Internal view of the west side of the barn

4.2.5 Internally, the main part of the barn is of identical appearance to the exterior (Plate 4) and collapsed sections of wall reveal the barn to be three skins thick of brickwork. The ground floor is of broken concrete, and the roof is of timber

construction with a single pine king post truss (of pegged joint construction) visible together with purlins of similar timber. All of the timber appears to be original and none is obviously reused. The asbestos roof is visible and there are no rafters. Pit saw marks are visible on the soffit of the truss tie beam, but due to its height the truss was not closely inspected. An inserted concrete wall divides the west part of the barn into two areas. An old telegraph pole has been used partly in its construction.

- 4.2.14 The main part of the barn consists of a large square space, which is open up in to the roof space (Plates 4 and 5). It is quite plain in appearance and all the walls are of brick construction which is identical to the exterior. There is a single king post truss present, together with three purlins on each slope of the roof which are trenched in to the principal rafters. The cross wall obviates the need for a second truss. Close inspection of the roof structure was impossible but pit saw marks were visible on the soffit of the tie beam. No metal work or bolts were visible on the truss but a wooden peg was visible at the base of each principal rafter. The truss rests upon two brick piers which are attached to each of the long walls. An inserted concrete wall divides the space into two to the west of the truss.

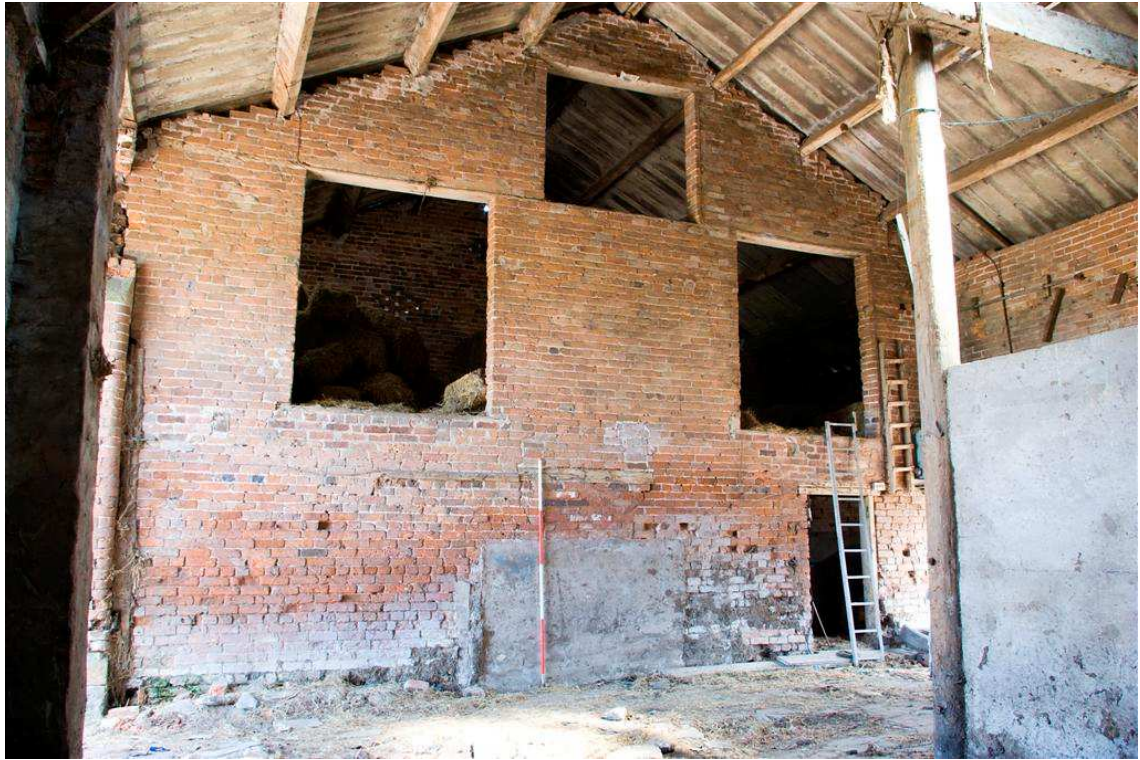
Plate 5: Brick cross wall in the barn

- 4.2.6 There is a hand-made brick cross wall dividing the main part of the barn from the shippon and loft (Plate 5). This is of the same construction as the rest of the barn and appears to be contemporaneous. There are three apertures on the upper part and a single doorway on the ground floor. All of the upper openings have timber lintels and sills. The door on the ground floor (which allows internal access to the shippon) has a timber sill and door surround. There is a blocked window (blocked with similar hand-made brick) to the north of this, which also has a timber lintel. The shippon contains five stalls, all of which are of concrete construction of twentieth century appearance. Milking equipment is also present. The floor is concrete and the ceiling is of joist and rafter construction (8feet high). The timber being of similar appearance and scantling to those in the roof structure. The floor of the loft space above is laid with 4 ½ inch wide tongue and groove pine boards. The loft is of identical appearance to the main part of the barn.

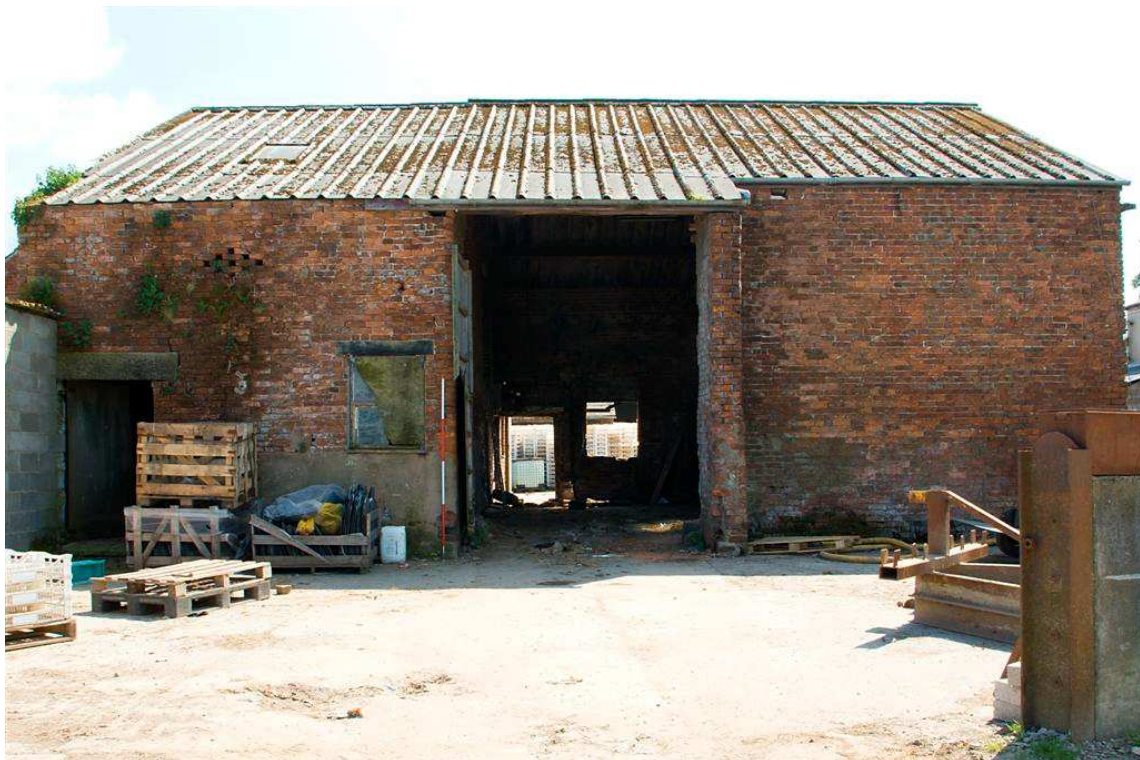
Plate 6: The north elevation of the barn

- 4.2.7 **Exterior Details:** all the elevations are plain and exhibit no significant decorative detail. The north elevation contains the main entrance and consists of a full height porch that contains a single surviving side of the large barn doors which are of heck type (Plate 6). The corners of the projecting porch are bullnosed. There is a secondary access into the ground floor shippon that also has bullnosed corners. A small casement window allows light into the shippon and has a gritstone lintel and timber sill. Above the door and window is a diamond-pattern ventilation arrangement which ventilates the loft. The lower part of the wall has been cement rendered.

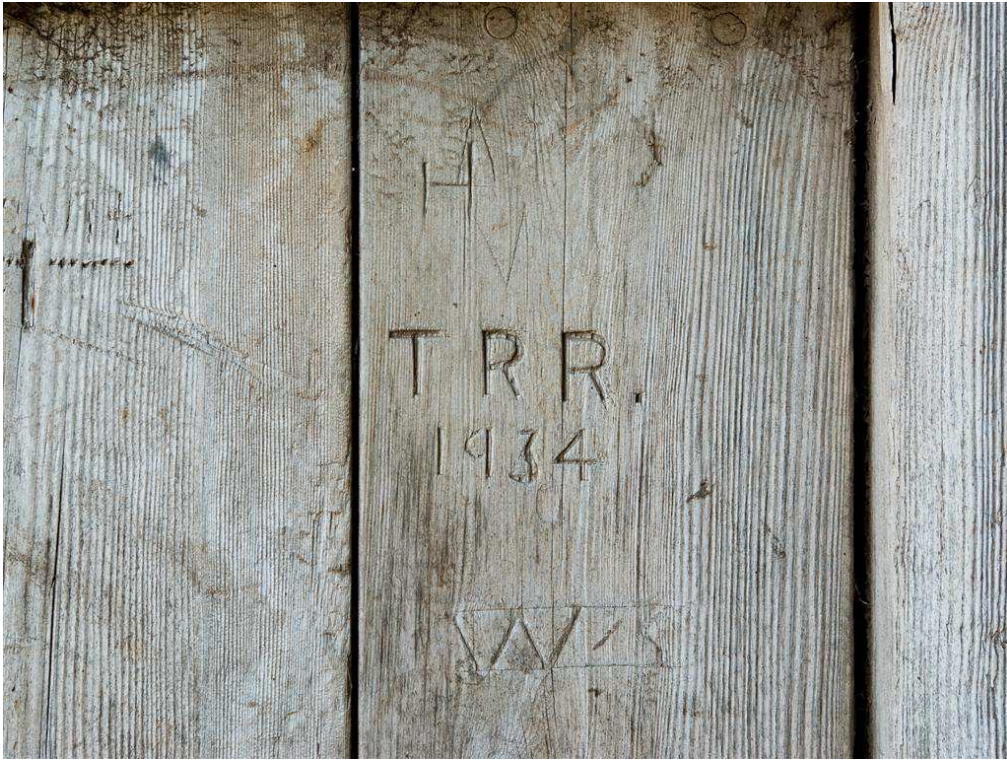
Plate 7: Graffiti in the main doors of the barn

- 4.2.8 The remaining heck door is hung upon iron pintles and has large bolted strap hinges. The pintles are set into large sandstone blocks, which are part of the original construction. The doors are of plank and ledge construction, the ledges exhibiting chamfering with run-out stops. The join between the doors is arched and the lower heck door has incised graffiti that consists of three initials and a date 'TRR 1934' (Plate 7). Other graffiti, including the letters 'W' and 'H', are visible.

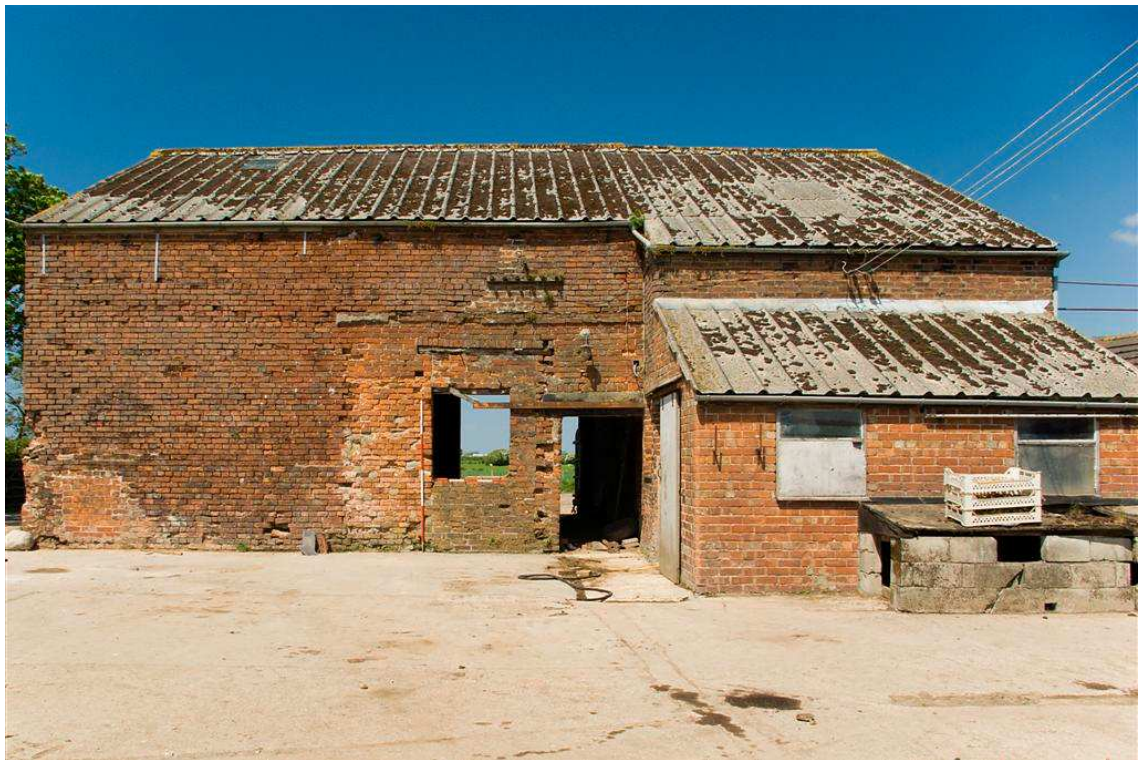
Plate 8: The south elevation of the barn

- 4.2.9 The south elevation is similarly plain and contains a further doorway that allows access into the main part of the barn (Plates 8 and 9). This appears to have been inserted later, together with the adjacent window aperture. There was clearly a previous, larger opening which has been filled in (with very similar brick) to create the smaller doorway. The door has a sandstone lintel of similar appearance to the others. Above this, header bricks are visible. A vertical join to the west of the window provides evidence of the larger previous doorway. A second vertical scar to the west of that scar suggests that a projecting wall once existed here and further evidence in the form of a

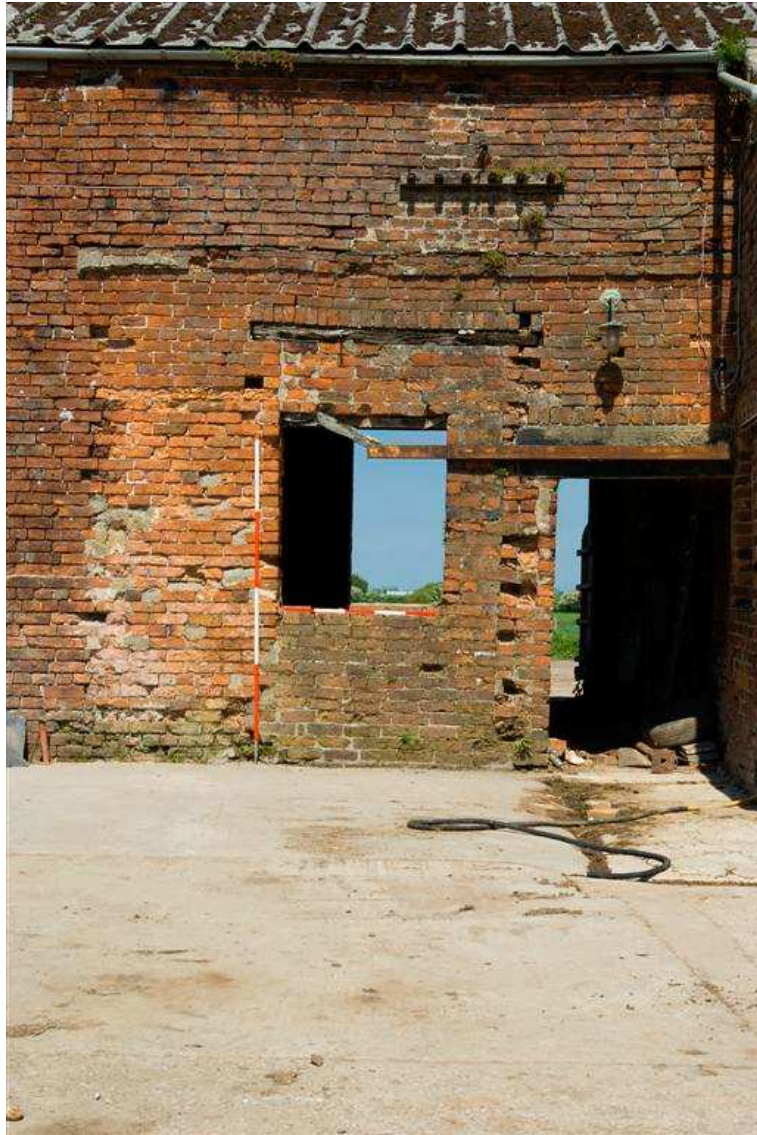
Plate 9: The remodelled door in the south elevation

sloping scar on the east side of the projecting wing (Plate 10) suggests that a porch was once present. This appears to have been lower than that on the north side as a horizontal scar above testifies (Plate 9). There is a small window to the right of this which allows light into the shippon (Plate 9). It is located in the east-facing side of the south wing and is unusual in that it has a fine slate sill and lintel. The sill exhibits moulding and appears to have been reused. Above the lintel header bricks are visible of a similar appearance to others seen elsewhere in the structure. Repaired brickwork is visible at the west end of the elevation.

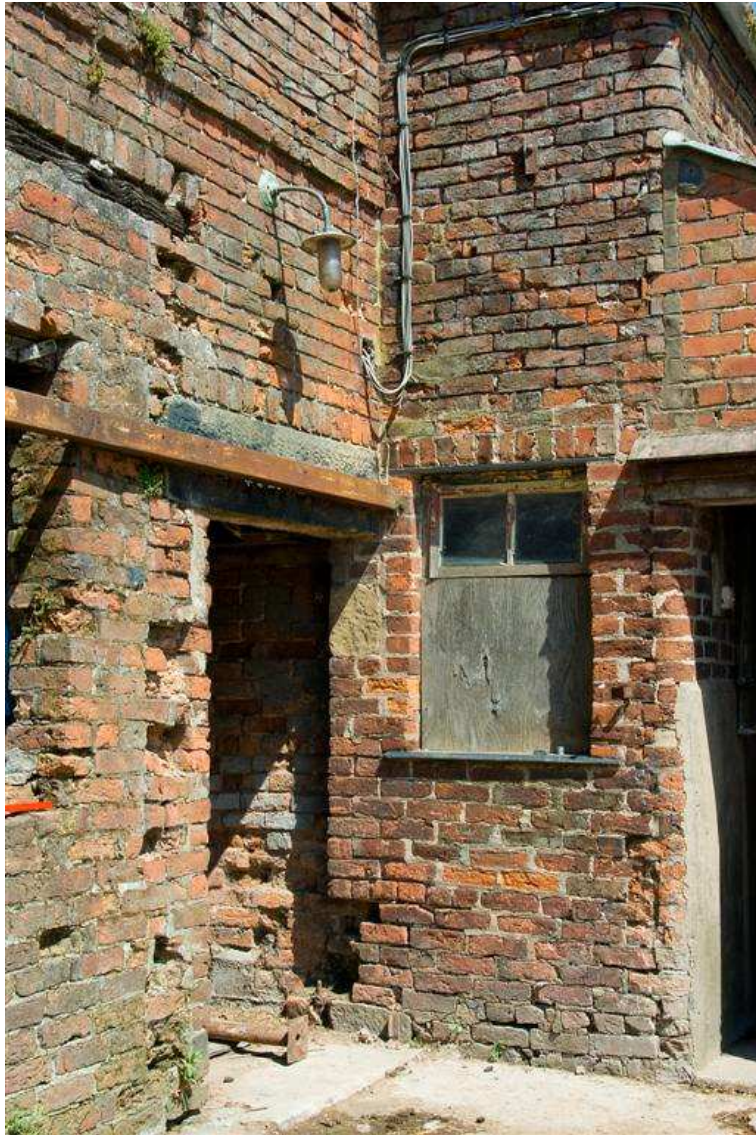
Plate 10: Evidence of the porch on the south side of the barn and join of the outshut

- 4.2.10 To the right of this and attached to the south wing is a brick outshut, which is clearly a later addition due to it being of different brick and the vertical butt joint is visible where it meets the main barn (Plate 10). This structure was disused but contained modern dairy equipment. It is plain internally and has a concrete floor. A further cinder block structure is attached to the south wall.

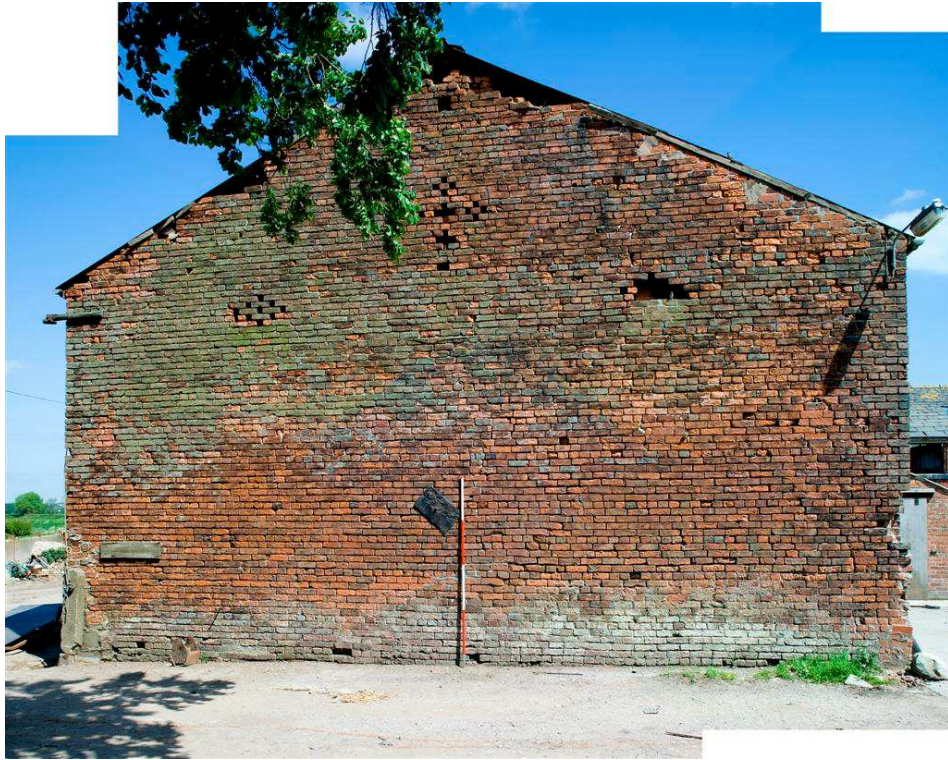
Plate 11: Digitally stitched image of the west elevation, showing cruciform ventilation in the centre

- 4.2.12 The west elevation is plain and is in relatively poor condition. The ventilation (Plate 11), which is damaged, includes an interesting cruciform-shaped arrangement in the upper centre of the elevation. It is flanked by diamond-shaped arrangements as with the east elevation and an owl hole is present at the apex. Some damage to the corners of the building has been sustained, presumably by passing vehicles, which has subsequently been repaired.

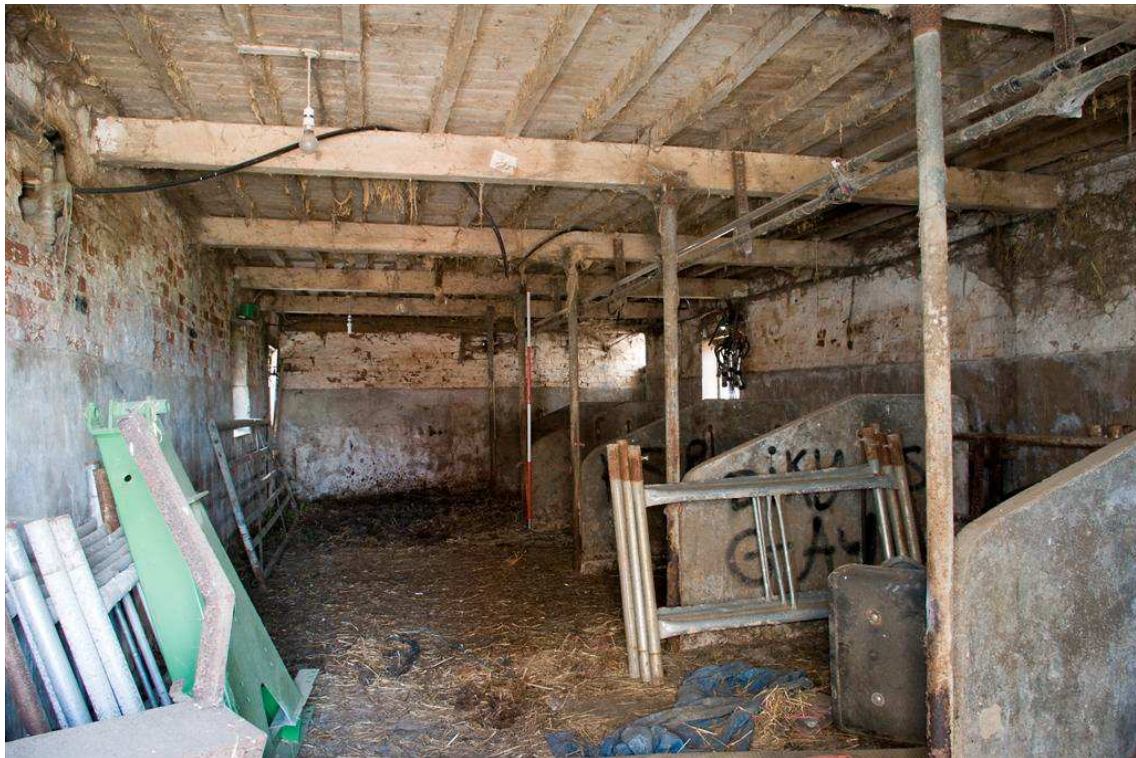
Plate 12: General view of the shippon, facing south

- 4.2.16 Entry into the shippon was available via three separate entrances (Fig 9), those from the north and east elevations being almost identical. The shippon itself has been modernised and now contains twentieth century milking stalls and equipment (Plate 12). The lower half of the walls has been rendered and much of the remaining brick walling has been whitewashed.

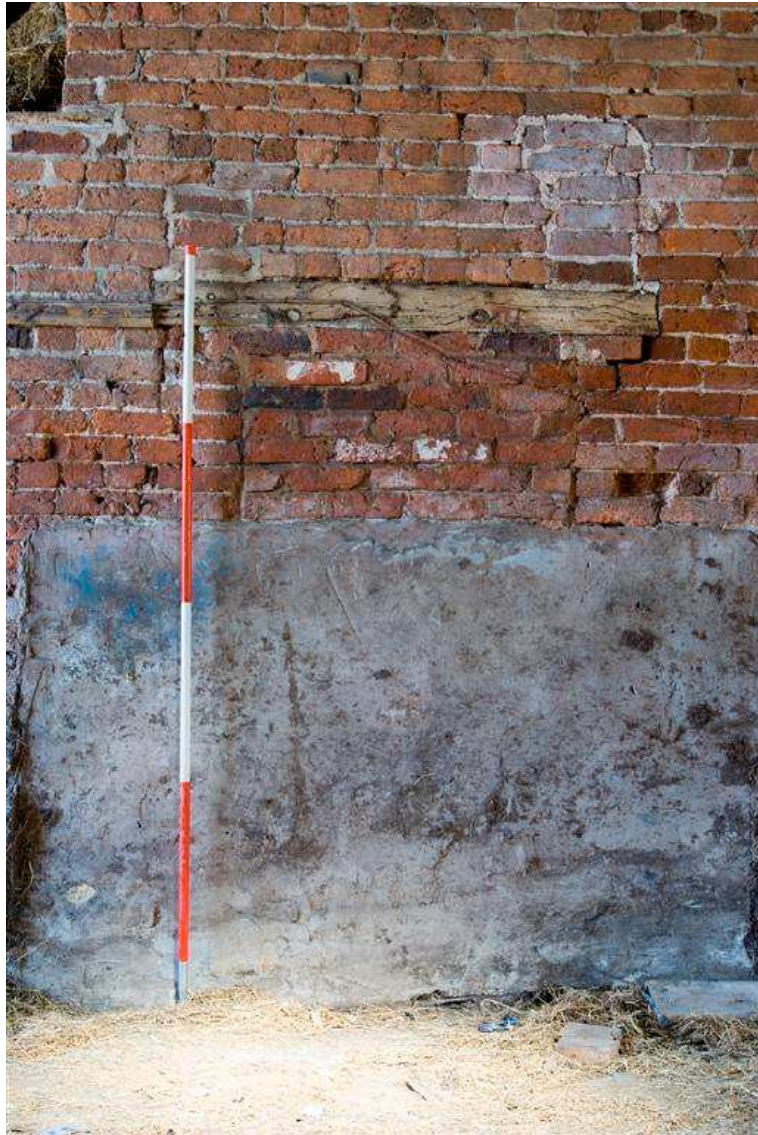
Plate 13: Blocked aperture in the cross wall of the barn

which itself appears to be contemporary with the rest of the barn. A blocked aperture is present in the centre of the cross wall (Plate 13), which has a timber lintel. The extent of the blocking is unknown due to part of the wall being rendered and the shippon wall is heavily whitewashed making inspection impossible. Access to the loft is only available via a modern ladder through one of the large openings (there was no evidence of a hatch in the shippon). A damaged timber loft ladder remains attached to the wall south of the doorway. The floor of the loft was in poor condition, which precluded inspection on health and safety grounds, but cursory inspection of the loft revealed little detail worthy of note other than the ventilation detail visible externally. The three openings are interesting, and all appear to be contemporary with the cross wall (ie they have not been inserted later). Also visible in the cross wall were the joist ends that support the loft floor.

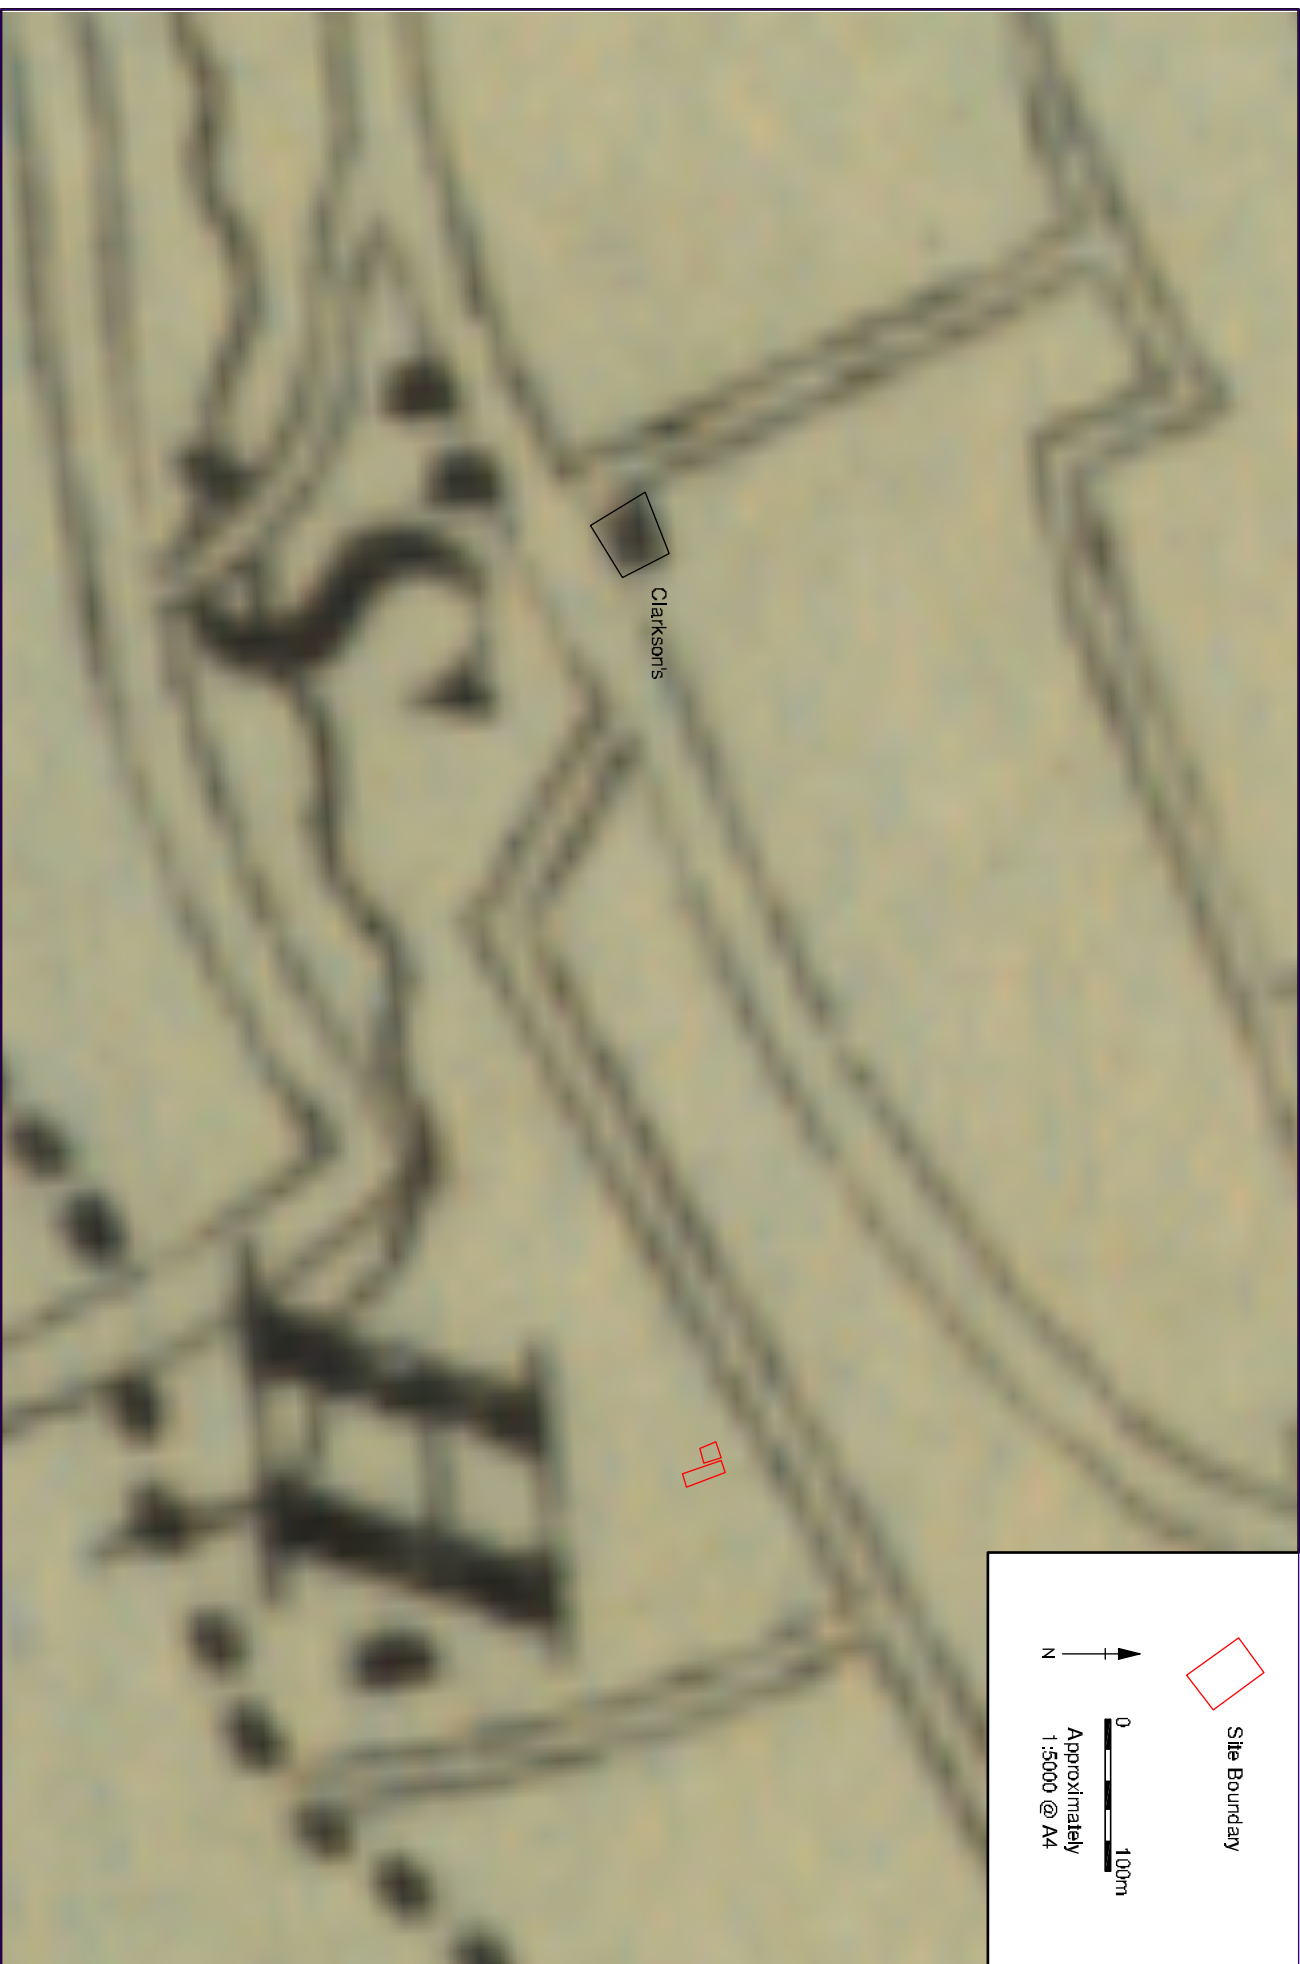
Figure 2: Hennet's map of Lancashire, 1830

3.2.2 *Hennet's Map of Lancashire, 1830 (Fig 2)*: this map was surveyed by George Hennet in 1828 and 1829 and published in 1830 by Henry Teesdale. The scale is 7½ inches to 10 miles and therefore does not show much detail. However, this map does illustrate the road layout (a pattern similar to the modern layout), and a single house where 'Clarksons' is located on the later 1833 Inclosure map (*Section 3.2.3*, Fig 3), at the junction of two roads, possibly Crook Dale Lane and Moss Side Lane. Two other properties are located to the south-west, which are on Moss Side Lane and may represent Moss Side Farm and Roe's Farm. No other buildings are illustrated in the immediate area. Pilling Moss is still illustrated but now Stalmine Moss is also labelled.

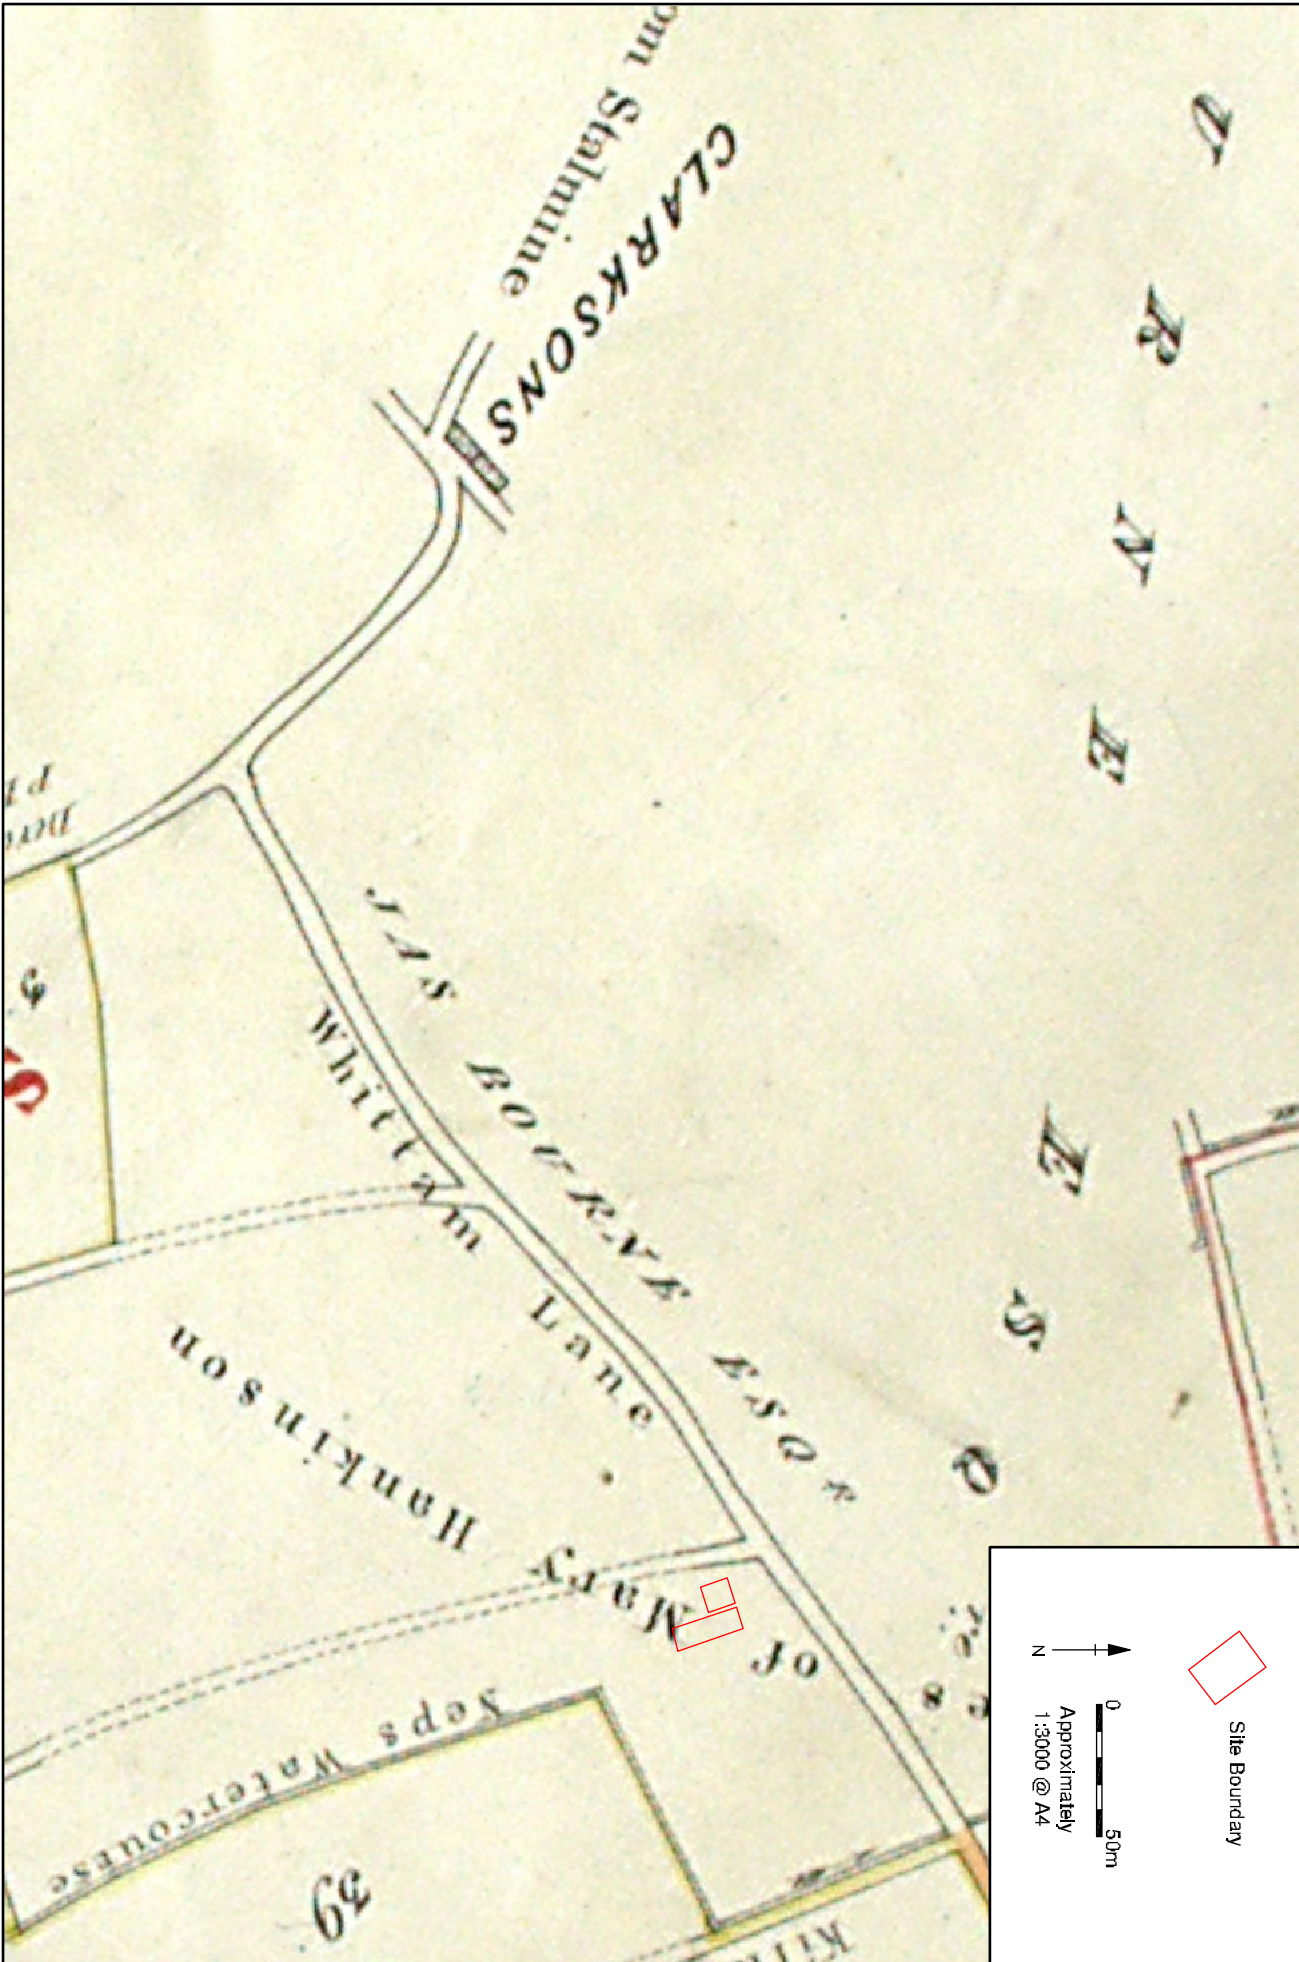
Figure 3: Rawcliffe and Stalmine Inclosure, The Commissioners Award (LROAE 17)

3.2.3 *Rawcliffe and Stalmine Inclosure, The Commissioners Award LRO AE 1/7 (Fig 3)*: this document dated 4th April 1833, outlines the details of allotment lands awarded during the enclosure of the area. The map illustrates the names to which land was allotted following the improvement and enclosure of Stalmine Moss. A building labelled 'Clarksons' at the junction of Crook Dale Lane and Moss Side Lane is illustrated which probably corresponds to that shown on Hennet's Map (Fig 2). The map shows various named buildings located predominately around the southern edge of the area, with a few structures illustrated within the allotted areas. It was during this time that most of the drainage system was created. A road called Kiln Dale Lane is illustrated which suggests a kiln, possibly for brick, was located in the vicinity.

3.2.4 A small area straddling Whittam Lane (now Moss Side Lane) is labelled 'Devises of Mary Hankinson' within which the current Hankinson's Farm buildings are located. Each of the allotments are documented in the text of the award book, wherein Mary Hankinson's particulars are outlined. Some of the other entries mention existing buildings, but no buildings are mentioned in the entry for Mary Hankinson and the map shows the site to be devoid of any structures.

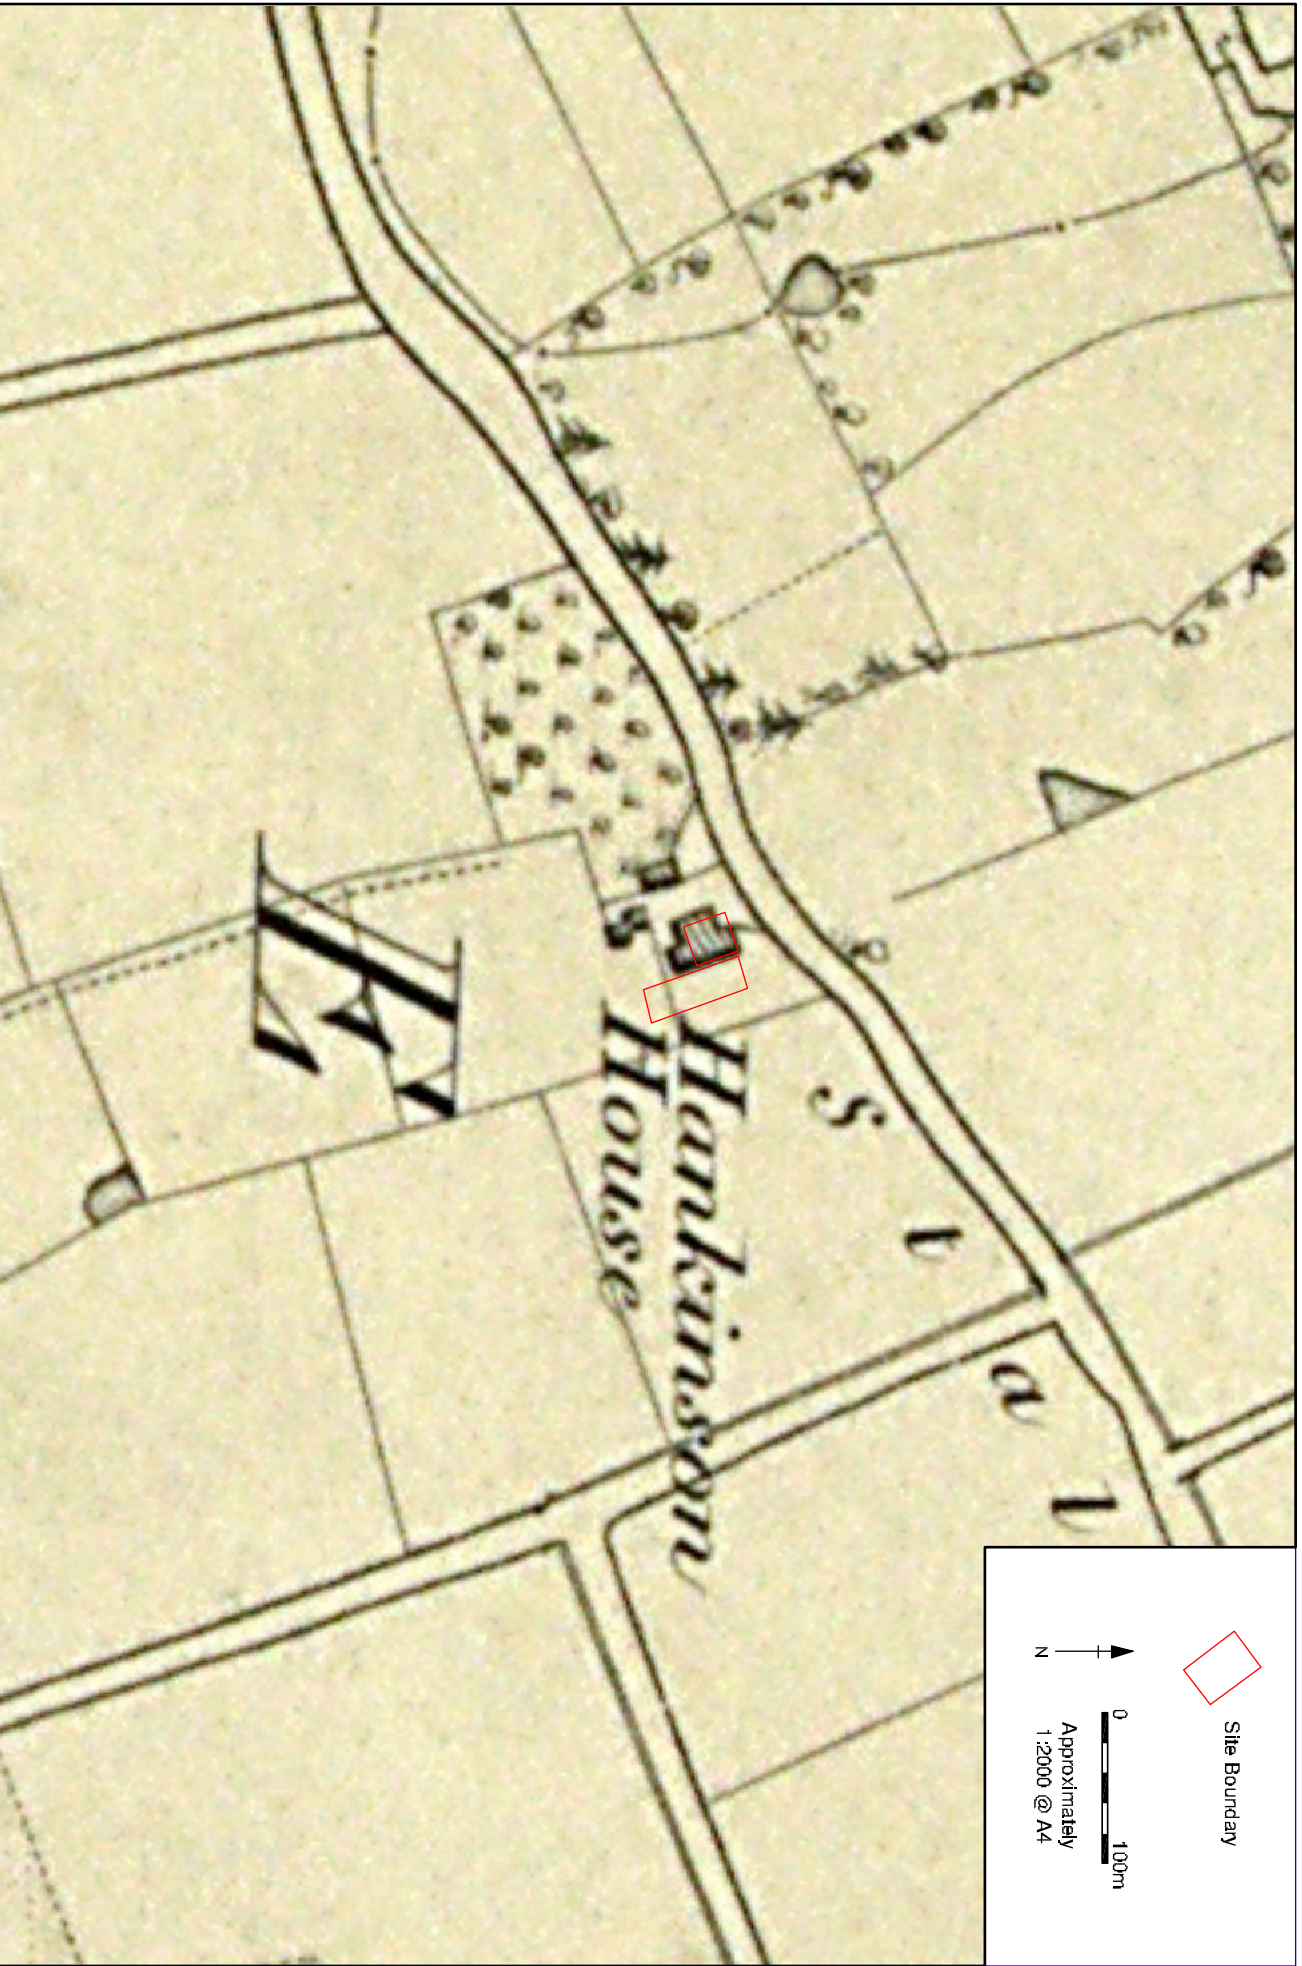
Figure 5: Ordnance Survey, Lancashire, Sheet 18, 6" to 1 mile, 1844

- 3.2.7 ***Ordnance Survey, Lancashire, Sheet 18, 6" to 1 mile, 1844 (Fig 5)***: the map shows essentially the same information as the tithe map (Fig 4), the general layout of the fields being the same. The buildings are now labelled 'Hankinson House' which presumably pertains to the farm house. The field containing the barn and pig sty has been subdivided and an additional structure appears to have been added to the pig sty. The shape of the barn is clearly discernable and Moss Side Lane is labelled as Stalmine Road.
