CRAVEN FOLD FARM, LANGHO, LANCASHIRE

Archaeological Building Investigation

Oxford Archaeology North

April 2010

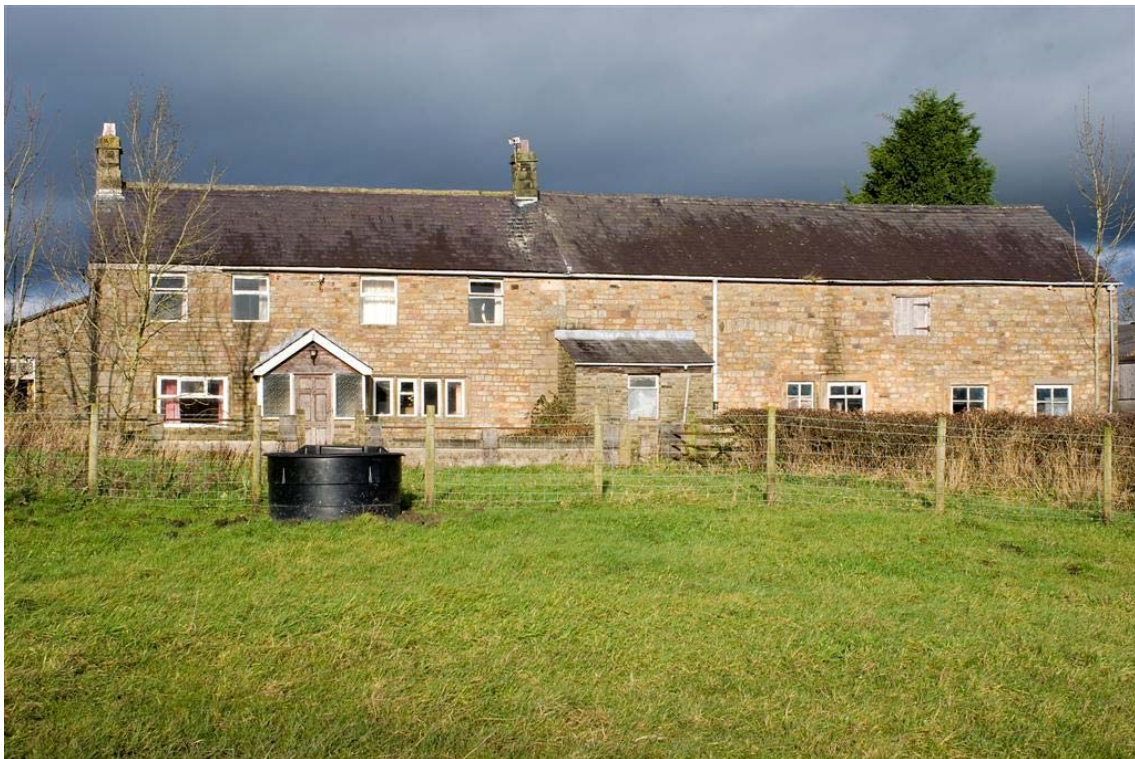
Plate 2: The principal (south) elevation of the farmhouse and attached barn, illustrating the laithe-house type arrangement

4.3.1 **Principal Elevation (South):** the principal elevation comprises two parts; these being the front elevation of the farmhouse and the barn (Plates 2-4). The line of division between the two buildings is clearly defined by alternating quoin stones. The doorway into the house is offset to the left (west) and housed within a modern porch. The current access into the barn, again within a modern porch, is located at its extreme west end. The front door into the house has a substantial sandstone surround, exhibiting chamfering, and a modern

glass door is present. Other than the current arrangement, there are two former doorways into the barn, which have been reduced in size to form windows. A high relieving arch located to the west of centre of the barn (Plate 2), suggests the presence of a former wagon door.

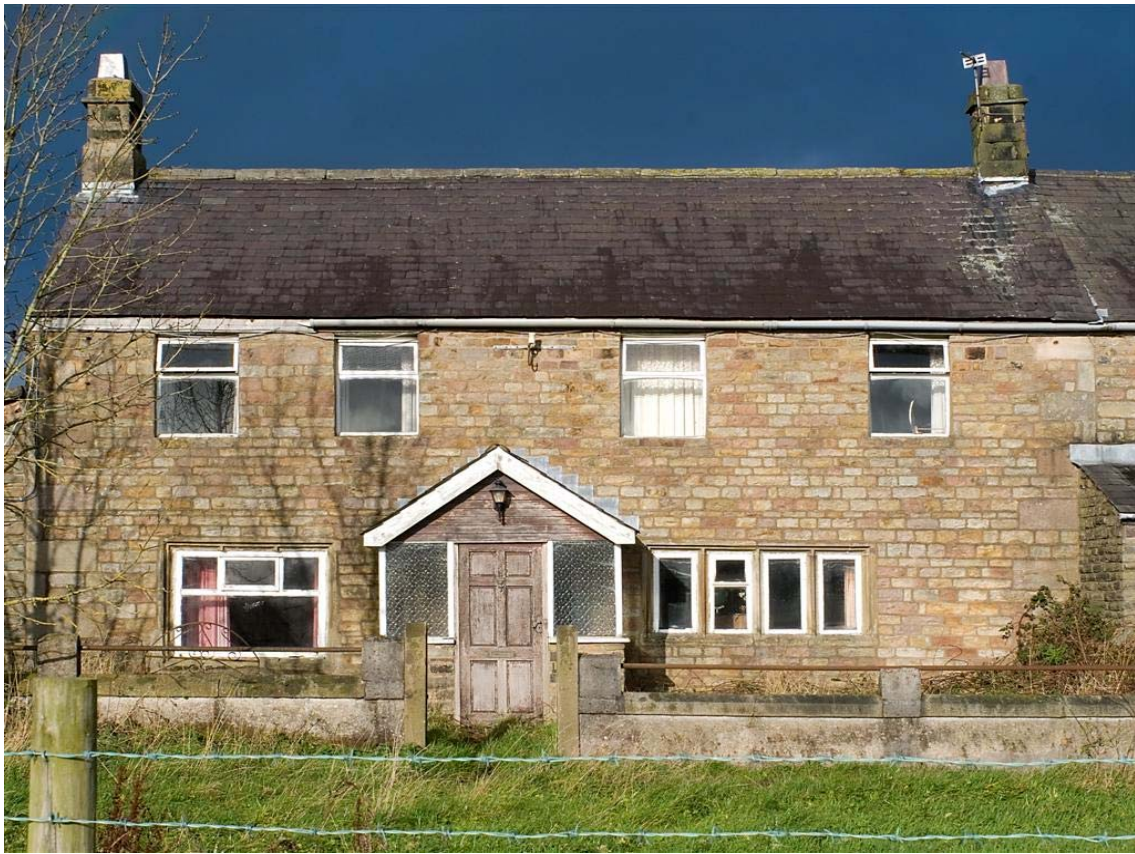
Plate 3: The principal elevation (south) of the farmhouse, showing the varying style of the windows.

- 4.3.2 There are six windows of differing styles to the principal elevation of the farmhouse: two at ground level, and four above. Those at first floor level are of a single pattern (tall and rectangular), and extend to eaves height. At ground floor, the window to the east of the doorway is a four-light stone-mullion window, with wooden casements (Plate 5). The remaining window (to the west) is a modern replacement of what was originally a three-light stone-mullion window (Plate 3). There is no obvious evidence to suggest the upper floor windows are later inserts.

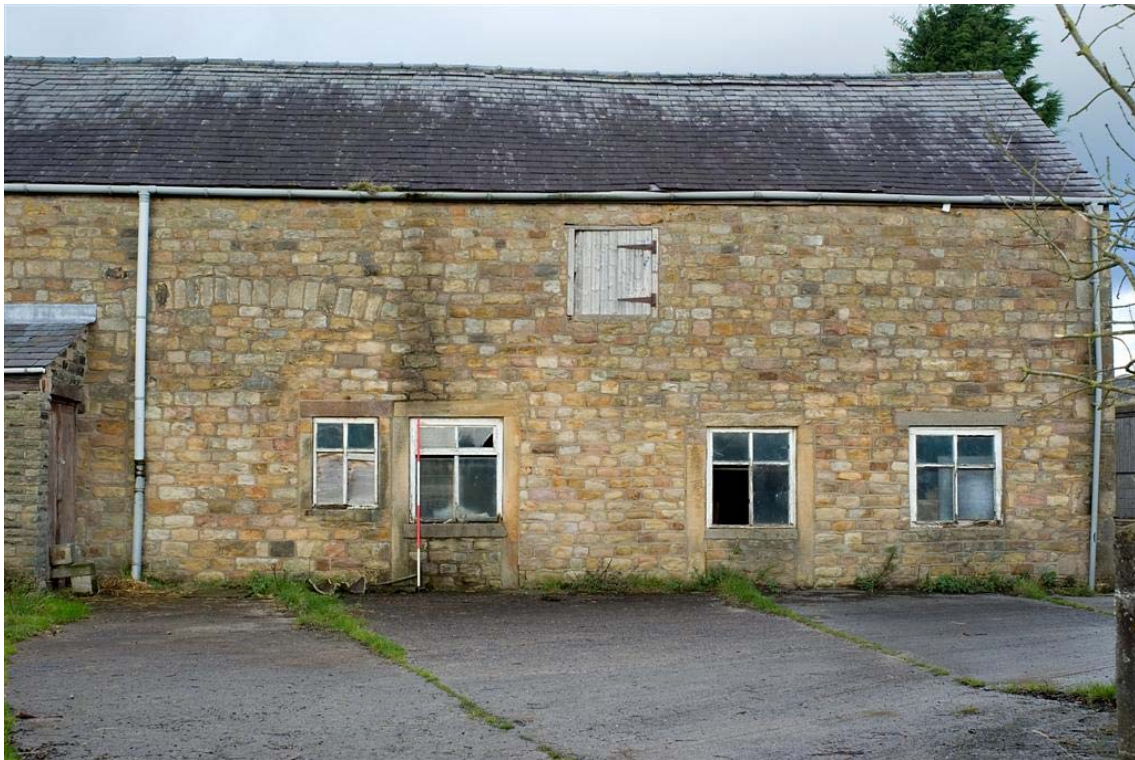
Plate 4: The principal (south) elevation of the barn. The conversion of doorways into windows can be clearly seen. The down-pipe obscures a joint in the masonry, suggesting the extent of the original wagon door.

- 4.3.3 Two of the four ground floor windows present in the barn are a result of blocked doorways (*Section 4.3.1 above*). The easternmost window appears original to the fabric of the barn, however it lacks the stone dressing of the other ground floor features; that to the west is within the stonework beneath the relieving arch, and its surround is very similar in design to the blocked doorways.

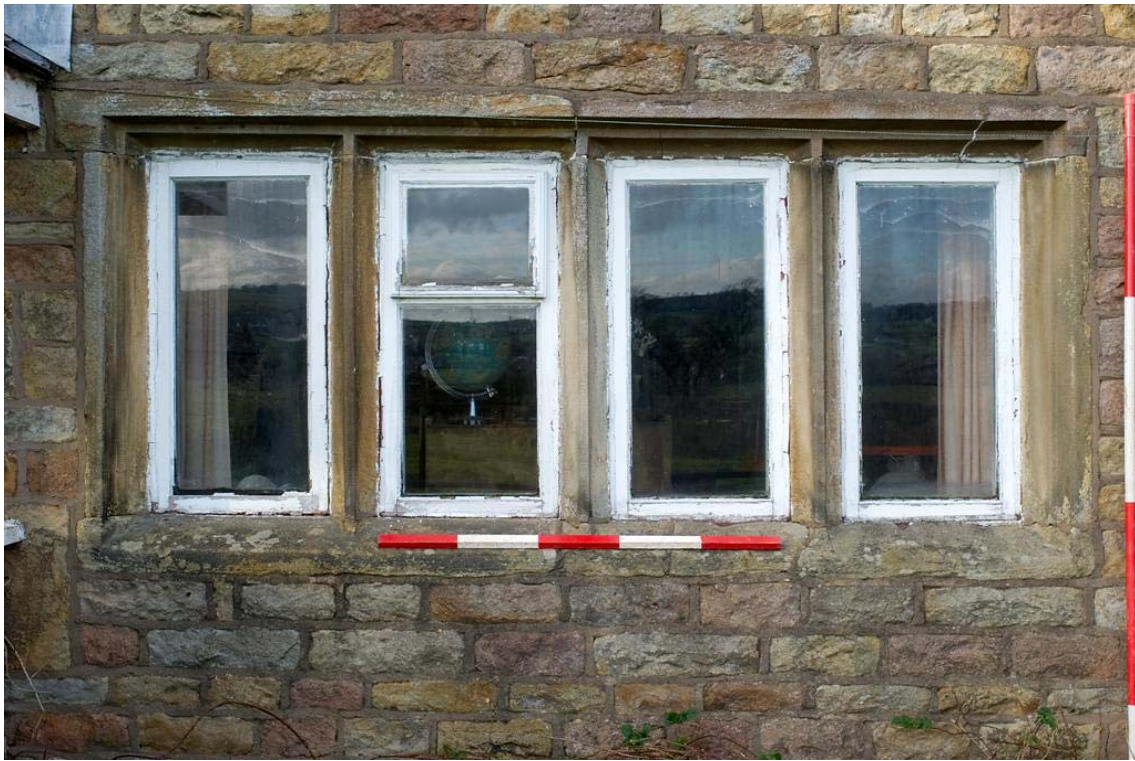
Plate 5: Extant mullion window at ground floor in the front elevation of the farmhouse. The larger of two mullion windows in the elevation, this provided light for the living room.

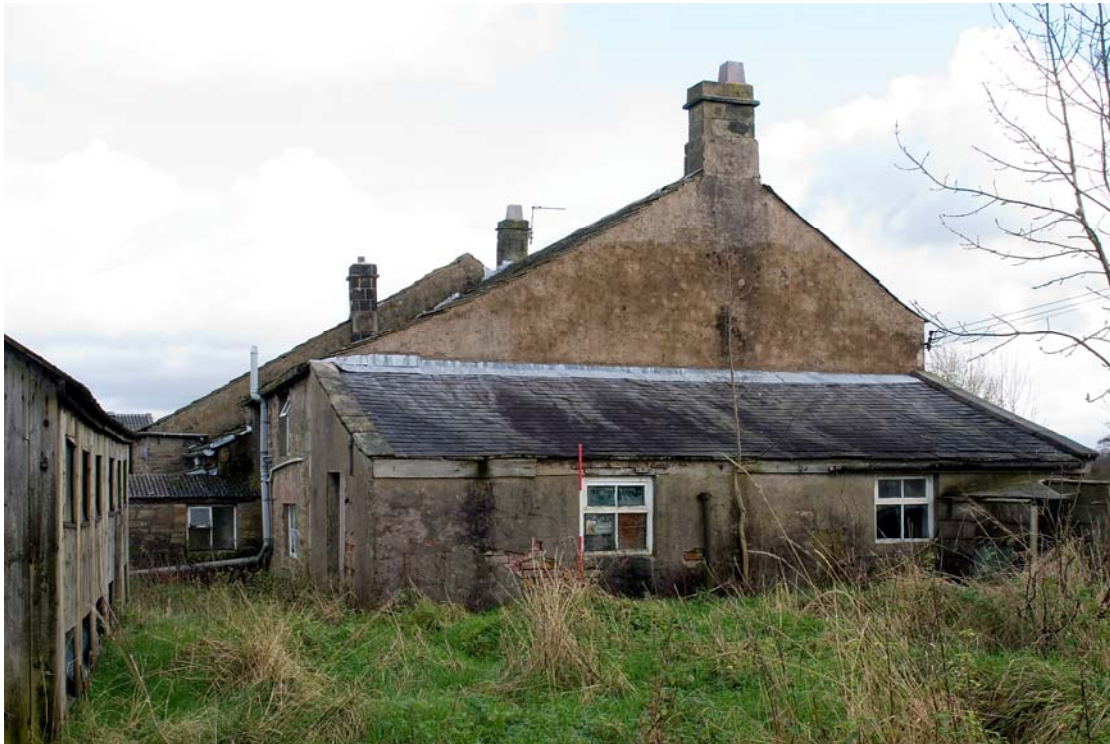
Plate 6: The west gable of the farmhouse with modern extension attached. The difference in the slope of the roof pitches between the farmhouse and barn is evident.

- 4.3.5 ***Gable end of Farmhouse (west):*** this is plain rendered, the ground floor being obscured by a twentieth century extension (Plate 6). The extension is of brick construction with a slate roof, and has two casement windows, and is also rendered. A doorway in the north wall allows access. What little that is exposed of the west gable end of the barn is again, also rendered.

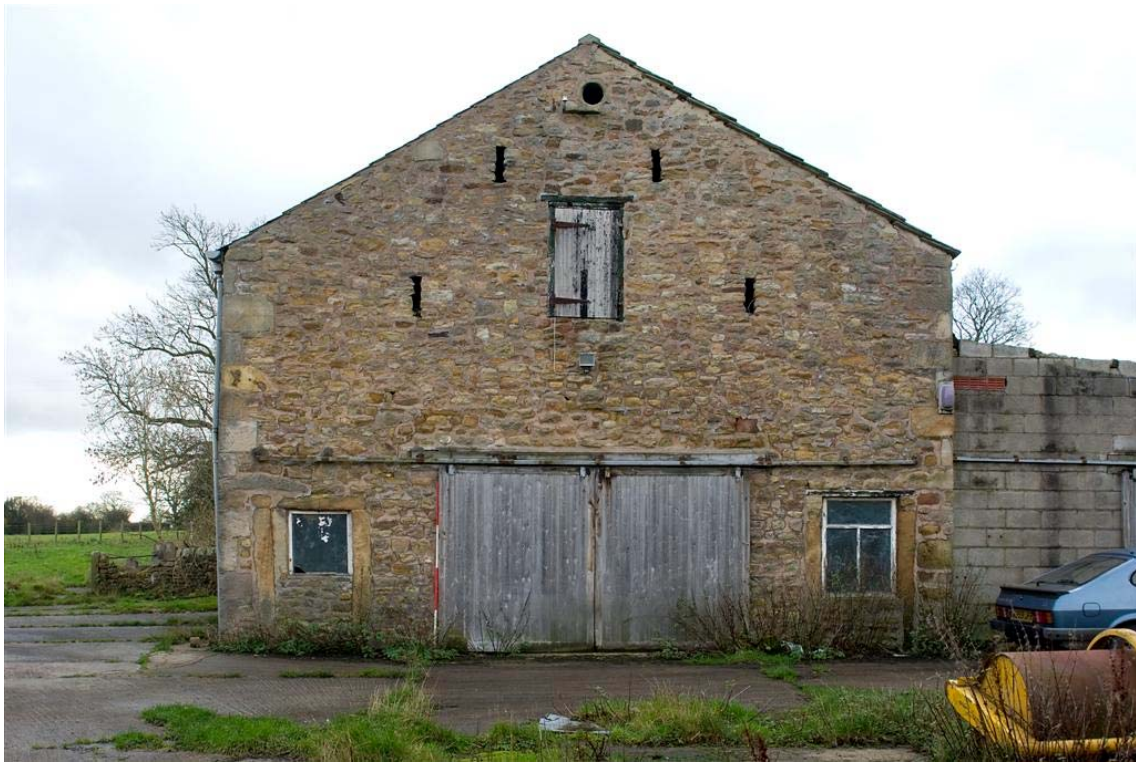
Plate 7: The gable end (east elevation) of the barn. The large doorway is not original. The windows were previously doorways.

- 4.3.4 ***Gable end of Barn (east):*** here again, two doorways, with similar dressing to those within the principal elevation, have been blocked and re-used as windows (Plate 7). Between these is a large doorway with sliding doors, which is of modern appearance. Above this is loft access, together with four vertical ventilation slits and an owl-hole.

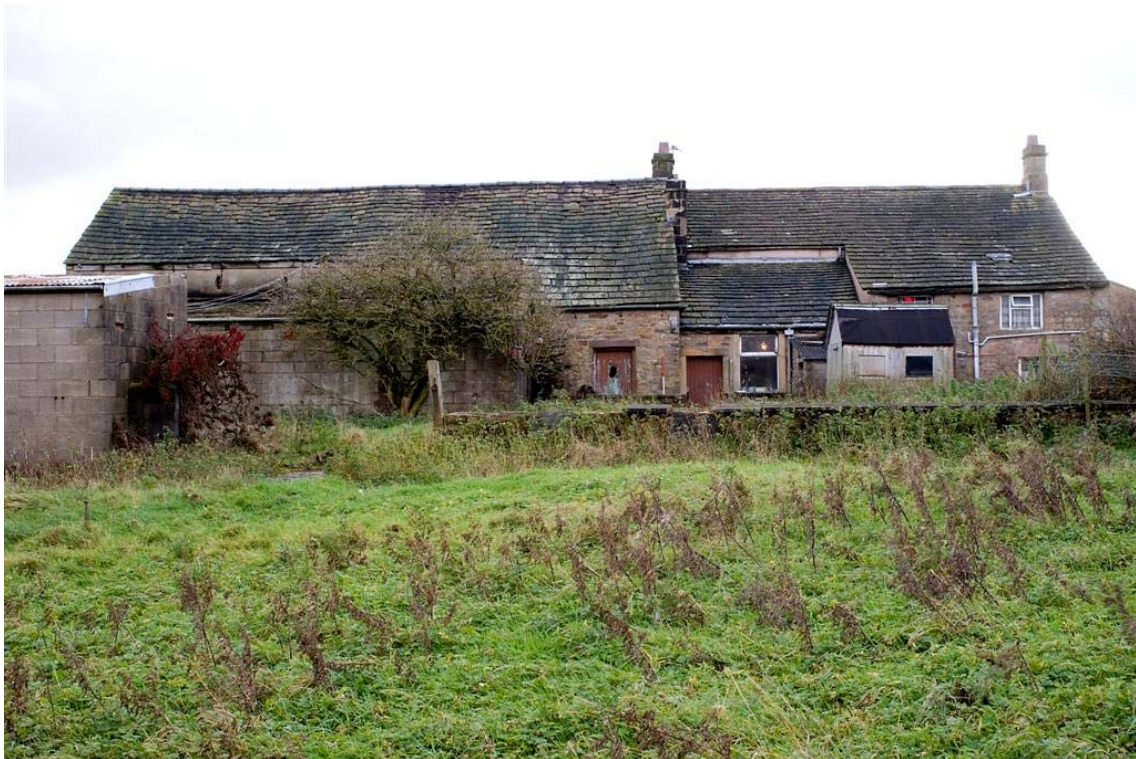
Plate 8: The rear (north) elevation of the building. This illustrates the projections from both the farmhouse and barn, and the kitchen extension to the back of the farmhouse.

- 4.3.6 ***Rear elevation (north):*** the back of the building has been added to in various phases and, consequently, a number of outshuts are present (Plates 8-10). Both the house and the barn have integral projections at their west ends (Plate 9). The gap between the projecting end of the farmhouse and the barn has been infilled with a kitchen outshut. Small, modern, outshuts are present against the kitchen wall and the rear of the house. Above the kitchen the small area of the exposed wall is rendered. A blocked doorway is present, slightly off centre, in the rear projection of the house. Adjacent, and to the west of this, is a wide, low window, beneath a substantial sandstone lintel. Off-set above this is a first floor window, reaching to eaves height. A stair window is located at the east end, and has elements of stained glass. A modern dairy has been constructed against the back of the barn, with just a small section of barn wall visible at eaves height, which is also rendered.

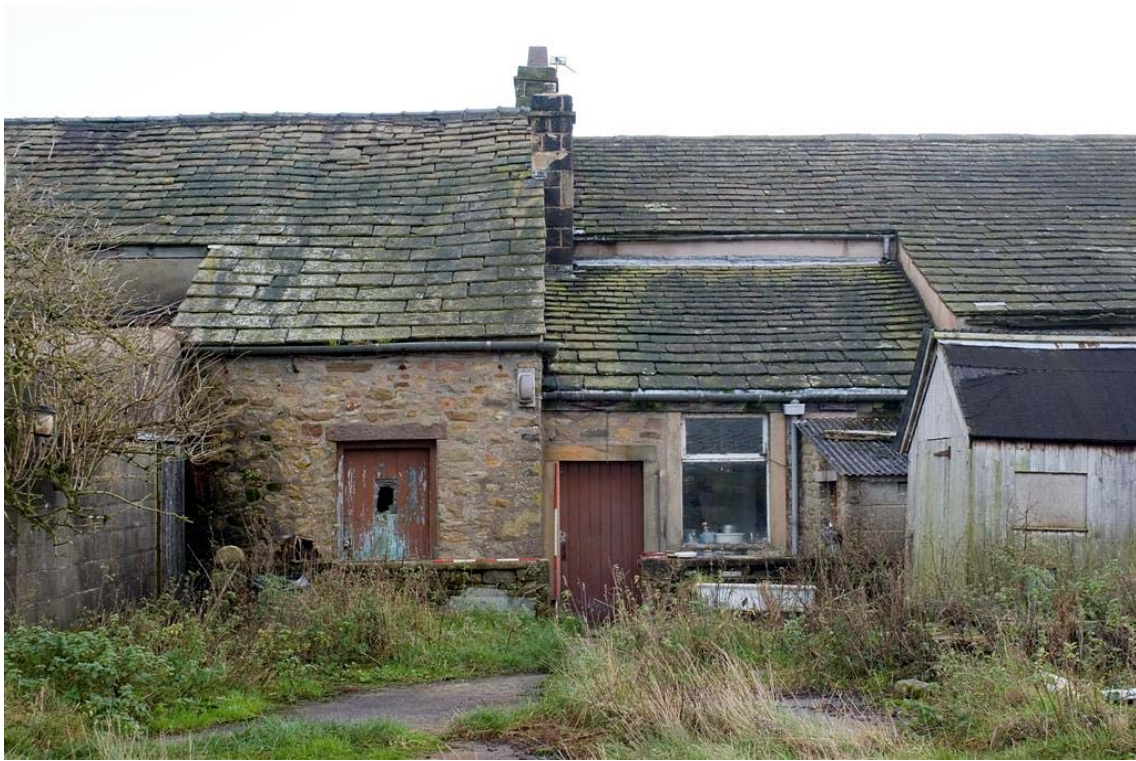
Plate 9: Detail of access arrangements into the barn and kitchen.

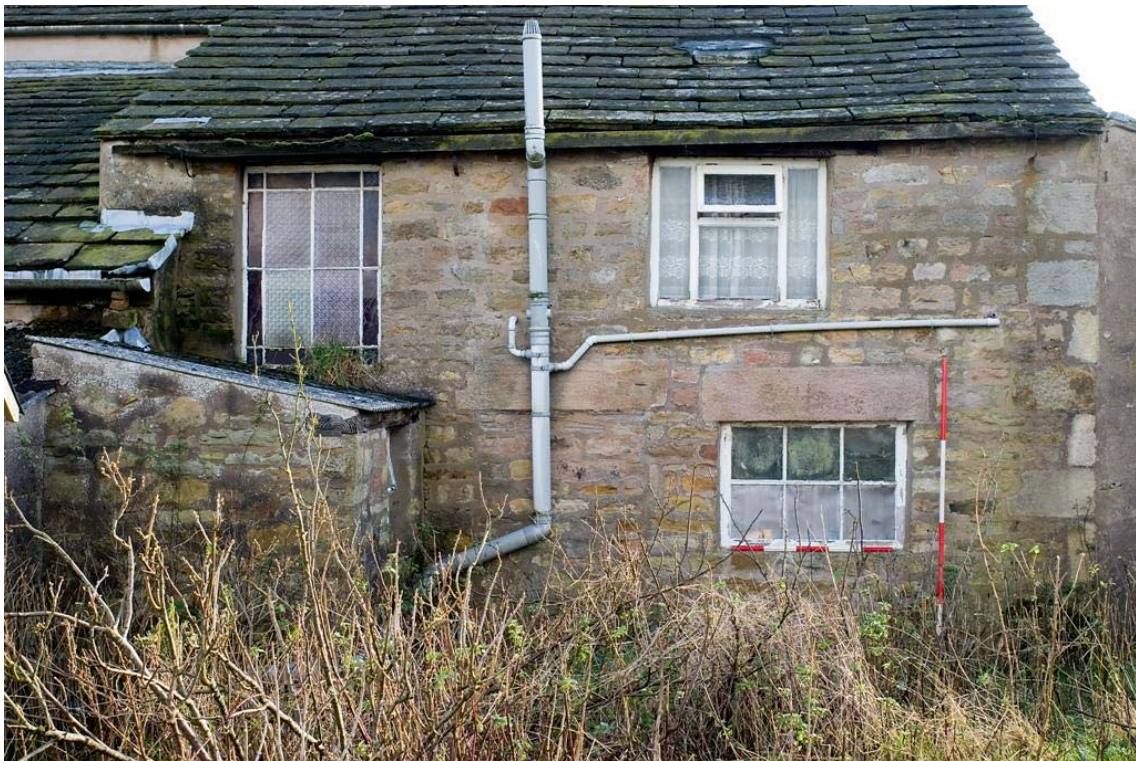
Plate 10: Window arrangements in the rear (north) elevation of the farmhouse. As in the front elevation, the upper window is taller than that at ground floor. A blocked doorway can also be seen behind the down-pipe.

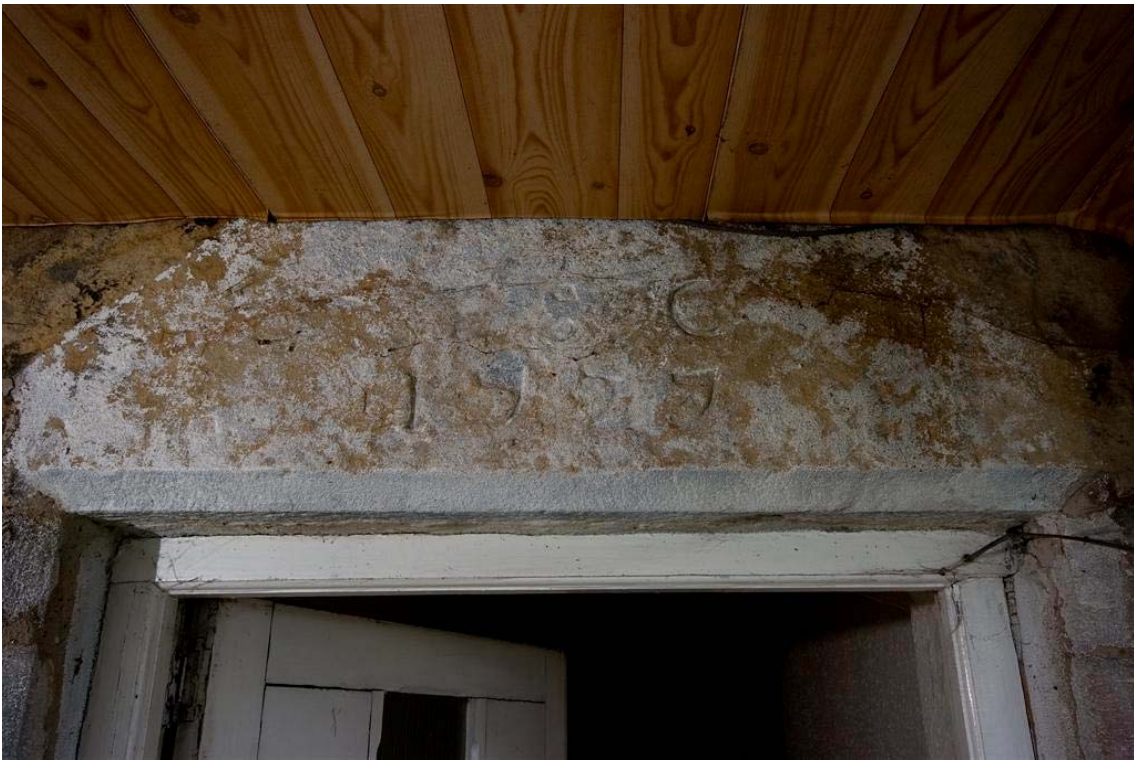
Plate 11: Date stone above the original front entrance, concealed within the porch, and inscribed 1725.

- 4.4.2 ***The Hallway (Room 1):*** the porch against the front door is of twentieth century appearance. A large sandstone lintel presides above the original front doorway and is inscribed TC 1725 (Plate 11). The lettering has eroded due to the effects of weathering.

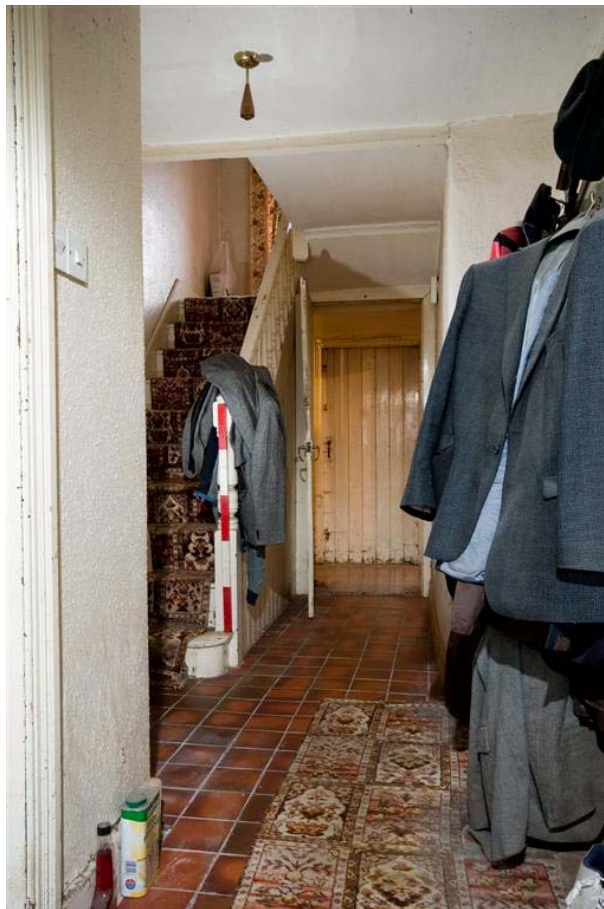
Plate 12: The ground floor passage. The stairway to the upper floor is located to the west of the passage.

- 4.4.3 The entrance passage is aligned slightly left of centre, and runs through to the rear of the building (Plate 12). It is all of fairly plain appearance, and all the walls are plain plastered and painted. The floor is laid down partly to carpet and partly to ceramic tiles (of late twentieth century appearance). The majority of the internal partition walls appear to be of brick construction. However, the wall alongside the kitchen is stone-built and was originally an external wall.

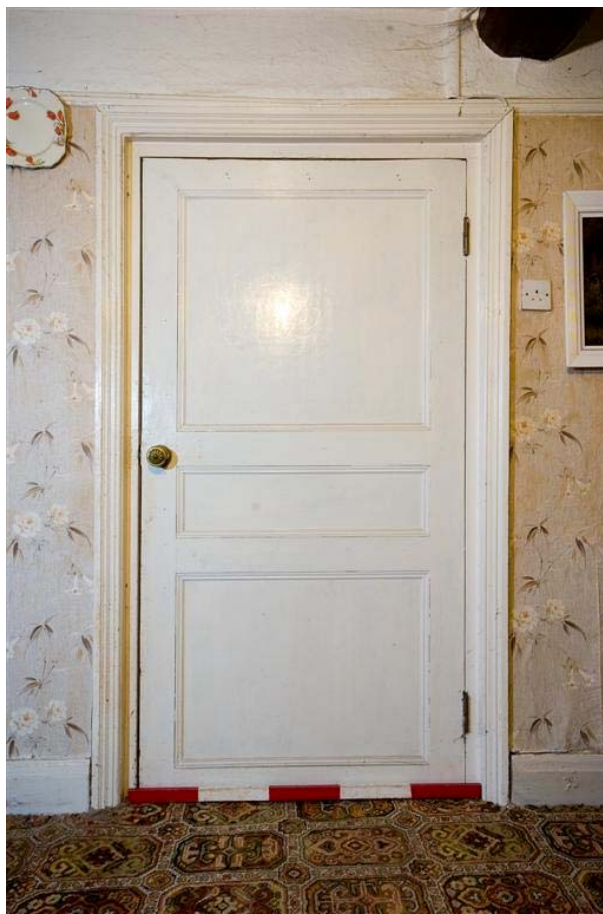
Plate 13: Typical example of a door leading off the ground floor passage.

- 4.4.4 The living room and parlour doors (Rooms 2 and 3) are probably of nineteenth century origin and comprise three horizontal panels (Plate 13). The remainder are ledged and braced. The flight of stairs up to the first floor is located at the back of the passage. It appears to be of nineteenth century origin and was probably inserted to replace an earlier arrangement. Opposite the base of the stairs is a built-in cupboard.

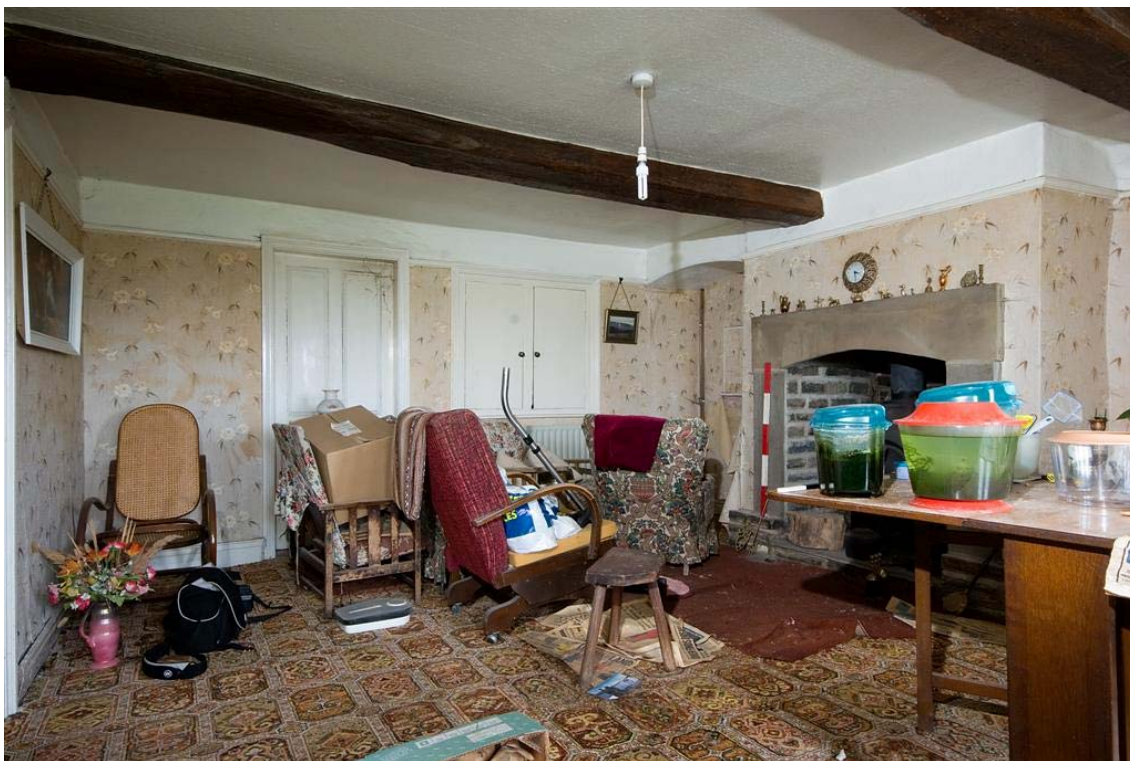
Plate 14: General view of the living room. Two exposed joists are visible below the ceiling, the joist towards the back of the room extends into the chimney-breast. The spice cupboard can be seen between the fireplace and the back wall. The cupboard in the back wall conceals a mullion window.

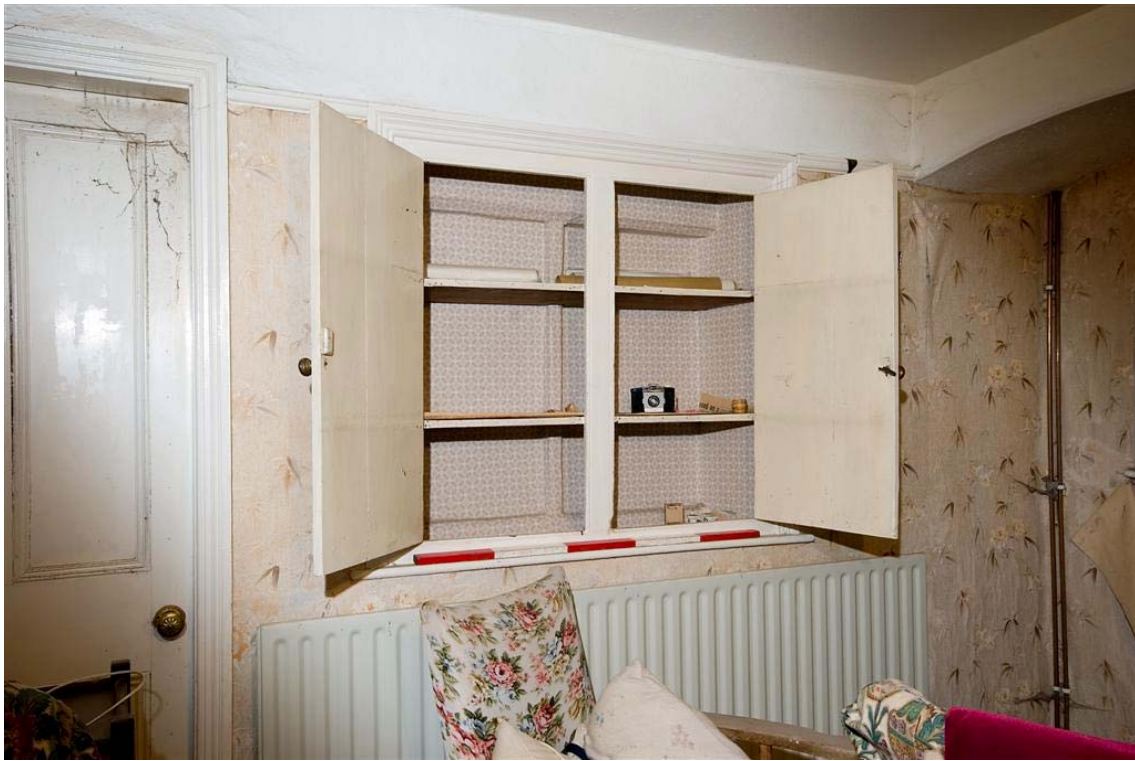
Plate 15: Mullion window concealed within a cupboard in the north wall of the living room.

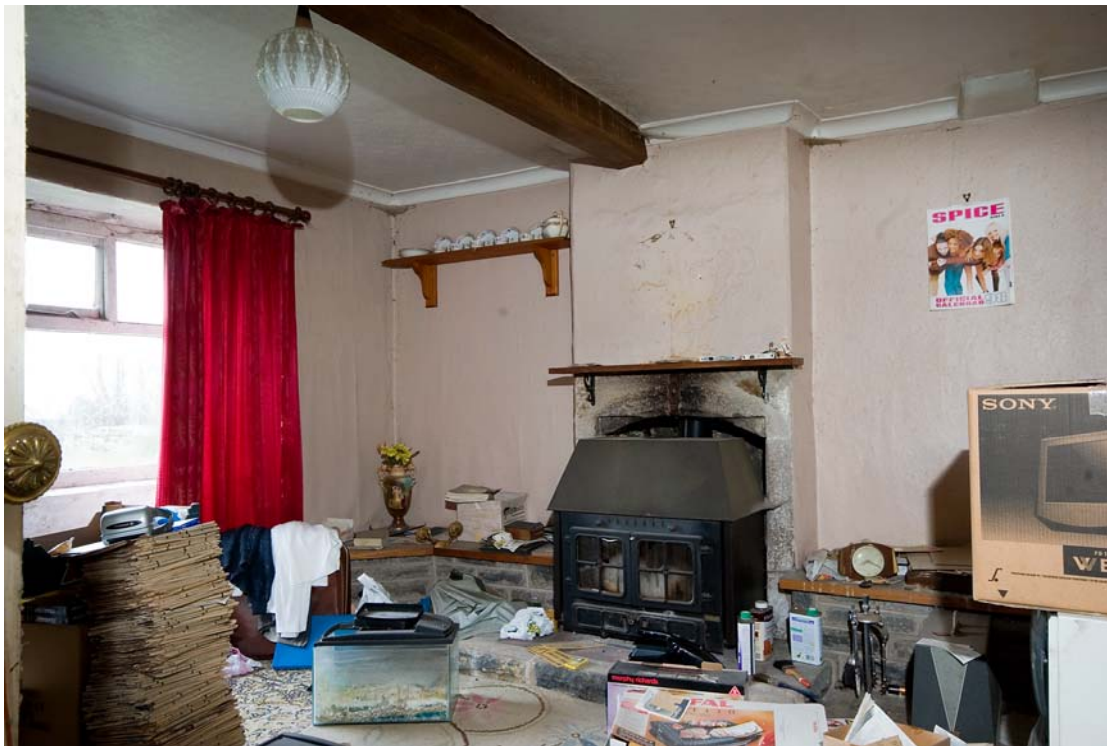
Plate 16: This shows the general arrangement of the parlour. The window is a modern insert, the exposed joist extends into the chimney-breast and the small protrusion to the right of the fireplace, at ceiling height, is possibly a corbel.

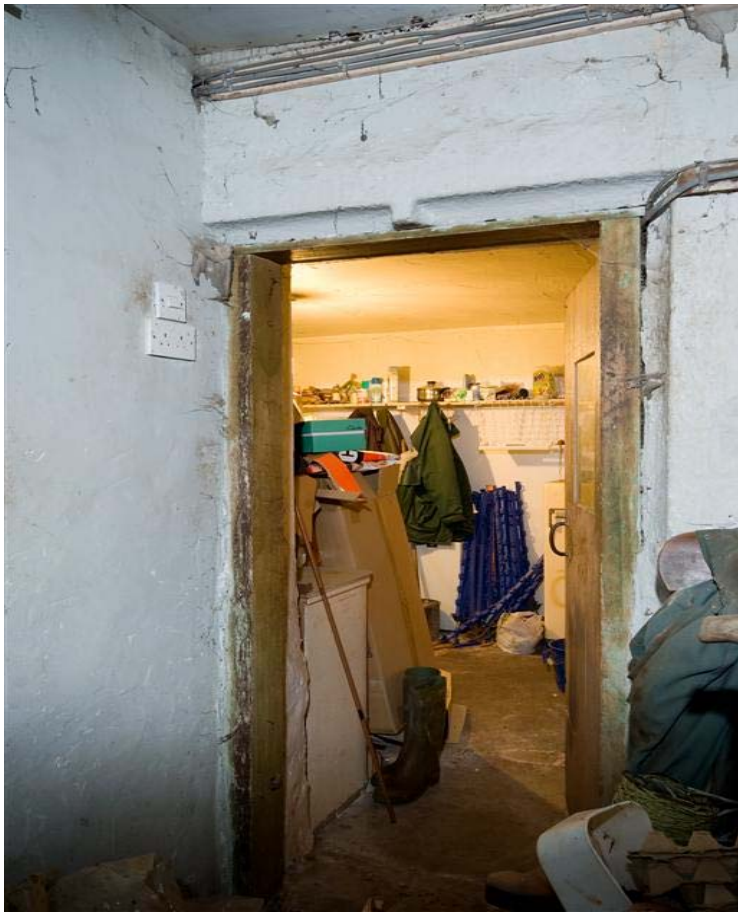
Plate 17: Doorway from the utility into the modern extension at the west end of the farmhouse. The doorway has been inserted into what was originally a two-light mullion window.

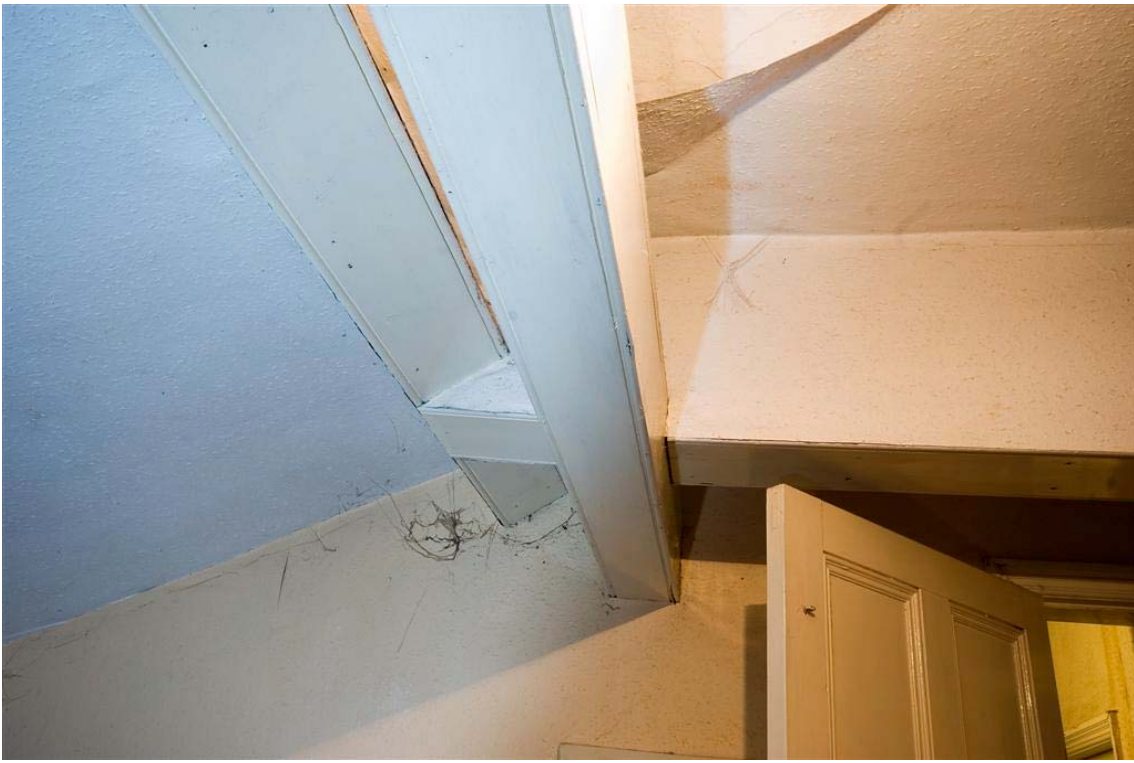
Plate 19: The exposed roof timbers in the bathroom comprise the wall beam and a purlin. The purlin is supported by the boxed tie-beam.

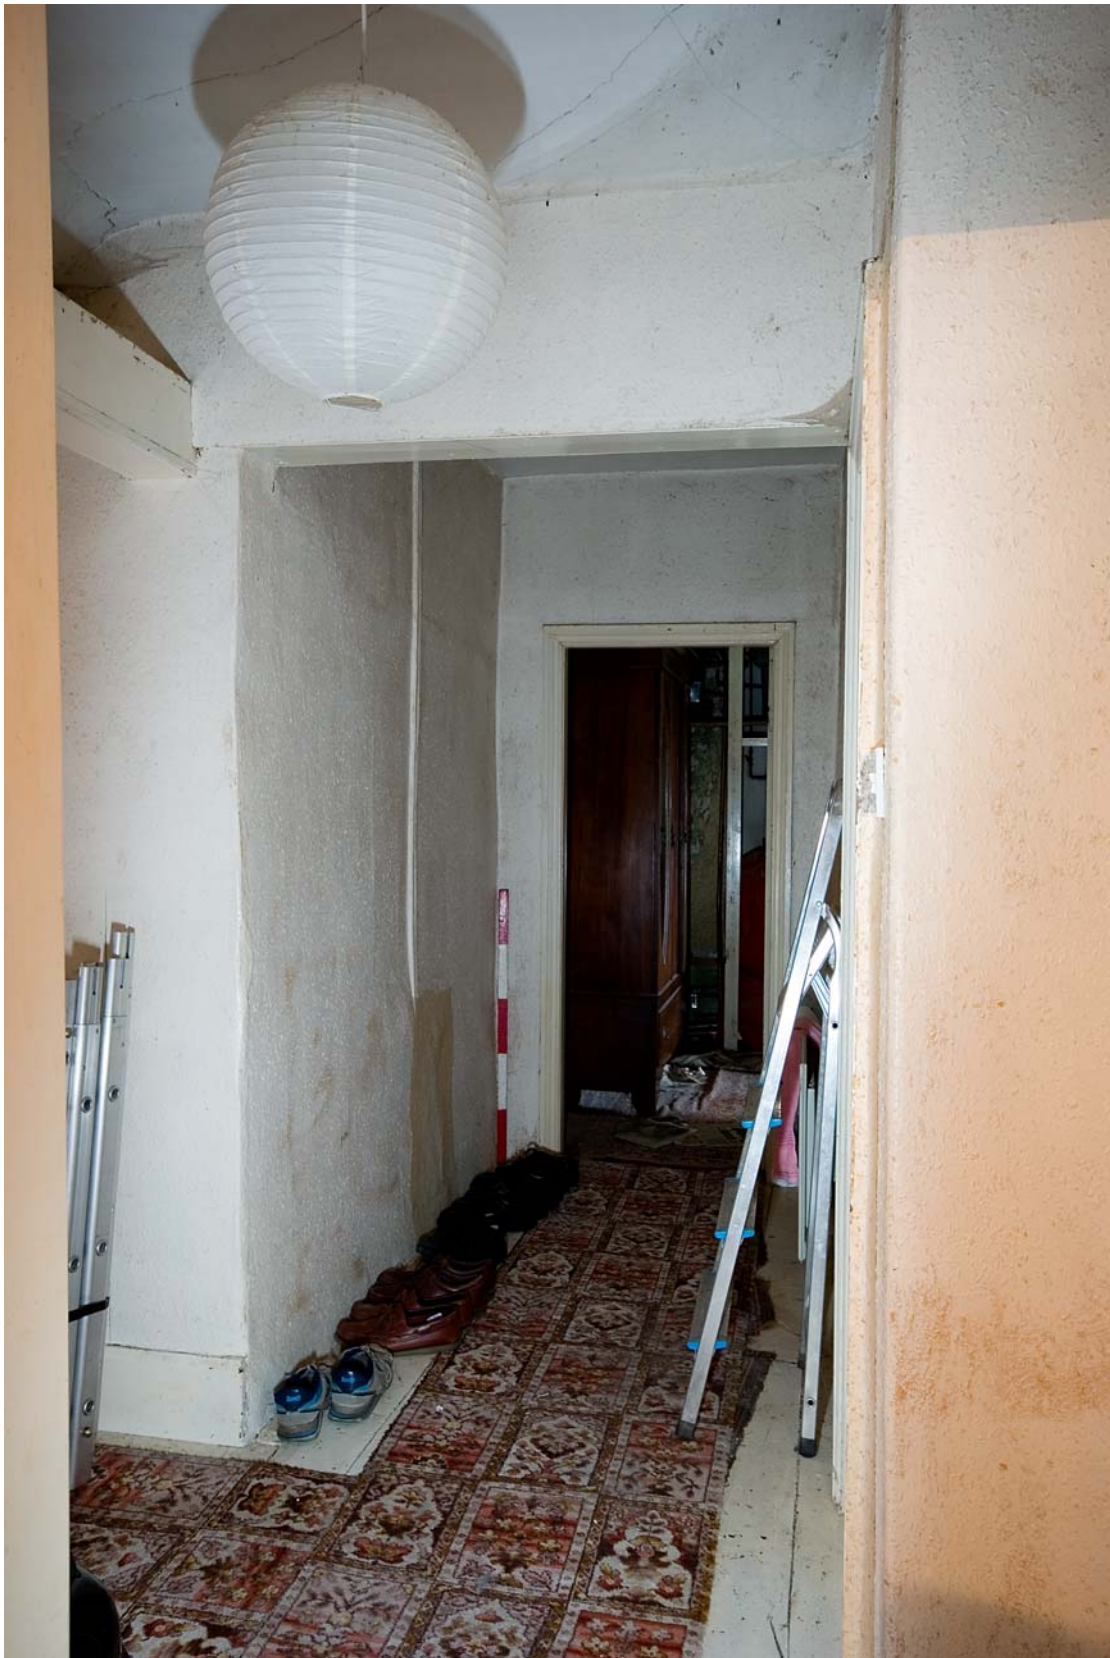
Plate 20: The exposed wall beam is just visible to the left of the picture. The height of the wall beyond this (extending above the wall beam) is evidence for the ceilings having been raised.

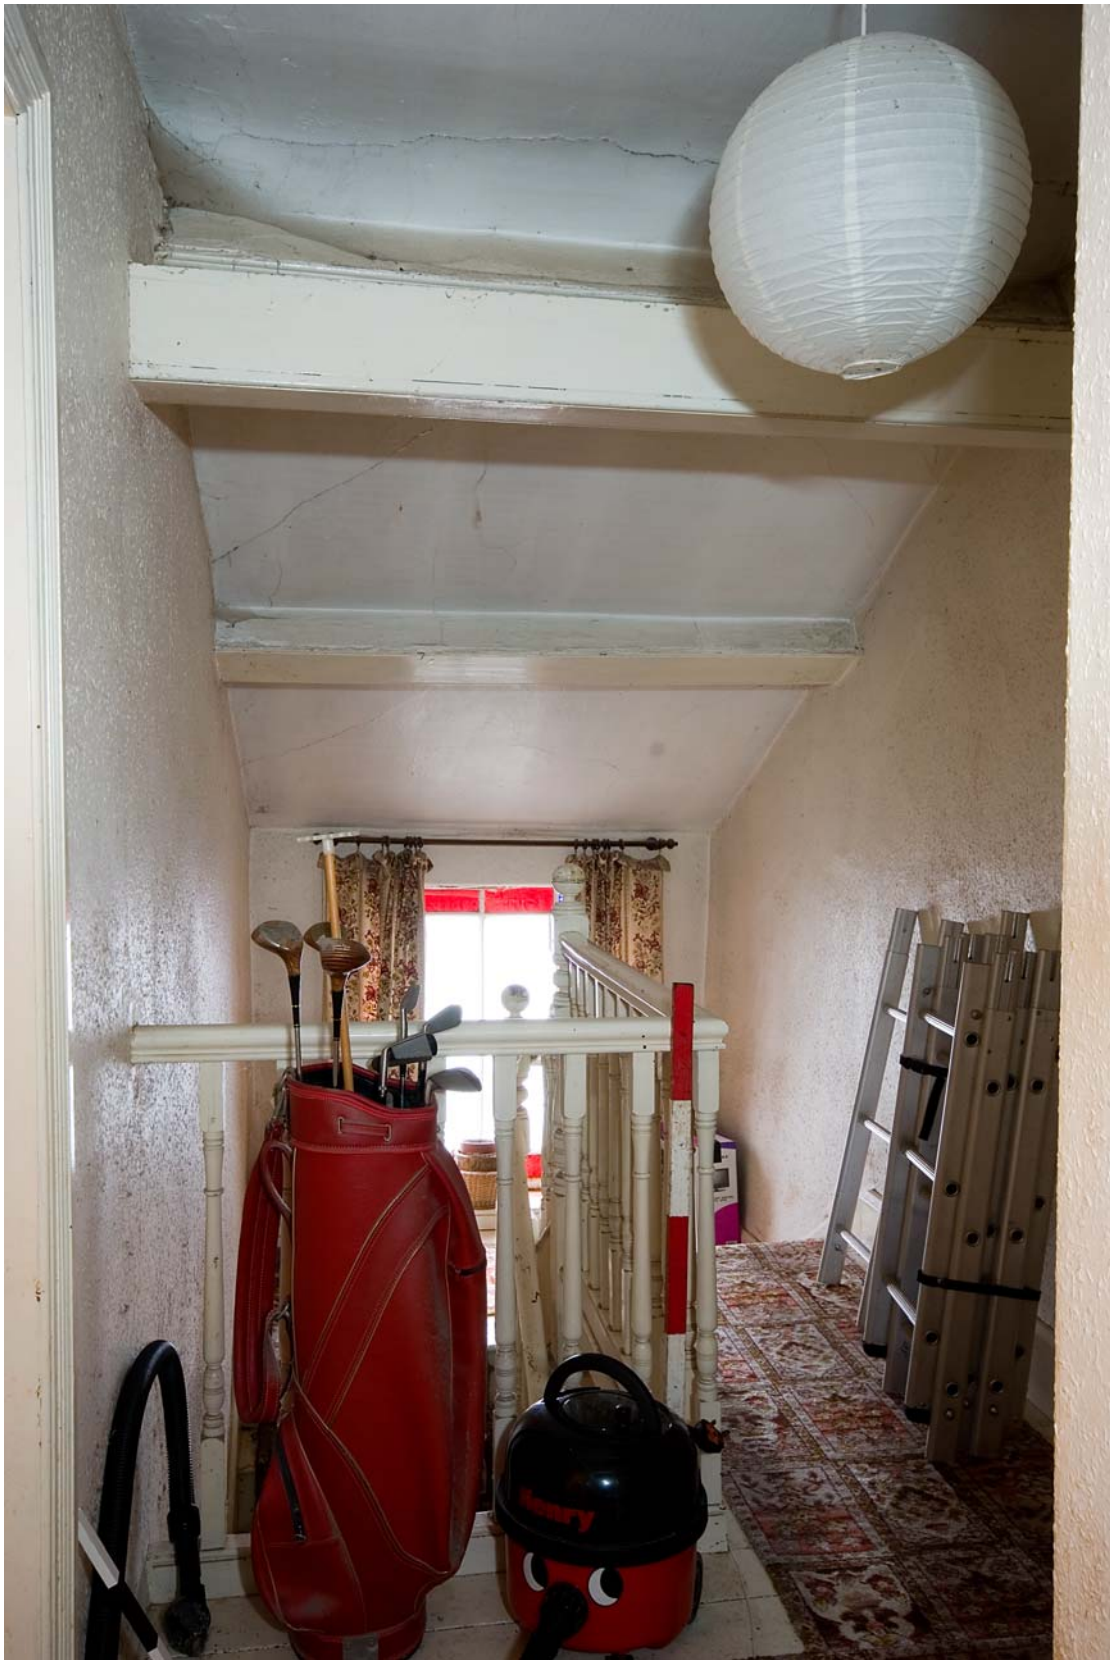
Plate 21: Wall beam and purlin exposed above the stairway. The wall beam indicates the position of the original wall of the farmhouse. The purlin relates to the construction of the rear projection.

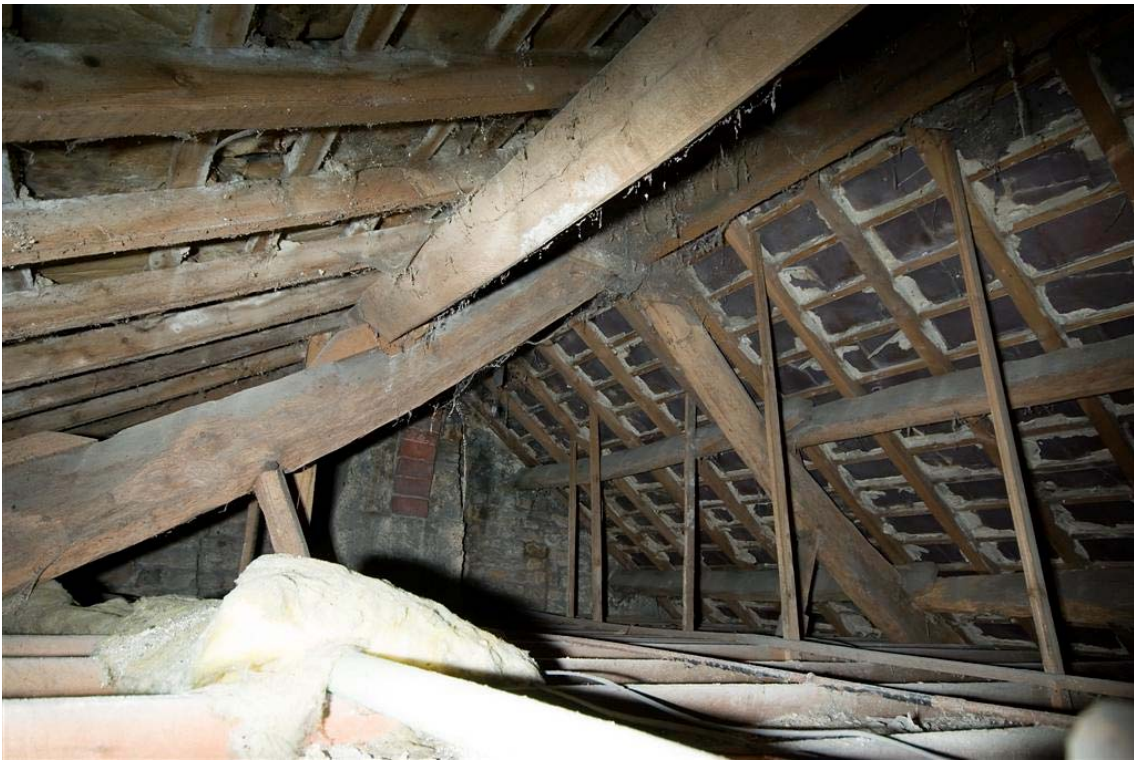
Plate 22: View of the roof space above the farmhouse. The original socket within the principal rafter, for what was a trenched purlin, is visible beneath the current position of the purlin.

- 5.3.3 Finally, investigation of the roof space provided evidence to show that the rear roof pitch had been altered – heightened, albeit a small amount, and this presumably to accommodate the catslide pitch of the roof. The purlins were lifted from their original trenched position, to sit upon the rafters. The illuminated dog-leg staircase of two flights is typical of that commonly found in the rear projection, being roofed by the continuation of the main roof. According to Brunskill (2002) houses built or extended to this plan date between 1730 and 1820.

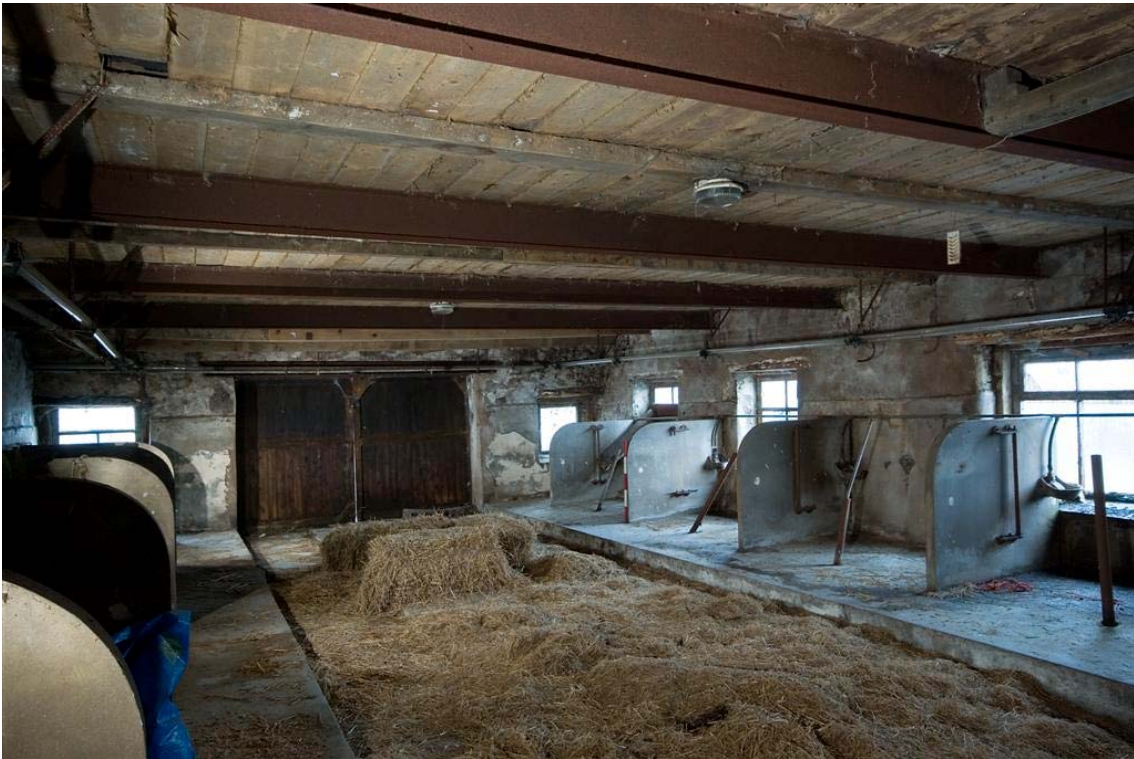
Plate 23: General view of former shippon, facing east. The stall, doorway and RSJ joists are all modern additions.

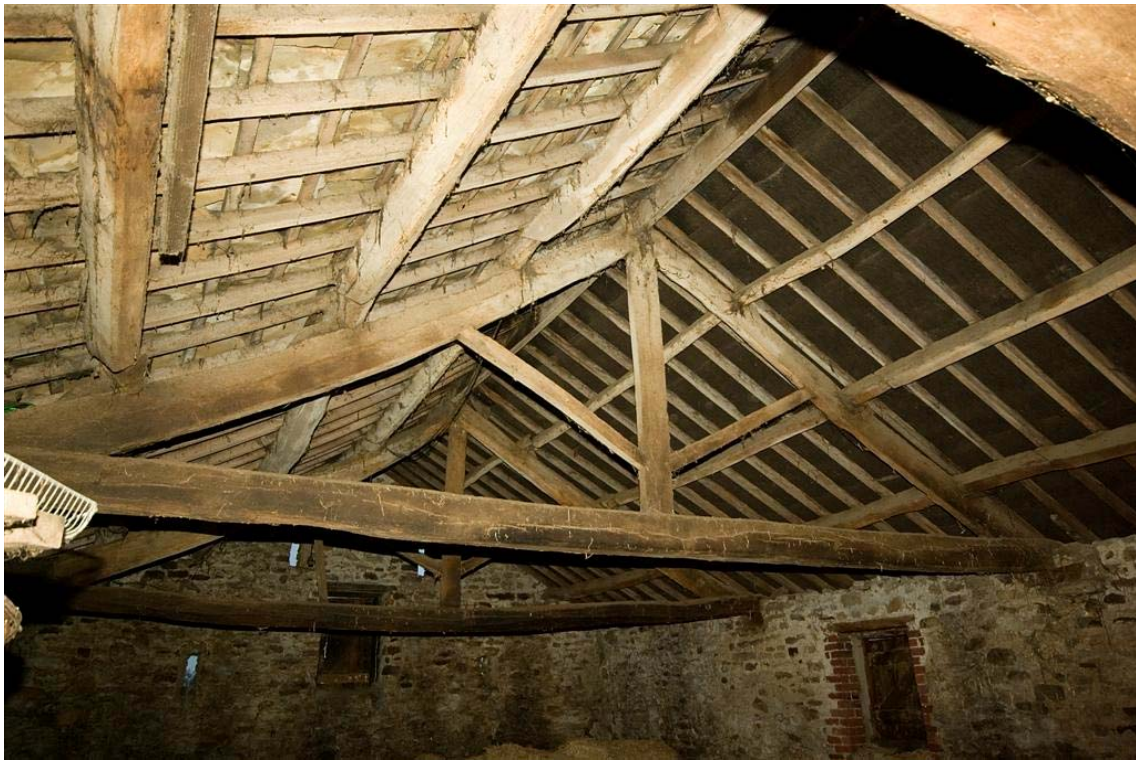
Plate 24: View of the hayloft, facing east.

4.5.3 **Hayloft (Room 16):** within the hayloft the roof is supported on three king-post trusses (Plate 24). The trusses, which appear to be of oak construction, rest on corbels. All the truss joints are tenoned. In addition to the roof plate, there are three sets of purlins to each roof pitch, and these are scarf-jointed. The rafters of the southern pitch are all modern, and whilst those on the north appear to be earlier, they have undergone some modification or repair. The original or stone-built element of the west wall retains evidence (in the form of a scar) to suggest a lower angle to the north pitch of the roof. Unfortunately, the floor of the hayloft was in an unsafe state, and so this was not investigated further.
