CRAVEN FOLD FARM, LANGHO, LANCASHIRE

Archaeological Building Investigation

Oxford Archaeology North

April 2010

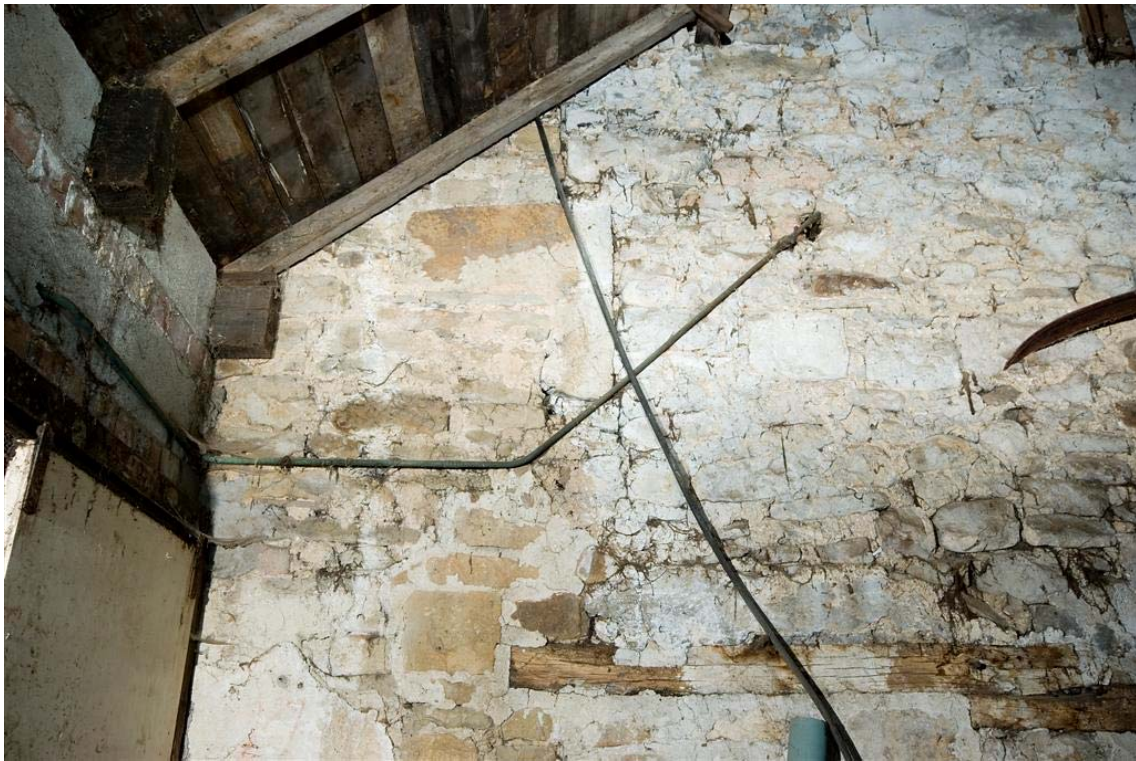
Plate 25: Vertical scar in the west wall of the barn store. This represents the original line of the back wall of the farmhouse.
