# Northern Hub, Manchester and Salford

## Archaeological Watching Brief

November 2014

**Document Type:** Archaeological Watching Brief

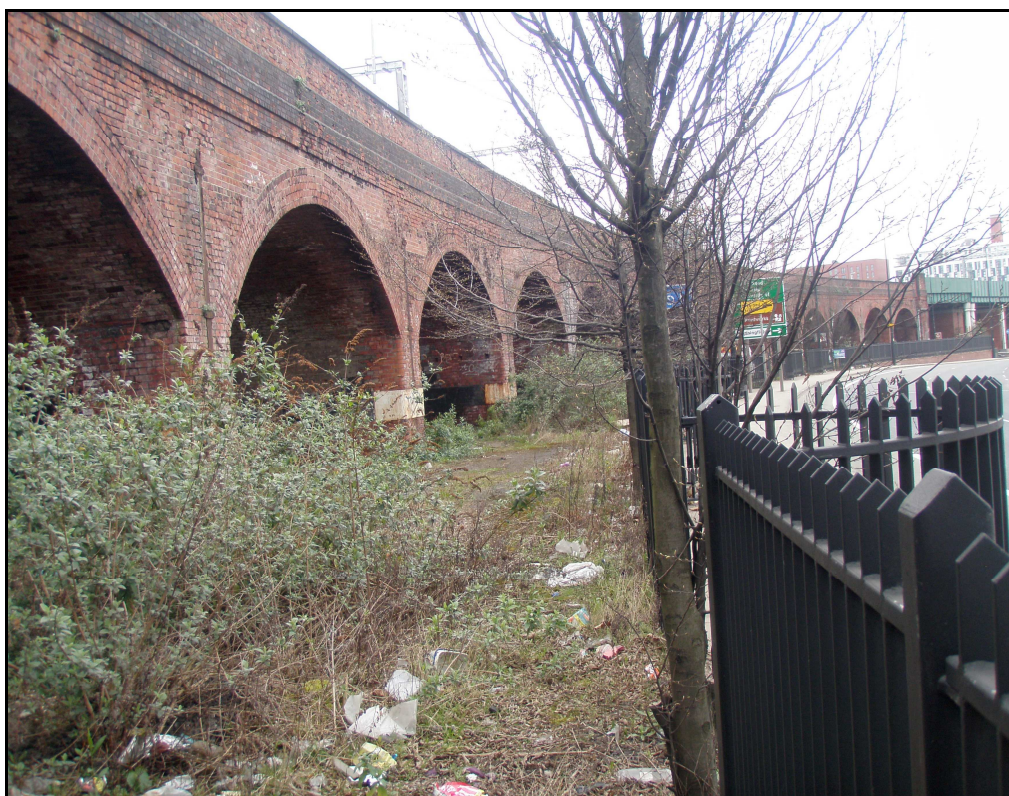
Plate 2. View along the viaduct (OA North, Site 91), leading to Irwell Street

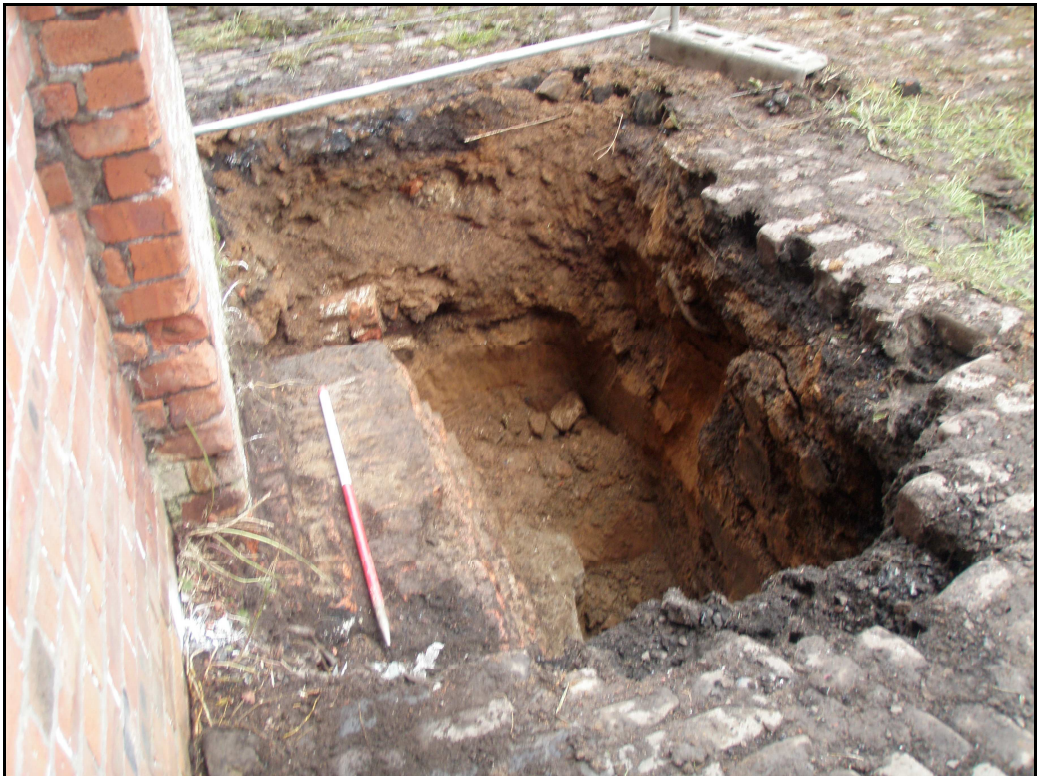
- 3.2.2 **Stone-sett surfaces:** a consistent feature of many of the test pits was the presence of a stone-sett surface (Plate 3), occurring at various depths and below variable deposits as described in *Appendix 1*. These surfaces were probably laid to facilitate access between the viaduct arches, although a cobbled surface observed in test pit G4WS06, located next to the River Irwell, was interpreted as a possible tow path.
- 3.2.3 Generally, the stone-sett surfaces almost certainly date to the late nineteenth and twentieth centuries, and are little archaeological interest. In most cases, the surfaces were laid on a thin levelling layer, which sealed the natural geology, with no indication of any buried remains of archaeological interest.

Plate 3. An example of the cobbled surfaces encountered across the site, from test pit G4HP07

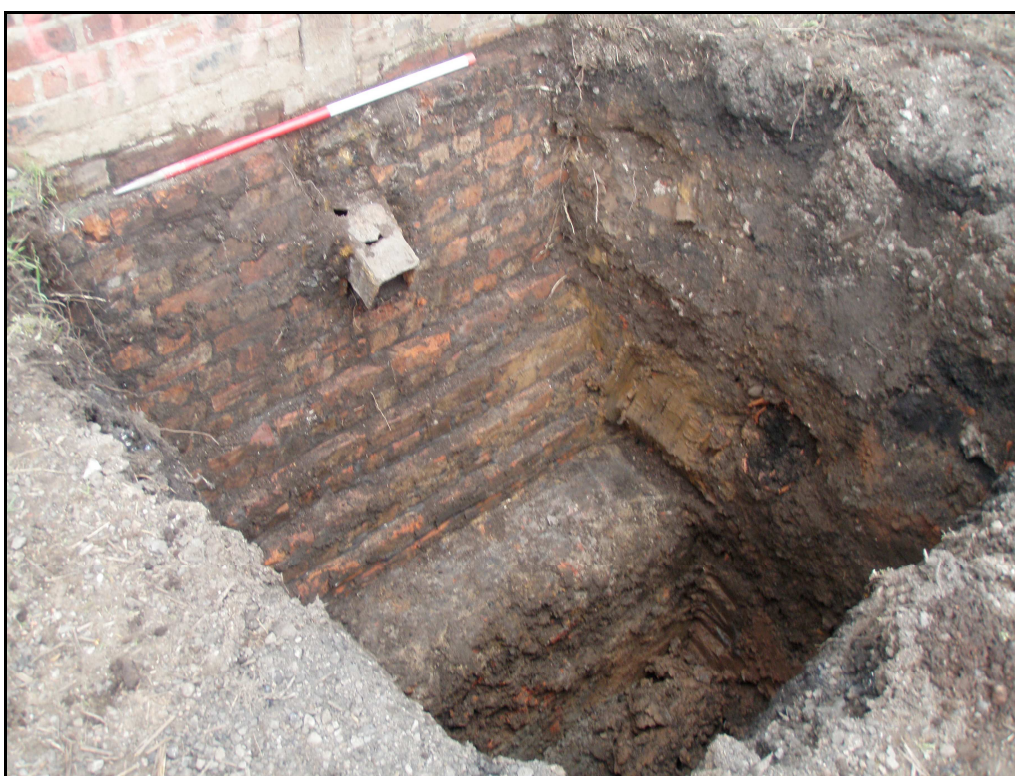
- 3.2.4 **Structural remains:** a number of structural features, primarily comprising sections of handmade brick walling were recorded in several test pits (*Appendix 1*). Many of these structures could be related to the footings of the various upstanding viaducts and rail bridges (Plate 4). Indeed, the exposure and recording of the extent and depth of these footings formed a primary aim of the test pits excavated in close proximity to the upstanding structures.

Plate 4. An example of the stepped viaduct arch foundations exposed during test pitting, from pit G4FP06 between arch 13 and 14

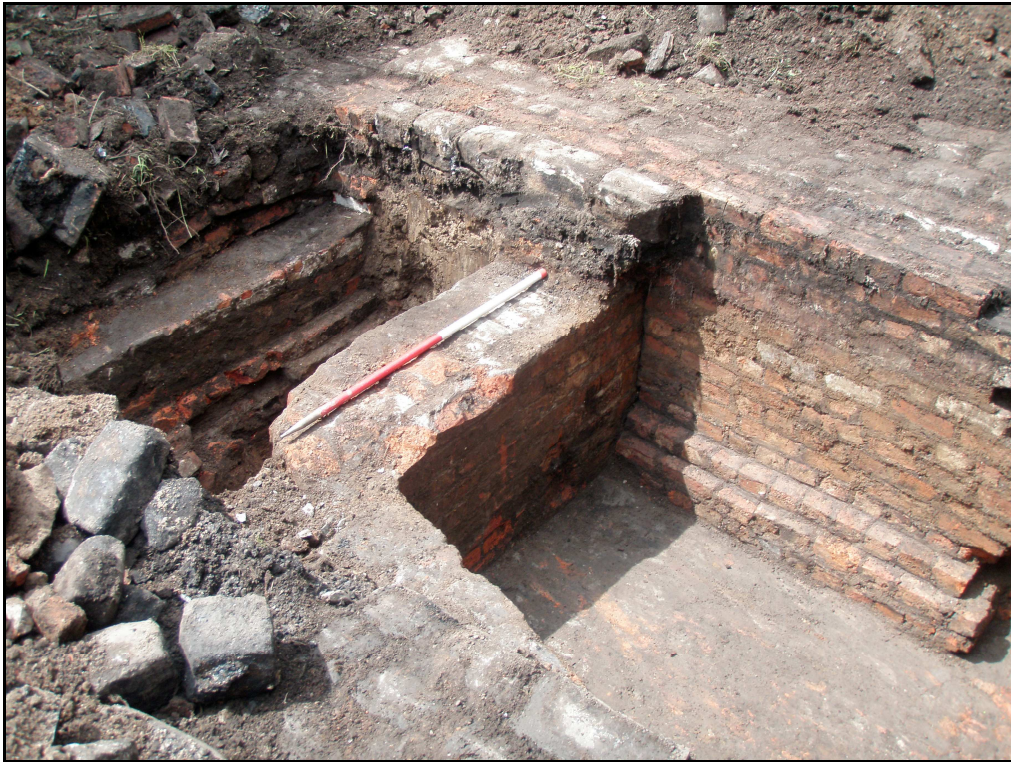
- 3.2.6 Other structural remains were recorded to the north of the Water Street viaducts, and to the south of Hampson Street. In TP03 these included the footings of a nineteenth-century wall that ran parallel with Hampson Street (Plate 5). This handmade brick wall was associated with Prince's Bridge and as such probably dates to *c* 1863 (*Section 1.3.20*). In addition to this wall, TP03 also revealed another brick and cobbled surface at a depth of 1.2m below present ground surface (Plate 5). This floor surface formed part of a small structure also defined within the context of the test pit by up to four separate wall sections (1-4), each constructed of handmade brick. Wall 1 was observed to be keyed into the retaining wall along Hampson Street and extend at 90° from it, while Wall 2 butted against Wall 1. Walls 3 and 4 extended between Walls 1 and 2 and ran parallel to one another, up to 0.65m apart, and the retaining wall. A further handmade brick wall, running parallel to the retaining wall along Hampson Street, was also identified to the west, in TP04.

Plate 5. The brick floor and associated walls in TP03. Walls 3 and 4 centre left
