3, Glass Wharf,
Temple Quay,
Bristol,
Avon

**Summary Report of
Archaeological Works**

Oxford Archaeology North

September 2014

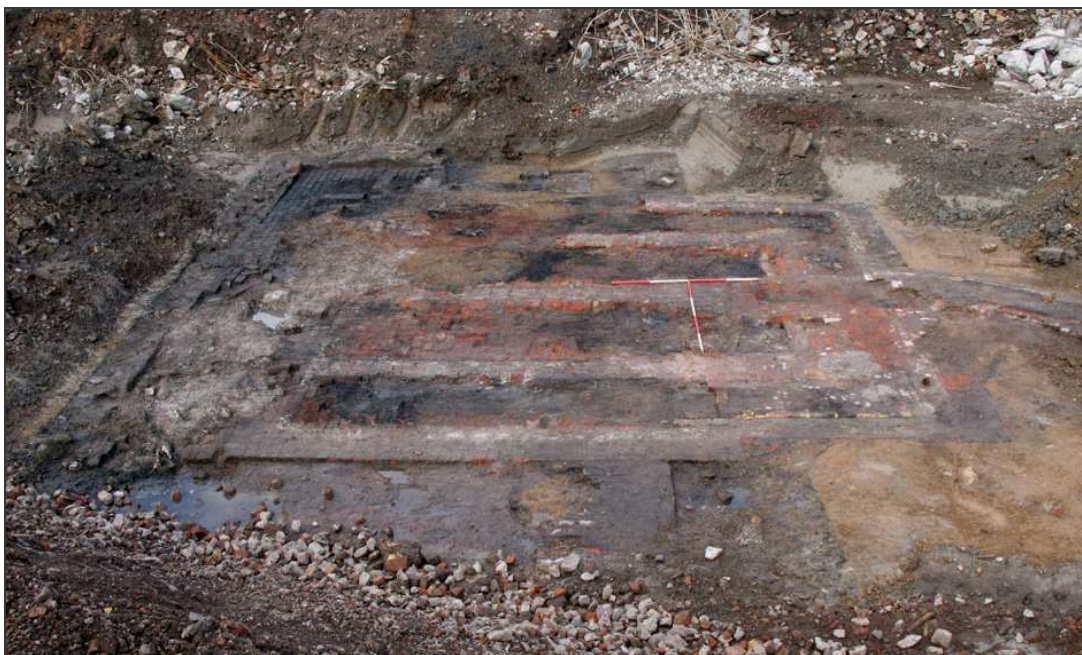
Plate 3: Furnace A earlier phase, looking west

- Heavily truncated structural remains and deposits relating to the establishment and early development of the **Soap Boilers' glasshouse** (Furnace A) (Plate 3);

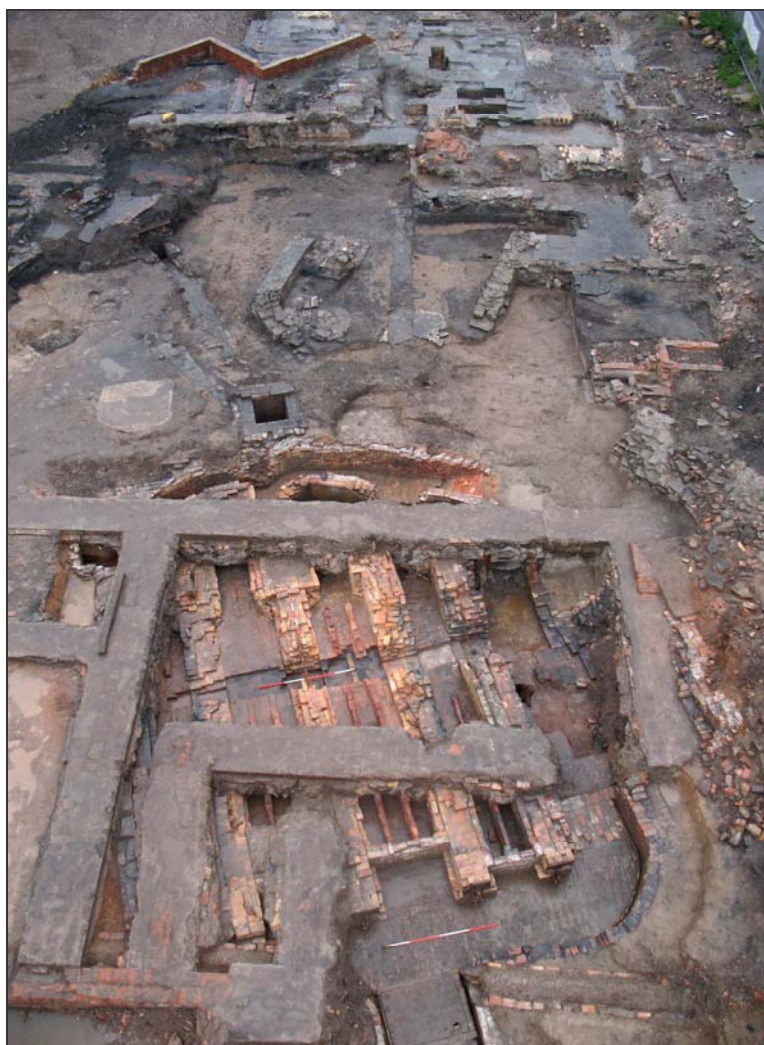
Plate 4: General view of Furnace B, with the Phase 2 sandstone walls visible, looking west

- Structural remains and deposits relating to the establishment and early development of the **Hoopers' glasshouse** (Furnace B) (Plate 4);
- A range of structures and deposits identified with ancillary buildings, *ie* an **annealing house**, outbuildings and land divisions;

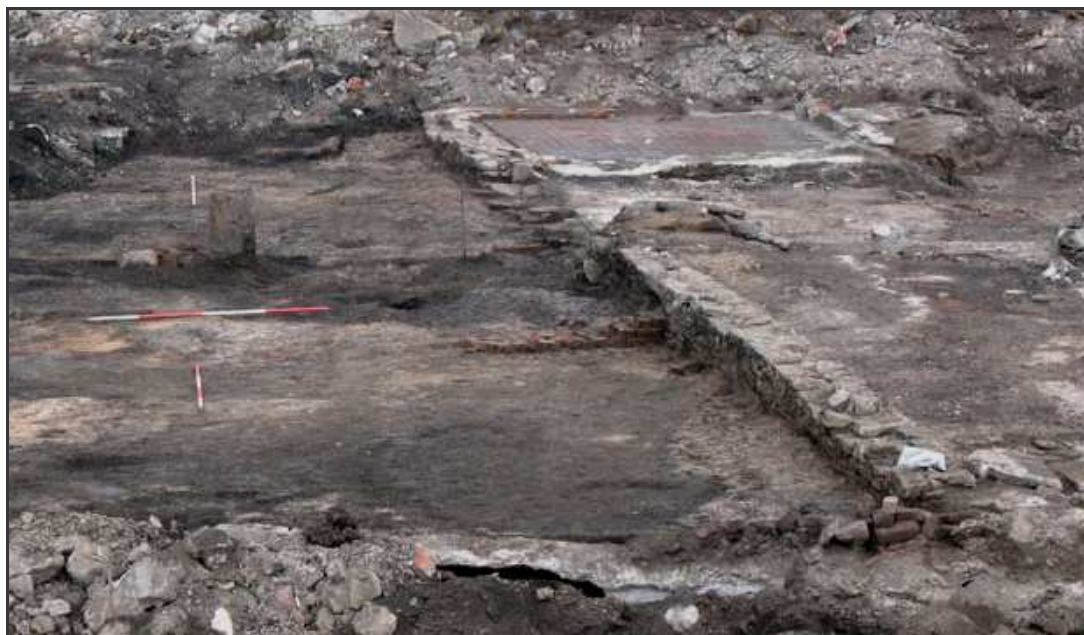
Plate 5: Sandstone-built wall 3390, looking south, thought to be part of William Lunds' brass and copper works

- Structural remains and deposits (characterised by the presence of brass slag blocks) probably associated with **William Lund's copper and brass works of 1749-55** (Plate 5);

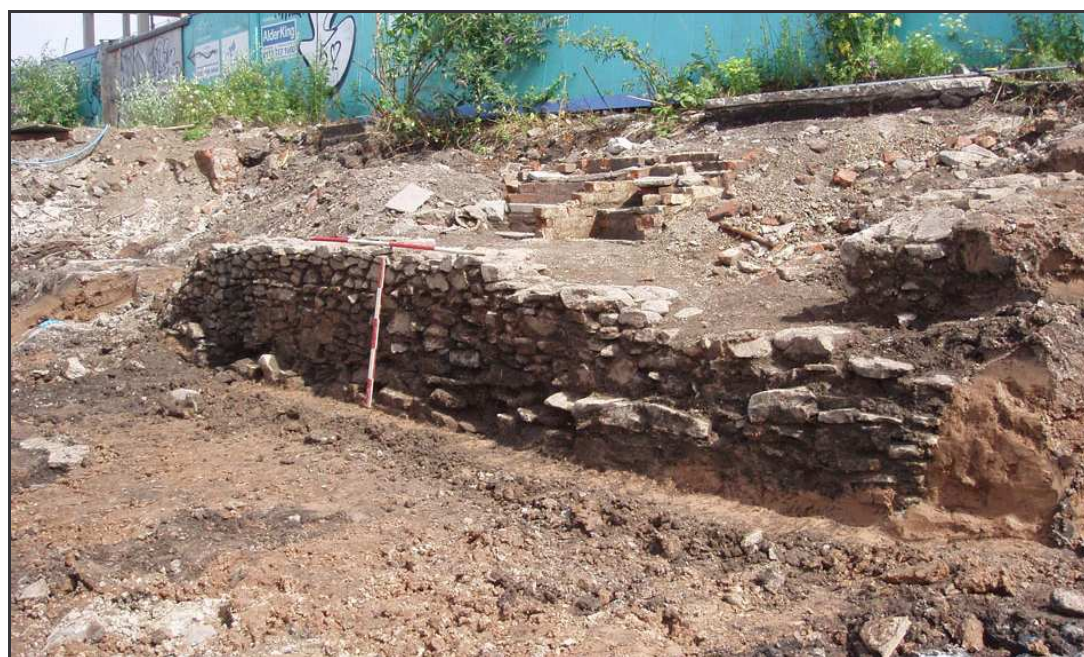
Plate 6: Wall 1149 in the north-western corner of ND5, with later brick steps, looking north-west

- A series of independent buildings, equipped with cellars (Plates 6 and 7), and walls of unknown function.

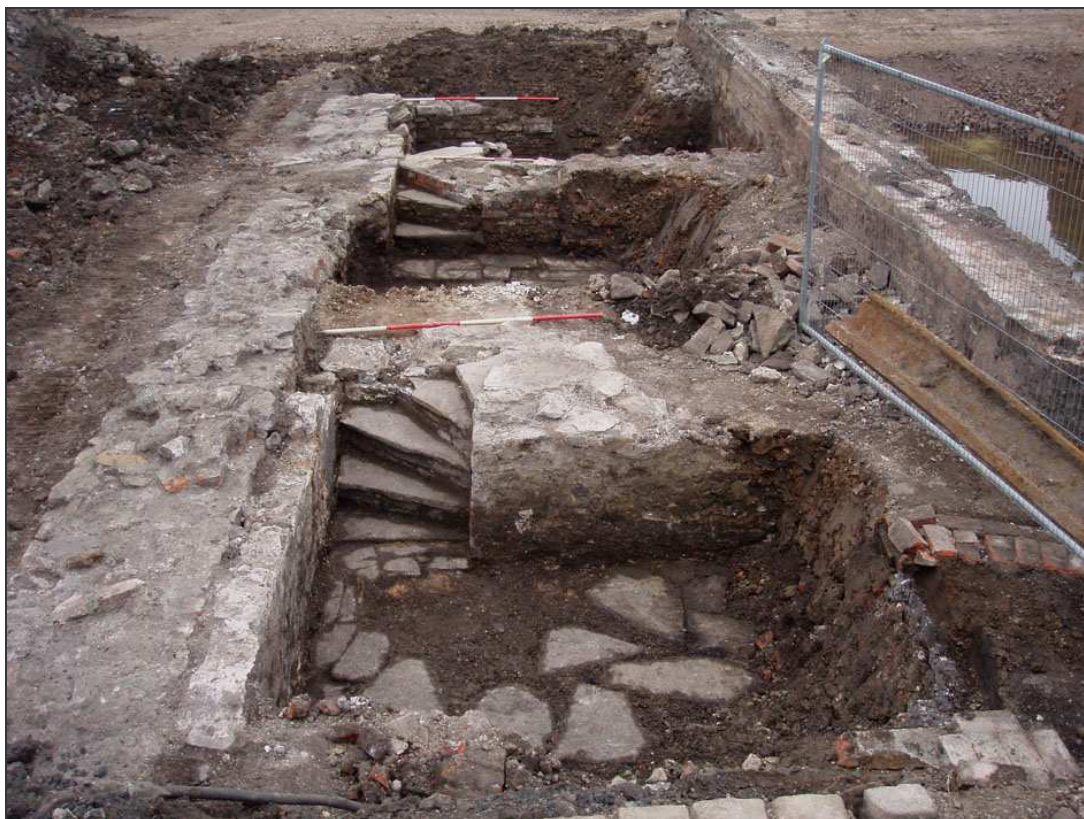
Plate 7: Wall 1268 with adjacent cellars, looking south

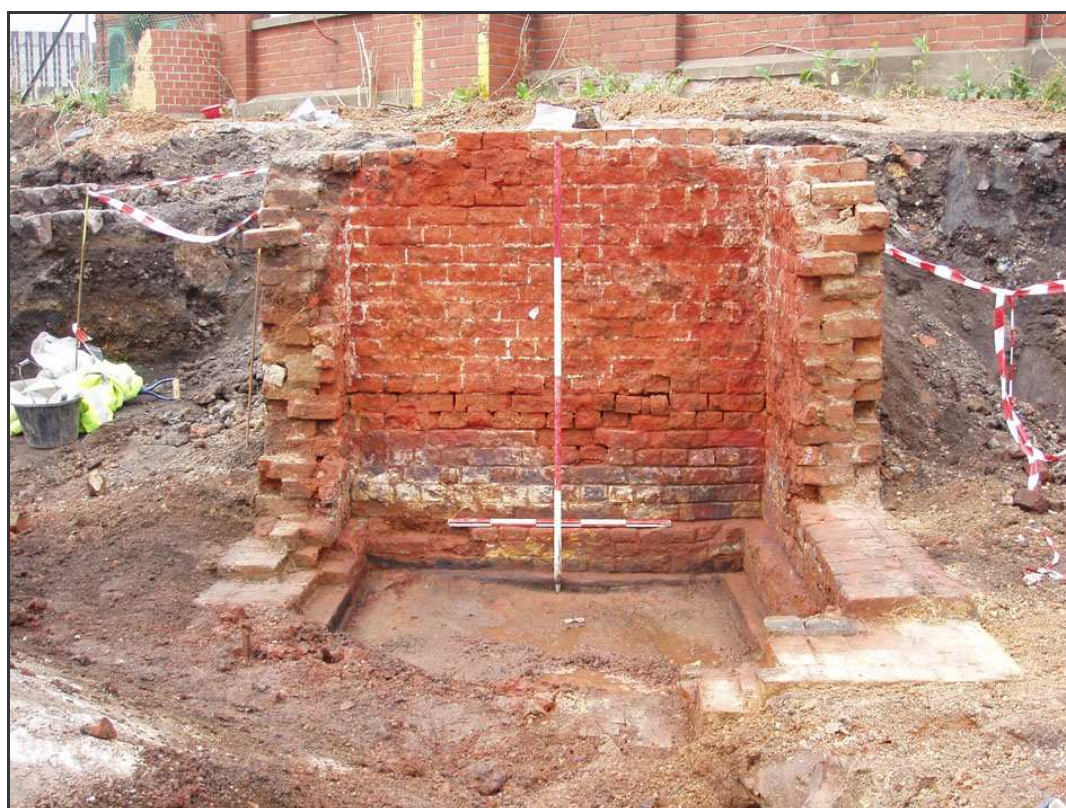
Plate 8: Furnace A, chimney 3093 associated with the earlier phase, looking north

- the large-scale modification and modernisation of the original furnaces (A and B) to incorporate the new Siemens design for a regenerative furnace. (Plates 8-10);
- the provision of two further regenerative furnaces (C and D) (Plates 11-15);
- Additional ancillary buildings, including several gas producers, providing a modern energy source for the new furnaces (Plate 16) and a further annealing house (Plate 17);
- Construction of the river side dock and slightly later railway infrastructure (Plate 18);

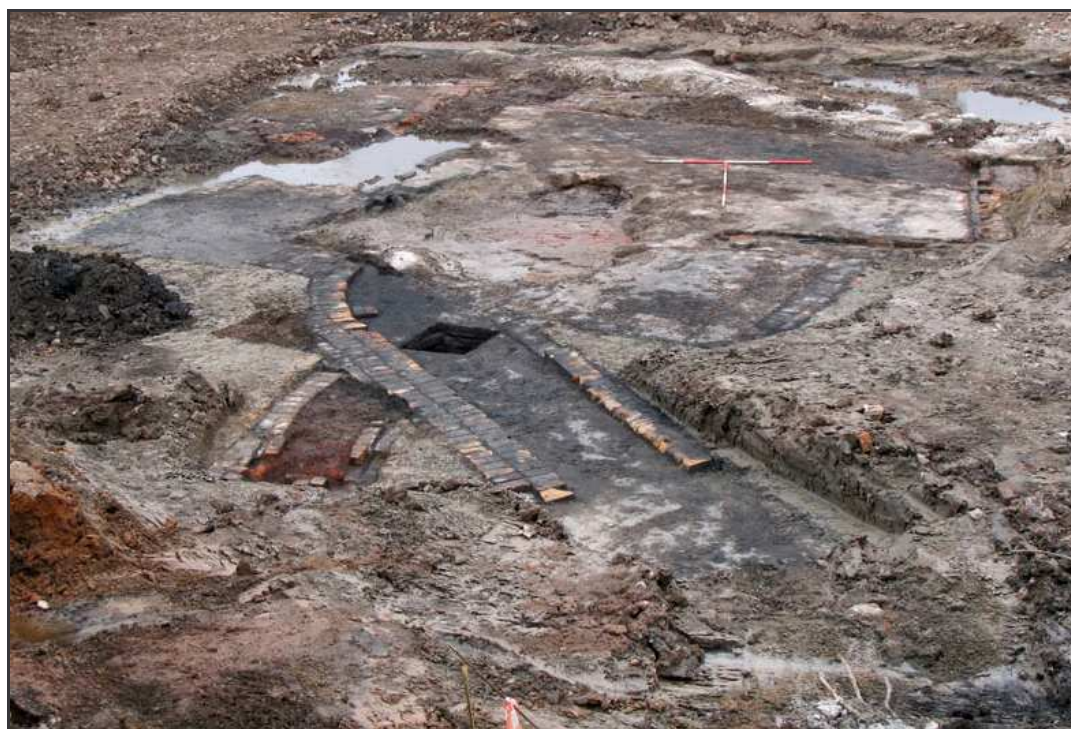
Plate 9: Furnace A later phase, looking south-west

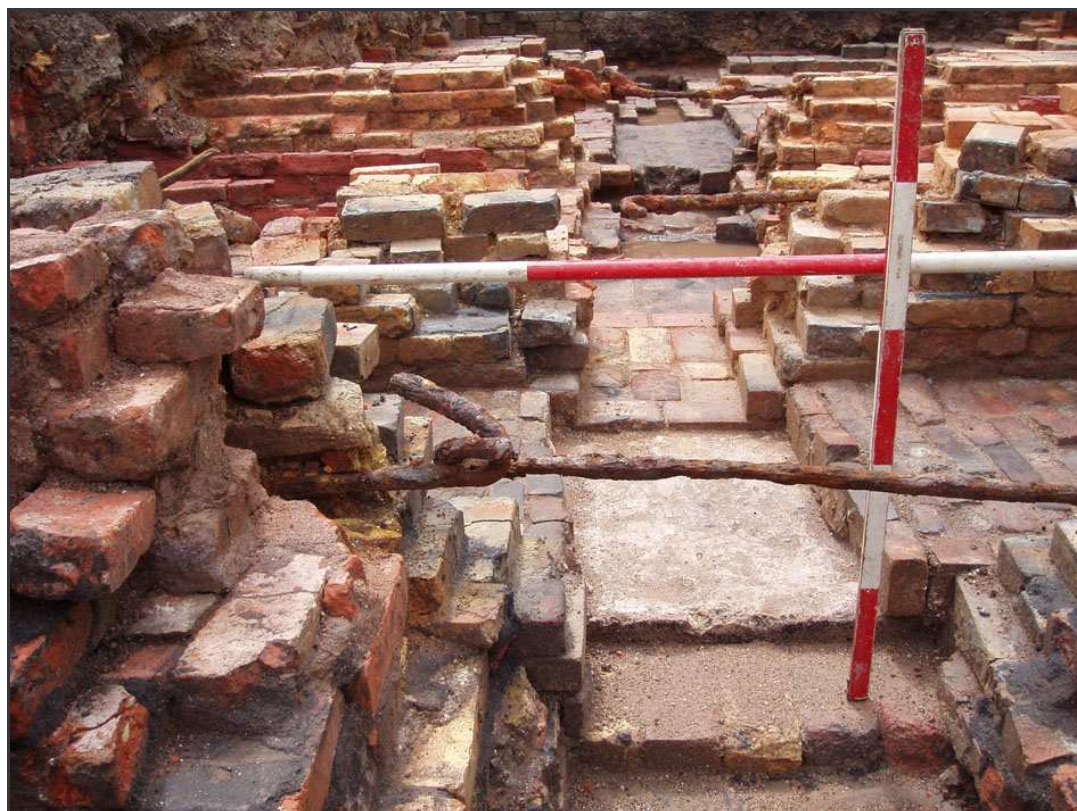
Plate 10: Furnace B, tension bars within the furnace walls, looking south

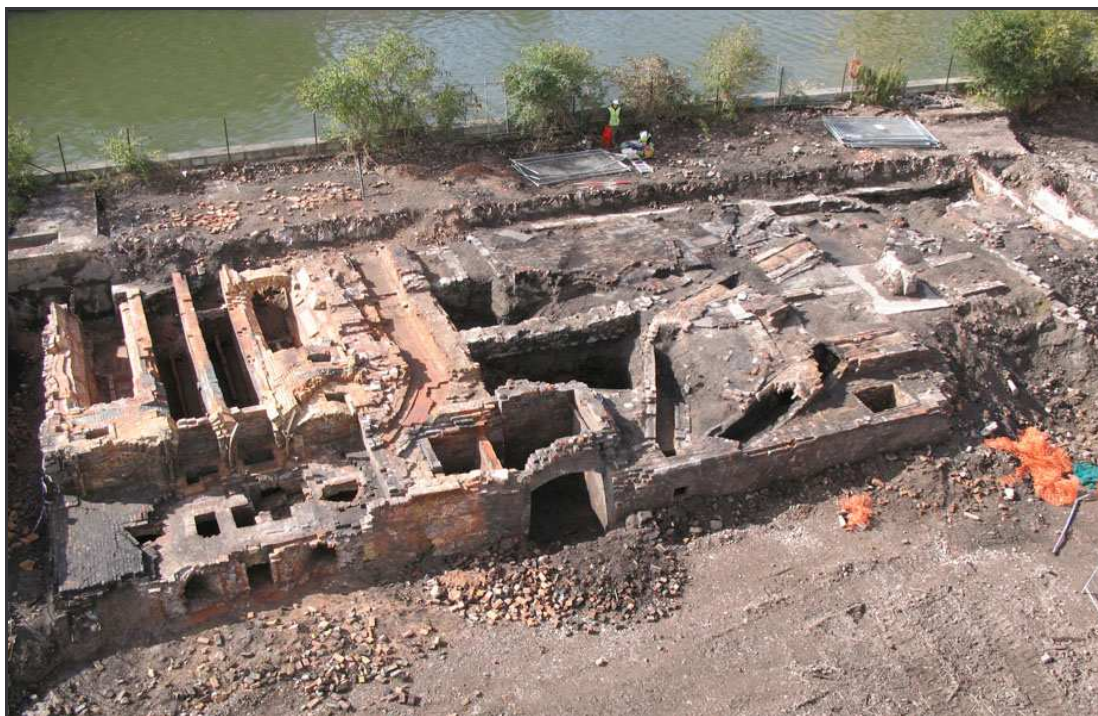
Plate 11: General view of Furnace C, looking south

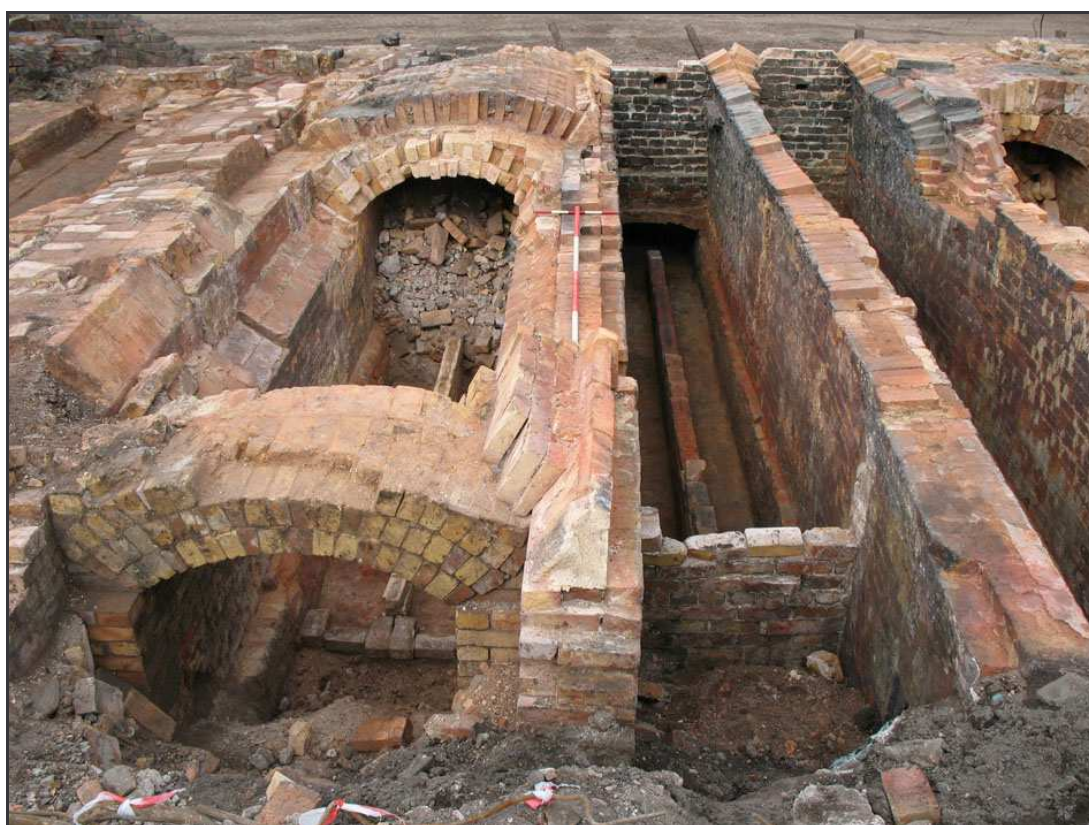
Plate 12: Furnace C regenerative furnace chambers, looking north. The wider chamber carried air and the narrower carried gas

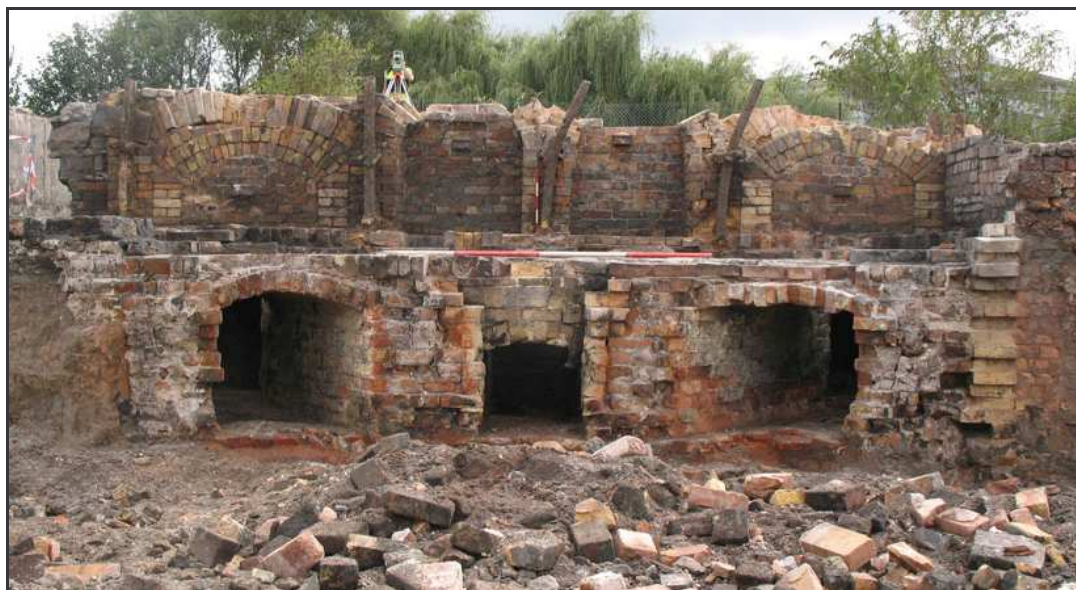
Plate 13: Elevations of flues in Furnace C, looking south

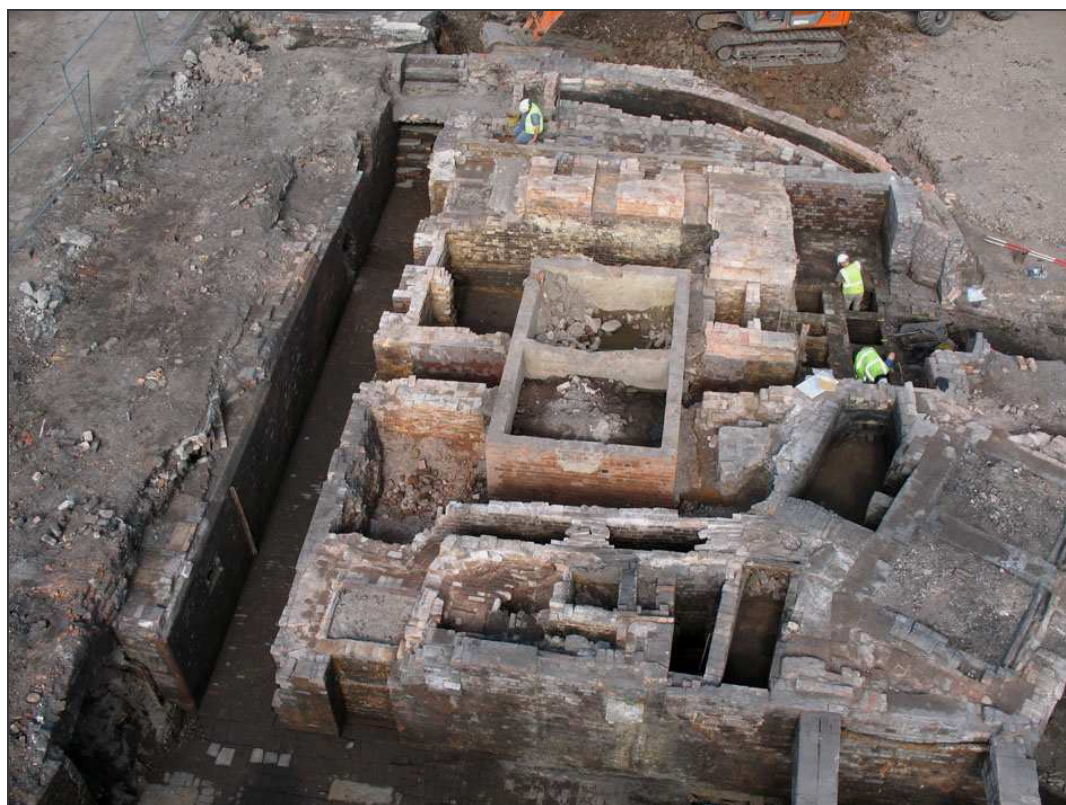
Plate 14: General view of Furnace D, looking west

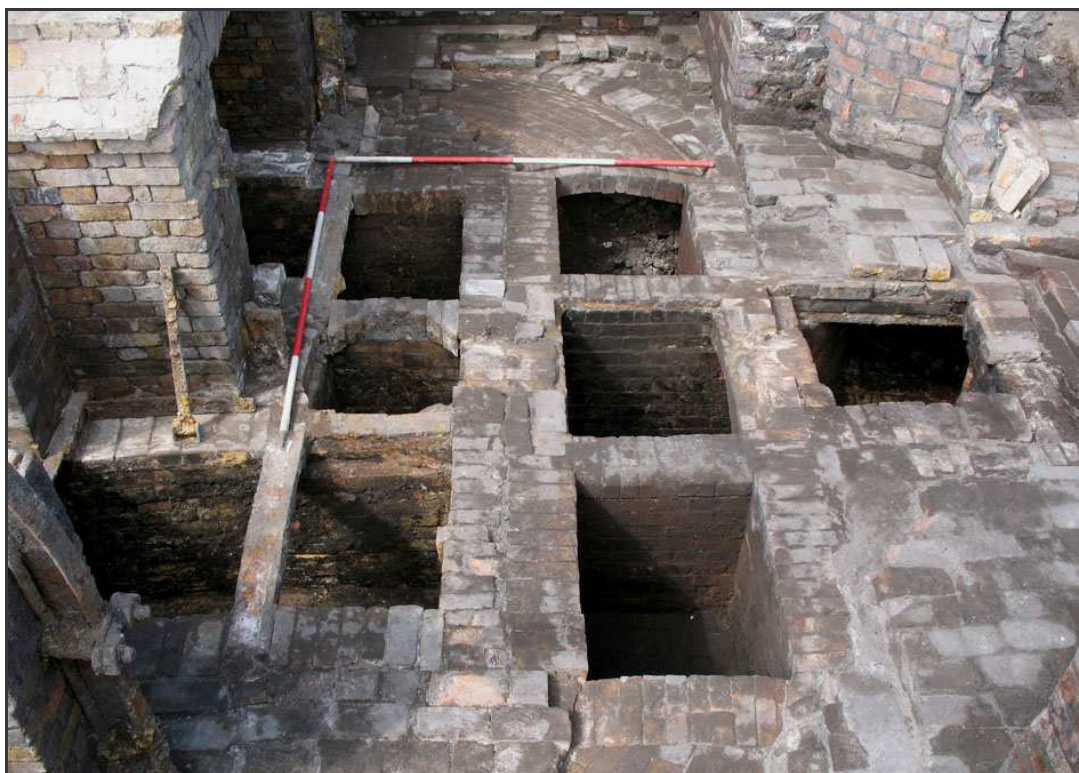
Plate15: Furnace D, arrangement of access pits in switch room 3506, looking west

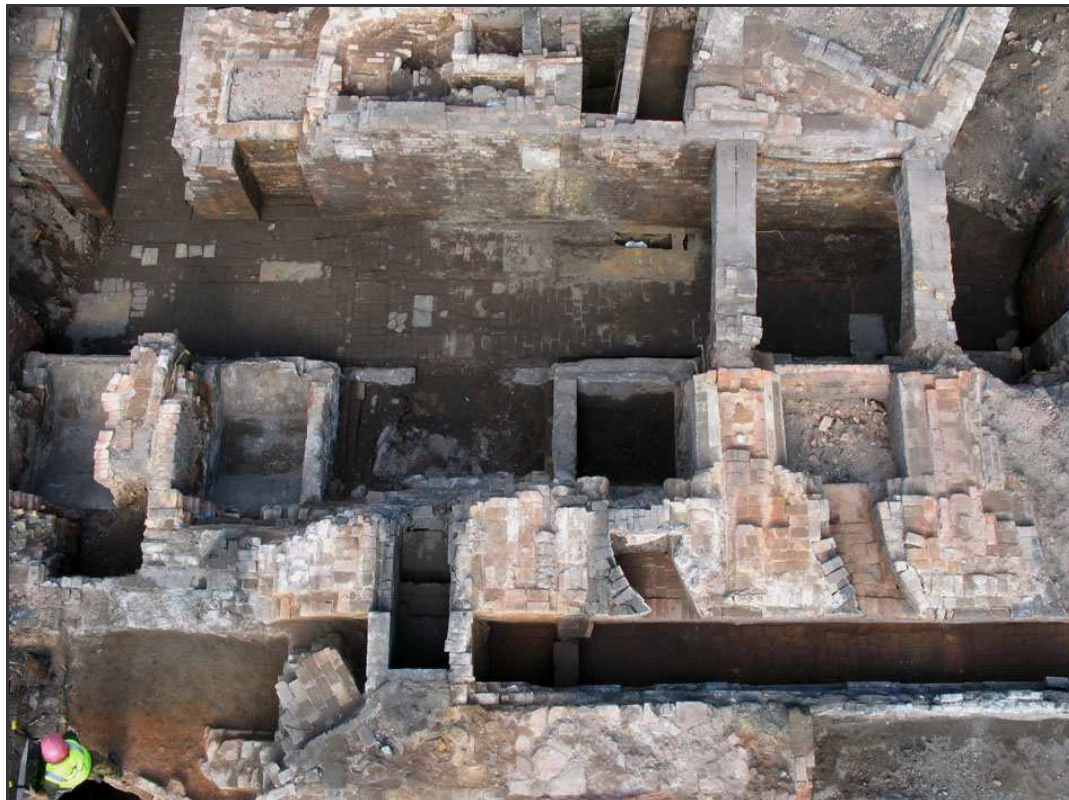
Plate 16: Gas producers 3709 towards the bottom of the picture, with the passageway, 3708, above, looking west

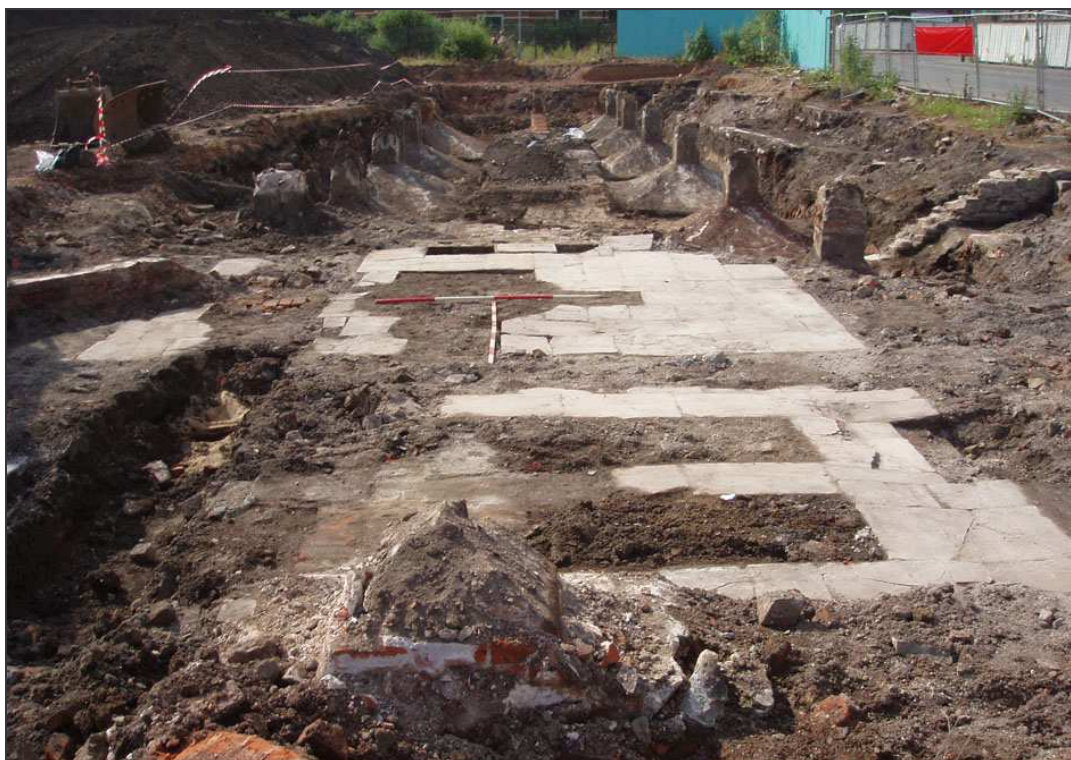
Plate 17: Area of the possible annealing house on the north side of the site, looking west

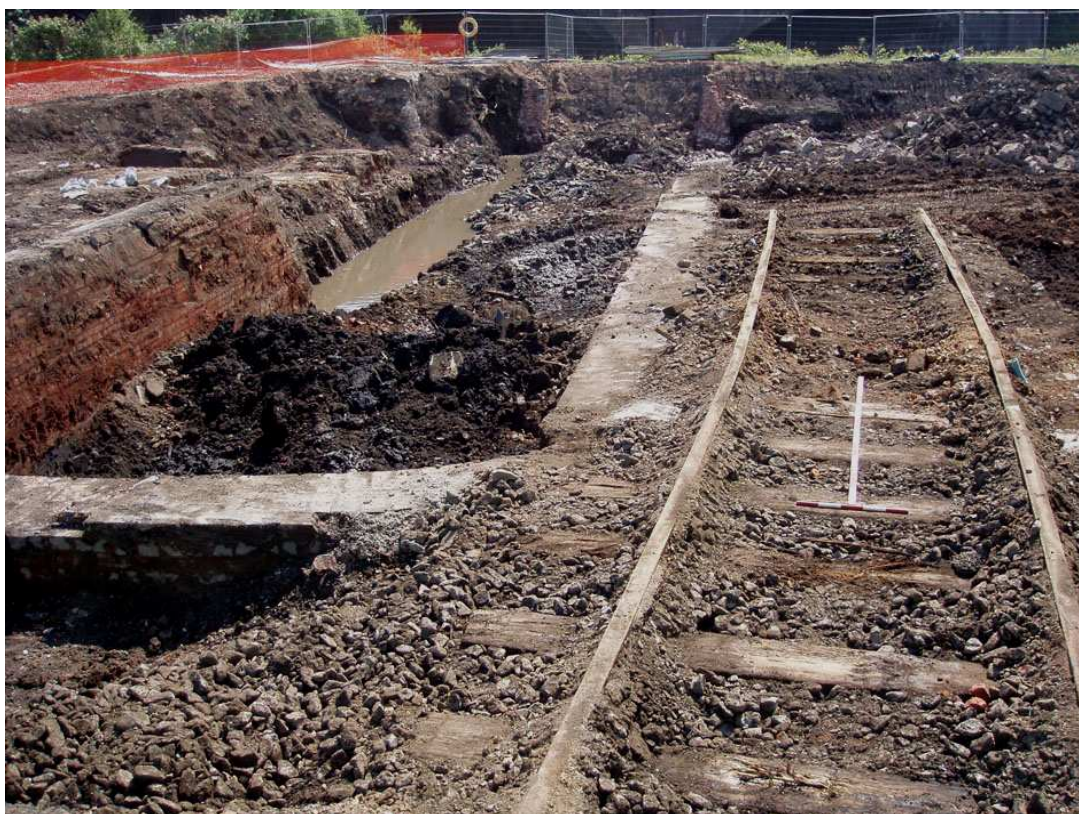
Plate 18: The north end of the dock 1003 with railway tracks adjacent, looking south

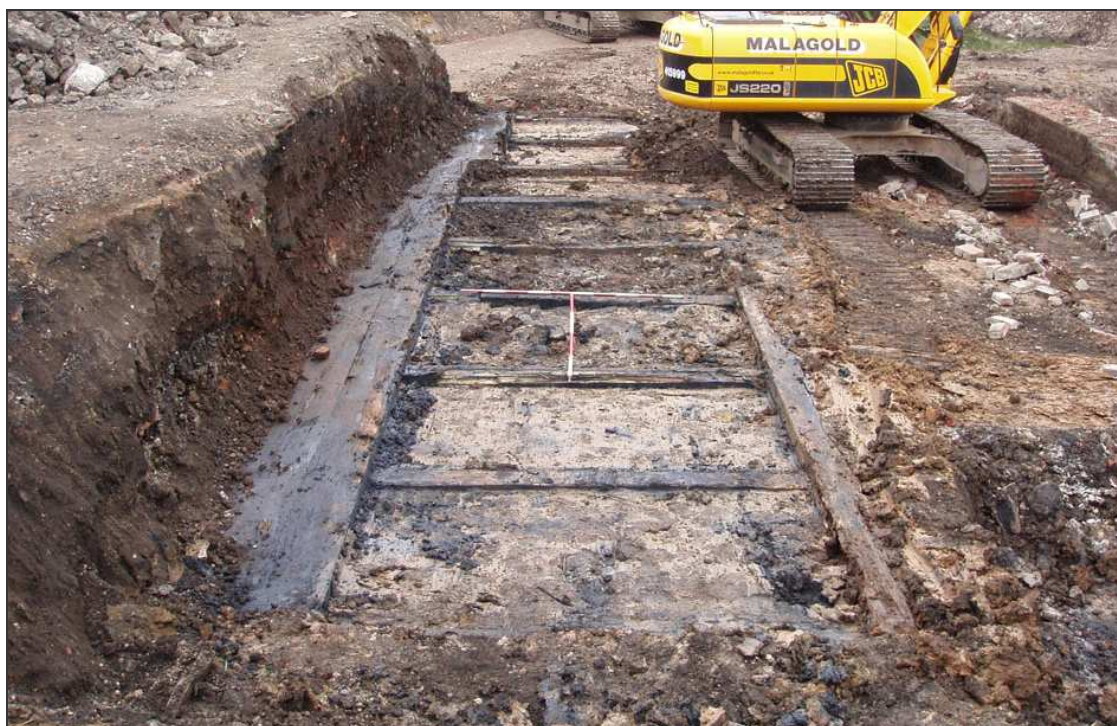
Plate 19: Later timber structure 1090, looking south

- extensive demolition deposits from the glass works;
- concrete foundation deposits for the establishment of a Yeast factory;
- various service trenches and further rail infrastructure;
- a late timber building of unknown use (Plate 19);
- a circular brick structure (Plate 20).

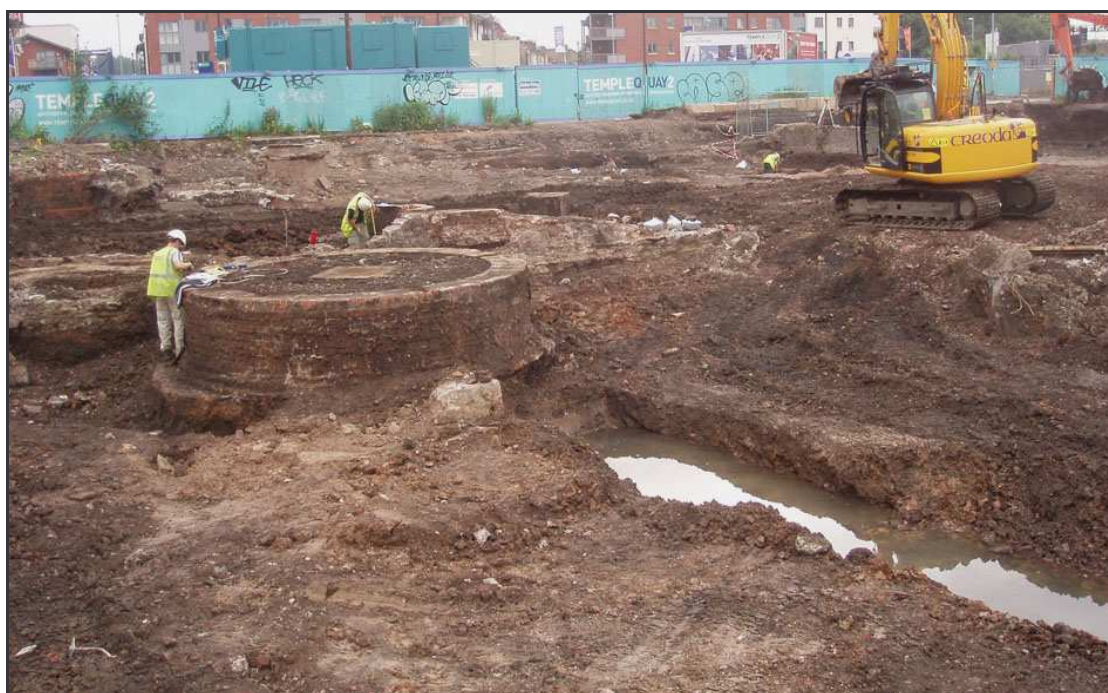
Plate 20: Late circular brick structures, looking north-east
