Galgate Silk Mills, Galgate, Lancashire

Heritage Assessment

June 2014

UK Mills Ltd

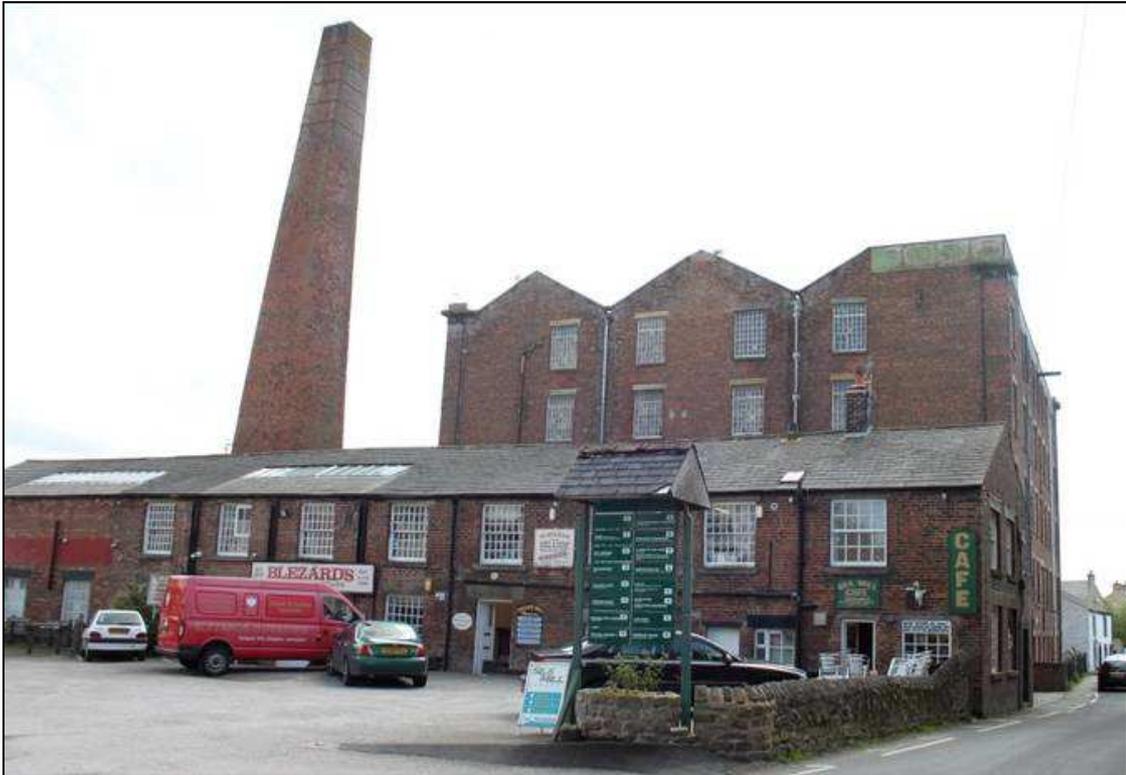
Plate 5: General view of Galgate Silk Mill (1851-2 block), looking south-west

- 4.2.2 The five-storey, nine by six bay, brick-built spinning block (Plate 5) was built in hand-made, mould-thrown brick, in five-stretcher English Garden Wall bond, with pilasters to the return of each elevation, capped with decorative sandstone capitals (Plate 6). The principal western façade has windows to each bay, either side of a central loading loophole (Plate 7), with a projecting hoist beam at fourth-floor level and remodelled loading doors at first- and third-floor level; these features were almost certainly late insertions, as they are not visible on a photograph of the building taken in 1959. The original vertical windows have flush sandstone lintels and projecting sandstone sills and house 56-light timber frames; the top two rows open as a swivel tilt (Plate 8).

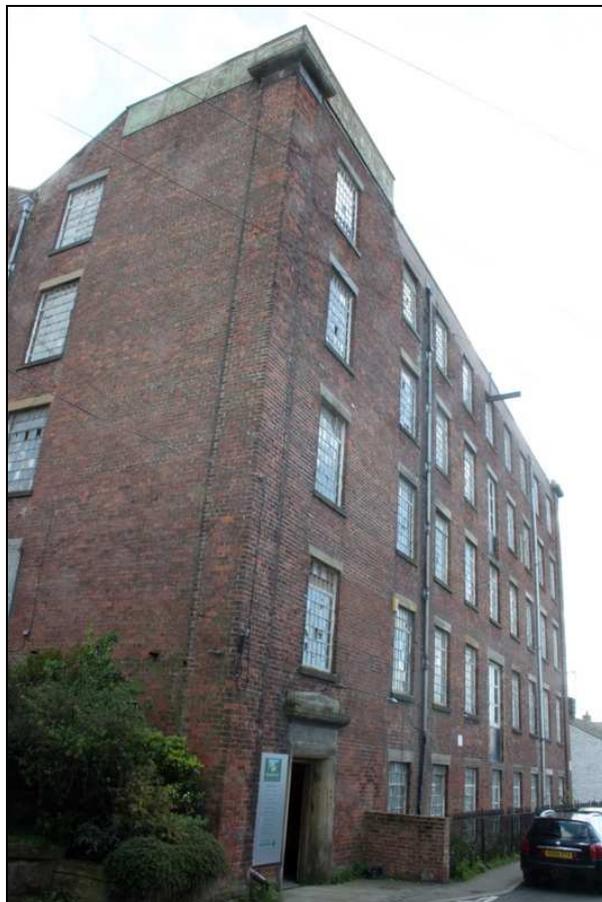
Plate 6: Oblique view of the front elevation of the mill

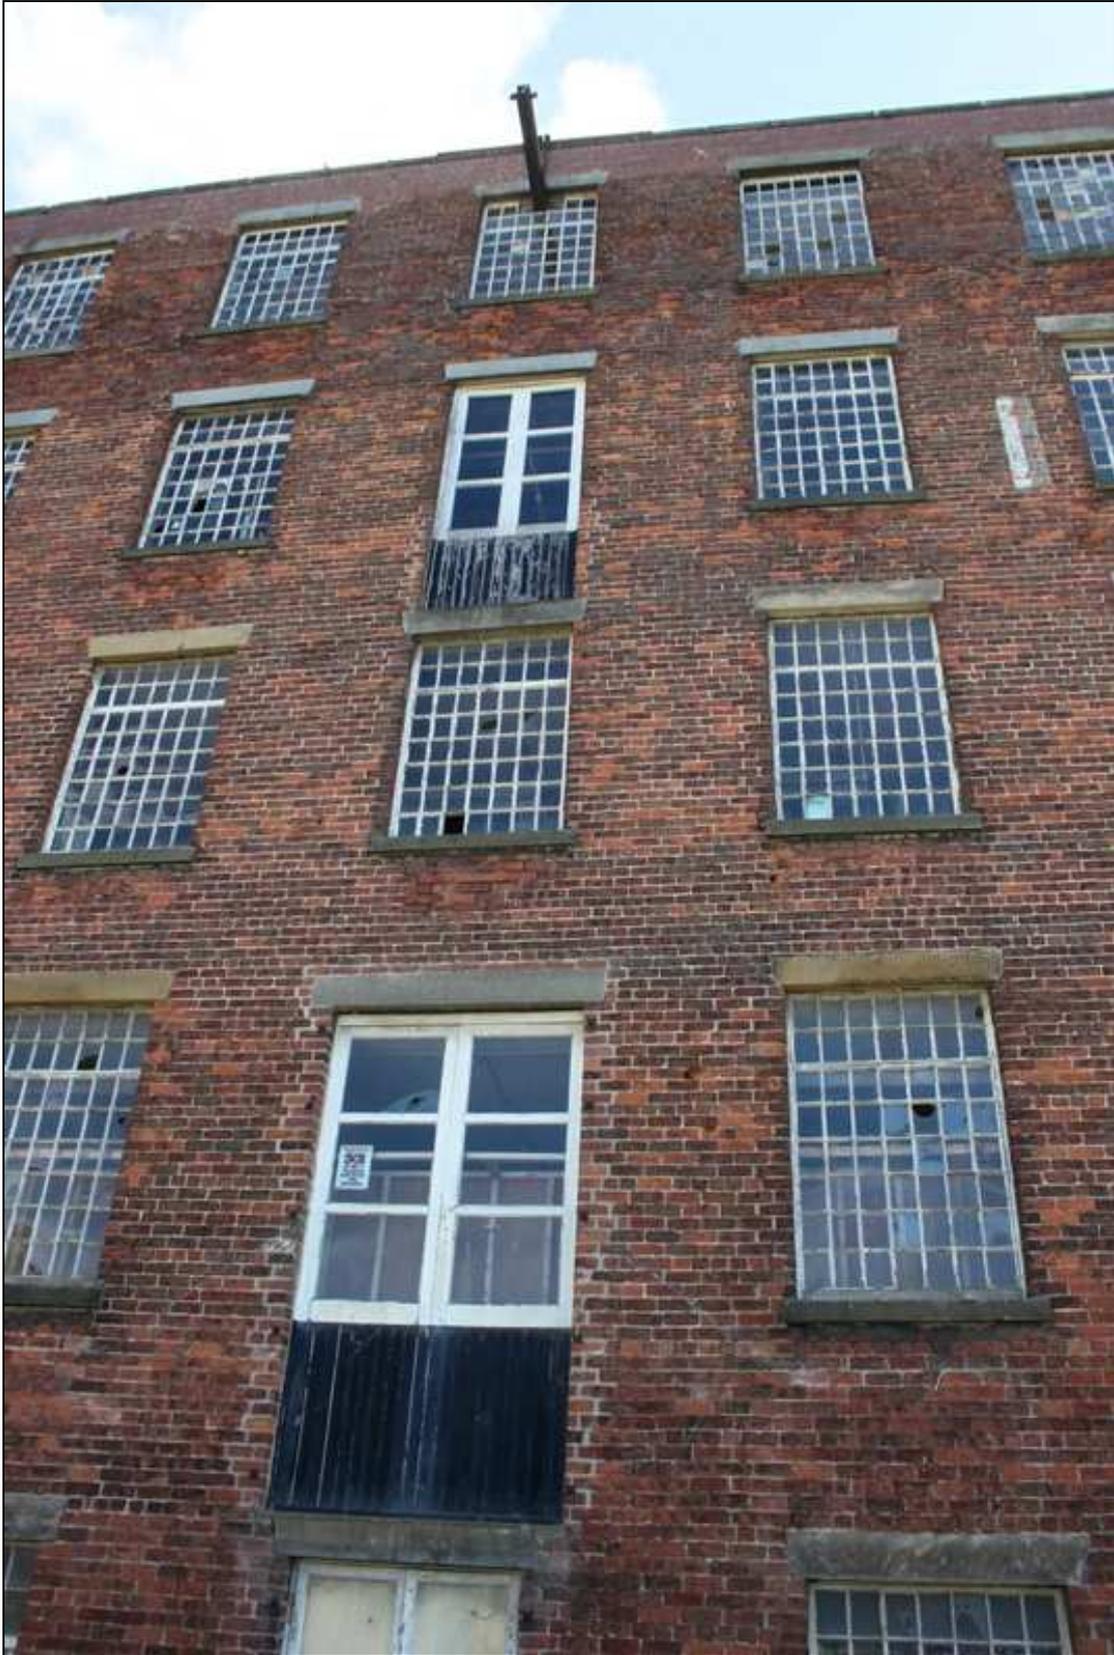
Plate 7: Central loading loophole in front elevation

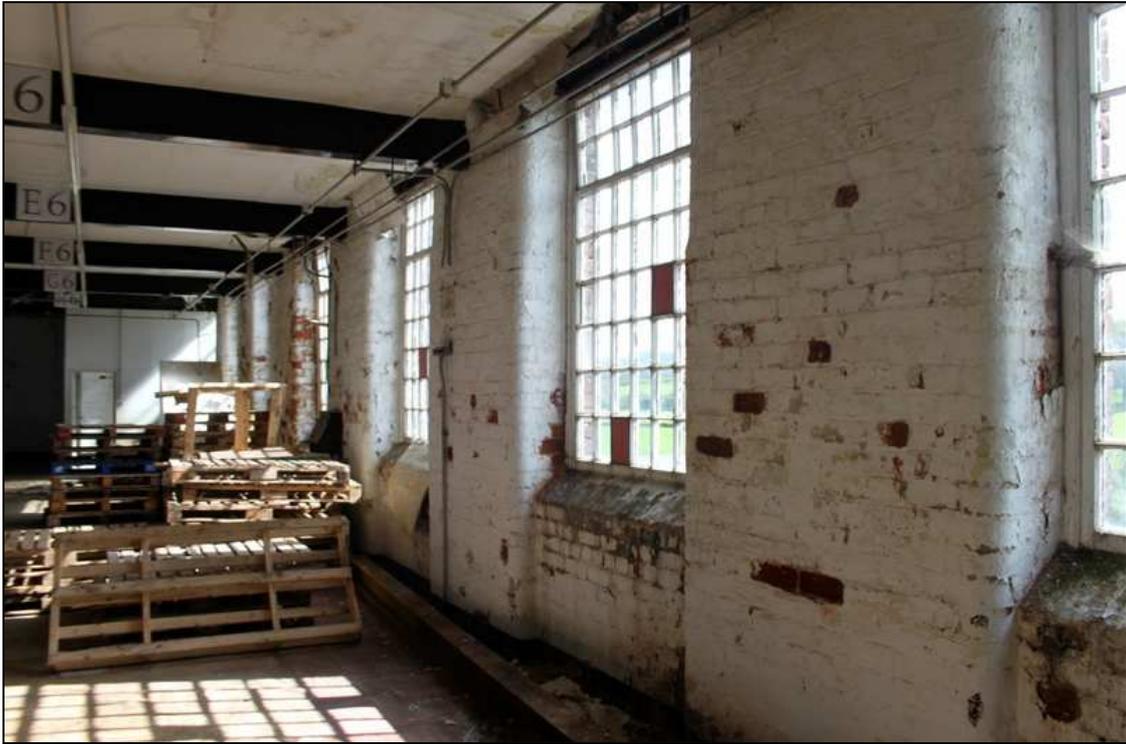
Plate 8: Interior view of the 56-light windows with top rows on opening swivel tilt

- **Window frames.** Although several are damaged, and a few have been replaced, the windows represent a relatively rare survival of mid-nineteenth century small window paned timber frames. Given their fragility, and external glazing, and the standards of draught exclusion required for modern dwellings, it is perhaps unlikely that these can be preserved *in situ*. Nevertheless, their size and form is typical of a mid-nineteenth-century mill, and have an *aesthetic value*;

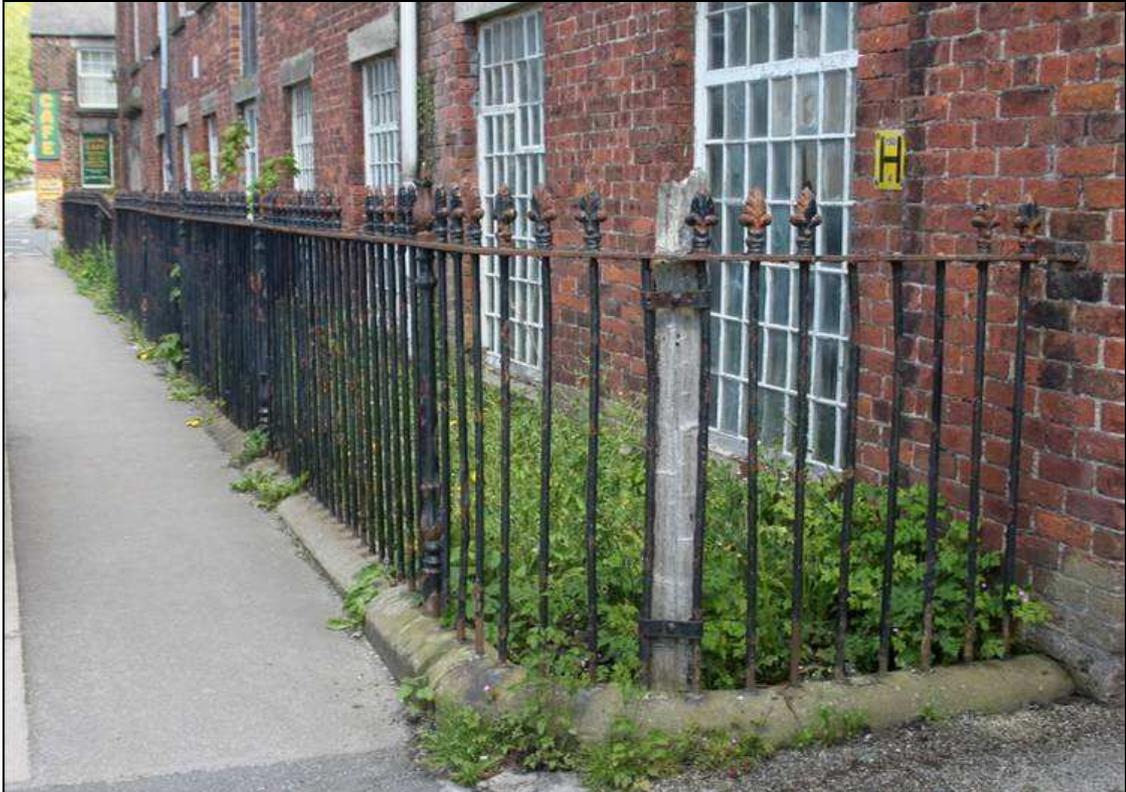
Plate 9: Wrought-iron railings along Chapel Street

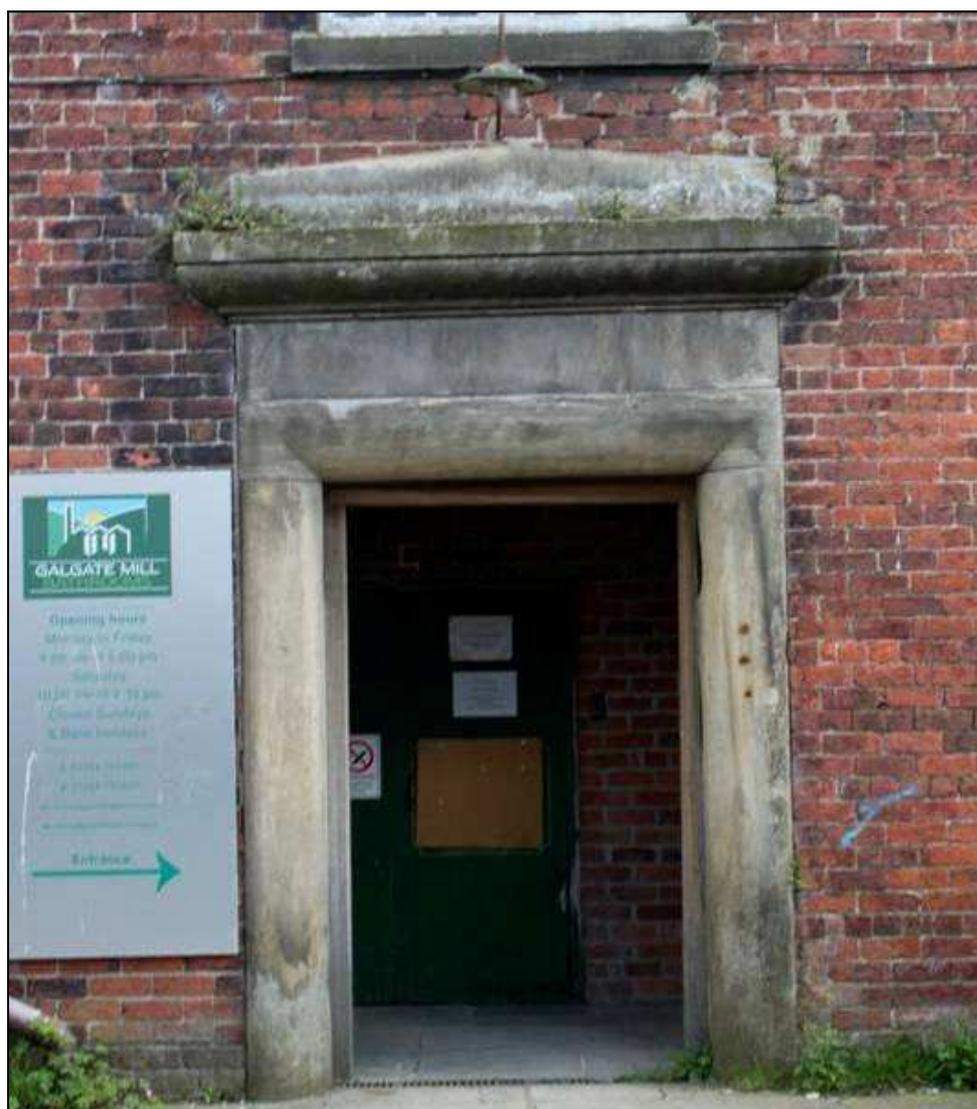
Plate 10: Doorway at northern end of the western façade

4.2.4 The main entrance doorway is at street level between semi-basement (ground) and first-floor level was positioned at the northern end of the western façade. This has a monolithic sandstone surround with curved jambs below a closed plain pediment (Plate 10). This afforded access to a stair and hoist tower, of fireproof construction, topped with a cast-iron water tank (Plate 11), providing a head of water for the engine and fire-fighting equipment. The remainder of the roof comprises a triple-span pitched roof, behind a low parapet wall (Plate 12). The gable elevations have windows similar to those of the principal façade, but not included in the outer bays. In the southern gable, the eastern of the central windows to each floor was remodelled to form a doorway into a modern lift shaft, now externally clad with metal sheeting (Plate 13), whilst the northern gable had only the western two windows below second-floor level. The east elevation has a projecting small privy tower at its southern end (Plate 14), with the windows of the adjacent bay having been remodelled into doorways upon the later addition of a cast-iron fire escape (Plate 14), installed by Fred^k Fox, Bradford. Originally, the northern bay did not have windows below second-floor level, although a horizontal window was latterly installed at first-floor level.

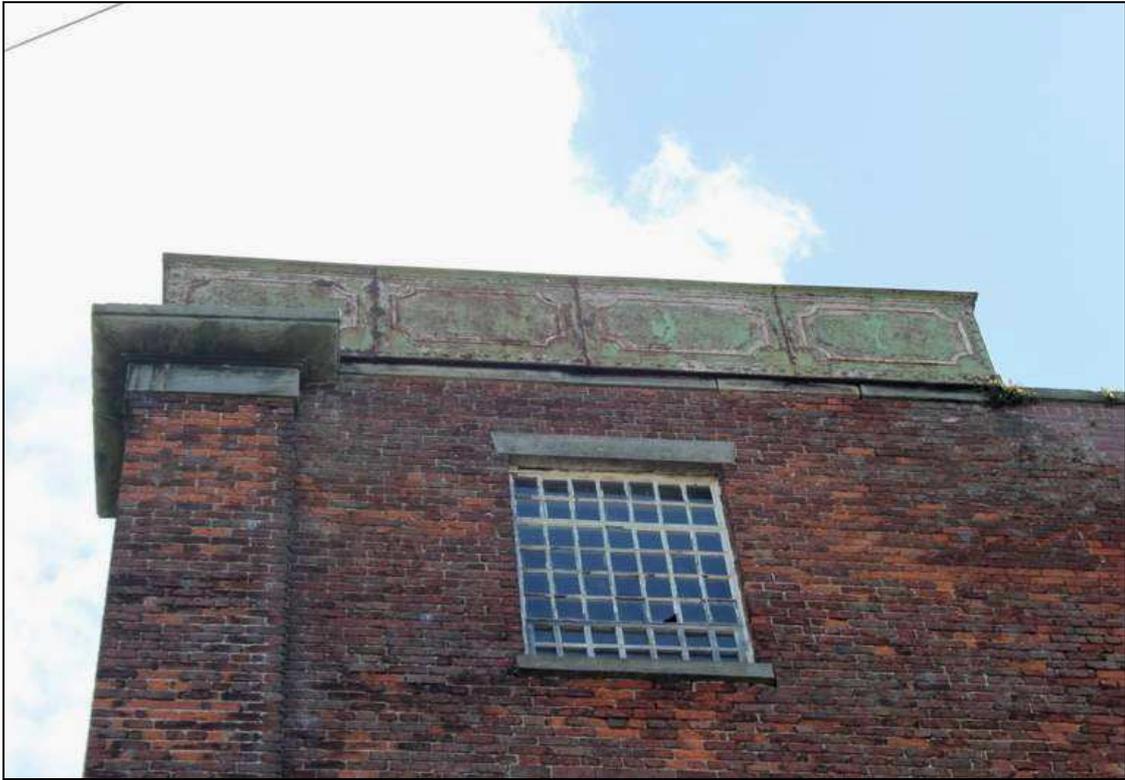
Plate 11: Cast-iron water tank

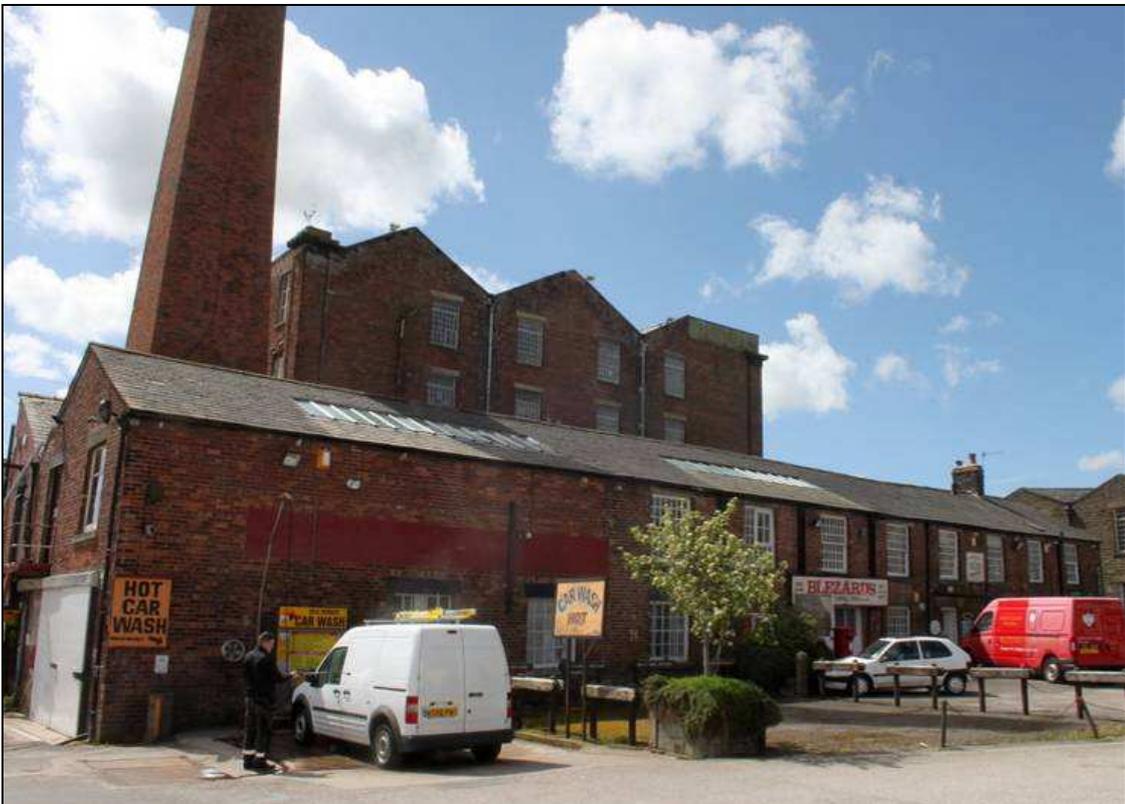
Plate 12: Triple-span pitched roof and parapet

- 6.2.5 The existing roof structure will be largely retained and will be subject to a programme of sympathetic repair work, together with the gutters and associated rainwater goods. Proposed alterations to the roofing material are limited to the insertion of a series of skylights, which will provide additional natural lighting. The skylights will be fitted to the central pitches of the multi-span roof, and will thus be largely obscured from view externally.

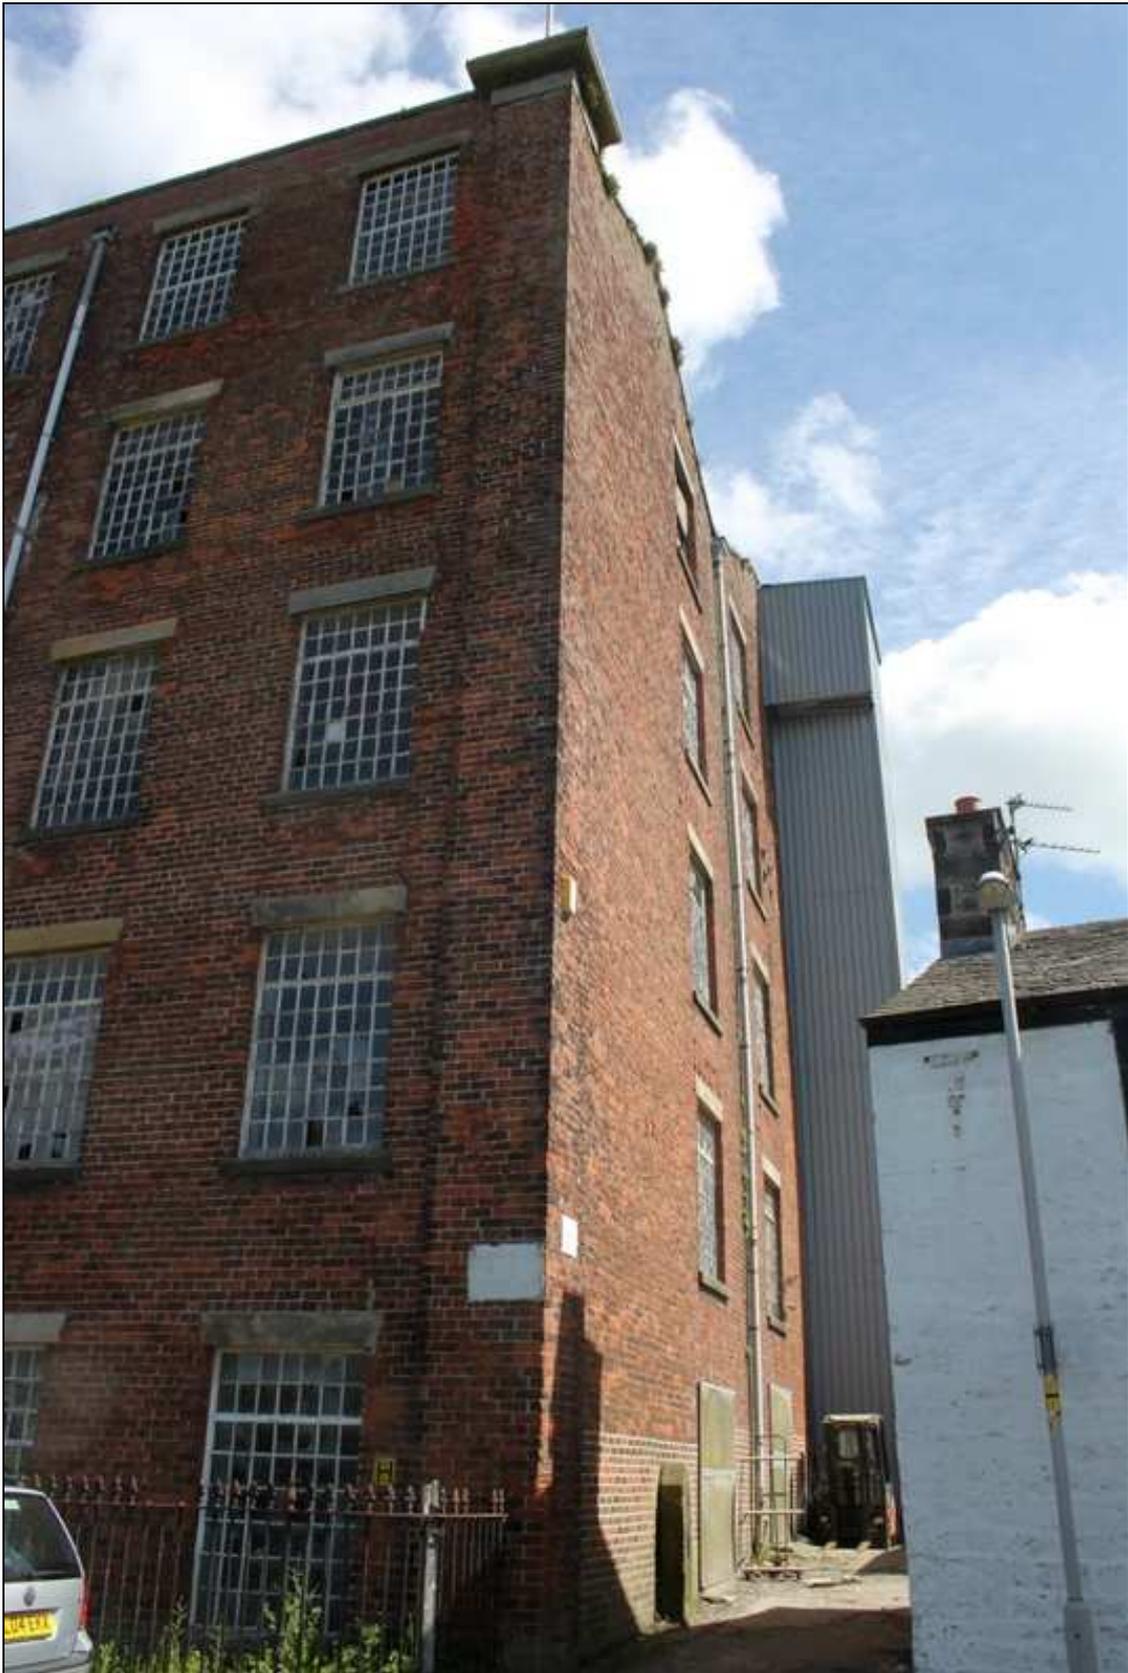
Plate 13: The southern gable of the mill, with late hoist tower clad in metal sheeting

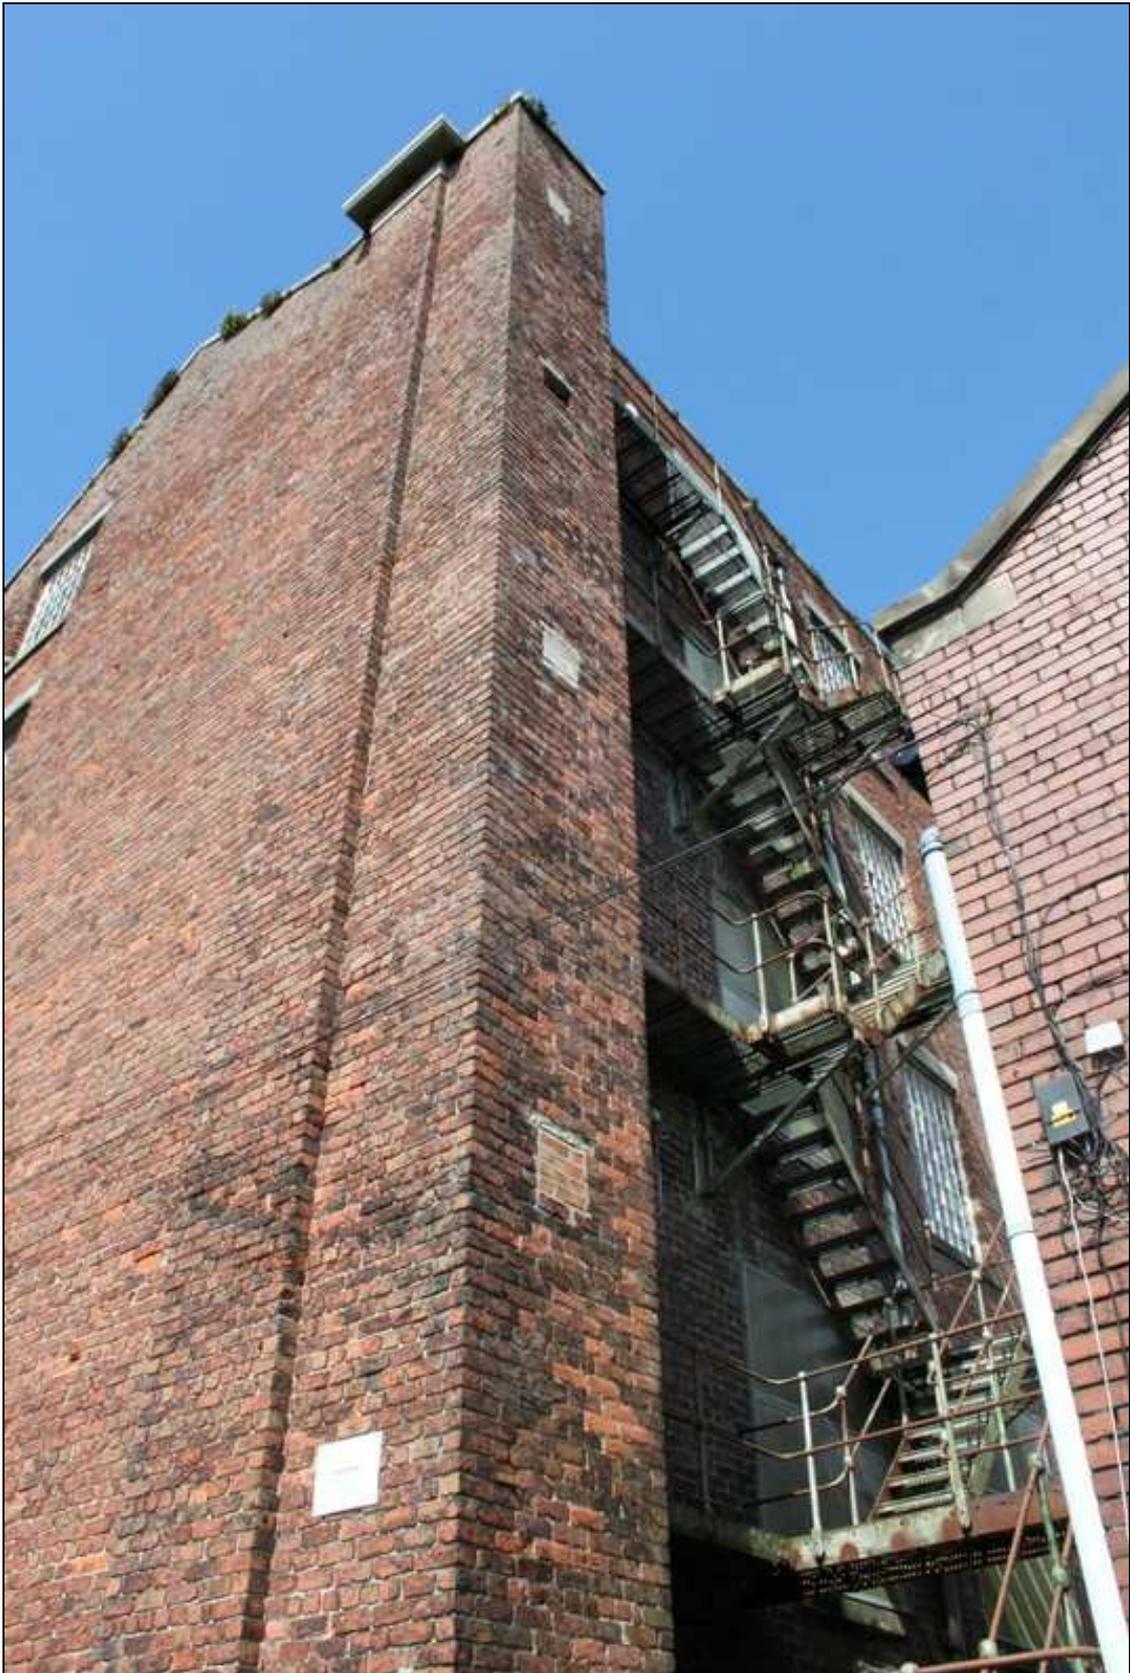
Plate 14: The privy tower and fire-escape stair

- 4.2.13 The slender privy tower at the south end of the east wall is extant internally, housing water closets that replaced original dry chute arrangements. Externally, the tower has blocked small vents in the east wall, and a blocked aperture in its south wall at ground level, representing soil collection access.

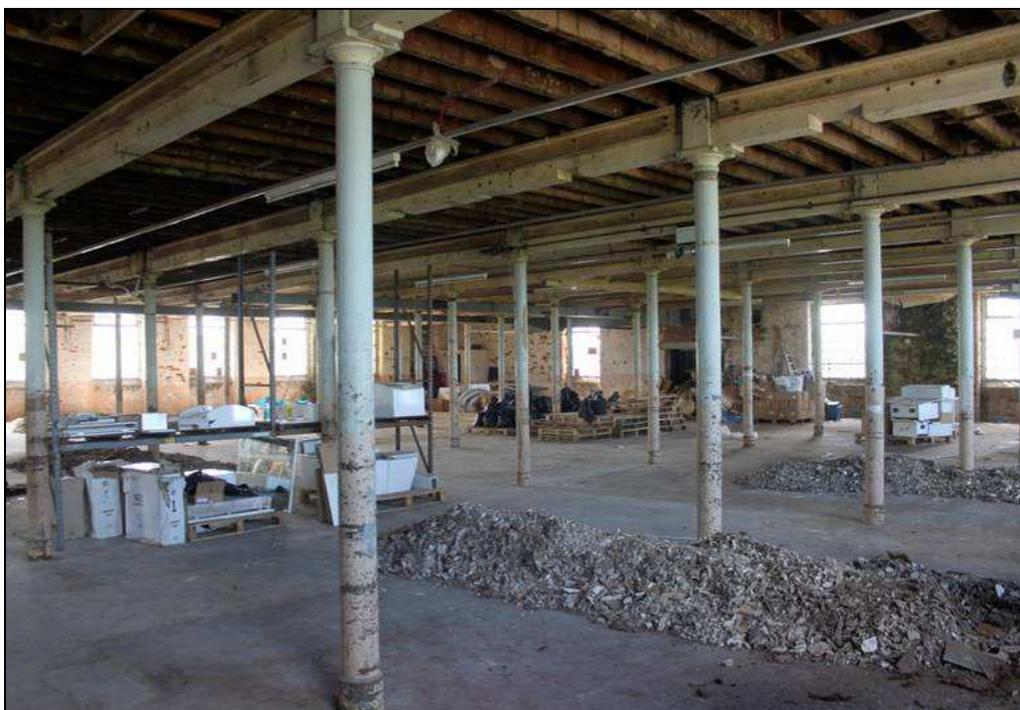
Plate 15: View looking south-east across the third floor, showing the column arrangement

- 4.2.5 Internally, the mill is of non-fireproof construction, with large-scantling timber ceiling beams carrying timber floors undersealed with lath and plaster. The beams are carried on five rows of hollow cylindrical cast-iron columns (Plate 15). These are of 6½" diameter, with a simple plinth at foot and a cruciform head plate bolted into the soffit of timber ceiling beams, which are jointed with bolting plates above the second and fourth rows of columns (Plate 16).

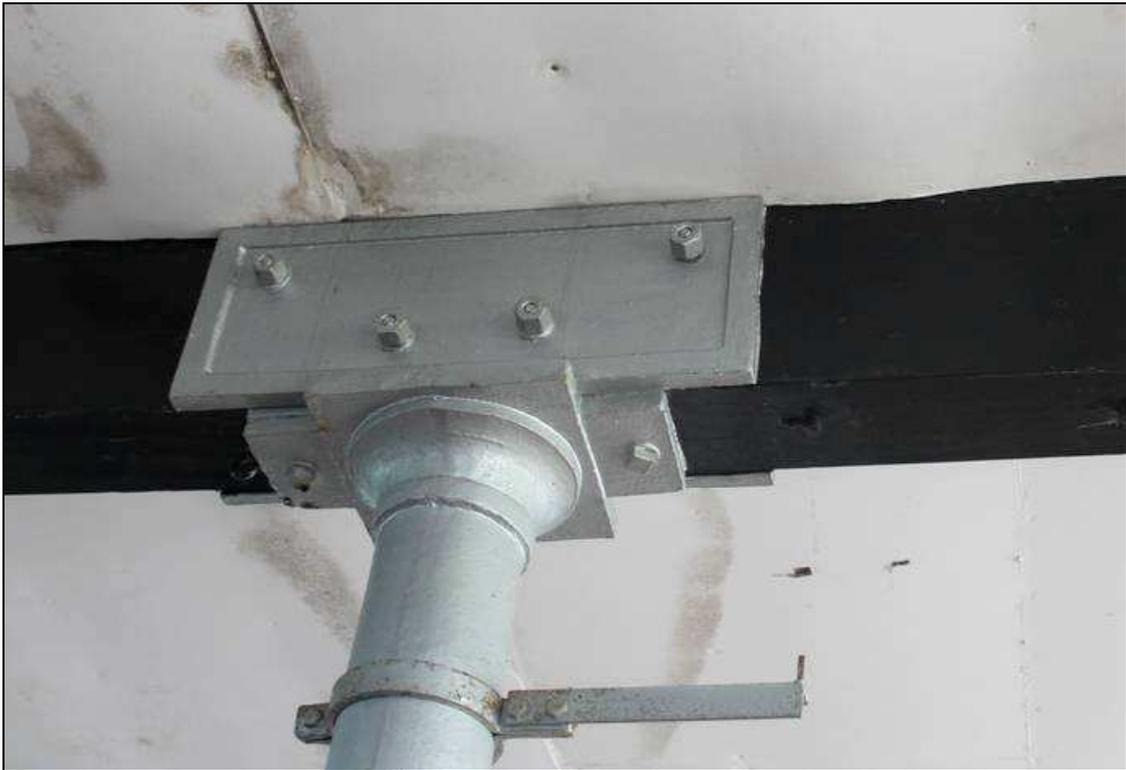
Plate 16: Column capital and bolting arrangement on a fourth-floor column

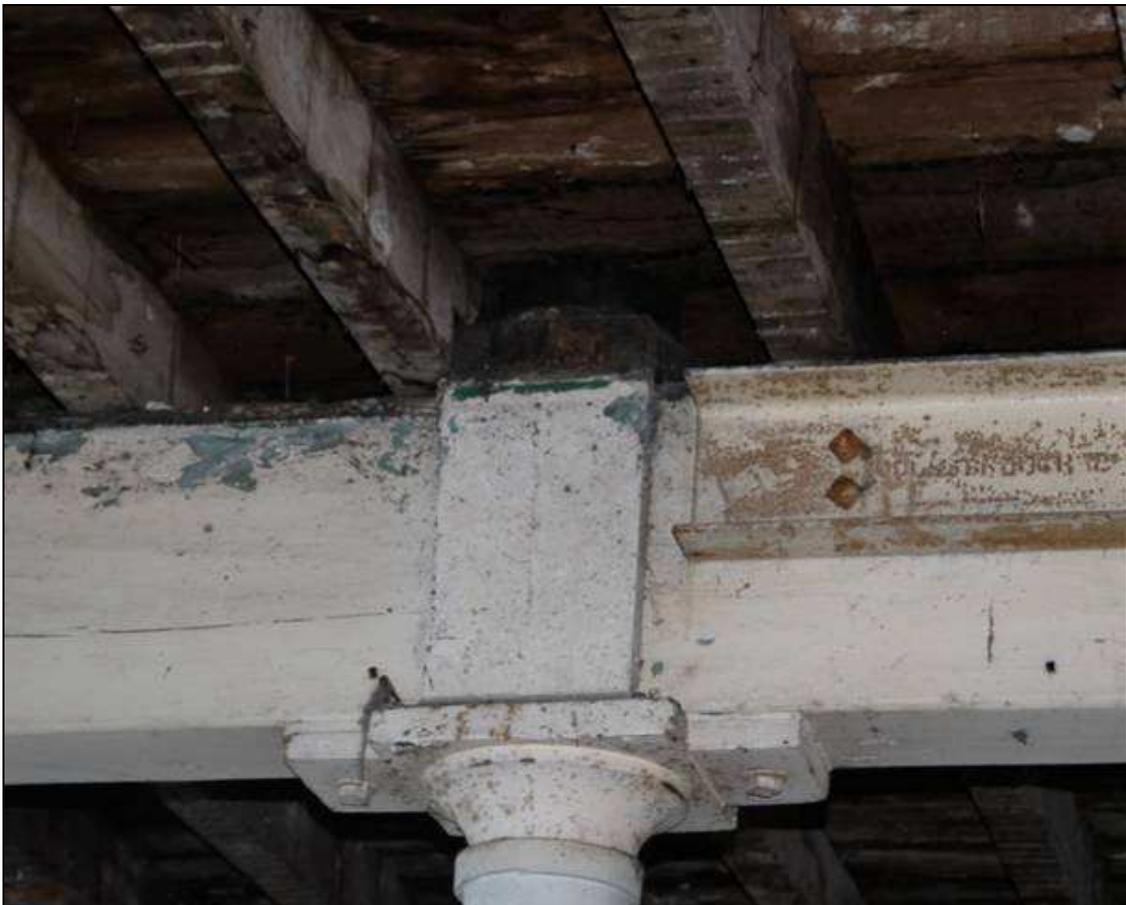
Plate 17: Example of a crush box attached to the head plate of a column

- 4.2.6 Below the top floor each column is capped with a cast-iron crush box (Plate 17), attached to the head plate of the column, and housing the foot of the column above, and transferring the weight around the timber beam, vertically through the column row. These floors also have columns within the central row that incorporate line shaft hanging brackets on their eastern faces, comprising a flat horizontal plate with T-section rib to the column shaft (Plate 18). At basement level, all the columns are of this type with several of the rows having the line shaft hanger on the western face (Plate 19).

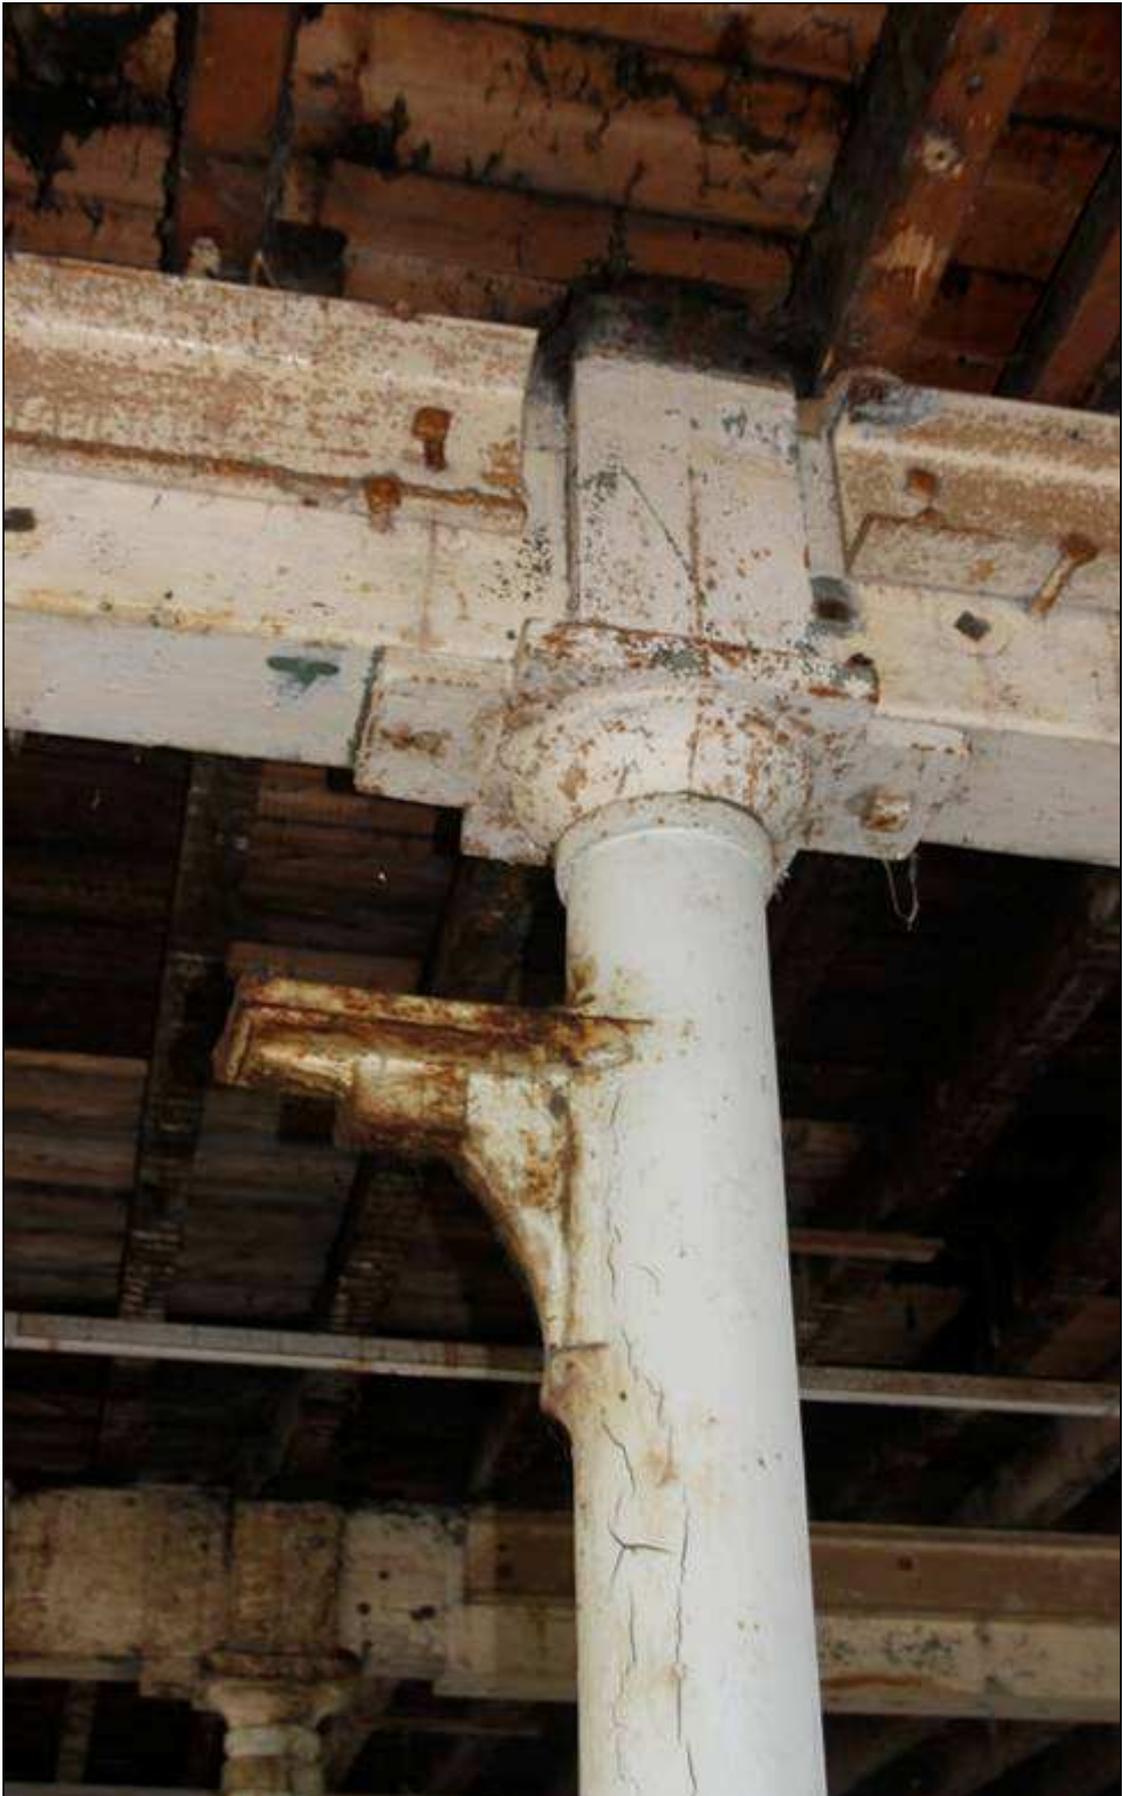
Plate 18: Example of a line shaft hanging bracket

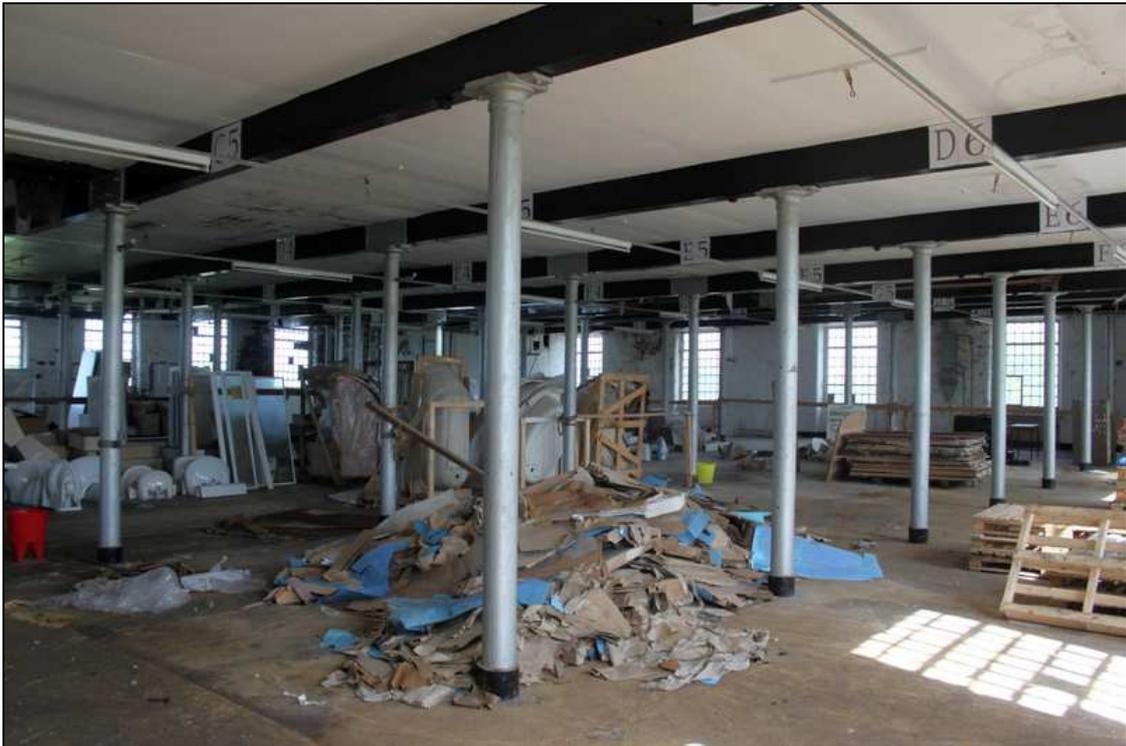
Plate 19: Columns on the ground floor, showing line shaft hanging brackets

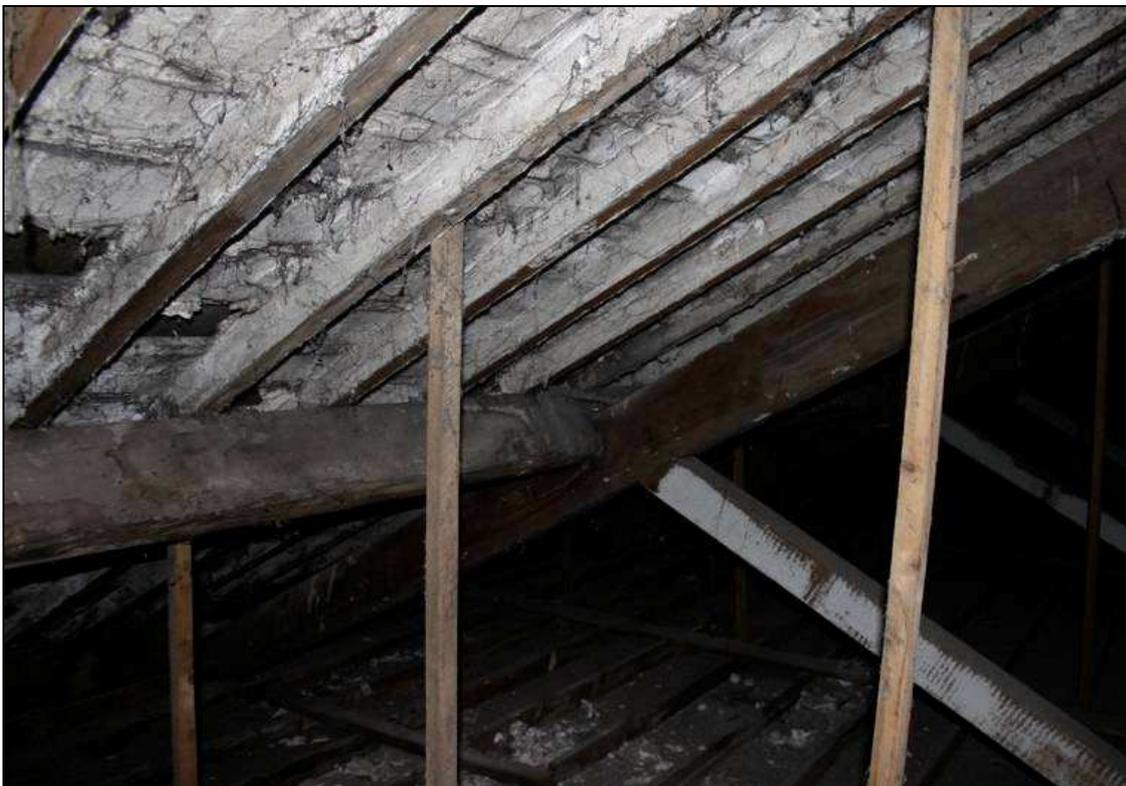
Plate 20: Roof purlins and slate roof undersealed with whitewash

- 4.2.7 On the top floor, the ceiling beams form the tie beams of king post trusses, which span two bays, and have a single butt-ended purlin to each pitch, below a clasped ridge board. The roof space is concealed above an inserted plaster board ceiling to all but third bay from north end, which has timber panelling to a six-light timber glazing band on the west pitch. This may represent original fenestration for part of the upper floor, although whitewash undersealing of the slate roof in the southern bay also appears relatively early (Plate 20). Valley gutters between the roof pitches are internally shuttered with timber.

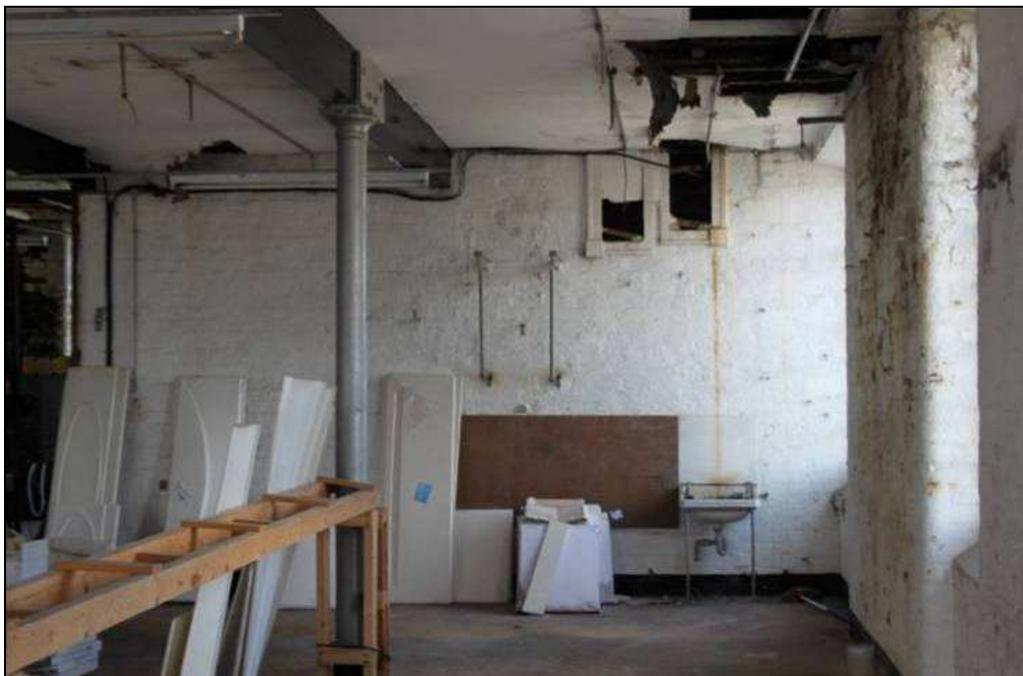
Plate 21: Bearing boxes in the east wall of the stair tower

- 4.2.8 On the fourth floor, alternative evidence for line shafting was observed on the outer face of both penultimate column rows, comprising bolt holes in the beam soffits, and blocked end bearing boxes in both gables. Two extant bearing boxes in east wall of stair tower in the north-western bay at this level were presumably for its hoist (Plate 21).

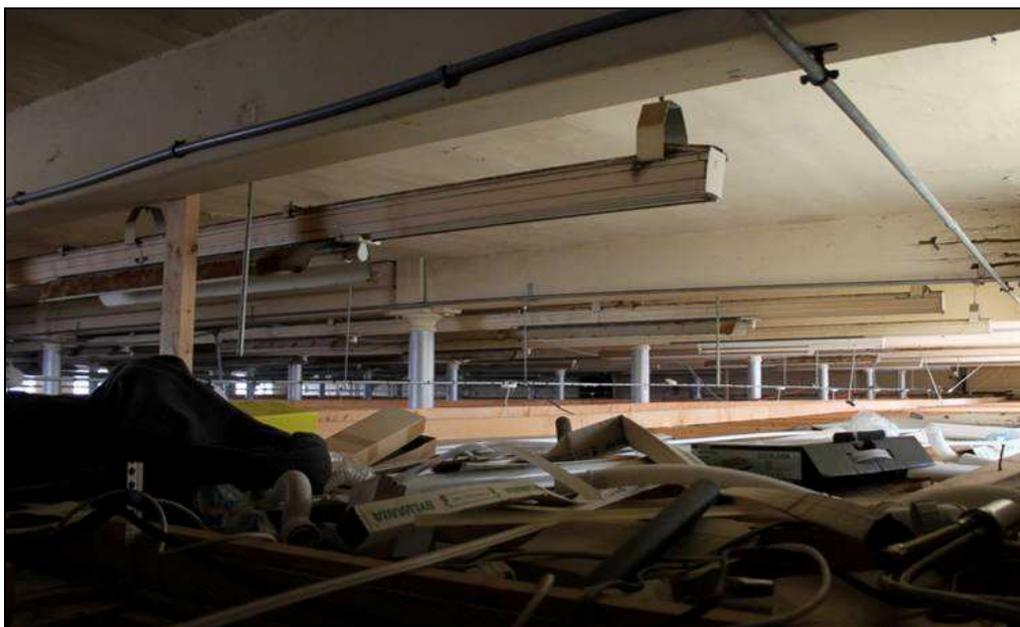
Plate 22: Top of the columns rising above modern suspended ceiling on the ground floor

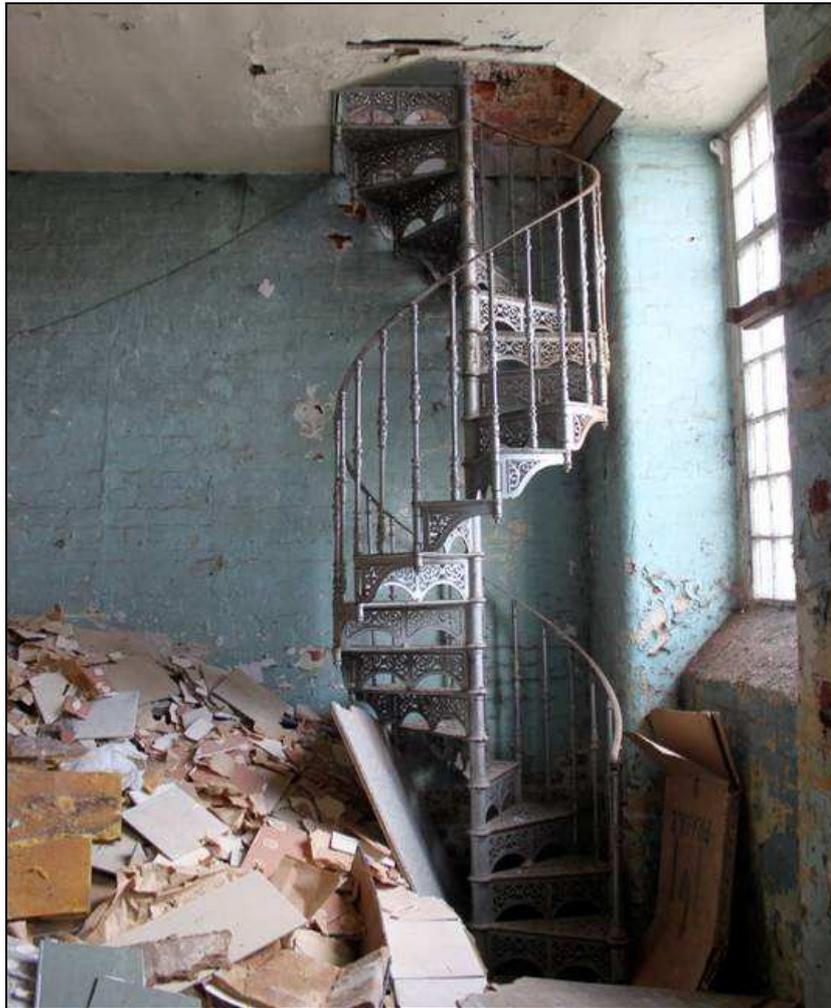
Plate 23: Inserted spiral stair providing alternative access to the ground floor

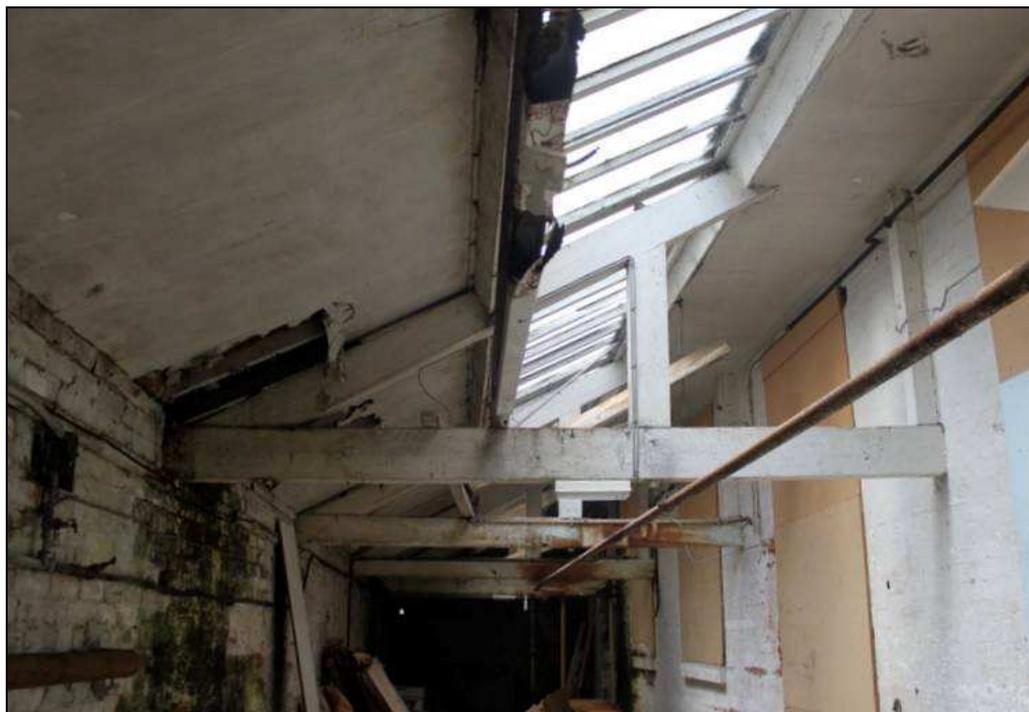
Plate 24: The extension to the eastern side of the mill

- 4.2.16 An extension was added to the eastern side of the mill, with cat-slide roof with glazing band above timber half trusses of queen post style (Plate 24). A narrow transverse chamber at its northern end is taller, and has a pitched roof, and includes a large bearing box in its east wall, which presumably housed a bevel gear to power a line shaft along the west wall of the extension. A later single-storey privy block was placed to the north.

- **Floorboards.** Original floorboards survive in several areas within the mill, representing an increasingly rare survival of such features;
- **Extension.** The small lean-to extension to the eastern side of the mill block is a late addition that is in poor structural condition, which reduces its overall significance;
