Galgate Silk Mills, Galgate, Lancashire

Heritage Assessment

June 2014

UK Mills Ltd

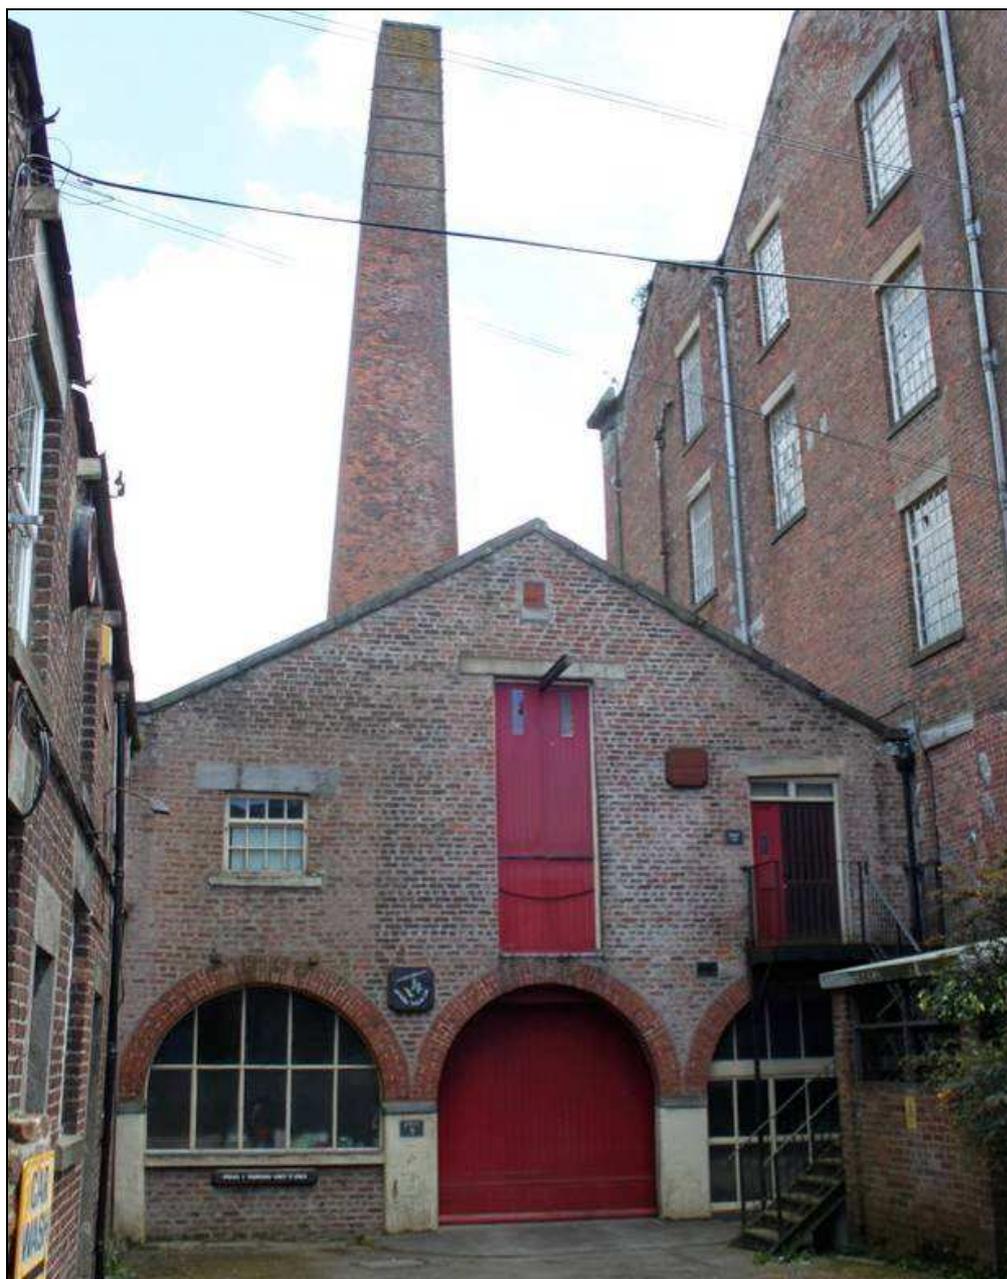
Plate 25: The two-storey boiler house abutting the north side of the main mill block, with the full-height chimney visible to the rear. The boiler house lies beyond the boundary of the Application Area

- 4.2.17 The northern side of the mill is abutted by a three bay, two-storey boiler house, with large round-headed arched openings in the western elevation (Plate 25). Whilst it is of similar construction to the main mill, the bricks are darker, and the pointing differs, and its size, erected to house three boilers, would appear exceptional for an engine of this date. It is more probable that it replaced an original smaller boiler house, perhaps undertaken following compounding of the engine by McNaughting - adding a new high pressure cylinder, retaining the existing cylinder for low pressure with a new set of three powerful higher pressure Lancashire boilers. This was common in the latter nineteenth century, increasing the power output at a relatively low cost. To the rear of the boiler house, a square-section tapering chimney is also in brick, with iron bands, and appears to survive to full height (Plate 25).

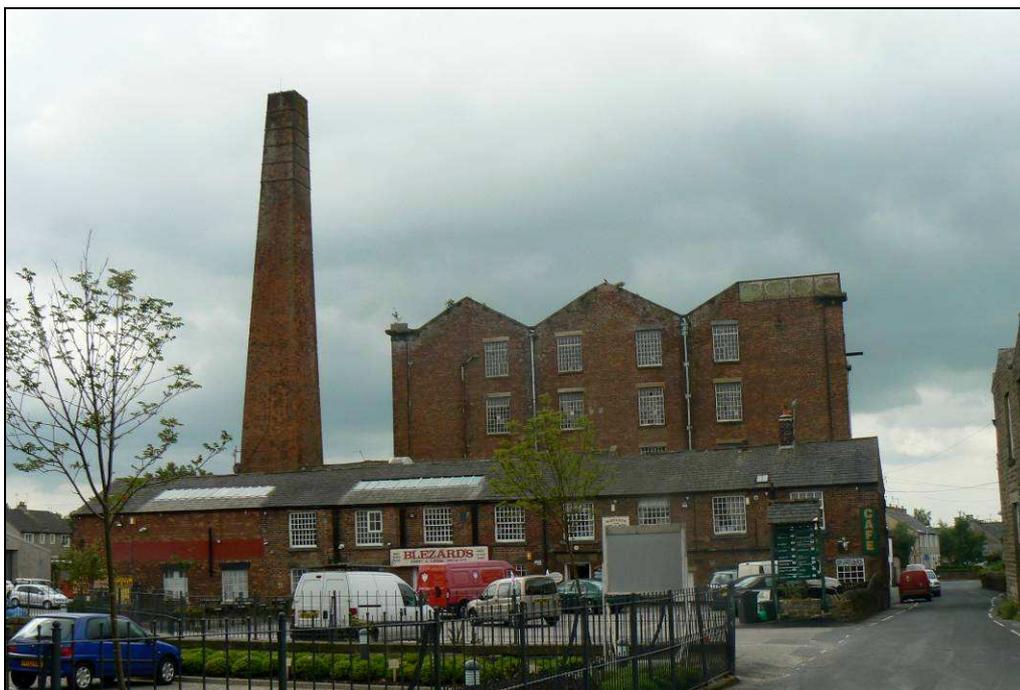
Plate 26: The two-storey office/warehouse, forming the north extent of the 1851-2 mill block

4.2.18 On its northern side, the boiler house abuts the window jamb of an eight bay, two-storey office and warehouse block in brick, which is of a more similar style to the main mill, with many of the upper floor windows incorporating panes of a similar size to those in the brick mill, but within vertical sash frames (Plate 26). The western four bays have doorways in both facades, giving an appearance of a row of cottages but may have been used in connection with putting out weft and warps for weaving. It is likely that later they were used as offices, particularly given the inclusion of a clock within the southern wall face. Only the western bay retains a chimney stack, placed against the internal dividing wall, suggesting that further back-to-back fireplaces may originally have been included. The remaining four bays appear to have formed a warehouse, which was extended subsequently by three bays.

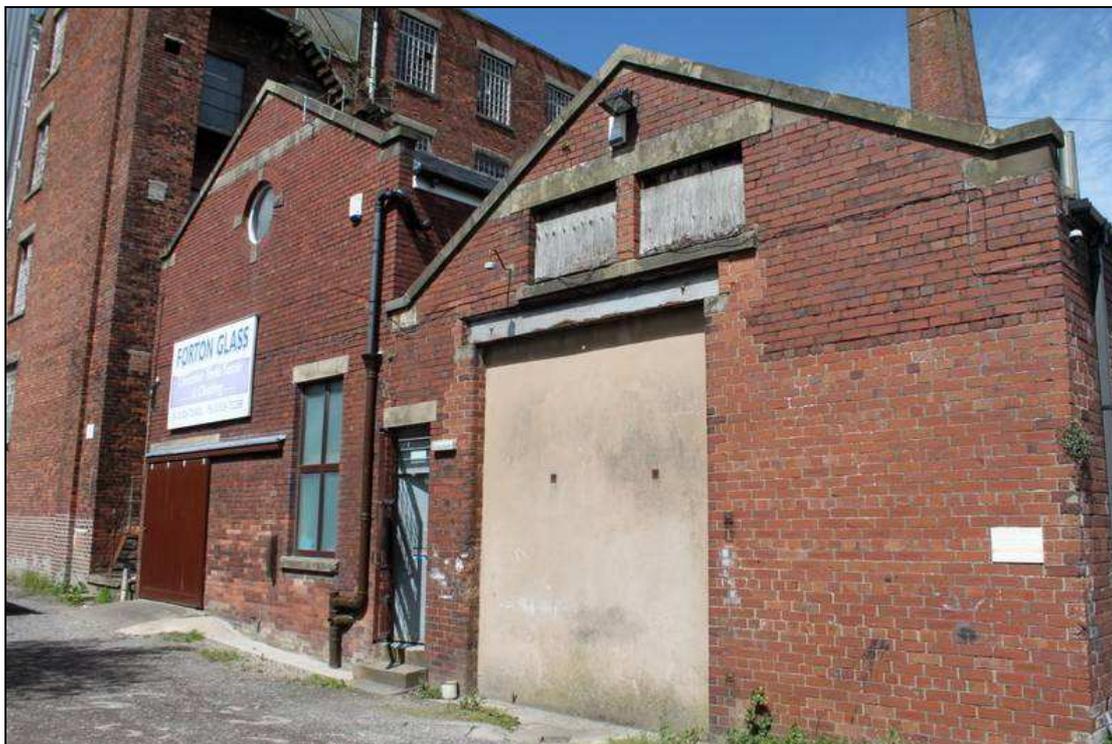
Plate 27: Twentieth-century workshops situated to the east of the 1851-2 mill block

- 4.2.20 Two workshops to the east of the mill (Plate 27), constructed in machine-made brick, appear contemporary, and of early twentieth-century date, certainly post-dating the Ordnance Survey map of 1891 (Plate 4). The western part is two storey, with the upper floor having brick infill to a steel frame and with a bulls eye window in the south gable (Plate 27). The eastern part has similar rubbed sandstone copings, and is of single-storey height, with large doorways in each gable. These may have been dye houses to produce coloured silk yarns.
