**Former Westcliffe
Hospital,
Turnhurst Road,
Chell,
Stoke-on-Trent**

**Archaeological
Investigation Final
Report**

Oxford Archaeology North

June 2014

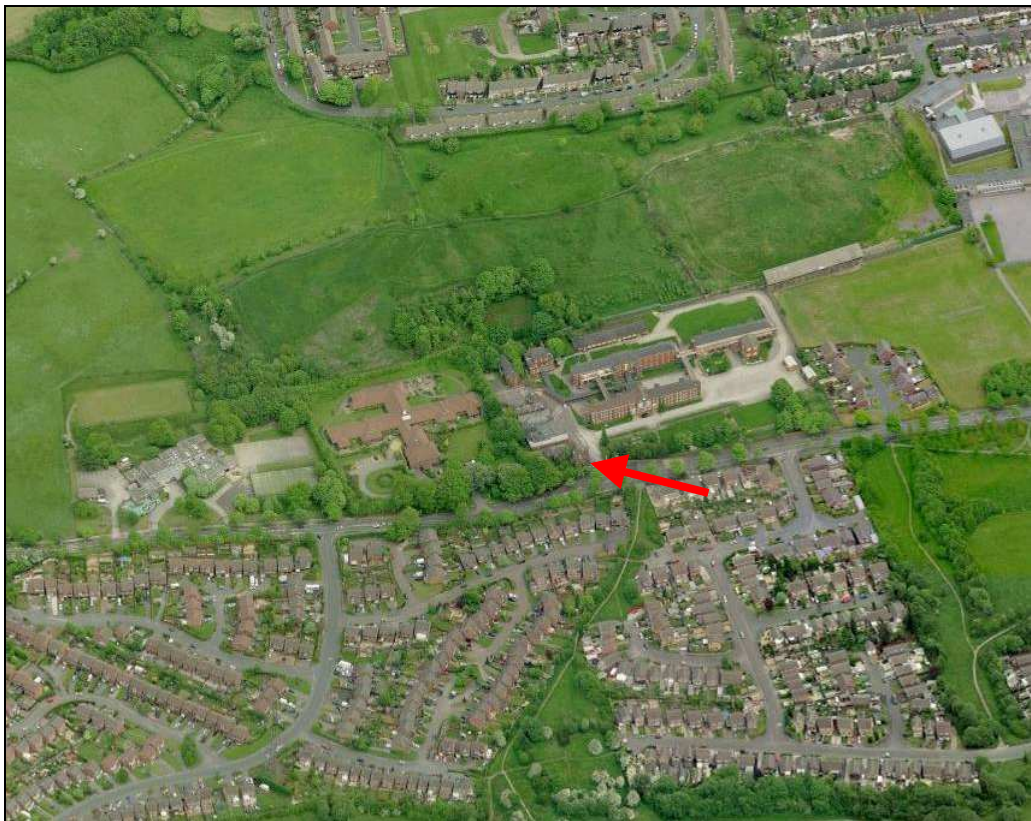
Plate 1: Aerial view of the study area in 2008, prior to the demolition of the last elements of the former workhouse complex. The arrow marks the position of the Lodge

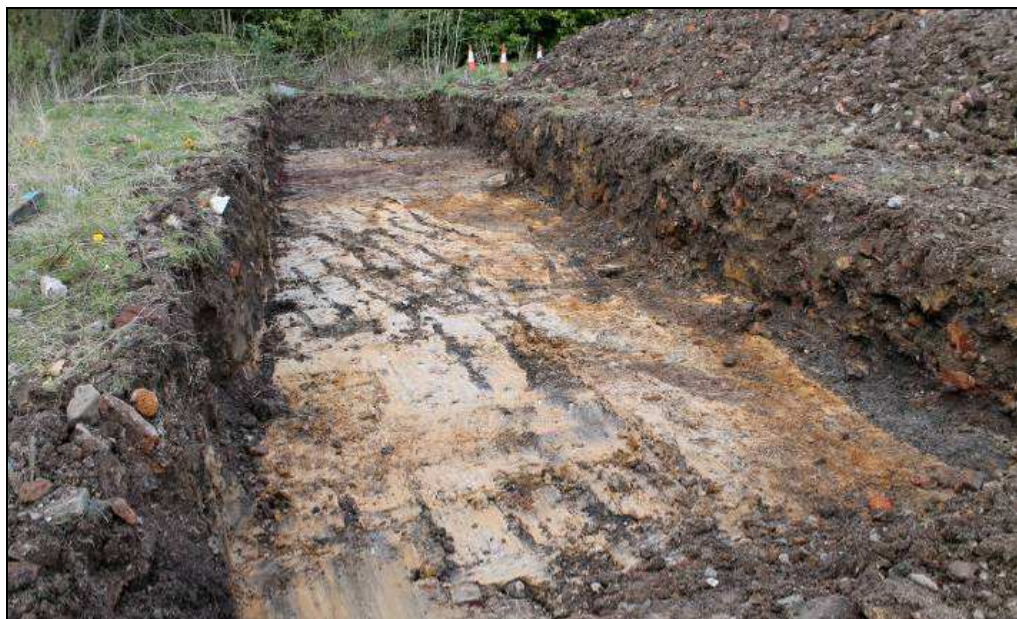
- 4.2.1 The evaluation trench was placed across the footprint of the former Vagrants' Ward (Fig 2). The trench was aligned north-west/south-east, and measured 20 x 4m (Fig 2). It was excavated to a depth of 1.7m at the north-western end, and 1.3m at the south-eastern end (Plate 4).

Plate 4: General view along the evaluation trench, looking north

- 5.1.2 The demolition of the Vagrants' Ward had evidently been very thorough. All traces of structural remains had been removed down to the natural clay at a depth of between 1.3m at the south-east and 1.7m at the north-west. This level of demolition, including the grubbing up of all foundations, removal of walls and floors and the subsequent levelling of the area using the demolished material is characteristic of modern demolition methods. This fits with the building being demolished after 2008.

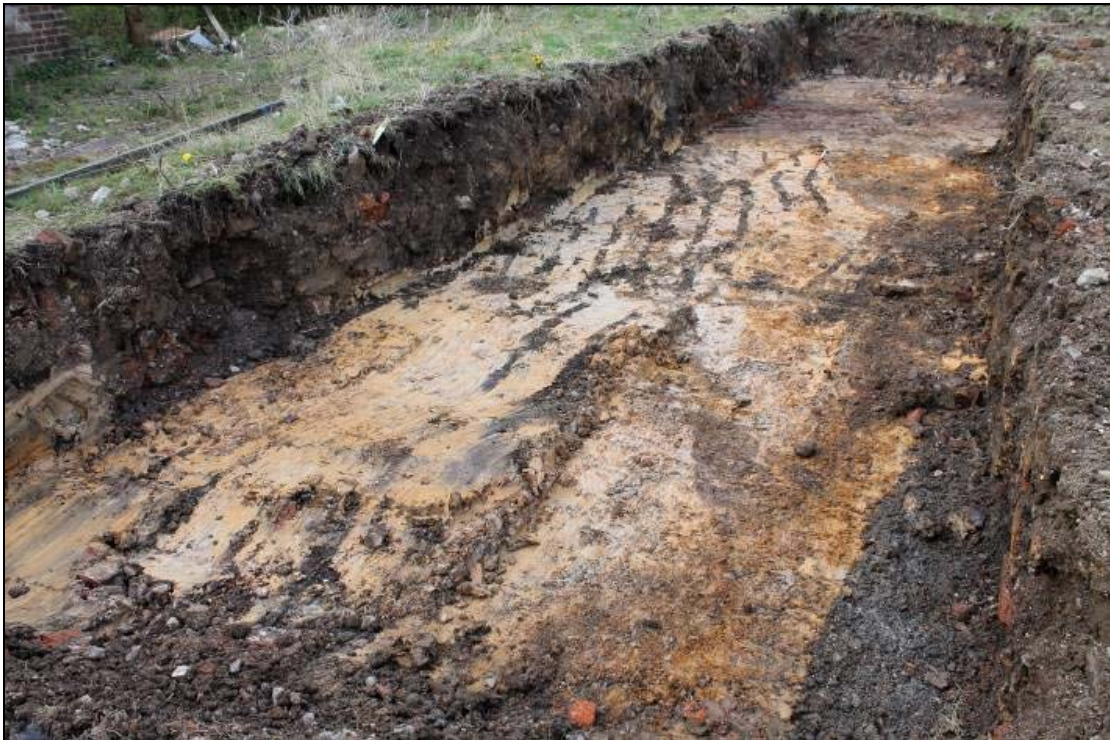
- 4.2.2 The trench was overlain by turf (**001**), which had a fairly uniform depth of 0.15m. This sealed a mixed layer (**002**) consisting of loam, clay, cinder and brick, with a depth ranging from 1.15 to 1.55m (Plate 5), and clearly represented the levelling of demolition material after 2008. Layer **002** contained a large amount of brick dating from the late nineteenth century to the late twentieth century. This overlay a thick deposit of mottled light grey to mid-brown clay (**005**), which clearly represented the natural geology.

Plate 5: North-east-facing section, looking north-west

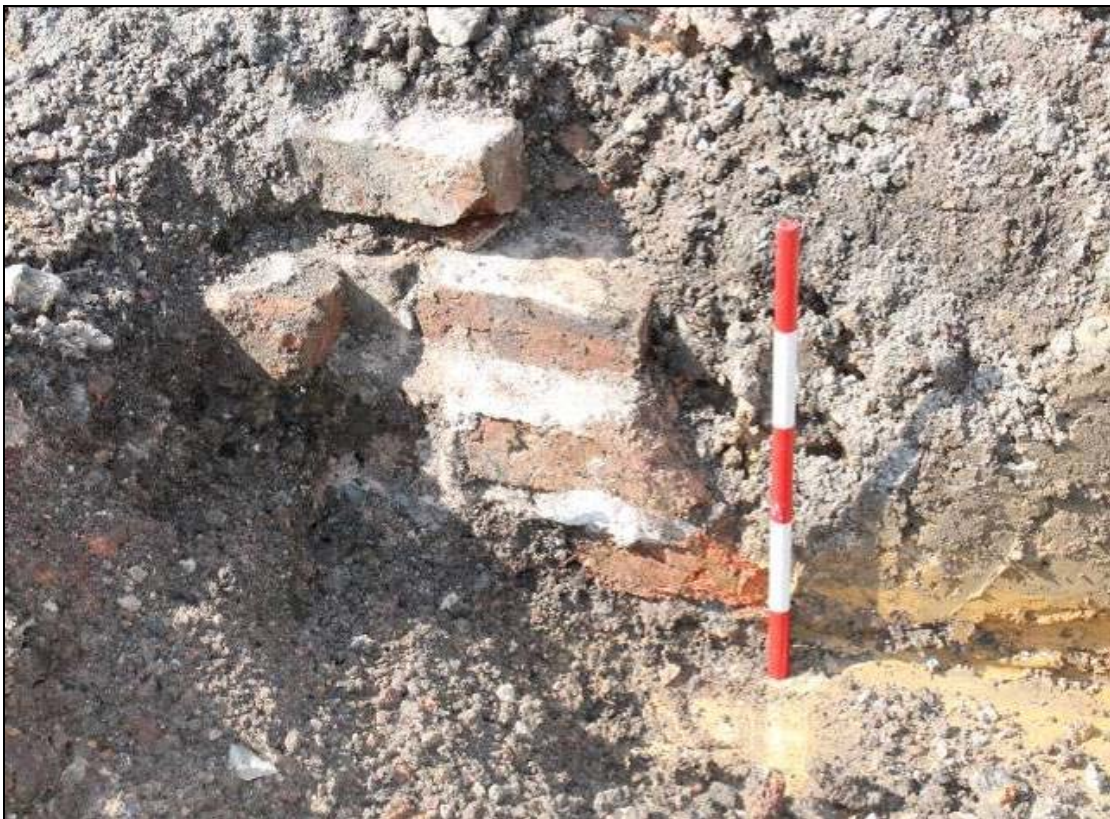
- 4.2.3 At the south-east corner of the trench was the stub of a brick wall **003** (Plate 6). The top of wall **003** was 0.41m below the surface. Wall **003** was 0.24 x 0.27m, and was three brick-courses deep and two-brick courses wide. The component bricks measured 0.24 x 0.11 x 0.09m, and were all of a mid- to late twentieth-century type, bonded with a very hard cement mortar (Plate 6).

Plate 6: Brick wall stub 003 looking south-east

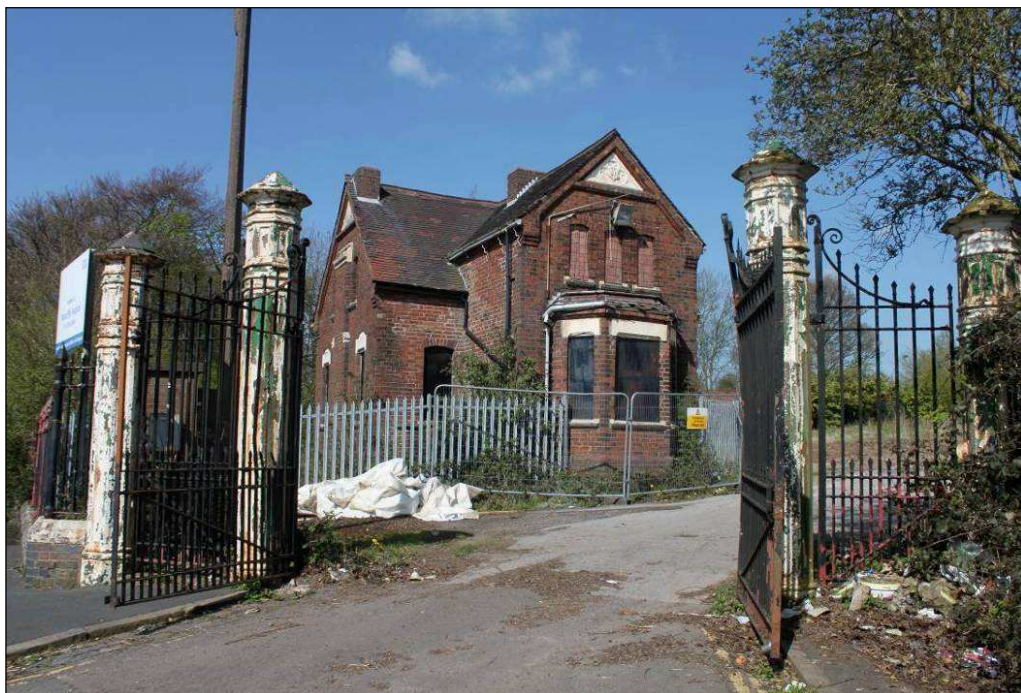
- 4.3.3 **Exterior:** the Lodge is a small, two-storey, red brick building constructed on a cruciform plan with narrow gabled wings to the east and west, a canted bay window to the south (Plate 8) and a single-storey lean-to structure to the north. It is located immediately to the north of the main entrance into the former hospital site, and was constructed in 1893 as an addition to the Wolstanton & Burslem Union Workhouse complex. The main entry was via either a doorway in the western wall of the southern cell, or from a doorway in the opposing wall.

Plate 8: The Lodge, looking north-east from the entrance gates

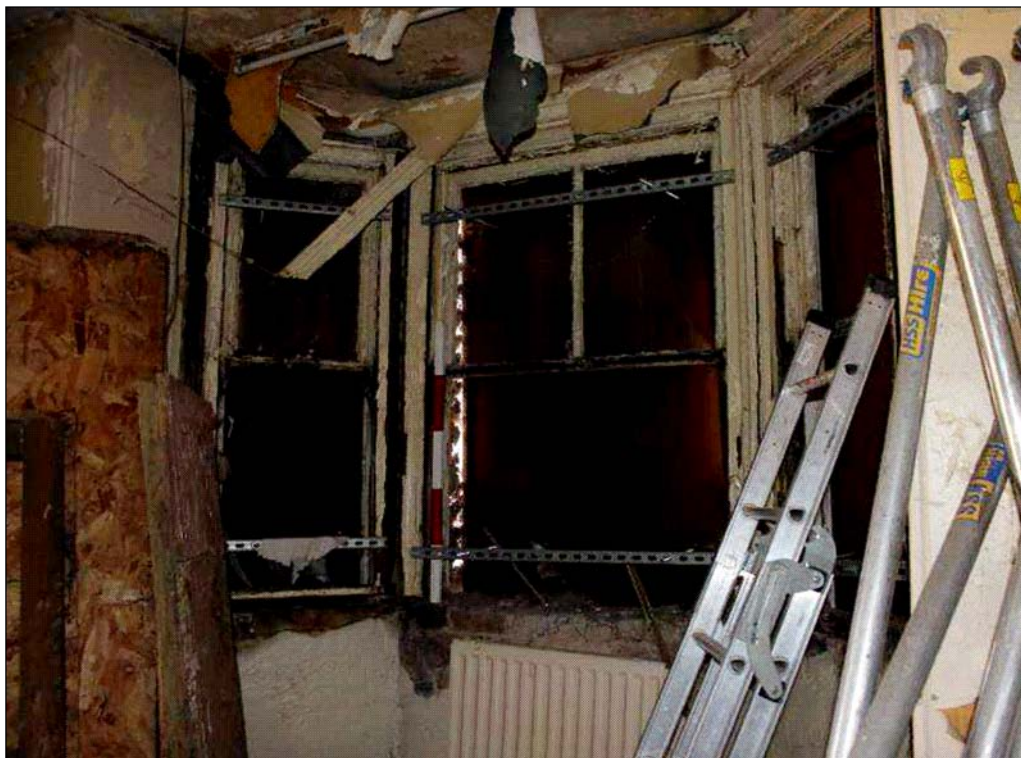
- 4.3.5 The front room had a canted bay window to the south (Plate 9), with a blocked fireplace to the north flanked to its east by a doorway leading into the back room. A two-over-two timber-sash window lay to the centre of the canted bay, with narrow one-over-one sashes to the east and west (Fig 4). Each window had a horn at either end of the underside of the upper meeting rail, and a fastener on its upper face.

Plate 9: Canted bay windows facing south, 1m scale

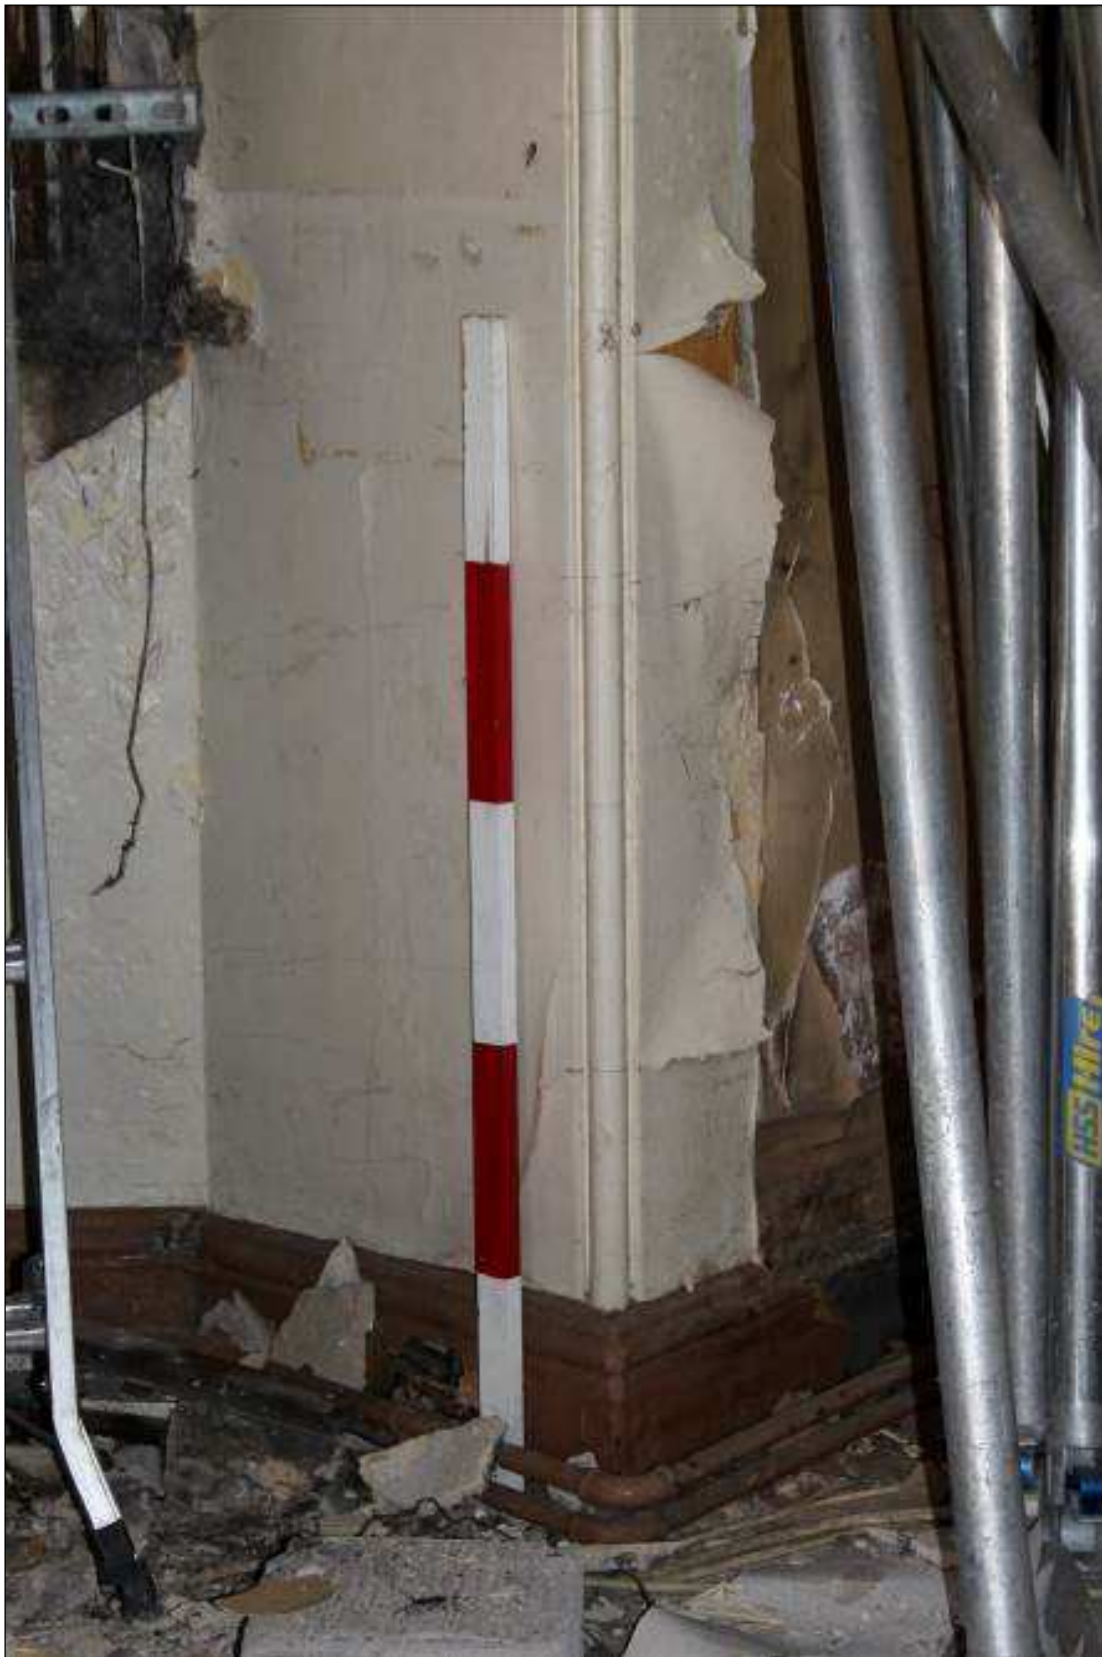
- 4.3.6 The walls were lime-plastered and coated in cream coloured paint, although much of this had peeled away from the surface. Plywood sheeting had been laid across the floor, although this may have obscured earlier floorboards, and the loss of sections of the lime plaster ceiling had revealed the sawn timber lathes, which were nailed to the underside of the first-floor joists. The ceiling timbers and floorboards above were suffering from advanced dry rot. With the fireplace blocked up, and the surround removed, few decorative elements survived, although the corners of the bay window had been finished with a roll mould, stopped just below the ceiling (Plate 10), and skirting board lined all four walls.

Plate 10: Roll-moulded jambs of canted bay window, 1m scale

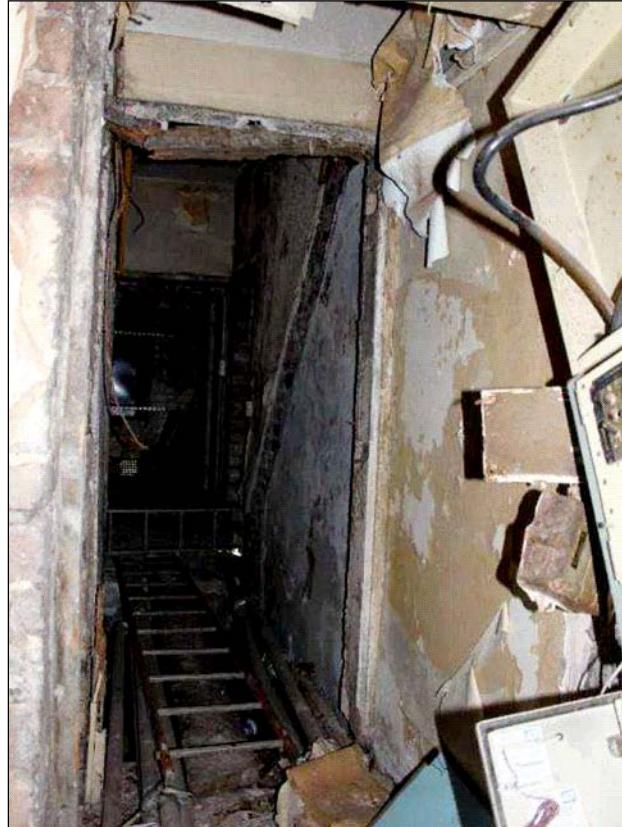
- 4.3.7 **Lobby:** the reception room and the back room were linked by a small square lobby, from which it was possible to proceed either south into the reception room, west in to the back room, or down a flight of steps below the first-floor stairs to the cellar (Plate 11). The only wall, to the east, retained fragments of wallpaper, and had a row of four metal coat hooks mounted upon a horizontal wooden rail just above the height of the door lintels (Plate 12).

Plate 11: Lobby between Reception room and Back Room, with staircase corridor beyond

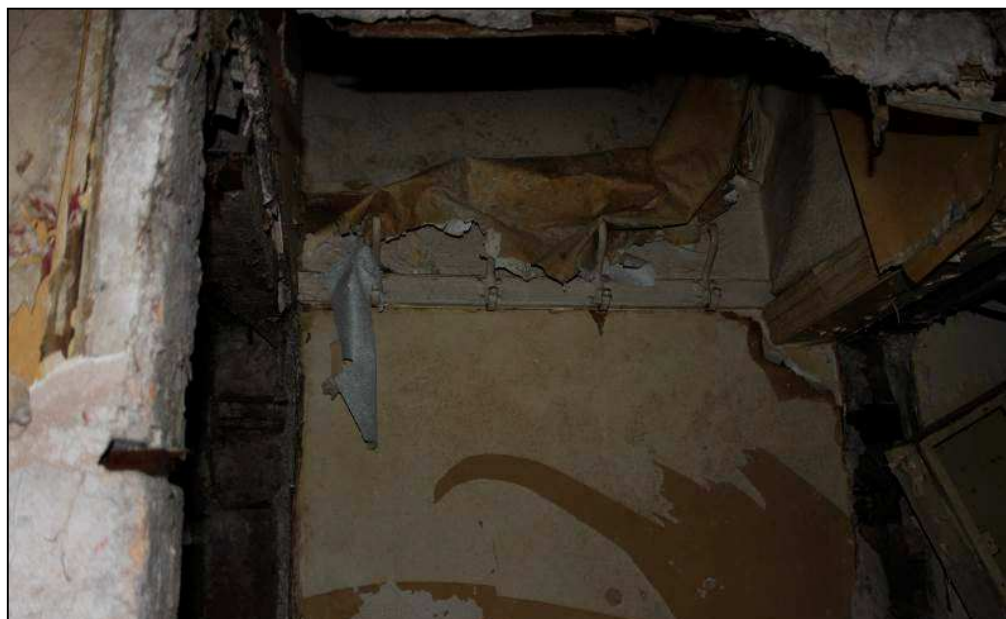
Plate 12: Coat hooks on eastern wall of Lobby

- 5.2.2 The remainder of the building can be identified as a private space for the use of the warden and his family, reflected in the coat hooks within the small linking lobby, which might otherwise typically be found closer to the front door. Access to the staircase, for example, and therefore the first-floor, is restricted to those who have been admitted via the lobby to the back and probably main living room.

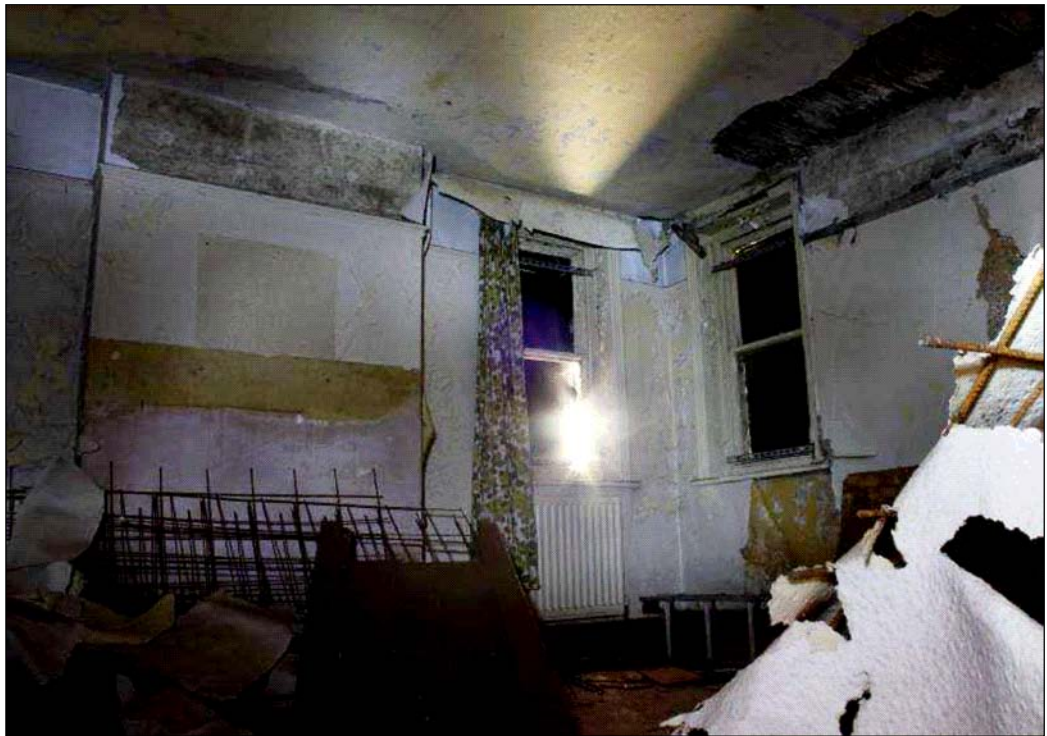
- 4.3.8 **Back Room:** the back room had a blocked fireplace to the centre of its western wall, flanked to the north and south by a single one-over-one timber sash window of identical design to those in the front room. There were two more of these windows, one on the northern and another on the southern wall (Plates 13 and 14).

Plate 13: Back room, facing north-west

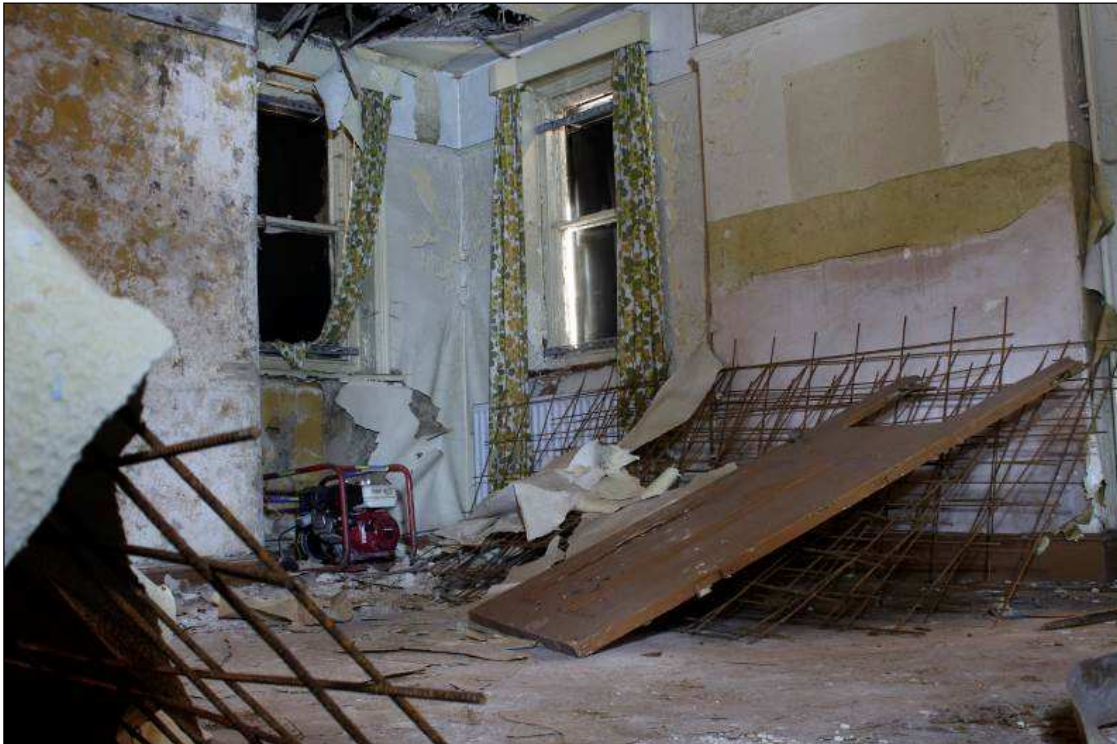
Plate 14: Back room, facing south-west

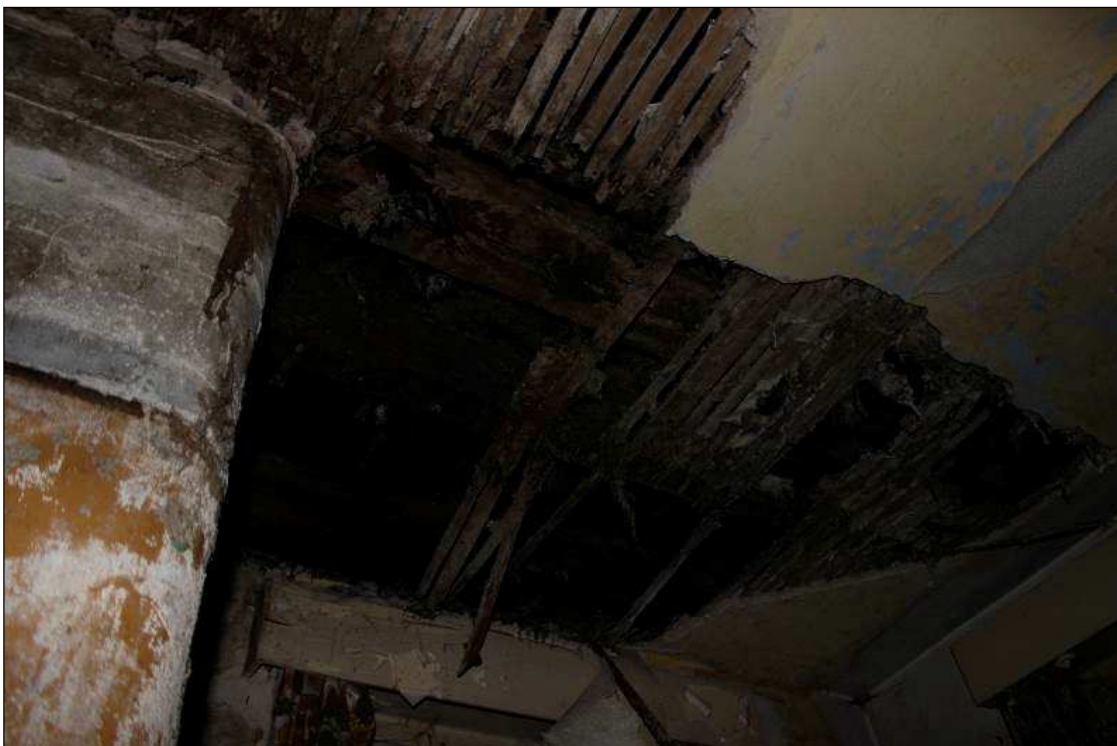
- 4.3.9 A doorway at the northern end of the eastern partition wall led onto the base of the first-floor staircase, while another at the southern end of this wall led back towards the front room. The partial collapse of the ceiling plaster and lathes in this room revealed transversely aligned floor joists (Plate 15).

Plate 15: Transverse joists above sawn lathes in south-western corner of the back room

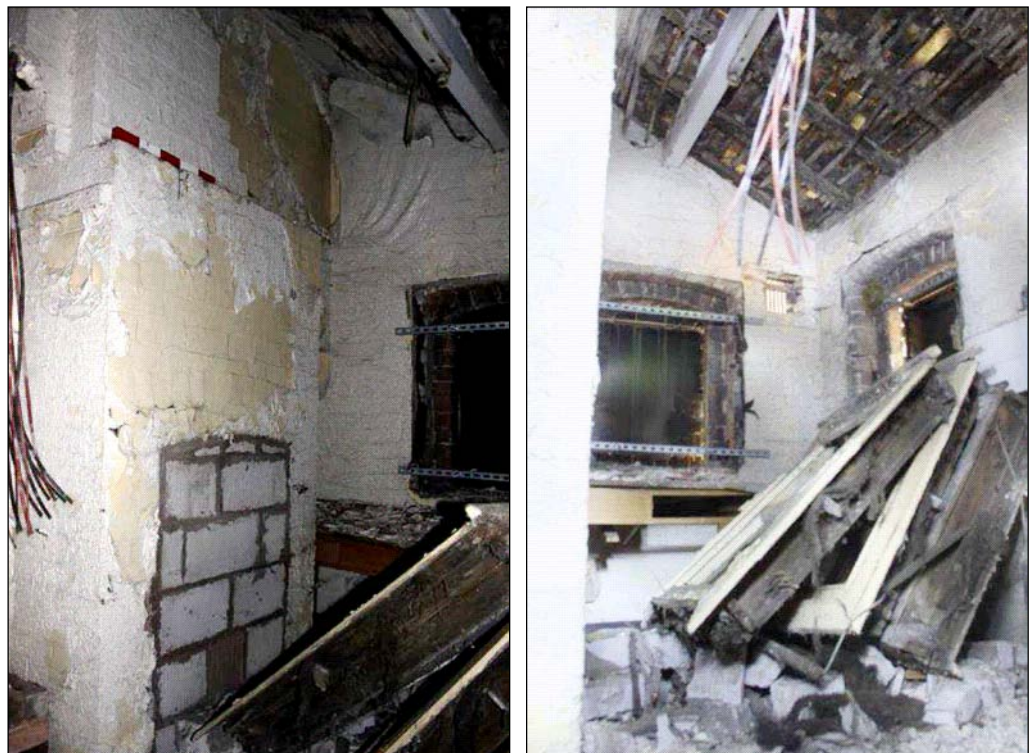
- 4.3.11 **The Kitchen:** the kitchen had a fireplace at the centre of its southern wall, and whilst this was blocked it was clearly surmounted by a shallow cambered arch formed in two courses of upright headers (Plate 16). There were three windows in total, two equally spaced on the northern elevation, and a third at the centre of the western elevation (Plate 17).

Plate 16 and 17: Blocked fireplace in the kitchen, facing west (1 m scale), and the kitchen facing north-west

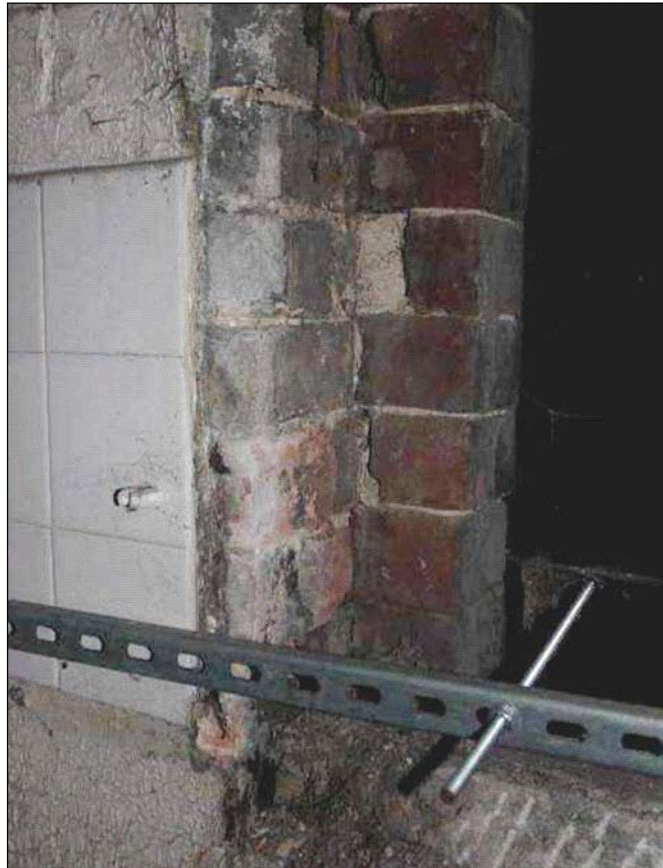
- 4.3.12 Each window had a shallow cambered brick arch above, reflecting the design of the fireplace, but also included fillets upon the angle of each jamb, stopped towards the base (Plate 18). None of the window openings retained their frames, although as there were three sash and case windows leaning against the southern wall, it seems likely that originally these windows contained simple casements.

Plate 18: Filleted and stopped jambs on kitchen window surrounds

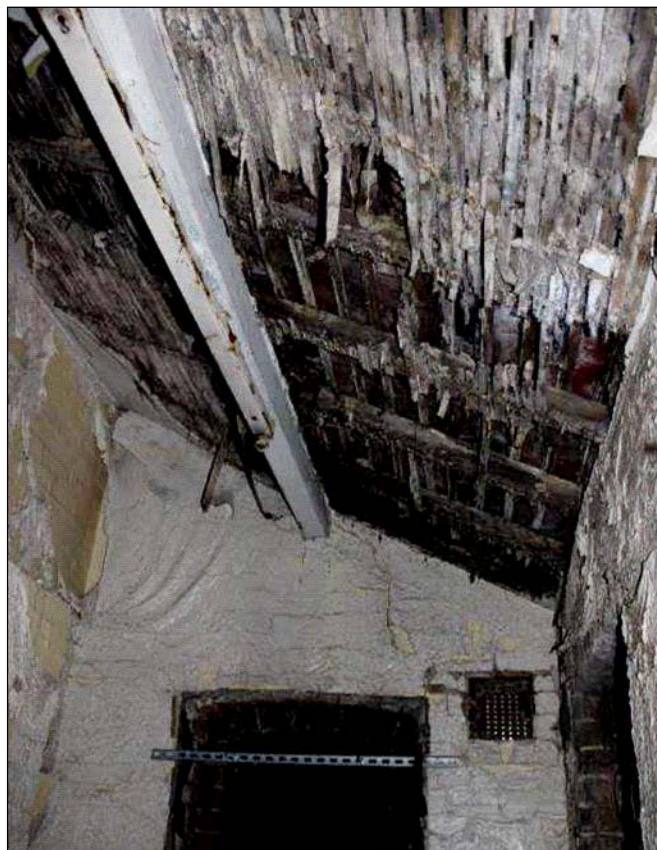
- 4.3.13 A doorway in the eastern wall provided direct external access, removing the need to pass through the building, but again it appears that originally there may have been an enclosed porch beyond. Much of the lathe and plaster ceiling had fallen away to leave the rafters exposed from beneath, and these projected downwards at approximately 30 degrees from the wall behind to rest upon the northern wall plate (Plate 19). A single purlin, resting within sockets at the head of the eastern and western walls supported the rafters at the mid-point. Horizontal battens were nailed to the backs of each rafter, and ceramic tiles were laid upon these.

Plate 19: Exposed section of roof structure

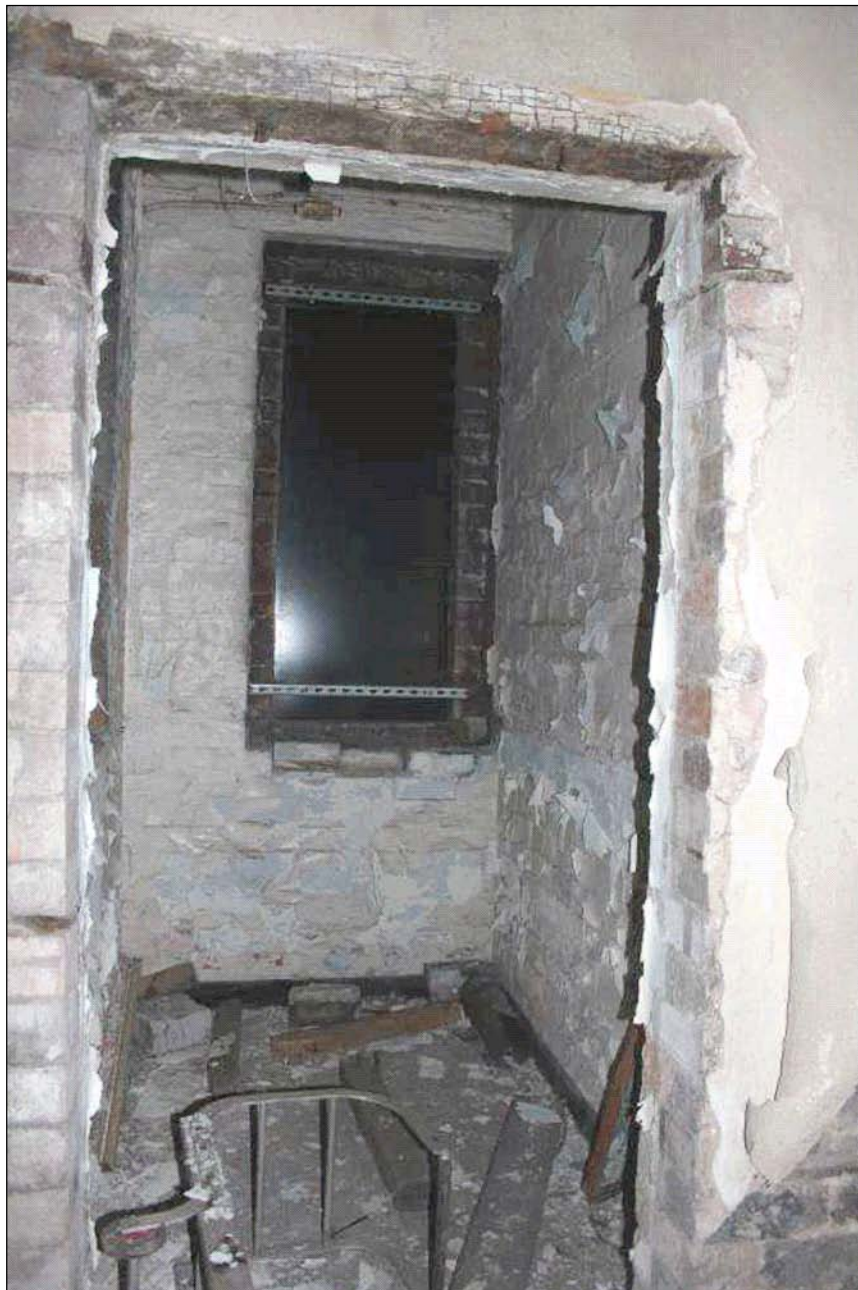
4.3.14 **Eastern Wing:** the eastern wing of the building had been sub-divided into a tiny northern cell accessed internally through a doorway to the east of the foot of the staircase, and a larger southern cell, entered from a doorway on the southern elevation. A window at the centre of the eastern elevation had been modified to provide a second narrow doorway into the larger cell. Unfortunately, no access was possible to the southern cell at the time of the survey, but the northern cell had exposed brick walls coated in white paint, a plastered ceiling, and a plywood sheet floor (Plate 20). There was a single window opening with a cambered brick arch and filleted jambs on the northern and eastern walls, but the window frames had been removed. As far as could be ascertained, the basic arrangement of the eastern wing was part of the original design, although the exact function of the very small but well-lit northern cell is unclear.

Plate 20: Northern cell of the eastern wing, facing east

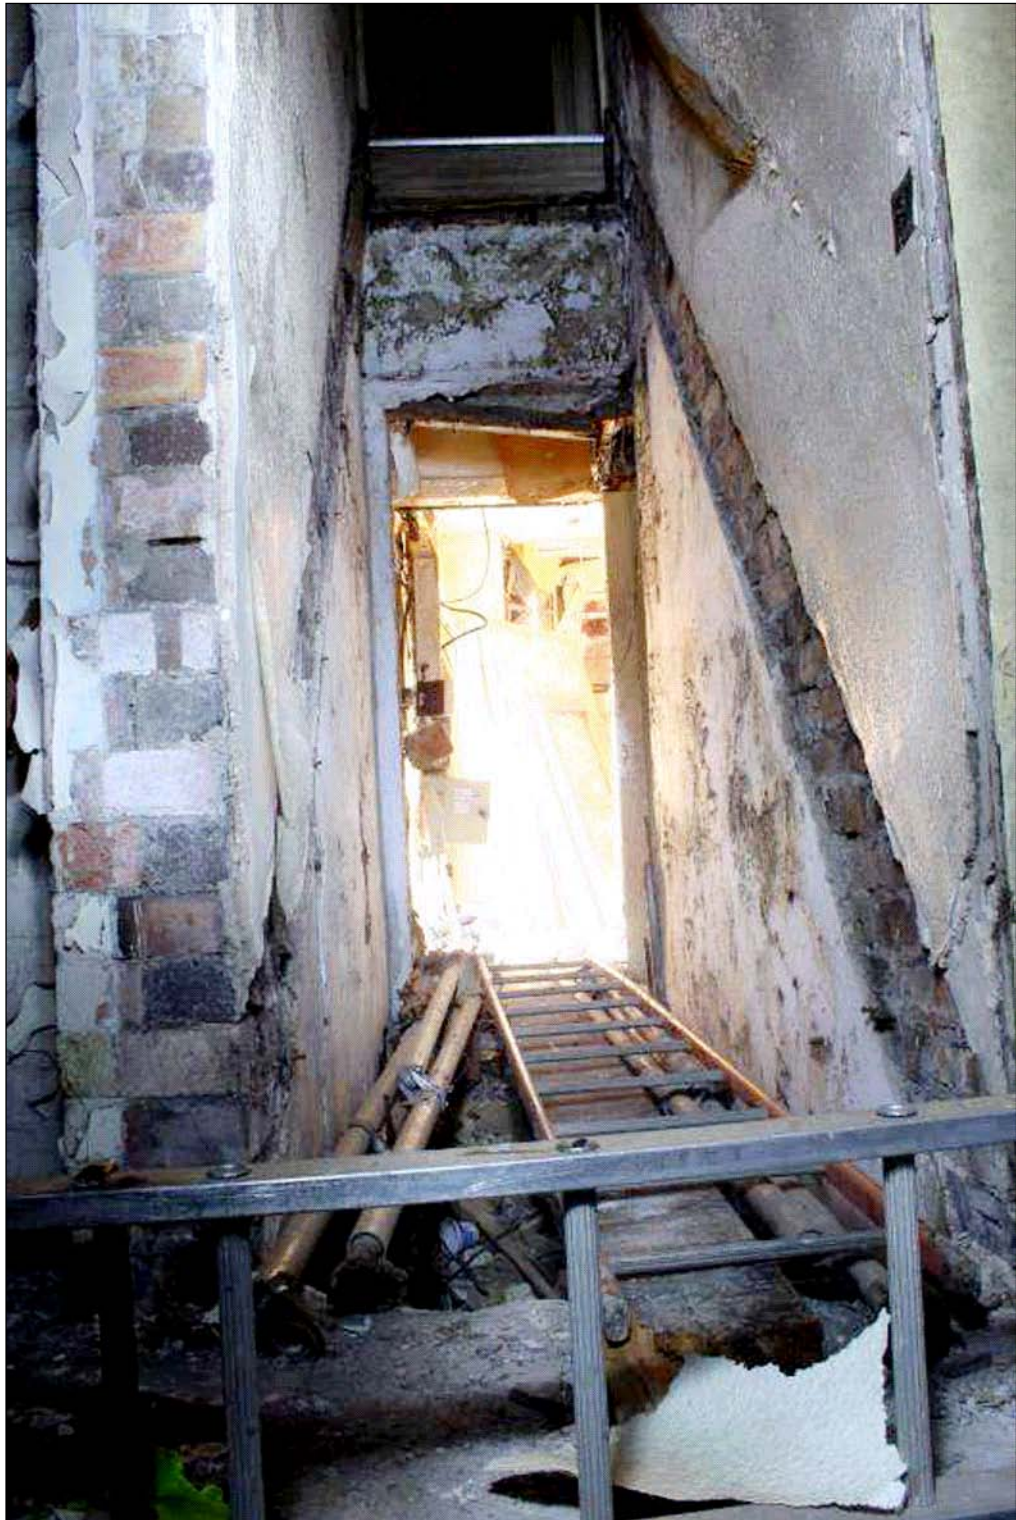
- 4.3.15 **Staircase:** prior to removal, the staircase had sat within a narrow corridor between the eastern wing and the back room, and from the scars in the wall plaster left behind by the string or raking beam, it evidently rose from north to south (Plate 21). The remnants of the timber hand rail were recorded on the western wall of the staircase corridor.

Plate 21: Staircase corridor facing south, showing scars of string beam and remnants of hand rail on western wall

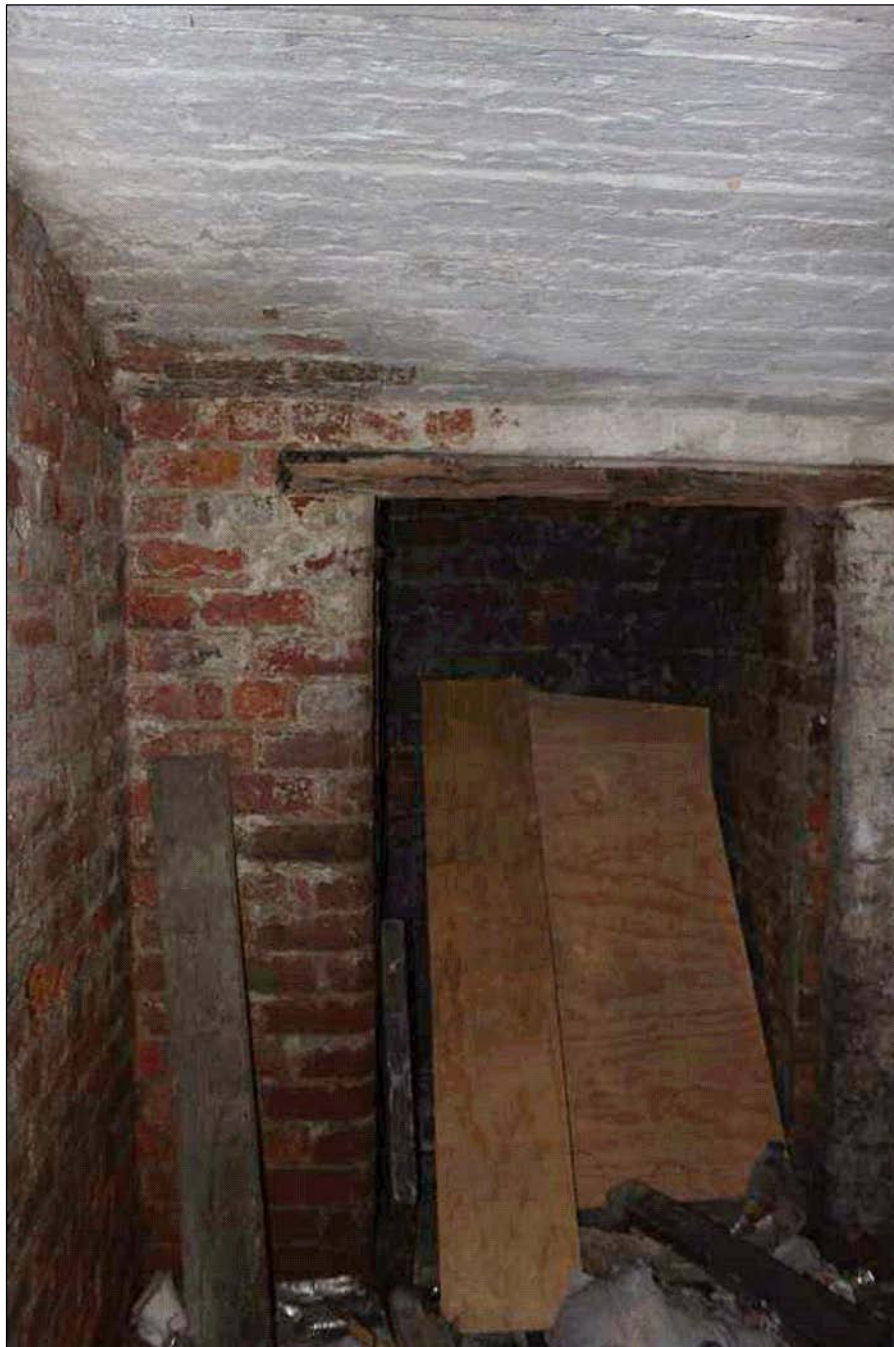
4.3.16 **Cellar:** at the southern end of the staircase corridor there was a set of steps which led from the small lobby space linking the reception room and back room, northwards down to a small coal cellar beneath the eastern wing. The ceiling was low, the floor laid in concrete, and the walls were of exposed brick coated in white paint, where it remained. There was a recess on the eastern wall with an opening at the top, now boarded over externally but through which coal had once been delivered (Plate 22). A series of flat wrought-iron bars protruded at regular intervals from the western wall at half height, and these presumably once supported a wooden shelf (Plate 23). The southern end of the cellar was not fully visible, although there may have been a low stone shelf on brick piers at the end (Plate 23).

Plate 22: Coal chute in eastern wall of cellar

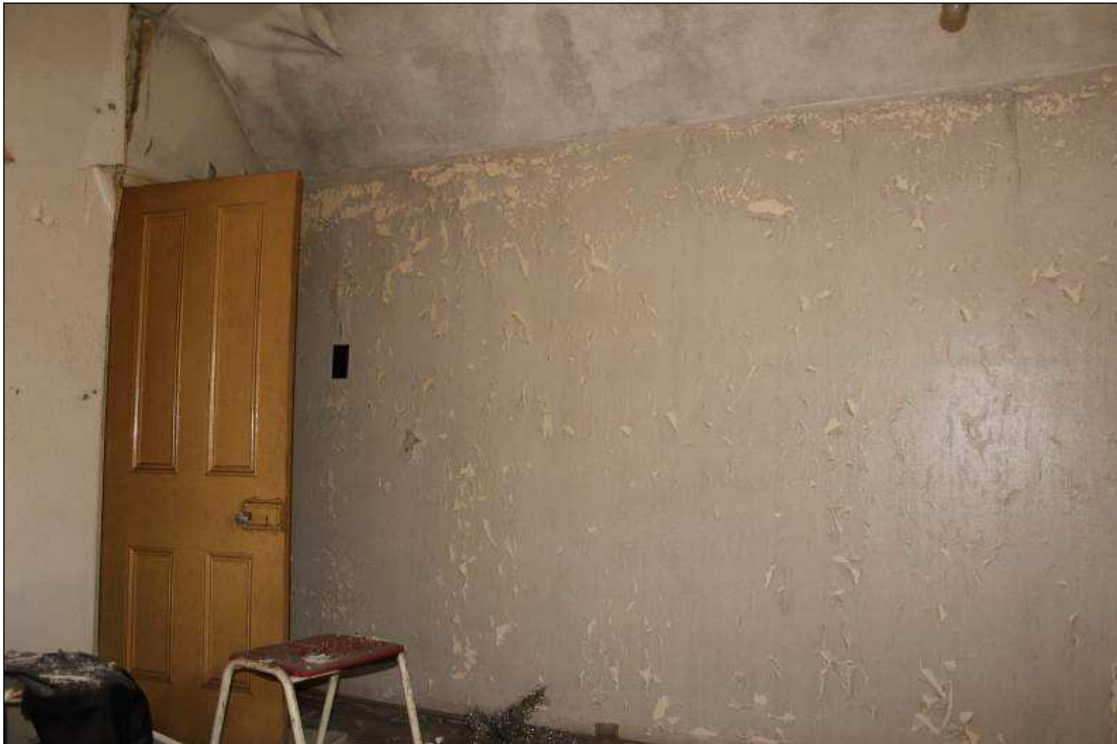
Plate 24: Southern bedroom, facing east

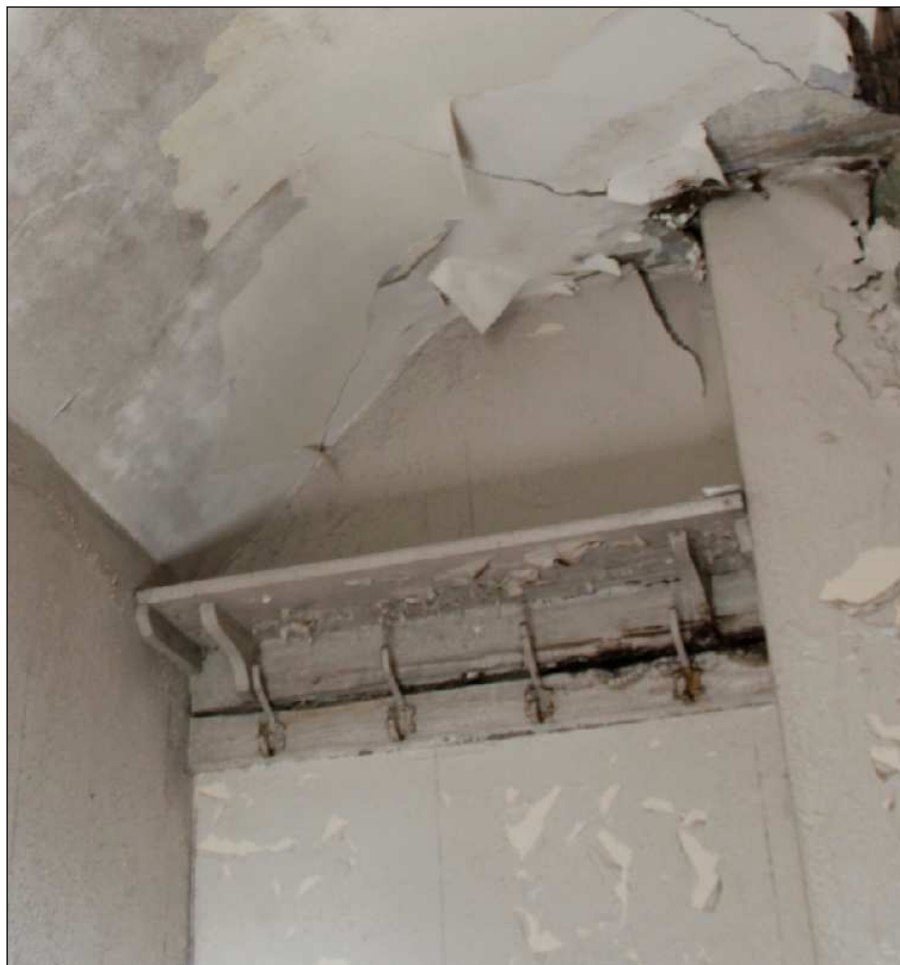
Plate 25: Wooden shelf and hooks in recess

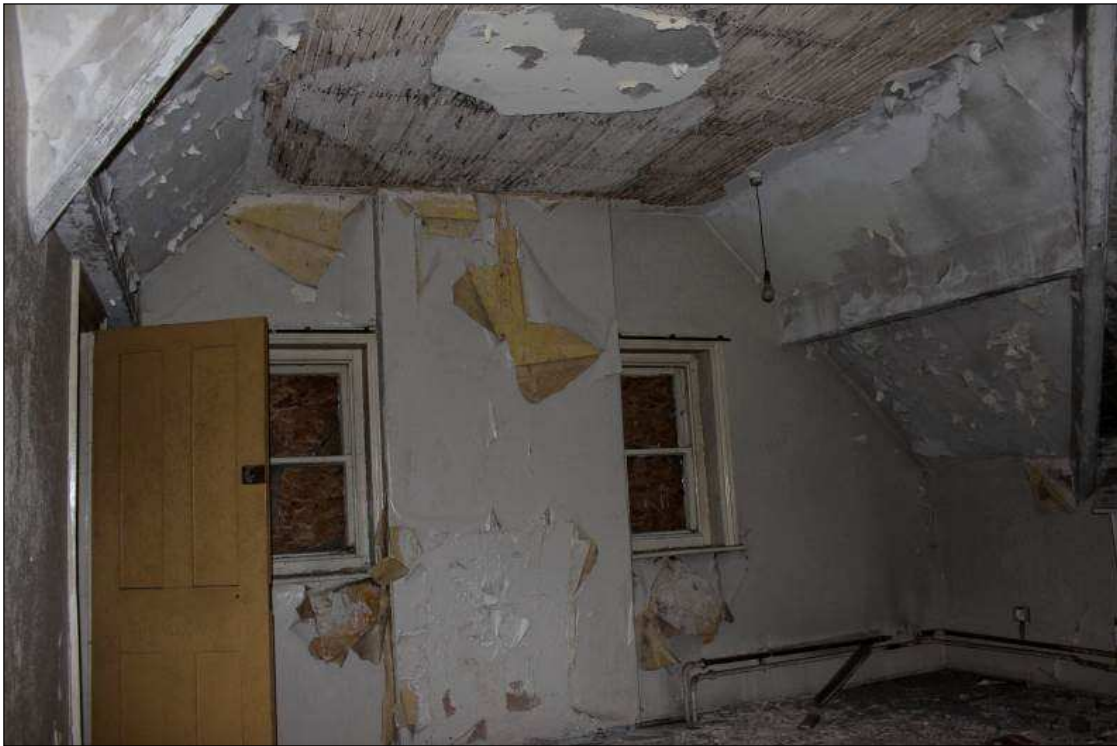
Plate 26: Back bedroom facing west

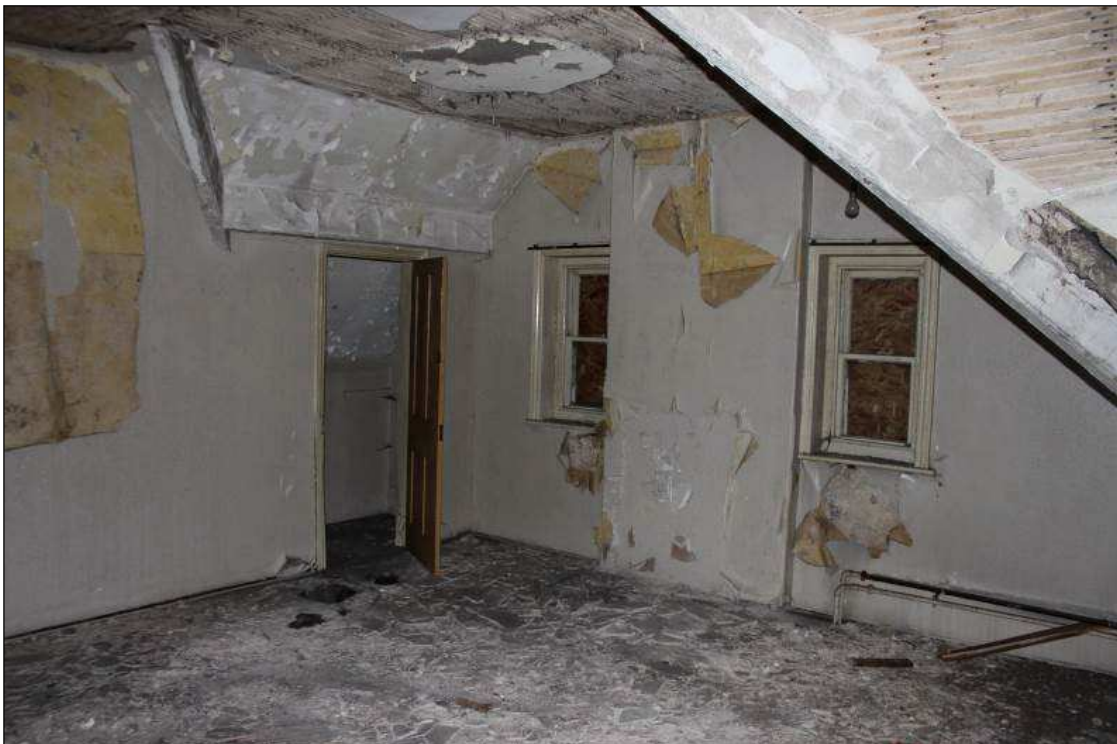
- 4.3.20 There were a total of four sash windows, two at the eastern end of the northern wall and another two on the western wall, either side of a projecting chimney breast. The windows were each as described previously, and the fireplace had been blocked. At the western end of the southern wall there was a deep recess into which a cupboard had been fitted beneath the eaves with a four-panel door at the centre (Plate 27). The room had not been fitted with a skirting board, and there were no other decorative features visible.

Plate 27: Back bedroom, facing south-west towards fitted cupboard
