**Former Westcliffe
Hospital,
Turnhurst Road,
Chell,
Stoke-on-Trent**

**Archaeological
Investigation Final
Report**

Oxford Archaeology North

June 2014

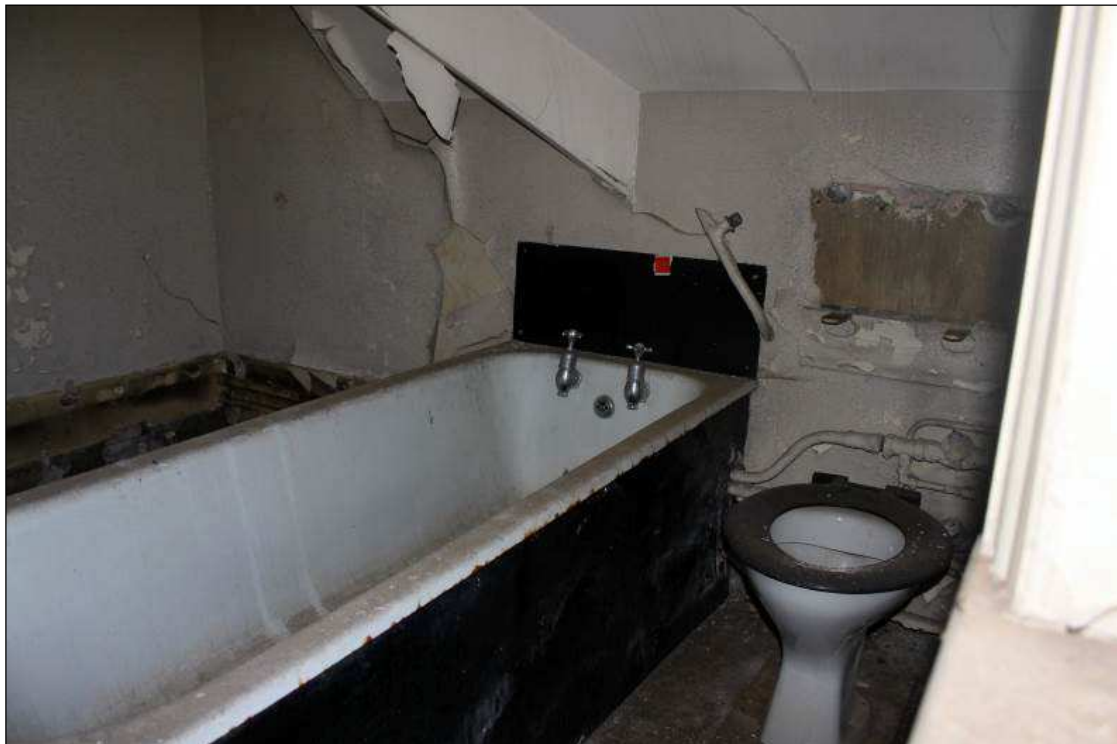
- 4.3.21 **First Floor, Bathroom:** the bathroom lay within the eastern wing, making it a narrow space, with a partial return around the northern end of the stair corridor to create an L-shaped plan. The walls were plastered and painted white, along side the ceiling, which was again canted to the north and south to allow for the pitch of the gable roof. The floor appeared to have been covered in plywood or perhaps linoleum, but the limitations of the present survey prevented further determination. There was a metal bath that projected south from the northern wall and a toilet to its east, missing its wall-mounted cistern (Plate 28). An enamelled sink lay to the west, mounted upon the southern wall of the western projection (Plate 29). At the southern end of the room there was a cupboard built into a deep recess and hung with a four-panelled door (Plate 30).

Plate 28: Northern end of bathroom

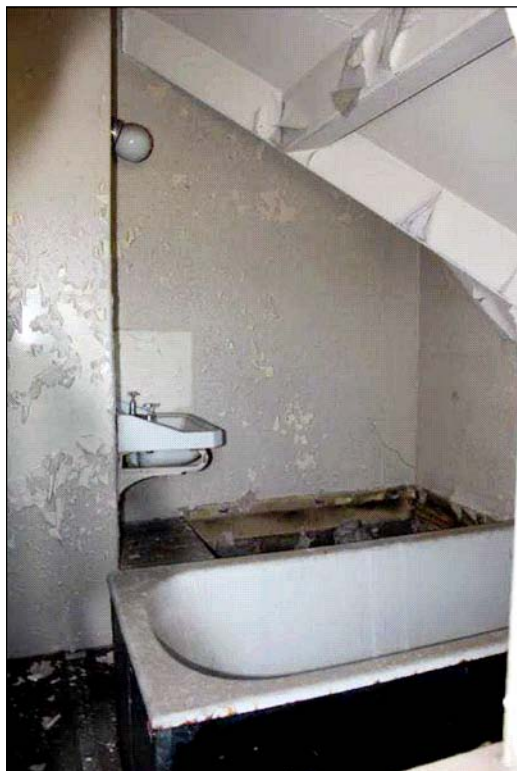
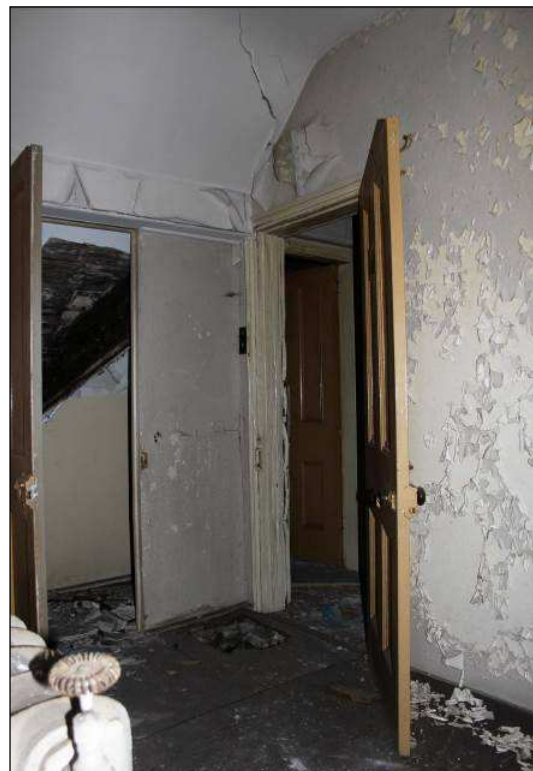
Plates 29 and 30: Sink on southern wall of the western projection with entrance door to right and cupboard

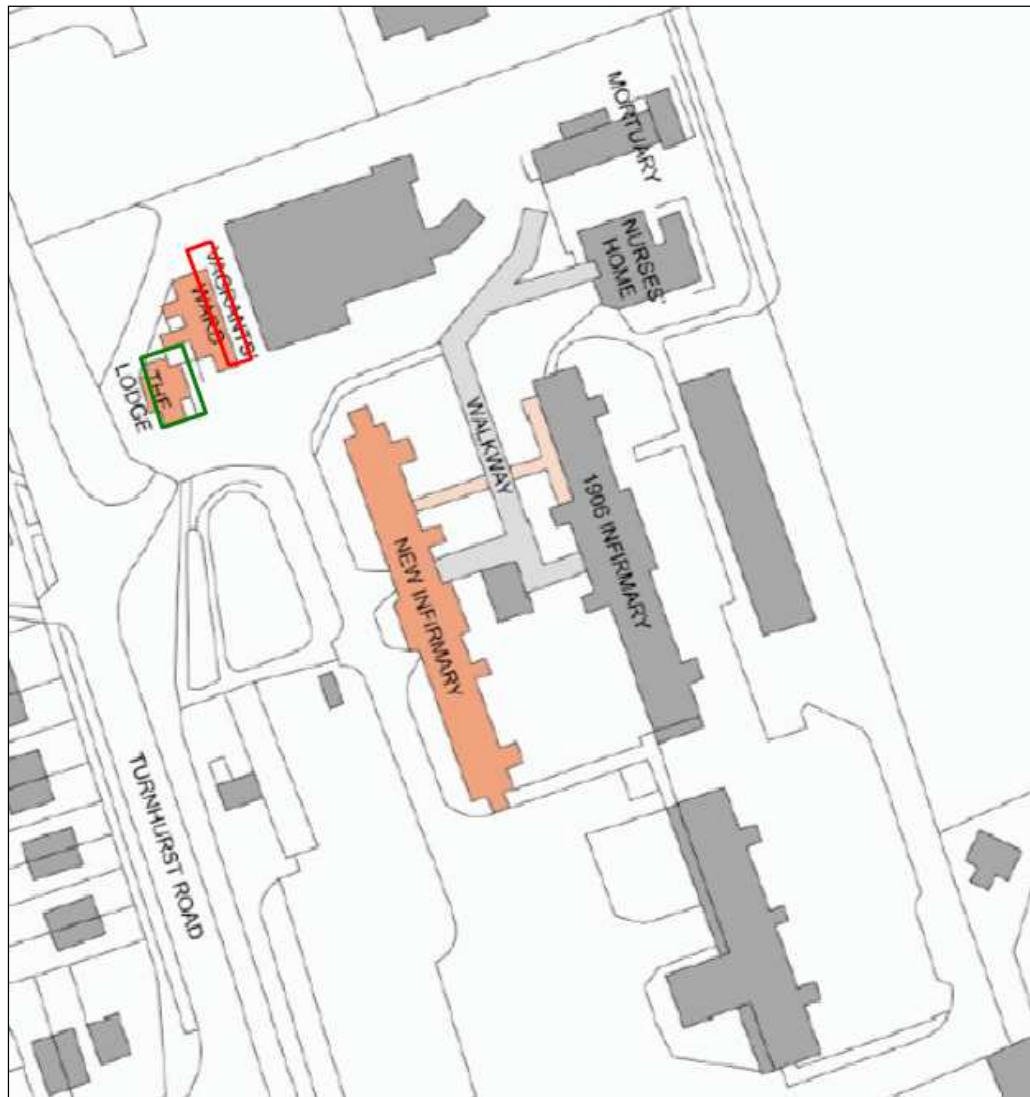
Plan of Westcliffe Hospital prior to demolition, showing the position of the Lodge (in green) and the location of the evaluation trench (in red) across the Vagrants' Ward

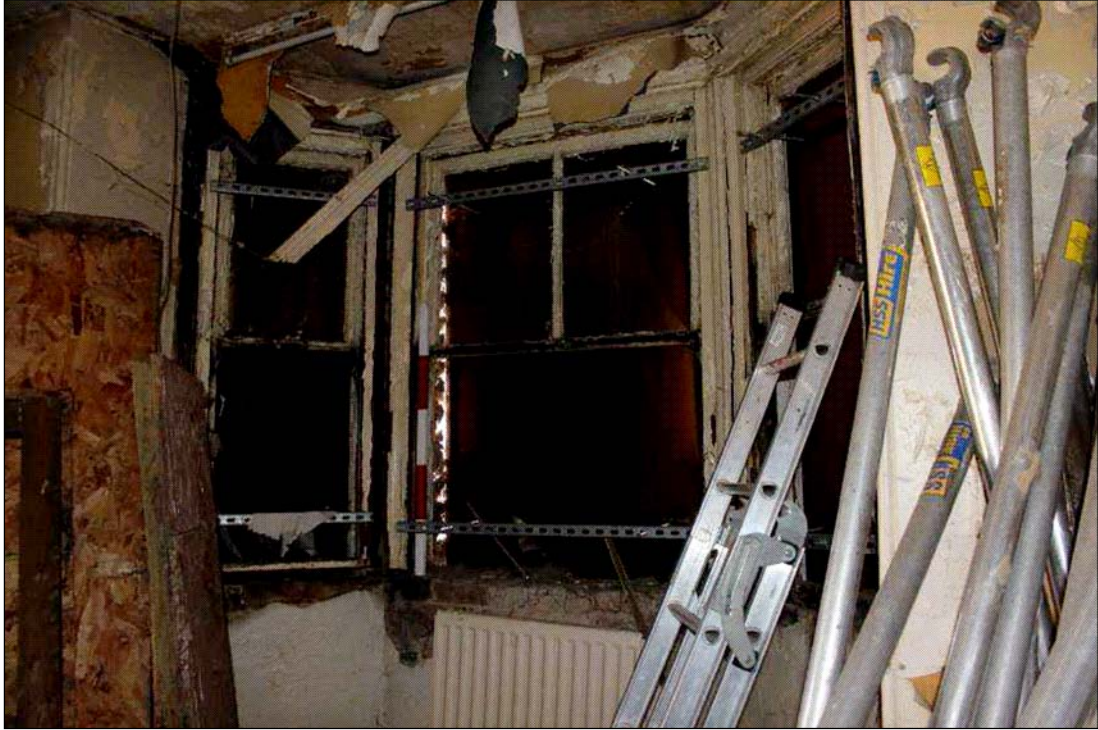
Image 2: Canted bay windows on the ground floor of the Lodge, facing south (1m scale)

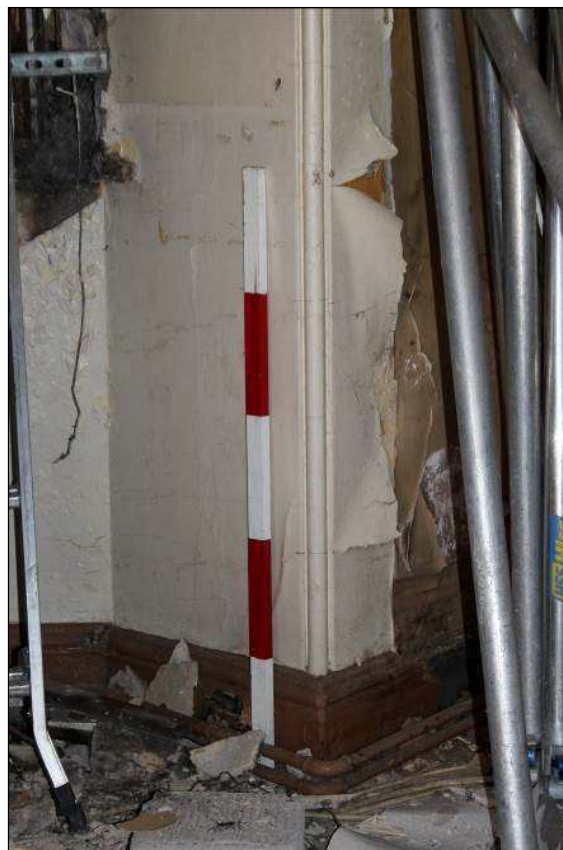
Image 3: Roll-moulded jambs of canted bay window on the ground floor (1m scale)

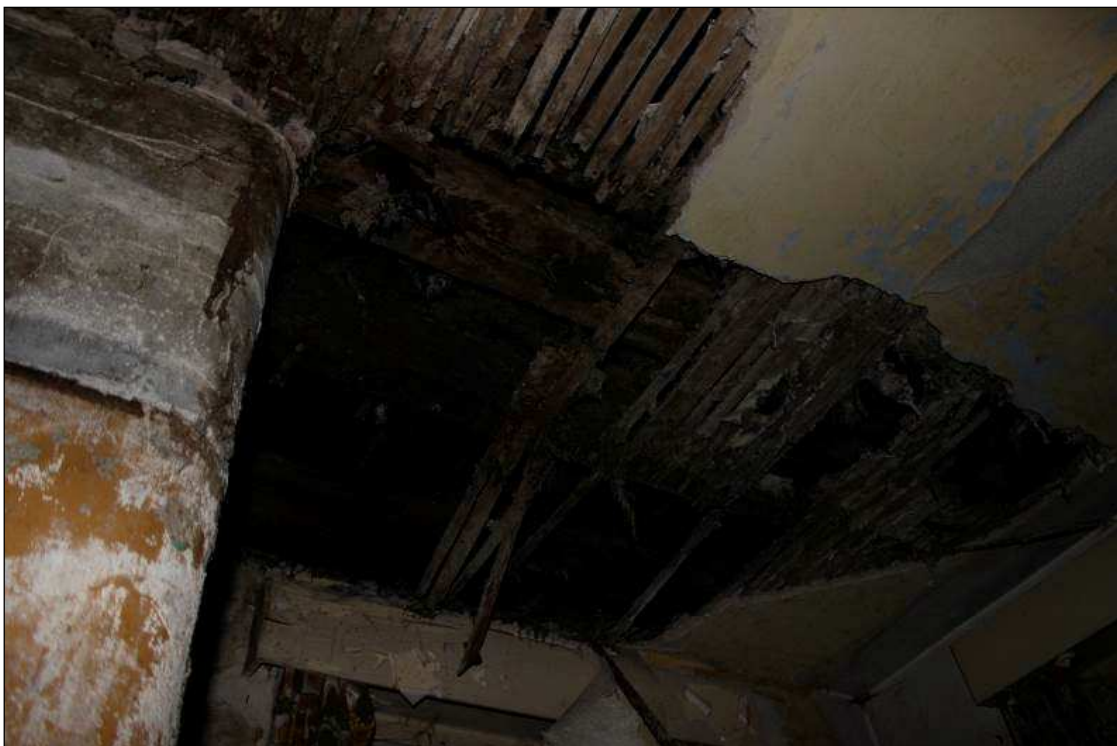
Image 8: Transverse joists above sawn lathes in south-western corner of back room at ground-floor level

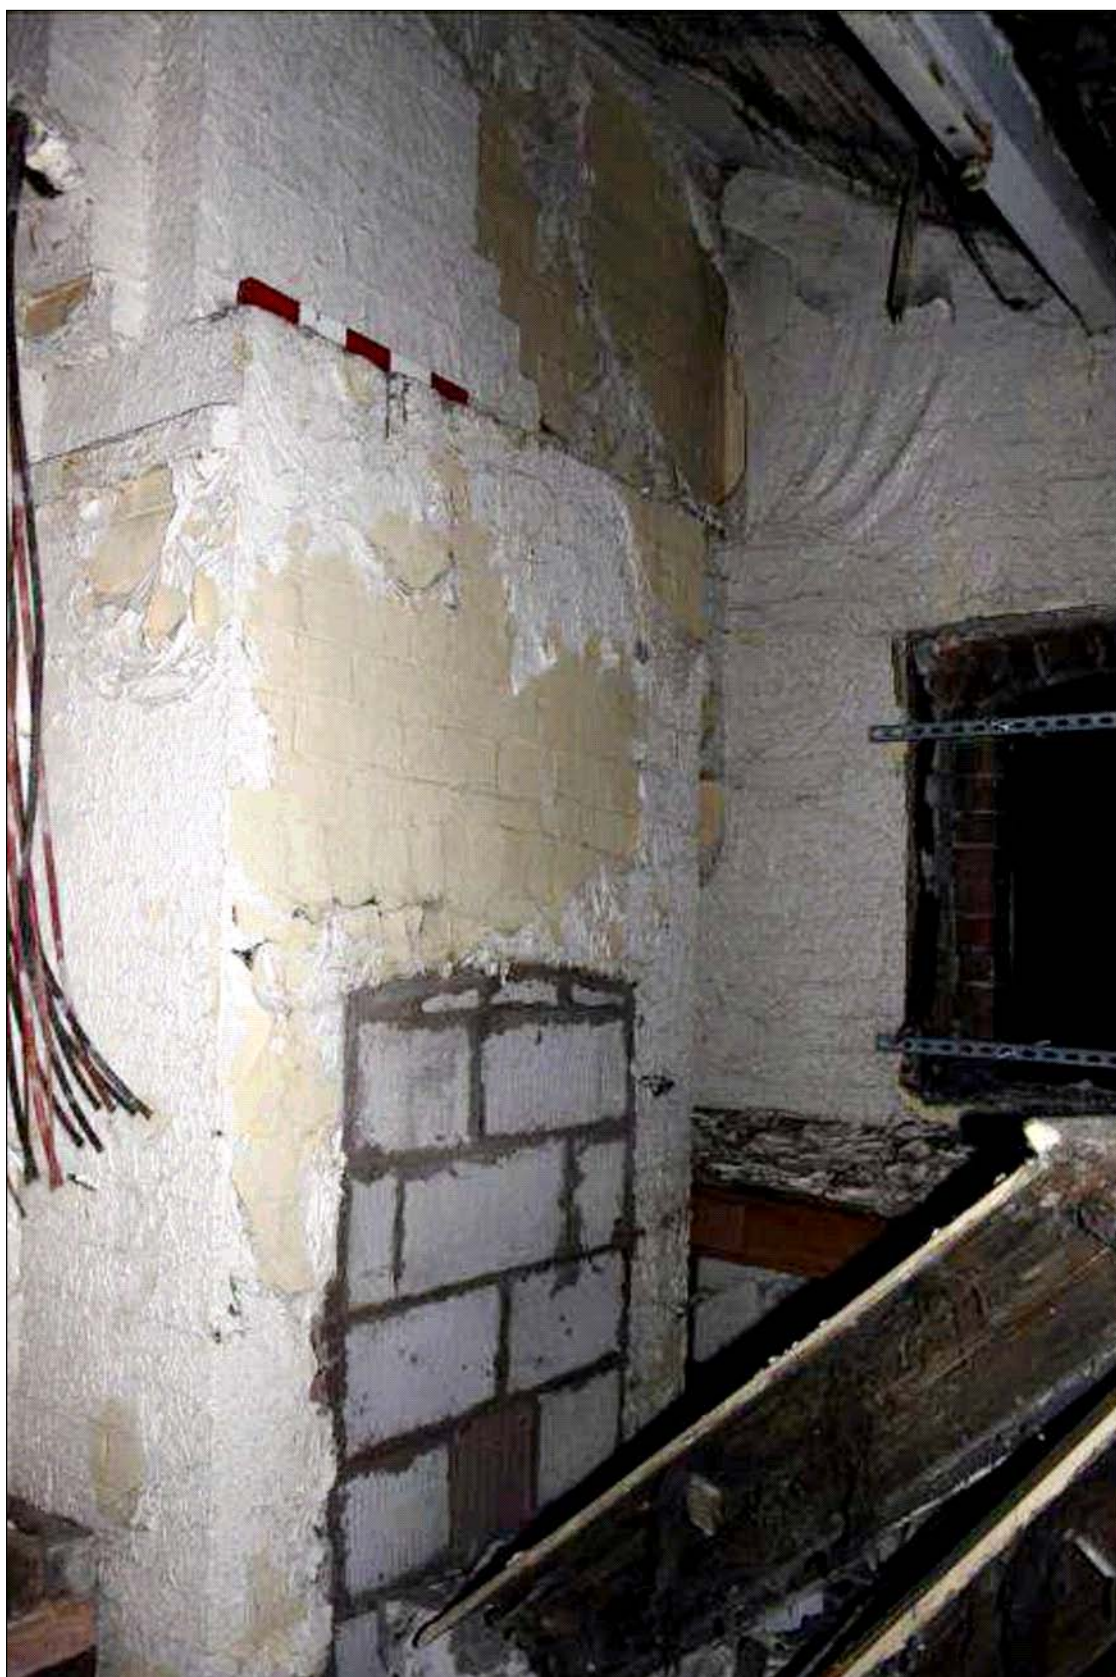
Image 9: Blocked fireplace in kitchen, facing west (1 m scale)

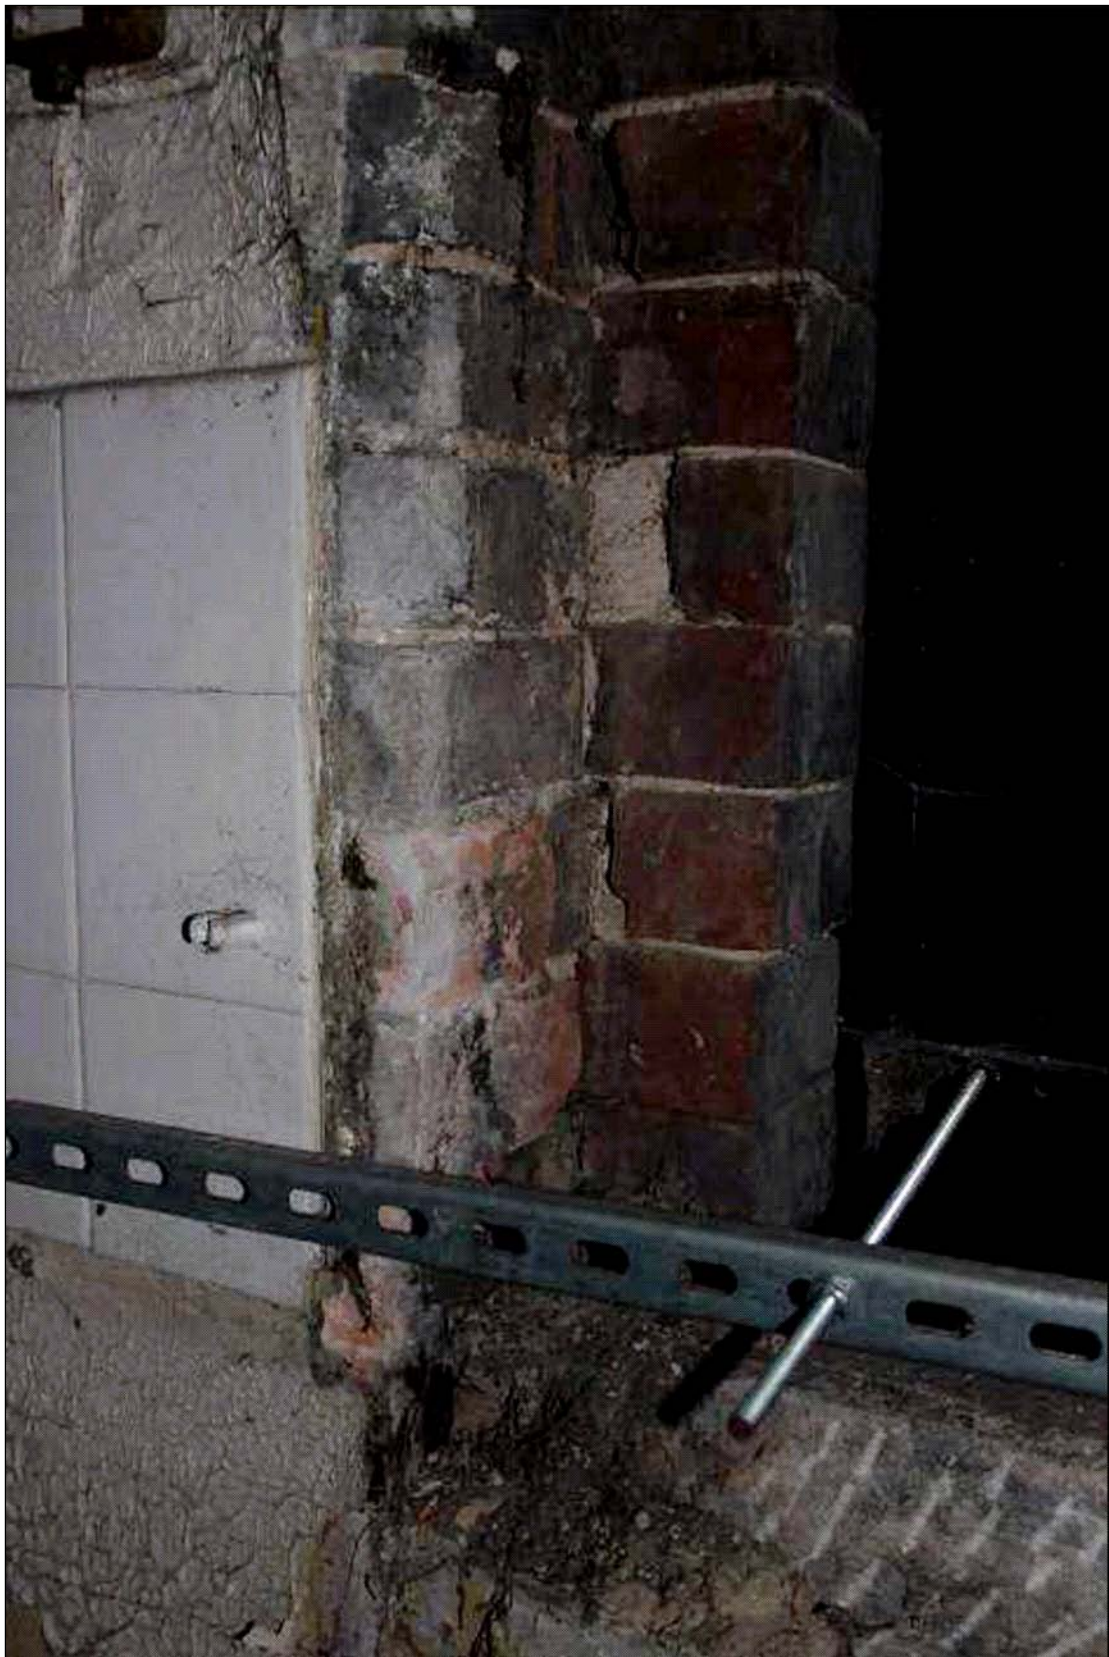
Image 11: Filleted and stopped jambs on kitchen window surrounds at ground-floor level

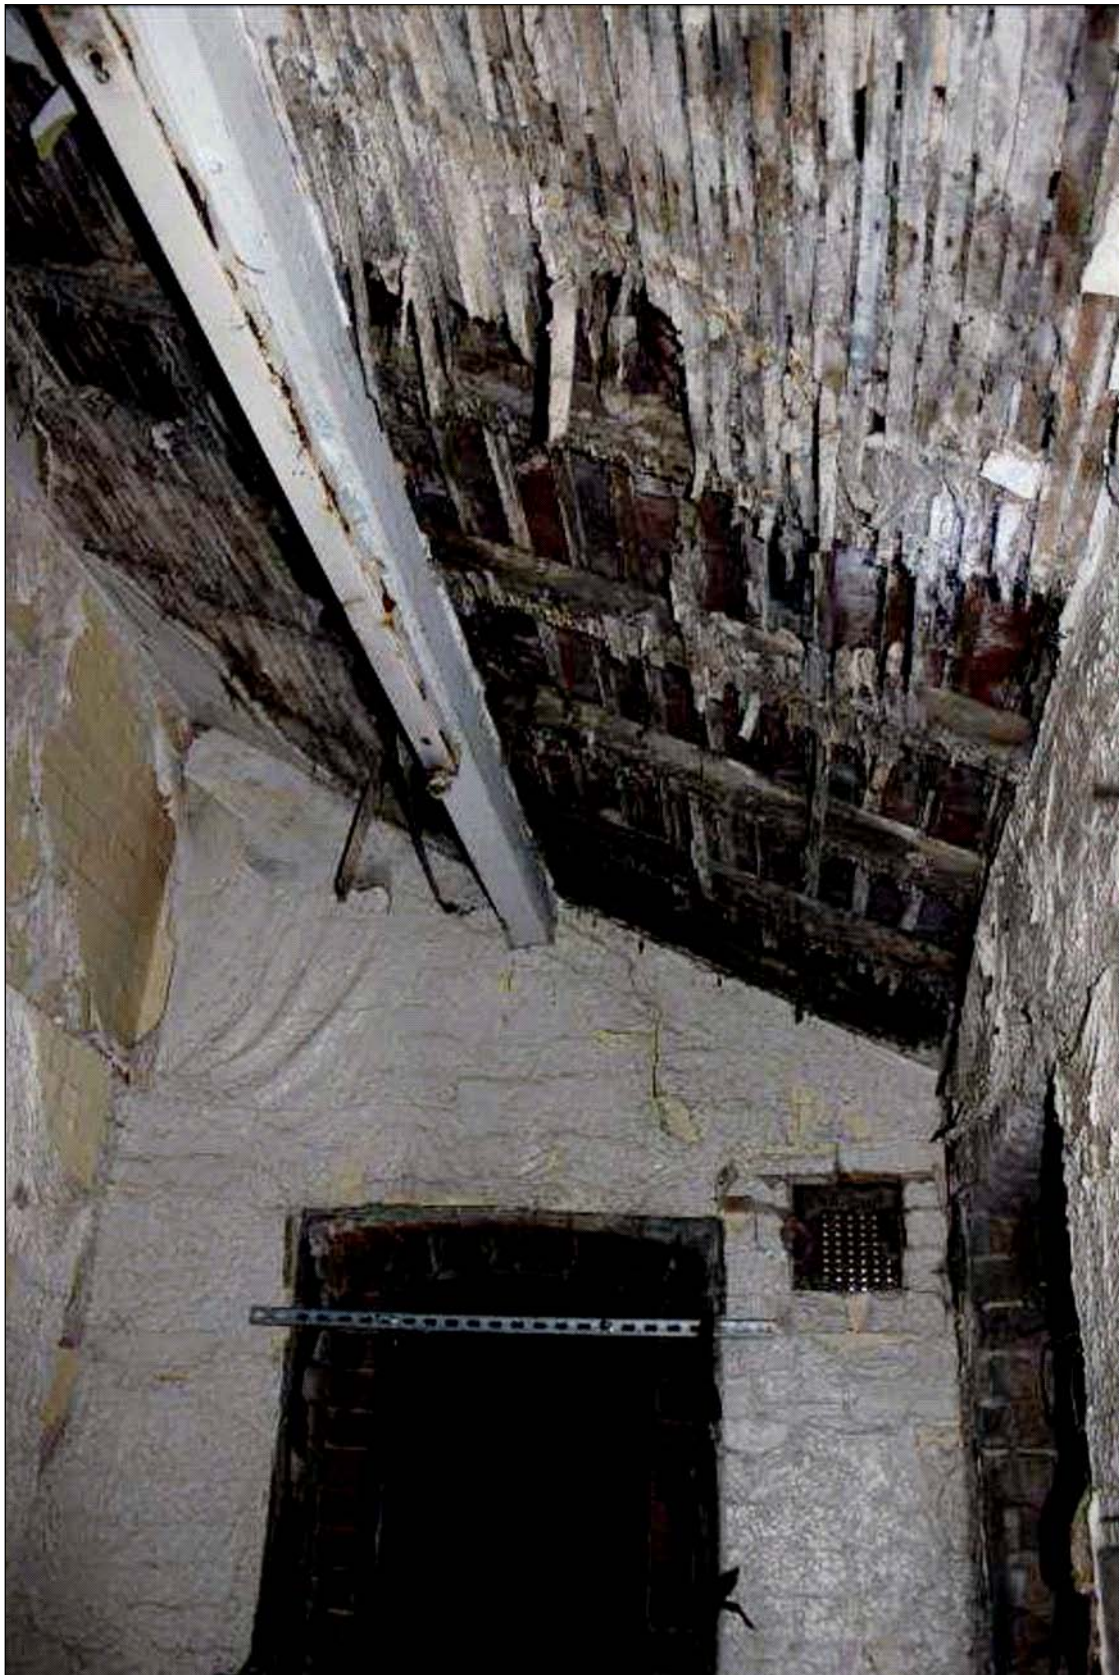
Image 12: Roof structure in the kitchen

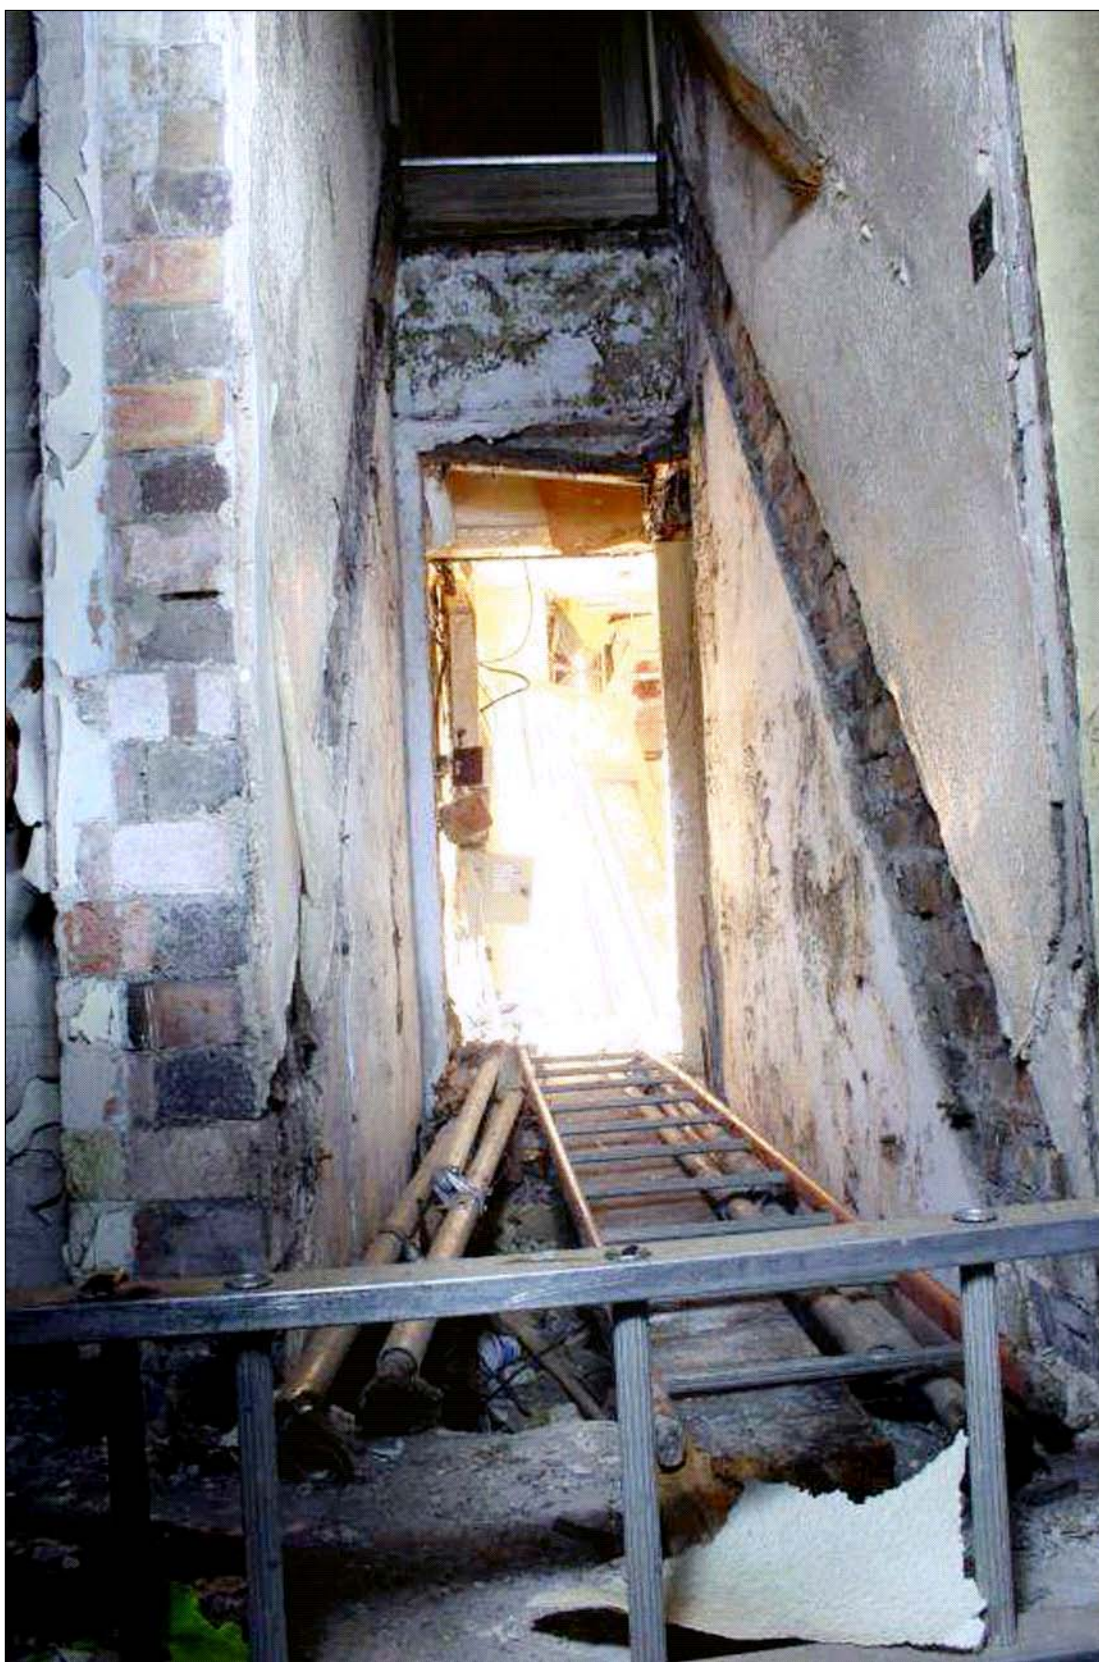
Image 14: Staircase corridor facing south, showing scars of string beam and remnants of hand rail on western wall

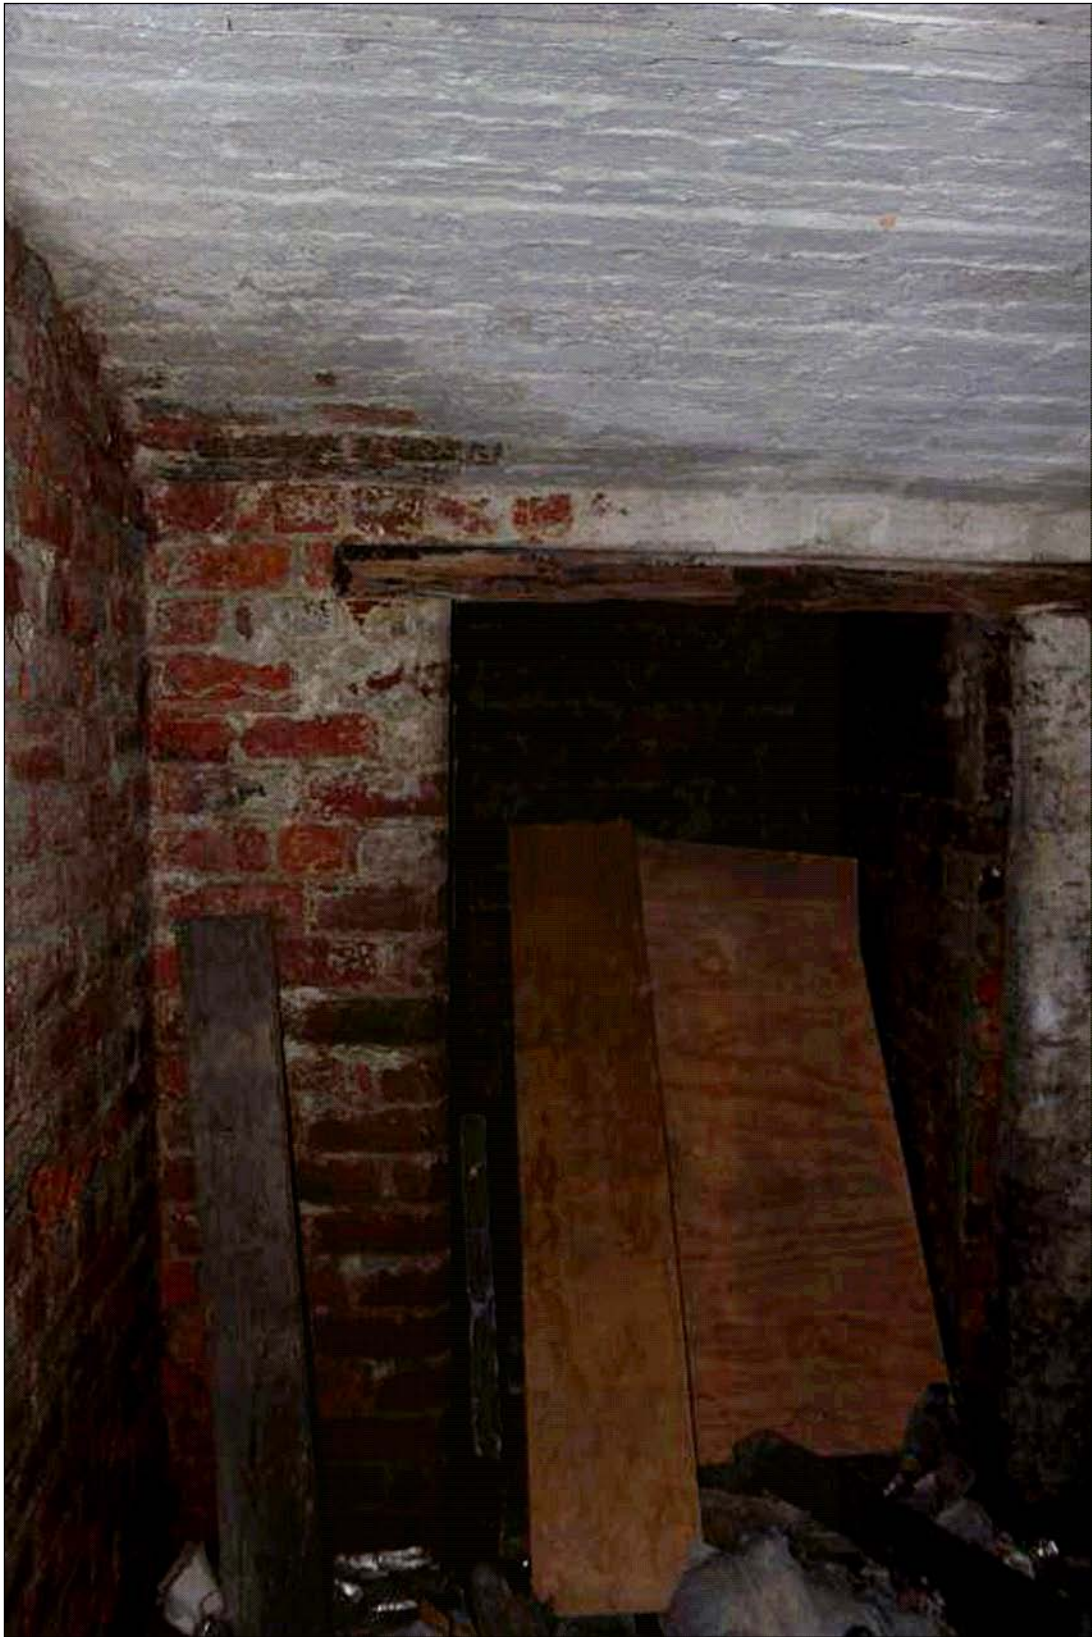
Image 15: Coal chute in eastern wall of the cellar

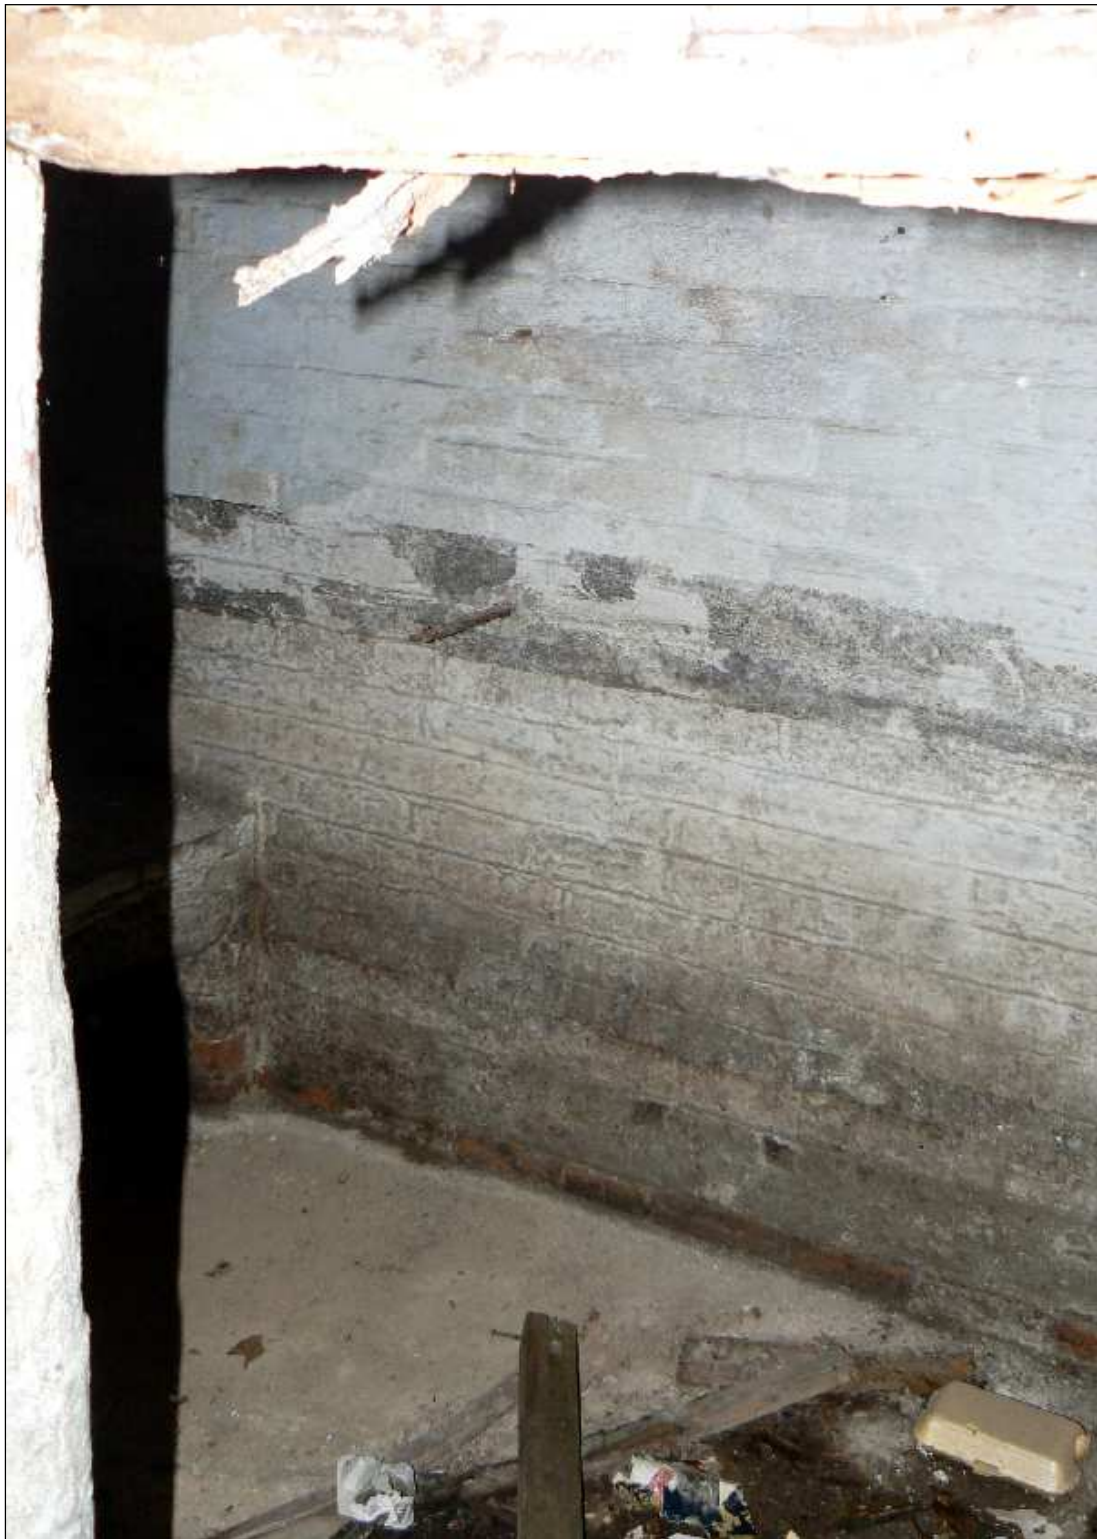
Image 16: Former location of shelf denoted by projecting flat iron bars and low stone shelf, just visible to left at southern end of cellar
