**29-35 TRAFALGAR
STREET
BURNLEY
LANCASHIRE**

**Archaeological Building
Investigation**

November 2014

Barnfield Construction

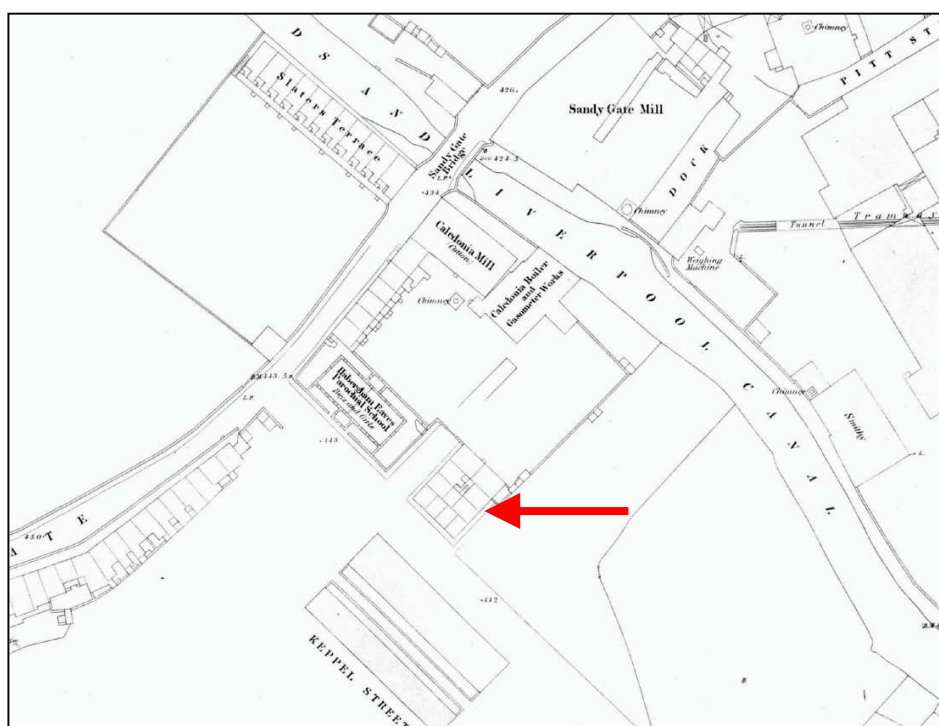
Plate 2: Extract from the Ordnance Survey 60": 1 mile map of 1851, with arrow marking the site of 29-35 Trafalgar Street

4.2.1 The basic extant plan represents a modification of that shown on the Ordnance Survey map of 1851 (Plate 2). The earliest phase appears to represent a U-shaped block of eight houses, fronting Trafalgar Street, Derby Street and what later became Varley Street. These are shown with a rear yard on the earlier 6": 1 mile edition of 1848, prior to the construction of two further dwellings on the northern side, enclosing the courtyard. The four properties fronting Trafalgar Street are narrower than those on either side street, but have been remodelled into a single shop at ground-floor level (Plate 3).

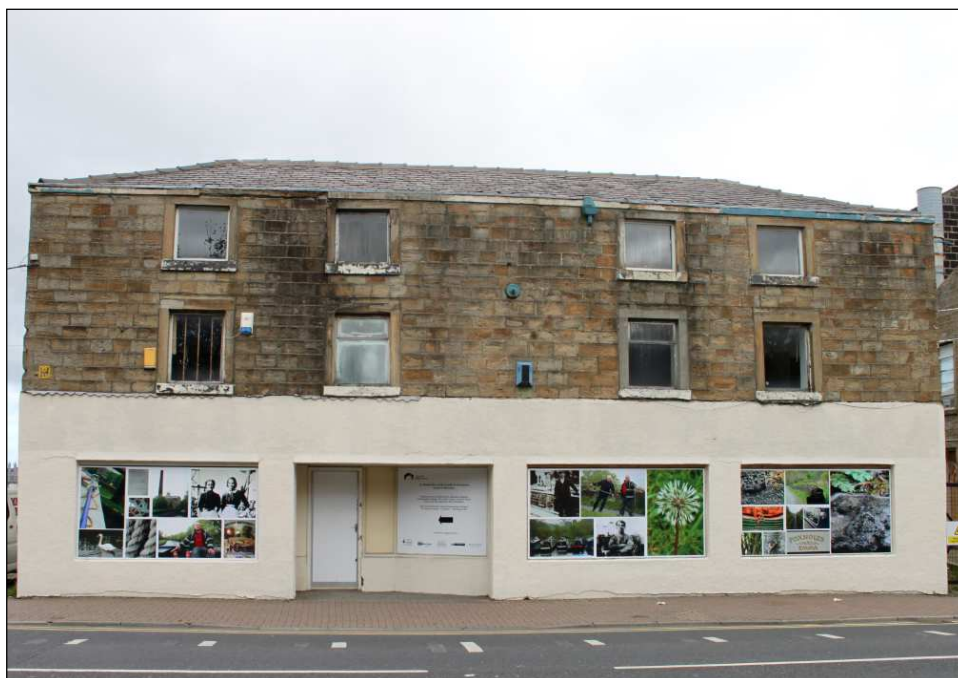
Plate 3: The front elevation of 29-35 Trafalgar Street

- 4.2.3 Both the first and second floors had two pairs of diminishing windows with dressed single-piece sandstone surrounds and projecting sills (Plate 3). Those on the upper floor are placed at wall-head height, with the rooms within being open to the rafters of the hipped roof. Although much of the internal detail has been removed, original partitions survived within the roof space of all the properties, and comprised single-skin, hand-made brick walls, although all had been remodelled with later inserted doorways (Plate 4). Painted plaster, with a single red stripe below the wall head (Plate 5) appears to form relatively early decoration, but may be contemporary with the insertion of the doorways, overlying an earlier coat of Dolly Blue whitewash (Plate 5).

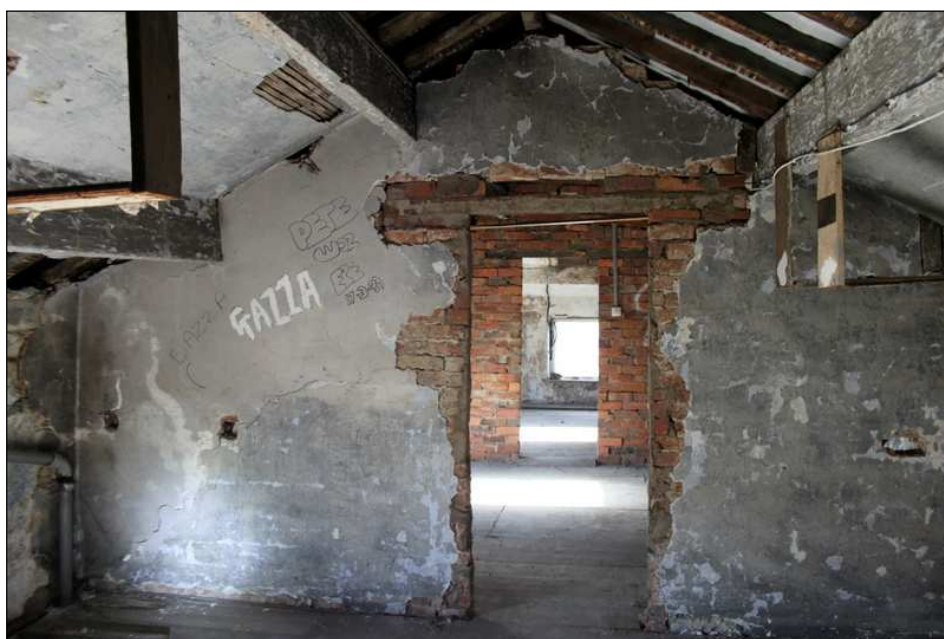
Plate 4: Original partitions at second-floor level

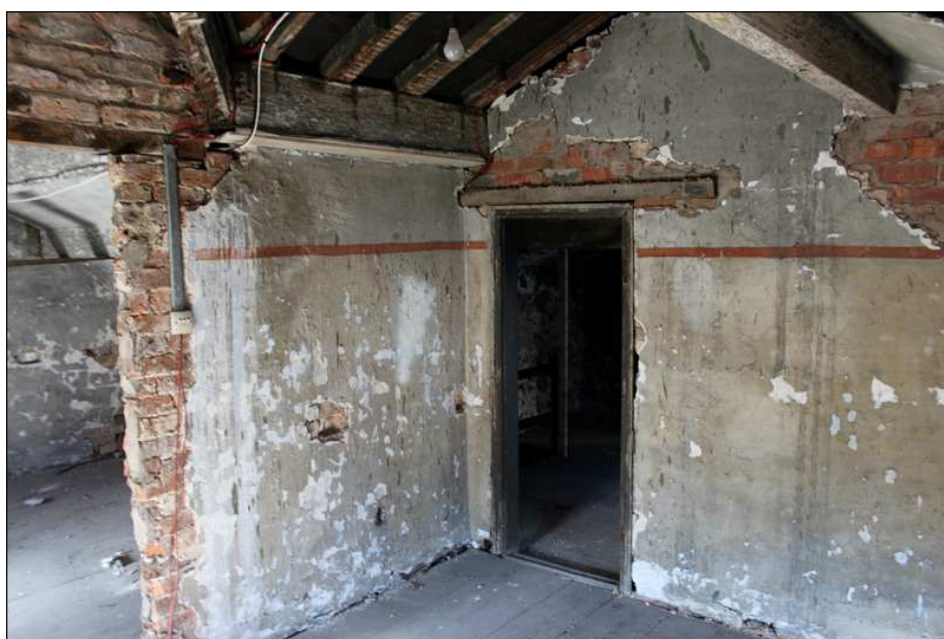
Plate 5: Painted plaster on original partitions

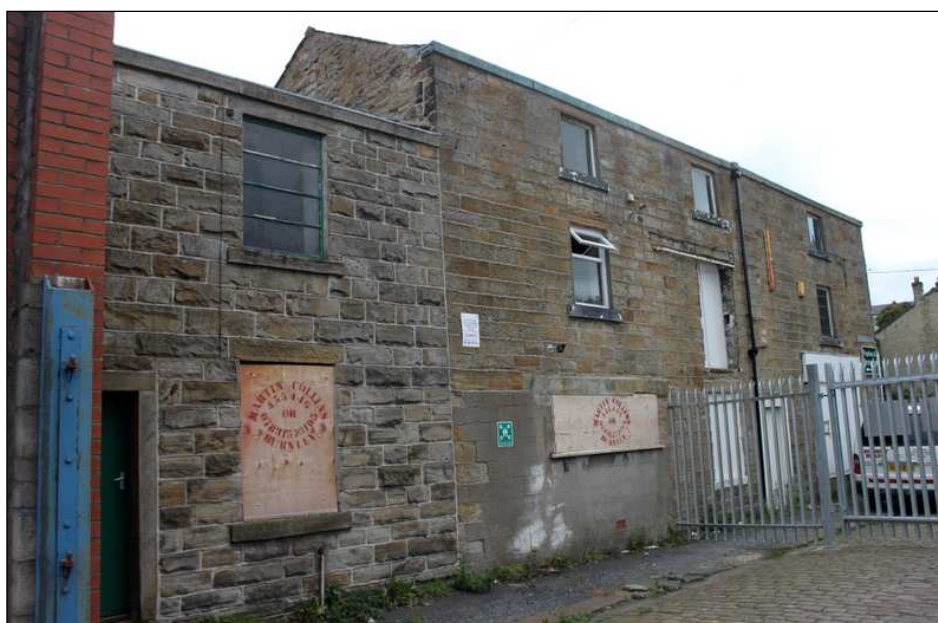
Plate 7: The Derby Street elevation of the building

- 4.2.4 The position of the windows, and those in the return bays on both Derby Street and Varley Street (Plates 6 and 7), reveal much of the original layout of the cottages. The windows on the main façade are arranged in two pairs, placed centrally within each half of the frontage. This demonstrates that the cottages were erected as two mirrored pairs of single-fronted, cottages, with the doorways being placed at either end of the façade, and as an adjacent pair in the centre. The wider gap between the windows of 33 and 35 Trafalgar Street reflects the slightly larger size of the western property (Fig 4), clearly shown on the 1851 plan (Plate 2).

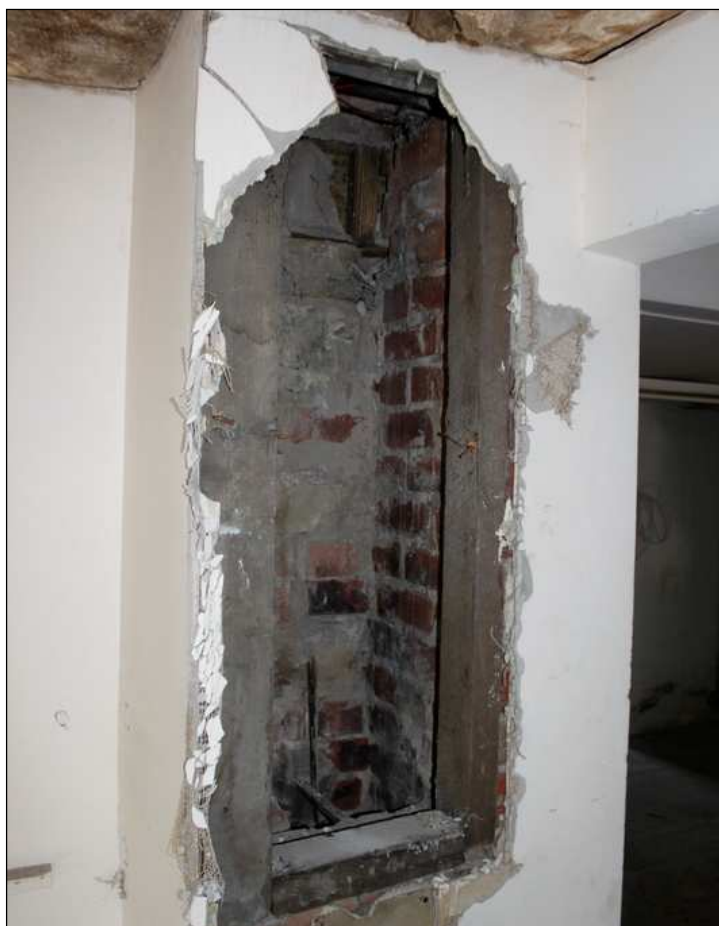
Plate 8: Flue within 33 Trafalgar Street at first-floor level

- 4.2.6 Mirroring the plan form generally allowed for fireplaces to be placed back-to-back on the party wall between each cottage, although a lack of flues in the extant internal walls within the roof space shows that this was not the case with the Trafalgar Street properties (Plate 4). Evidence for possible fireplace flues survived instead at the rear of these structures at first-floor level, in all but the larger western structure (Plates 8 and 9), suggesting that they were placed centrally in the inner cottages and in the inner corner of the outer cottages (Fig 5). Within the southern of the two properties fronting Derby Street, the rear of ground floor flue of 33 Trafalgar Street was observed, with a similar flue adjacent on its western side (Plate 10), presumably serving a fireplace placed against the south wall of the Derby Street cottage.

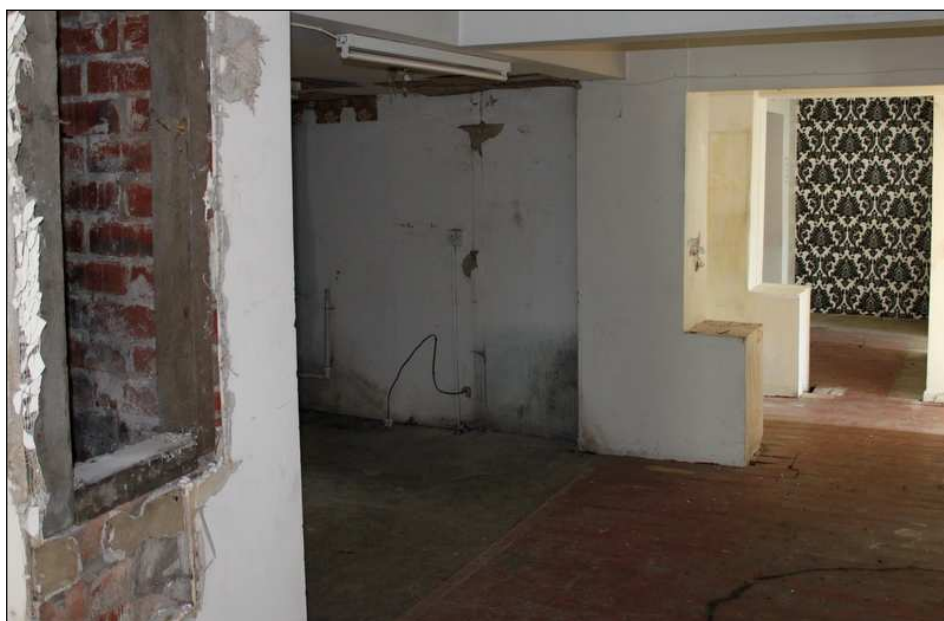
Plate 9: Capped flues within 29 and 31 Trafalgar Street

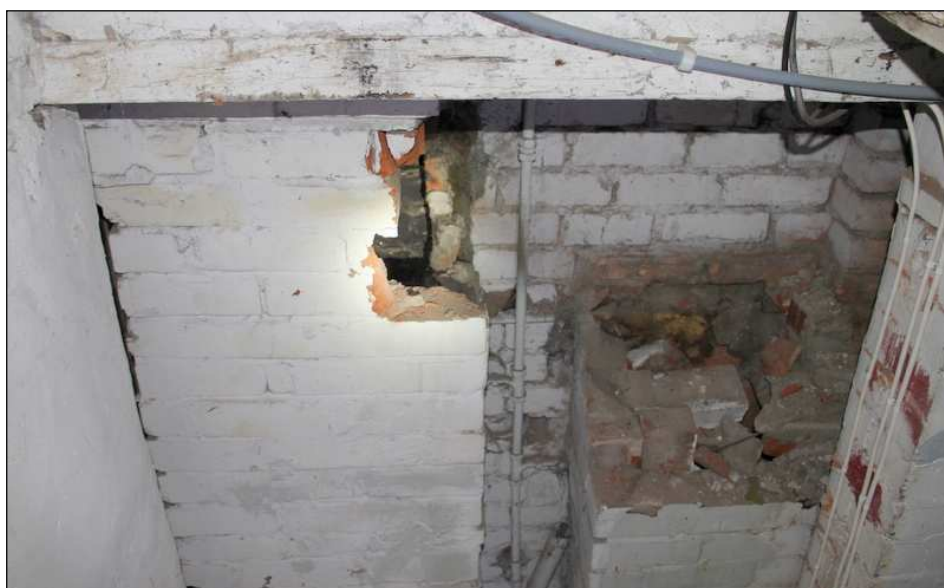
Plate 10: Flues in the south party wall on Derby Street

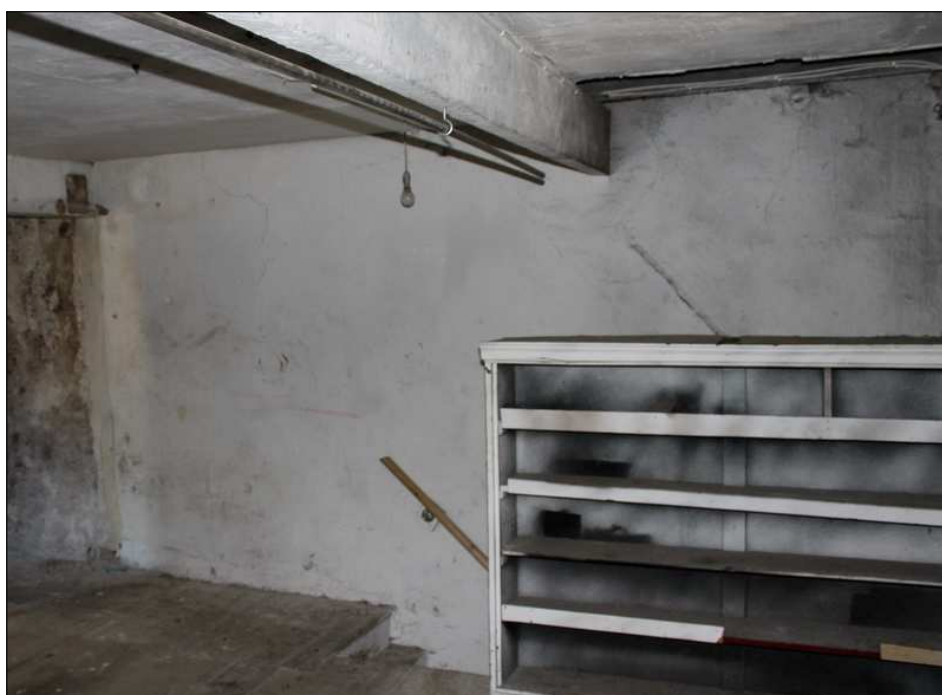
Plate 12: Scar for further stair to second floor in southern property on Derby Street

- 4.2.9 Given the probable placement of fireplaces or ‘set pots’ in mirrored pairs on the back wall, as seen in the flues at first-floor level, it is highly likely that the stairs comprised steep, quarter-turn staircases placed against the rear wall, and accessed at the opposite end to the fireplace. An extant stone stair survives in this position in the southern of the two properties fronting Derby Street (Plate 11). A scar at first-floor level above denotes the position of a stair against the back wall to the second floor (Plate 12), with an extant timber stair in this position in the corresponding cottage fronting Varley Street (Fig; Plate 13).

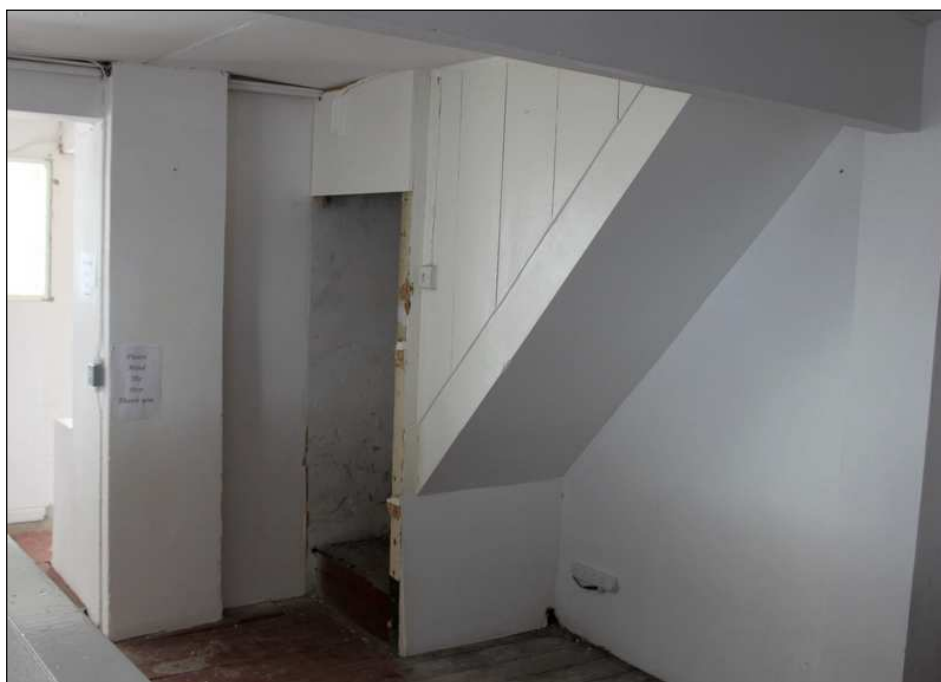
Plate 13: Timber stair to second floor in southern property on Varley Street

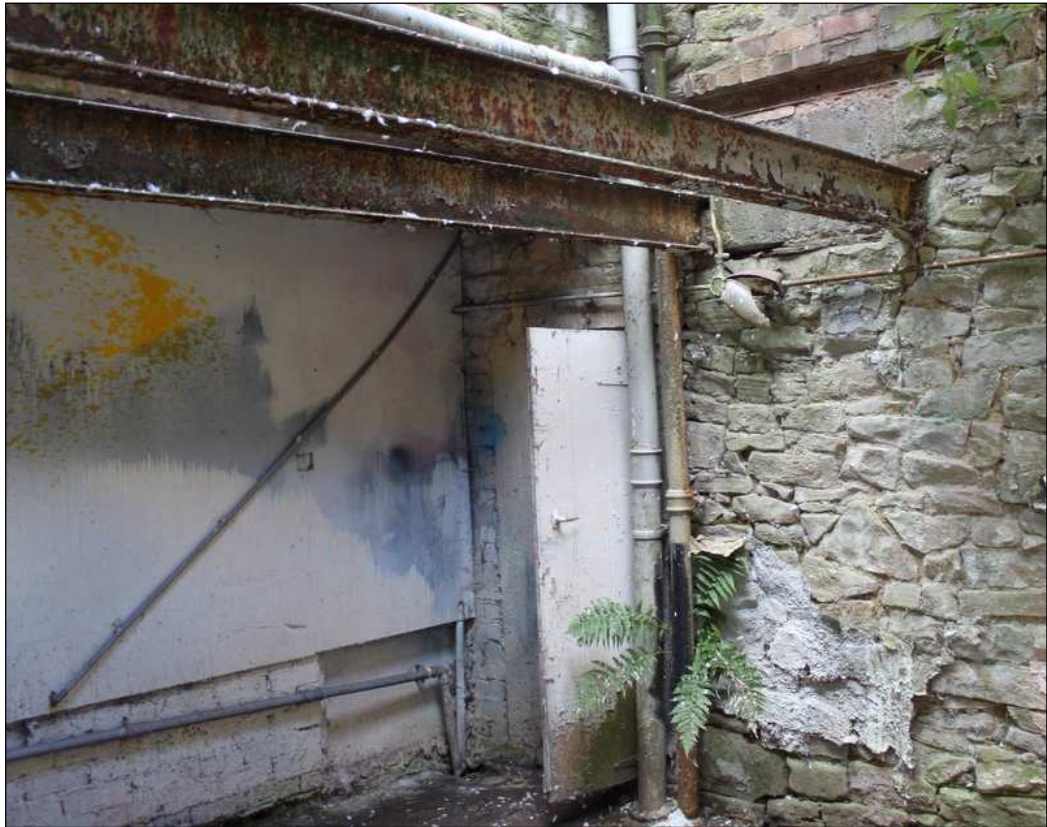
Plate 14: Extant and blocked doorway into courtyard

- 4.2.11 At the northern end of the Varley Street row the doorway of the cottage was placed slightly to the south, with a further door in a position matching those in the other cottages forming a corridor into a narrow courtyard (Fig 4; Plate 15). Quoin stones above this doorway suggest that the elevation mark the original return of the block of dwellings.

- 4.2.14 The courtyard also had narrow doorways into the rear of the two northern properties (Plate 14), the eastern one being blocked subsequently. The Ordnance Survey plan of 1851 appears to show an outshut extension on the rear of the northern of the cottages on Derby Street. There is no evidence for this, either within the cottage (which is heavily rendered), or on the exposed rubble wall face within the courtyard. It is probable that the structure represents a lean-to privy in the courtyard, serving all the original cottages, with an enclosed area to the north probably representing an ash pit. Access to this privy for the two southern cottages on Derby Street and Varley Street presumably involved using the external passage.

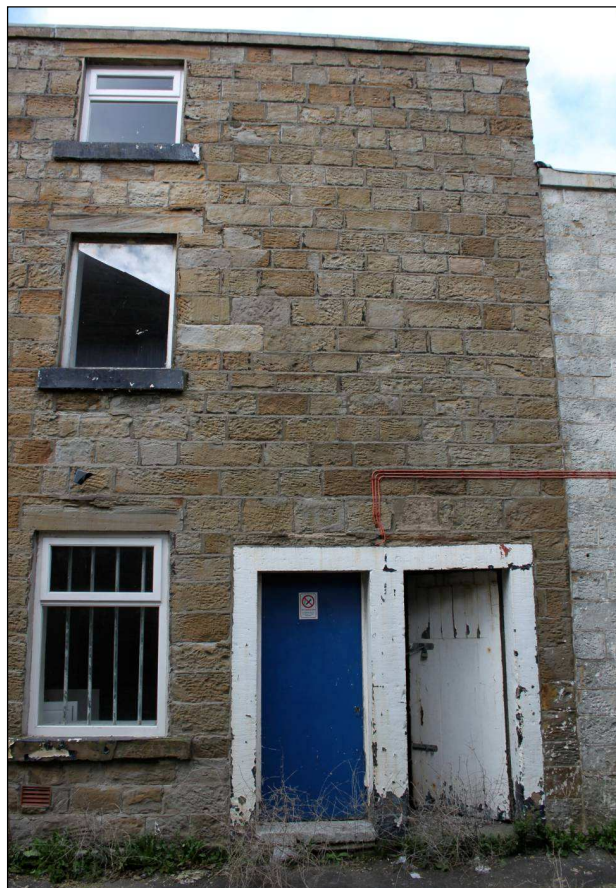
Plate 15: Doorway (to the right) affording access to the enclosed courtyard to the rear

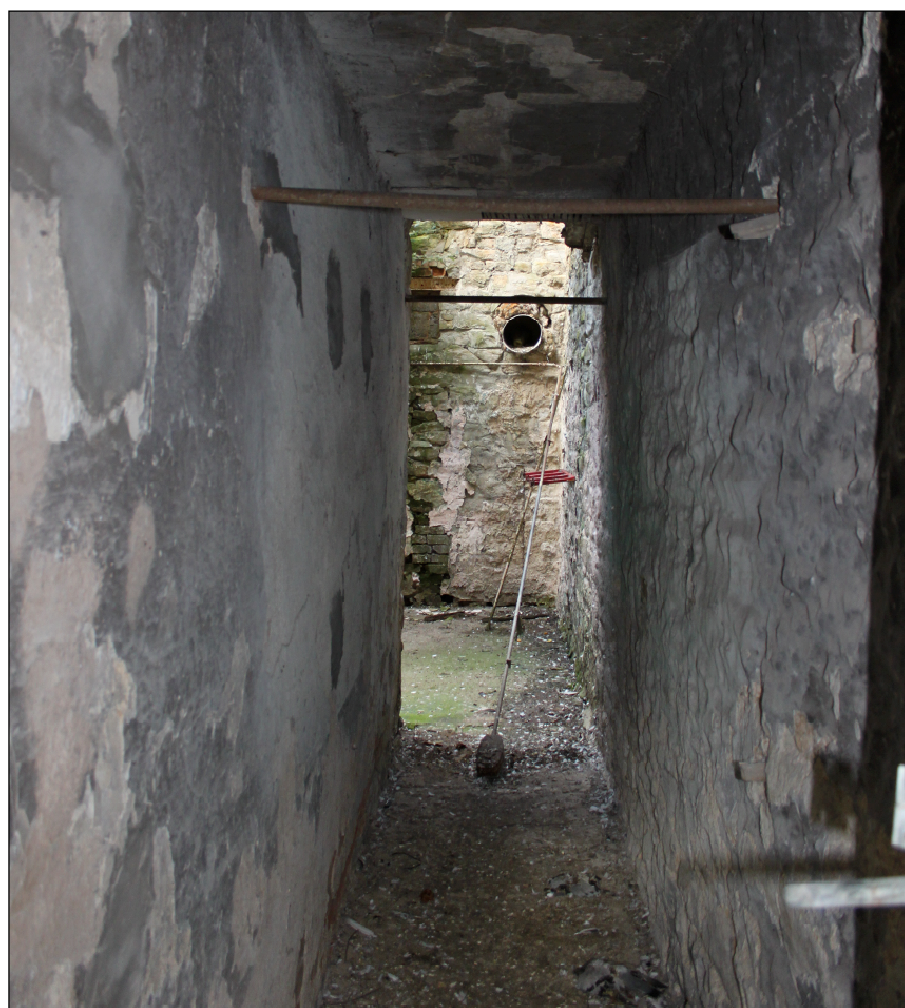
Plate 16: Access passage from Varley Street to the enclosed courtyard

4.2.12 The courtyard is shown on the Ordnance Survey plan of 1848 as being bounded on its northern side by a wall, hence the need for an access passage from Varley Street (Plate 16). This is a somewhat unusual arrangement, as access could more simply have been formed into the courtyard by the provision of a door in the northern boundary wall. However, it appears that such straightforward access was prevented by either land ownership issues, or that the construction of the two cottages on the northern side of the courtyard, which were completed within a relatively short space of time, was already planned.

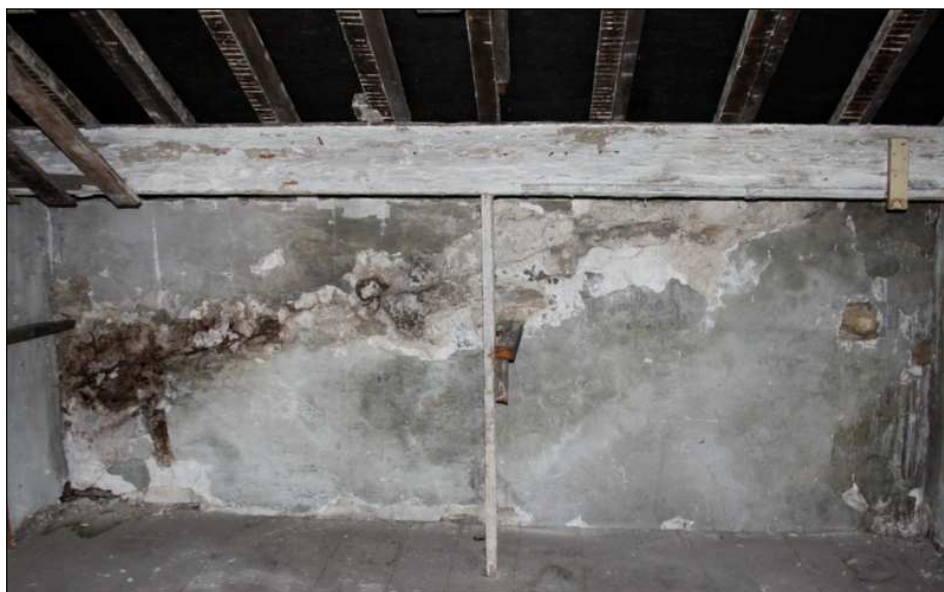
Plate 17: Roof scar for cottage on south side of courtyard

4.2.13 The courtyard appears to have given access on its southern side into a narrow blind-backed cottage (Plate 2) into which there was latterly no external access at ground-floor level, because the door at its western end was blocked (Plate 14). This very small dwelling was remodelled subsequently to form ground-floor outshut extensions to the two central cottages fronting Trafalgar Street, with the rear elevation being entirely rebuilt in brick, bonded in black sooty mortar, and depicted on the Ordnance Survey edition of 1892 (Fig 3). At first-floor level it was knocked through into the cottages fronting Trafalgar Street, being converted into indoor privies. A scar for its shallow roof was visible at second-floor level either side (Plate 17).

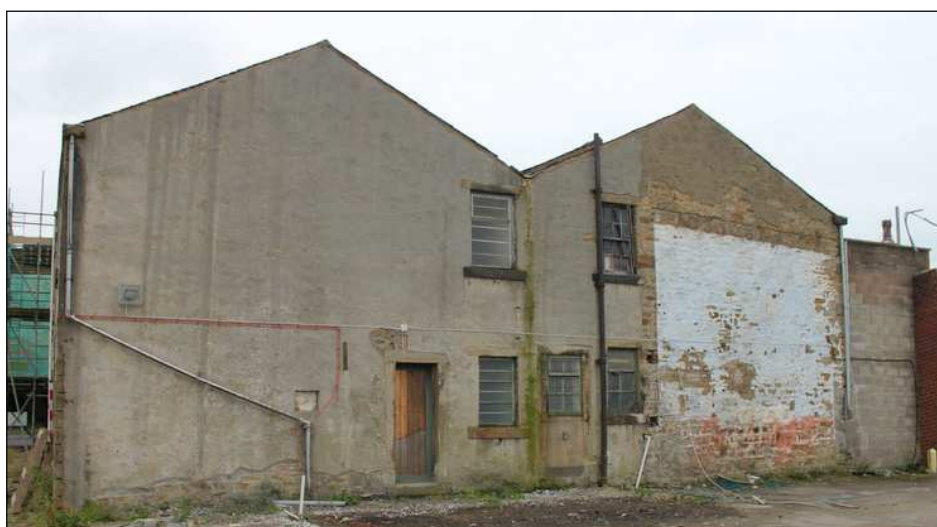
Plate 18: Northern gable of the later extensions

- 4.3.2 The eastern of these two cottages is of similar dressed stone to the row of buildings to the south, and butts the earlier structures, utilising the earlier wall to form its southern internal wall. Although it appears to have had a walled yard at the northern end of Varley Street, which appears to have formed part of the boundary wall of the Caledonia Boiler and Gasometer Works, the Varley Street façade matches that of the earlier structures, but with the windows to the two taller stories placed slightly higher, and with a string band below the eaves. This suggests that it formed the principal access into the structure, which also has a doorway in its northern gable wall (Plate 18). This may represent an insertion affording access into a courtyard created by the erection of further dwellings along Varley Street, and a large weaving shed, erected prior to 1892 as part of Caledonia Mill.

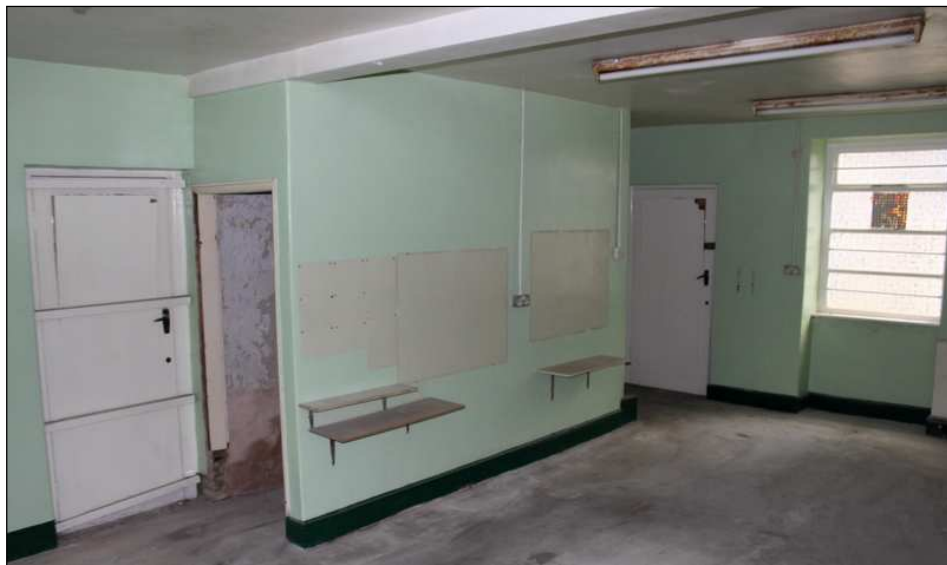
Plate 19: Stairwell and window within recessed bay fronting Varley Street

- 4.3.3 Internally, the window in the front elevation at ground-floor level was recessed within a bay (Plate 19), and a similar blind bay in the rear wall suggests that this cottage was built prior to that to the rear, and that a window originally placed in this position was blocked. An extant adjacent doorway up a slope into the western cottage may represent an original entrance if the cottages were of different date, but would have been blocked subsequently, being re-opened when the buildings were combined into a single property in the late twentieth century. The straight stone stairs were placed adjacent to the north wall, with only a short hallway from the door in the Varley Street façade (Plate 19), representing a slight variant of the typical single-fronted cottage plan, which had the stairs placed further from the front door, adjacent to the back room (Brunskill 1997, 115).

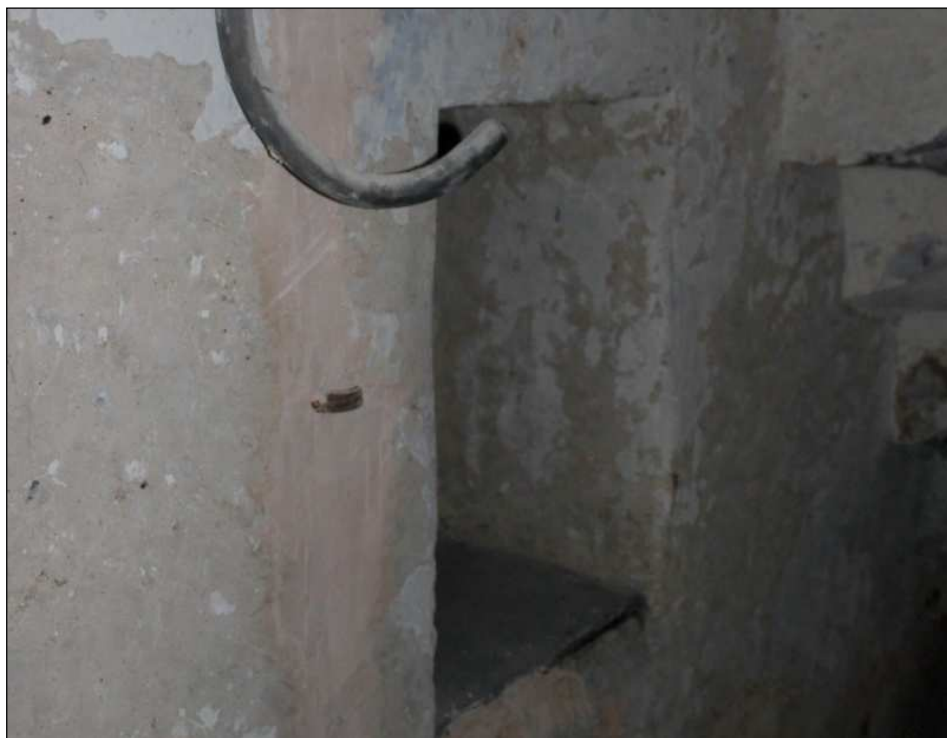
Plate 20: Keeping hole below stairs in Varley Street extension

- 4.3.4 A keeping hole was incorporated into the wall below stairs (Plate 20), and no evidence was observed to suggest the presence of a cellar. The placement of the doorway adjacent to the stairs in a gable wall is uncommon (Fig 4; Plate 19), further suggesting its insertion. No evidence for internal partitions survive at ground-floor level, but an encased ceiling beam across the ground-floor level with the western edge of the stair wall (Plate 19) probably represents the position of a partition between the front, eastern room, and the smaller scullery, which appears to have been devoid of a fireplace, to the rear.

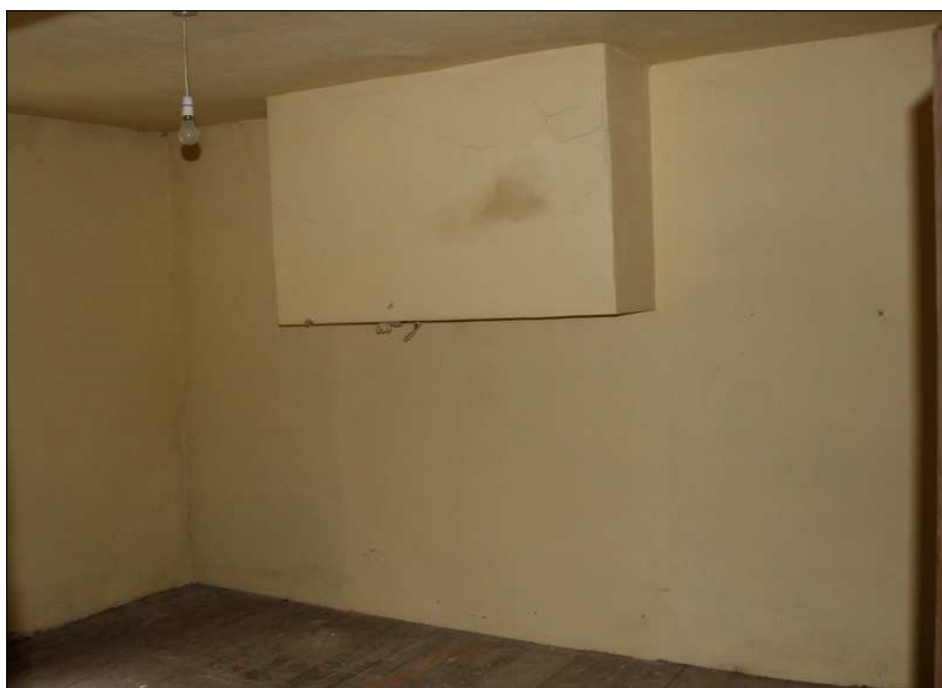
Plate 21: Remains of chimney breast at first-floor level

- 4.3.5 Original lath and plaster partitions survive on the upper floor, with a small landing affording access to a larger front room with a window overlooking Varley Street, and a smaller rear room with a smaller vertical window in the gable wall. A chimney breast survived only above floor level in the front room (Plate 21), constructed against the external wall of the earlier cottages to the south, and also visible as a brick stack within the roof space (Plate 22), was keyed with stone into the cottages to south. The quoined return of the rear wall of the earlier cottages was also visible within the west side of the roof (Plate 22). The attic was accessed through a 3' x 2'6" hatch above the stairs from the ground floor, with a doorway placed 34" above the floor of 8.5" wide boards (Plate 23). The ceiling is of lath and plaster, to band or pit-sawn joists, with three vertically-set purlins to each pitch of the replaced roof (Plate 22).

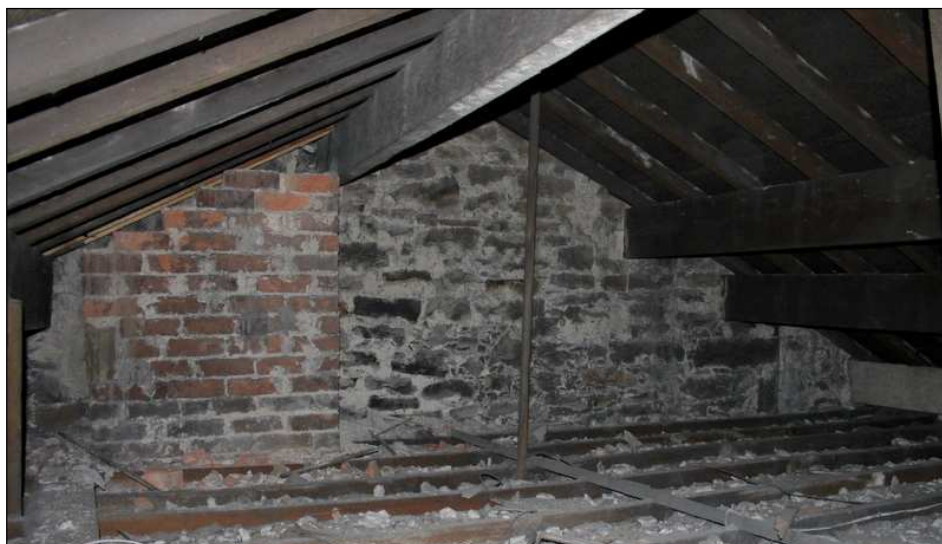
Plate 22: Roof space of extension to Varley Street properties

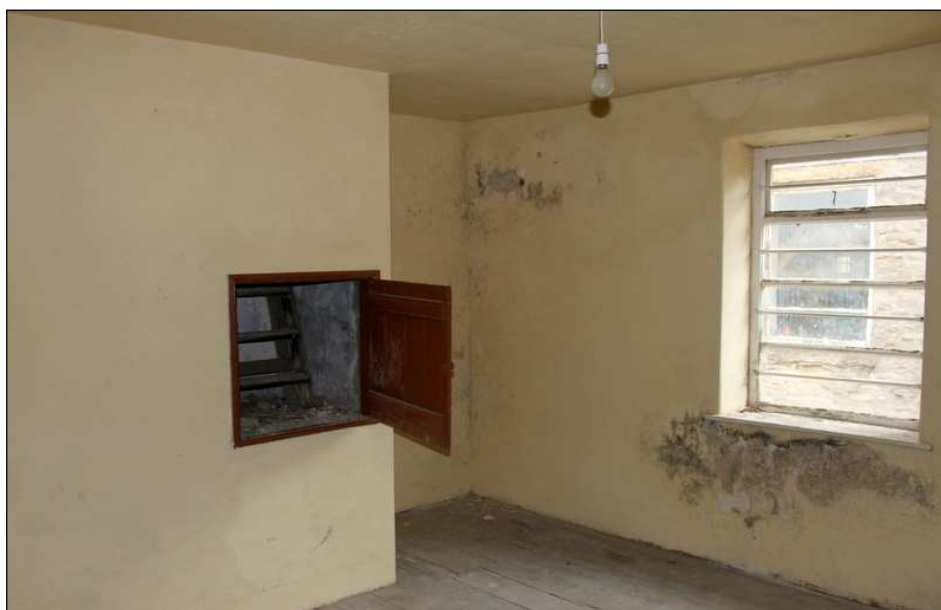
Plate 23: Access hatch to roof space of Varley Street extension

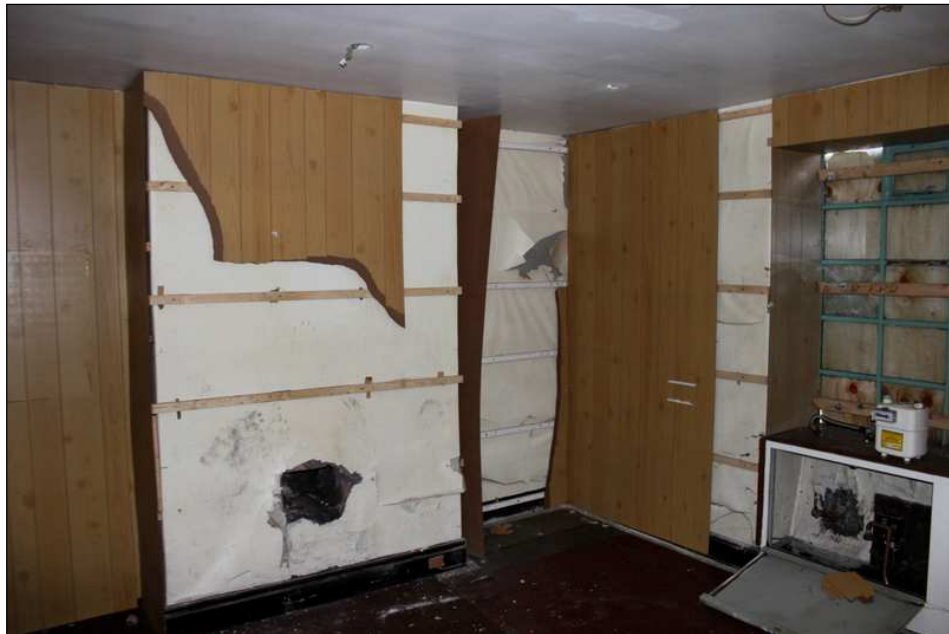
Plate 24: Front room of Derby Street extension

- 4.3.7 The front room, which appears to have originally comprised a living room / kitchen was accessed from the northern end of the Derby Street facade, with a centrally-placed vertical window providing the only source of light (Plate 24). A large central fireplace survived behind a late partition on the southern wall (Fig 4; Plate 24), whilst the east wall of the front room was of single-skin brick construction and had doorways at either end (Fig 4; Plate 25). That at the southern end of the wall afforded access into the stairwell, with a perpendicular sandstone stair affording access to the first floor (Fig 4; Plate 26). This differs from the cottage to the east, further suggesting a different date of construction, or different builder, and represents an alternative plan form for small urban cottages, typical nationally, but uncommon in the north of England, being replaced here by the rear stairs at a relatively early date (Muthesius 1982, 87, 123).

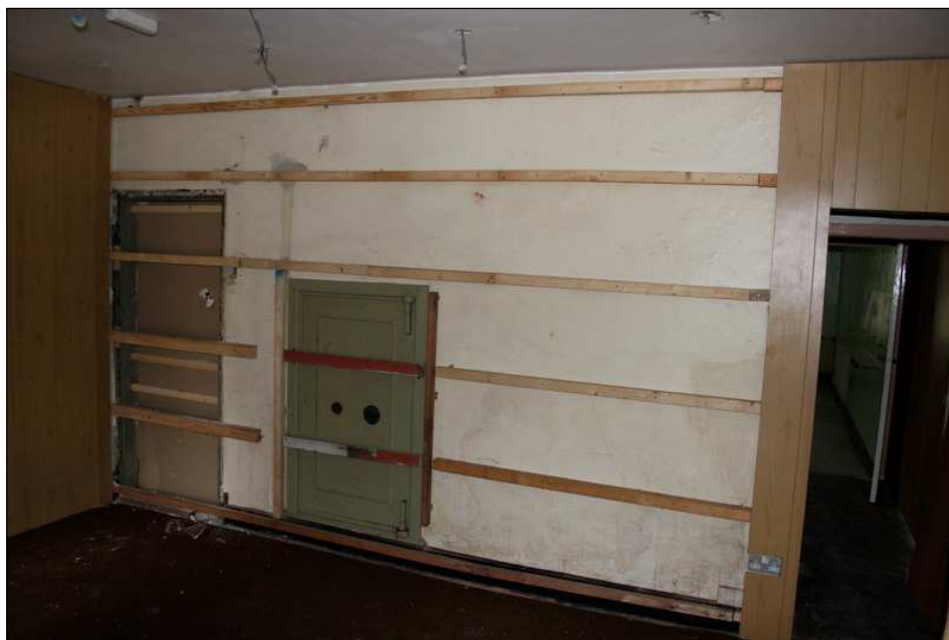
Plate 25: Rear wall of front room of Derby Street extension

- 4.3.8 The doorway at the northern end of the western stair wall gave access to a further short sandstone stair into a small, approximately 6 x 5' chamber, of probably 5' height, although the majority was obscured by rubble infill. The southern and western walls of this probably cold store / pantry retained 11" wide, 2" thick sandstone shelves, set 22" below ceiling height (Plates 27 and 28). The eastern stair wall above was carried on 4" thick flagstones, supported by a one brick square (9") pier with sandstone capping (Plate 28). Access to the cellar was blocked, possibly in the early/mid-twentieth century, with a timber floor inserted to carry the rear of a safe, which was placed in the front room (Plate 25).

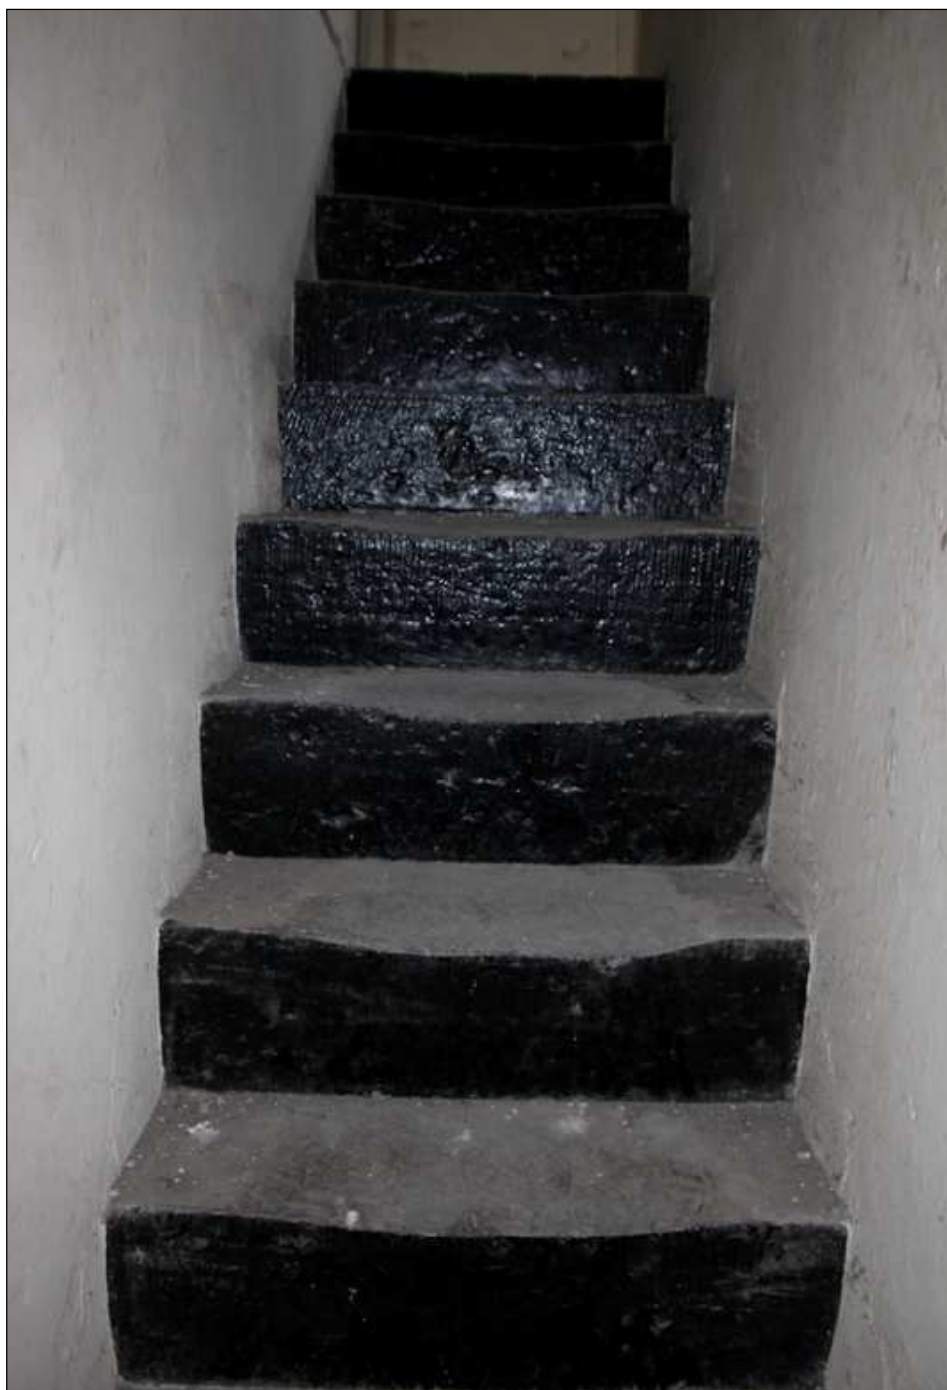
Plate 26: Straight stone stair in Derby Street extension

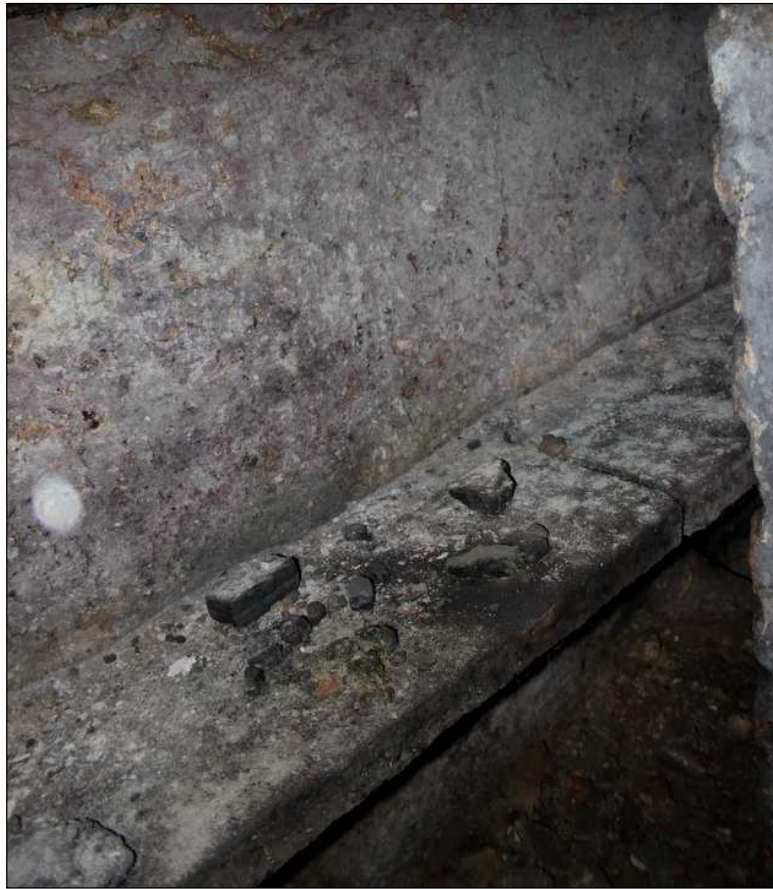
Plate 27: Shelves within pantry cellar

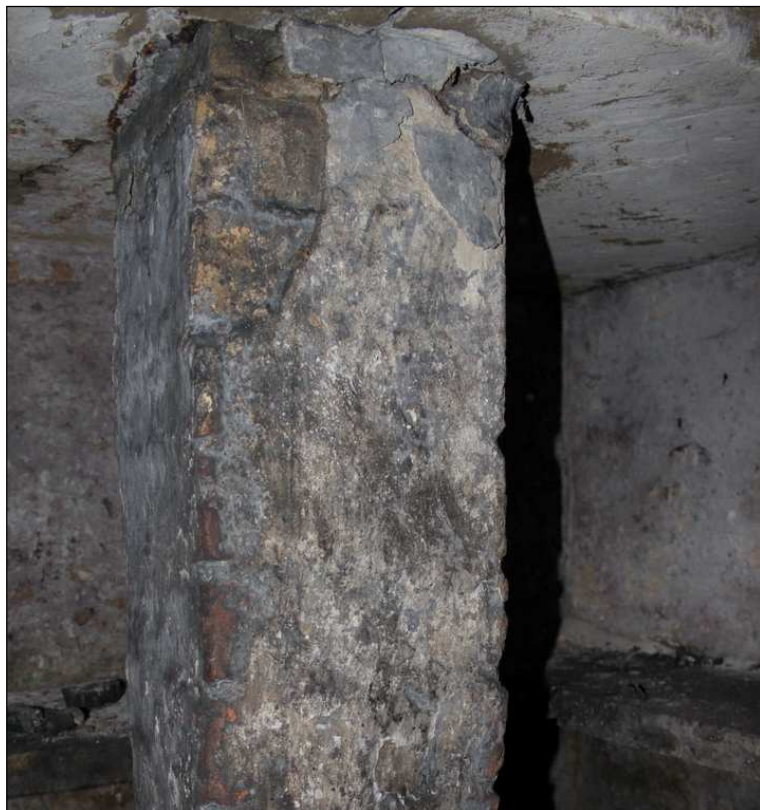
Plate 28: Brick pier with sandstone cappings supporting floor above cellar

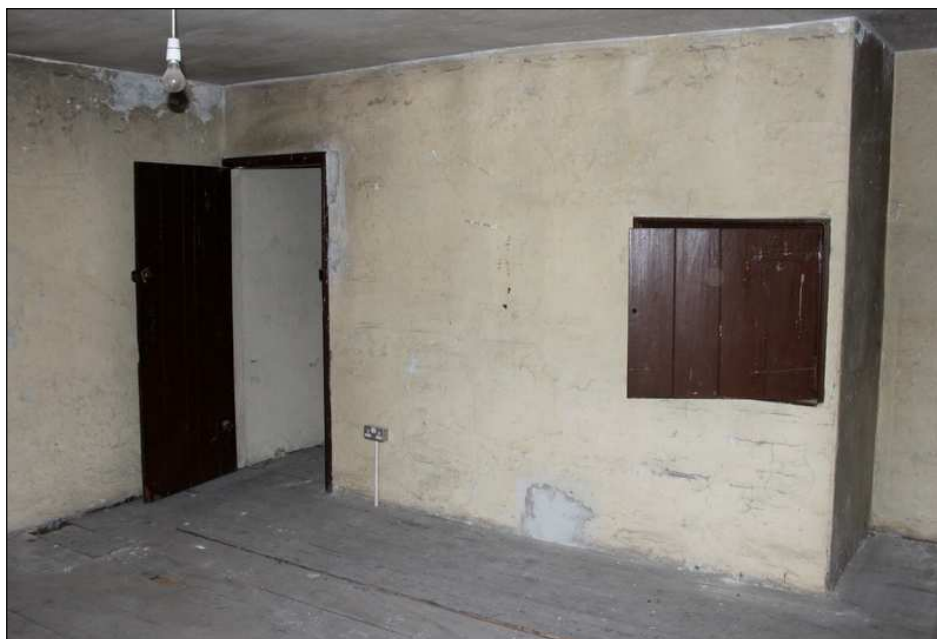
Plate 30: Front room of Derby Street extension, with attic hatch above stairs

4.3.10 The first-floor arrangement retained its original layout (Fig 5), with a small landing leading to a larger front room (Plate 30), with a blocked fireplace in its southern wall (Plate 31) and several, possibly original 8” (0.21m) wide timber planks within the floor. A hatch to the loft was placed above the stairwell (Plate 30), similar to that in the dwelling to the east, but contained a Phillips and Son safe, which was far more ornate than that on the ground floor below, having its handle cast in the shape of a hand (Plate 32).

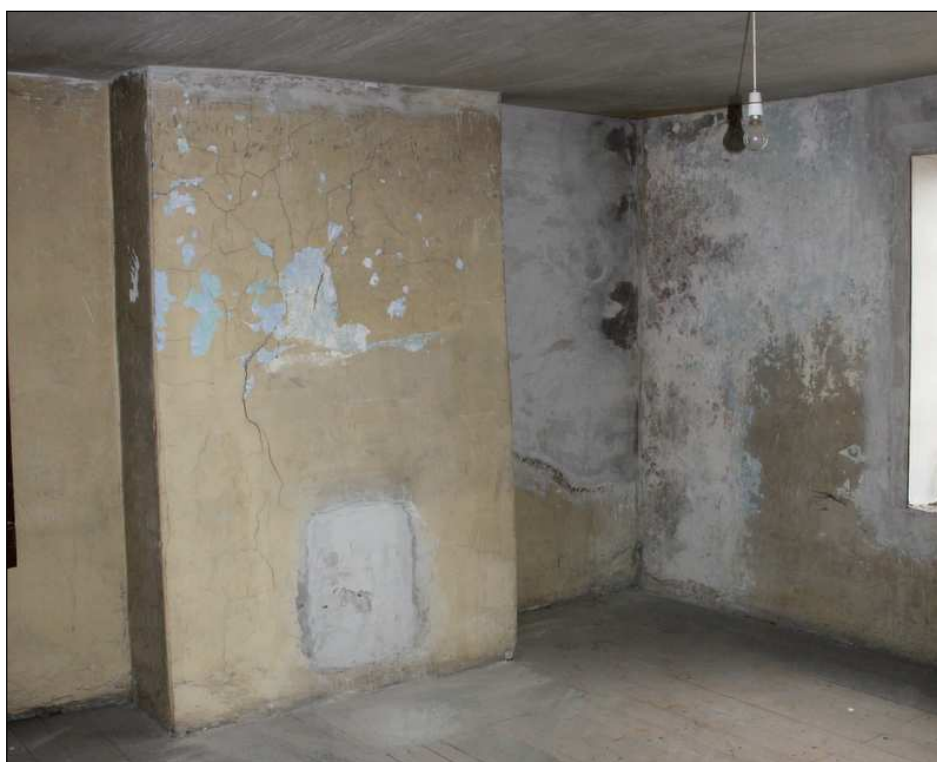
Plate 31: Blocked fireplace in south wall of Derby Street extension

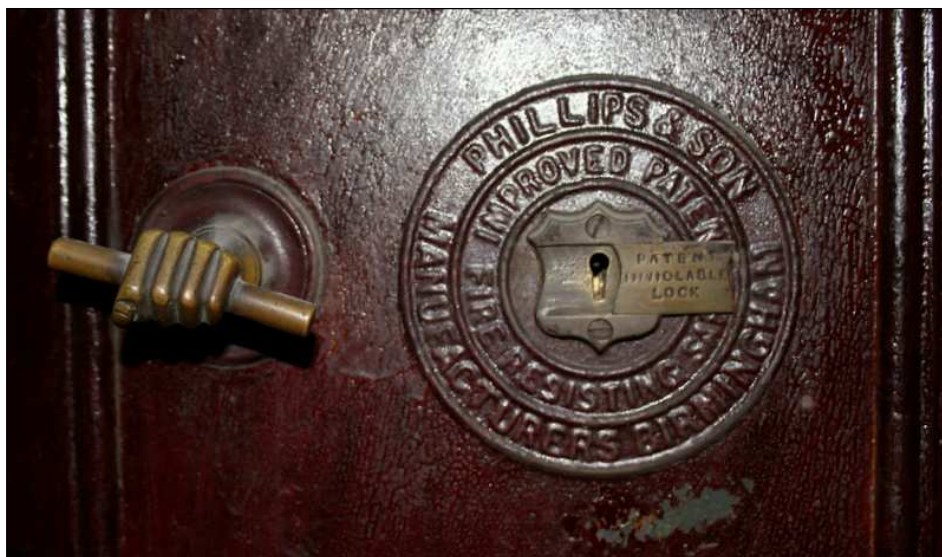
Plate 32: Decorative safe handle within attic hatch

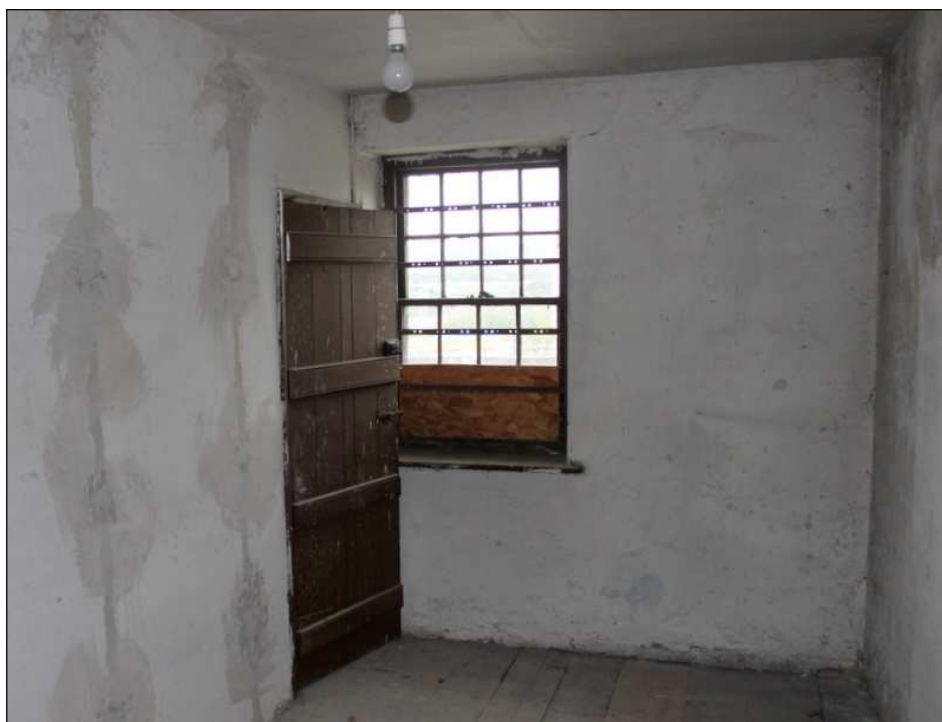
Plate 33: original sash window in small rear room

4.3.11 The smaller rear room at first floor level retained what appeared to be an original vertical 16-light timber sash window (Plate 33), and appears to have formed a small bedroom chamber.
