**29-35 TRAFALGAR
STREET
BURNLEY
LANCASHIRE**

**Archaeological Building
Investigation**

November 2014

Barnfield Construction

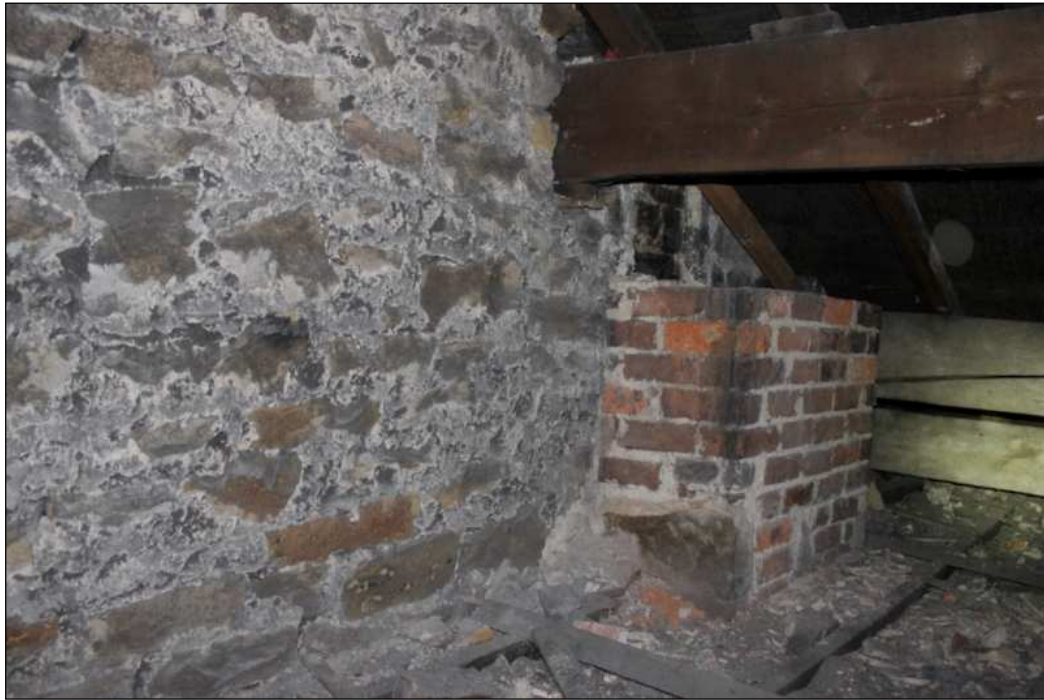
Plate 34: Chimney stack for fireplace in front room

4.3.12 The attic was accessible above the safe and had the reduced height brick and stone chimney stack for the fireplace below *in-situ* (Plate 34). The quoined return of the earlier cottages to the south was also visible, as in the structure to the east (Plate 35). A timber pegged stone roofing flag was also observed within the rubble within the roof space (Plate 36).

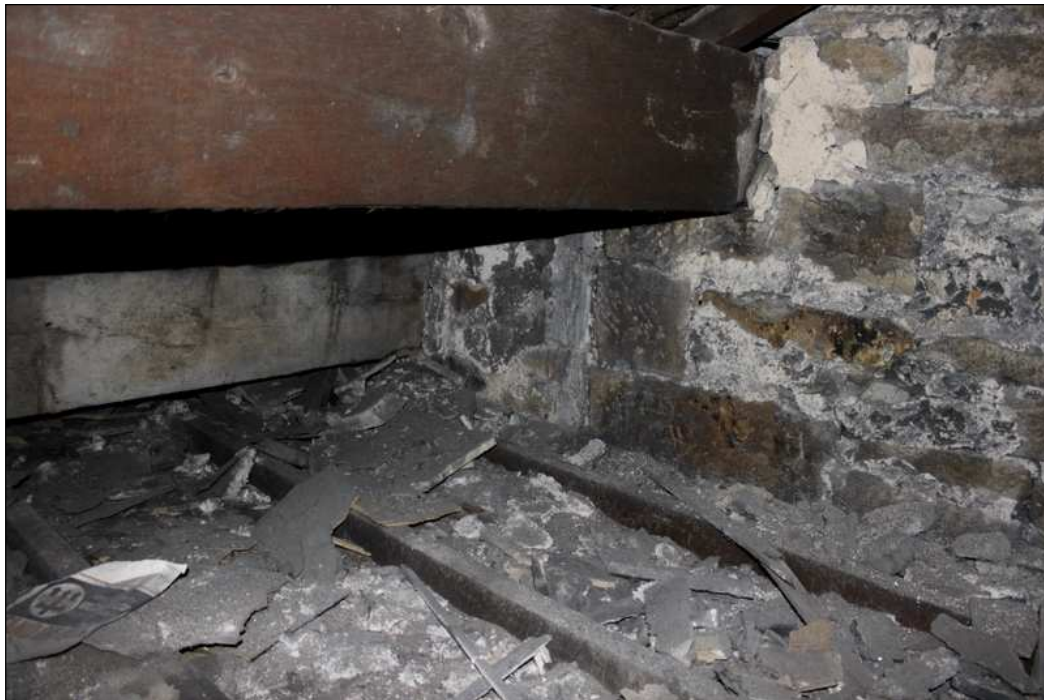
Plate 35: Quoined return of earlier Derby Street cottages

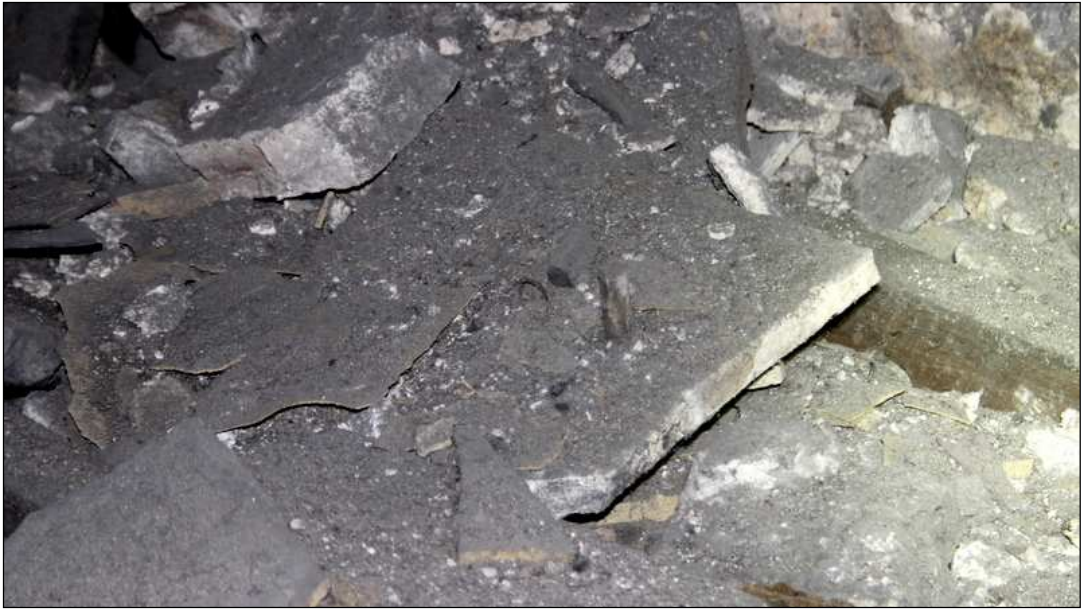
Plate 36: Timber-pegged roofing flagstone in Derby Street extension
