Royal Pew Chapel Royal Hampton Court Palace

Historic Building Recording and Investigation

Oxford Archaeology

April 2009

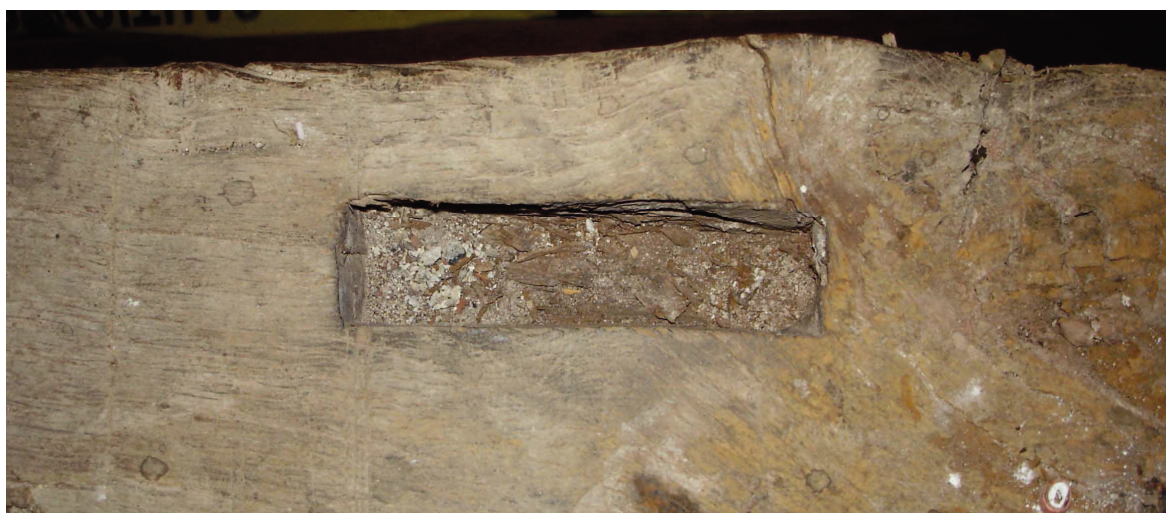
Photograph of mortice in upper gallery beam for missing upright post VI in Lady Chapel (D Miles)

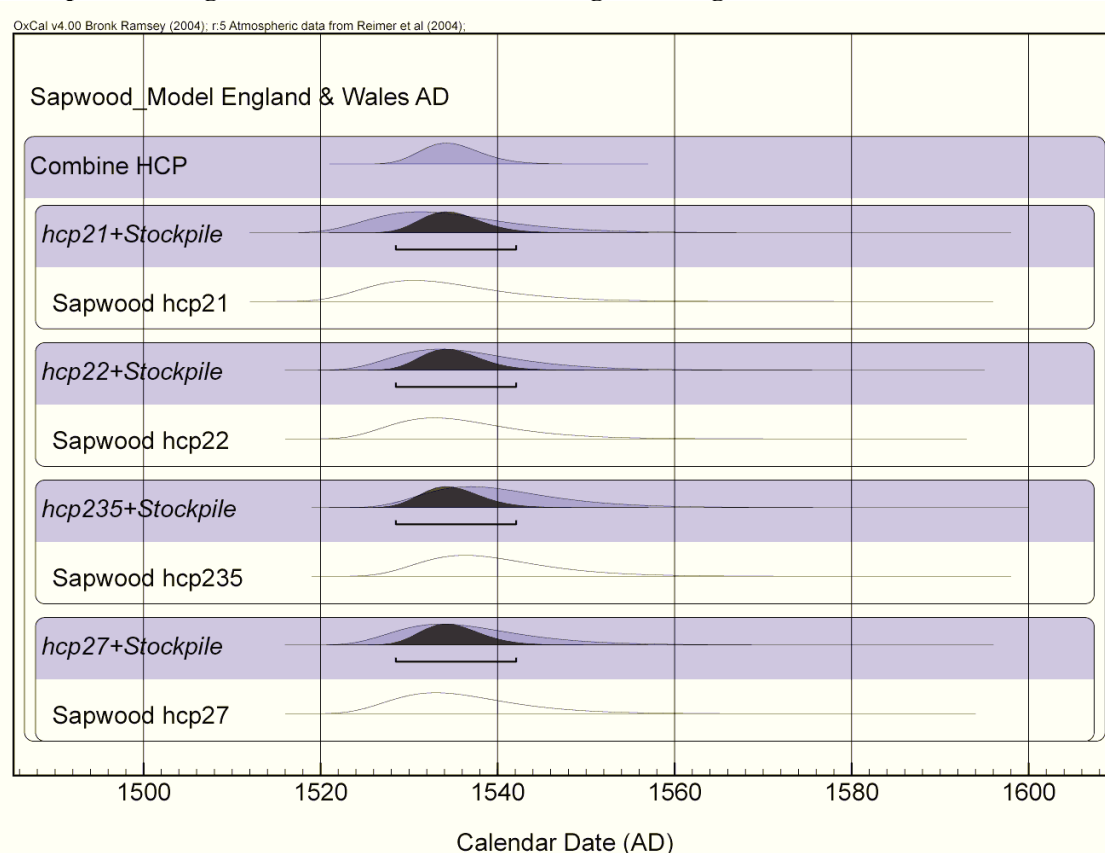
OxCal plot showing individual and combined felling date ranges

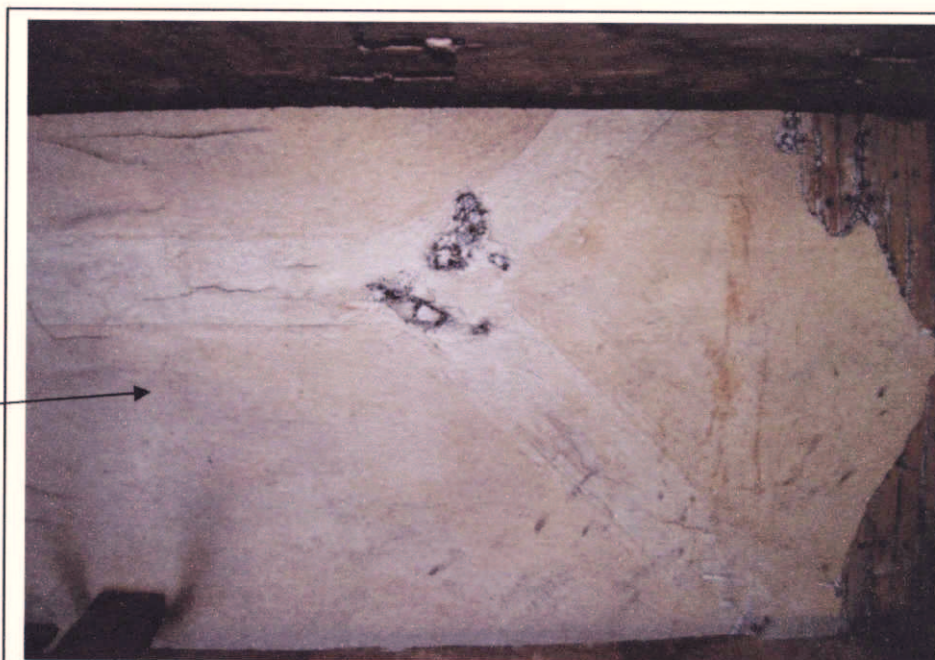
Removed ceiling mouldings

Either side of the shapes left by the mouldings is a single thin layer of white soft distemper. This distemper is the original decoration, as it is clear that the ceiling was never decorated again.

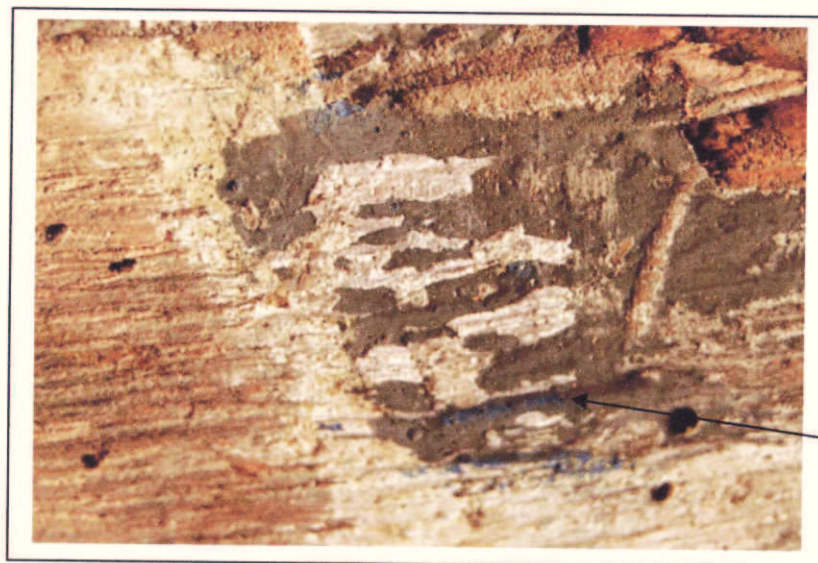
Sample 19 was taken from a blue area, but it did not make a satisfactory cross-section as the blue particles crumbled off, and only the black survived. However, we can see in this detail that the black was intended as a ground for the blue.

The azurite has only survived where it is in a hollow of the wood grain.

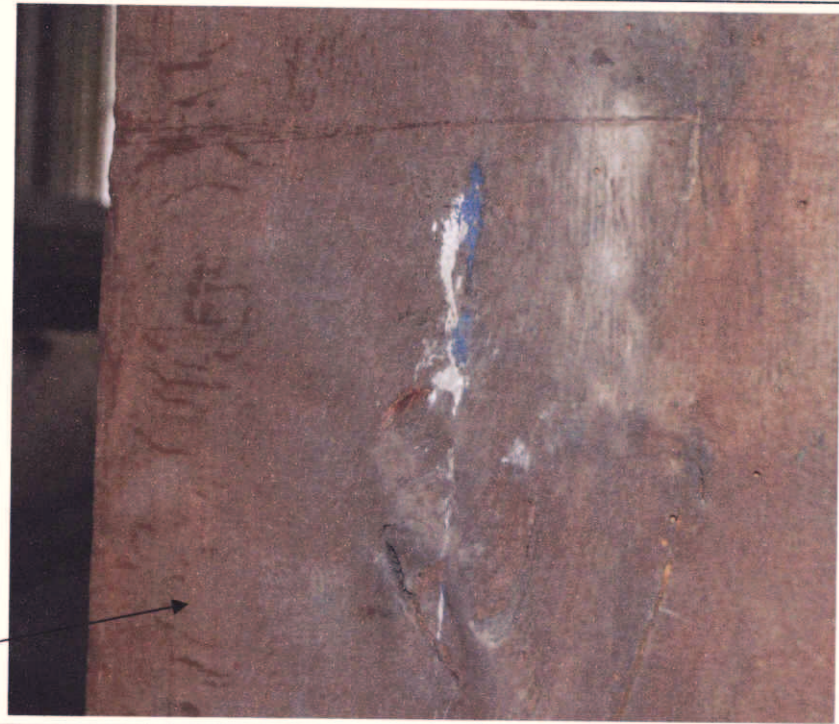
South face of post

There are no nails, or other fixings, but something vertical, and painted blue, must have butted up against this post

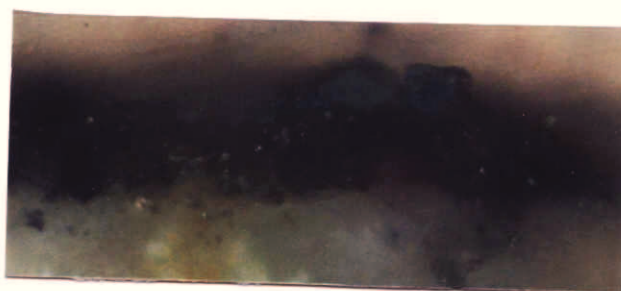
Blue over moderately thick black undercoat.

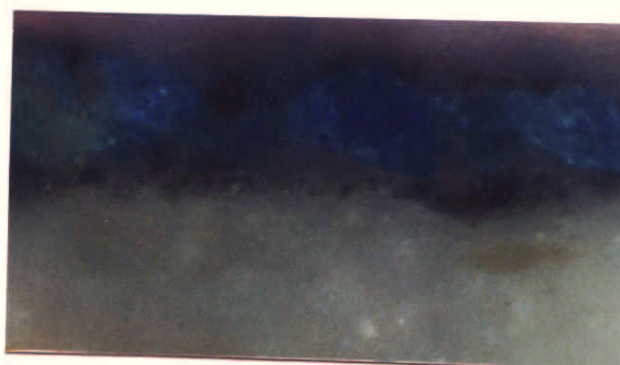
← 2 blue particles
} black.

Azurite over a mere skim of the black undercoat. The blue has survived better. [x200]

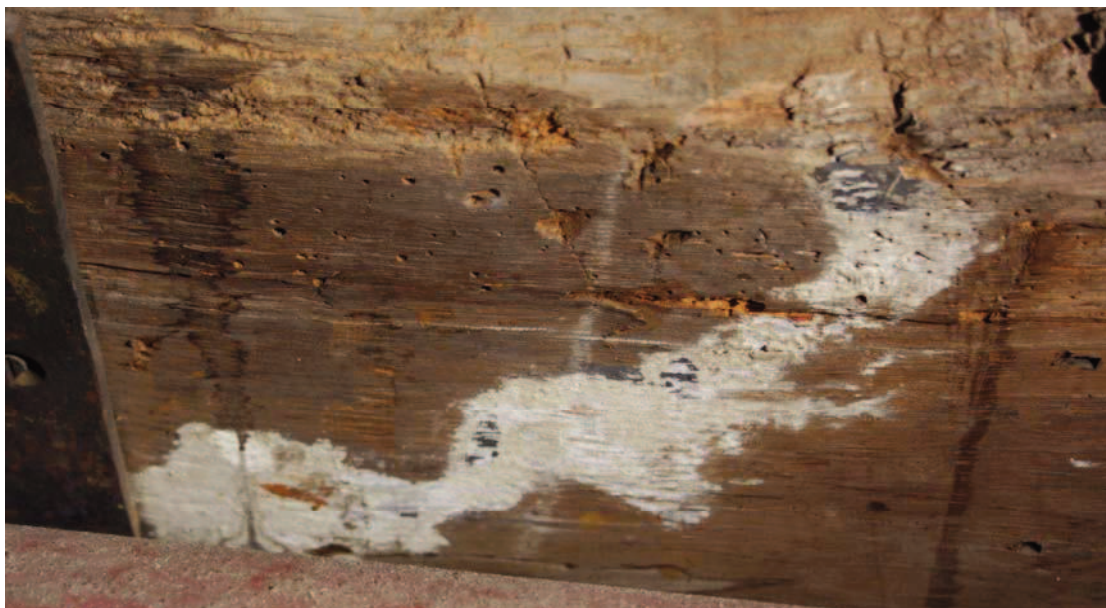
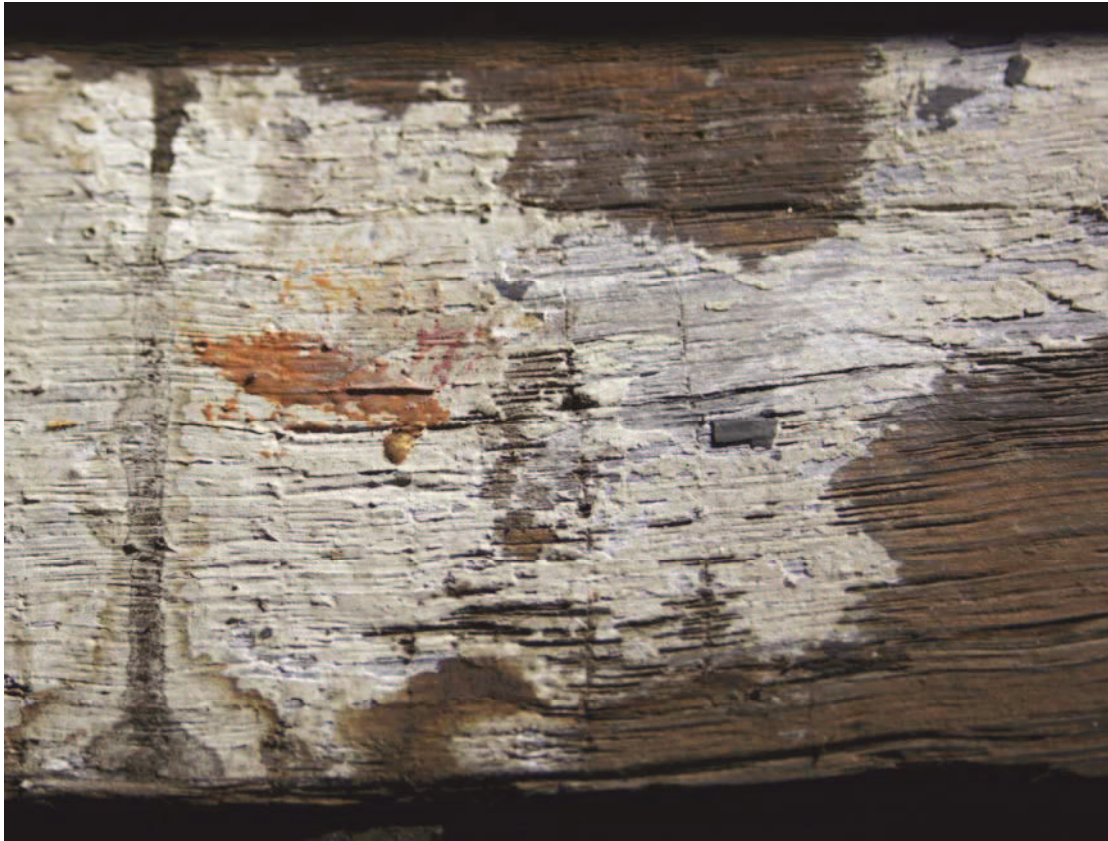
Plate 3: detail of white preparatory layer surviving on the east face of the balcony beam. The remains indicate the outline of a former oriel window - see Plate 1

Plates 4 & 5: details of the white preparation surviving on the east face of the balcony beam. The random dribs and daubs of other colours (black, red, dark yellow ochre and gold) are visible. Note widespread losses in the white layer and losses to the black drips.

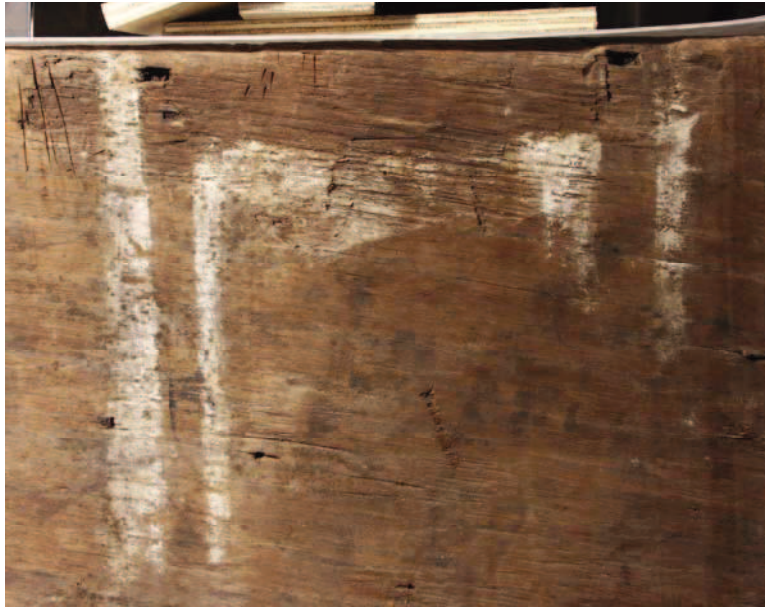
Plate 6: detail of the vertical tracks within the white preparation on the east face of the balcony beam at the base of former post 2. Similar traces are visible on the north side of the beam, at the base of former post 6.

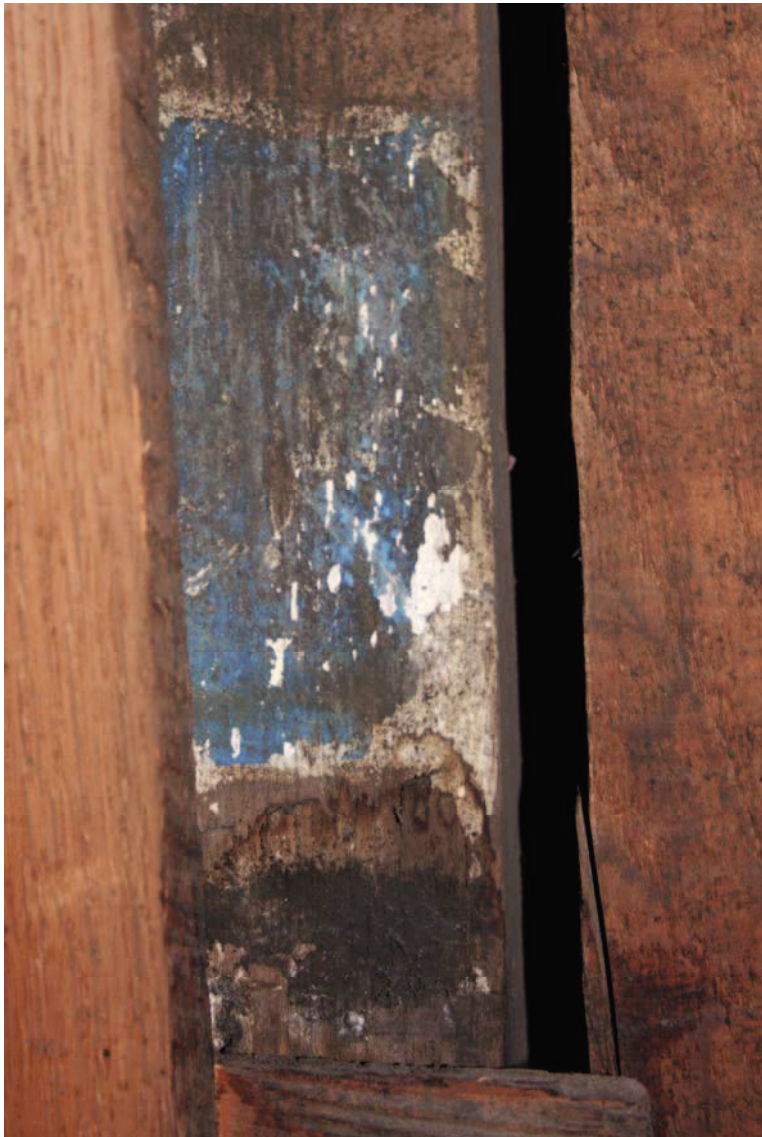
Plate 7: detail of an area of bright blue decoration on the east face of post 5 – see Plate 1. The upper edge appears intentional, suggesting a previous fixture. Note small, fresh-looking paint losses.

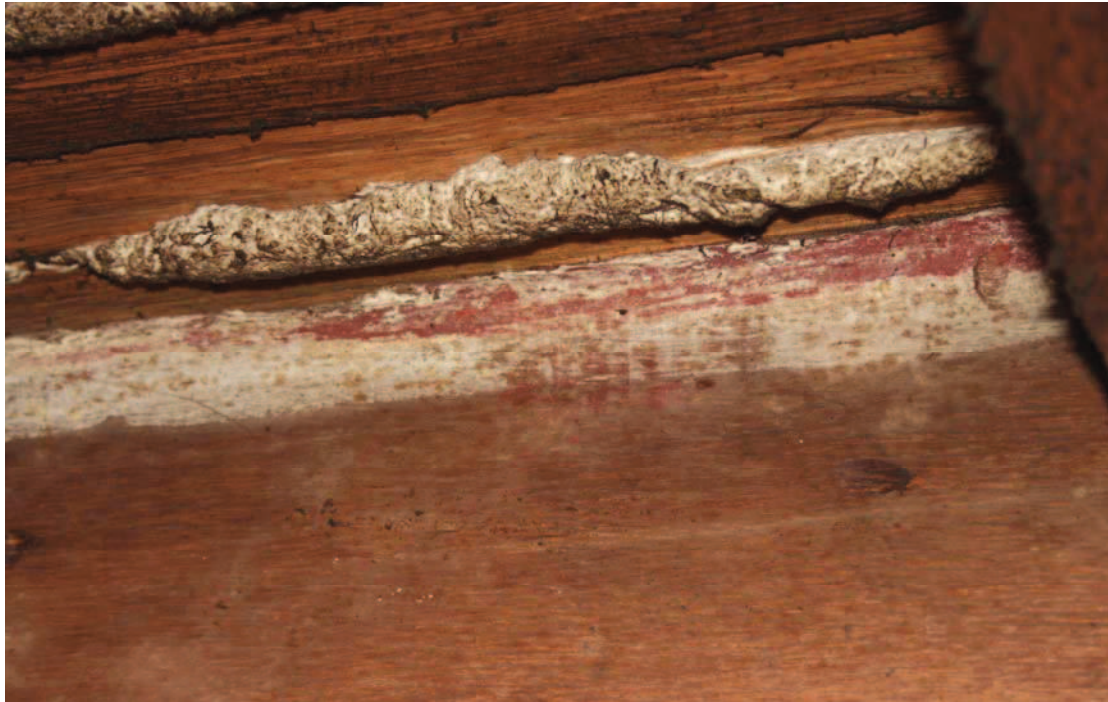
Plate 8: detail of red decoration on the north bracing beam (above the Thornhill ceiling) showing an intentional edge – the limit of the decoration. See Plate 2

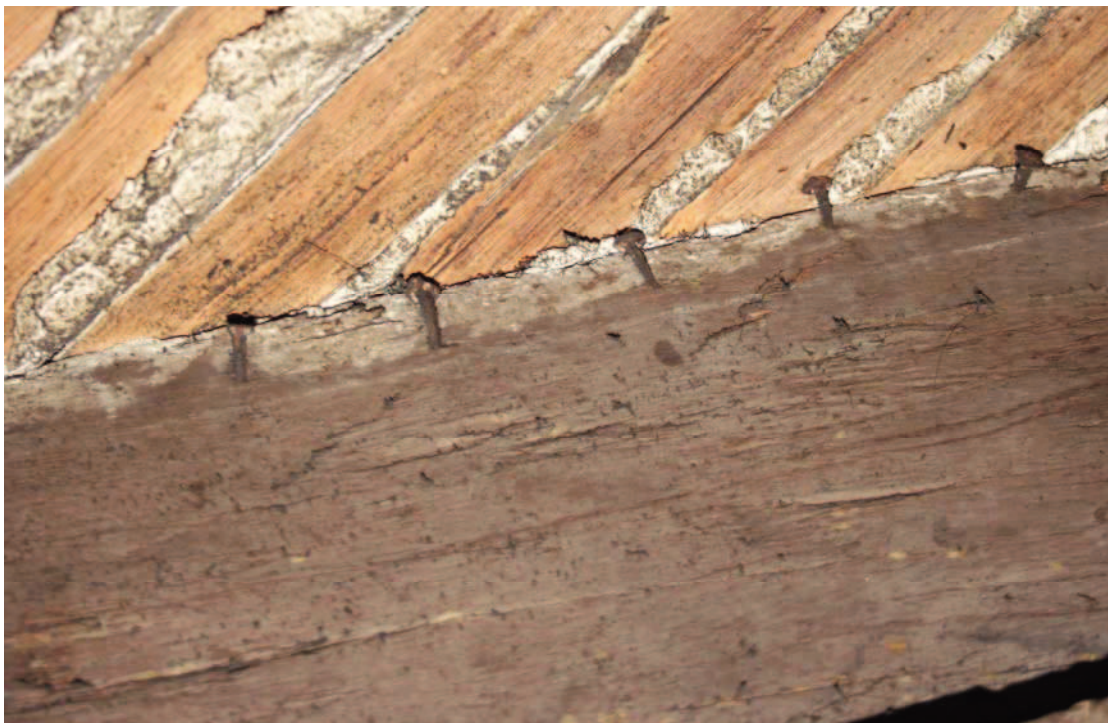
Plate 9: detail of the surviving nails with the outline where a cloth was formerly attached, south bracing beam (above the Thornhill ceiling). See Plate 2

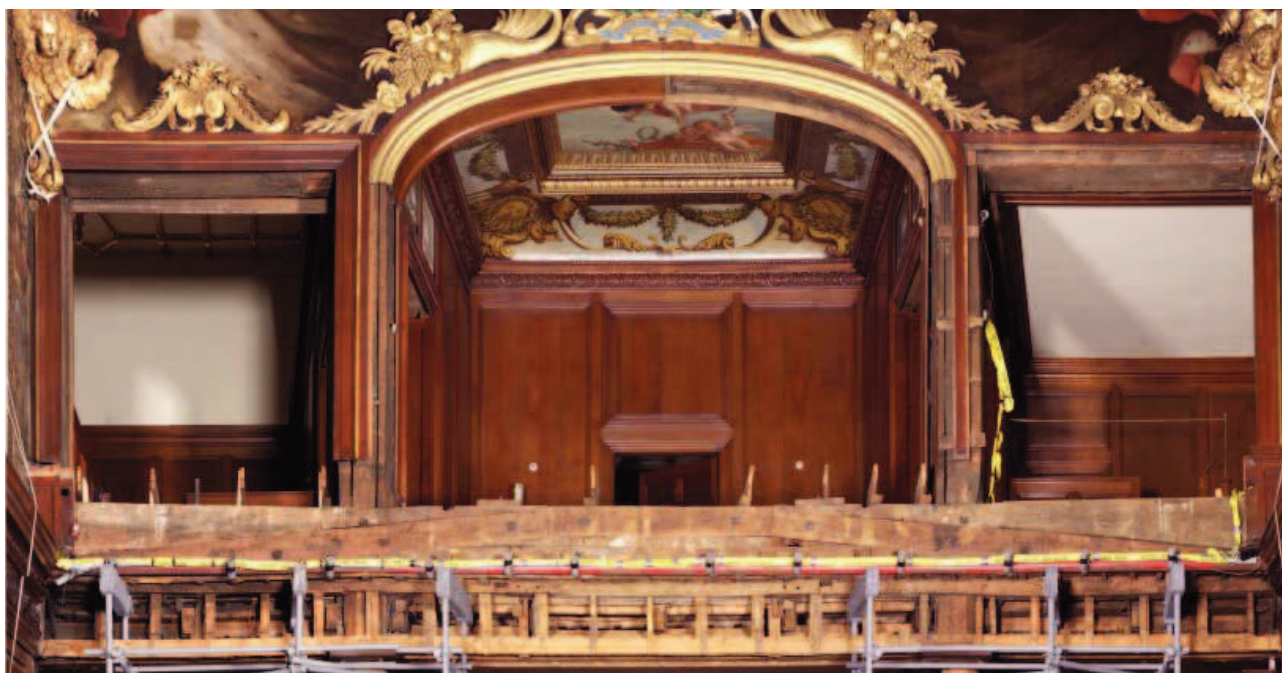
Plate 1: Royal Pew, Chapel Royal, Hampton Court Palace: View of the east elevation of the Royal Pew prior to commencement of works in November 2005.

- 2.2.1 The Chapel Royal at Hampton Court Palace has a T-shaped plan and is constructed of brick with stone dressings. At the west end of the chapel there is a timber-framed pew inserted at first-floor level occupying the whole of the ante chapel (Plate 1). Originally divided in two, the pew is now tripartite, with six room divisions:

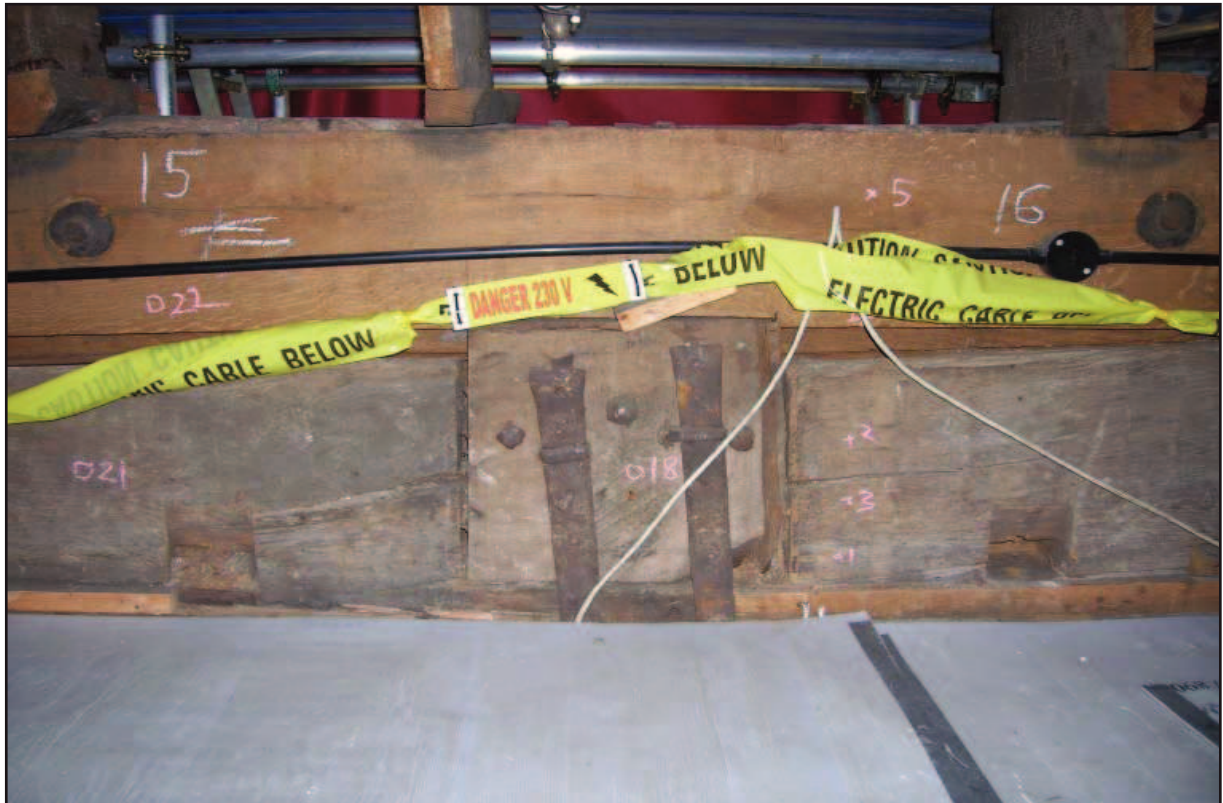
Plate 7: Royal Pew, Chapel Royal, Hampton Court Palace: Royal Pew, west elevation, detail of central section.

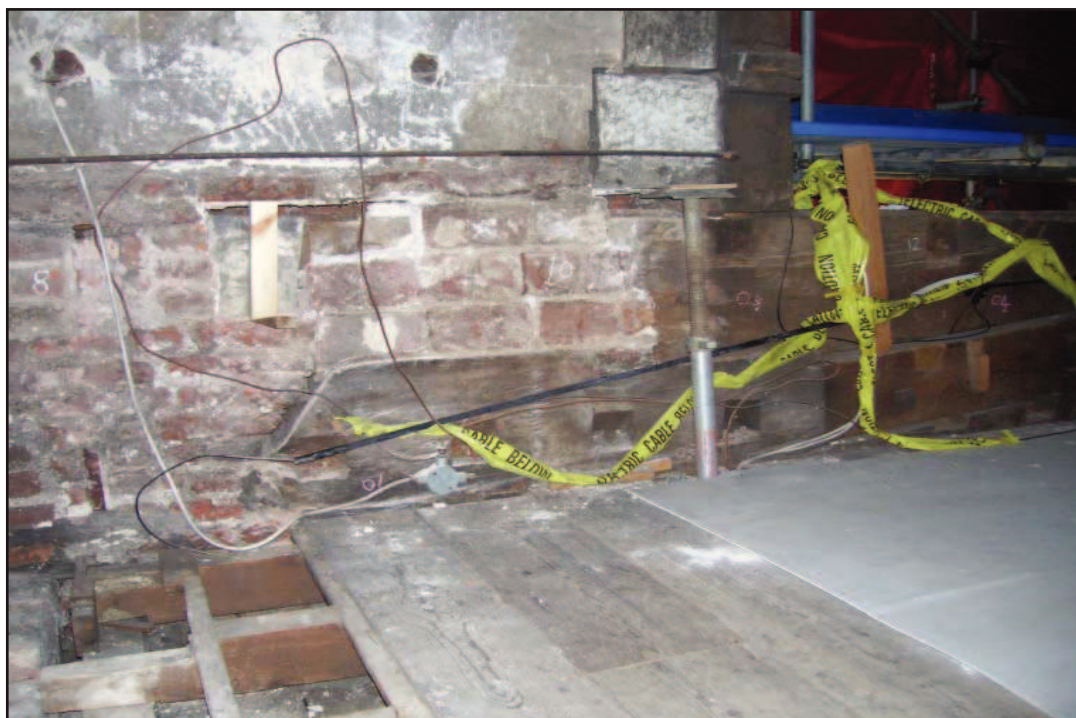
Plate 8: Royal Pew, Chapel Royal, Hampton Court Palace: Royal Pew, west elevation, primary beams extending north into ante chapel wall prior to removal of brickwork.

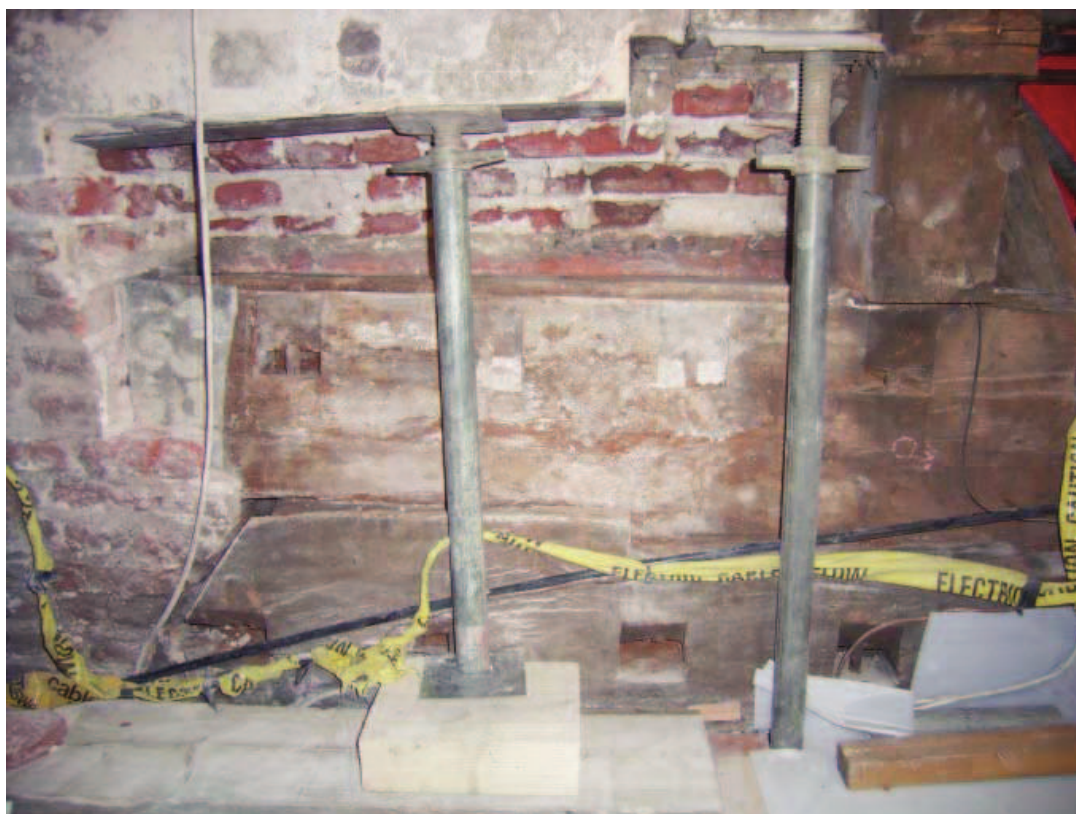
Plate 9: Royal Pew, Chapel Royal, Hampton Court Palace: Royal Pew, west elevation, primary beams extending north into ante chapel wall following removal of lower quoin and brickwork.

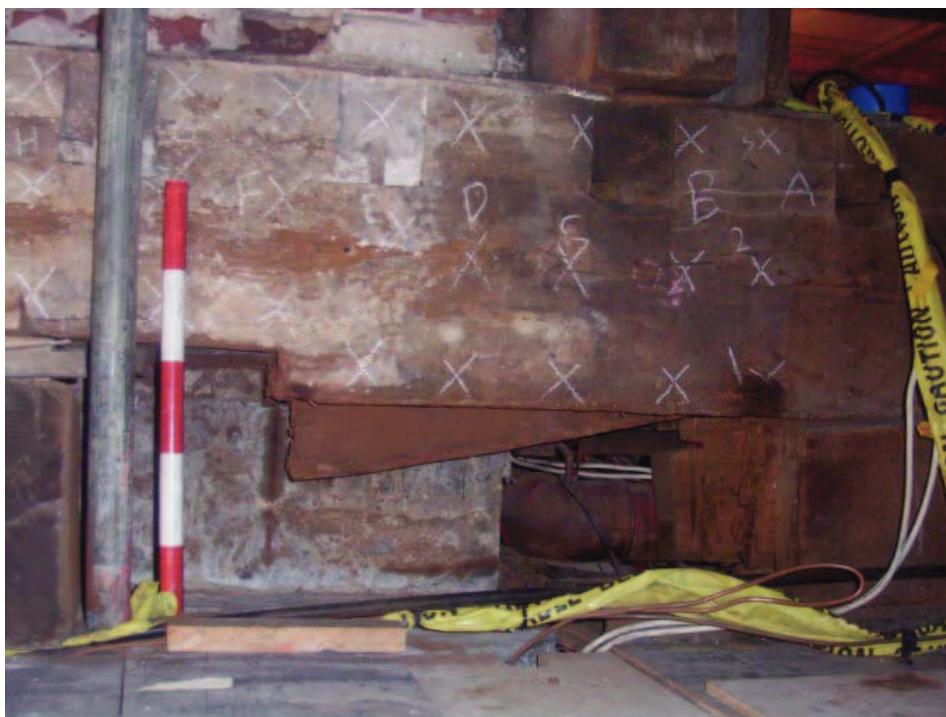
Plate 10: Royal Pew, Chapel Royal, Hampton Court Palace: Royal Pew, west elevation, detail of tenon following removal of lower beam

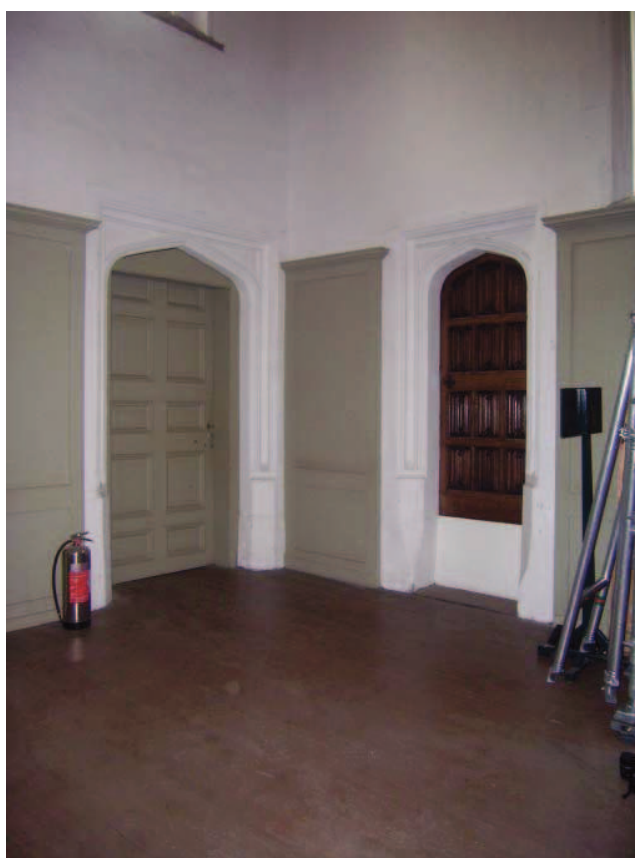
Plate 11: Royal Pew, Chapel Royal, Hampton Court Palace: Royal Pew, model room, primary phase doorways to Royal Pew. The left doorway was the entrance to the pew and the doorway on the right was for the vice stair leading down to the chapel. Note the difference in floor height.

- 2.2.2 The main entrance is now in the centre, but the two original doors from the gallery were at the north and south ends; the Model Room has two Tudor doorways, one leading to the gallery outside and one which led to the adjacent vice stair (Plate 11). There is a fireplace centrally located on the northern elevation between high level windows with Tudor style chimneys on the roof above. It is assumed these features were duplicated on the southern wall. The Lady Chapel has a window in the east wall, while the Winter Pew and Model Room have windows in the south wall.

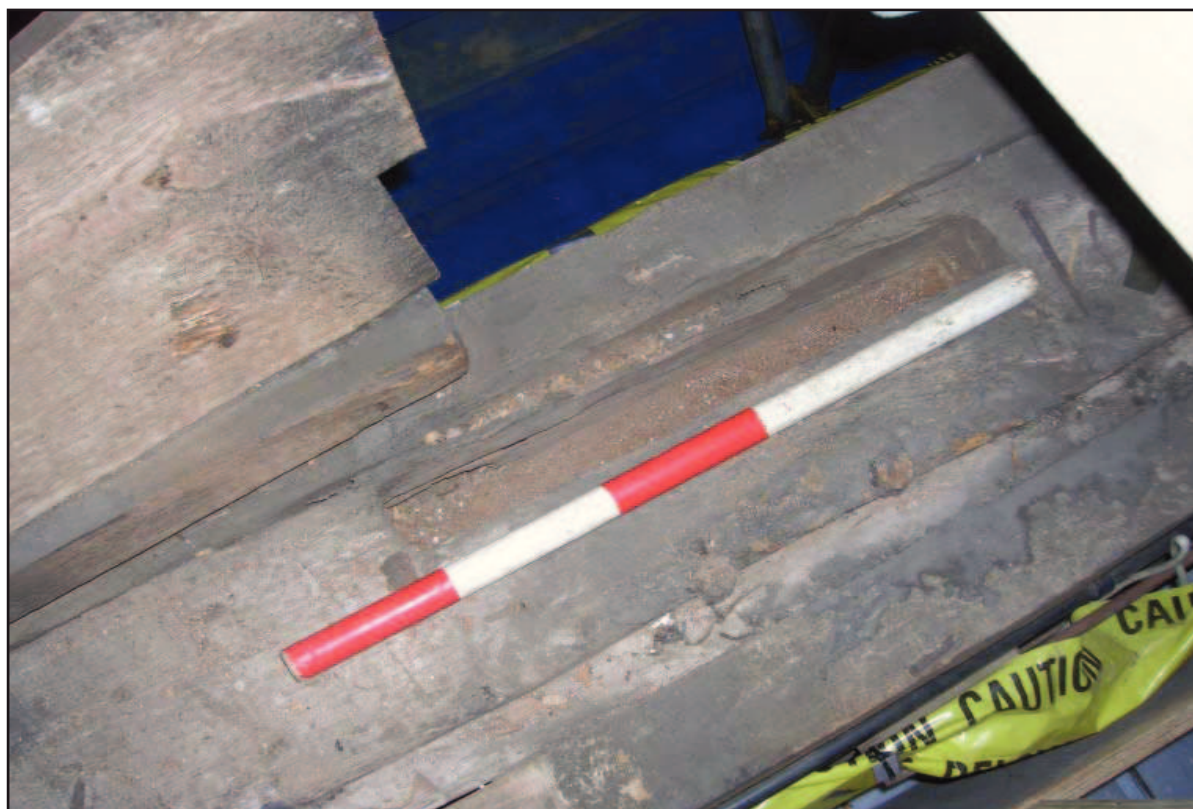
Plate 13: Royal Pew, Chapel Royal, Hampton Court Palace: Royal Pew, surviving mortice for central main post (view east).

- 5.3.2 This division into three parts was not original, and Henry's pew was rather divided into two. On the top face of the upper beam, centrally located, is the mortice for a substantial central post that divided the Royal Pew into two compartments (Figure 4, plate 13). The mortice measures 0.41 x 0.05m with a depth of 0.09m, and while the majority of this post has been removed, the upper section can still be observed as a surviving stub in the small space above the Thornhill painted ceiling (Figure 12 & 13, plate 54). The post rises to the topmost horizontal beam at the level of the wallplate. The pew upper beam also has two smaller mortices measuring 0.19-0.21 x 0.04 x 0.06m situated between posts 1 and 3 and posts 5 and 7 (Figure 4). These indicate the location of posts 2 and 6. The upper section of post 2 can be seen on the west elevation within the hidden room above the winter pew (Figure 12, plate 53) and it is assumed the upper section of post 6 remains in situ in the frame within the lady chapel, however this was unseen. Investigation has shown that the removed sections of posts 2 and 6 were reused as lintels during 18th century refurbishment works and this is discussed more fully in § 7.3.4.

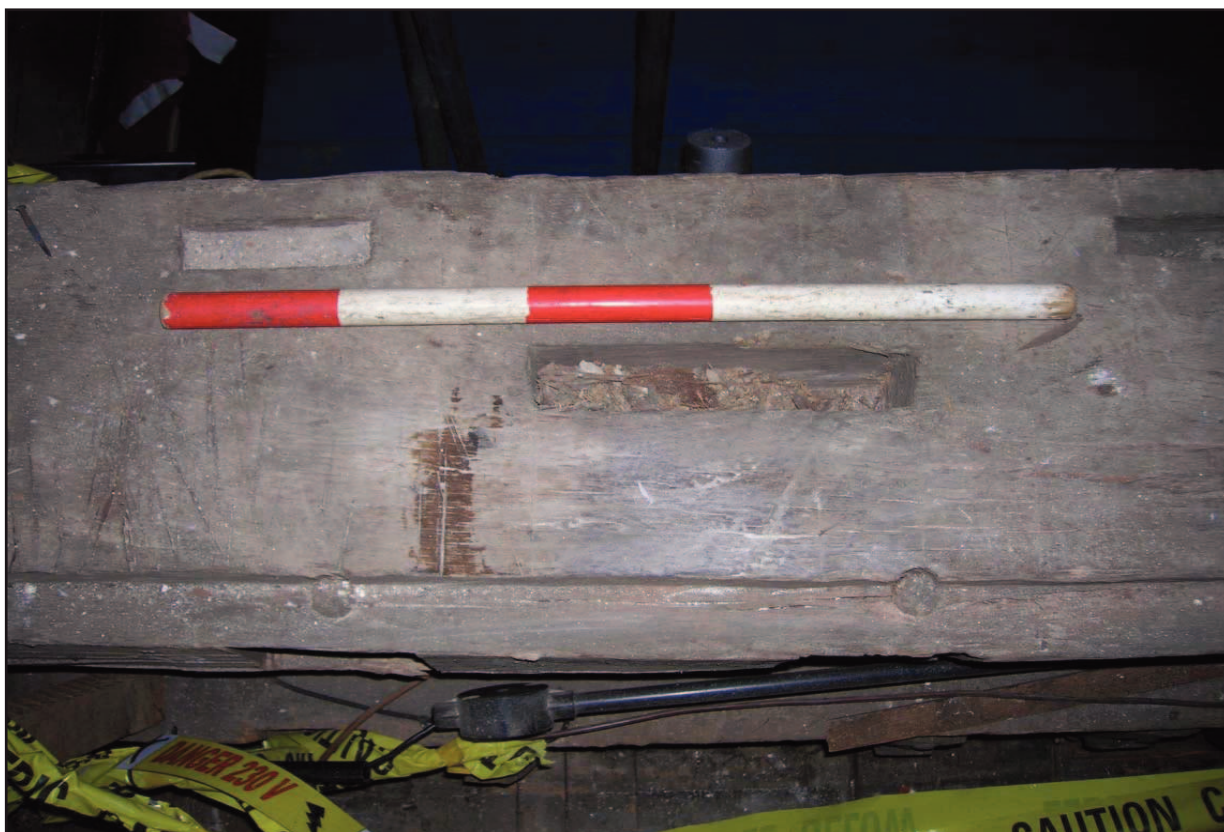
Plate 14: Royal Pew, Chapel Royal, Hampton Court Palace: Royal Pew, further mortices and floorboard rebate surviving on the top surface of the upper primary beam.

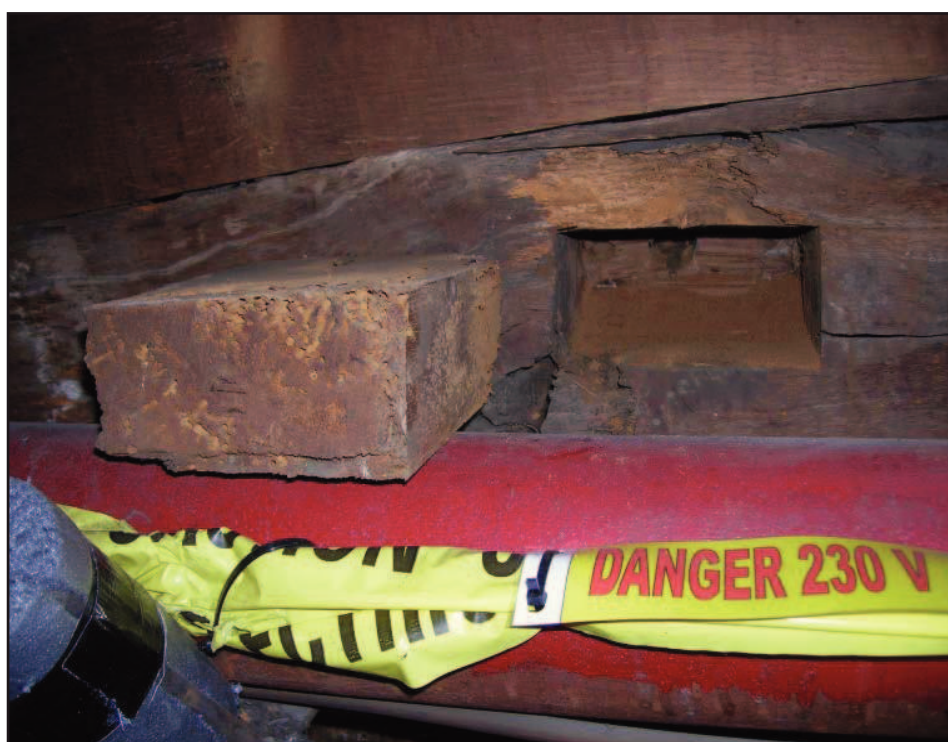
Plate 15: Royal Pew, Chapel Royal, Hampton Court Palace: Royal Pew, detail of a mortice relating to the possible Oriel window (south end).

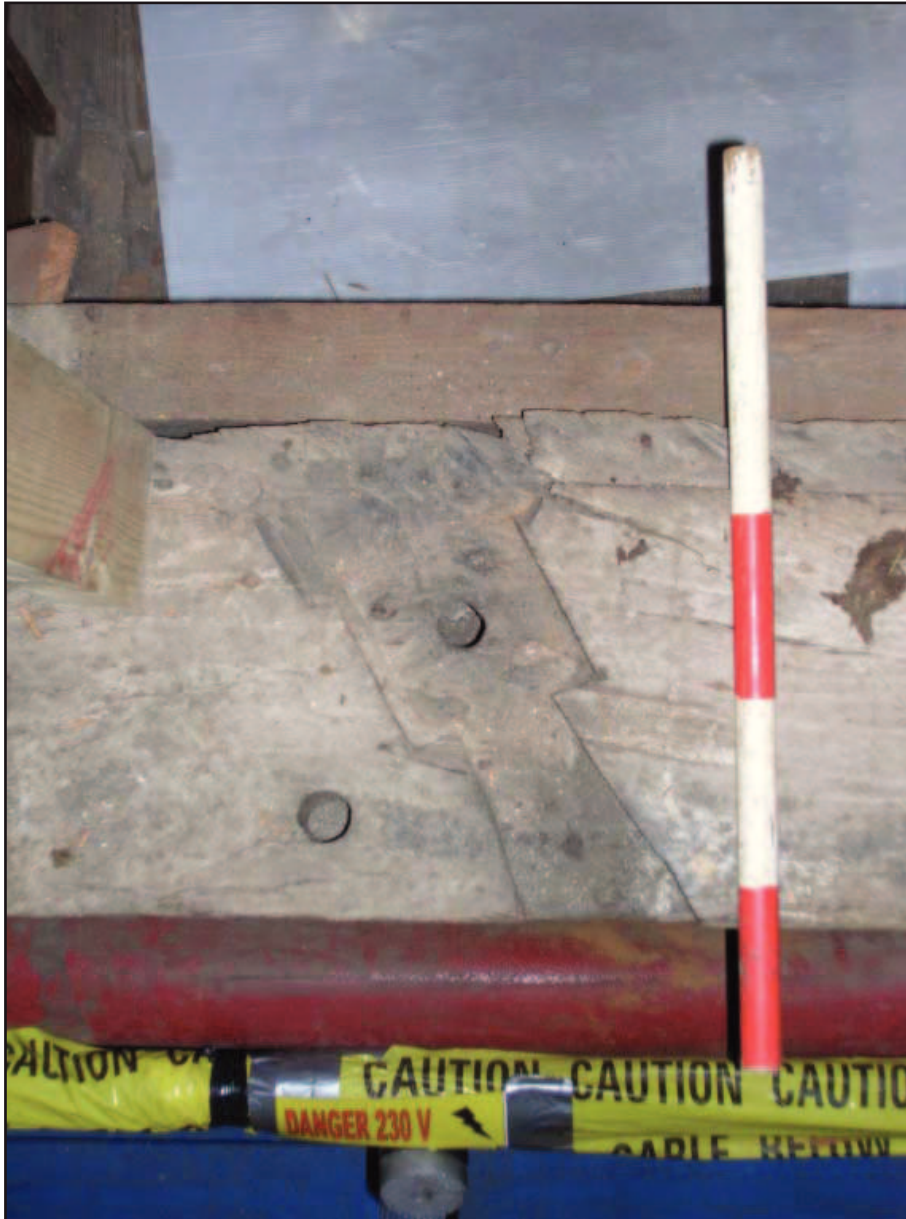
Plate 16: Royal Pew, Chapel Royal, Hampton Court Palace: Royal Pew, detail of carved trench (4) relating to the possible Oriel window (north end).

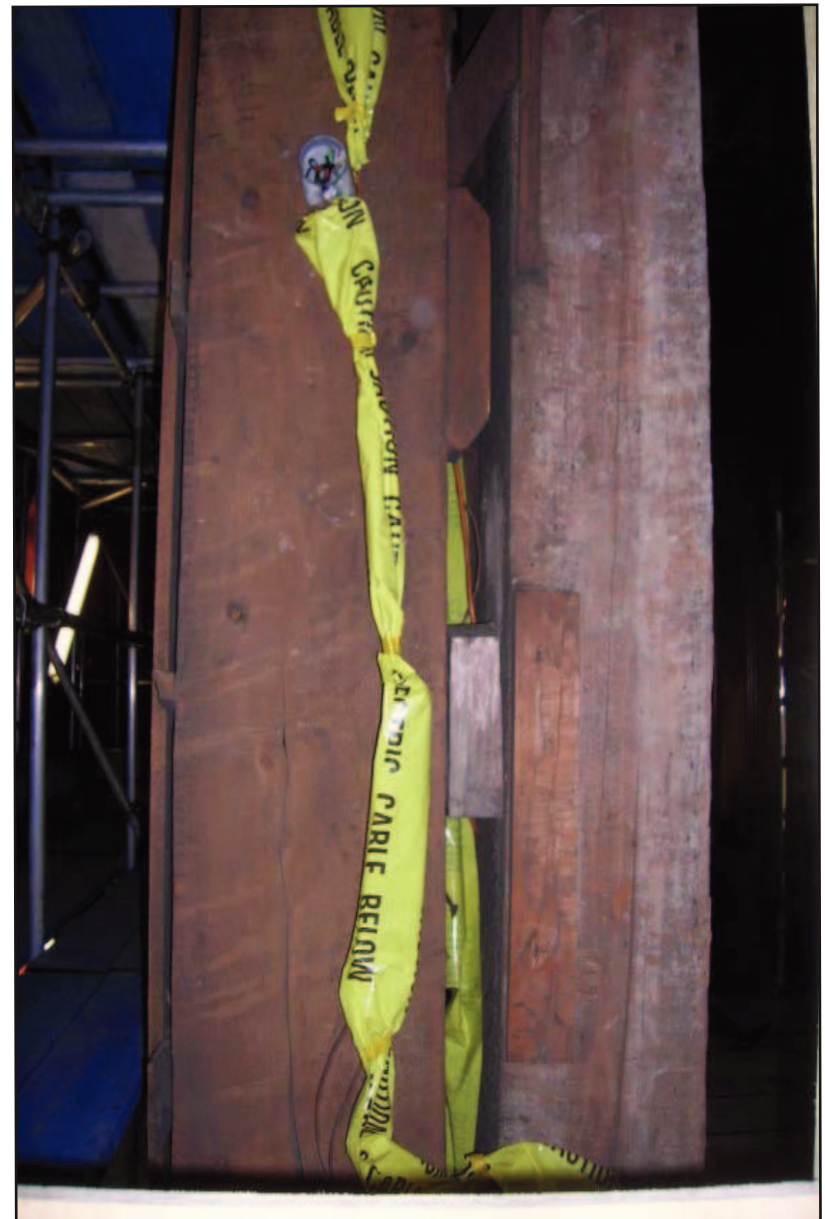
Plate 17: Royal Pew, Chapel Royal, Hampton Court Palace: Royal Pew, detail of 17th century upright and iron brace attached to main pew structure.

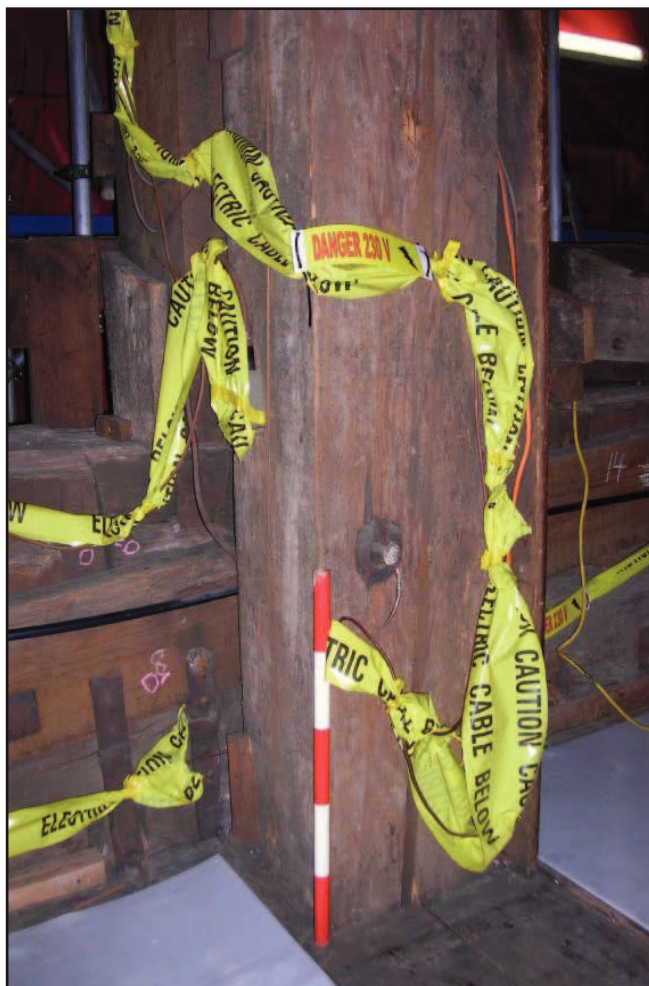
Plate 18: Royal Pew, Chapel Royal, Hampton Court Palace: Royal Pew, detail of forelock used to attached 17th century upright to main pew structure.

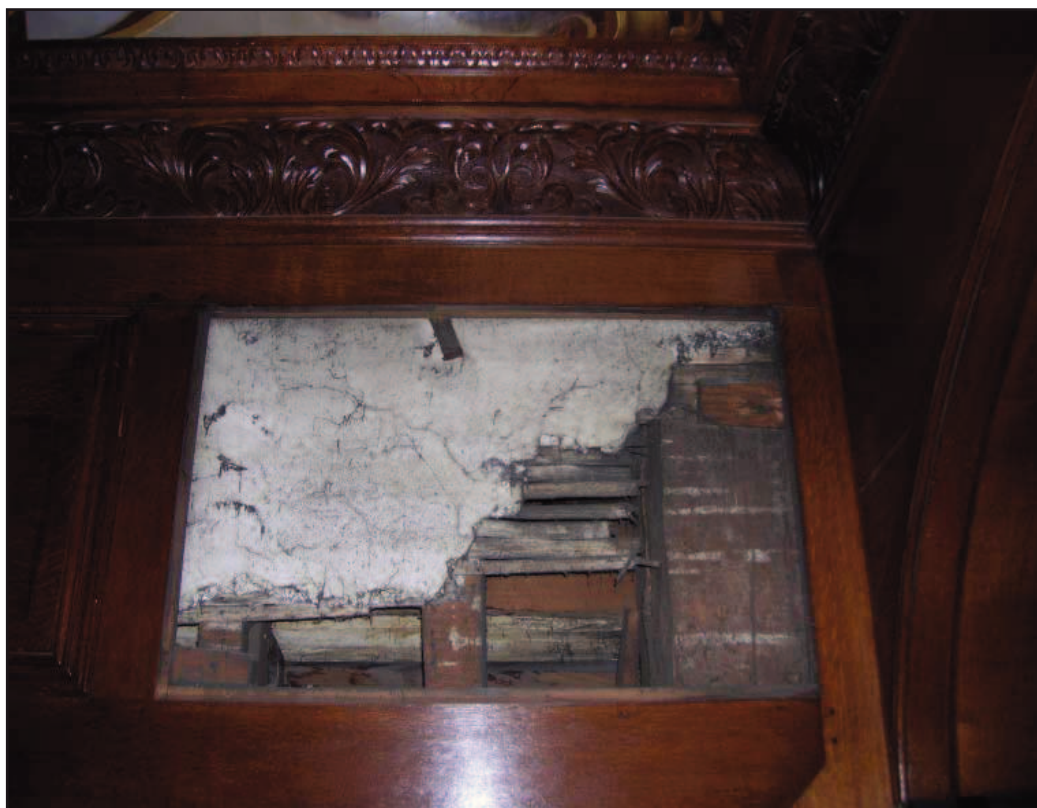
Plate 19: Royal Pew, Chapel Royal, Hampton Court Palace: Royal Pew, lath and plaster and timber framework, south elevation of south partition.

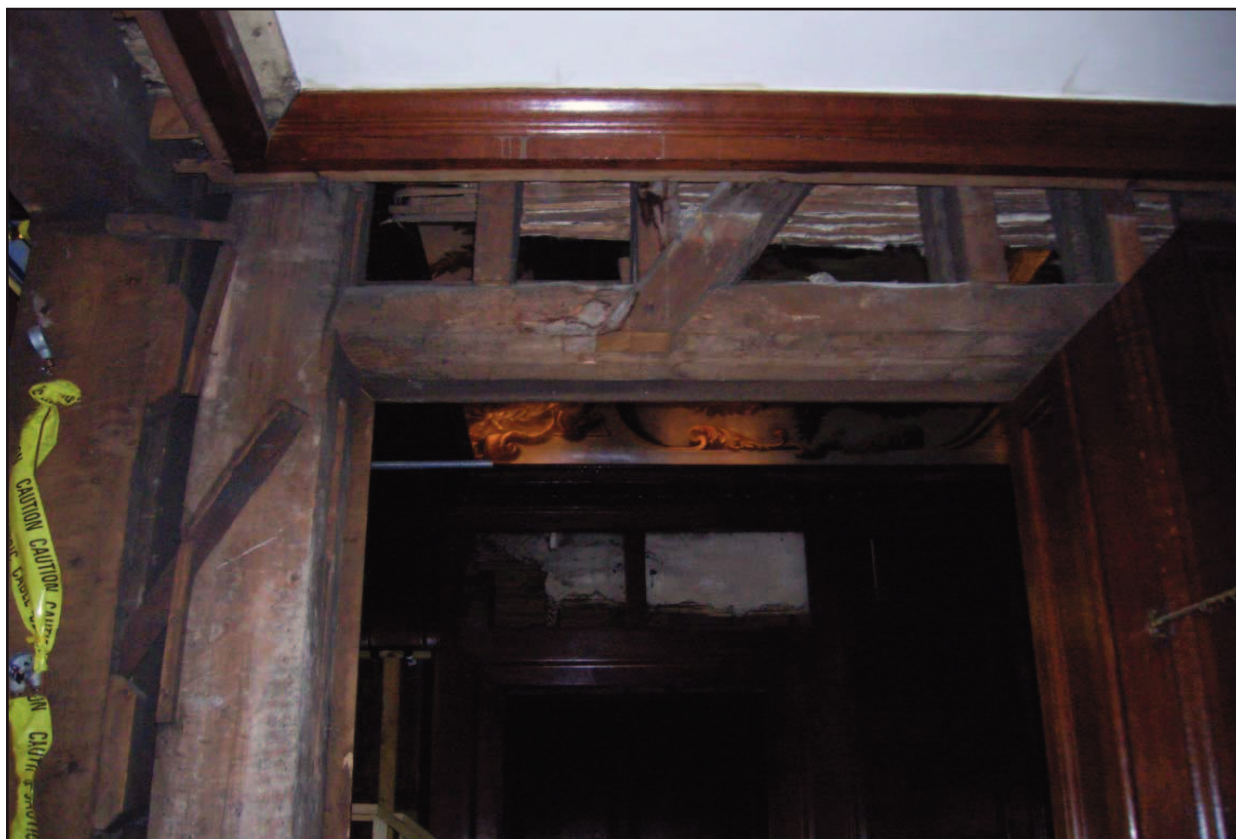
Plate 20: Royal Pew, Chapel Royal, Hampton Court Palace: Royal Pew, exposed timber framework, north elevation of north partition.

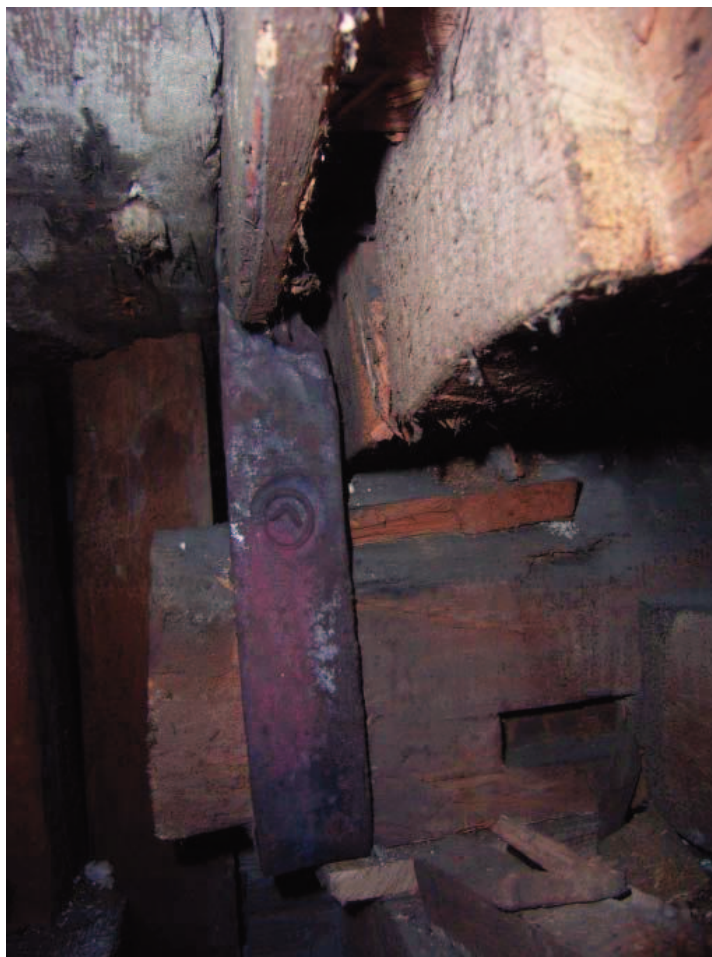
Plate 22: Royal Pew, Chapel Royal, Hampton Court Palace: Royal Pew, east elevation, detail of foundry stamp on iron strap.
