Royal Pew Chapel Royal Hampton Court Palace

Historic Building Recording and Investigation

Oxford Archaeology

April 2009

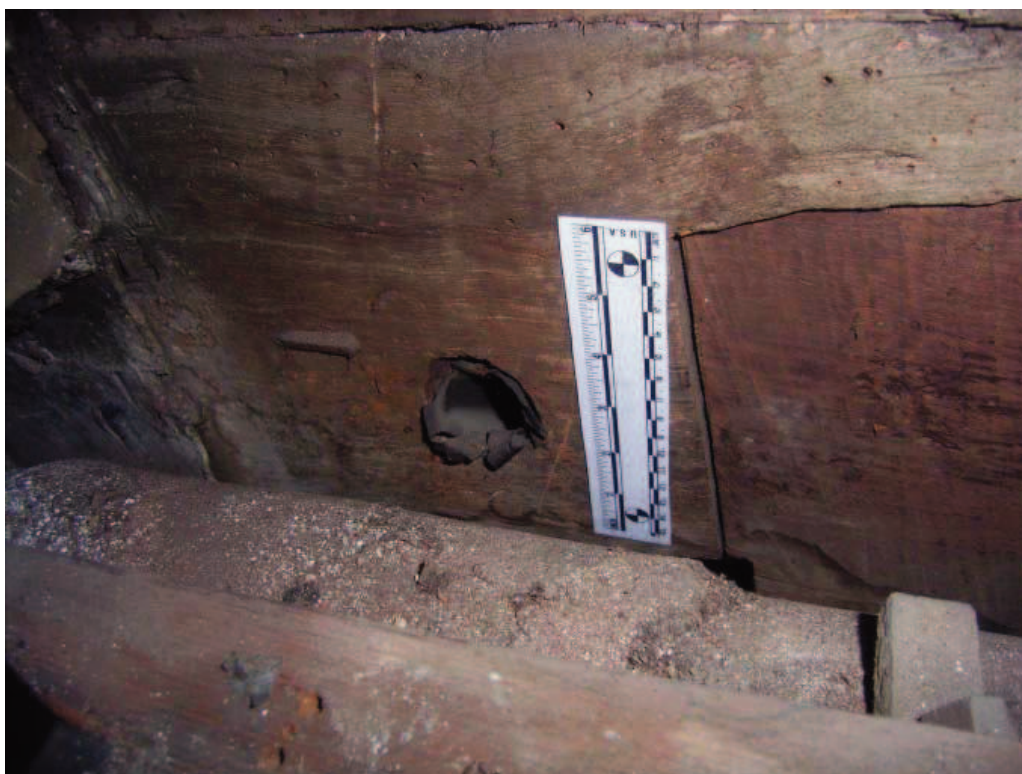
Plate 23: Royal Pew, Chapel Royal, Hampton Court Palace: Royal Pew, Lady Chapel, Detail of iron pipe set within lower beam.

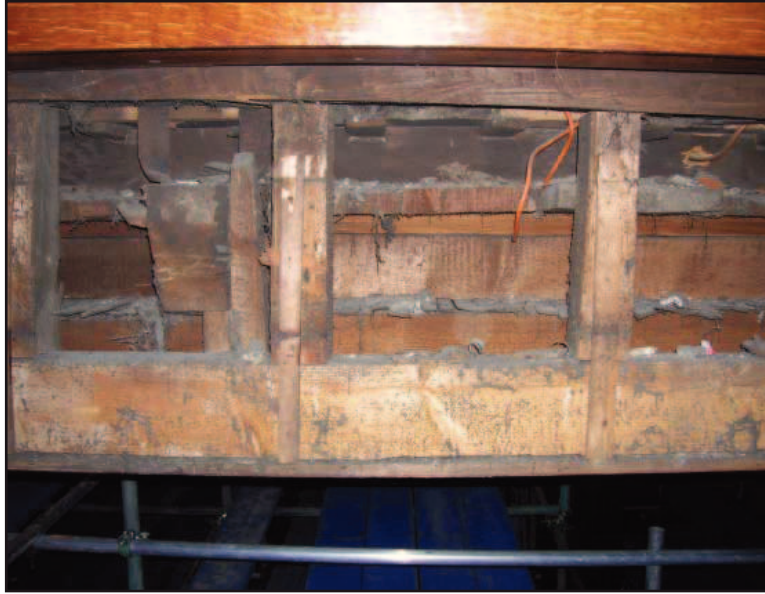
Plate 24: Royal Pew, Chapel Royal, Hampton Court Palace:
Royal Pew, east elevation, detail of re-used floorboards at
the south end of the main structure.

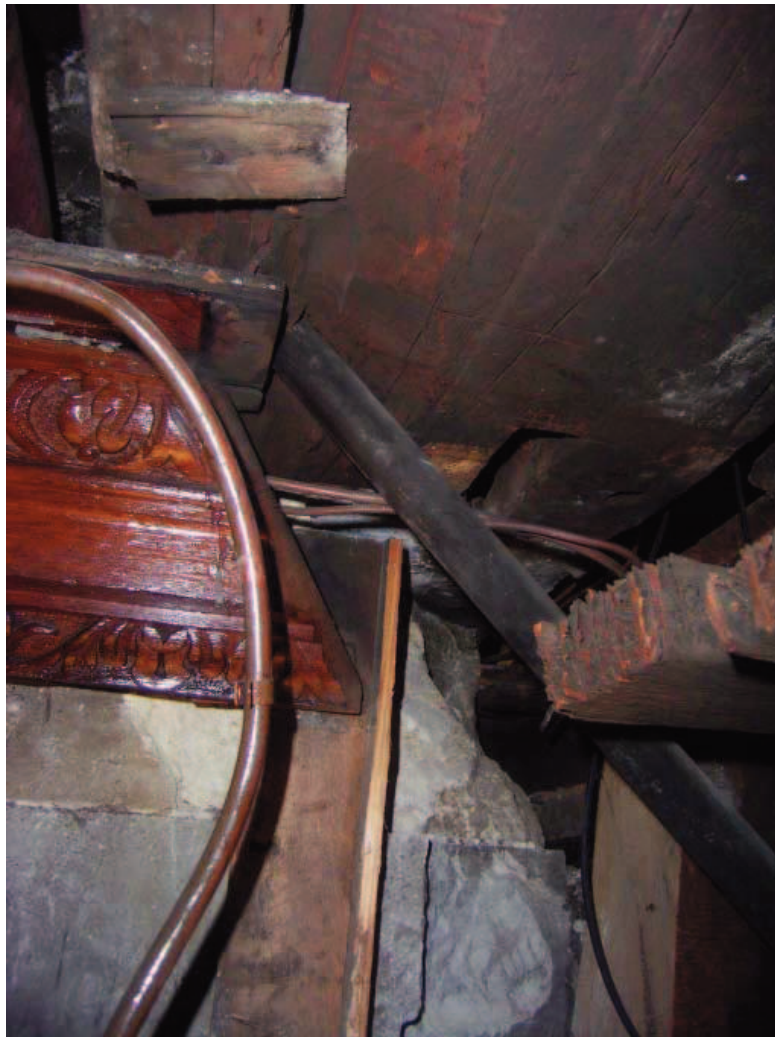
Plate 25: Royal Pew, Chapel Royal, Hampton Court Palace:
Royal Pew, Lady Chapel, detail of hidden mortice and rebate
within quoin below.

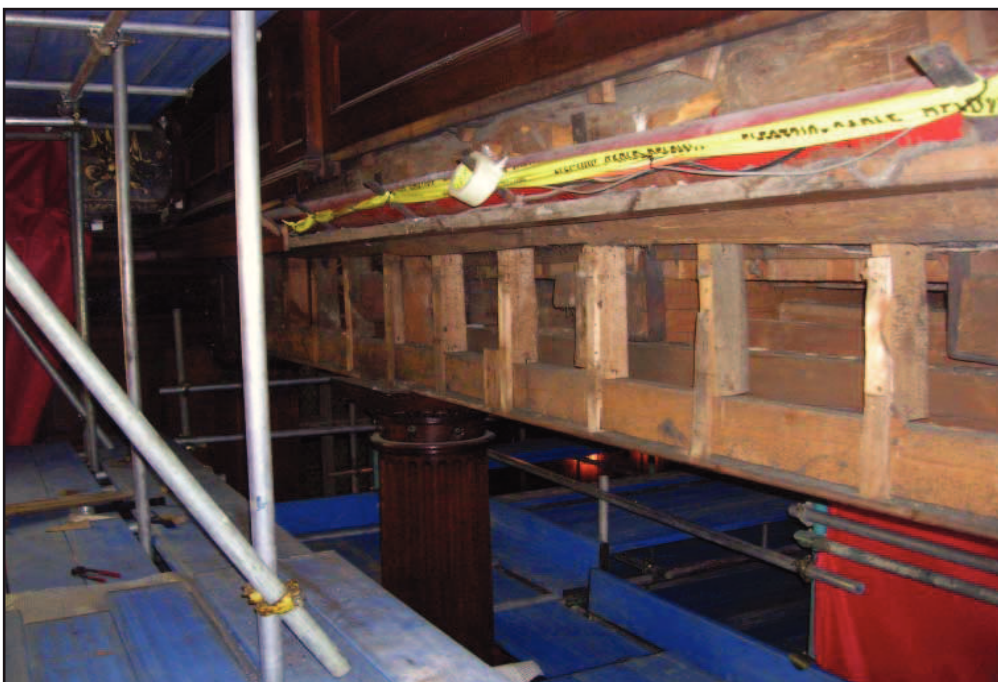
Plate 26: Royal Pew, Chapel Royal, Hampton Court Palace: Royal Pew, east elevation viewed south, overall detail of the lower softwood structure.

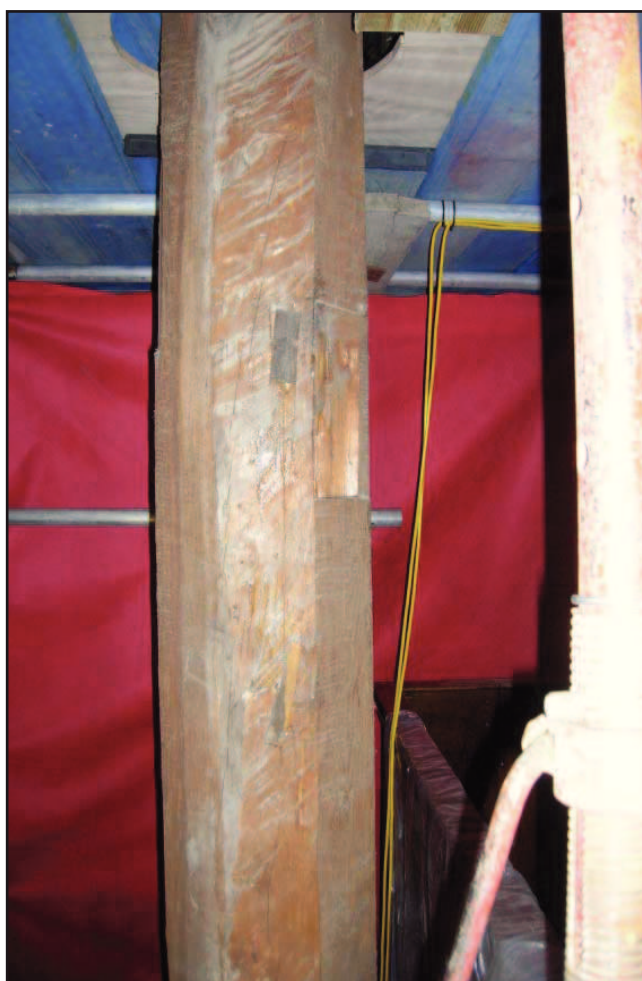
Plate 27: Royal Pew, Chapel Royal, Hampton Court Palace: Royal Pew, octagonal supporting column (south), detail of mortice for screen.

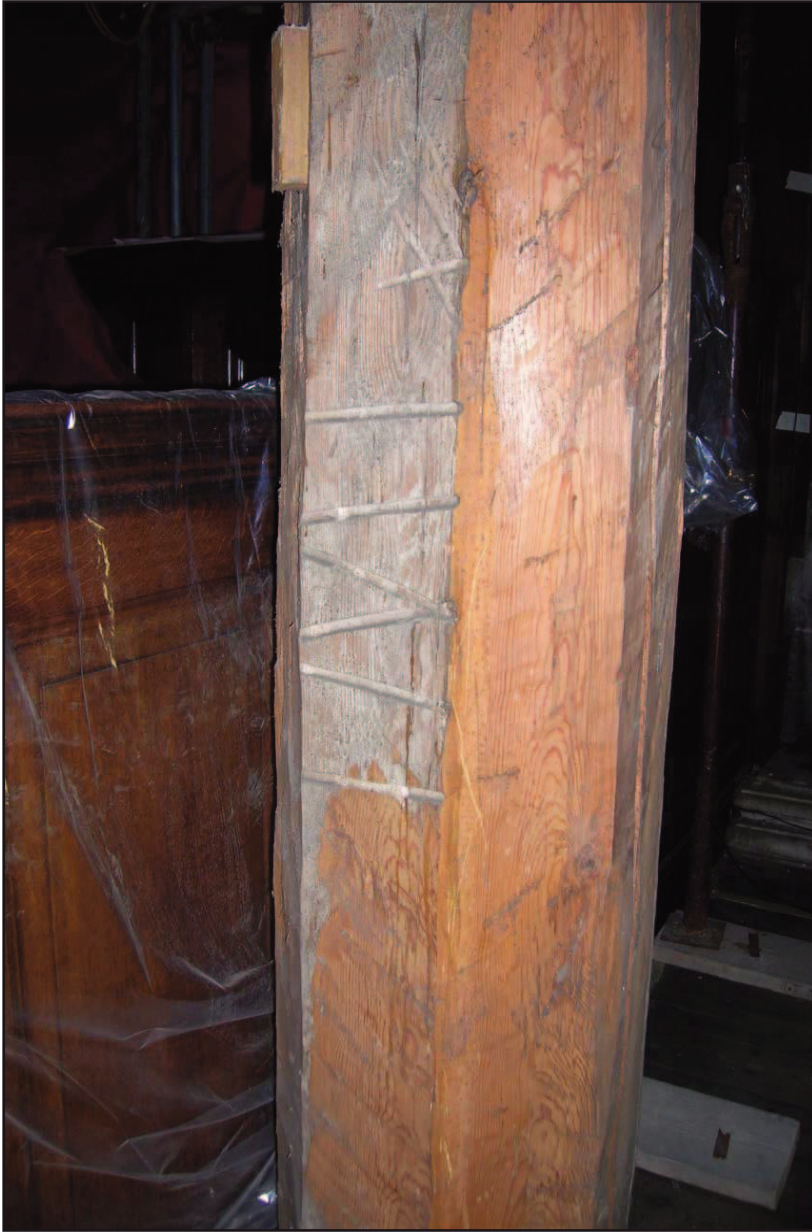
Plate 28: Royal Pew, Chapel Royal, Hampton Court Palace: Royal Pew, octagonal supporting column (north), detail of markings on north face.

- 7.3.14 Underneath the main horizontal structure of the pew are two octagonal, roughly-cut pinewood columns tenoned into the main structure above and currently supporting most of the downward load of the Royal Pew structure (Figure 3, plates 27 & 28). The two columns are set on circular stone plinths with a width at ground floor level of 0.34 - 0.36m tapering off to a width of 0.26 - 0.28m where they reach the lower face of the main lower beam of the Royal Pew. The overall height of the columns at this point is 4.02m. These columns were clad in panelling that were temporarily removed as part of the investigative works, and due to the roughness of their construction it can be reasonably inferred that they were never meant to be visible. It is possible that the history of structural instability of the Royal Pew may in part

- 7.3.15 The north column had a noticeable cut mark all the way around at a height of 0.21m and all eight faces below this level had been chamfered to take some form of fitting or panelling around the base as described below. At a height of 1.51m above the current floor level a wedge 0.25m high and 0.11m deep had been cut into the column with a width of 0.33m at this point (Plate 27). This corresponds with a similar size slot at the same height in the south column and with two slots in the stone quoins at the north and south sides of the ante chapel (Plate 25). Presumably these were to secure a screen or other structure at both ends. It is assumed that these are retaining slots for a cross beam or screen of some form that was in place earlier in the history of the Royal Pew, but certainly no earlier than the late 17th/early 18th century when the columns are likely to have been inserted as part of the refitting of the pew. White chalk marks 'A' and 'B' can be seen on the upper section of the column on the west elevation whilst various other horizontal and vertical chalk marks were observable elsewhere on all sides. The south column only had a partially chamfered bottom edge at a height of 0.17m and also an identical slot to that of the north column at a comparable height. White chalk letters were also visible on the upper part of the shaft on six of the eight faces, labelled 'D', 'E', 'G', 'H', 'I', 'J' and 'K' oddly leaving out 'F' and 'C' or 'L'. On the east faces of both columns the slots for the screen had subsequently been filled, each with three blocks of timber of both hard and softwood. On the lower 1.20m of the north elevation (three faces) were a variety of heavy tool marks diagonally cut across the column and above that a deliberate criss-cross of ten carved, deep cuts 6 - 7mm wide, cut solely within the confines of the central face of the north elevation (Plate 28). These are commonly known as Baltic timber marks, which refer to the shipping marks made on timbers to be transported showing their origin and destination, size and quality etc. Baltic marks were also been noted on the softwood beams supporting the panelling on the ante chapel ground floor. The use of Baltic timber was common throughout, but not confined to, the 18th and 19th centuries suggesting these columns are an early use of imported timber. Baltic marks are further discussed in Appendix VII.

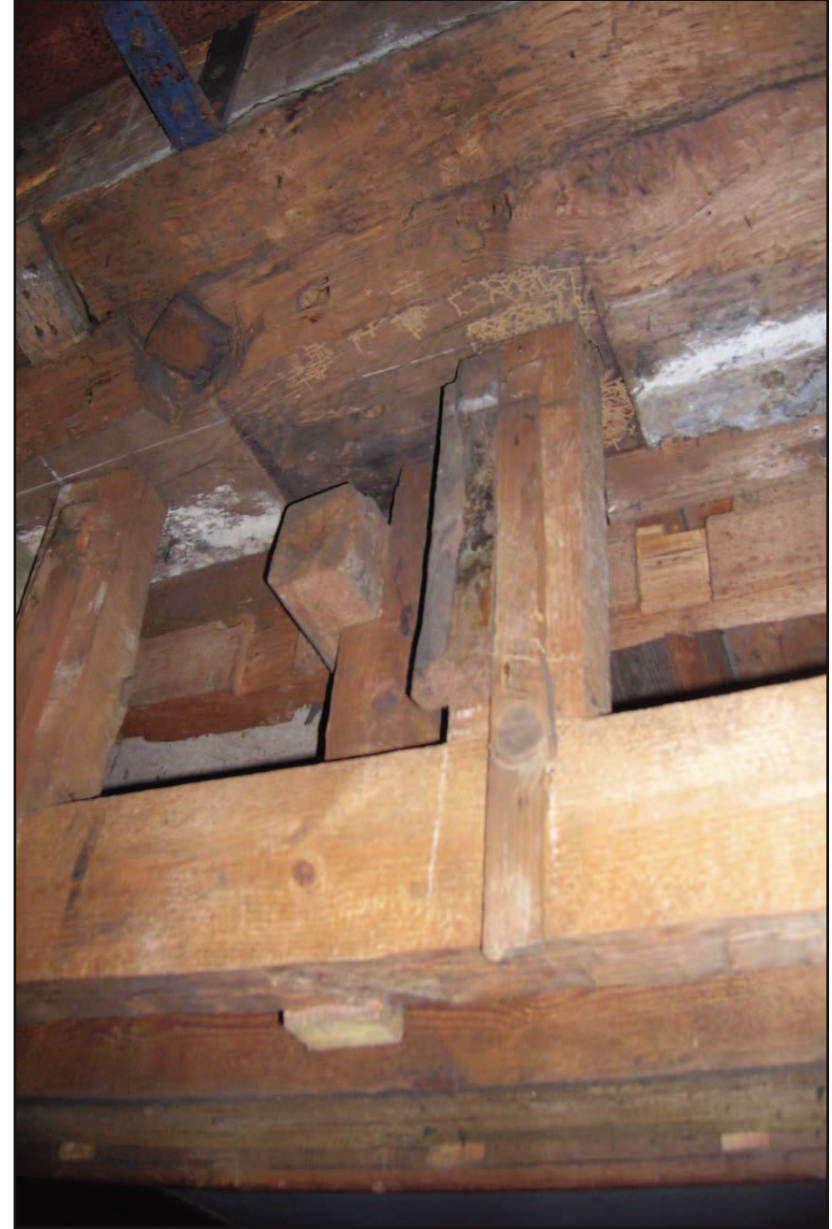
Plate 29: Royal Pew, Chapel Royal, Hampton Court Palace: Royal Pew, soffitt of lower primary beam showing peg holes and mortice for earlier

- 5.3.18 The underside of the pew lower beam was noted to have a roughly applied layer of white gesso (Plate 29). This paint was also seen under UV light to be present on the surface which includes the mortices for the central earlier arrangement of columns. The presence of paint on these surfaces tell us that the columns were not in situ at this time and were probably added later before being replaced with the octagonal columns which we see today. No paint traces were noted within the mortices at the outermost edge of the pew, adjacent to the quoins in the antechapel wall below, suggesting either these posts were in situ at the time of decoration or the decoration did not extend to the outer ends of the lower beam soffit.

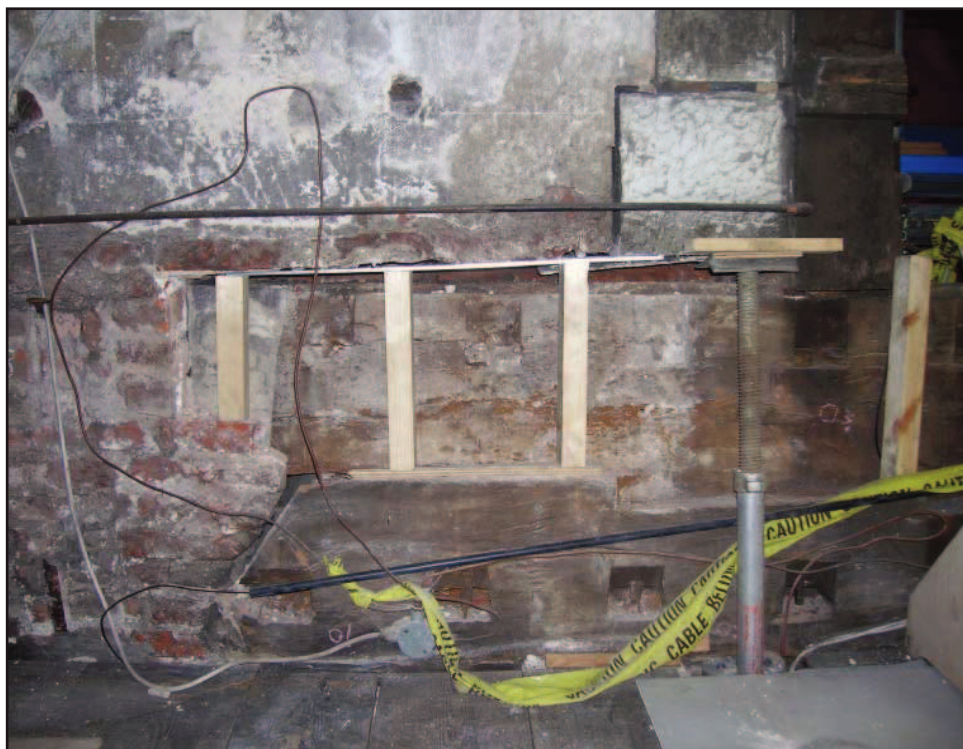
Plate 32: Royal Pew, Chapel Royal, Hampton Court Palace: Royal Pew, west elevation (south), detail of beam in ante chapel wall on removal of brickwork.

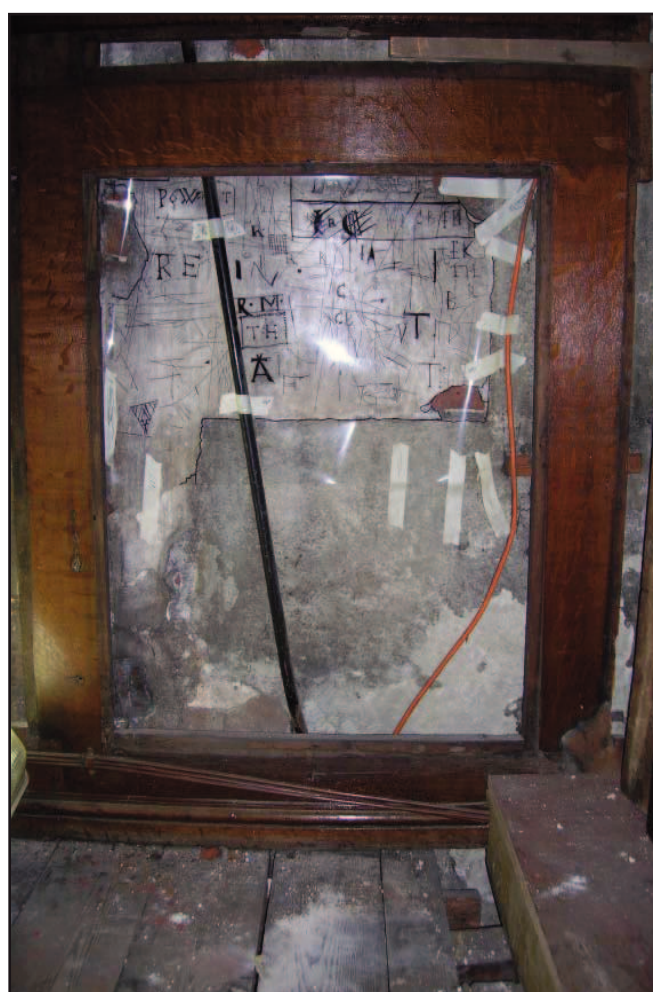
Plate 33: Royal Pew, Chapel Royal, Hampton Court Palace: Royal Pew, ground floor, west elevation of ante chapel wall. Graffiti tracing.

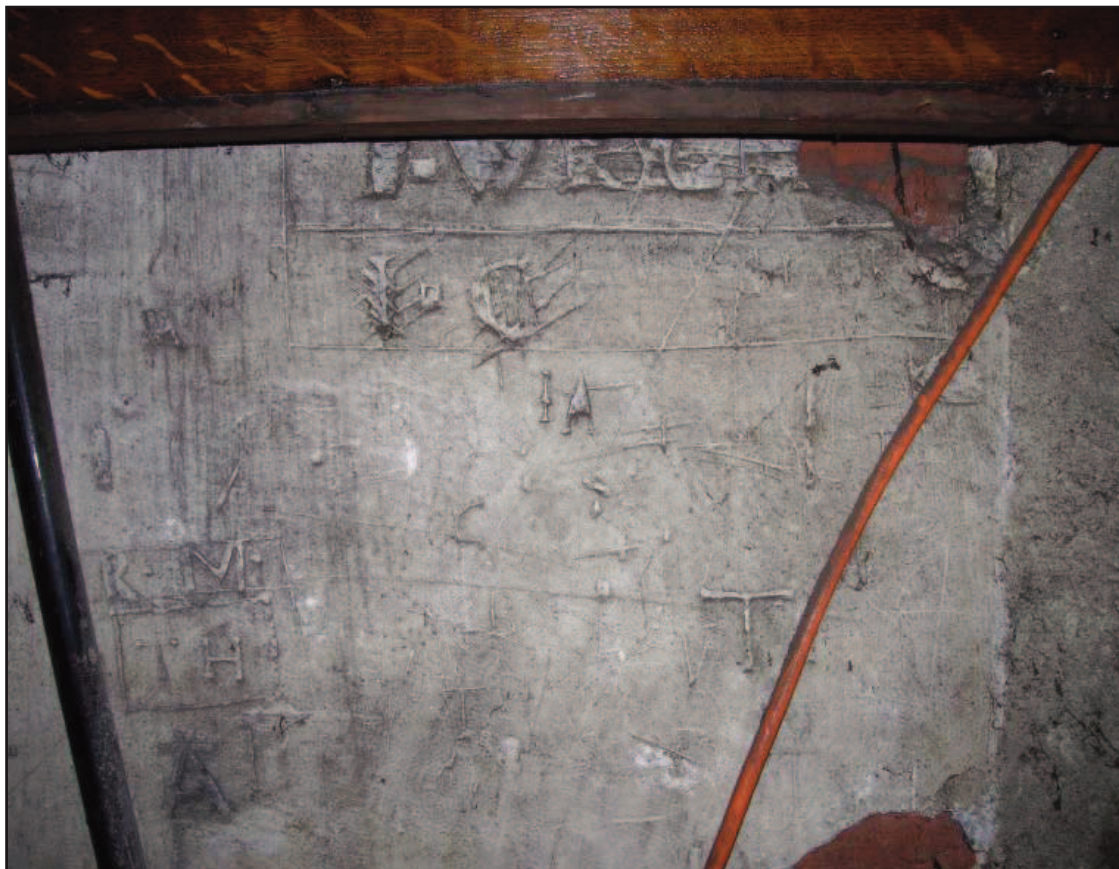
Plate 34: Royal Pew, Chapel Royal, Hampton Court Palace: Royal Pew, ground floor, west elevation of ante chapel wall. Detail of graffiti. See Appendix I - VI for detailed tracings.

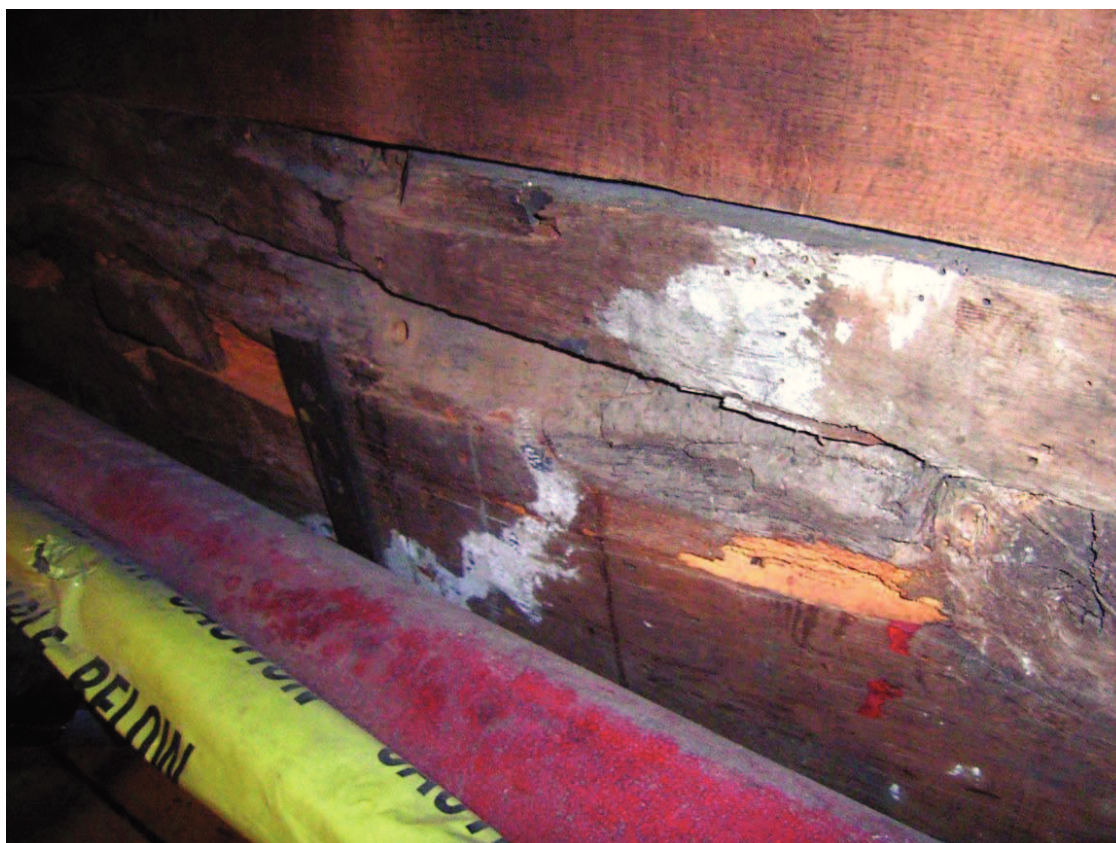
Plate 35: Royal Pew, Chapel Royal, Hampton Court Palace: Royal Pew, east elevation, detail of oriel corbel paintwork

- 5.3.14 Further analysis of the pew structure revealed traces of painted decoration. The paintwork recorded on the east elevation of the main pew structure can be seen in figure 14 and plates 35 & 36. Further analysis of the paint was undertaken by Catherine Hassall and this report is included as Appendix IV. A condition survey of the paintwork was undertaken by Granville & Burbidge and this is included as Appendix V. The paint traces on the upper and lower beams were recorded on acetate at a scale of 1:1.

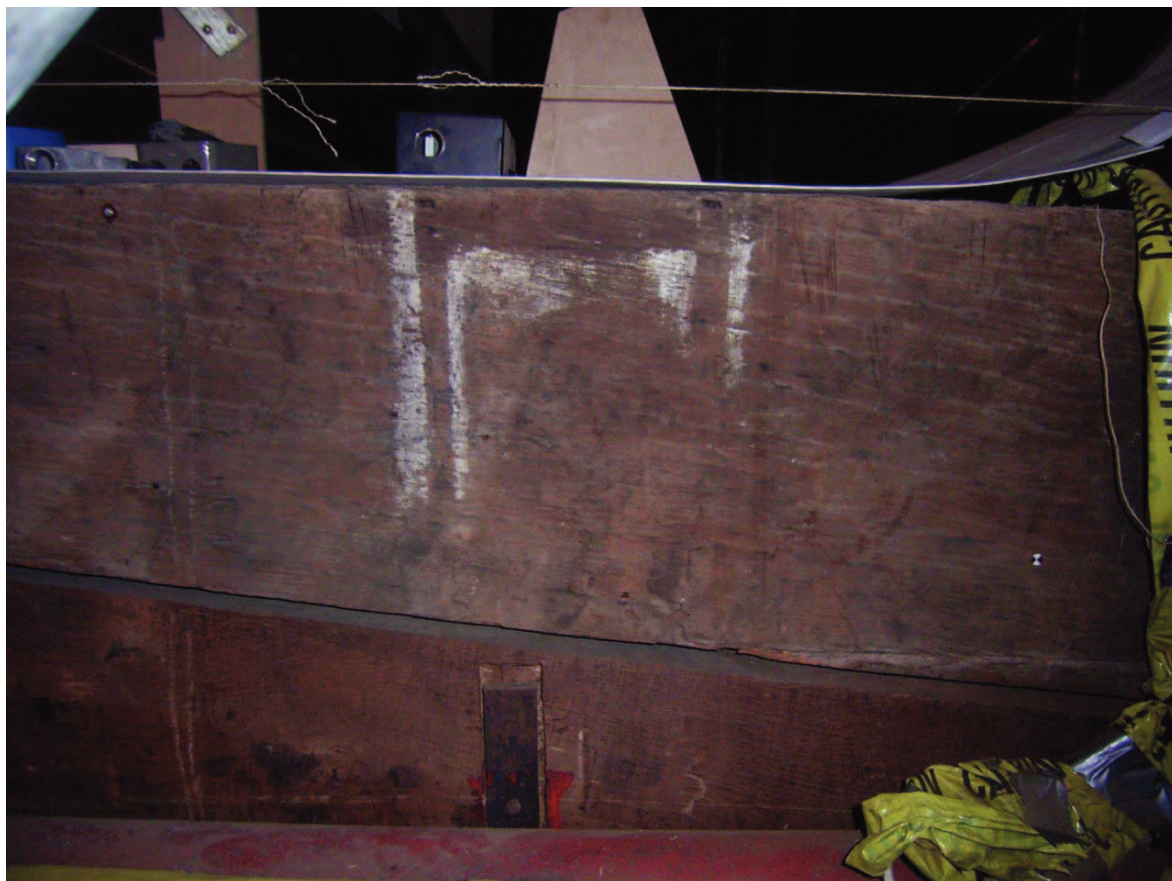
Plate 36: Royal Pew, Chapel Royal, Hampton Court Palace: Royal Pew, east elevation, detail of paintwork on upper beam at location of post 2.

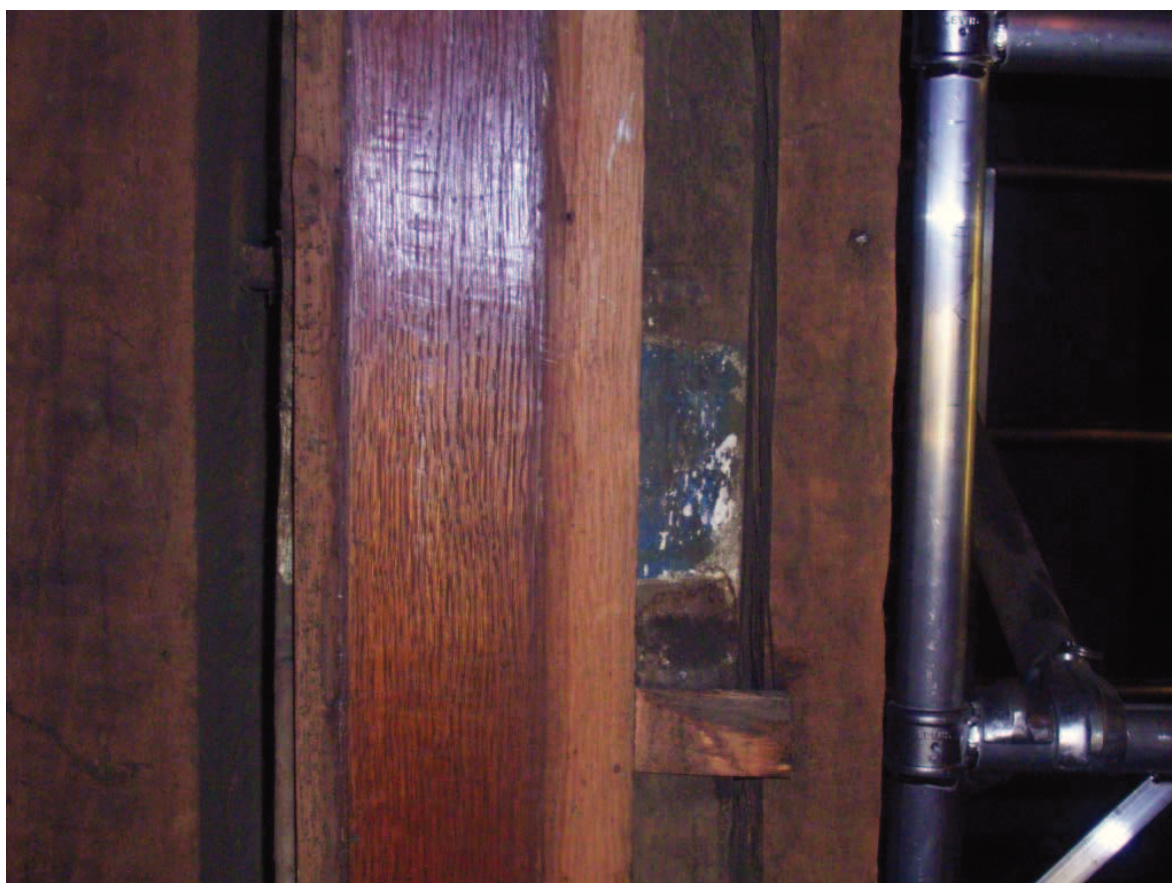
Plate 37: Royal Pew, Chapel Royal, Hampton Court Palace: Royal Pew, east elevation, detail of paintwork on post 5.

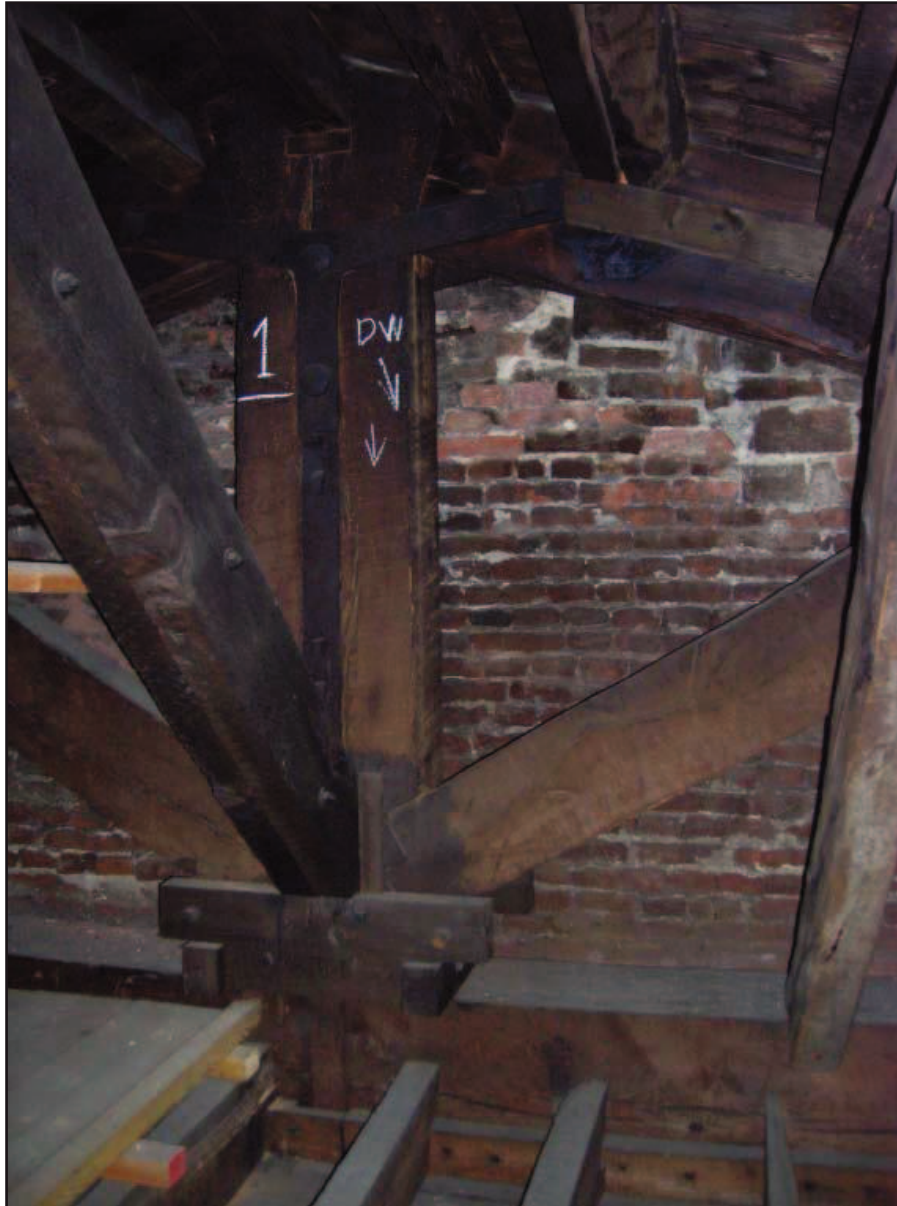
Plate 38: Royal Pew, Chapel Royal, Hampton Court Palace: Roof space over the Royal Pew, south elevation showing brick detail and King post truss.

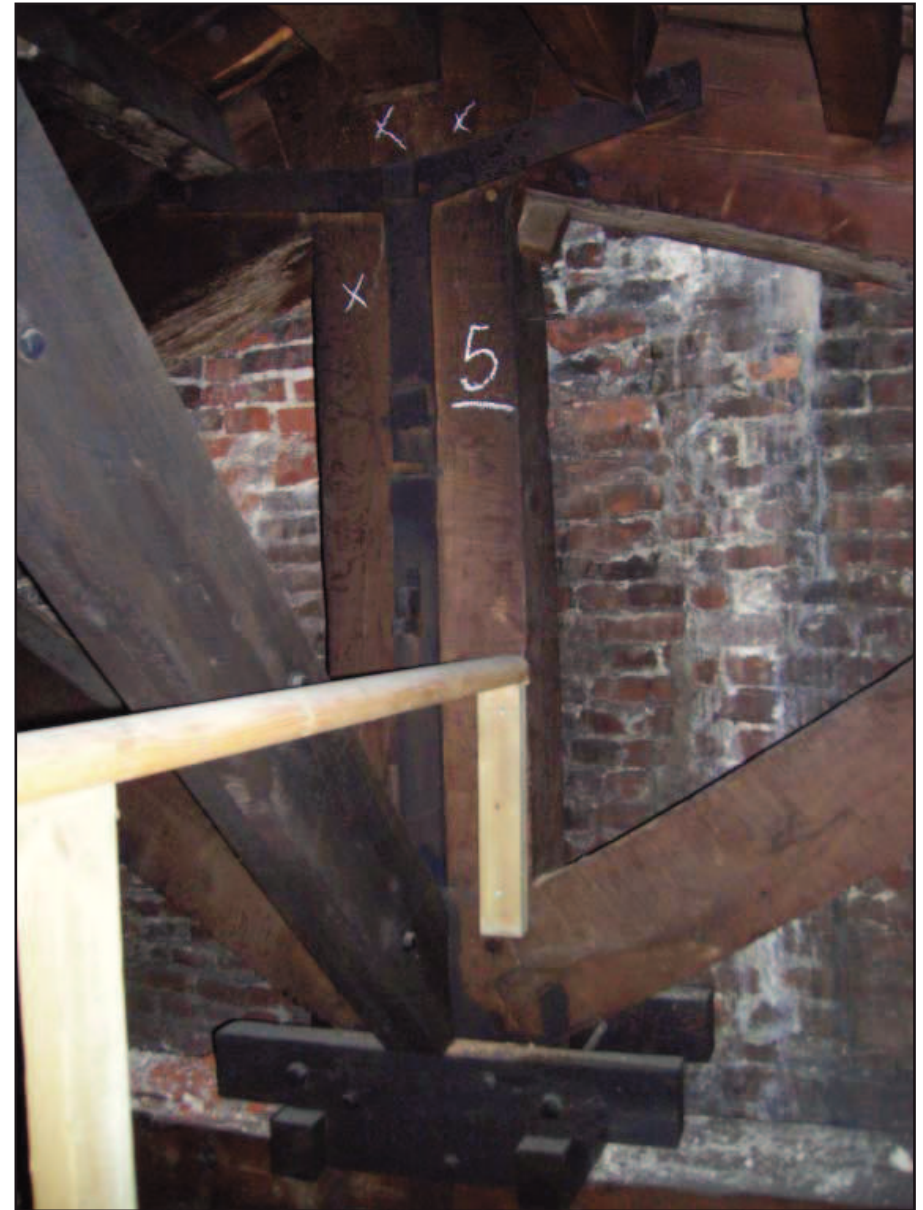
Plate 39: Royal Pew, Chapel Royal, Hampton Court Palace: Roof space over the Royal Pew, north elevation showing brick detail and King post truss.

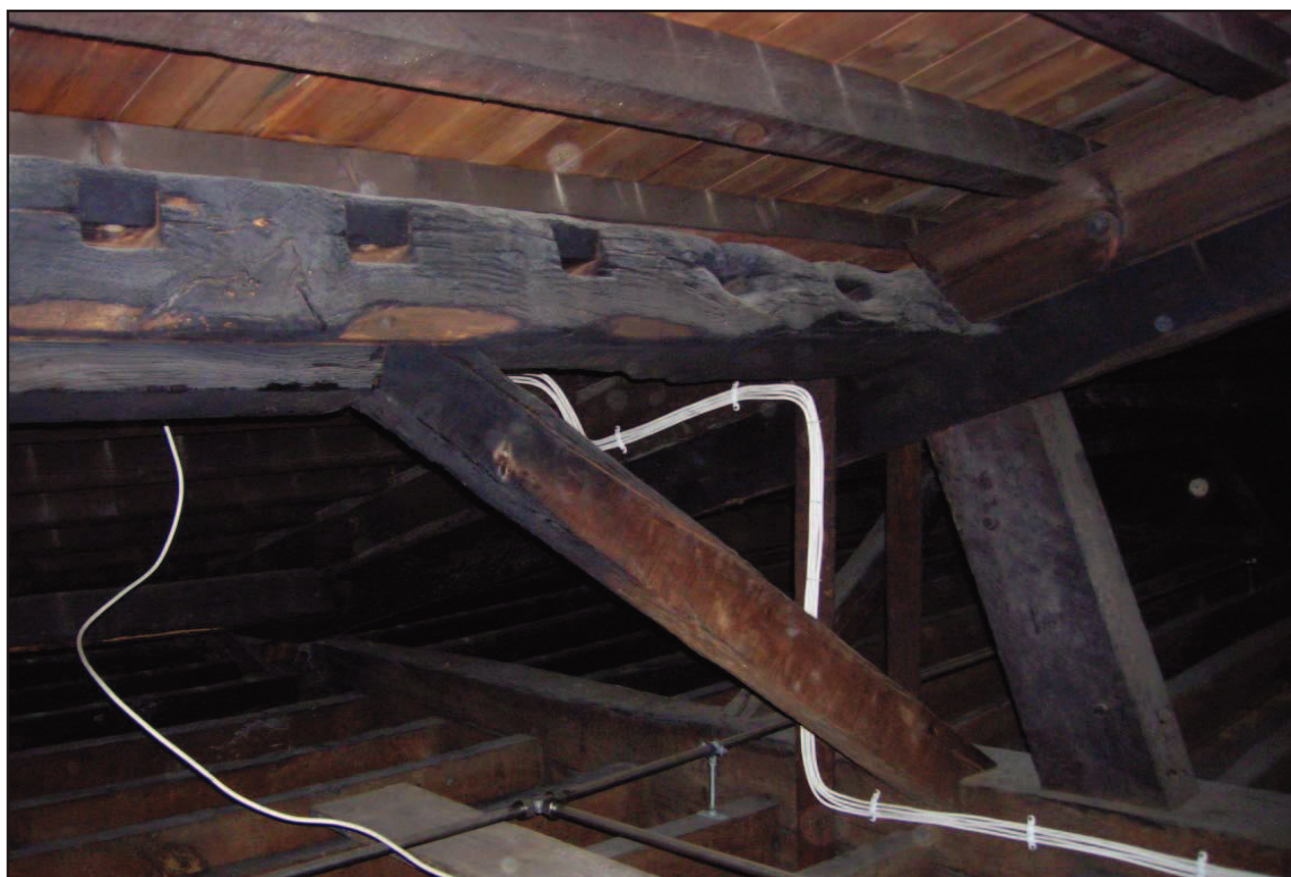
Plate 41: Royal Pew, Chapel Royal, Hampton Court Palace: Roof space over the Royal Pew, east side, detail of re-used timbers as primary purlin.

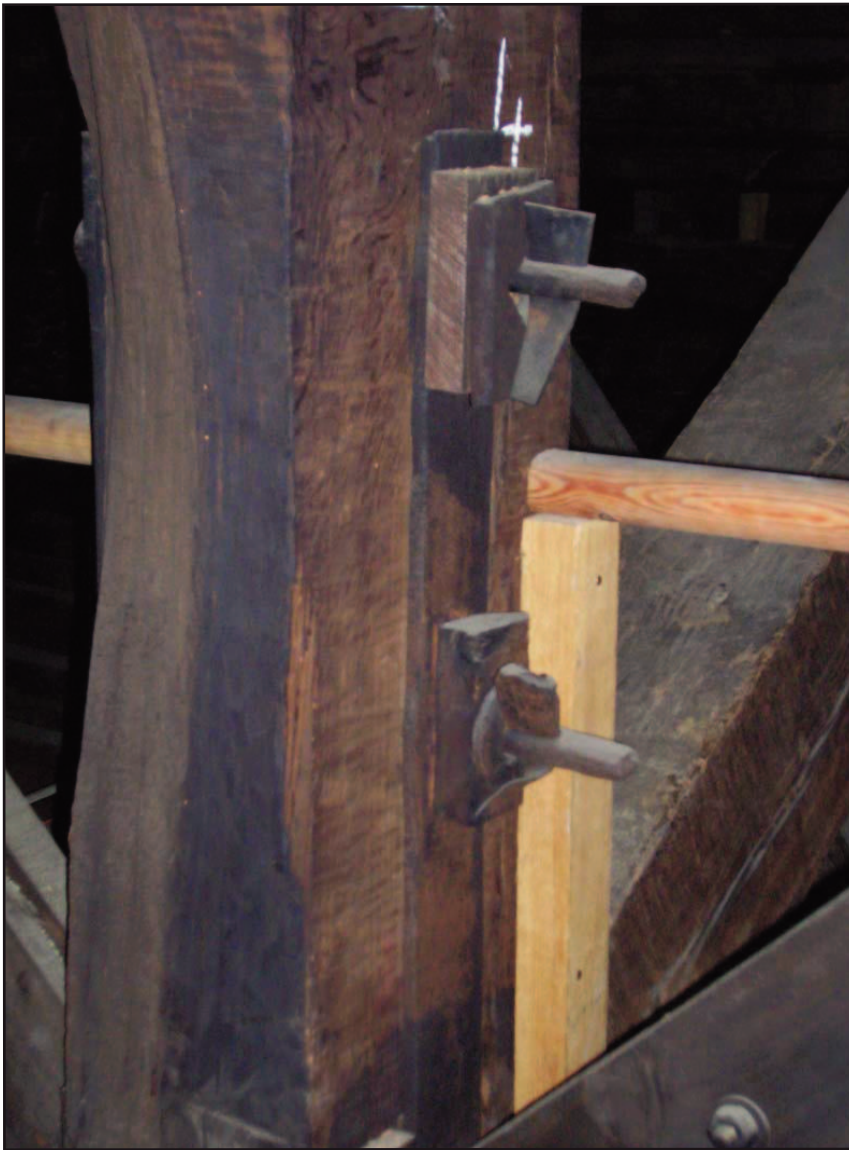
Plate 42: Royal Pew, Chapel Royal, Hampton Court Palace: Roof space over the Royal Pew, detail of forelocks used on one of the King posts.

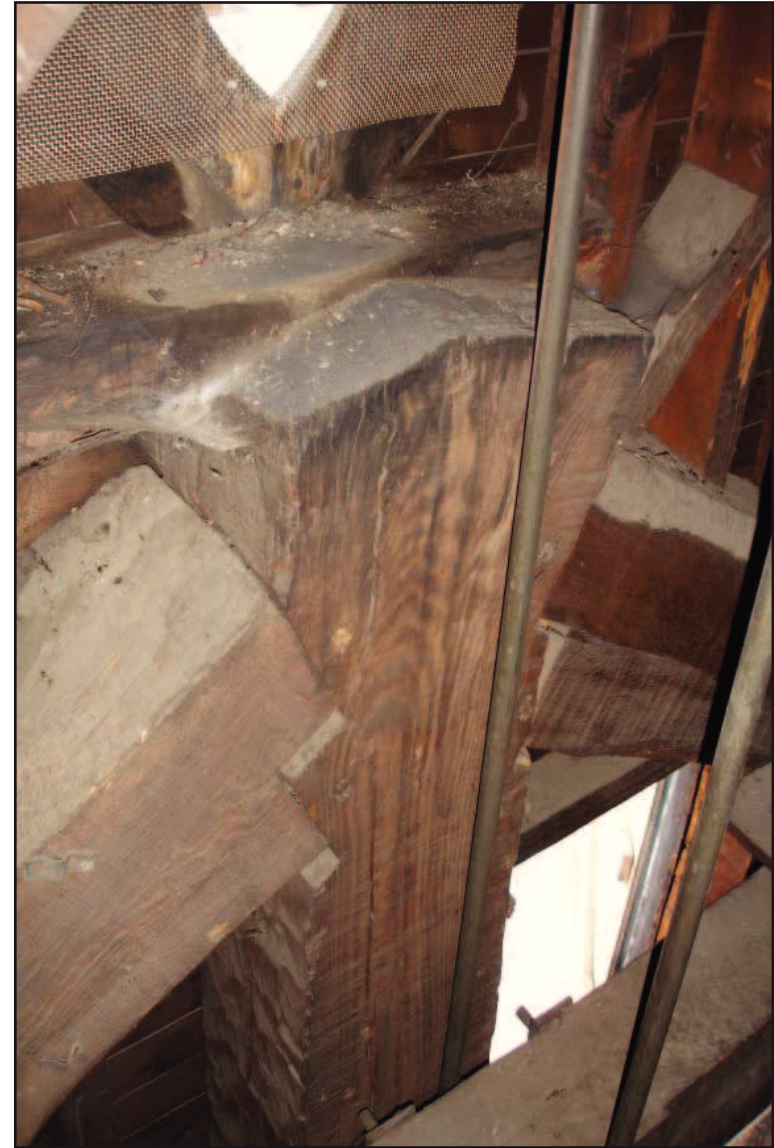
Plate 43: Royal Pew, Chapel Royal, Hampton Court Palace: Roof space over the Chapel Royal, Hampton Court Palace. Detail of the 17th century (?) king post at the west end of the Chapel Royal forming part of the overall framework of the Royal Pew structure.

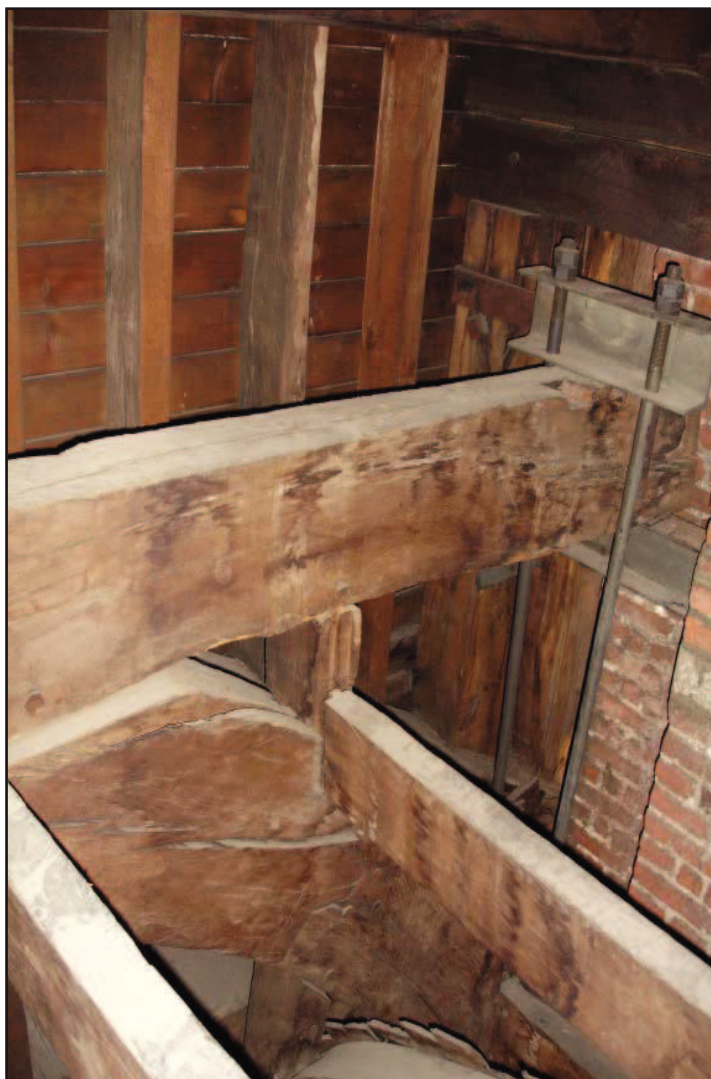
Plate 44: Royal Pew, Chapel Royal, Hampton Court Palace: Roof space over the Chapel Royal, Hampton Court Palace. Detail of the 17th century (?) truss in the north west corner of the Chapel Royal roof space, forming part of the overall framework of the Royal Pew structure.

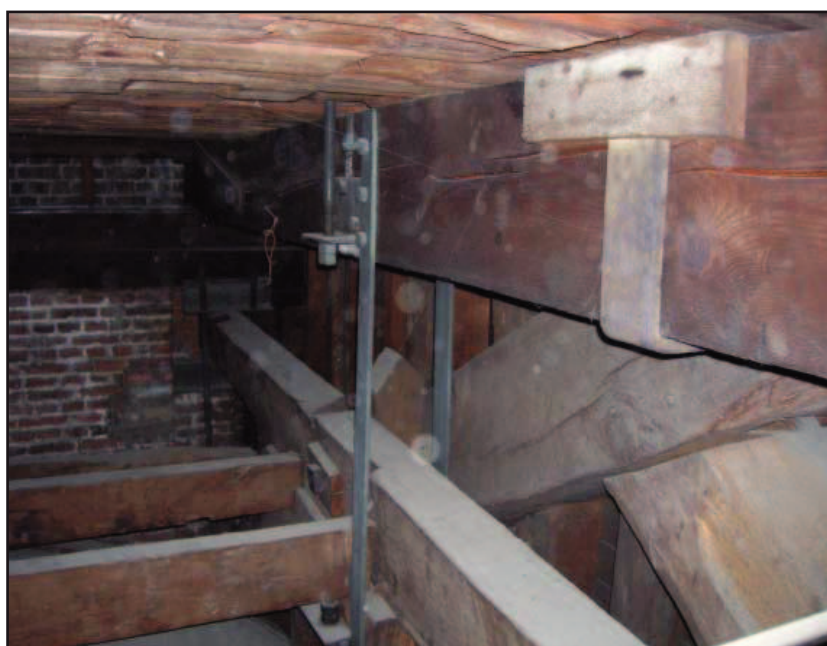
Plate 45 : Royal Pew, Chapel Royal, Hampton Court Palace: Roof space over Chapel Royal. View to the south showing details of truss and 'u' support.

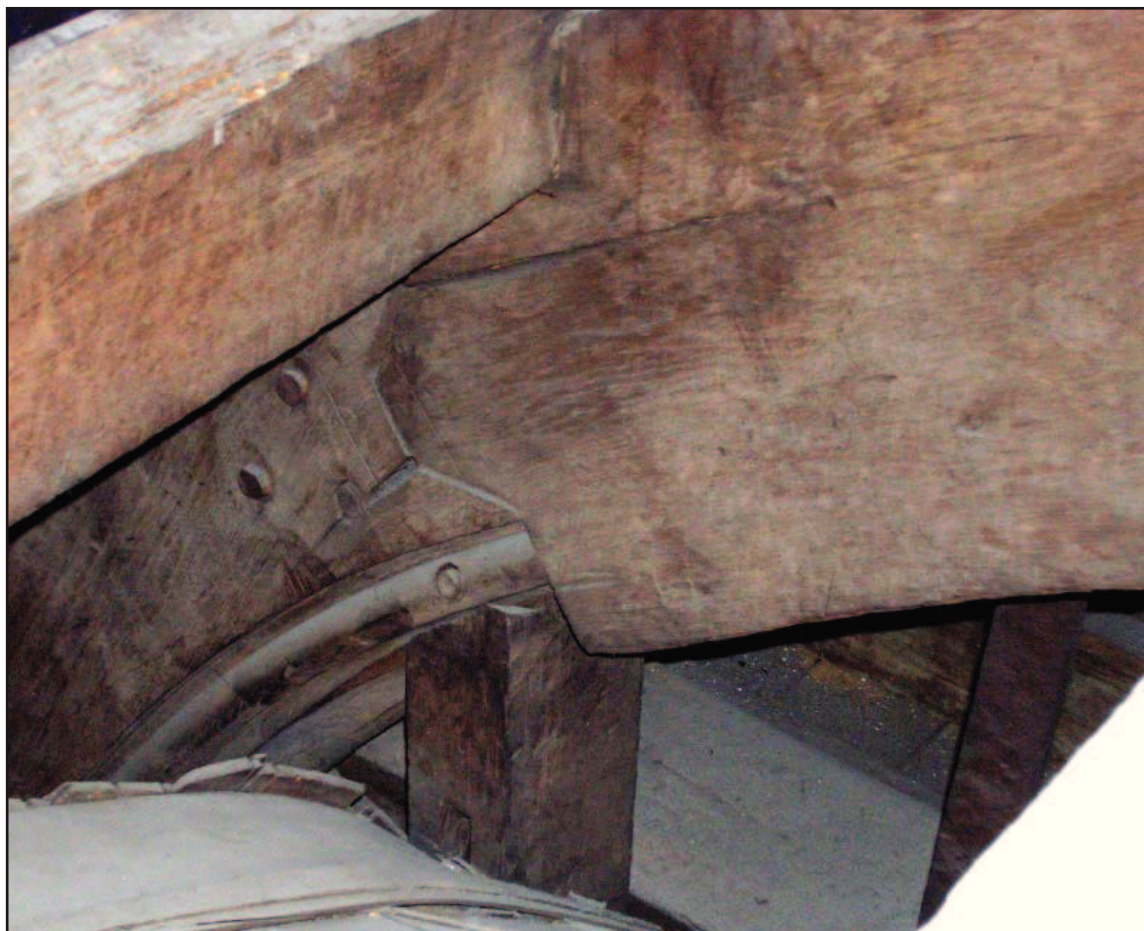
Plate 46: Roof space over Chapel Royal, detail of moulding on underside of truss at the south end.

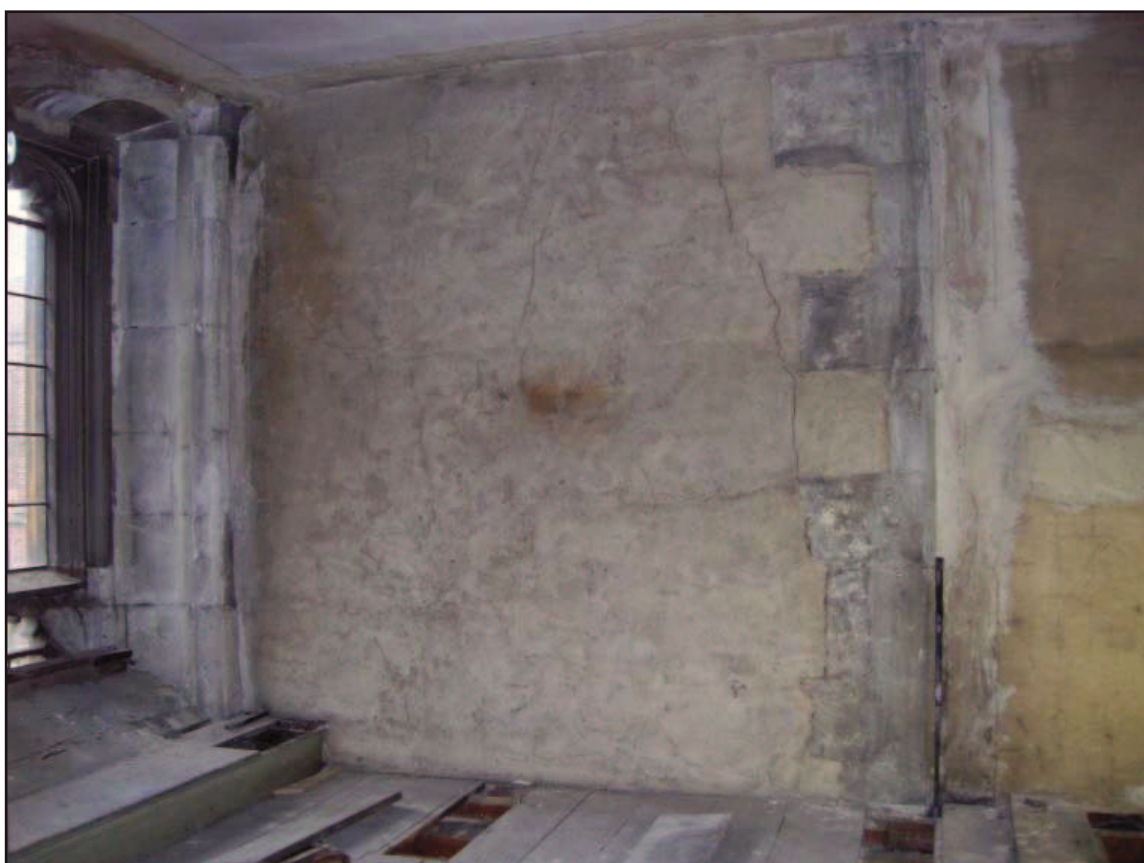
Plate 47: Royal Pew, Chapel Royal, Hampton Court Palace: 'Secret Room' above Winter Pew, east elevation, quoins and plastered wall.

- 7.3.5 Located above the Winter Pew is a hidden room formed through the insertion of a ceiling which cuts the Tudor stone window (Plate 67). The north elevation of this room includes the top 0.50m of the Tudor window which is made up of two sets of six window lights. Running along the width of the window are vertical wooden boards approximately 20cms high. Horizontal timbers, the outermost with a rounded edge, lay across the vertical boards. From this flat surface further boards covered with paper slope upwards towards the window and the stone mullions are cut to accommodate these boards. Wooden rafters provide support from underneath and there is lath and plaster to the underside. The plaster contains hair and probably has a construction date of 16th/17th century (Plate 47 & 48).

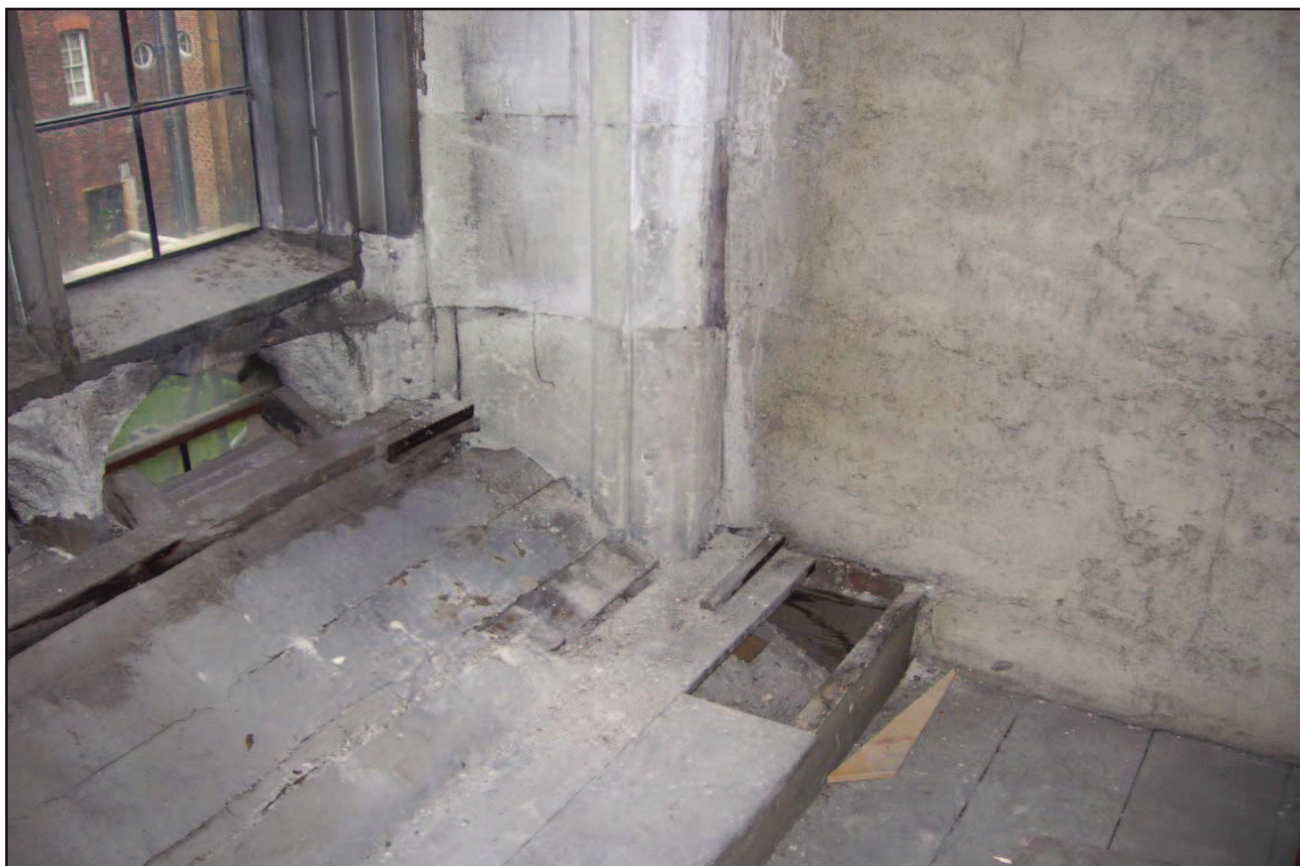
Plate 48: Royal Pew, Chapel Royal, Hampton Court Palace: 'Secret Room' above Winter Pew, rise of floor in north east corner.
