Royal Pew Chapel Royal Hampton Court Palace

Historic Building Recording and Investigation

Oxford Archaeology

April 2009

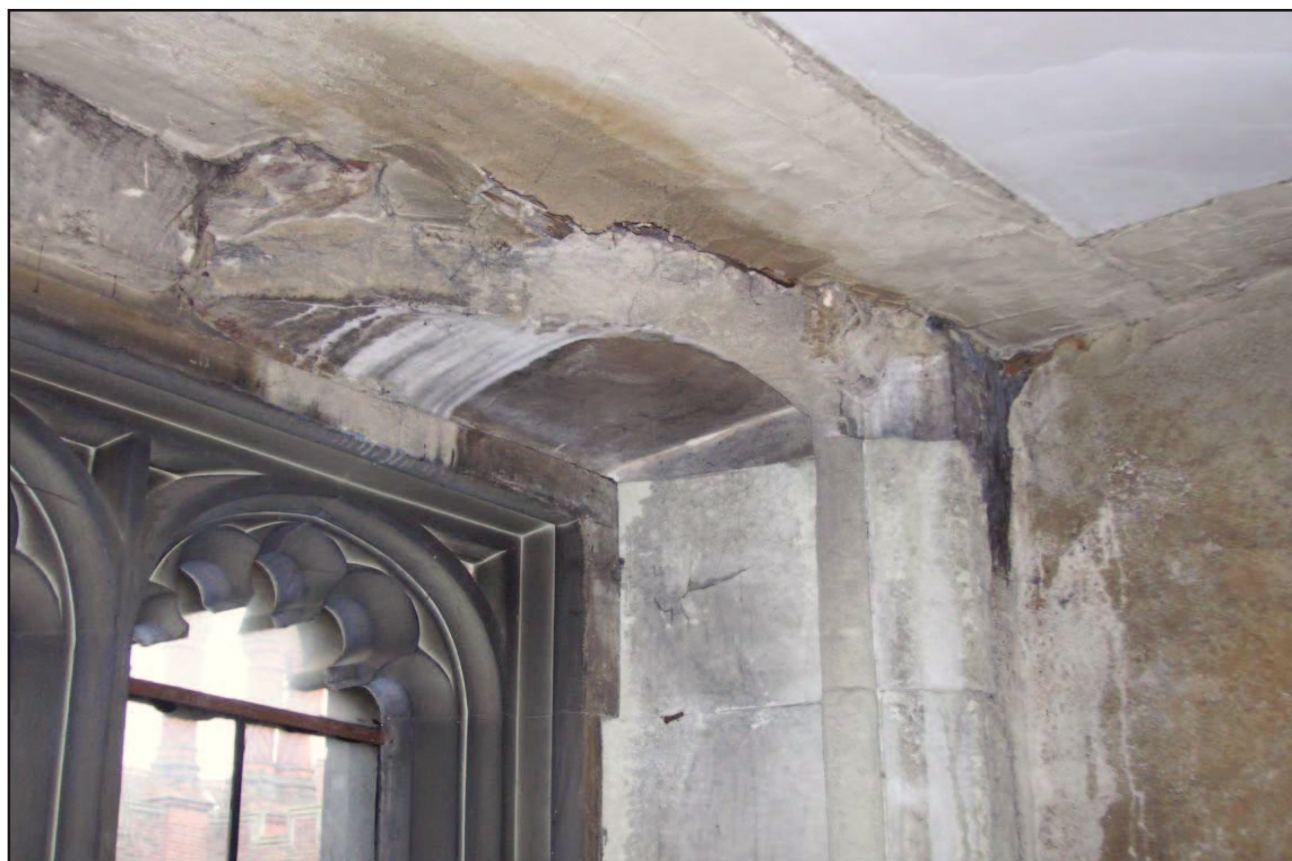
Plate 49: Royal Pew, Chapel Royal, Hampton Court Palace: 'Secret Room' above Winter Pew, detail of truncated stone moulding north east corner.

- 7.3.6 The plain west stud wall of the hidden room also crudely butts up against the west end of the upper set of lights, leaving a gap between the end of the wall and the window. The lower light at this point has a rough wood insert blocking it. Additionally within this room stone mouldings have been cut through both at ceiling height on the west side (the moulding having been removed almost all the way across to the east side), along with some of the vertical mouldings on the east side (Plate 49).

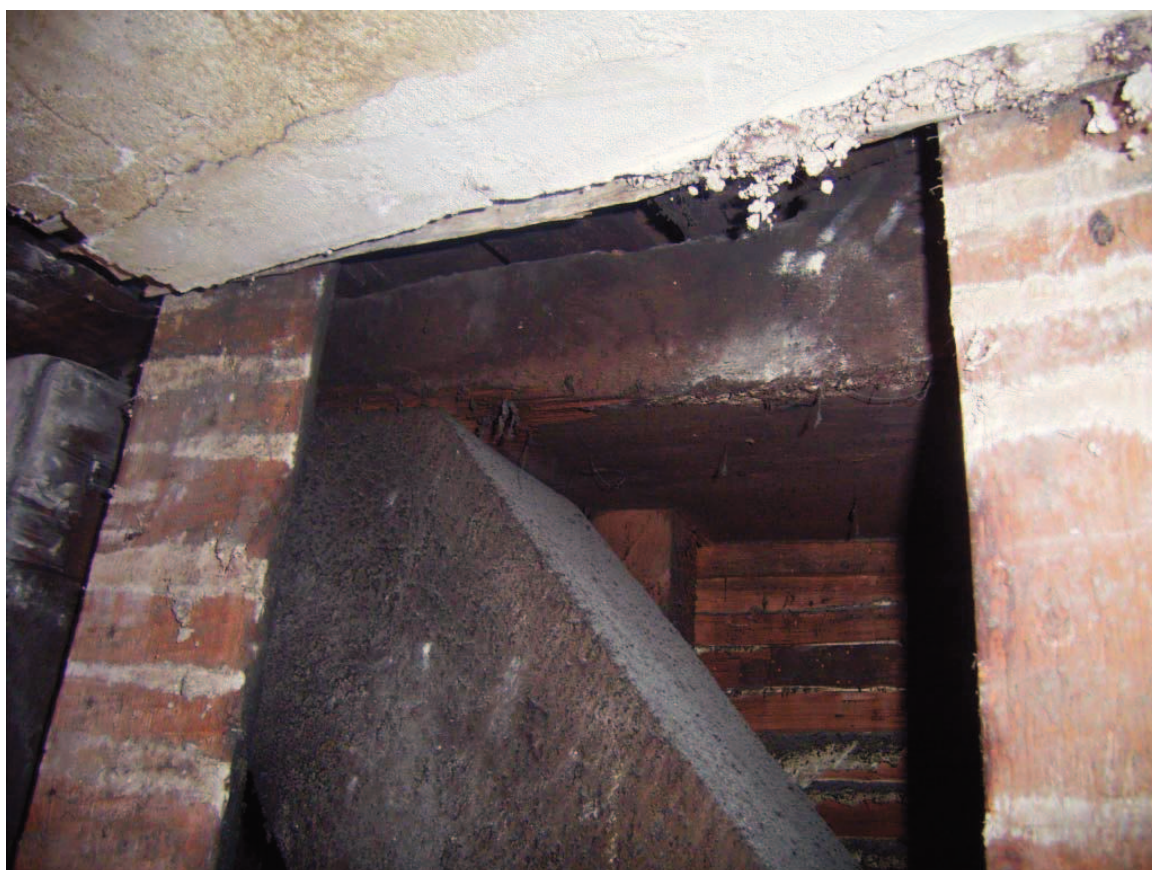
Plate 51: Royal Pew, Chapel Royal, Hampton Court Palace: Hidden room above Winter Pew, east elevation following removal of plaster, reduced Tudor wall plate.

- 5.3.8 Plaster removal on the west elevation of the frame within the hidden room (Figure 12, plates 50 - 52) and study of the frame seen within the Thornhill void shows that the wallplate is in at least 2 sections with potentially a further unseen joint concealed in the framework above the Lady Chapel. The visible sections of post at the upper levels (i.e. posts 1, 2, 3, 4 and 5) are tenoned into this topmost beam, and a gap at the top of post 2 is probably due to the failure of support in this area. It is not known if the truncated post 2 is tenoned into the lintel below. The central sections of the posts within this area have been cut (the cut measures approximately 0.64m) to produce an angle on the edge, presumably to accommodate decorative spandrels which would have been visible within the Royal Pews below.

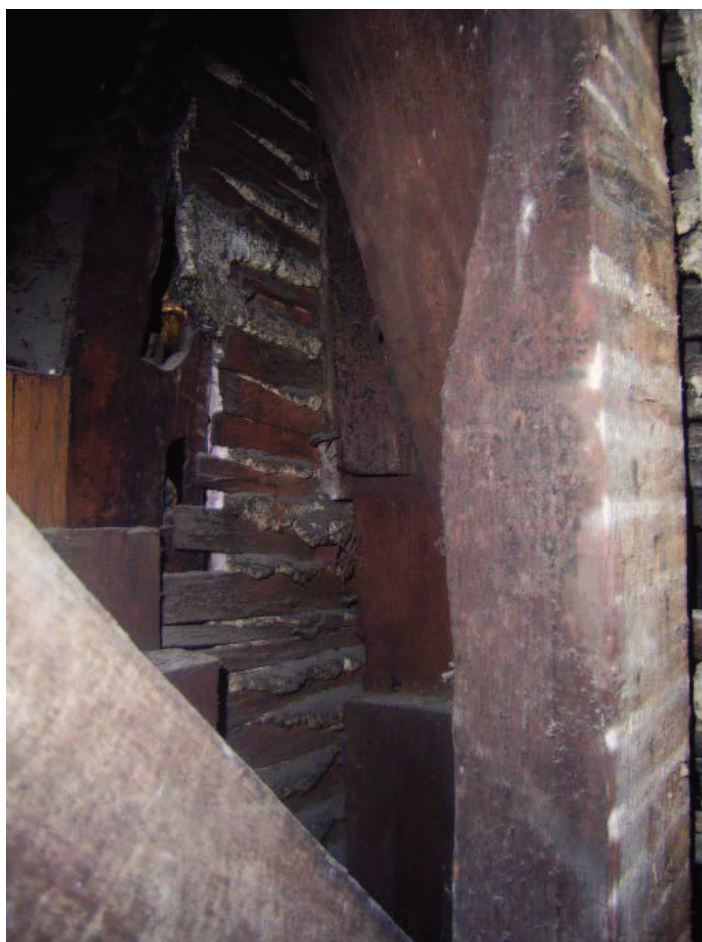
Plate 52: Royal Pew, Chapel Royal, Hampton Court Palace: Hidden room above Winter Pew, east elevation following removal of plaster, rebates on post 3 for possible arch.

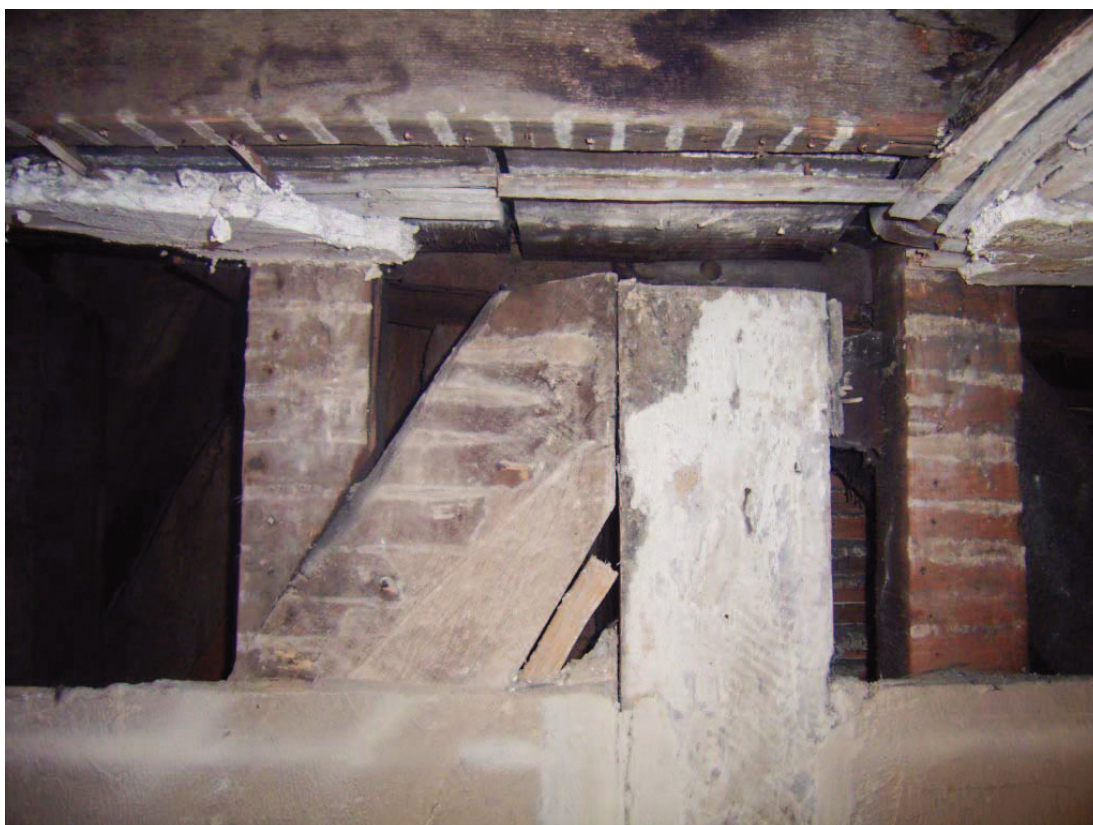
Plate 53: Royal Pew, Chapel Royal, Hampton Court Palace: Hidden room above Winter Pew, east elevation following removal of plaster, top of post 2

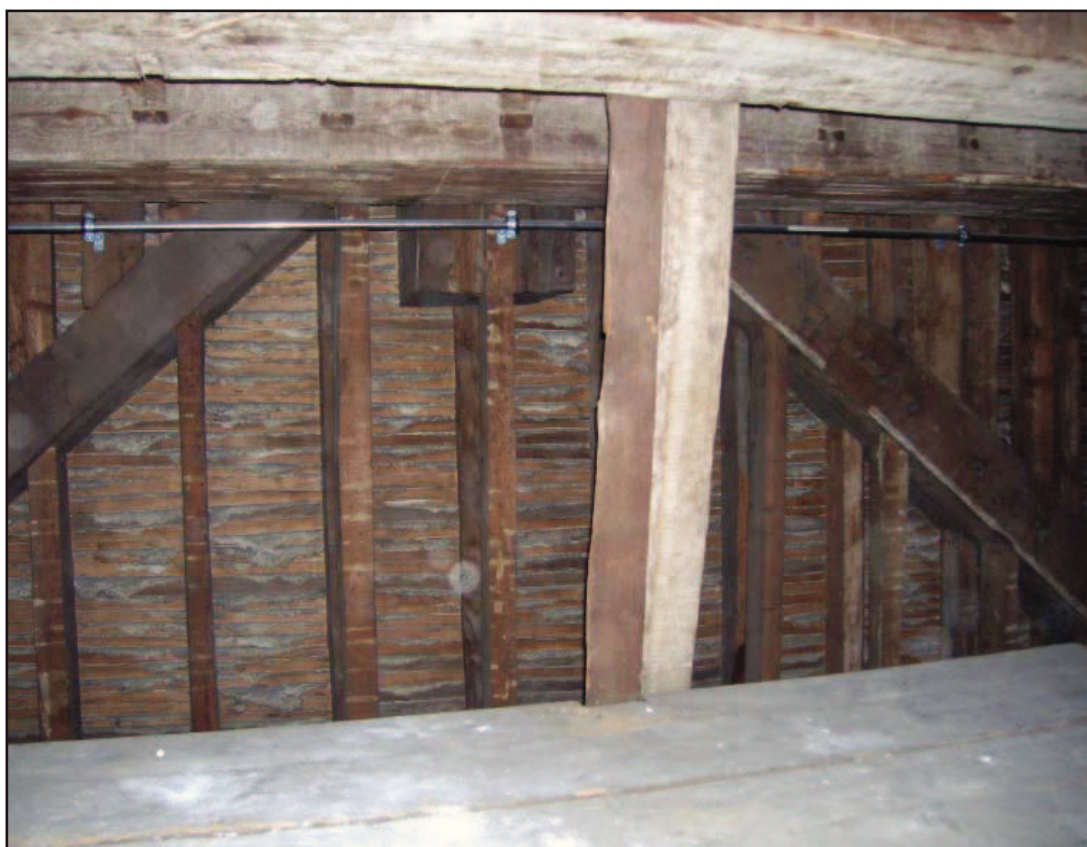
Plate 54: Royal Pew, Chapel Royal, Hampton Court Palace: Small room over Thornhill Ceiling, east elevation, supporting braces and remains of central post (post 4)

- 7.3.8 Within the void above the inserted Thornhill ceiling the structure of the Thornhill ceiling and the partition wall separating the top of the pew frame with the main part of the chapel can be seen (Figure 12, plate 54). Posts 3 and 5 have a continuation of the supports joined to each side during this phase. From these posts rise two sets of double braces. Of the two braces the north brace was 0.17m wide and the south thicker at 0.22m wide with at least eight mortices cut into it, all with dimensions approximately 8 x 8mm. The brace behind this and adjacent to the lath and plaster also has mortices cut into it although it was not possible to observe these in any

9.3.2 The five major additional support beams (Figure 6, plates 54 - 58) running north-south overhead across the Thornhill void were possibly inserted during this phase. They are clearly reused as they show mortices for either floor or ceiling joists.

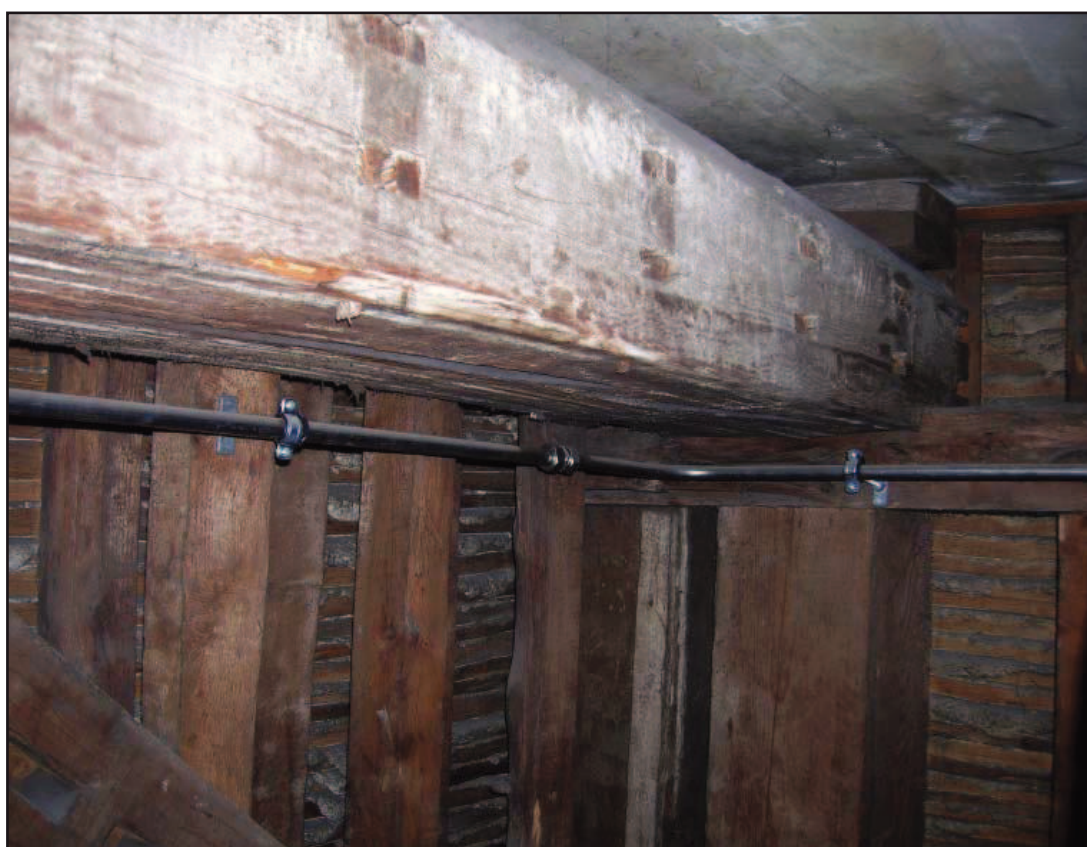
Plate 55: Royal Pew, Chapel Royal, Hampton Court Palace: Void over Thornhill Ceiling, east elevation, substantial re-used timber running in front of east elevation.

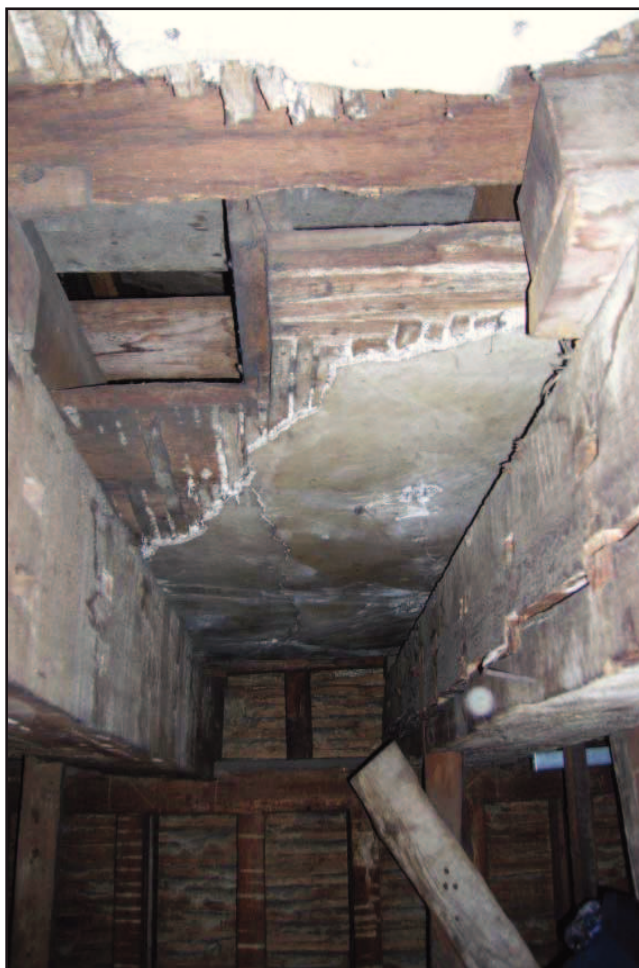
Plate 56: Royal Pew, Chapel Royal, Hampton Court Palace: Void over Thornhill ceiling, view to the north revealing surviving elements of the former plaster ceiling.

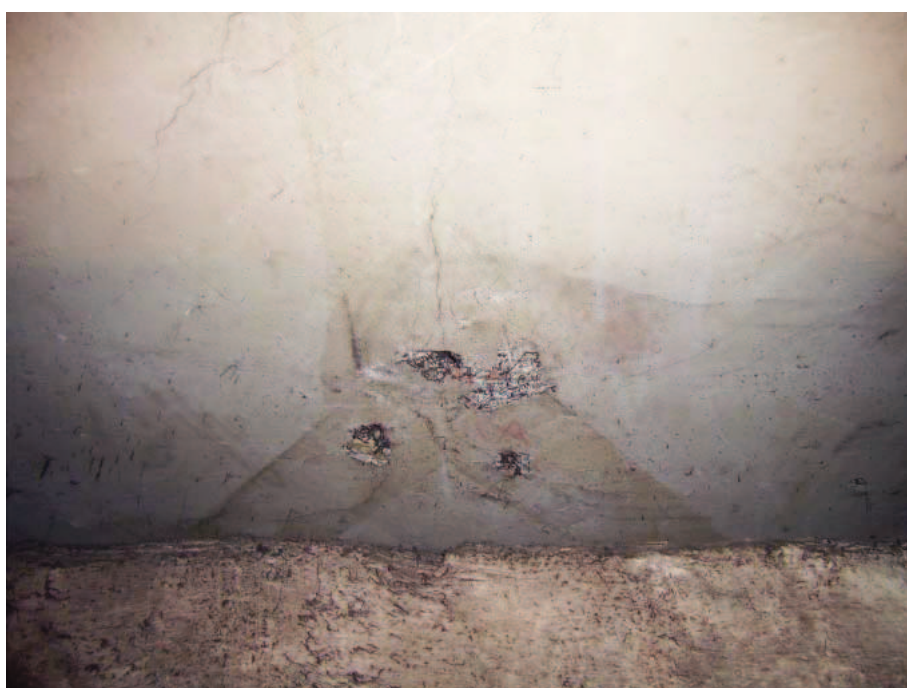
Plate 57: Royal Pew, Chapel Royal, Hampton Court Palace: Void over Thornhill ceiling, detail of ceiling moulding fixing point on former plaster ceiling. The lines are scored and the central boss location is marked with red paint

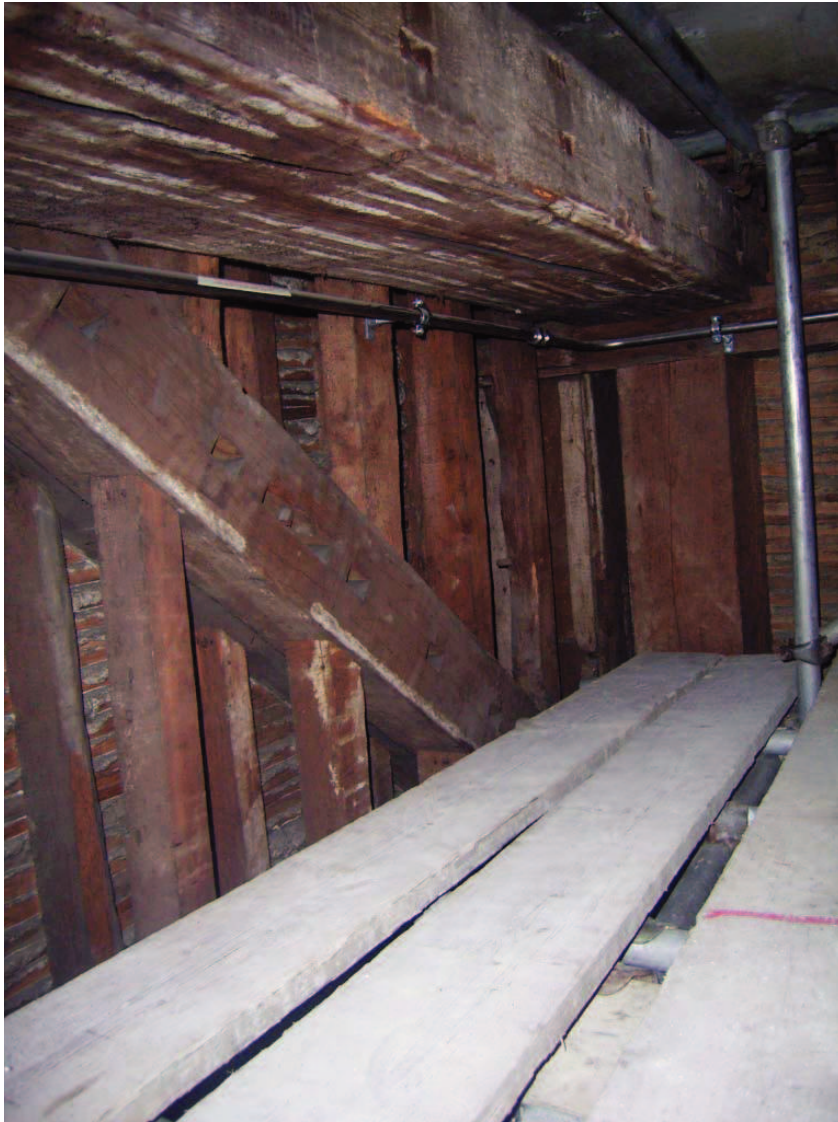
Plate 58: Royal Pew, Chapel Royal, Hampton Court Palace: Void over Thornhill ceiling, west elevation reset brace (south) with empty mortices and paint traces.

detail. The south brace has clear traces of white paint as seen on the Tudor posts below suggesting this brace and possibly the rear south brace are formed of reused Tudor timbers from the Henrician phase structure (Plate 58). It is unlikely that these are in situ. The majority of the timber work visible in this elevation is softwood, notably the studs in between the main braces. The thin studs show residual evidence for at one stage having supported lathe and plaster either in this position or elsewhere, whilst the plaster skim over the Chapel Royal side of the stud work can be partially observed. The arched timber framework for the plaster of the Thornhill ceiling was only partially visible under the modern fibrous wool insulation material.

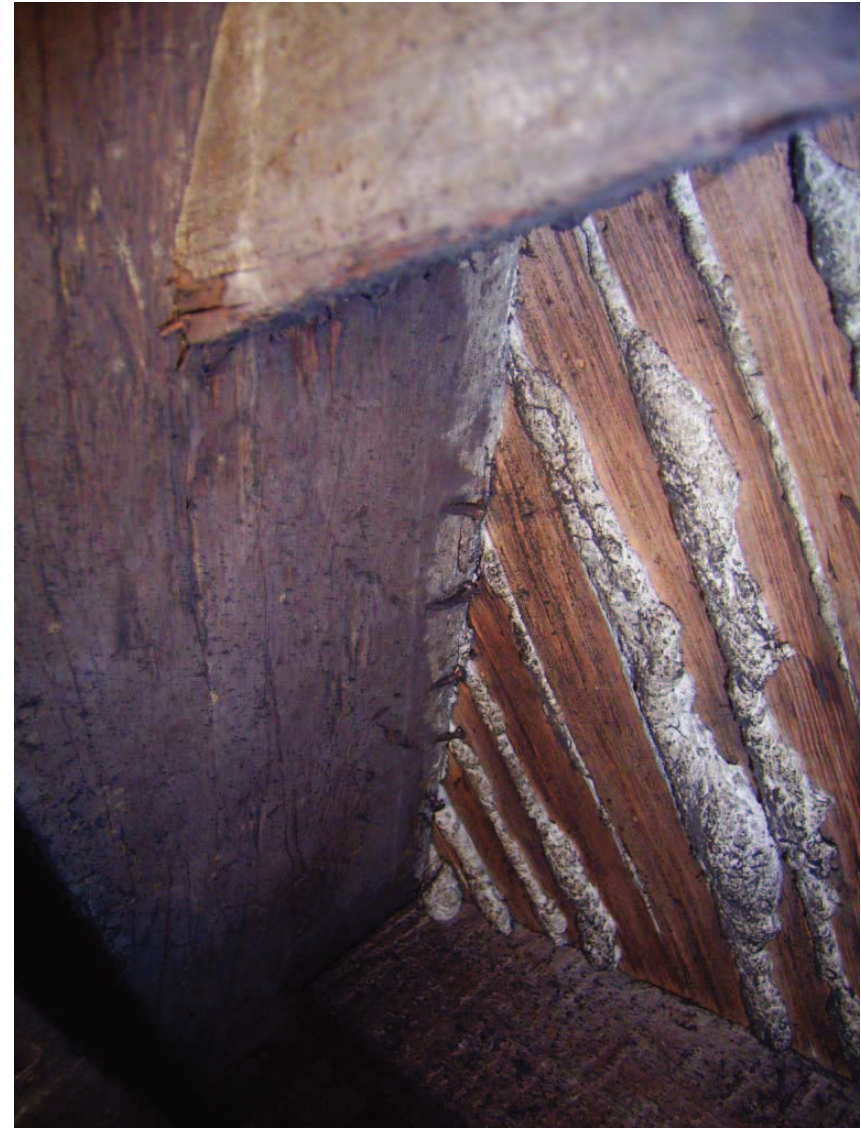
Plate 59: Royal Pew, Chapel Royal, Hampton Court Palace: Void over Thornhill ceiling, detail of paint on inside of northern brace with nails and looping evidence for material fixing.

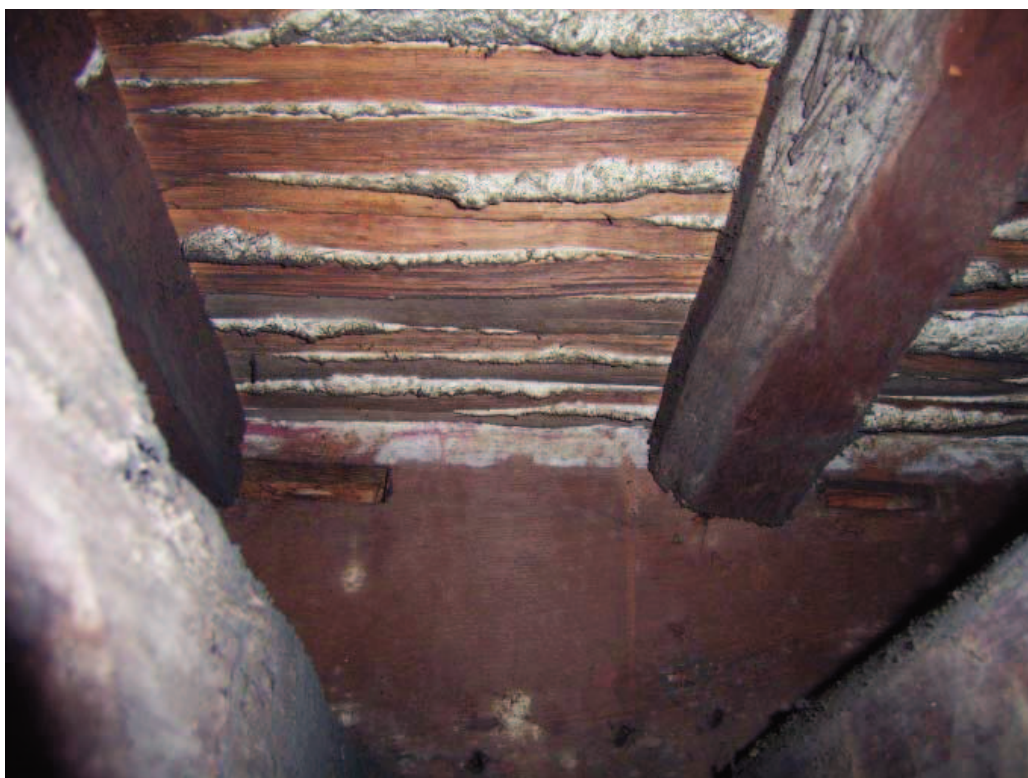
Plate 60: Royal Pew, Chapel Royal, Hampton Court Palace: Void over Thornhill ceiling, red and white paint traces on soffit of beam

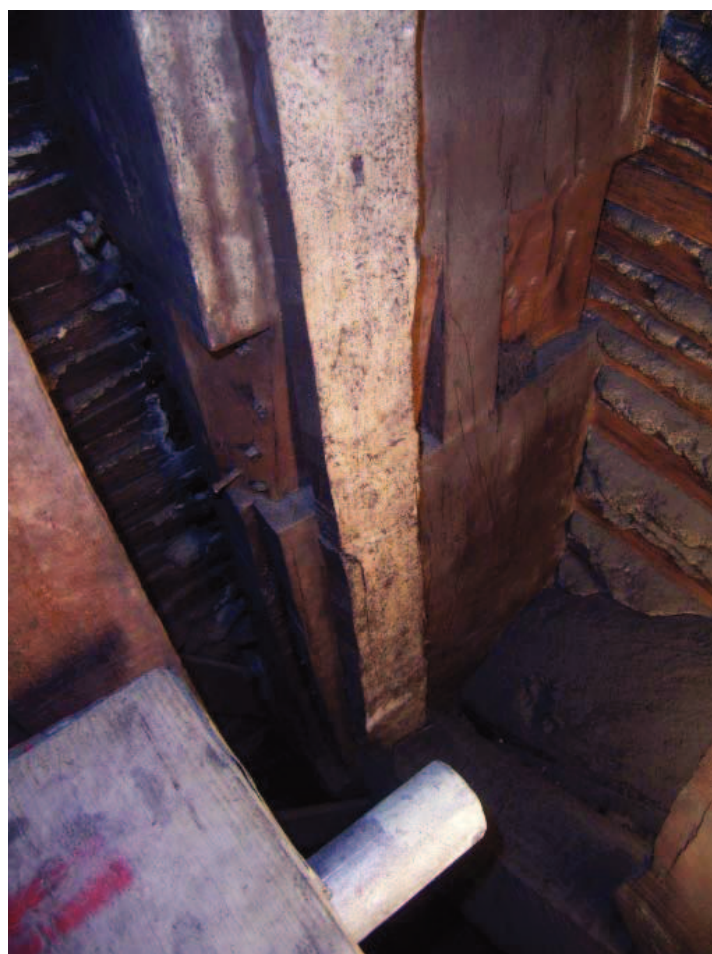
Plate 61: Royal Pew, Chapel Royal, Hampton Court Palace: Void over Thornhill ceiling, rebates for possible arch detail on post 3

Plate 61	Void over Thornhill ceiling, rebates for possible arch detail on post 3
Plate 62	Void over Thornhill ceiling. Surviving Tudor post and 17 th century supporting post strapped in front of it (north side). The Tudor post is chamfered on the closest edge and is recessed in two places halfway up the photograph

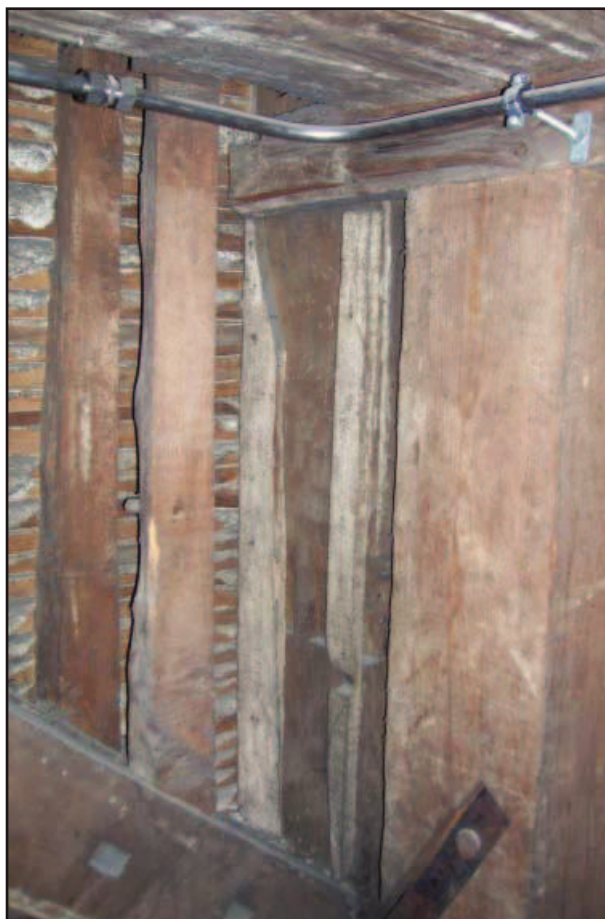
Plate 62: Royal Pew, Chapel Royal, Hampton Court Palace: Void over Thornhill ceiling. Surviving Tudor post and 17th century supporting post strapped in front of it (north side). The Tudor post is chamfered on the closest edge and is recessed in two places halfway up the photograph.

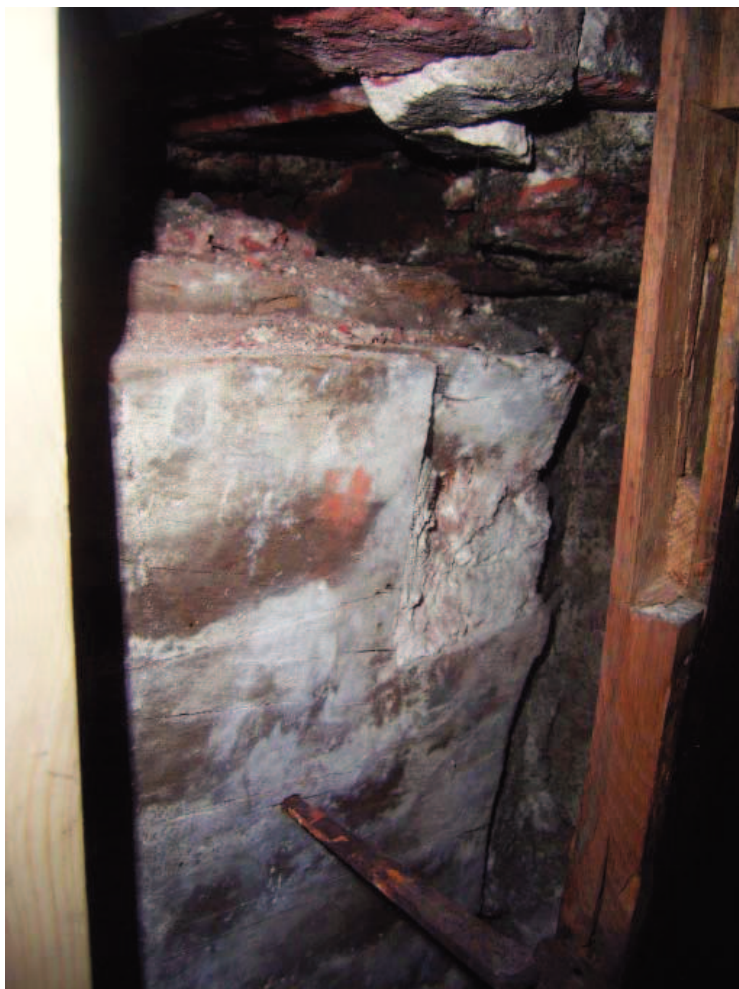
Plate 64: Royal Pew, Chapel Royal, Hampton Court Palace: Royal Pew, Lady Chapel, cut floor joist mortice at end of upper beam

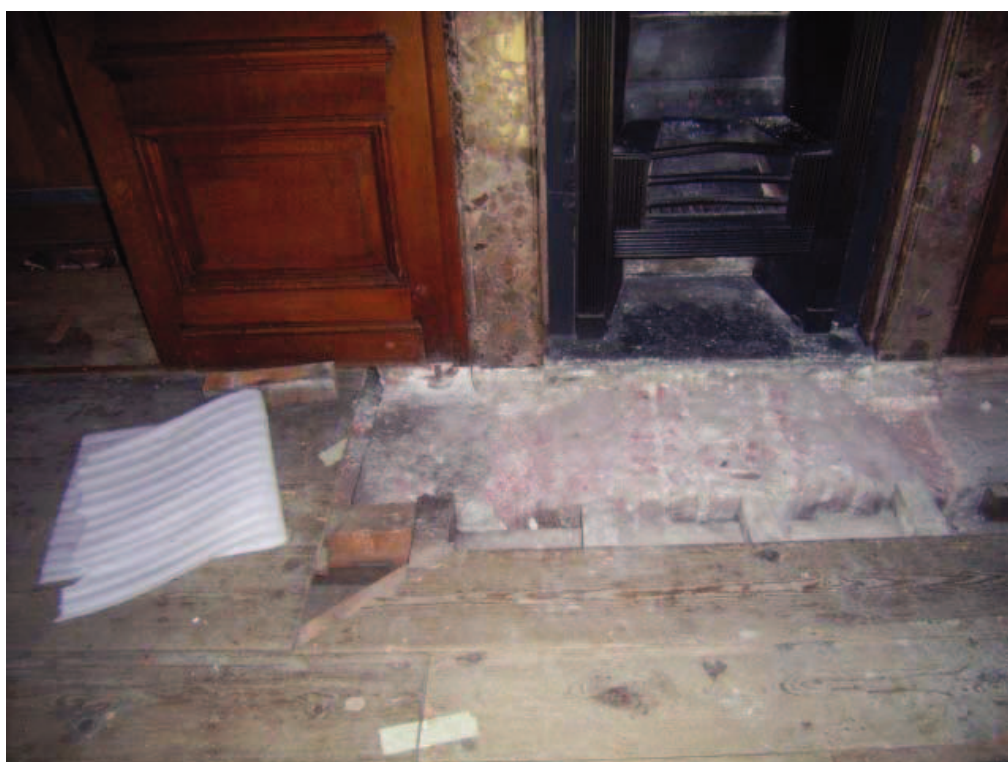
Plate 65: Royal Pew, Chapel Royal, Hampton Court Palace: Royal Pew, Winter Pew, detail of hearth showing forelock

- 7.3.10 Of more interest was the hearth structure beneath the fireplace (Figure 15, plates 65 – 66). This was a red brick platform slightly arched in the centre, 1.12m long and 0.42m wide, butting up against the floor joists to the south and the Winter Pew wall to the north. A total of 13 lines of brick could be identified (0.20 x 0.07m) all set as stretchers except for the central line at the top of the arch that was constructed using half bricks set east-west. At either end of the brick arch there were areas of grey stone, 0.35 x 0.40m that appeared to butt the arch and perhaps support it from underneath although this was not conclusive. Also of note was an iron strap, 0.01m wide x 1.50m, slightly curved and fixed into the stone blocks at either end. It runs along the east face of the exposed arch and appeared to have been inserted to prevent any movement of the brick arch to the south. On the basis of observation of the relationship between the hearth and the brick walls of the Winter Pew to the north and east the whole structure seems to be cantilevered solely out of the north-east corner of the room, with further support from iron ties fixed into the exterior wall.

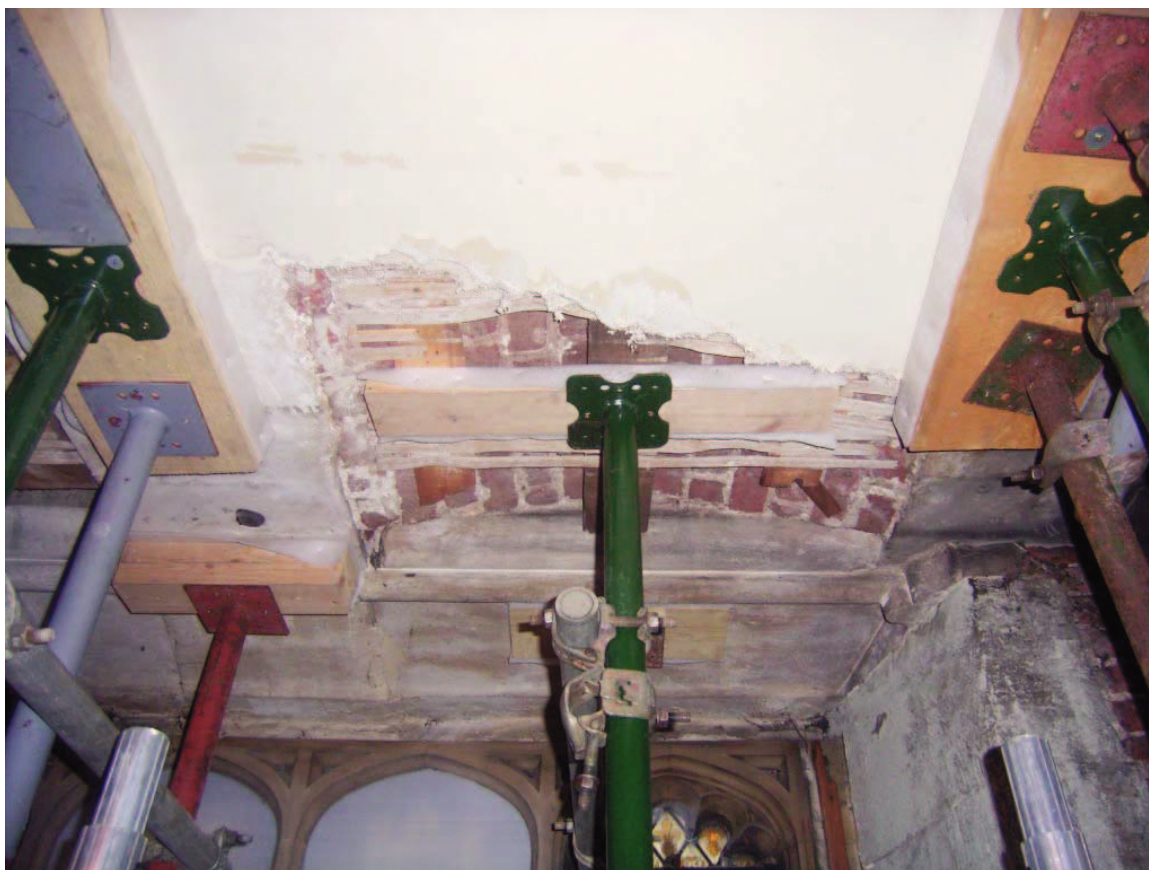
Plate 66: Royal Pew, Chapel Royal, Hampton Court Palace: Royal Pew, ground floor ante chapel, underside of hearth within Winter Pew

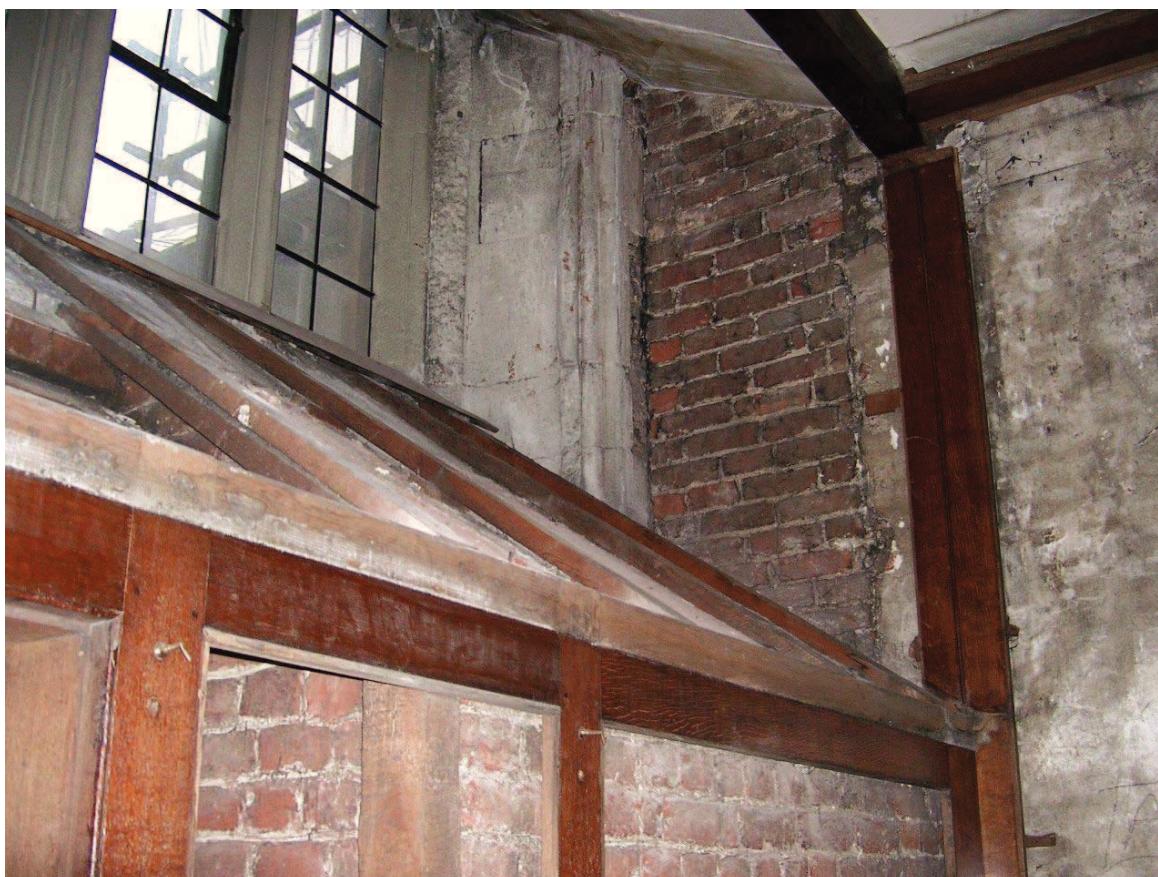
Plate 67: Royal Pew, Chapel Royal, Hampton Court Palace: Royal Pew, Winter Pew, window cut by inserted ceiling

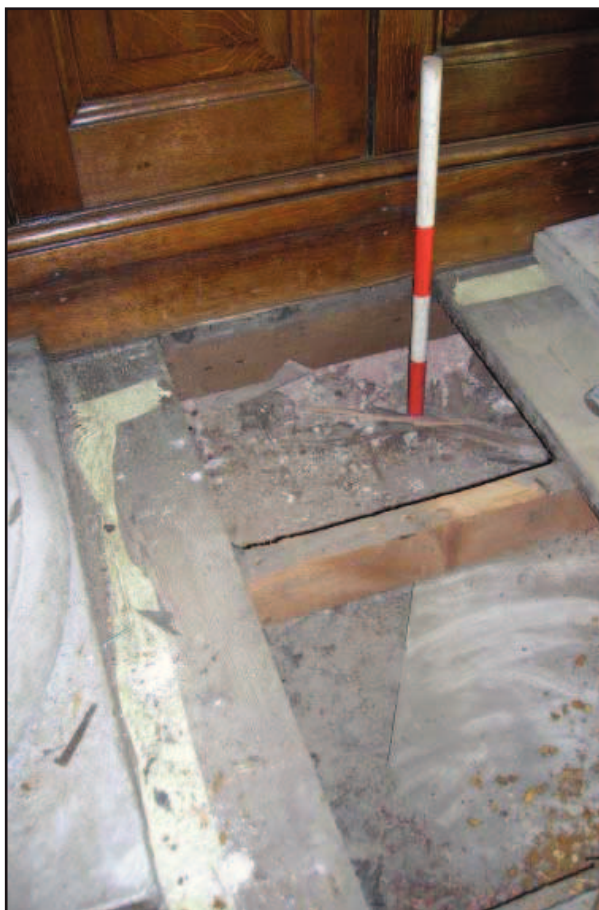
Plate 68: Royal Pew, Chapel Royal, Hampton Court Palace: Royal Pew, lifting of the floorboards on the south side of the ante chapel. Detail of floor joist and marble floor tiles.

9.3.1 Removal of the ante chapel south column base revealed marble floor tiles which may be part of the paving of the chapel undertaken in 1727 (Plate 68). The removal is further discussed in Appendix VIII.

- 1.7 The south column stone base was removed for repair work during the 2007 works. The stone base is 0.66m square in plan, with a height of 0.22m and is in two sections, sitting atop a void 0.37m deep. The removal of the column base revealed a marble floor underneath, with the tiles forming a pattern. These marble tiles are possibly the ante chapel floor laid in 1727 (Hanoverian period) which consisted of marble hexagons with lozenges in black and white. The stones were mortared on and traces of a creamy, friable, fine grained mortar with no major inclusions remained. Several bricks were to be seen underneath the marble tiles and, approximately 29cm below the current floor level (16.8cm below the top of the marble tiles) two terracotta tiles approximately 20cm square were discovered. These tiles are on a bed of creamy, friable mortar with small-medium lime inclusions on top of a bed of sand, and there is a possible indentation for a missing third terracotta tile. Brick one was removed as part of the cleaning work and was pinky/orange in colour, loosely square with no frog, and creased in parts - it also shows stacking lines. The depth of the brick is 10cm, and the height 6cm. Brick two was blackened but not vitrified, with a thick, black paint/substance on the corner and is possibly later in date than brick one as it is more clearly defined, yet also has no frog. Below the hole is a brick lined channel which lies approx. 28cm below the marble floor, and appears to be around 36cm deep and it may form part of the Victorian heating system which was installed. Around the hole is a fill of rubble and mortar in which a rusted square-headed nail was found.
